Southampton to London Pipeline Project

Environmental Statement (Volume D)
Appendix 7.7: Bat Factual Report (1 of 3)

Appendix 7.7: Bat Factual Report

B2325300-JAC-000-ENV-APP-000077

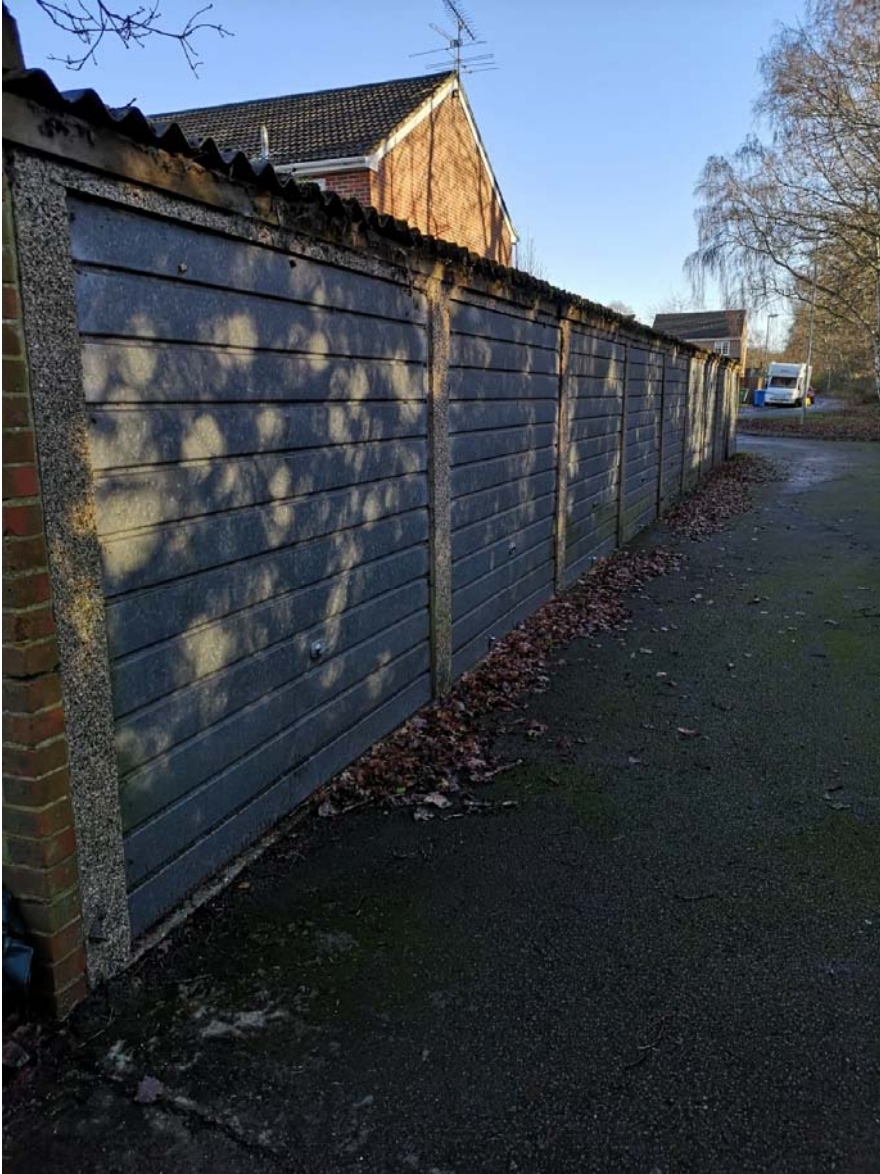
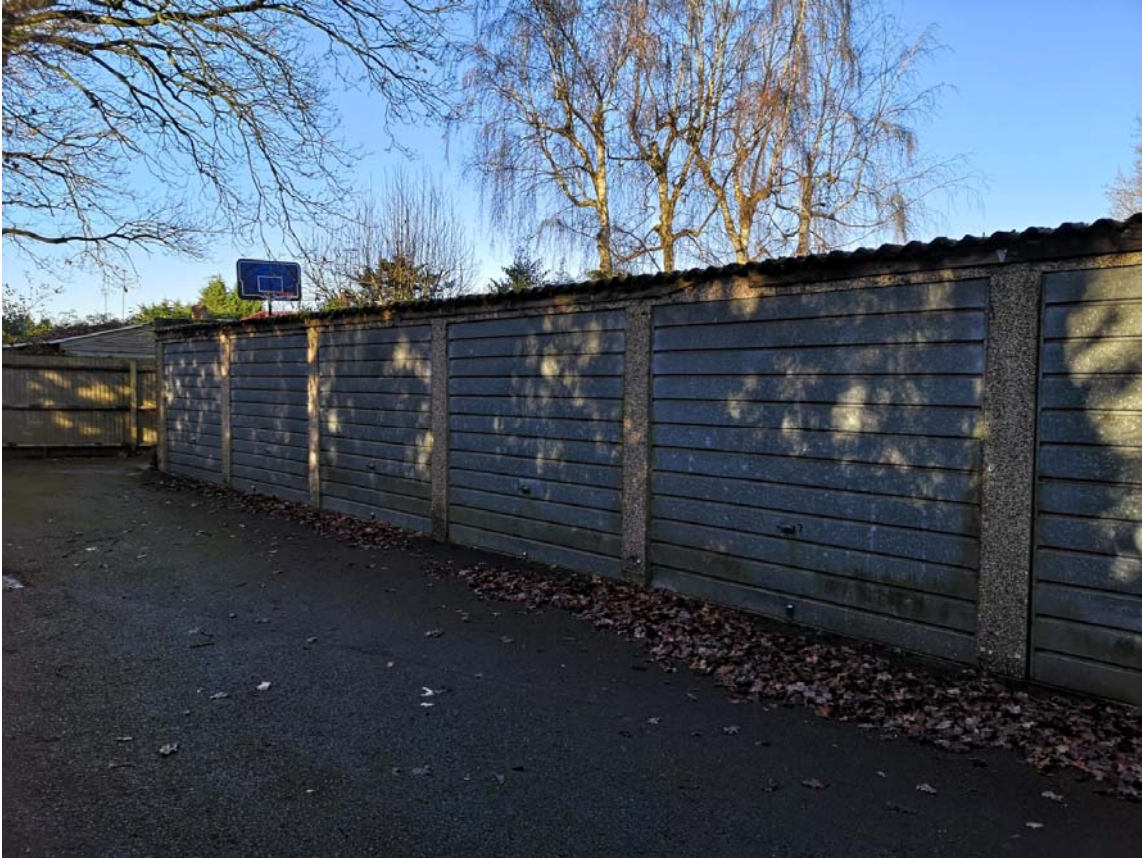
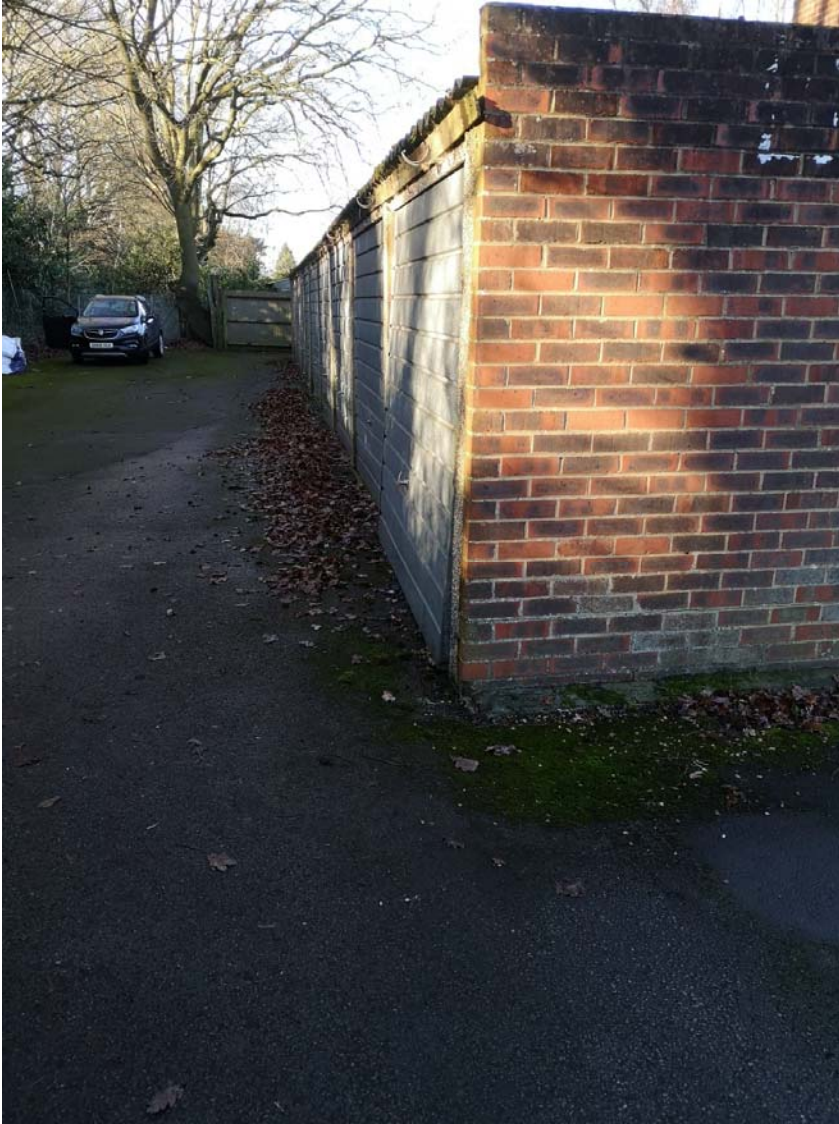
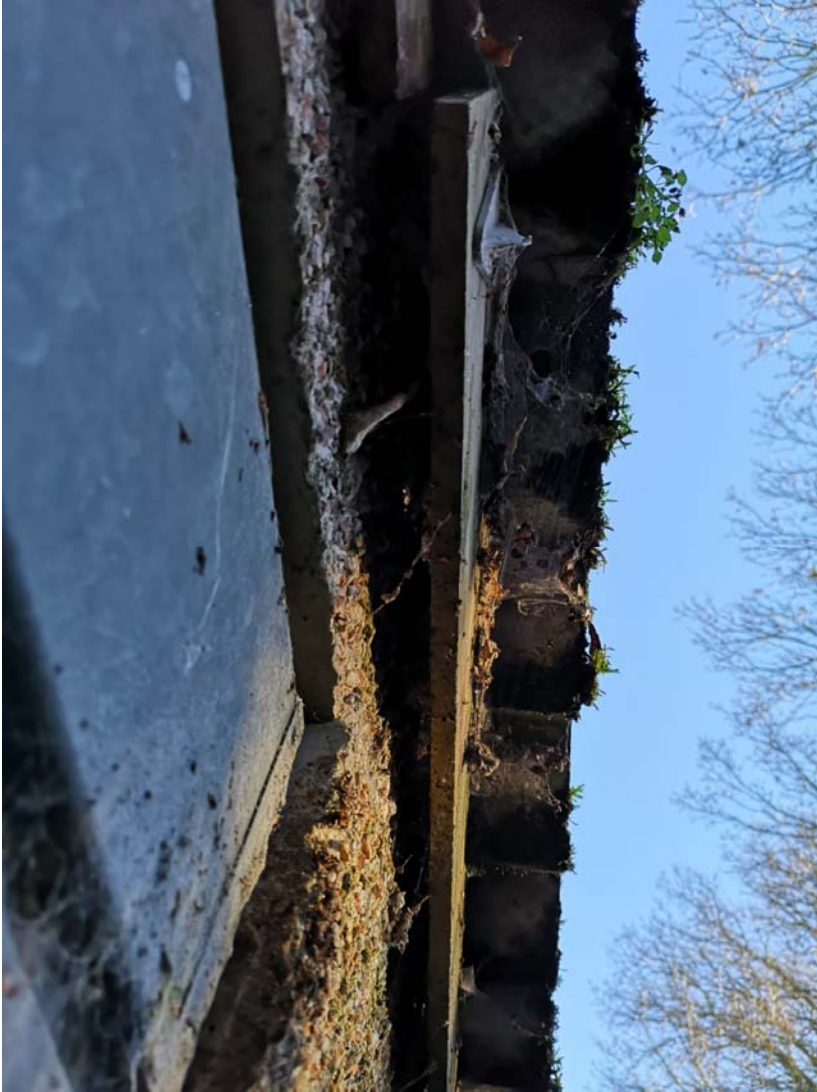
Photograph 7.7.1: Stakes Lane garages, 16/01/2019, standard lens

- 3.2.11 The garages were given a preliminary external inspection and photographs were taken on the 16/01/2019, See Photographs 7.7.1 to 7.7.4. No internal inspection or detailed inspection using an endoscope was undertaken at this time.

- 3.2.12 Given the design and age of these garages, they are considered to have low suitability for bat roosts as they do not provide sufficient features to be used on a regular basis or by larger numbers of bats (i.e. unlikely to be suitable for maternity or hibernation) (Collins, 2016). The barrage boards provide only opportunistic transitional roosting potential for one or two bats.

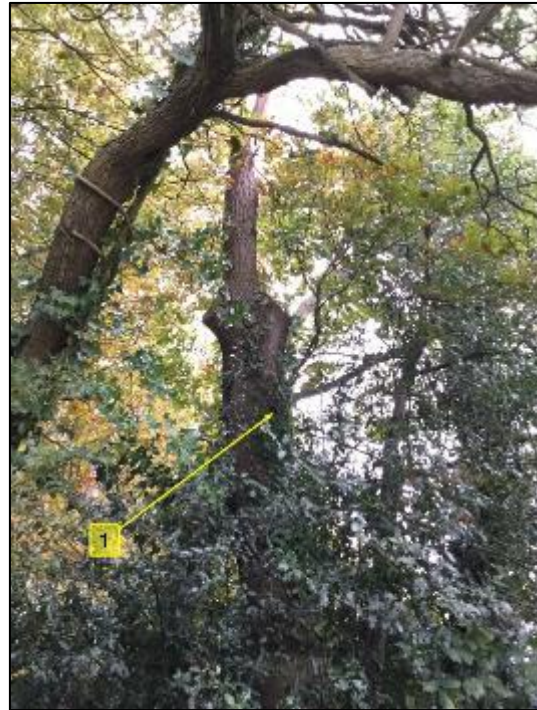
Photograph 5: Tree 200_3_00546, Land Parcel 200, 20/09/2018, standard lens

Tree 200_3_00546 was a dead tree in a hedge adjacent to an arable field. The survey recorded lifted bark on the north west aspect of the main stem at approximately 4m height that appeared to extend upwards. However, due to the unsafe condition of the tree a climbing survey was not possible, so the feature was inspected from the ground using an endoscopic camera and the tree was recommended for emergence and re-entry surveys, as a full inspection was not possible. This tree retained its original classification of moderate suitability to support roosting bats (see photograph 5 below).

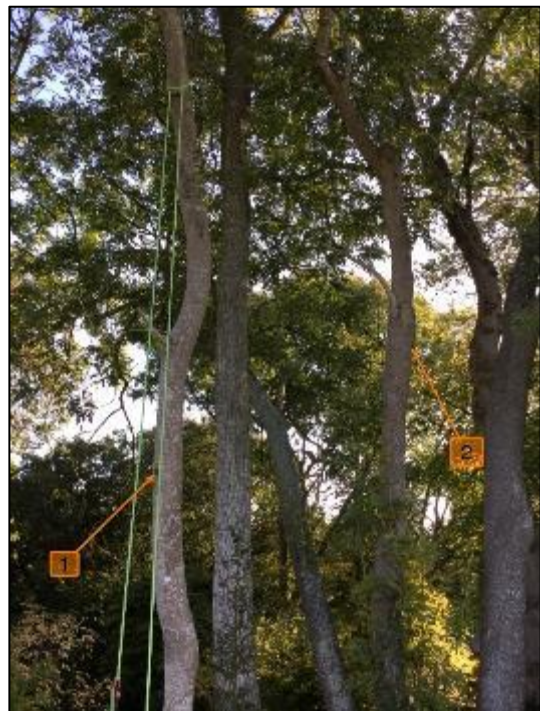
Photograph 9: Tree 420_00328, Land Parcel 420, 05/10/2018, standard lens

Tree 420_00328 was a mature ash group by the main gate on Cross Lane. The survey recorded woodpecker holes on the north aspect of the main stem, and the south aspect of the right-hand tree at approximately 2.5m and 5m respectively. An aerial survey confirmed that the former lead up 20cm, and was dry, clean and smooth; the latter holes were 4cm by 3cm both going up 1m. Multiple dry, secure and sheltered chambers with coned apices were found. Overall suitability was confirmed as high after aerial inspection (see photograph 9 below).

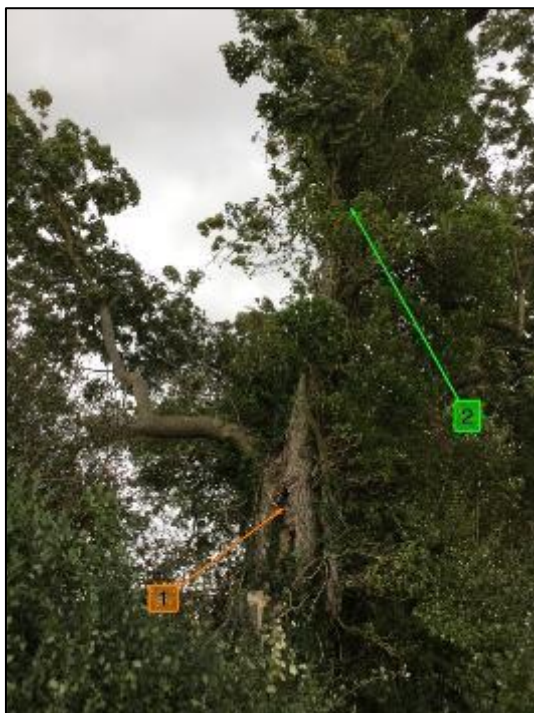
Photograph 11: Tree 440_835, Land Parcel 440, 29/09/2018, standard lens

or no change)		
440_835	Y	No change	High	High

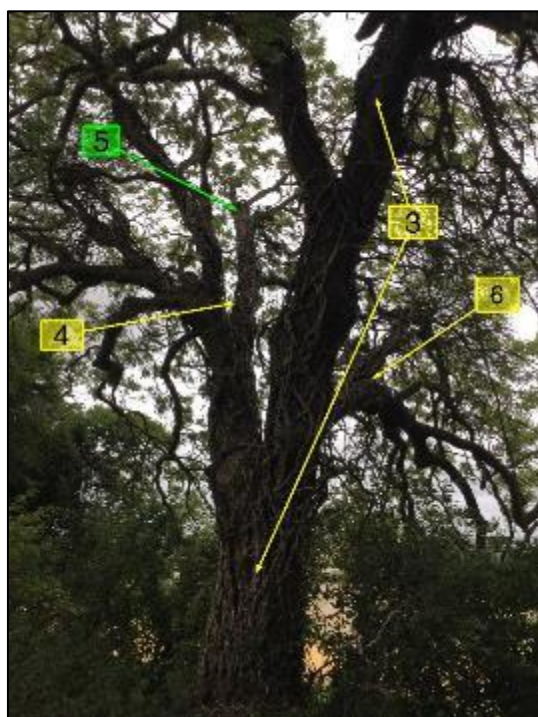
Photograph 12: Tree 461_836, Land Parcel 461, 29/09/2018, standard lens.

Tree ID	Climbed (Y/N)	Re-classified? (up down or no change)	Original Classification following GBBRA	Classification after aerial inspection
461_836	Y	No change	Moderate	Moderate

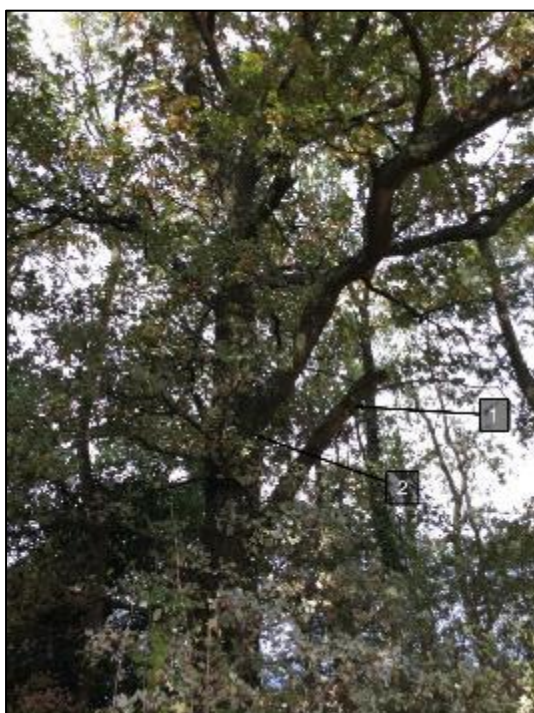
Photograph 64: Tree 2380_00163, Land Parcel 2380, 02/10/2018, standard lens.

Tree ID	Climbed (Y/N)	Re-classified? (up down or no change)	Original Classification following GBBRA	Classification after aerial inspection
2380_00163	Y	Down	Moderate	Negligible
2380_00162	Y	No change	Moderate	Moderate
