ENVIRONMENTAL STATEMENT – (VOLUME III)

Appendix 9-6 Riparian Mammal Survey Report (Clean)

HyNet Carbon Dioxide Pipeline DCO

Document Reference Number D.6.3.9.6

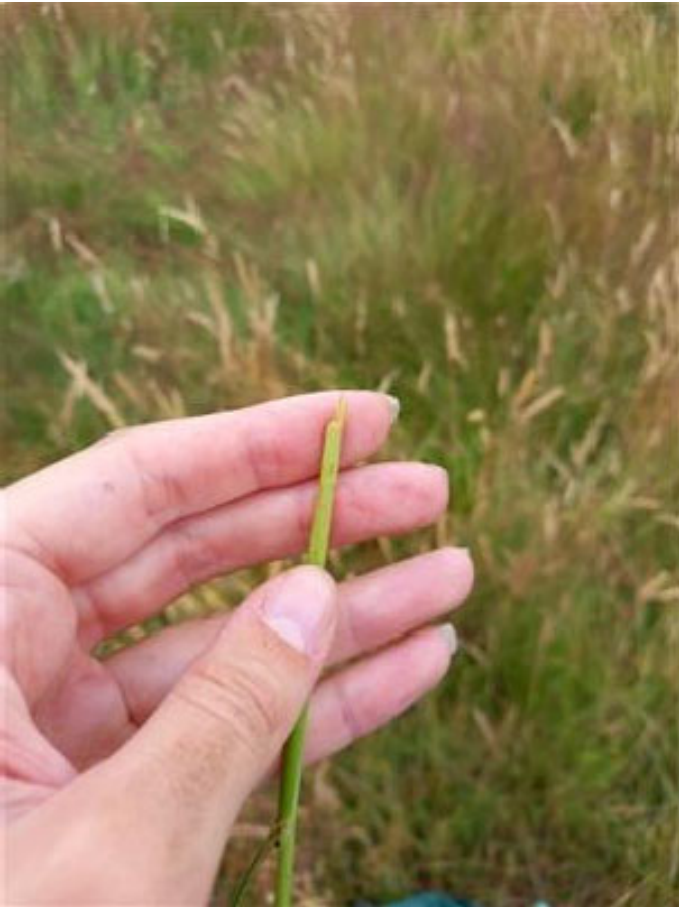
Watercourse Group: Watercourse Name	Field Sign Reference	Location in Relation to Newbuild Infrastructure Boundary	Grid Reference	Field sign Description	Photograph
Group 2: West Central Drain B	WCDB2	Within the Newbuild Infrastructure Boundary	SJ468297 5567	Terrestrial grasses were recorded as having been eaten at a 45 degree angle. This is a suspected feeding station.

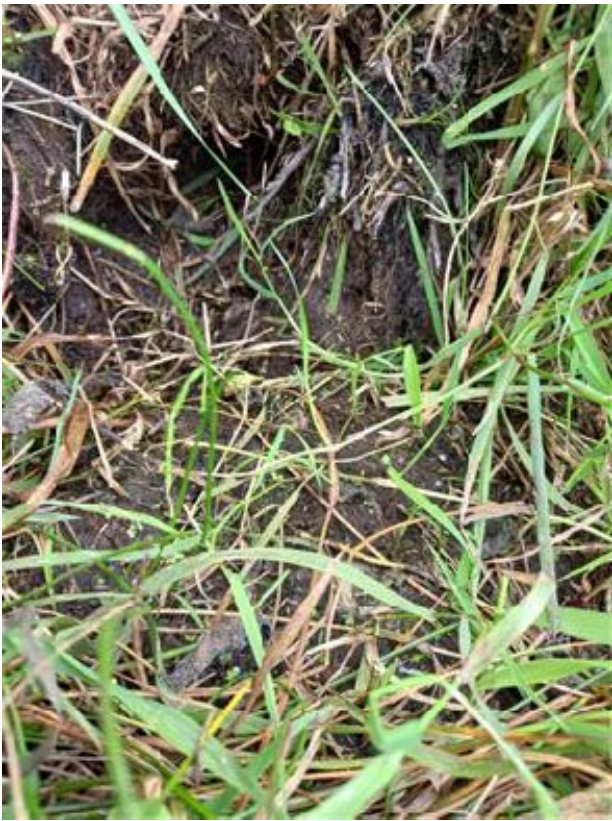
Watercourse Group: Watercourse Name	Field Sign Reference	Location in Relation to Newbuild Infrastructure Boundary	Grid Reference	Field sign Description	Photograph
Group 2: West Central Drain B	WCDB6	115m from the Newbuild Infrastructure Boundary	SJ469217 5353	Terrestrial and bank side burrow, 10 by 10 cm approx. eroded at edges.

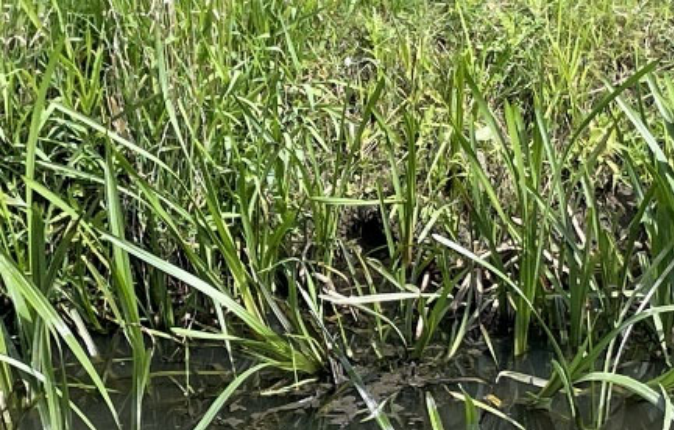
Watercourse Group: Watercourse Name	Field Sign Reference	Location in Relation to Newbuild Infrastructure Boundary	Grid Reference	Field sign Description	Photograph
Group 1: West Central Drain A	WCDA1	Within the Newbuild Infrastructure Boundary	SJ 46765 75978	A water vole burrow located at the top of the bank leading directly into the water. Evidence of torn vegetation in front of hole was also found. Several other burrows were found within 5m.

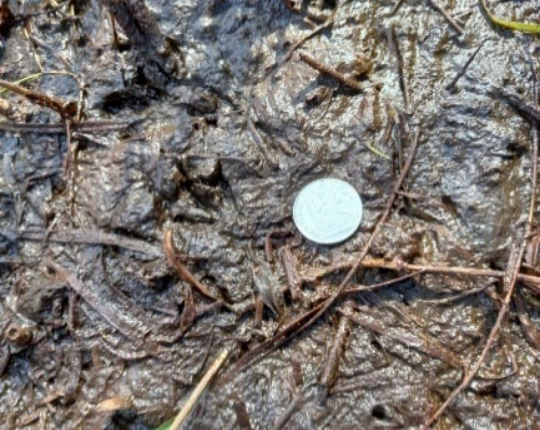
Group 2: Elton Marsh 1	EM1.1	Within the Newbuild Infrastructure Boundary	SJ 46927 75613	Possible footprint of a small mammal.

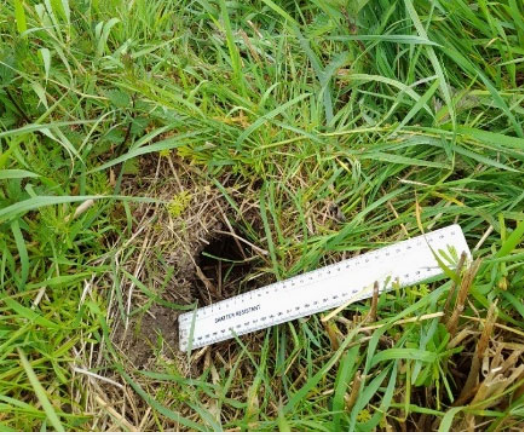
Watercourse Group: Watercourse Name	Field Sign Reference	Location in Relation to Newbuild Infrastructure Boundary	Grid Reference	Field sign Description	Photograph
Group 2: Hapsford Brook	HB1	257 m north of the Newbuild Infrastructure Boundary	SJ 46558 75612	An entrance to a terrestrial water vole burrow found approximately 1 m from the water's edge.

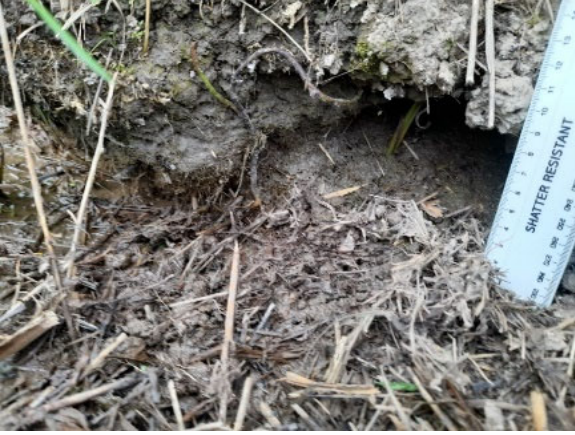
Group 2: Hapsford Brook	HB2	215 m north of the Newbuild Infrastructure Boundary	SJ 46571 75564	A water vole burrow entrance found in an undercut bank at water level.

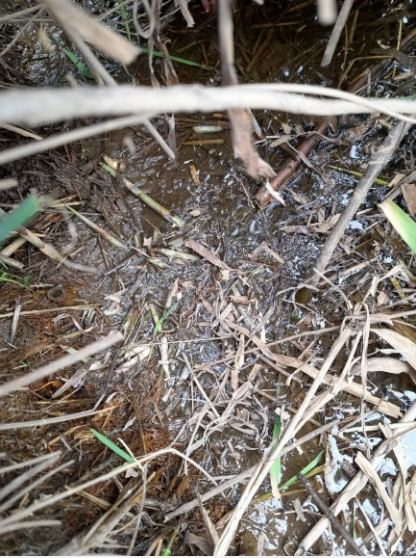
Watercourse Group: Watercourse Name	Field Sign Reference	Location in Relation to Newbuild Infrastructure Boundary	Grid Reference	Field sign Description	Photograph
Group 2: Hapsford Brook	HB3	194 m north of the Newbuild Infrastructure Boundary	SJ 46583 75544	A feeding station found amongst rush and sweet reed grass. Vegetation was found to be fairly old.

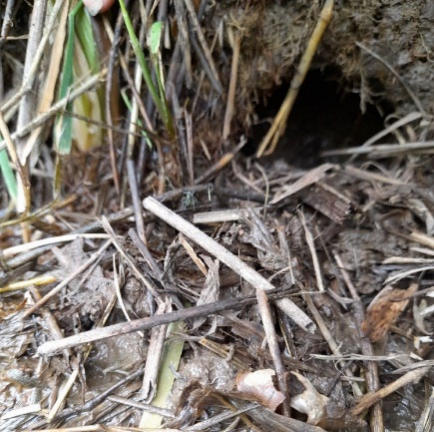
Watercourse Group: Watercourse Name	Field Sign Reference	Location in Relation to Newbuild Infrastructure Boundary	Grid Reference	Field sign Description	Photograph
Group 2: Hapsford Brook	HB4	171 m north of the Newbuild Infrastructure Boundary	SJ 46593 75529	A burrow entrance found at the water's edge, leading directly into the water course.

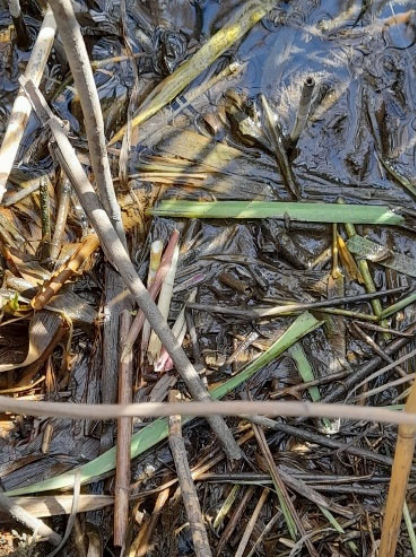
Watercourse Group: Watercourse Name	Field Sign Reference	Location in Relation to Newbuild Infrastructure Boundary	Grid Reference	Field sign Description	Photograph
Group 2: Hapsford Brook	HB6	99 m south of the Newbuild Infrastructure Boundary	SJ 46763 75201	Location of a water vole feeding station within reed sweet grass <i>Glyceria maxima</i> at the water's edge. Vegetation was freshly chewed at a 45-degree angle.

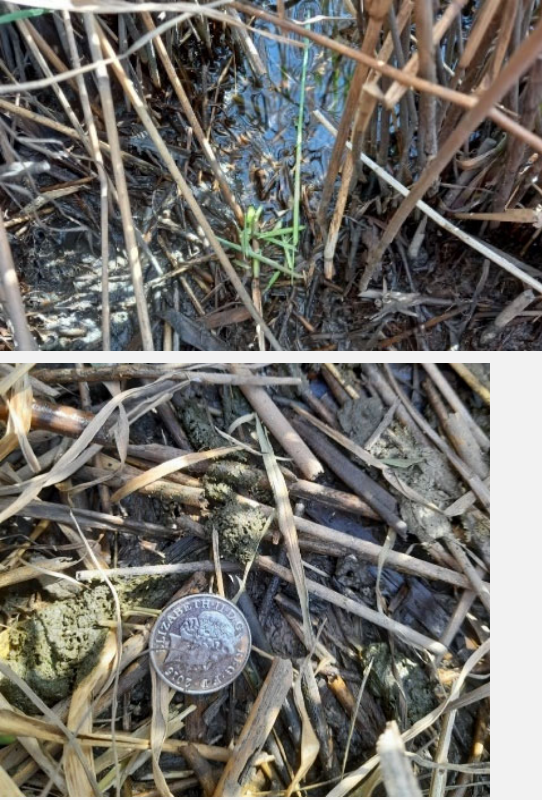
Watercourse Group: Watercourse Name	Field Sign Reference	Location in Relation to Newbuild Infrastructure Boundary	Grid Reference	Field sign Description	Photograph
Group 2: Hapsford Brook	HB7	140 m south of the Newbuild Infrastructure Boundary	SJ 46764 75159	A water vole feeding station and latrine found along a mammal path by the water's edge and within reed sweet grass. Feeding remains were found to be fresh but droppings were degraded.

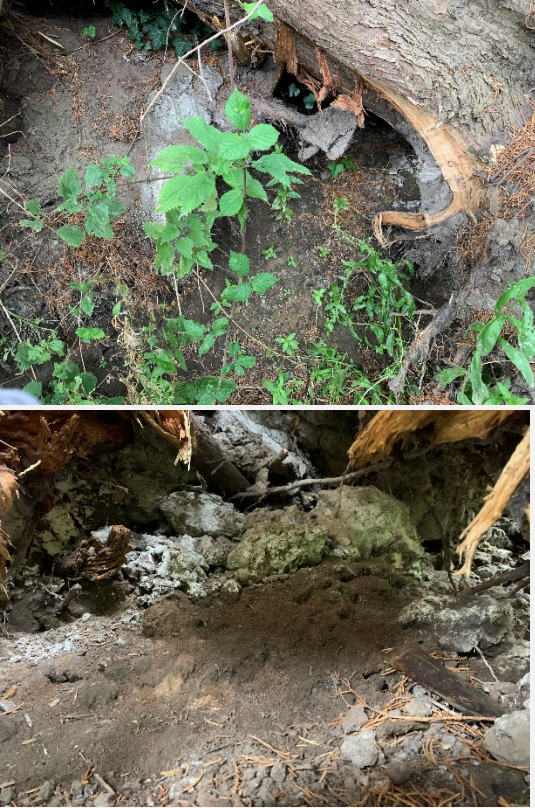
Watercourse Group: Watercourse Name	Field Sign Reference	Location in Relation to Newbuild Infrastructure Boundary	Grid Reference	Field sign Description	Photograph
Group 4: Thornton Uplands	TU3	Within the Newbuild Infrastructure Boundary	SJ444927 3297	A possible otter holt/laying up area underneath a fallen willow. It included several worn entrances leading underneath the willow, with a visibly flattened area leading into the water.

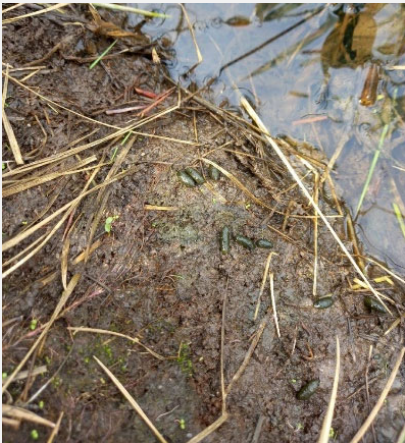
Watercourse Group: Watercourse Name	Field Sign Reference	Location in Relation to Newbuild Infrastructure Boundary	Grid Reference	Field sign Description	Photograph
Group 5: Thornton Ditch 5b	TDRG7	Within the Newbuild Infrastructure Boundary	SJ 43846 72862	A water vole latrine.

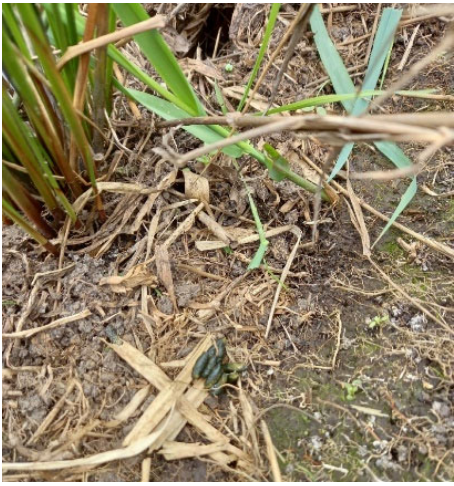
Watercourse Group: Watercourse Name	Field Sign Reference	Location in Relation to Newbuild Infrastructure Boundary	Grid Reference	Field sign Description	Photograph
Group 5: Thornton Ditch 5b	TDRG8	Within the Newbuild Infrastructure Boundary	SJ 43895 72889	A water vole latrine found near a burrow in the south side bank.

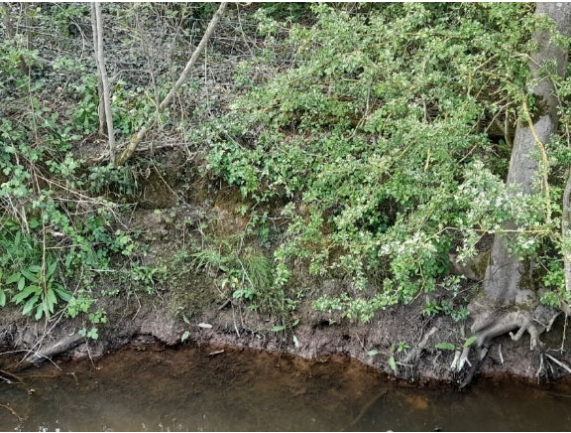
Group 5: Thornton Ditch 4	TDRG10	Within the Newbuild Infrastructure Boundary	SJ 44057 72942	Steep banks, suitable for water voles, found on the western edge of the water course with burrows present.

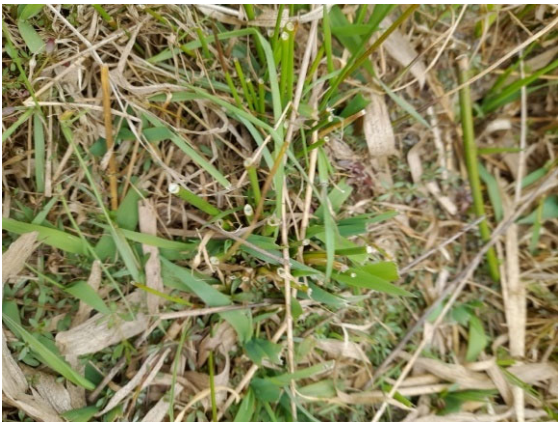
Group 5: Thornton Ditch 8	TDRG28	128 m east of the Newbuild Infrastructure Boundary	SJ 43692 72541	Water vole feeding station found on northern bank with rushes chewed at a 45 degree angle.

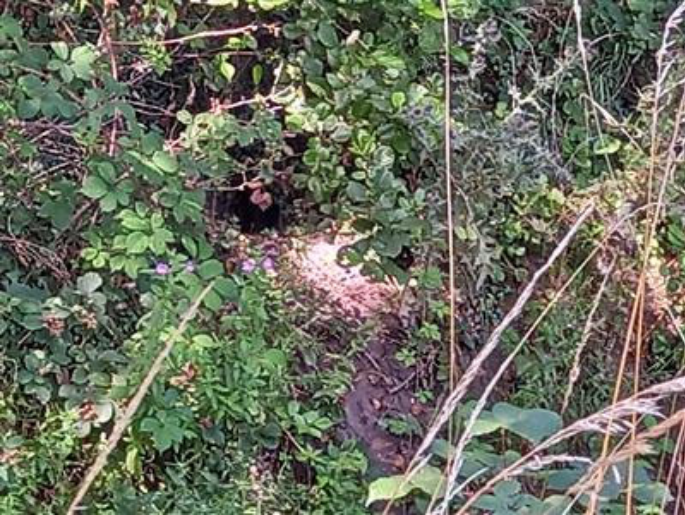
Watercourse Group: Watercourse Name	Field Sign Reference	Location in Relation to Newbuild Infrastructure Boundary	Grid Reference	Field sign Description	Photograph
Group 5: Thornton Ditch 4	TDRG41	Within the Newbuild Infrastructure Boundary	SJ440907 2889	Potential otter holt on western side of bank. Path to waterway, smooth with no vegetation overgrown suggesting use. Observed in August and September 2022.

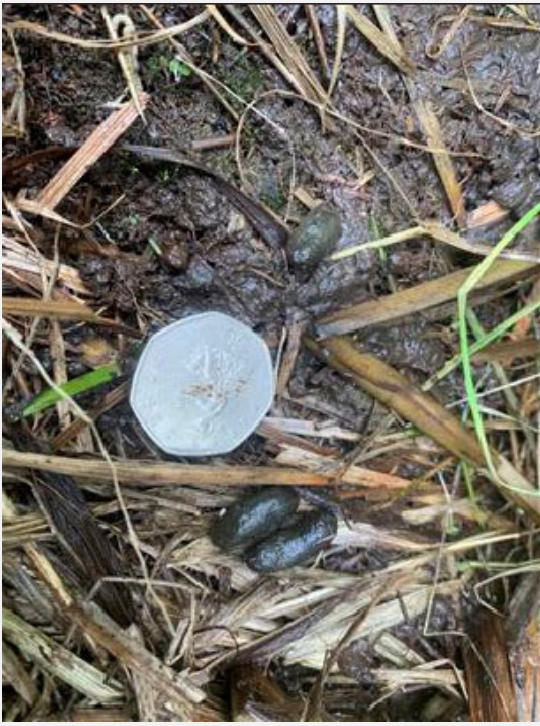
Watercourse Group: Watercourse Name	Field Sign Reference	Location in Relation to Newbuild Infrastructure Boundary	Grid Reference	Field sign Description	Photograph
Group 5: Thornton ditch 6	TDRG45	Within the Newbuild Infrastructure Boundary	SJ439077 2736	Water vole droppings, latrines and burrow. Approximately 6 separate distinct water vole droppings outside a small mammal burrow. Burrow located on the southern side of the ditch.

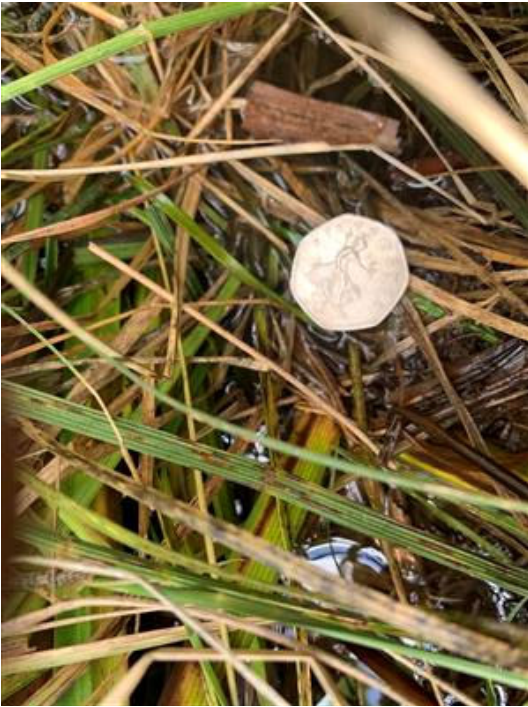
Watercourse Group: Watercourse Name	Field Sign Reference	Location in Relation to Newbuild Infrastructure Boundary	Grid Reference	Field sign Description	Photograph
Group 5: Thornton Main Drain	TDRG46	Within the Newbuild Infrastructure Boundary	SJ438897 2738	Water vole latrines and feeding remains were found. This included three distinct droppings on sedges, found at the SE side of ditch.

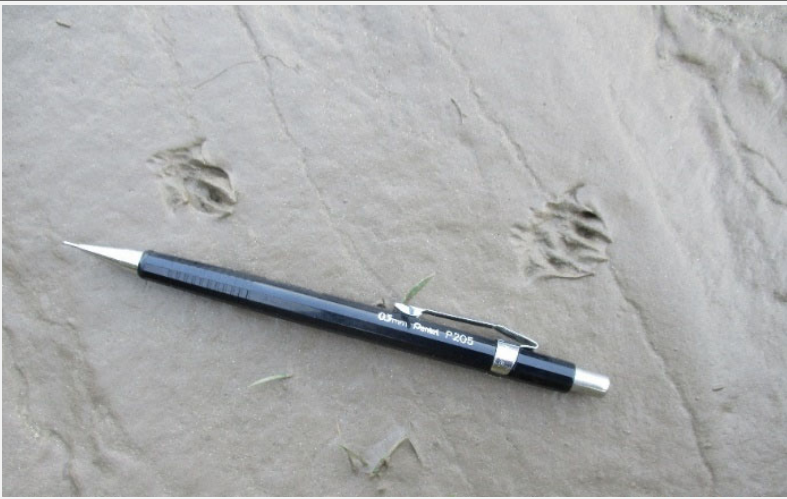
Watercourse Group: Watercourse Name	Field Sign Reference	Location in Relation to Newbuild Infrastructure Boundary	Grid Reference	Field sign Description	Photograph
Group 14: River Dee	RD1 and RD2	From 400 m outside of the Newbuild Infrastructure Boundary along the river bank to within the Newbuild Infrastructure Boundary.	SJ 30548 66906 to SJ 34971 66954	Footprints running along edge of riverbank. Identified as rat No droppings or burrows found during survey. Only other footprints present were of birds.

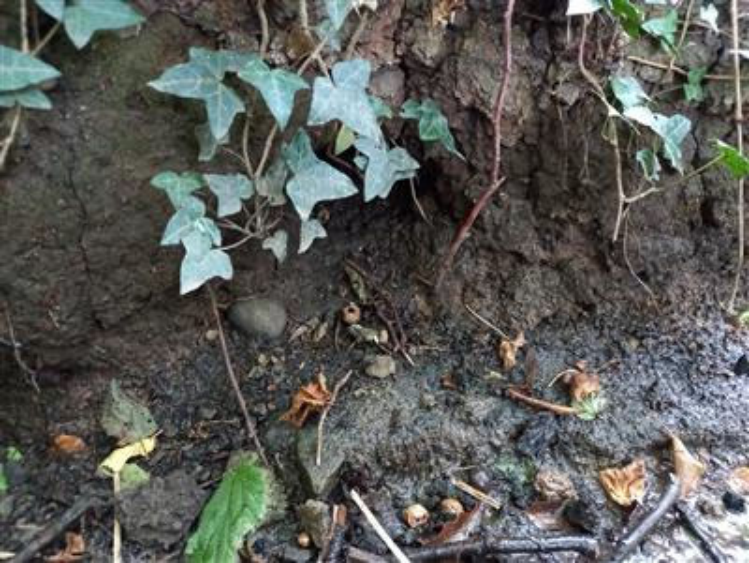
Watercourse Group: Watercourse Name	Field Sign Reference	Location in Relation to Newbuild Infrastructure Boundary	Grid Reference	Field sign Description	Photograph
Group 19: Willow Park Brook	WPB2	Within the Newbuild Infrastructure Boundary	SJ317346 7318	Two rat burrows recorded next to each other. One was approximately 10 cm by 10 cm on the north-western bank, its size restricted by roots. Degraded footprints also found on the bank. The second rat burrow was on the south-eastern bank. Approximately 15 cm by 15 cm. A rat chewed hazelnut was also found outside burrow.

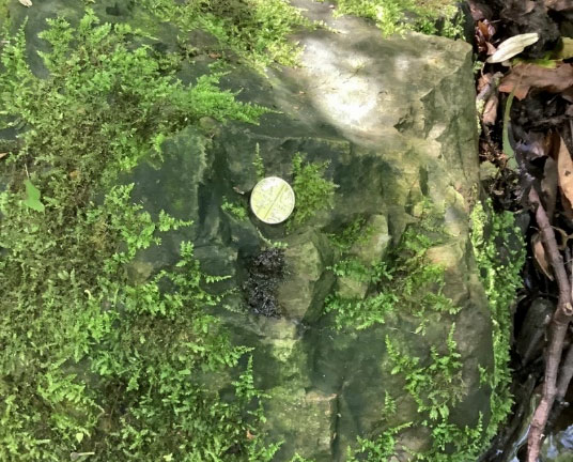
Watercourse Group: Watercourse Name	Field Sign Reference	Location in Relation to Newbuild Infrastructure Boundary	Grid Reference	Field sign Description	Photograph
Group 22: Wepre Brook A	WB1	16 m north of the Newbuild Infrastructure Boundary	SJ 27017 67456	An otter spraint found on a rock in the stream.

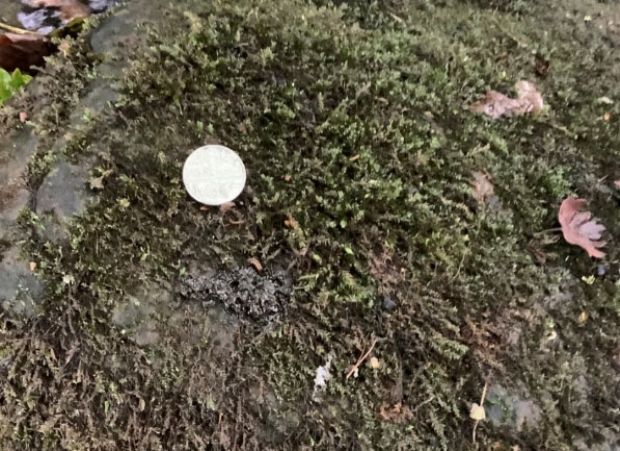
Watercourse Group: Watercourse Name	Field Sign Reference	Location in Relation to Newbuild Infrastructure Boundary	Grid Reference	Field sign Description	Photograph
Group 22: Wepre Brook A	WB2	19 m north of the Newbuild Infrastructure Boundary	SJ 27095 67451	A fresh otter spraint found on a rock in the stream.

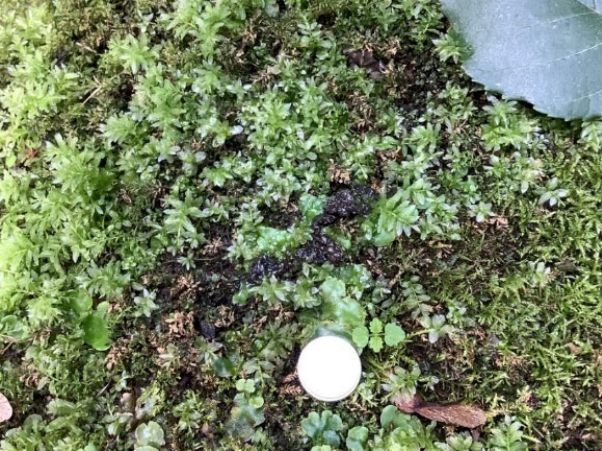
Group 22: Wepre Brook A	WB3	15 m north of the Newbuild Infrastructure Boundary	SJ 27174 67452	A fresh otter spraint found on a rock in the stream.

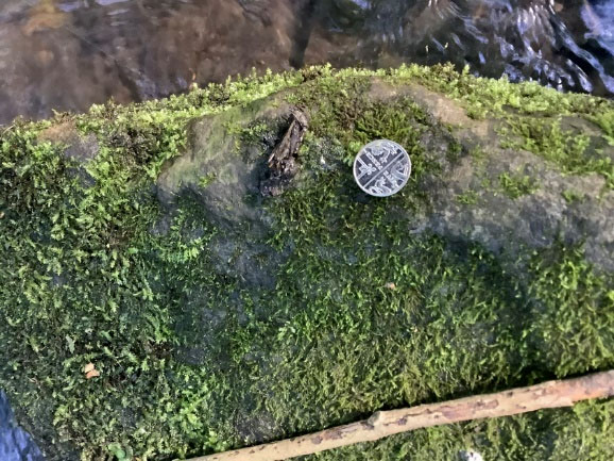
Watercourse Group: Watercourse Name	Field Sign Reference	Location in Relation to Newbuild Infrastructure Boundary	Grid Reference	Field sign Description	Photograph
Group 22: Wepre Brook A	WB4	13 m north of the Newbuild Infrastructure Boundary	SJ 27258 67449	A fresh otter spraint found on a rock in the stream.

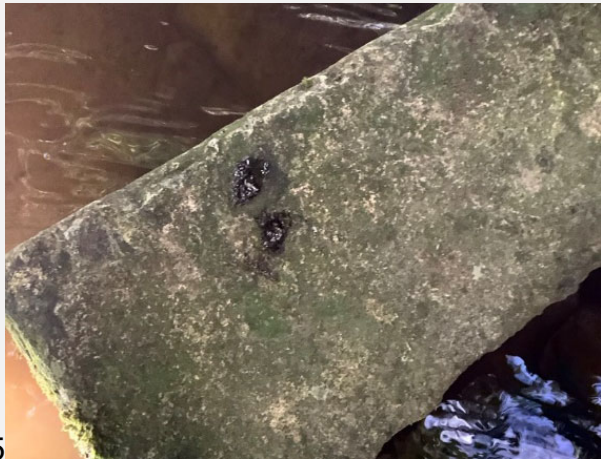
Watercourse Group: Watercourse Name	Field Sign Reference	Location in Relation to Newbuild Infrastructure Boundary	Grid Reference	Field sign Description	Photograph
Group 22: Wepre Brook B	WB5	20 m north of the Newbuild Infrastructure Boundary	SJ 27191 67477	A fresh otter spraint found on a rock under the bridge where the stream passes under the road.

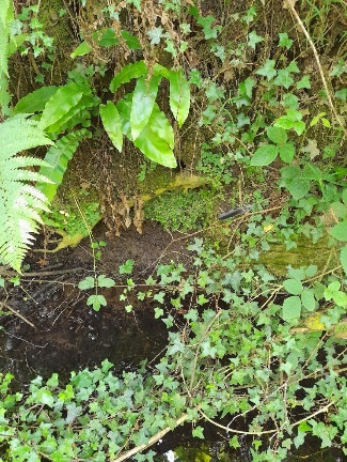
Watercourse Group: Watercourse Name	Field Sign Reference	Location in Relation to Newbuild Infrastructure Boundary	Grid Reference	Field sign Description	Photograph
Group 22: Wepre Brook A	WB6	29 m north of the Newbuild Infrastructure Boundary	SJ 27301 67440	Possible laying up spot, compacted ground at edge of bank. Also gap beneath small pedestrian bridge (north-western corner) potentially extends in, suitable for otter.

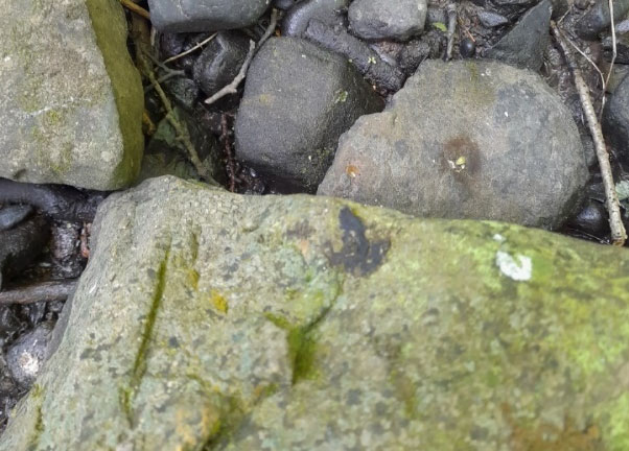
Watercourse Group: Watercourse Name	Field Sign Reference	Location in Relation to Newbuild Infrastructure Boundary	Grid Reference	Field sign Description	Photograph
Group 22: Wepre Brook A	WB7	19 m north of the Newbuild Infrastructure Boundary	SJ 27271 67444	Degraded spraint on boulder within channel

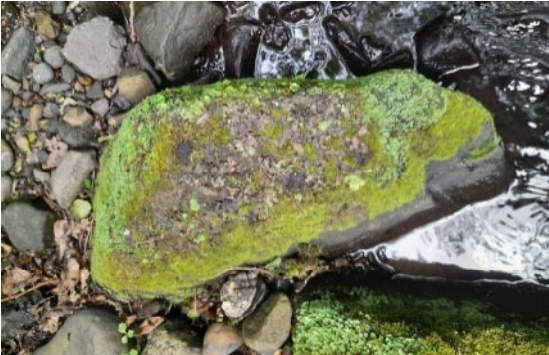
Watercourse Group: Watercourse Name	Field Sign Reference	Location in Relation to Newbuild Infrastructure Boundary	Grid Reference	Field sign Description	Photograph
Group 22: Wepre Brook A	WB12	22 m north of the Newbuild Infrastructure Boundary	SJ 27109 67446	Multiple degraded spraints on boulders within stream

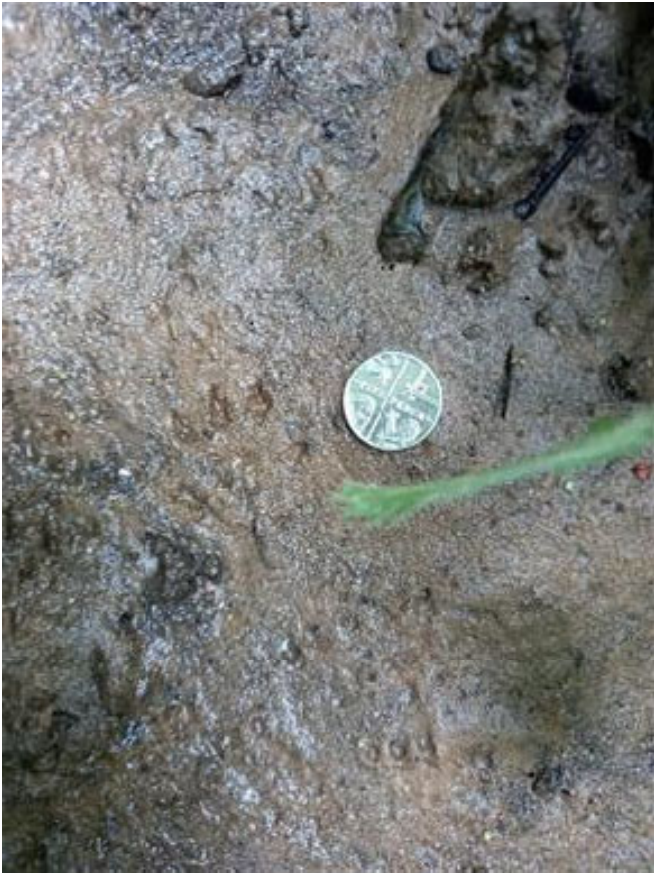
Watercourse Group: Watercourse Name	Field Sign Reference	Location in Relation to Newbuild Infrastructure Boundary	Grid Reference	Field sign Description	Photograph
Group 24: Northop Brook	NB4	Within the Newbuild Infrastructure Boundary	SJ253476 8934	Highly degraded, possibly mink or rat footprint on southern bank.

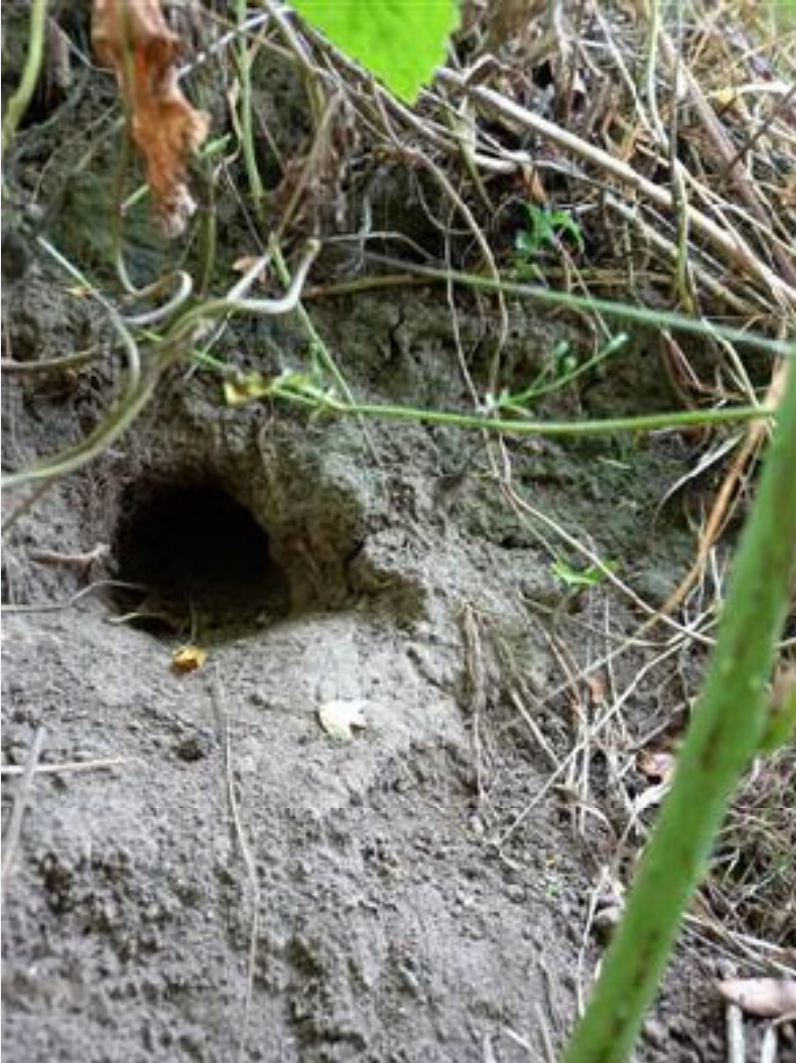
<p>Group 24: Northop Brook</p>	<p>NB5</p>	<p>9 m from the Newbuild Infrastructure Boundary</p>	<p>SJ253166 8913</p>	<p>Multiple mammal burrows in the bank. one potential slide into the brook, approximately 10 cm high by 5 cm wide. Two further burrows noted higher up the bank approximately 10 cm by 10 cm all with soil in entrance. Mammal path into field.</p>

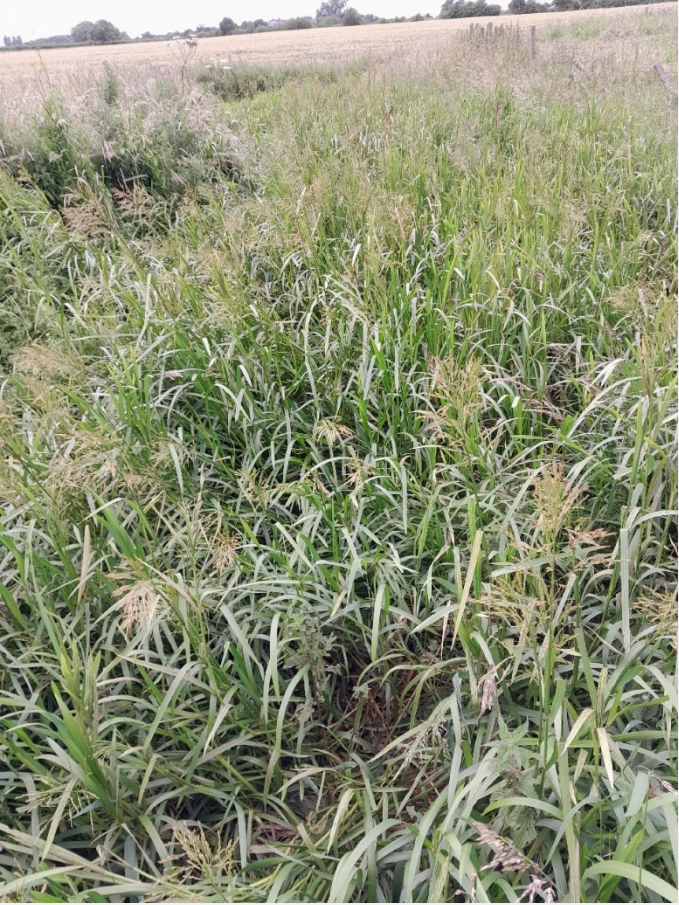
Stanney Mill Brook, densely vegetated banks and mostly dry.

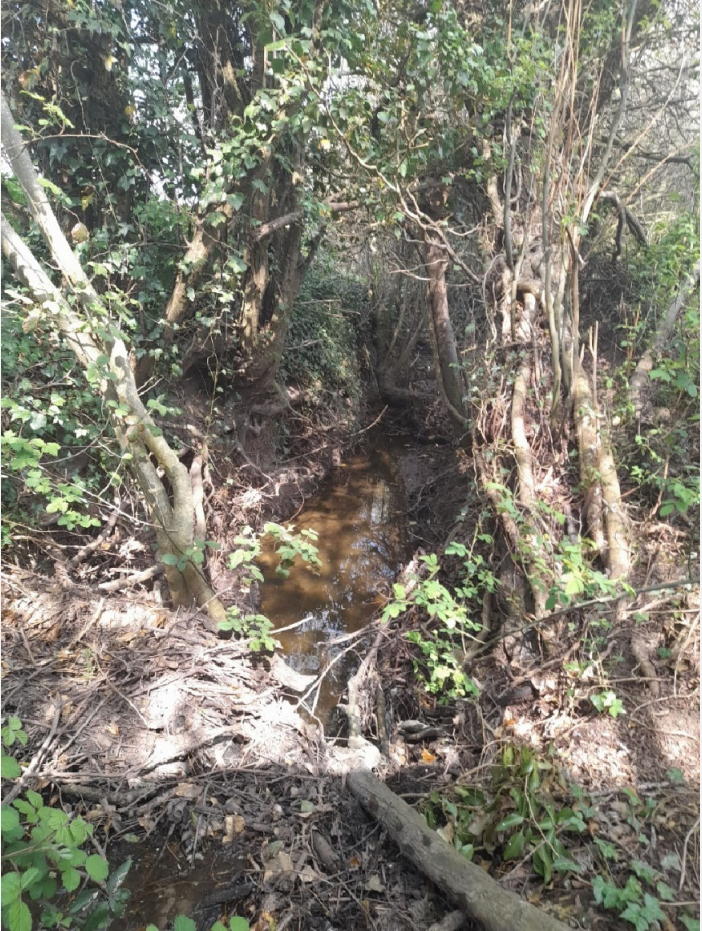
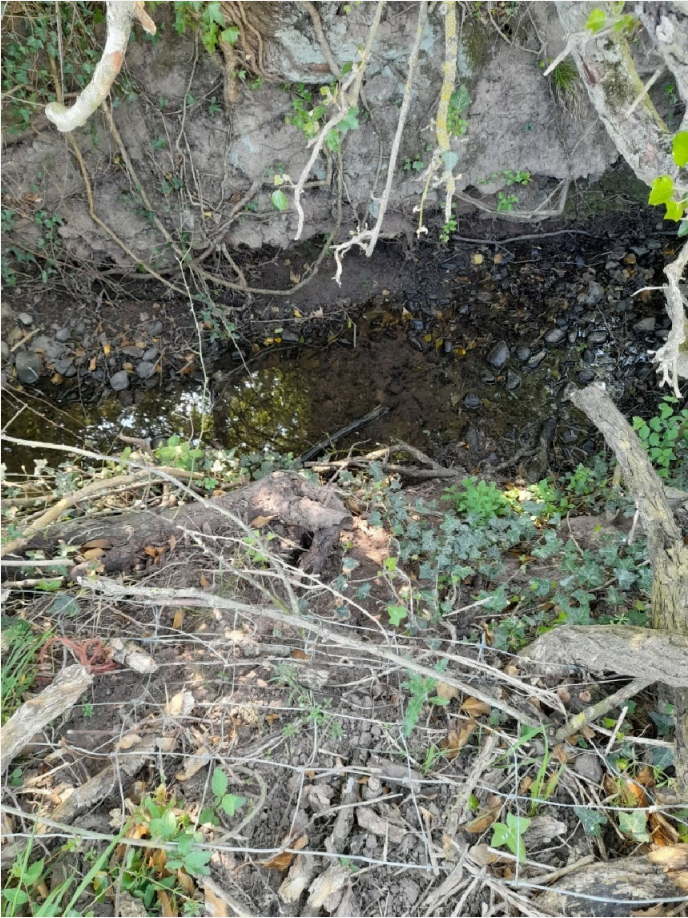
<p>Photos of Gowy Tributary 2, running through a wooded area, with a stony substrate in places.</p>

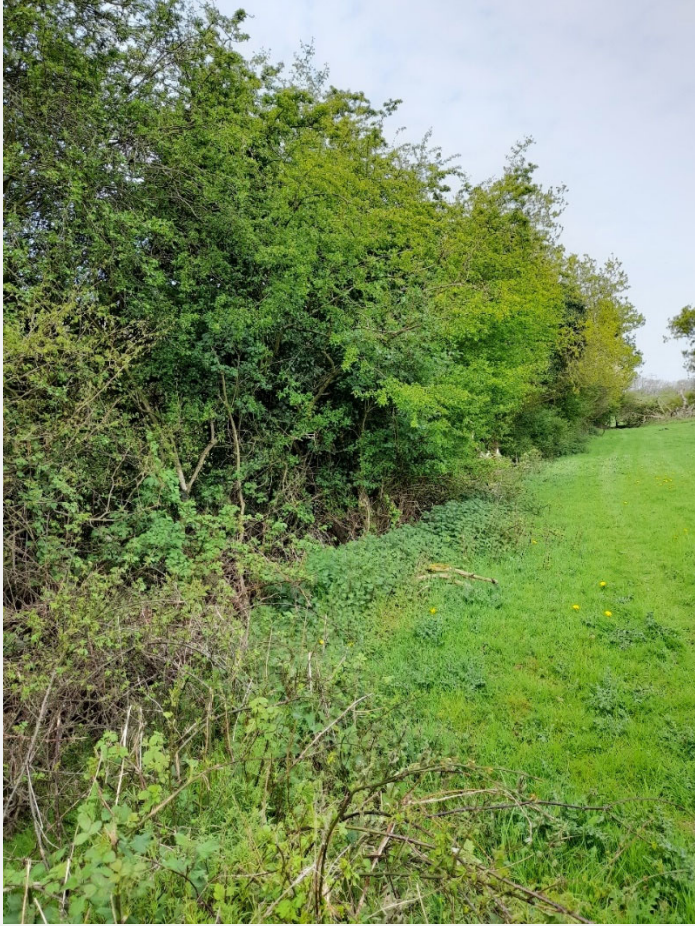
<p>Photos of Friars Park Ditch. Mostly ephemeral, with little aquatic vegetation.</p>

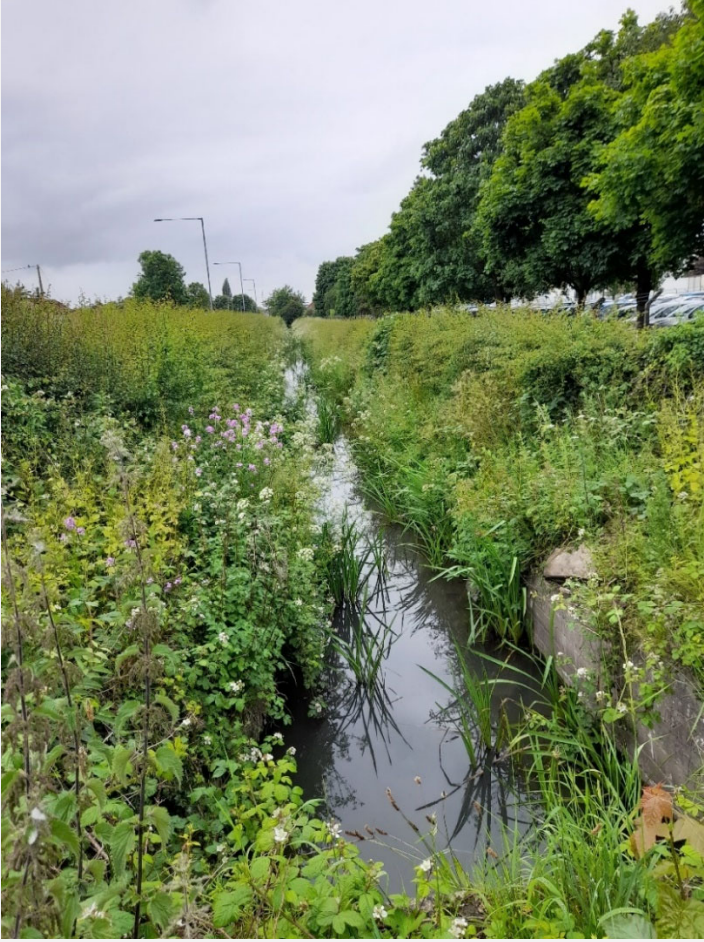
<p>Photos of Chester Road Drain North, cement lined where it is culverted under the road.</p>

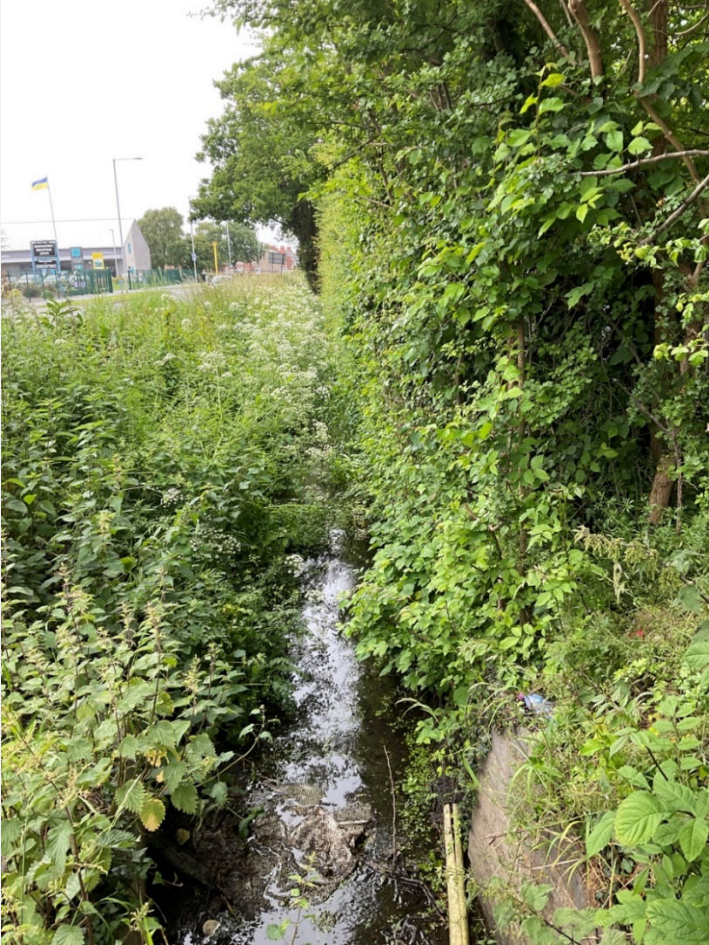
<p>Photos of Chester Road Drain Tributary 1, with cement lined banks for part of it's length.</p>
