# HyNet North West

## HYDROGEOLOGICAL IMPACT APPRAISAL OF OPEN CUT CROSSING, ALLTAMI BROOK

HyNet Carbon Dioxide Pipeline DCO

**Document Reference Number D.7.36**

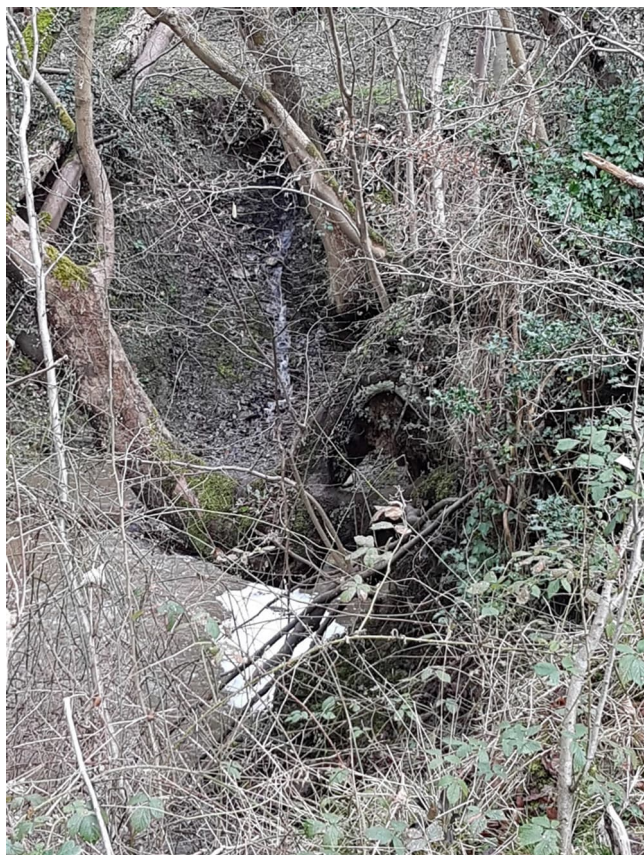
**Seepage through made ground creating small waterfall**

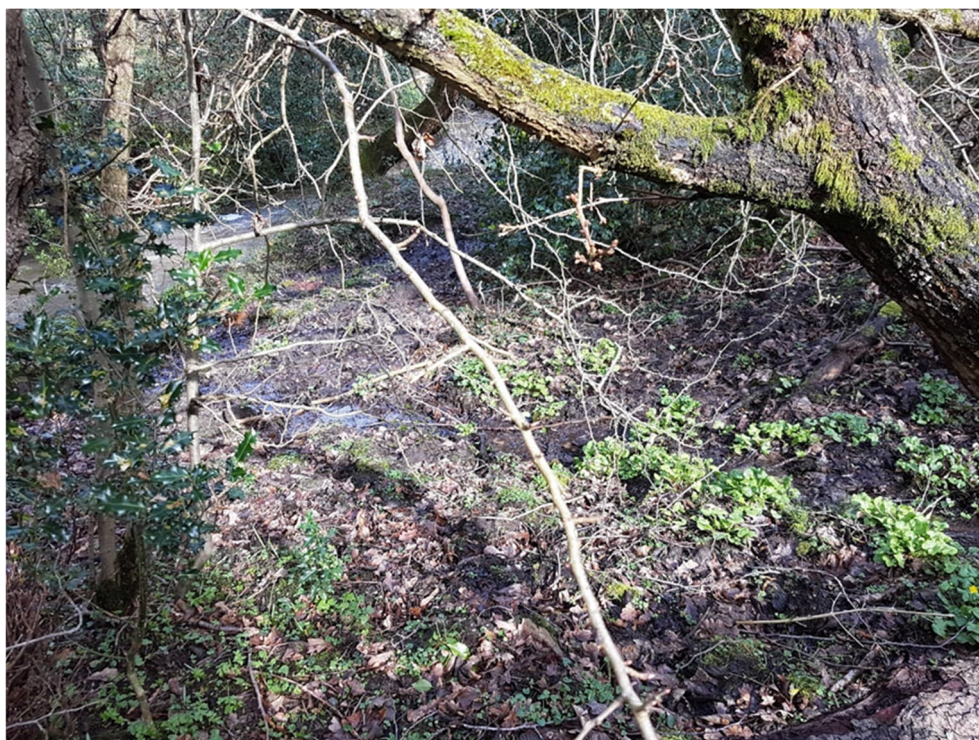
**Seepage from made ground discharging into Alltami Brook**

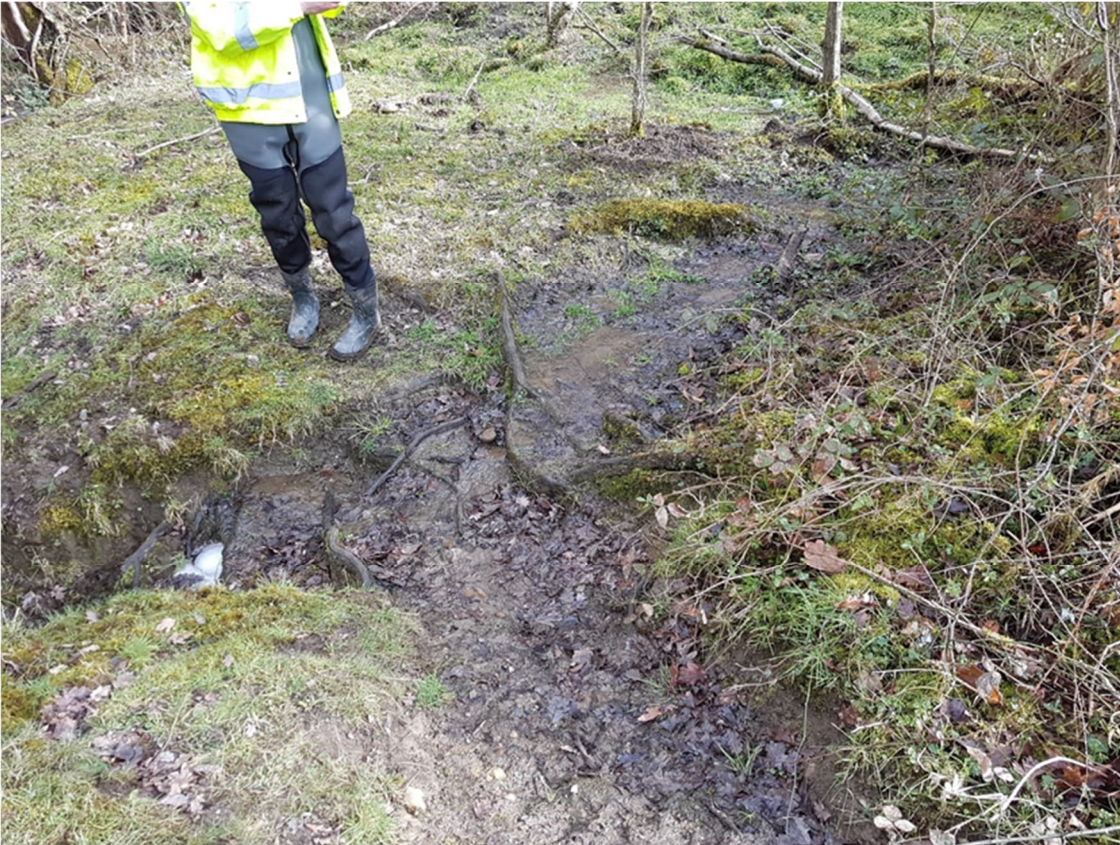
**Saturated made ground/seepage**

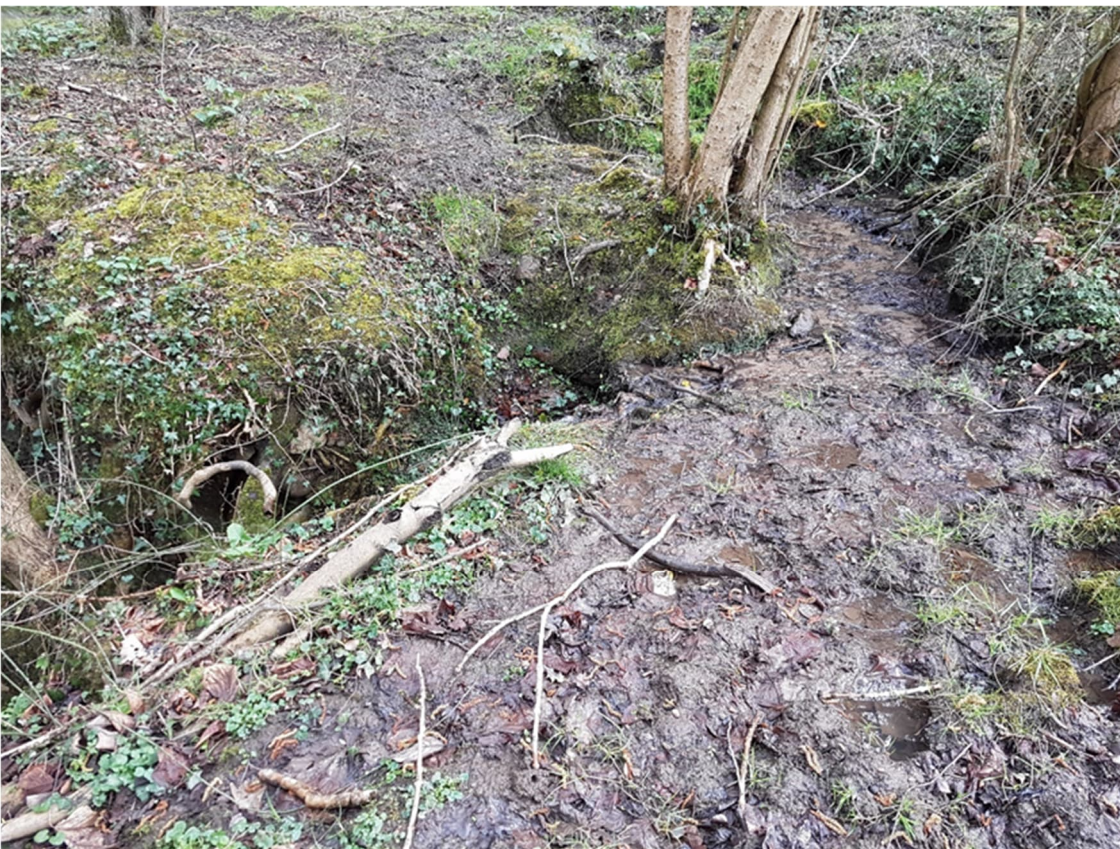
**Saturated made ground/seepage**

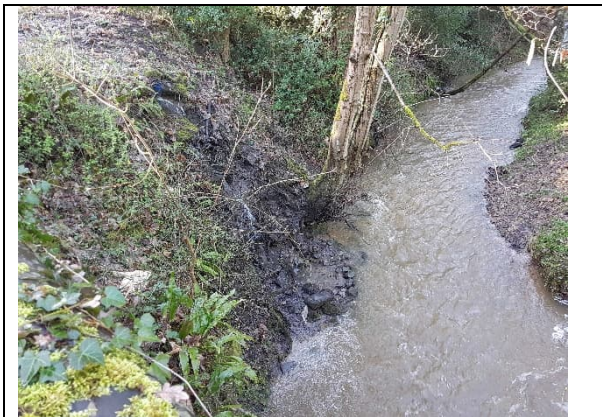
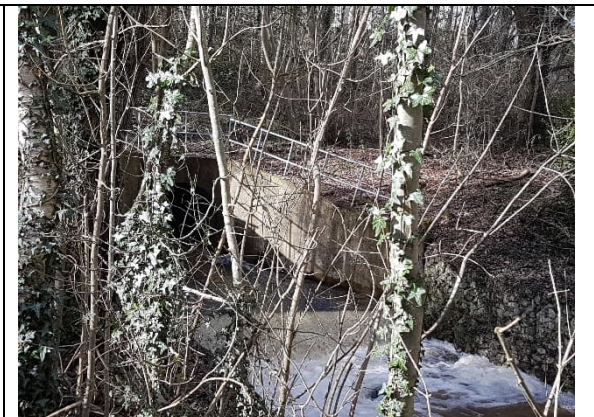
<p>View looking upstream of the minor road bridge. Spate flow following heavy overnight rain on saturated ground. Deep v-shaped channel in otherwise flat landscape. A minor tributary of land drainage is discharging into the Alltami Brook on the right bank.</p>	<p>Outlet of the A55 culvert. Large pipe culvert discharging onto a concrete slab perched above bed level. Banks are lined with gabion baskets. Fast-flowing water and high step from concrete ledge to natural bed (height difficult to estimate due to elevated flows but possibly 0.3-0.3m). Bedrock channel with boulders and gravel deposits downstream of the step along with trash (tyre observed in the middle of the channel).</p>

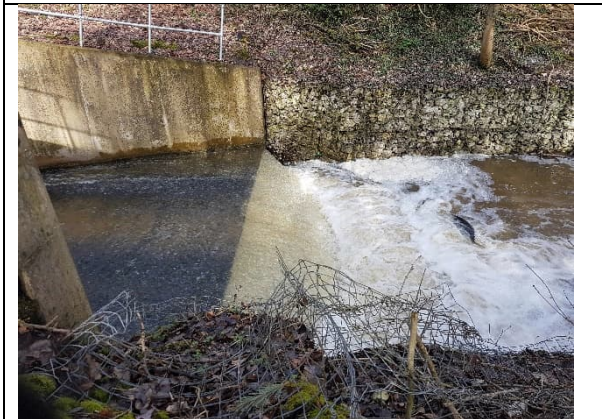
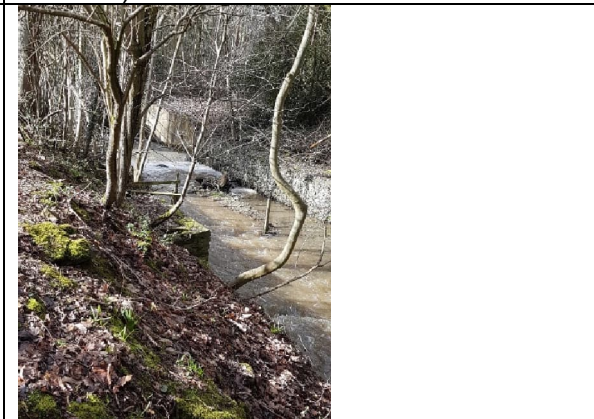
<p>Immediately downstream of the A55 culvert outlet. Concrete wingwalls and gabion mattress bank reinforcement on both banks. Concrete slab at the culvert outlet and high step down to the natural channel. It is likely that this culvert structure arrangement is not passable to fish.</p>	<p>View looking upstream towards the A55 culvert outlet showing the transition from the modified reach with gabion basket bank reinforcement to natural banks. Bedrock was observed on the left bank face downstream of the culvert where the bank renaturalised.</p>

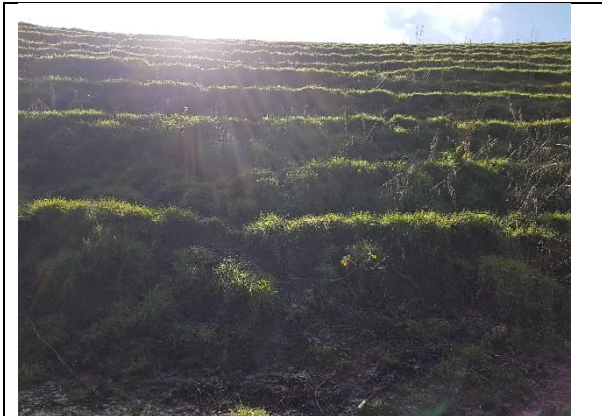
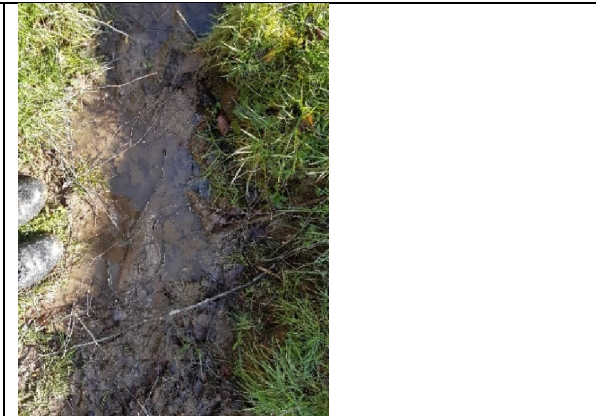
- 2.5.2. The BGS geological maps do not record made ground at the preferred crossing location. However, made ground was observed to be present during the site walkovers along the eastern bank (see walkover photos in Annex A) and whilst it is assumed to be material resulting from the construction of the A55, the origin of this is not confirmed.

<p>Made ground on the right bank. Very high and steep engineered bank with a composite bank profile due to creep.</p>	<p>The made ground was saturated with extensive surface water puddling.</p>

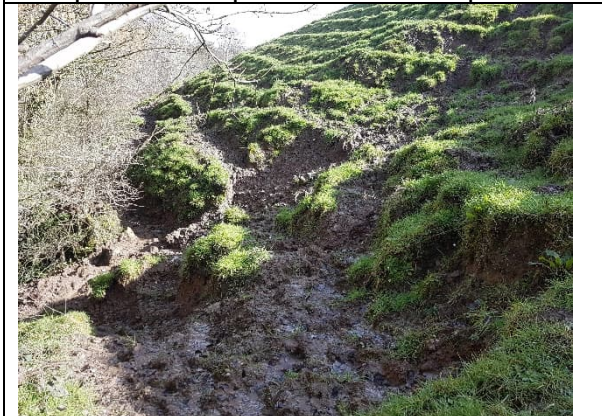
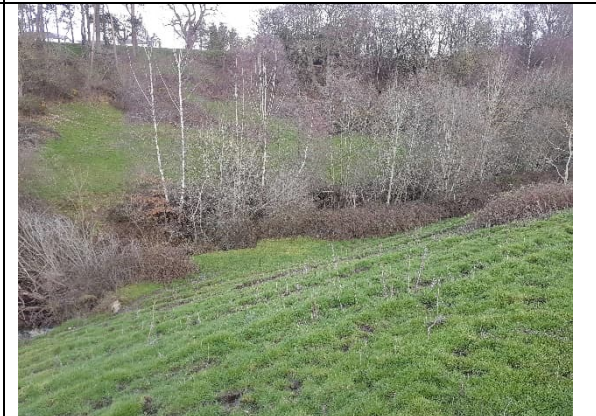
<p>Made ground bank profile with surface water puddling due to saturation of the earth.</p>	<p>View looking down to the Alltami Brook from the top of the made ground on the right bank. View looking downstream. The left bank is also steep and high but possibly a more natural landscape feature. Approximate crossing location for the pipeline.</p>

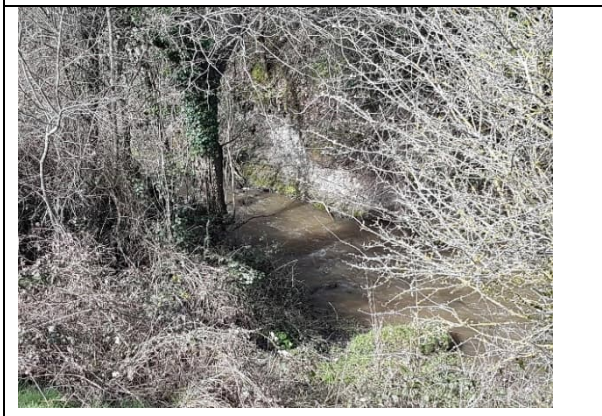
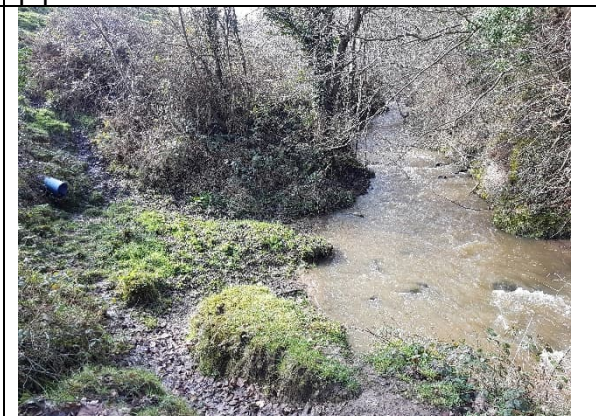
- 2.7.9. Springs occur at the junctions of the jointed sandstone with underlying mudstones and shales (**Ref 12**). During the site walkover, groundwater seepage issuing from the bedrock was observed at NGR SJ 27726 67182 (see photos in Annex A). This is located at the boundary of the Lower Coal Measures Formation (mudstone) and the Gwespvr Sandstone according to the geological map. This observation suggests that the Gwespvr Sandstone in the area is likely to be saturated and may contribute baseflow to the Alltami Brook.

<p>Seepage observed from bedrock on the left bank face immediately upstream of SJ 27726 67182.</p>	<p>Land drainage pipe discharging water into the brook on the right bank face. Small volume of water seeping from the pipe. SJ 27726 67182. Bedrock and boulder channel</p>

bed. Chute and broken standing wave flow types observed.

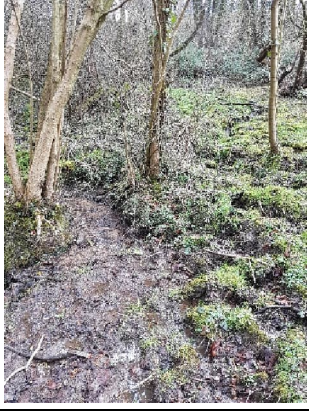
- 2.8.2. During the site walkover undertaken on 14<sup>th</sup> March 2023, a small surface water inflow was observed to be discharging into the Alltami Brook from the eastern bank upstream of the A55 at approximate NGR SJ 27793 67229 (see walkover photo in Annex A). A small waterfall discharging from the right bank was also observed to be discharging into the Alltami Brook at NGR SJ 27786 67196 (see photographs in Annex A). To cross the A55 (upstream of the Newbuild Infrastructure Boundary) the Alltami Brook flows through a large culvert which discharges onto a concrete slab perched above the bed level (photos in Annex A). The bedrock channel immediately downstream of the concrete culvert was observed to have boulders and gravel deposits.

<p>Surface water flow draining the right bank hillside into the Alltami Brook at SJ 27793 67229.</p>	<p>Surface water flow draining the right bank hillside into the Alltami Brook at SJ 27793 67229.</p>
