HYDROGEOLOGICAL IMPACT APPRAISAL OF OPEN CUT CROSSING, ALLTAMI BROOK

HyNet Carbon Dioxide Pipeline DCO

Document Reference Number D.7.36

Applicant: Liverpool Bay CCS Limited

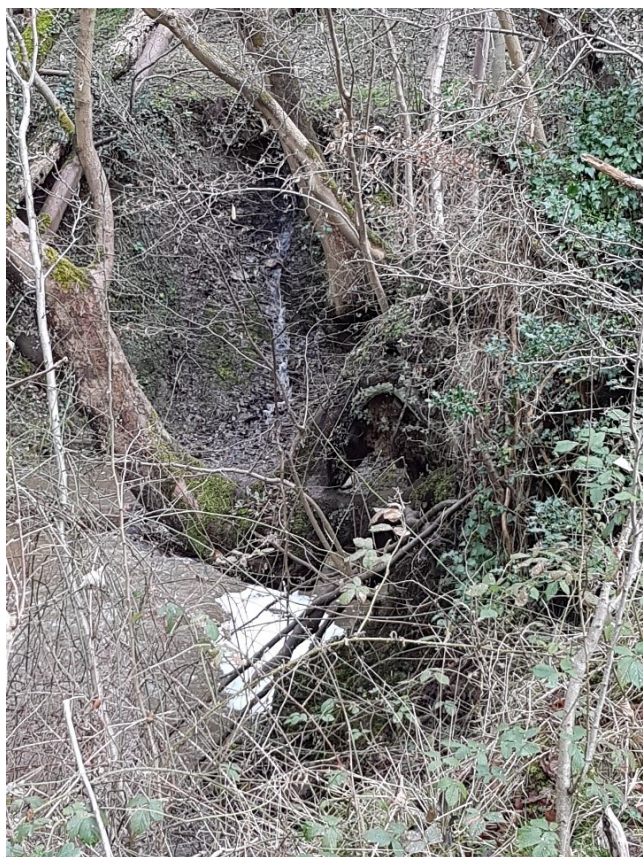
Seepage through made ground creating small waterfall

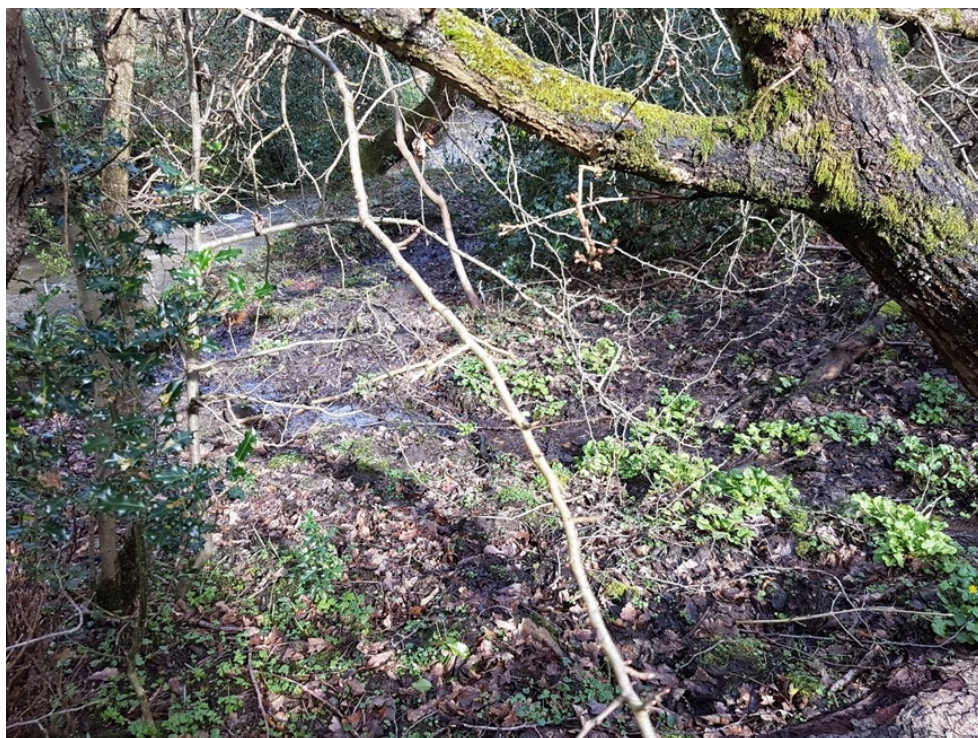
Seepage from made ground discharging into Alltami Brook

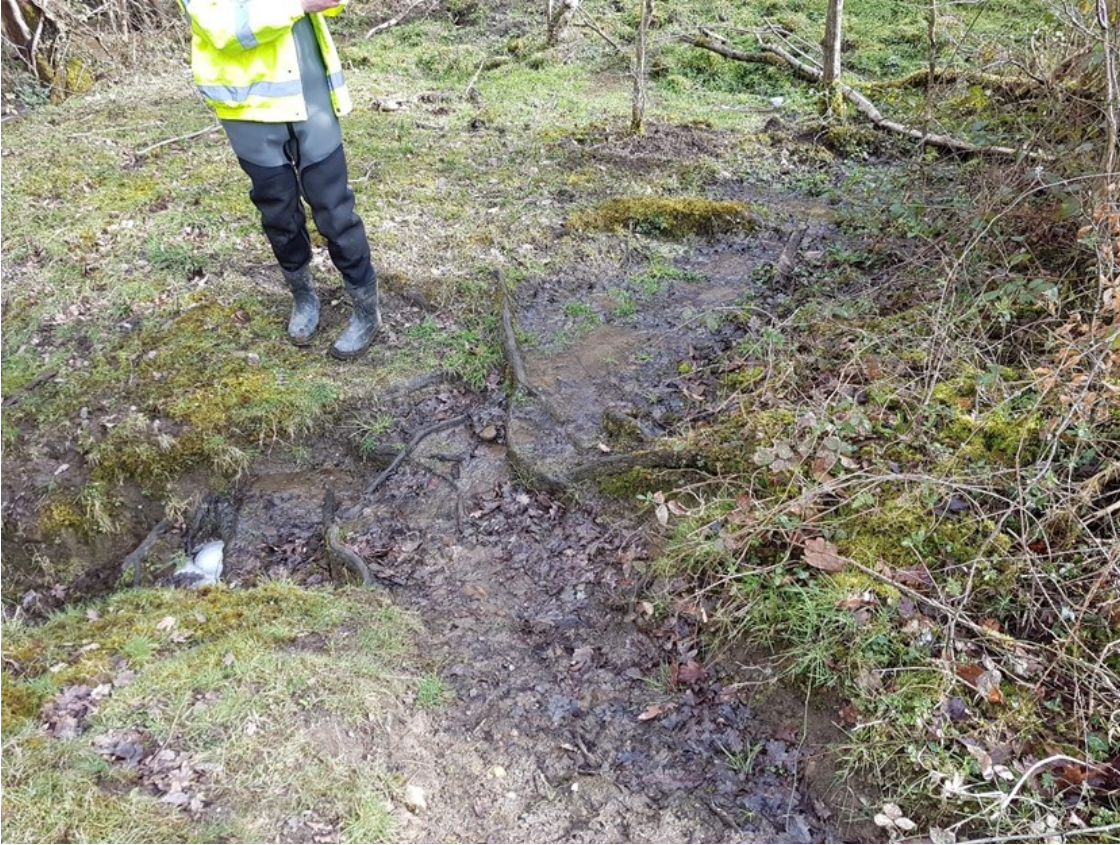
Saturated made ground/seepage

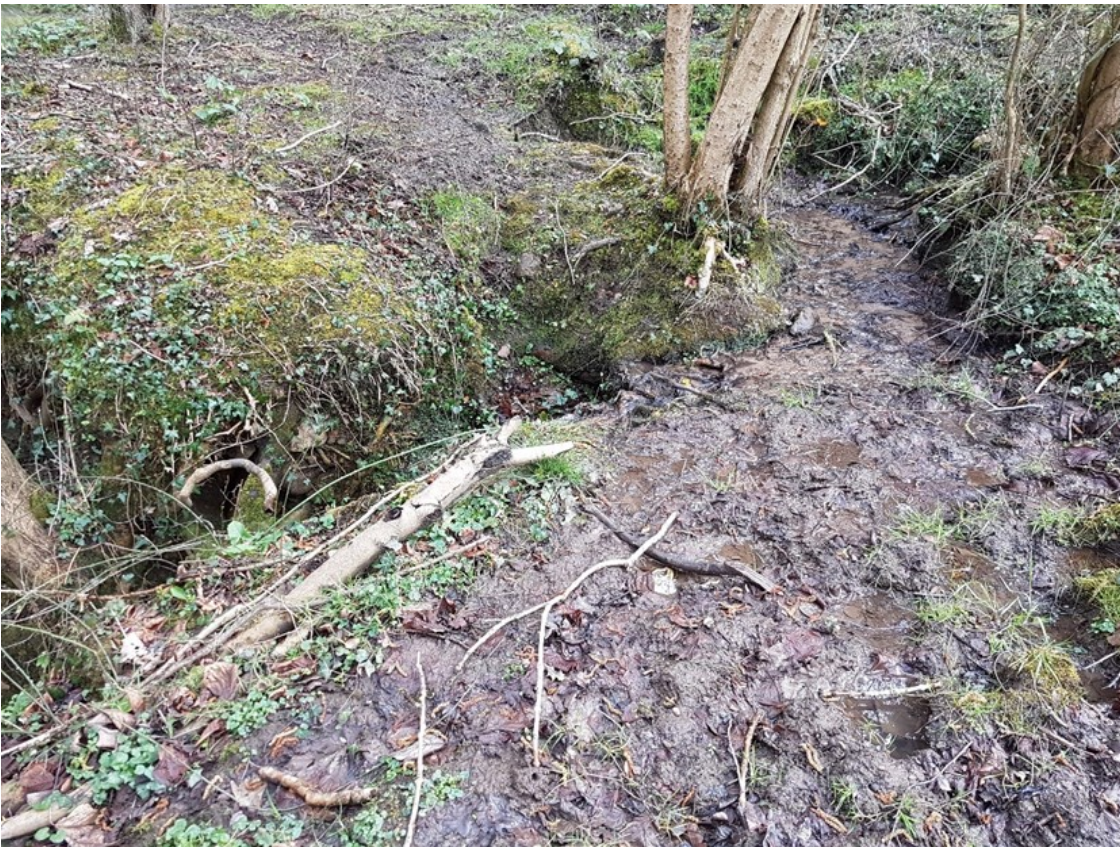
Saturated made ground/seepage

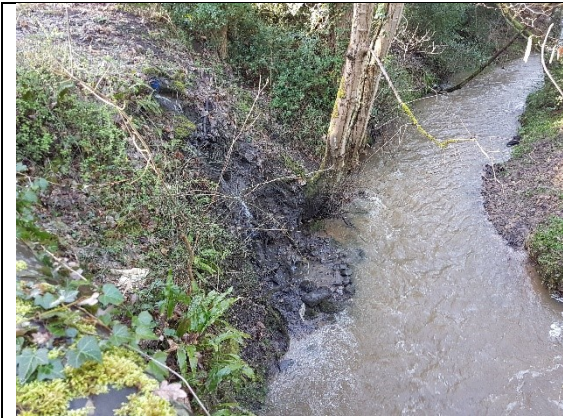
View looking upstream of the minor road bridge. Spate flow following heavy overnight rain on saturated ground. Deep v-shaped channel in otherwise flat landscape. A minor tributary of land drainage is discharging into the Alltami Brook on the right bank.

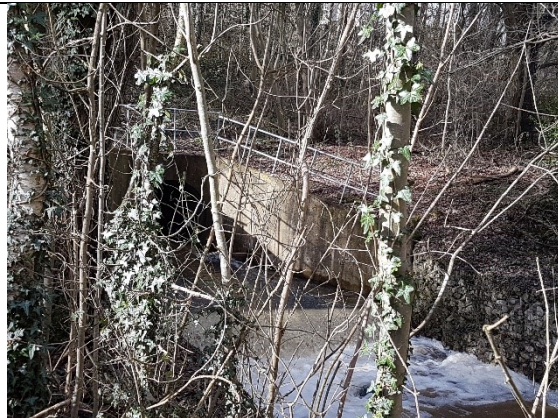
Outlet of the A55 culvert. Large pipe culvert discharging onto a concrete slab perched above bed level. Banks are lined with gabion baskets. Fast-flowing water and high step from concrete ledge to natural bed (height difficult to estimate due to elevated flows but possibly 0.3-0.3m). Bedrock channel with boulders and gravel deposits downstream of the step along with trash (tyre observed in the middle of the channel).

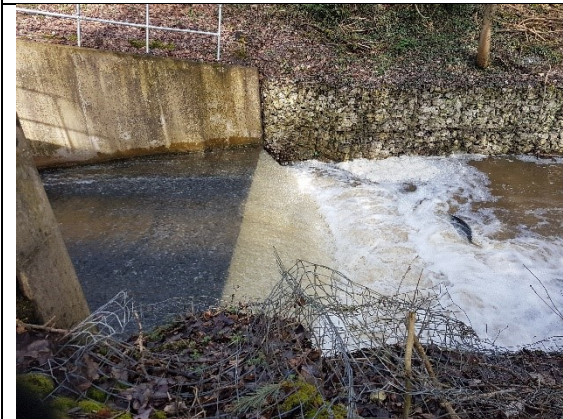
Immediately downstream of the A55 culvert outlet. Concrete wingwalls and gabion mattress bank reinforcement on both banks. Concrete slab at the culvert outlet and high step down to the natural channel. It is likely that this culvert structure arrangement is not passable to fish.

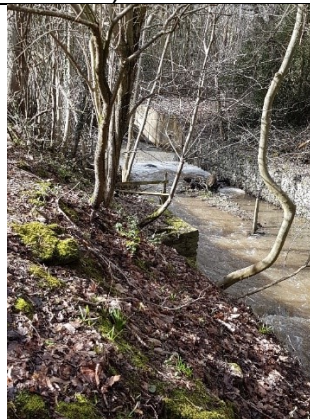
View looking upstream towards the A55 culvert outlet showing the transition from the modified reach with gabion basket bank reinforcement to natural banks. Bedrock was observed on the left bank face downstream of the culvert where the bank renaturalised.

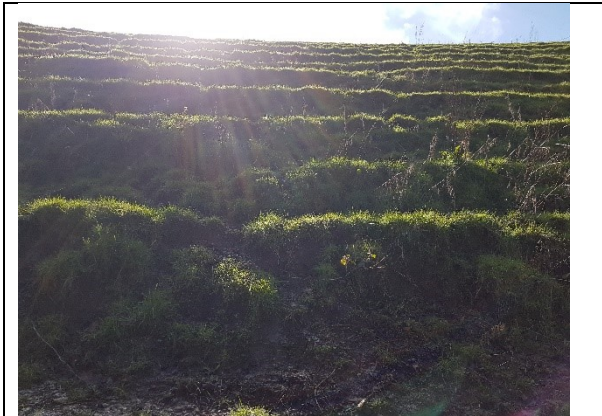
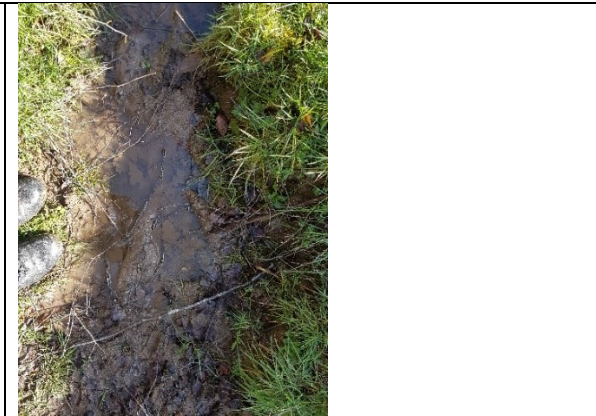
<p>Made ground on the right bank. Very high and steep engineered bank with a composite bank profile due to creep.</p>	<p>The made ground was saturated with extensive surface water puddling.</p>

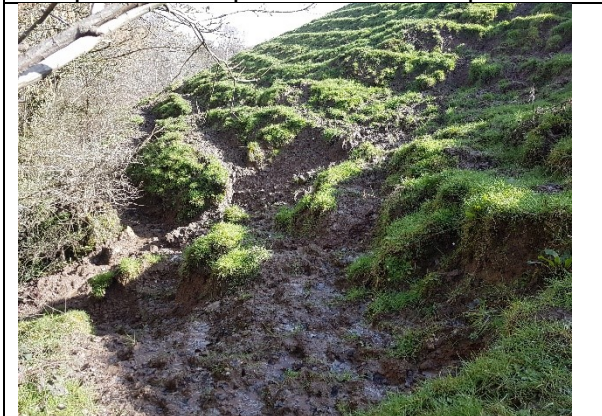
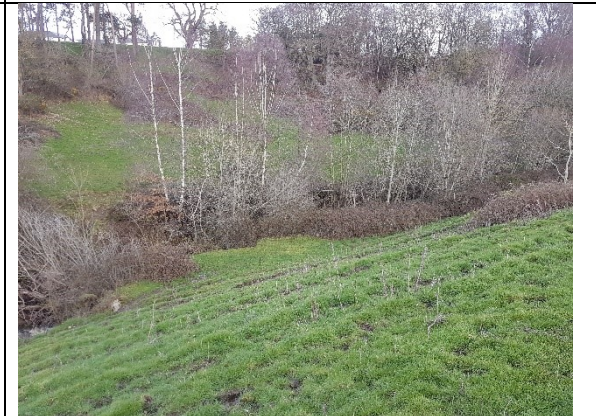
<p>Made ground bank profile with surface water puddling due to saturation of the earth.</p>	<p>View looking down to the Alltami Brook from the top of the made ground on the right bank. View looking downstream. The left bank is also steep and high but possibly a more natural landscape feature. Approximate crossing location for the pipeline.</p>

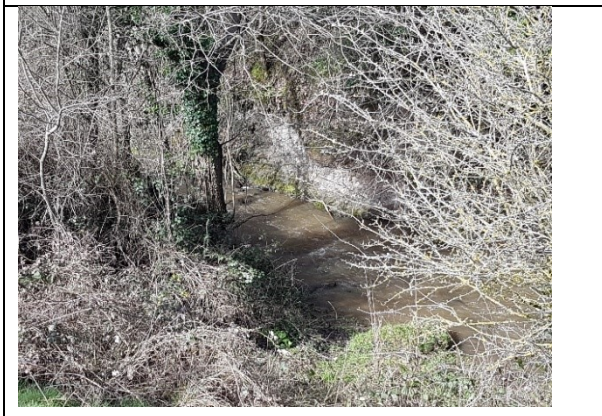
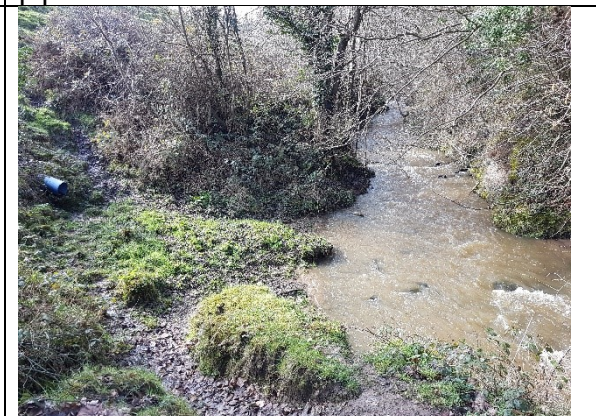
- 2.7.9. Springs occur at the junctions of the jointed sandstone with underlying mudstones and shales (**Ref 12**). During the site walkover, groundwater seepage issuing from the bedrock was observed at NGR SJ 27726 67182 (see photos in Annex A). This is located at the boundary of the Lower Coal Measures Formation (mudstone) and the Gwespvr Sandstone according to the geological map. This observation suggests that the Gwespvr Sandstone in the area is likely to be saturated and may contribute baseflow to the Alltami Brook.

<p>Seepage observed from bedrock on the left bank face immediately upstream of SJ 27726 67182.</p>	<p>Land drainage pipe discharging water into the brook on the right bank face. Small volume of water seeping from the pipe. SJ 27726 67182. Bedrock and boulder channel</p>
