A38 Derby Junctions

**Appendix 8.5b: River Habitat and River
Corridor Survey in 2015**

River Corridor Survey and River Habitat Survey Report

Report Number: 47071319-URS-05-RP-EN-015
March 2016

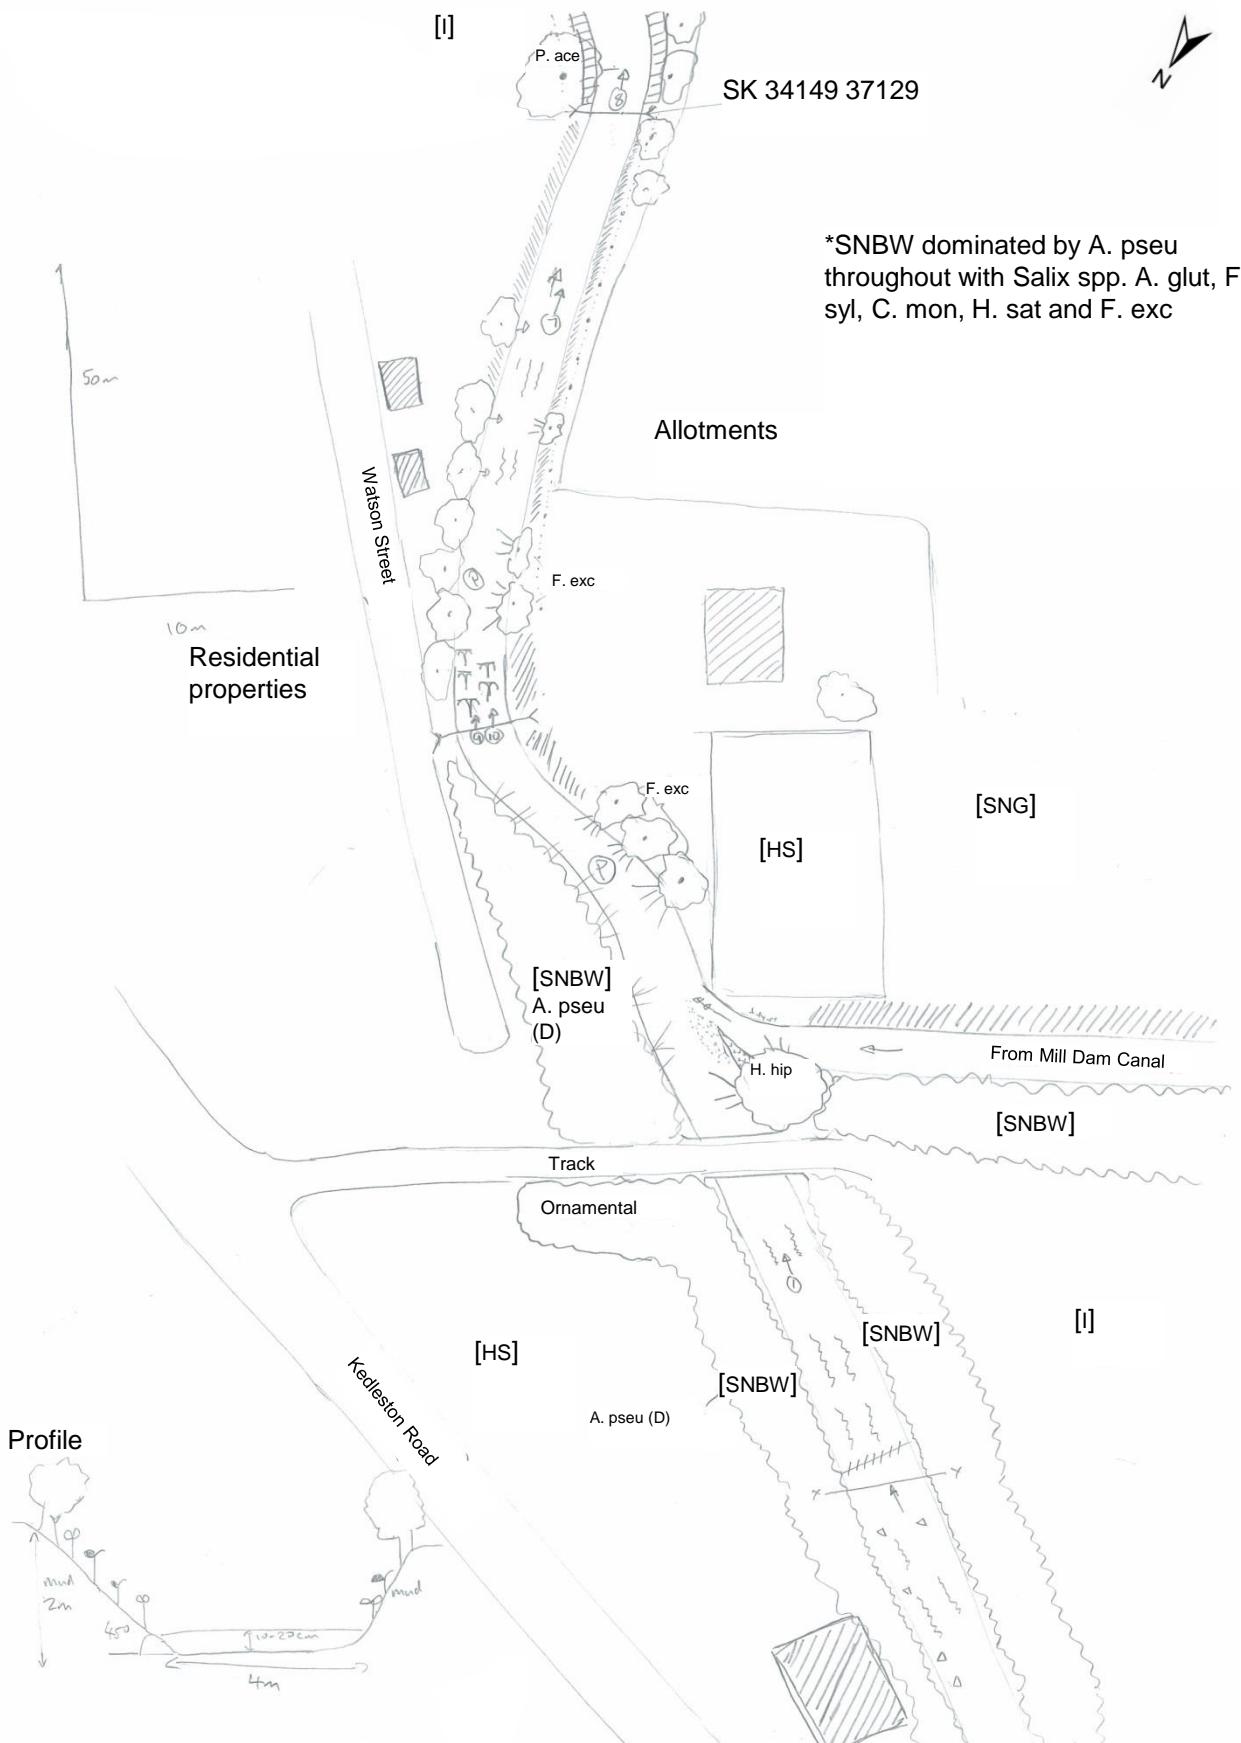
Heavily engineered channel
Vertical sides and reinforced
base to channel
Substrate is mix of reinforcement
gravel, sand and deep silt.
Very few in-channel features due
to the heavy engineering
Steep vertical mud banks
Bankside vegetation mix of tall
grasses, shrubs and ruderals
