**A38 Derby Junctions**

**Appendix 10.4: PSS Addendum Link  
Road K2**

**Preliminary Sources Study Addendum  
Link Road K2**

**HA GDMS No. 29038**

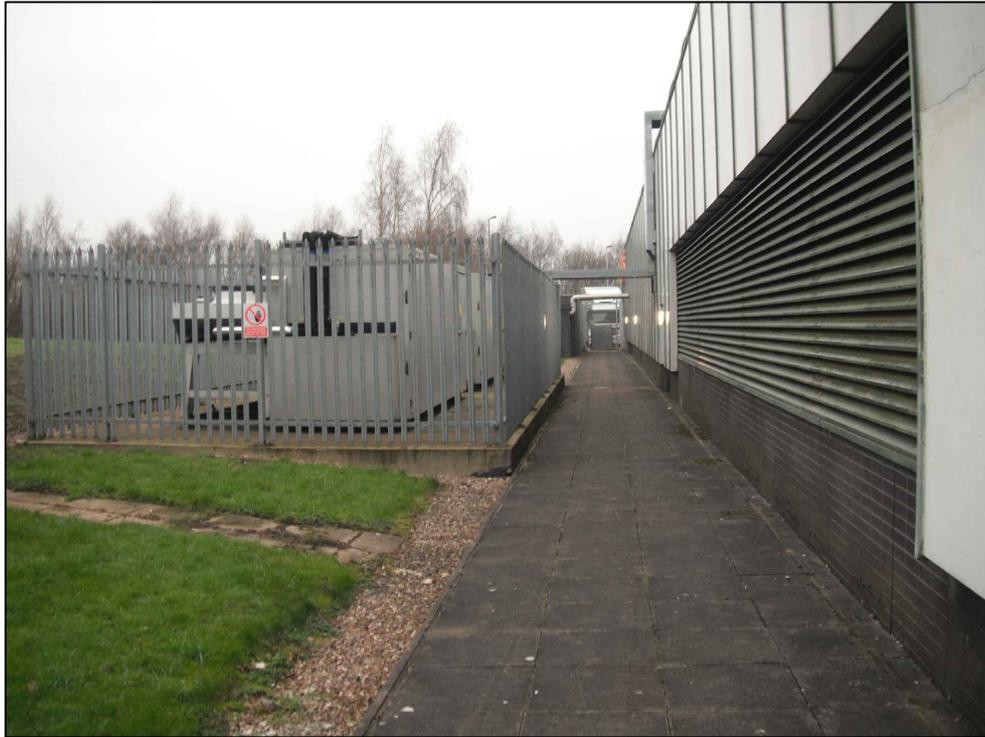
PLATE 1A: Gate access to site at rear of supermarket

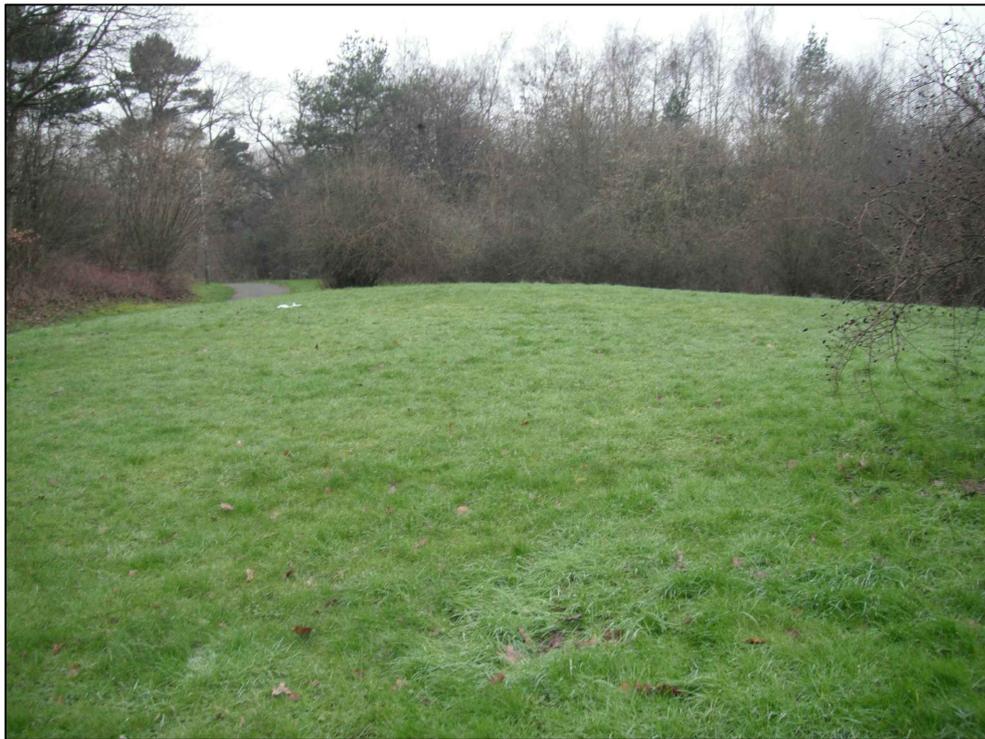
PLATE 1B: View North West towards Kingsway Junction and the A5111

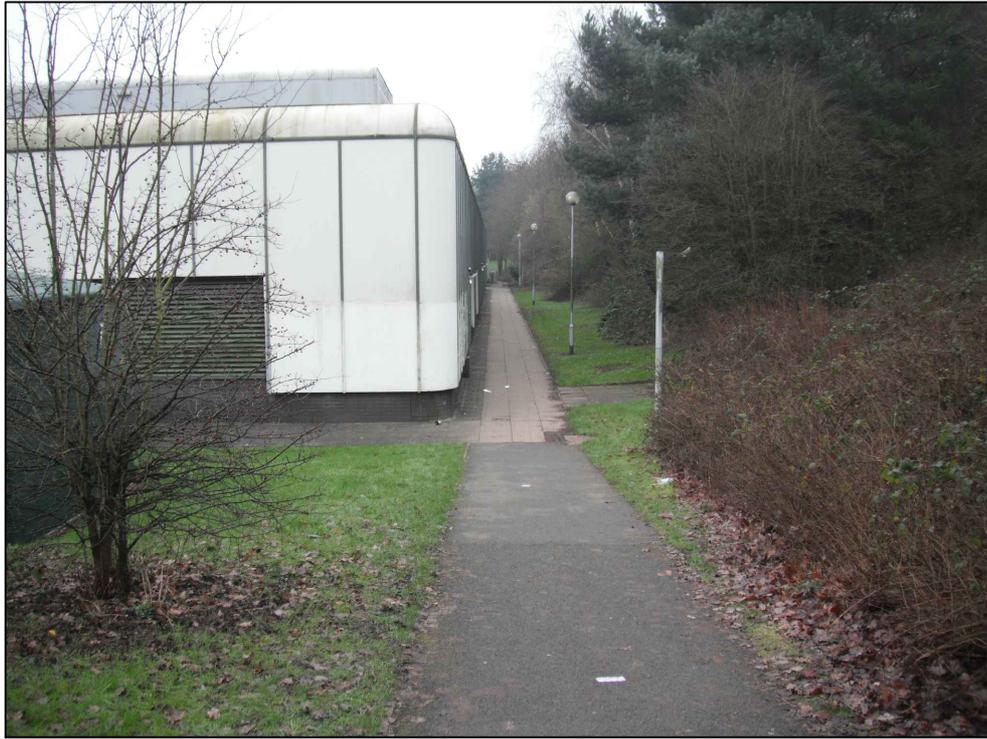
PLATE 2A: View of the public access along south eastern perimeter of supermarket

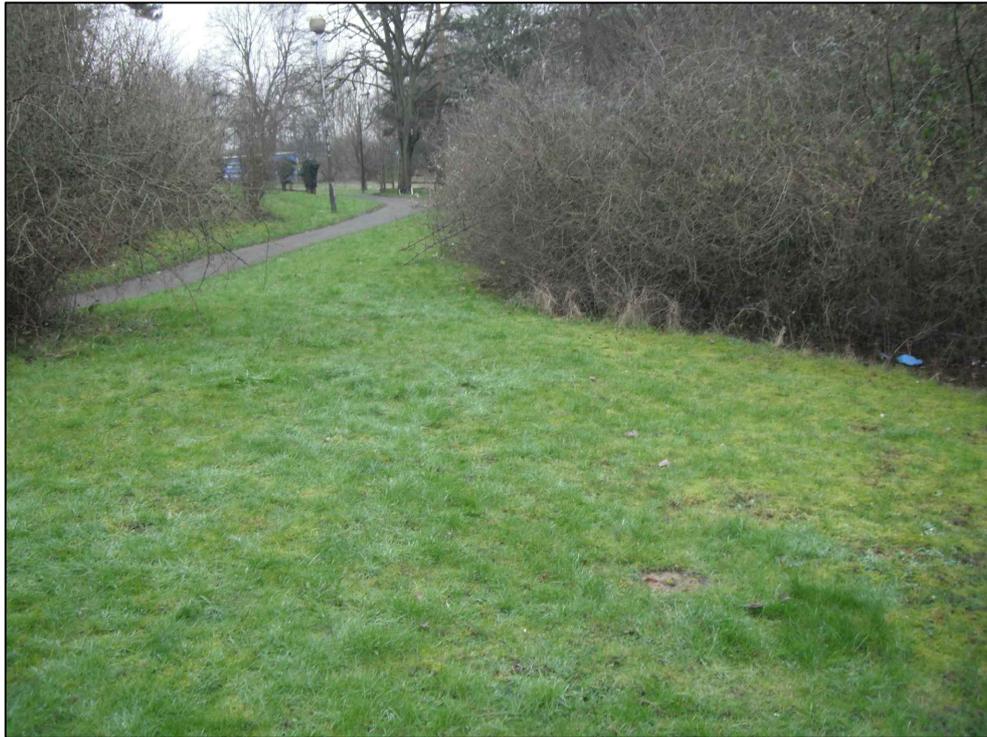
PLATE 2B: Public access route West of the site towards the A5111

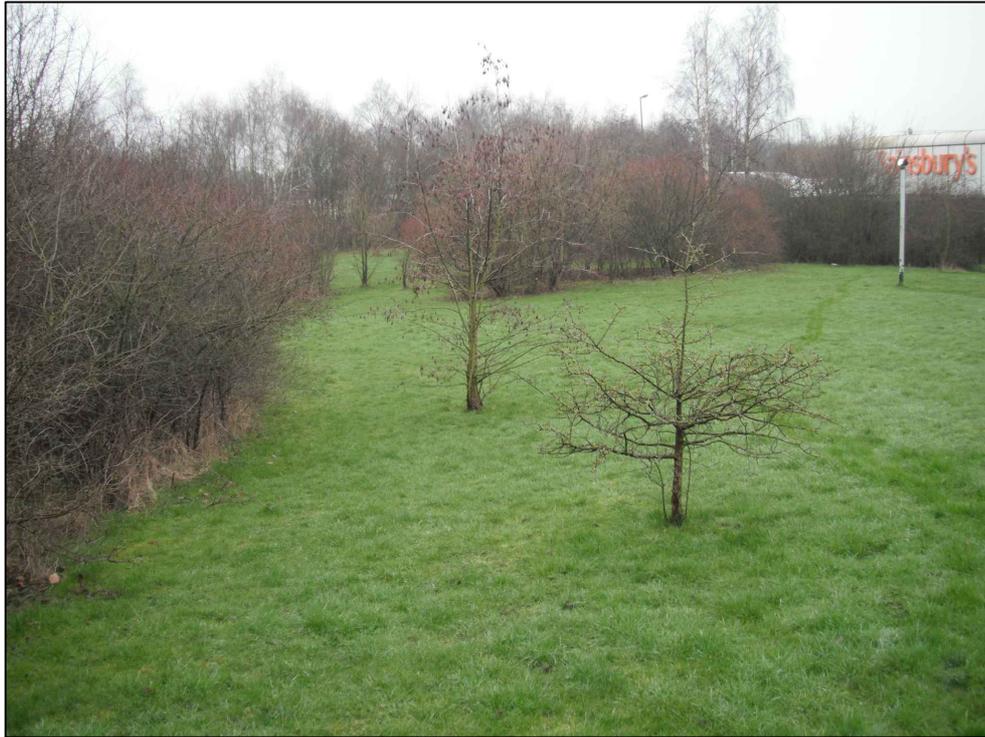
PLATE 3: View looking towards northern perimeter of the site towards the disused railway
