# A303 Amesbury to Berwick Down

### Appendix 8.6A River Habitat Survey River Avon

**Subject:** River Habitat Surveys of the River Avon

**Reference:** HE551506-AA-EWE-SWI-SU-YE- 000004 P01

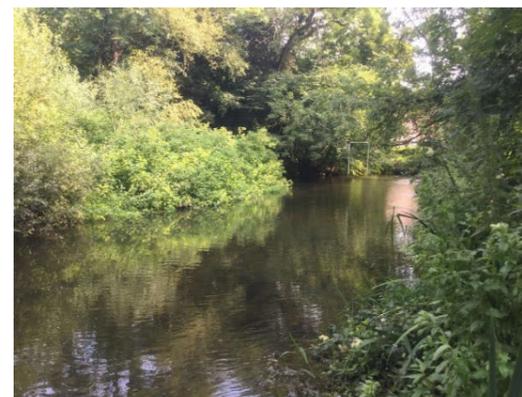
Photo ATT-14 – Upstream at the first cross-section

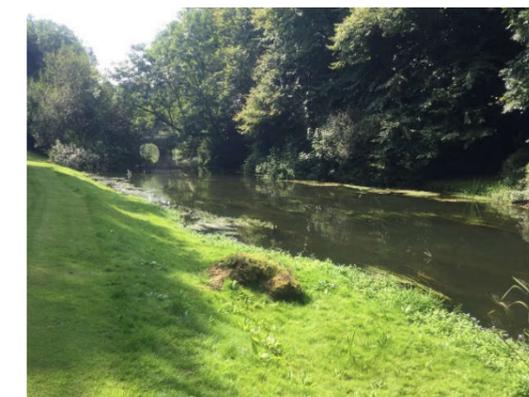
Photo ATT-17 – An artificial two-stage channel

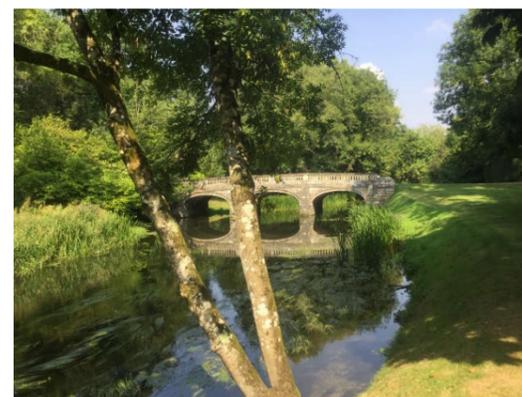
4.5.6 The channel falls into HMC 5, 'severely modified', due largely to bank and channel resectioning, and a major bridge which spans the channel at the upper section of the reach. While the channel morphology results in a high HMS, the macrophytes and surrounding trees provided fish habitat, with the River Avon through West Amesbury being renowned for its thriving grayling and trout populations.

Photo ATT-113 Looking upstream at the major bridge recorded

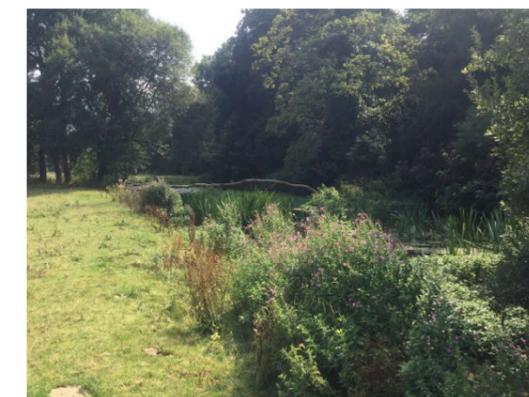
Photo ATT-124 – Abundant emergent vegetation

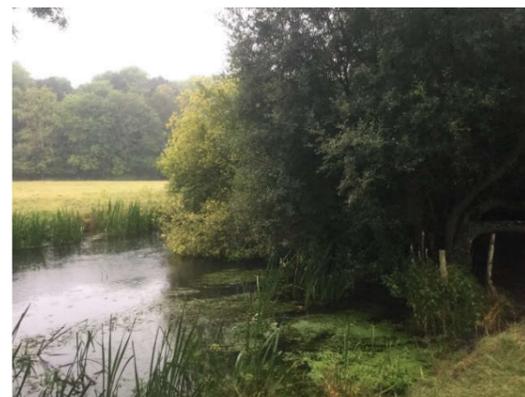
Photo ATT-132 – Overhanging boughs

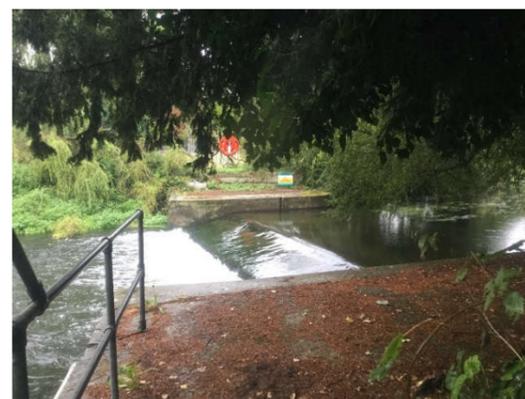
4.1.3 A6r is located immediately downstream of A5r. The surrounding land use is rough pasture with broadleaved woodland recorded in the lower section. As with A6r the channel has been historically resectioned and flow is impounded for much of the survey length by the weir, which is located upstream of spot-check 10.

Photo ATT-146 – Gauging weir

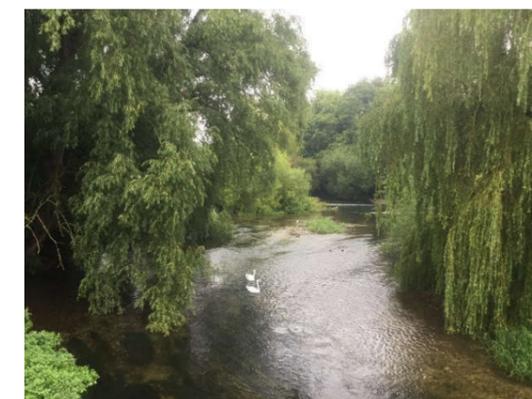
Photo ATT-147 – A view upstream of the A303 road crossing
