A303 Amesbury to Berwick Down

Appendix 8.6B River Habitat Survey River Till

Technical Note

Subject:	River Habitat Surveys of the River Till	
Date:	08 June 2017	Date amended: 10 June 2017
Reference:	HE551506-AA-EWE-SWI-SU-YE-000008	P01
Prepared by:	Bonnie Boulton

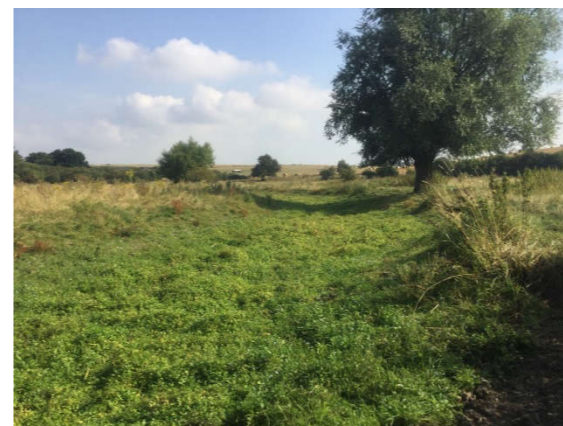
4.1.4 At the upstream extent of the survey reach the channel and banks were relatively natural, with a gentle gradient. The dry channel was overgrown with emergent broad-leaved herbs (dominated by water cress *Rorippa nasturtium-aquaticum* with water forget-me-not *Myosotis scorpioides* and brooklime *Veronica beccabunga* also recorded), indicating that the watercourse had only recently dried. No channel or bank resectioning was recorded in the upper 150m.

Photo ATT-54 – Upper section

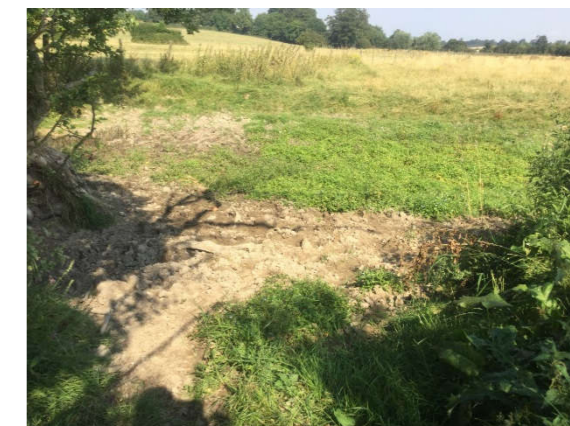
4.1.6 The channel substrate was almost consistently recorded as earth, however the bed was almost entirely covered by macrophytes, making the substrate difficult to observe. There were no livestock present at the time of survey but the banks were extensively poached (more than 33% of reach) which had caused the banks to slump in places which will accelerate sediment delivery into the channel during times of flow.

Photo ATT-60 – Bank poaching

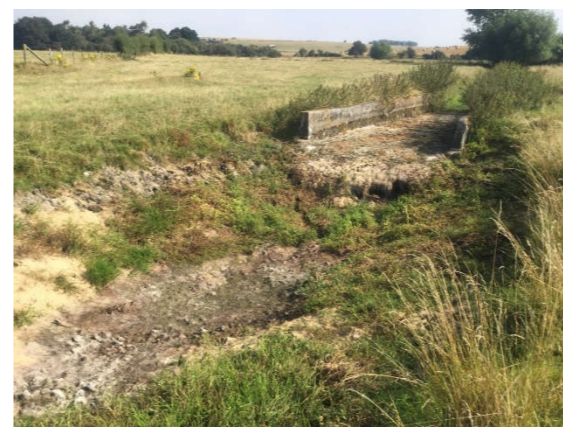
4.1.5 Moving downstream, resectioning was recorded for both the channel and banks. The channel cross-section became increasingly uniform and is likely to have been subject to historical realignment for agriculture. A number of structures were also recorded which would have acted to form the observed scour pools immediately downstream, at times of flow (see photo ATT-65). The channel falls into HMC 5, 'severely modified', as a result of the historical resectioning described above.

Photo ATT-65 – Scour downstream of structure

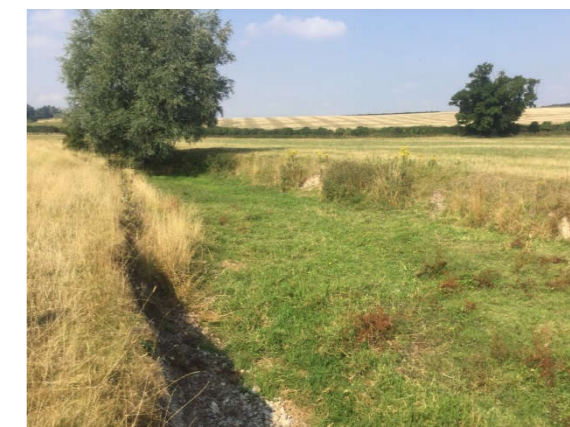
Photo ATT-74 – Modified cross-section in lower half of survey

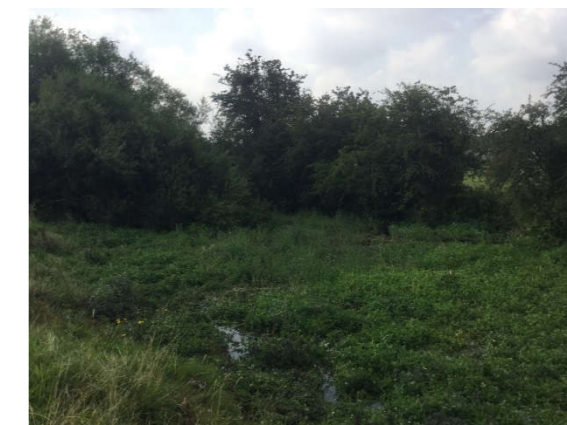
Photo ATT-89 – Channel lined by trees on right bank

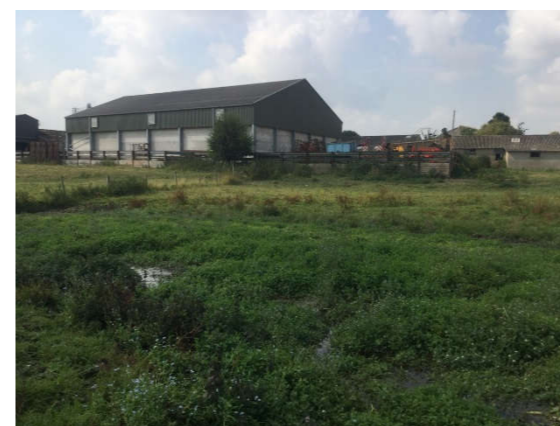
4.2.3 This section of watercourse was sited immediately downstream of T1r. The surrounding land use was rough pasture and there was evidence of historical modification through the survey reach. The channel planform comprised a relic meander through the middle sections with greater connectivity to the surrounding floodplain. In addition, clumps of trees lining the banks are likely to have helped the channel to naturalise.

Photo ATT-93 – Start of meander

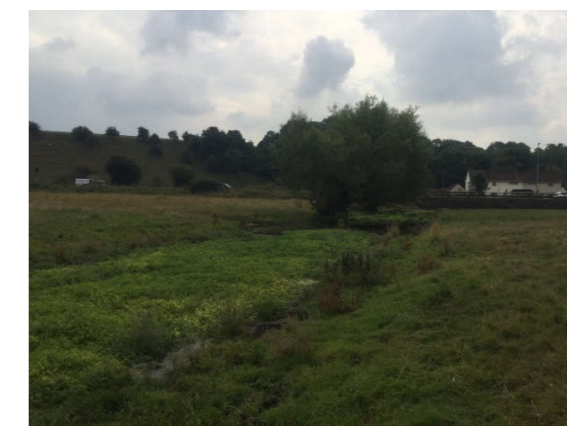
4.2.4 Despite a degree of naturalisation, bank and channel resectioning was recorded at the spot-checks in the upper and lower sections of the survey extent, where the channel planform was straight and the cross-section relatively uniform. At the lower extent the planform takes a 90 degree turn to the west to flow parallel to the A303 before it is crossed by it. Here the left bank is reinforced with concrete, which contributes to the overall HMS.

Photo ATT-98 – Straightened section immediately before the channel bends 90° to flow parallel to A303

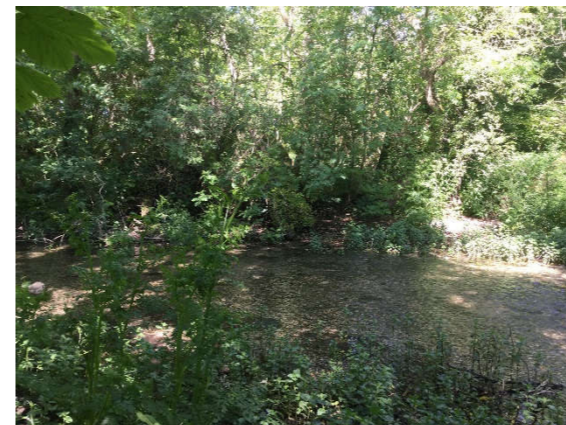
4.3.4 Given the low energy of the system and localised bank reinforcement, widespread recovery of a natural bank profile is unlikely. Where the channel was unshaded by trees the river had recovered to a more natural wetted width, predominantly through emergent marginal vegetation encroachment rather than through fluvial processes of erosion and deposition. The most widespread emergent species noted were hemlock water dropwort *Oenanthe crocata* and water mint *Mentha aquatic*.

Photo IMG_0062: The channel has a more natural width where marginal vegetation encroaches

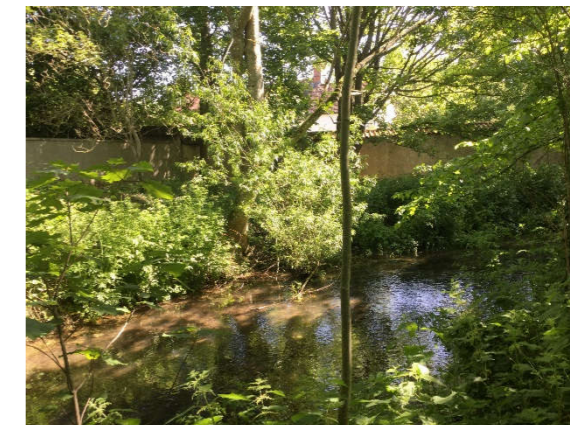
4.3.5 Semi-continuous tree cover provided extensive shading of the channel, which suppressed the growth of marginal vegetation. The tree-line did provide a source of woody channel features, with overhanging boughs, exposed bankside roots and large woody debris all recorded by the survey. These features served to locally affect substrate and flow character, and increase river habitat variability.

Photo IMG_0067: Extensive shading suppressed the growth of vegetation

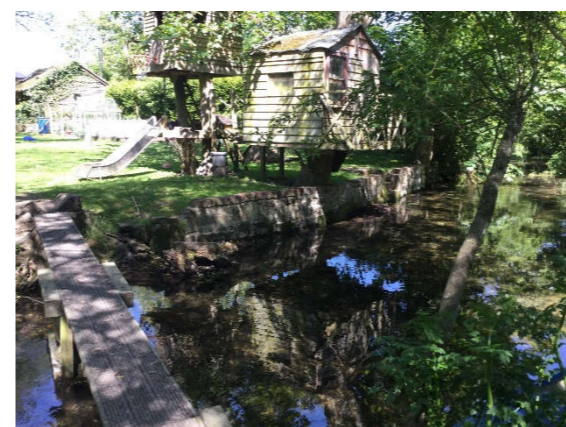
Photo IMG_0081: Minor wooden footbridge and bank reinforcement on the right bank

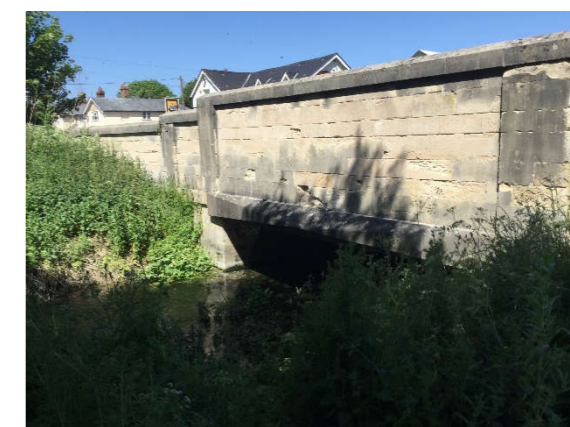
4.3.3 Surrounding land use was dominated by rough pasture in the lower half of the reach and the private gardens of Winterbourne Stoke in the upper section. Broadleaved trees almost continuously lined both banks resulting in extensive shading of the channel. Three bridges were recorded, associated with the A303 and surrounding settlement, as well as a ford to the lower extent of the reach where cattle can access the channel causing fine sediment input. In addition to these structures, the HMS is driven by widespread historical bank and channel resectioning, and isolated bank reinforcement along the right bank. However, in the lower section the bank profile had re-naturalised in places through localised deposition.

Photo IMG_0086: A303 road bridge

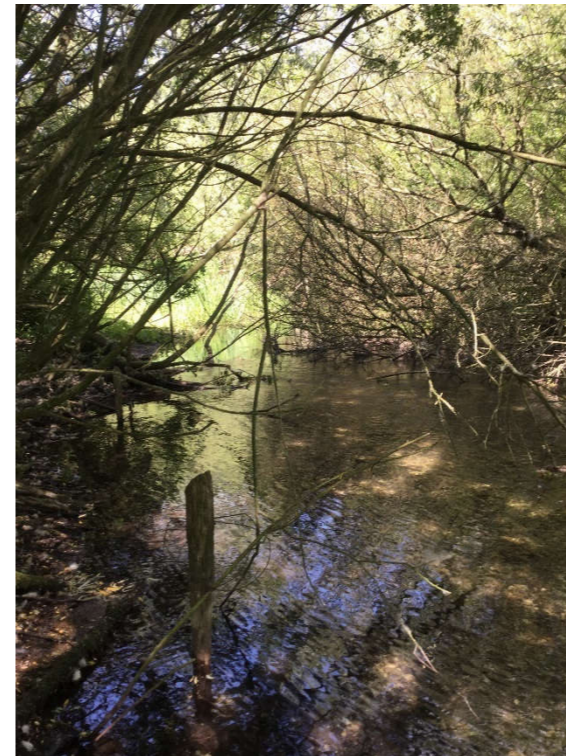
4.4.3 Surrounding land use was dominated by rough pasture with a buffer of broadleaved trees continuously lining both banks. One minor footbridge and a minor ford were recorded, these were in addition to wooden deflectors or possible historic bank reinforcement (likely decades old and in a state of disrepair). The HMS is driven by widespread historical bank and channel resectioning, the aforementioned structures and poaching at one spot-check.

Photo IMG_0040: Defunct deflectors/historic reinforcement

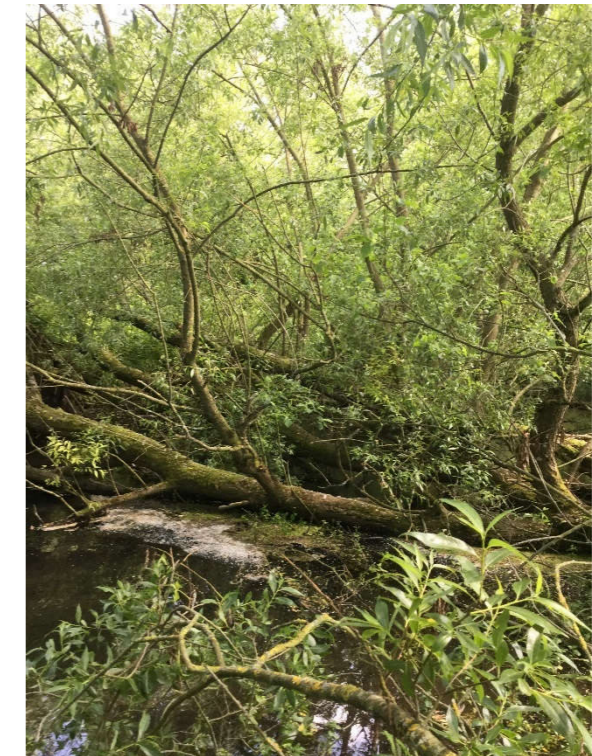
4.4.4 The channel had been historically over-widened which had led to predominantly slow laminar flows. However, the surrounding trees provided a significant source of woody debris to the channel, which caused faster flows and added habitat complexity where present. Overall, given the low energy of the system widespread recovery of a natural bank profile is unlikely, and the historical modification of the channel cross-section is likely to be decades if not centuries old.

Photo IMG_0047: Significant woody debris adds habitat complexity

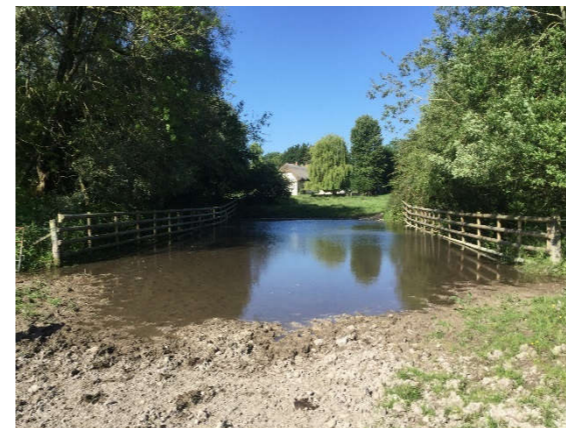
Photo IMG_0053: Ford/cattle access point

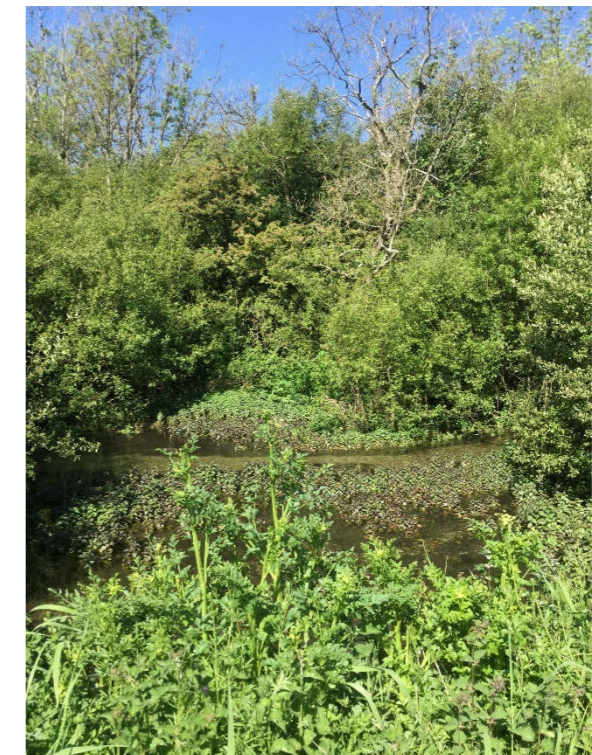
4.4.5 Where the channel was unshaded marginal vegetation encroached into the channel and acted to narrow the main flow path. *Oenanthe crocata*, *Mentha aquatic* and *Myosotis scorpioides* were the predominant species noted.

Photo IMG_0059: Marginal vegetation encroaches where channel is unshaded

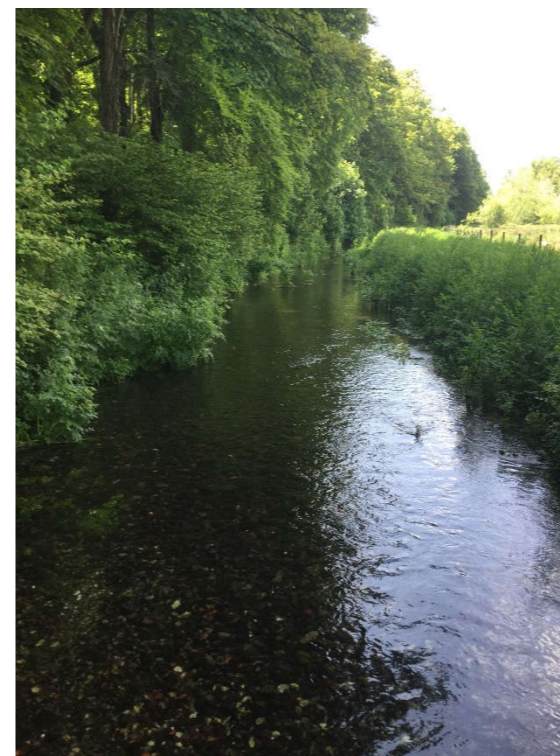
4.5.3 Surrounding land use was dominated by rough pasture with broadleaved trees semi-continuously lining the banks. Artificial structures recorded were limited to two minor footbridges. In addition to these structures, the HMS is driven by widespread historical bank and channel resectioning, localised reinforcement and poaching at one spot check. The upper section of the reach is over-wide and heavily shaded, similar to Tr4 upstream. At spot check 7 the channel narrows but remains heavily modified, with any bank recovery almost entirely absent.

Photo IMG_0018: The channel highly modified and shaded on the left bank

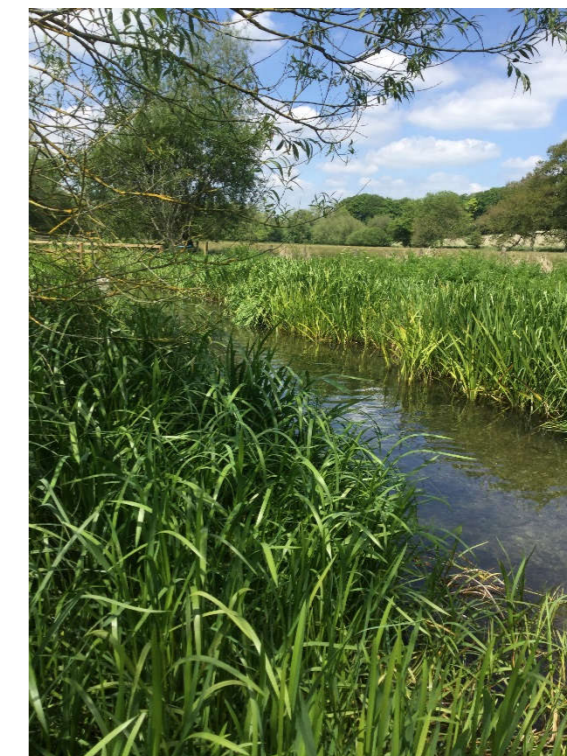
4.5.4 Downstream of spot check 7 the river recovered a more natural width through fringing reeds on banks narrowing the flow, rather than through fluvial processes of erosion and deposition. In the lower section the left bank is confined by the valley side, which is wooded and acts to shade the channel. Despite some shading, marginal vegetation encroaches, primarily *Oenanthe crocata* on the right bank. Downstream of the reach (start of T6r) a historic sluice structure forces the channel to take a right-angle bend to the north west. Despite this, flows were faster though the lower section than upstream with clean gravel substrate dominant.

Photo IMG_0022: Fringing reed banks

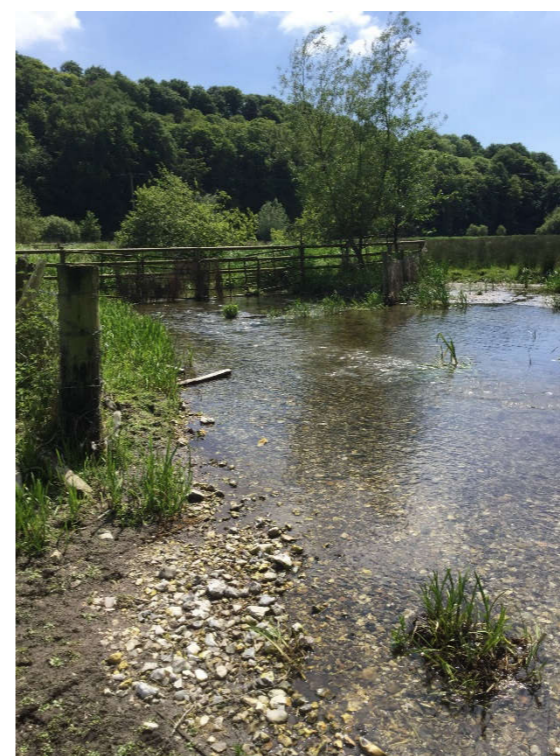
Photo IMG_0031: Cattle access point

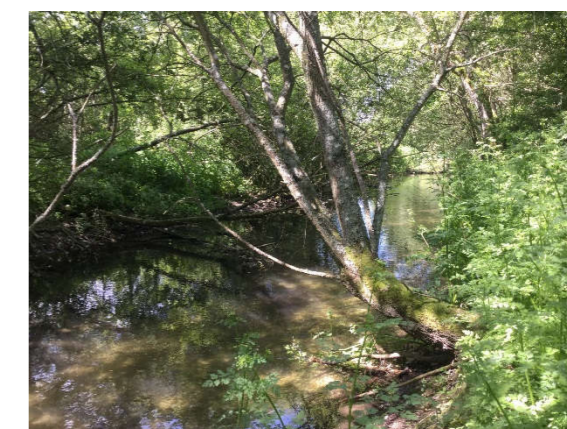
Photo IMG_0036: Heavily shaded channel through tree-lined section in the upper half of the reach

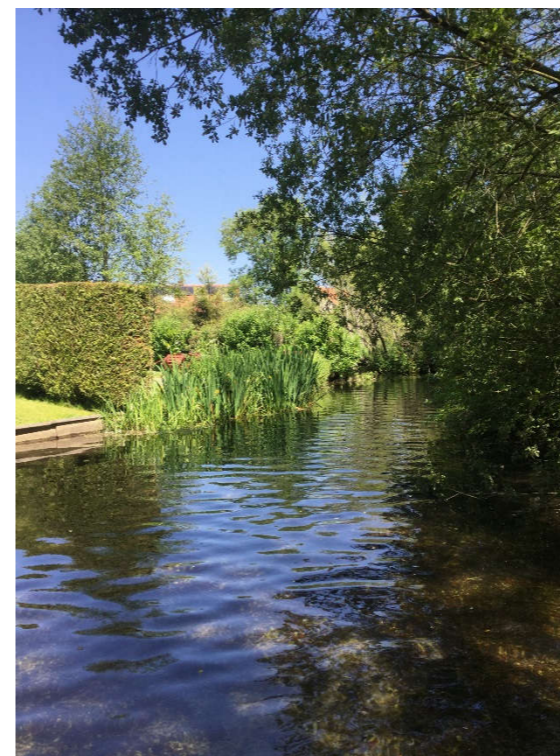
Photo IMG_0089: A view upstream of the road crossing at Berwick St James

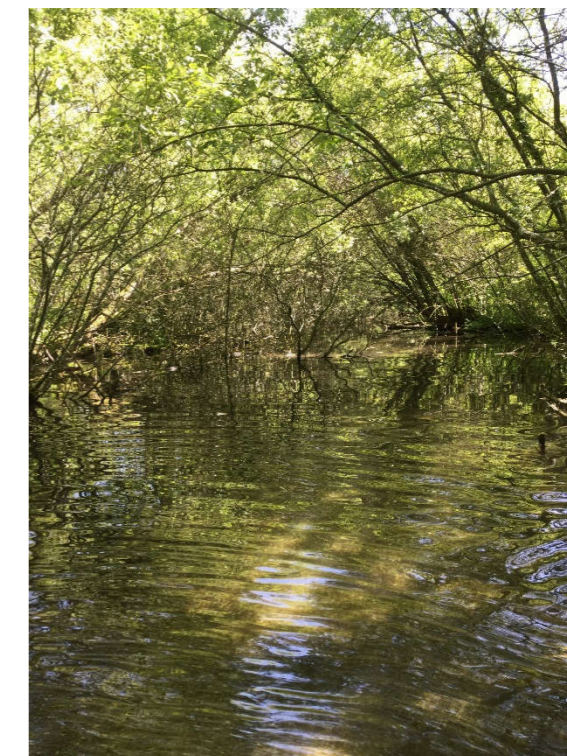
4.6.4 Upstream of the sluice the channel maintained the same character as T5r upstream; shaded on the right bank confined by the valley side with marginal vegetation encroaching from the left bank. Downstream of the sluice the channel was overwide and extensively shaded by trees (predominantly willow). Through this lower section the water was deeper, flows were slower and the margins were covered in silt. Due to the extensive shading, in channel vegetation growth was minimal. Despite an absence of marginal habitat from in-channel vegetation, the tree-lined banks provided a source of woody debris, bankside routes and over-hanging boughs. These features served to locally affect substrate and increase river habitat complexity.

Photo IMG_0095: A over-wide heavily shaded channel for majority of reach

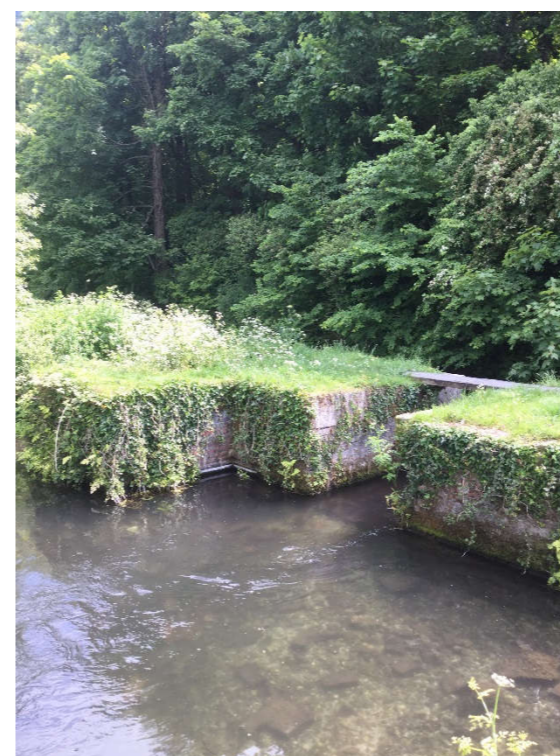
4.6.3 Surrounding land use was dominated by broadleaved woodland on both banks. The woodland was bordered by the village of Berwick St James on the right bank and rough pasture on the left bank. A major sluice was recorded in the upper half of the reach and an intermediate bridge at the road crossing marked the end of the reach. In addition to these structures, the HMS is driven by widespread historical bank and channel resectioning, localised reinforcement (largely associated with the sluice structure), a minor outfall at the bridge and defunct wooden deflectors/historic reinforcement.

Photo IMG_007: Historic sluice structure

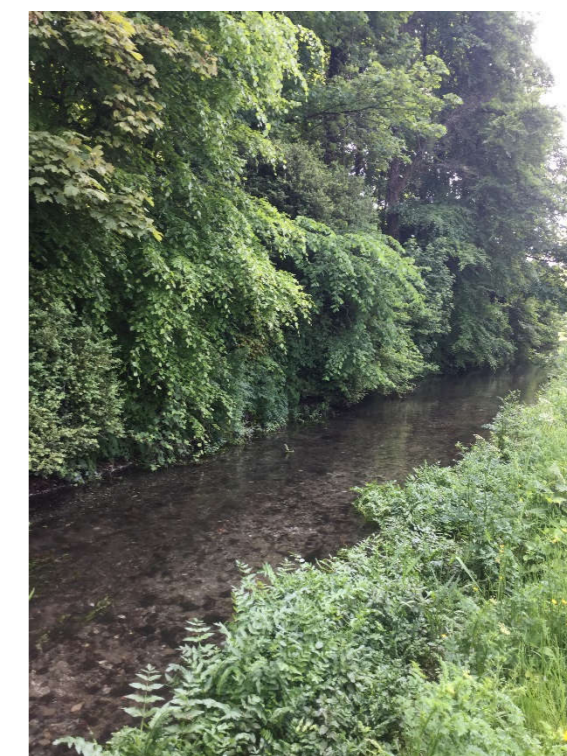
Photo IMG_0012: Upstream of the sluice the channel is shaded on the left bank
