A1 Birtley to Coal House

Scheme Number: TR010031

6.3 Environmental Statement – Appendix 8.4 Preliminary Roost Assessment

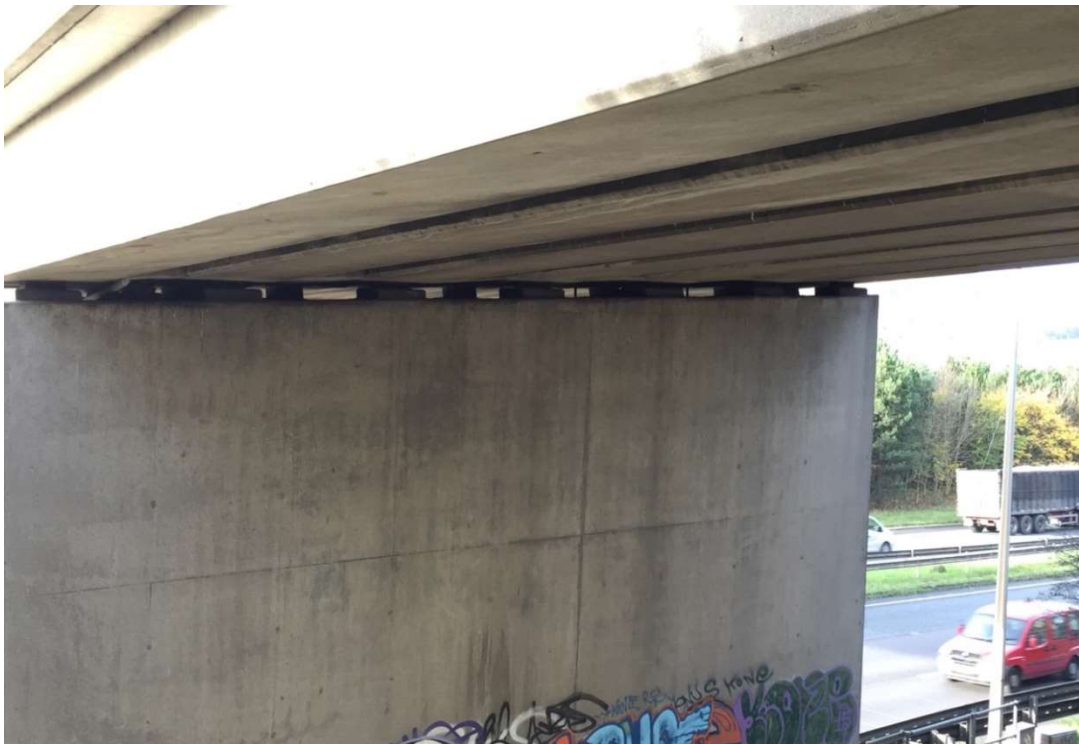
Photo 2- Potential roosting feature of the gaps between abutments and bridge deck on Smithy Lane Overbridge, as well as the gaps between the concrete beams on the underside of the bridge deck

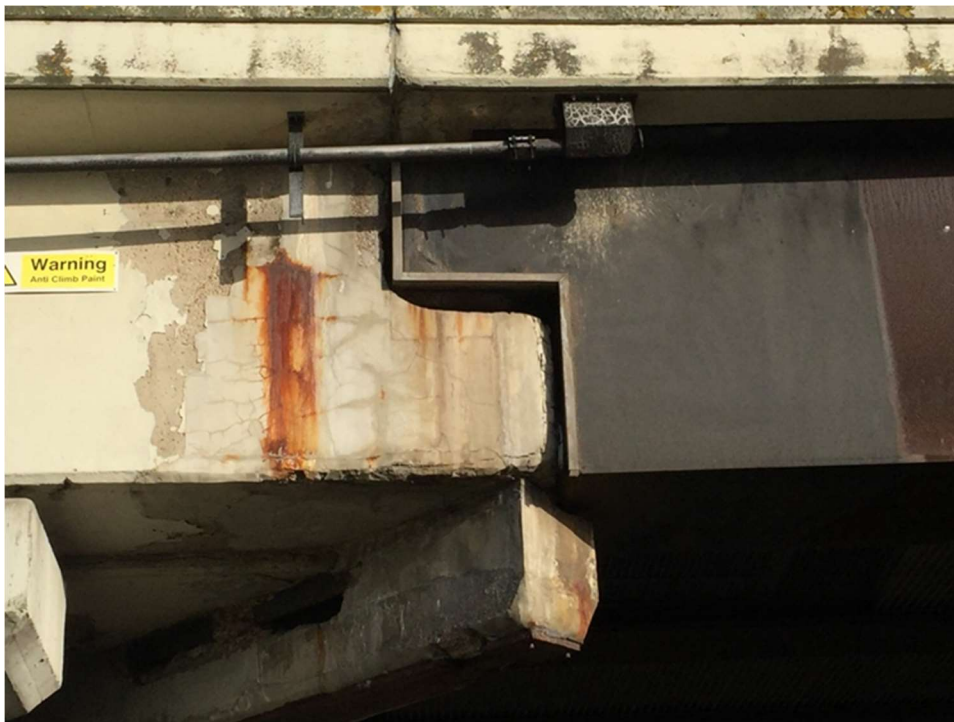
Photo 4- Potential roosting feature of the cavity between the concrete and steel deck structure on the southern end of the western pillar on Allerdene Bridge

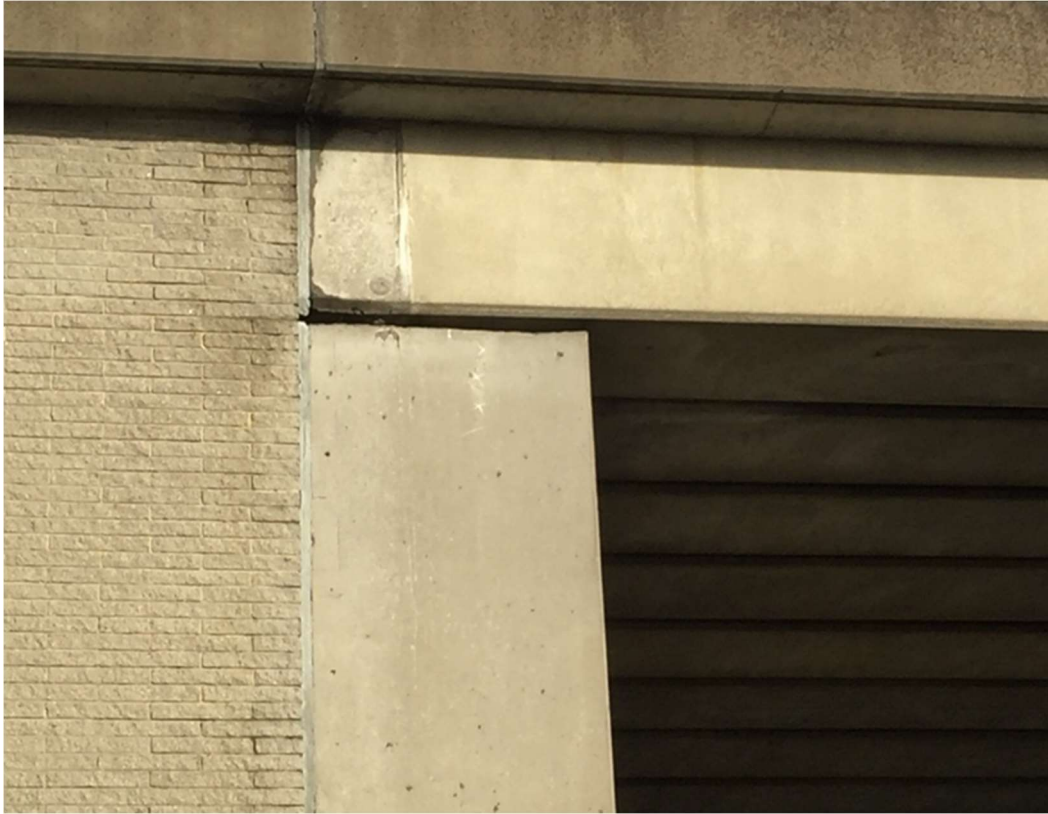
Photo 7- Potential roosting feature of the gap between the abutment and bridge deck on the north-east side of Eighton Lodge north underbridge

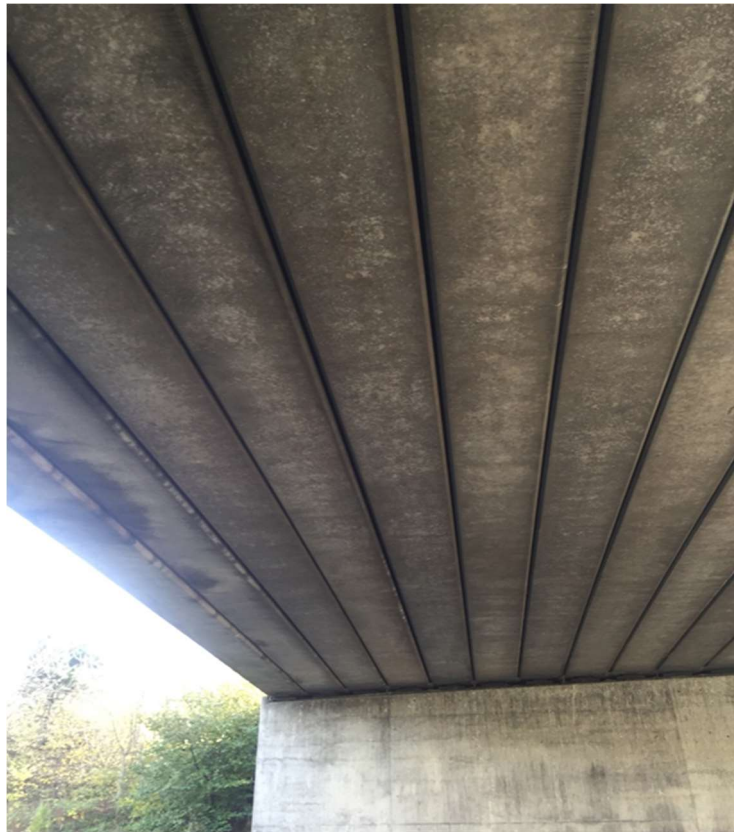
Photo 8- Potential roosting feature of the gaps between the concrete beams on the underside of the deck of Eighton Lodge north underbridge

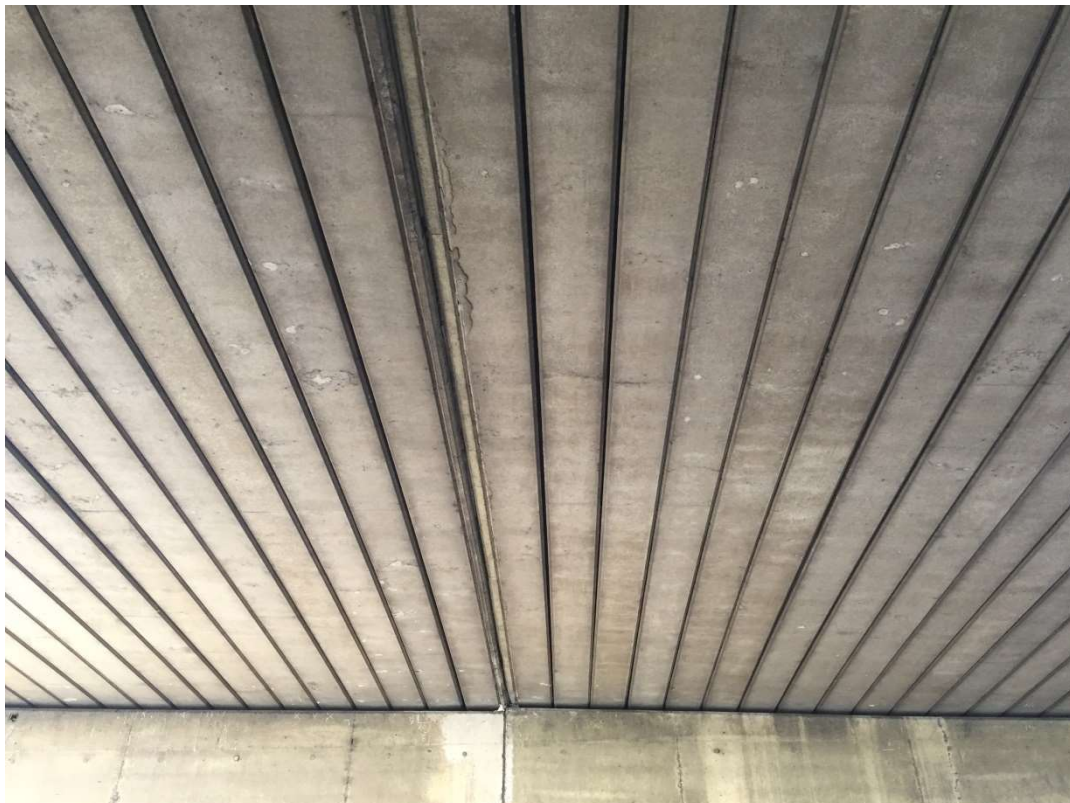
Photo 10- Potential roosting features of the gaps between the parallel concrete beams on the underside of Eighton Lodge south underbridge

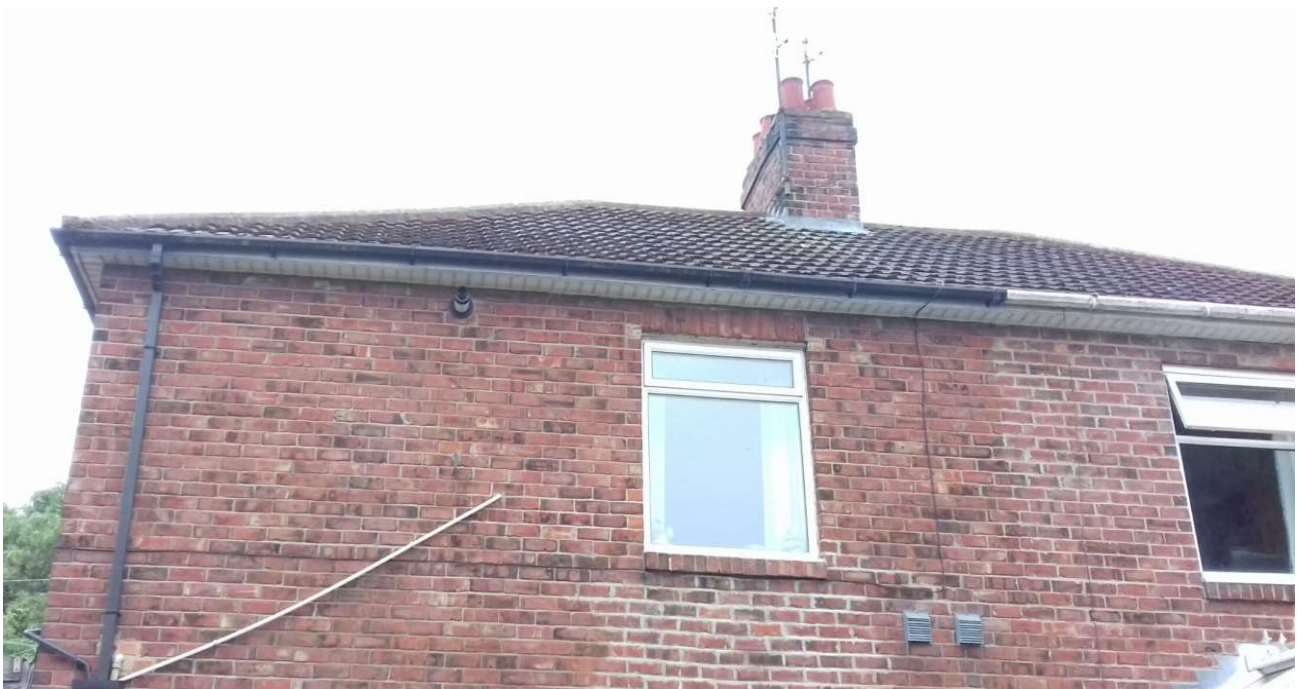
Photo 16 – North facing elevation of Building B1, with evidence of a new roof and brickwork following a recent leak, as clarified by the homeowner.

2	Red brick property in good condition. Recently repaired roof was in good condition with neat flashing and neat tiles. Ridge looked sound. Soffits and eaves had no gaps or cracks. 3 bird boxes (2 rear and 1 gable). No value. Negligible

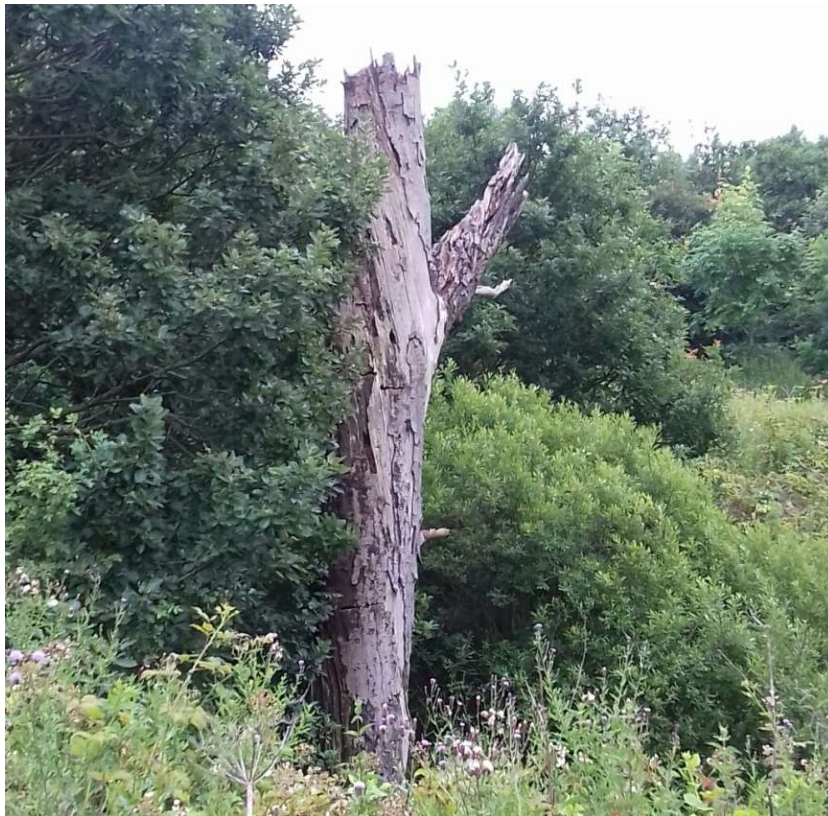
Photo 18- Evidence of holes in Tree T1

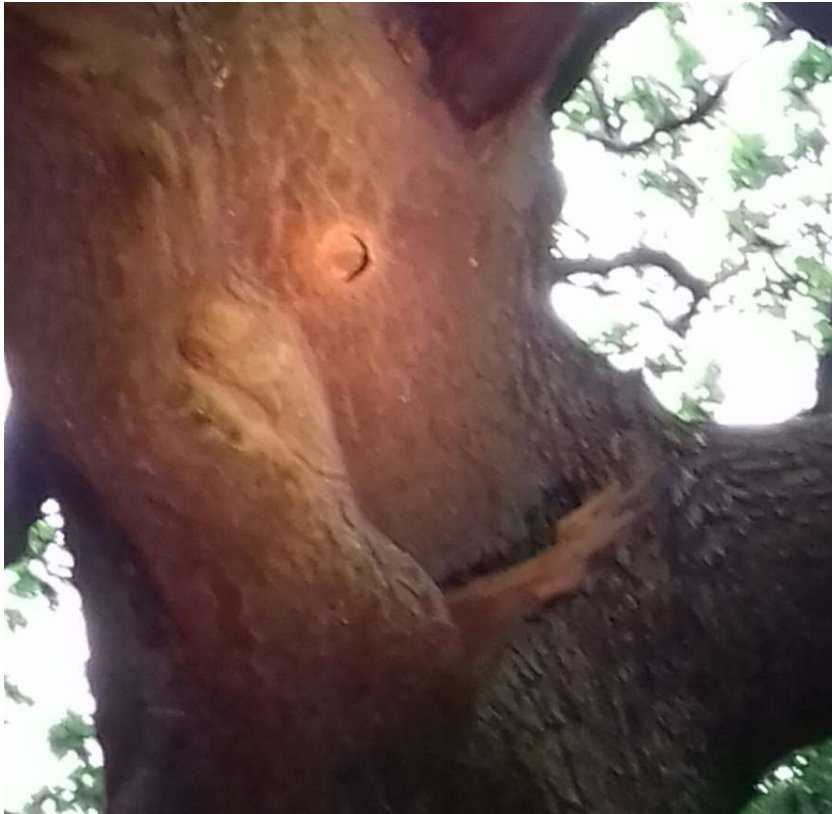
Tree No (T#)	Tree Species	Grid Reference	Description of Tree	Description of Potential Roosting Features	Evidence of roosting bats recorded?	Overall Assessment of Suitability to Support Bat Roosts	Further Survey Effort Required?
T1	Unknown	NZ 25898 58204	An over mature dead tree of unknown species. The tree is dead and there is significant evidence of rot and potential ingress of water. Surrounding habitat includes scrub and immature woodland.	<ul style="list-style-type: none"> ■ Flaking bark; ■ Rot holes; ■ Woodpecker holes; and ■ Evidence of damp rot has reduced the classification. See Photo 18. 	None	Moderate	No
T2	Oak species <i>Quercus</i> sp.	NZ 26004 57936	A mature tree approximately 12 meters tall. Bird box is situated on the northern elevation. Situated in a semi-mature plantation woodland.	<ul style="list-style-type: none"> ■ Three woodpecker holes; ■ Two rot holes; ■ A slim hazard beam; ■ There are splits at the top but these are likely to let in water. See Photo 19. 	None	Moderate	No

Photo 19 – Woodpecker hole on underside of trunk in Tree T2

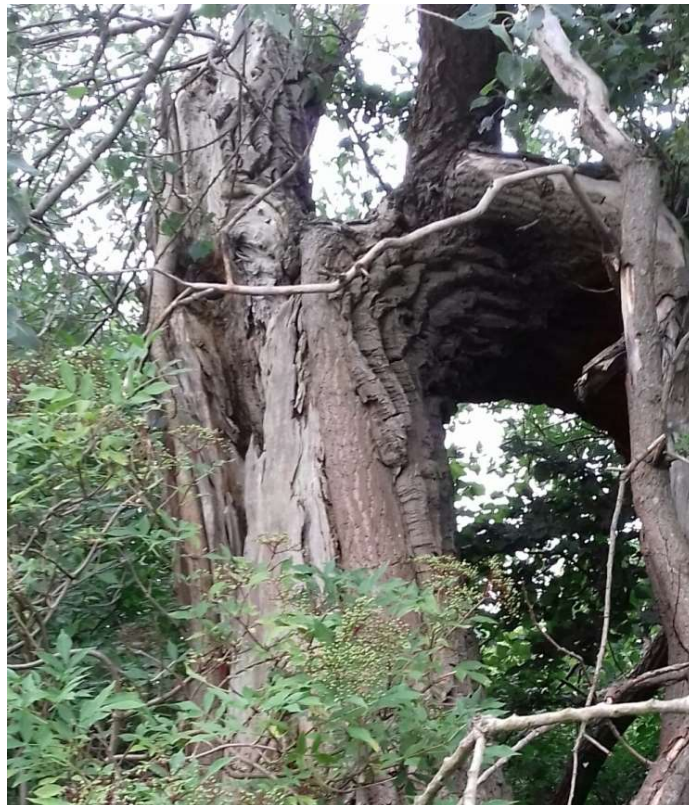
Photo 20 – Large cavity/hollow in trunk of Tree T3, likely as a result of a tear out.

- 5.1.14. Due to Tree T3 having 'Low' suitability, no further survey effort is required according to good practice guidance (Collins, 2016).
- 5.1.15. Tree T4 is classified as having 'Moderate' suitability for roosting bats and is within an area of land required for the Scheme. Subsequently, it is recommended that an endoscope survey of the cavity located on the tree trunk at chest height should be carried out prior to works commencing in close proximity to the tree.

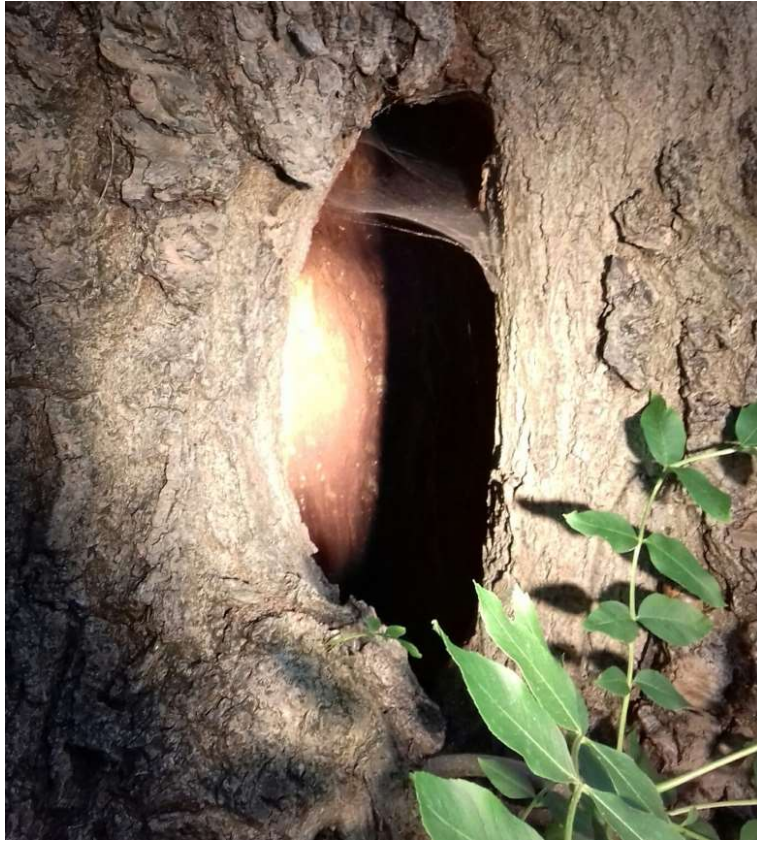
Tree No (T#)	Tree Species	Grid Reference	Description of Tree	Description of Potential Roosting Features	Evidence of roosting bats recorded?	Overall Assessment of Suitability to Support Bat Roosts	Further Survey Effort Required?
T3	Crack willow <i>Salix fragilis</i>	NZ 25090 58510	A mature tree situated on woodland edge near hedgerows. The 10 m tall tree contained features although they were heavily exposed to the elements.	<ul style="list-style-type: none"> The trunk is completely hollow and open to the elements along its length. Holes in the trunk provide access to the cavity. See Photo 20. 	None	Low	No
T4	Ash <i>Fraxinus excelsior</i>	NZ 25090 58452	A mature tree measuring approximately 15 meters tall was recorded along woodland edge and hedgerow habitats.	<ul style="list-style-type: none"> A single large hole at chest height was recorded. Hole is obstructed by branches. See Photo 21. 	None	Moderate	Yes

Photo 21 – A very advanced knot holes that has formed a large chest height rot hole in Tree T4

4	Ash tree. Approximately 15m tall. Mature tree, situated in woodland edge/hedgerow habitat. The ash has a large hole at chest level blocked by branches. Moderate.		
5	Oak species. Approximately 20m tall. Mature tree situated in small copse in splitter island. Tree has thin ivy exhibiting no crawl spaces or decent crevices. Remainder of the tree is in good condition with no features. Negligible.		
Woodland 1	0.46 ha of broadleaved semi-natural woodland comprising of semi-mature alder <i>Alnus glutinosa</i> , ash <i>Fraxinus excelsior</i> , field maple <i>Acer campestre</i> , oak species <i>Quercus</i> sp., willow species <i>Salix</i> sp. and horse chestnut <i>Aesculus hippocastanum</i> . Approximately 180 trees are present within this woodland, all of which have no bat roosting features and therefore all have negligible potential.		
Woodland 2	0.81 ha of broadleaved semi-natural woodland comprising of semi-mature alder, ash, field maple, oak species, willow species and horse chestnut. Approximately 135 trees are present within this

- 5.1.16. Should the endoscope survey indicate the presence of roosting bats and the tree is to be impacted or lost as part of the Scheme, a European Protected Species mitigation licence may be required from Natural England to permit the works. As part of the licence application, a mitigation and compensation strategy would be developed and implemented; detailing actions to avoid or reduce the potential impacts to roosting bats and how any loss or damage of roosts will be adequately compensated for.
