A417 Missing Link
TR010056

6.4 Environmental Statement
Appendix 13.11 Water Features Survey
(Part 1 of 2)

**6.4 Environmental Statement
Appendix 13.11 Water Features Survey
(Part 1 of 2)**

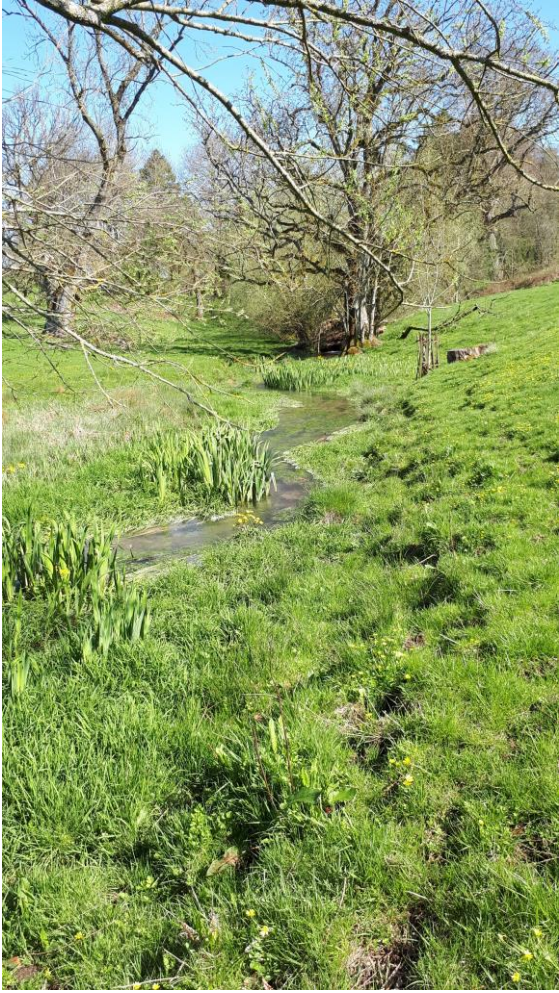
42_looking N US showing pooling and break of R
bank_190418

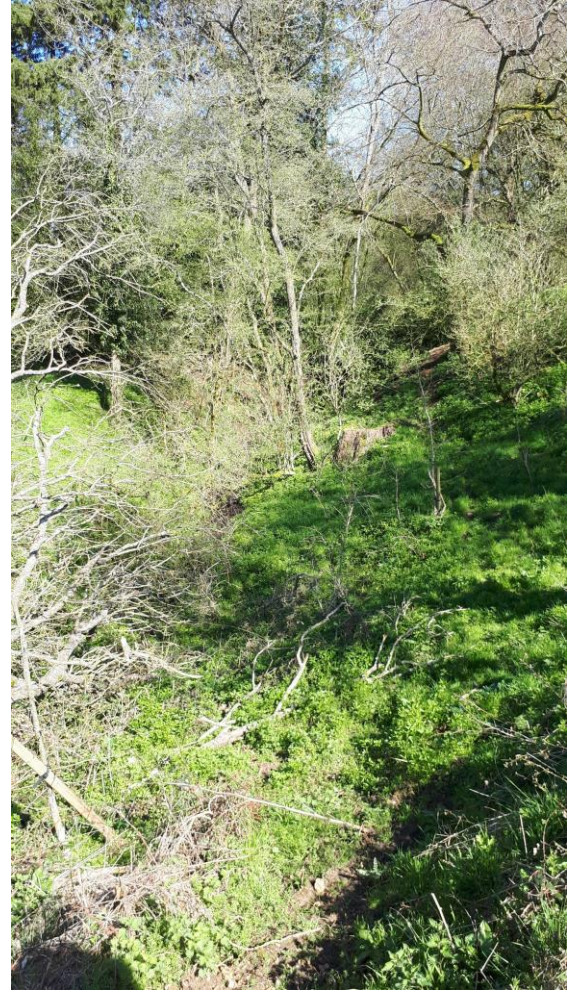
43_looking N US breaking
watercourse banks_190418

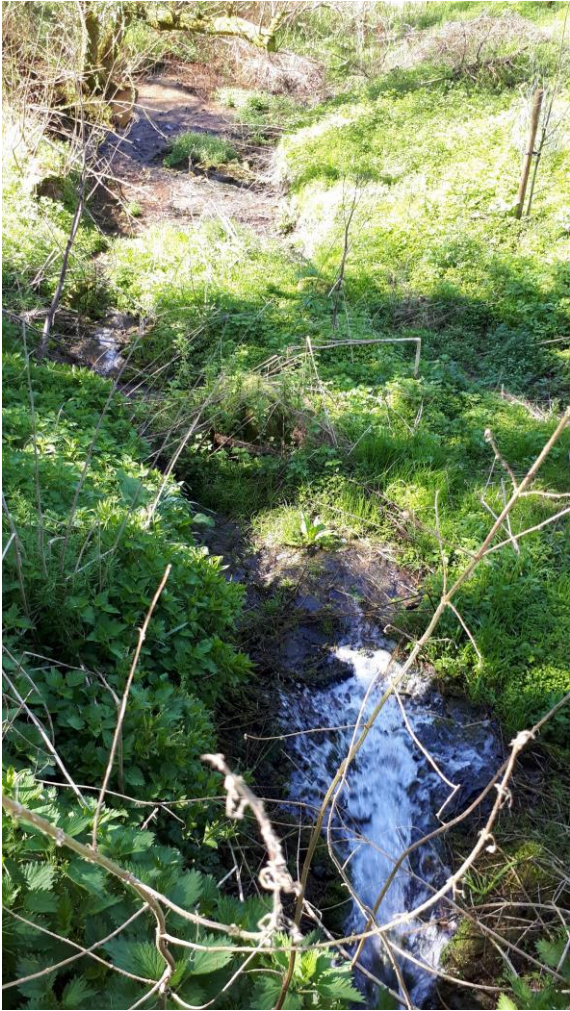
46_looking NE shows culvert_190418

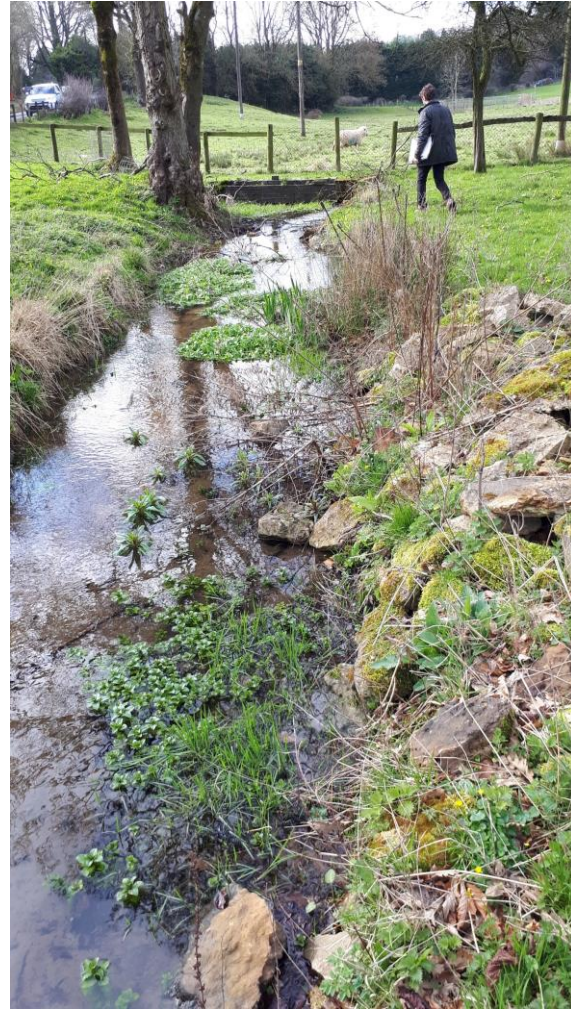
92_looking N US of 91_outfall
likely from road drainage

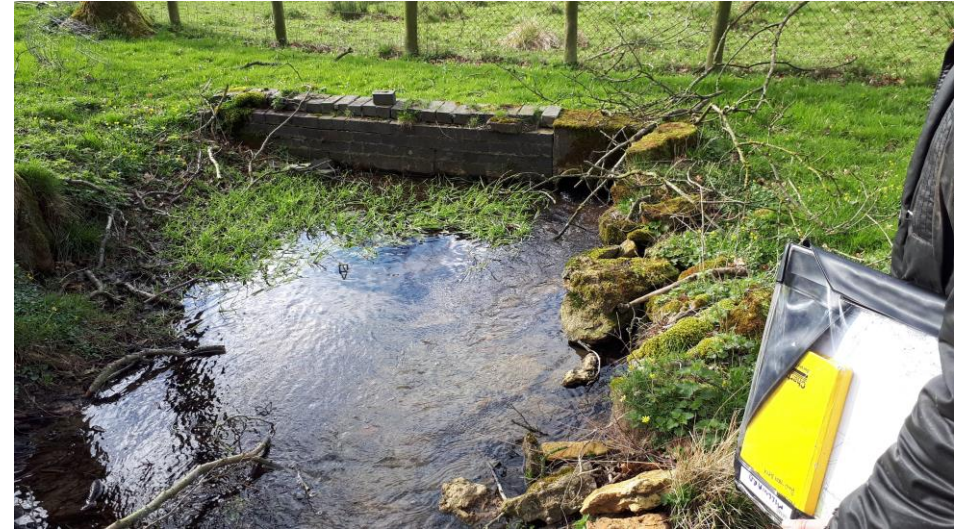
93_looking US of culvert and outfall,
showing outfall of flows from golf course,
college and seepages

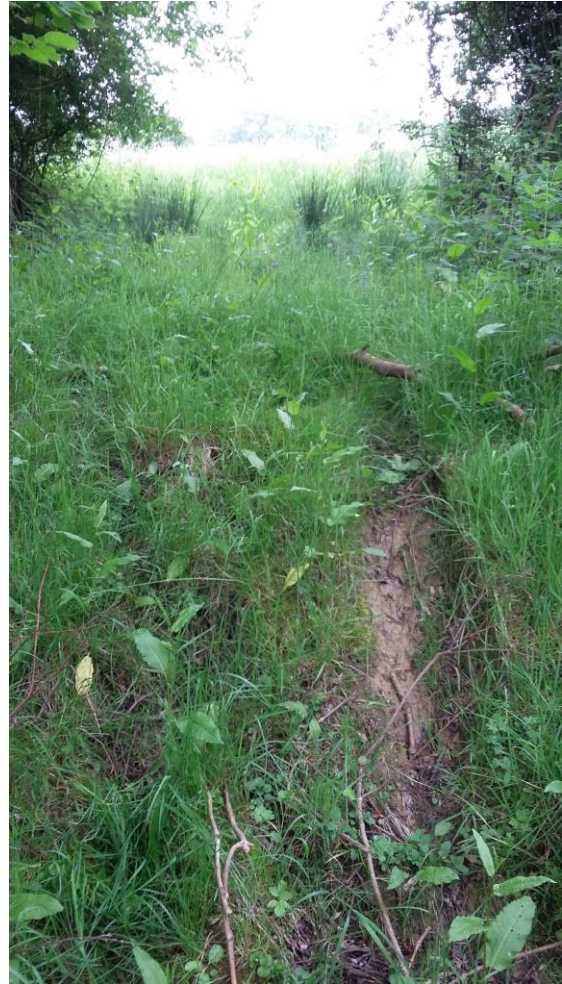
G58_spring fed watercourse
culverted under road facing S

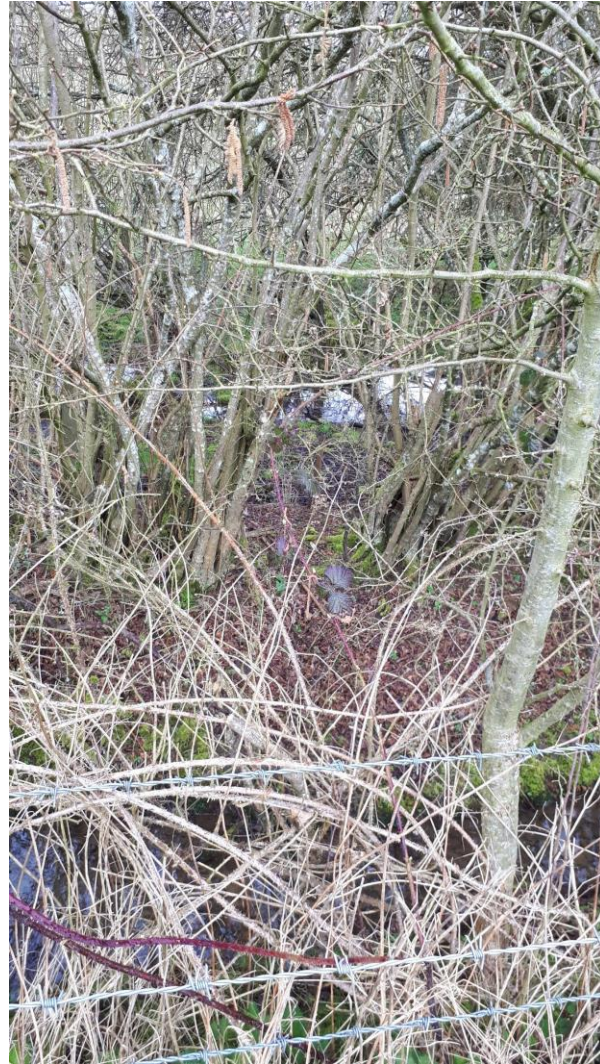
G136 _ disused well at Stockwell Farm
