A417 Missing Link
TR010056

6.4 Environmental Statement
Appendix 8.25 Tufa-forming
Springs: Selection of Potential
Compensation Sites

A417 MISSING LINK SCHEME

**TUFA-FORMING SPRINGS
SELECTION OF POTENTIAL COMPENSATION SITES**

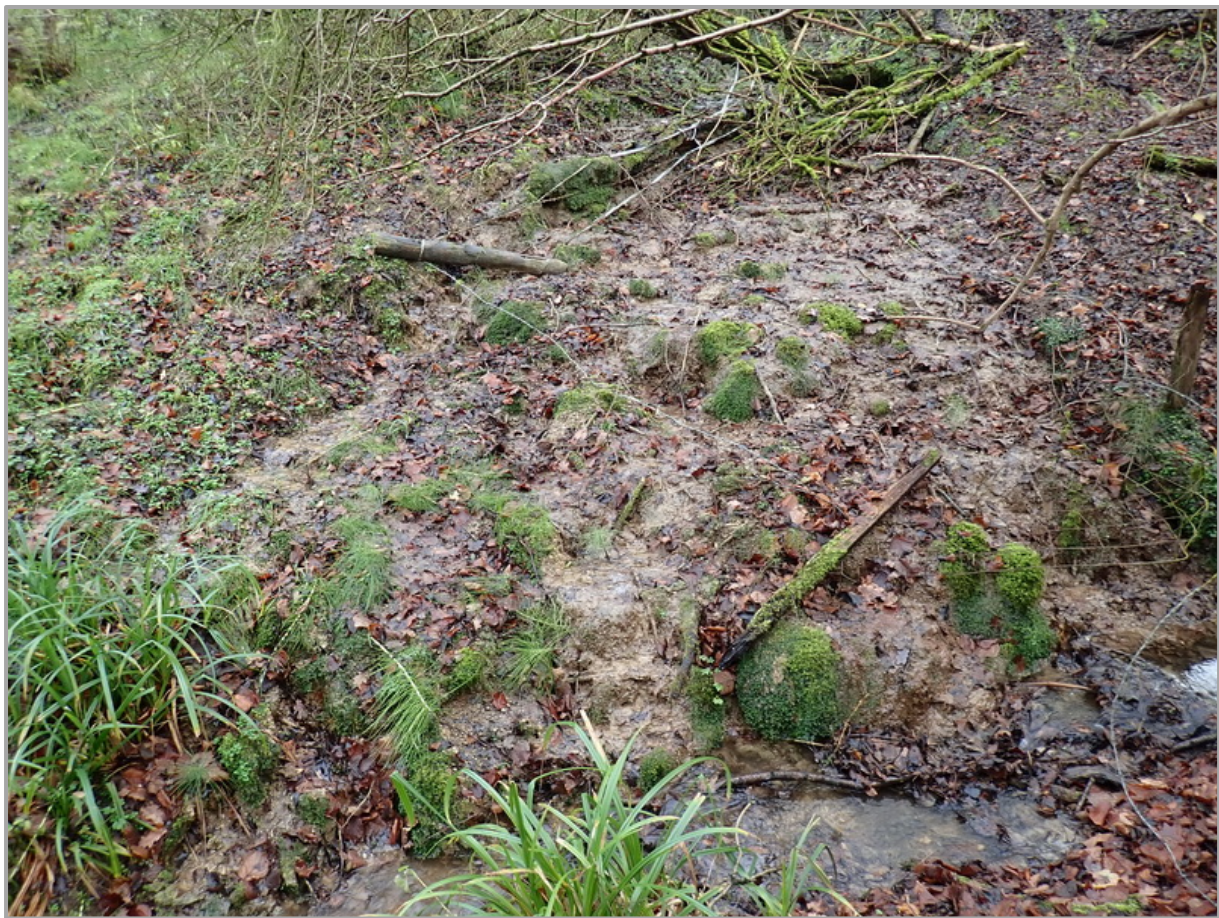
This is a small but actively depositing tufaceous spring rising on the eastern bank of a small stream at the edge of secondary stream corridor woodland. The distance from the spring to the point where it meets the stream in a low tufa step is approximately 12m. It is approximately 5m across at this point. There has been significant deposition of tufa and fan deposits are estimated to be mostly around 0.5m deep.

Although the water feeding this feature is clearly supersaturated with calcium carbonate, there is no *Palustriella commutata*, which suggests that the spring may on occasion cease flowing and/or that there is insufficient ambient light. It is therefore a poor example of the M37 *Palustriella commutata* - *Festuca rubra* spring community.

Plate I. Tufa fan at SO 92530 15488

- Feature B would benefit from the removal of the remains of a fence (wooden posts and wire) that have fallen on to it, as well as other dead wood remains on the surface of the tufa fan.
- Its vegetation would also benefit from more light reaching the tufa and therefore selective cutting back of scrub and trees immediately to the south (downhill of the fan) is recommended.

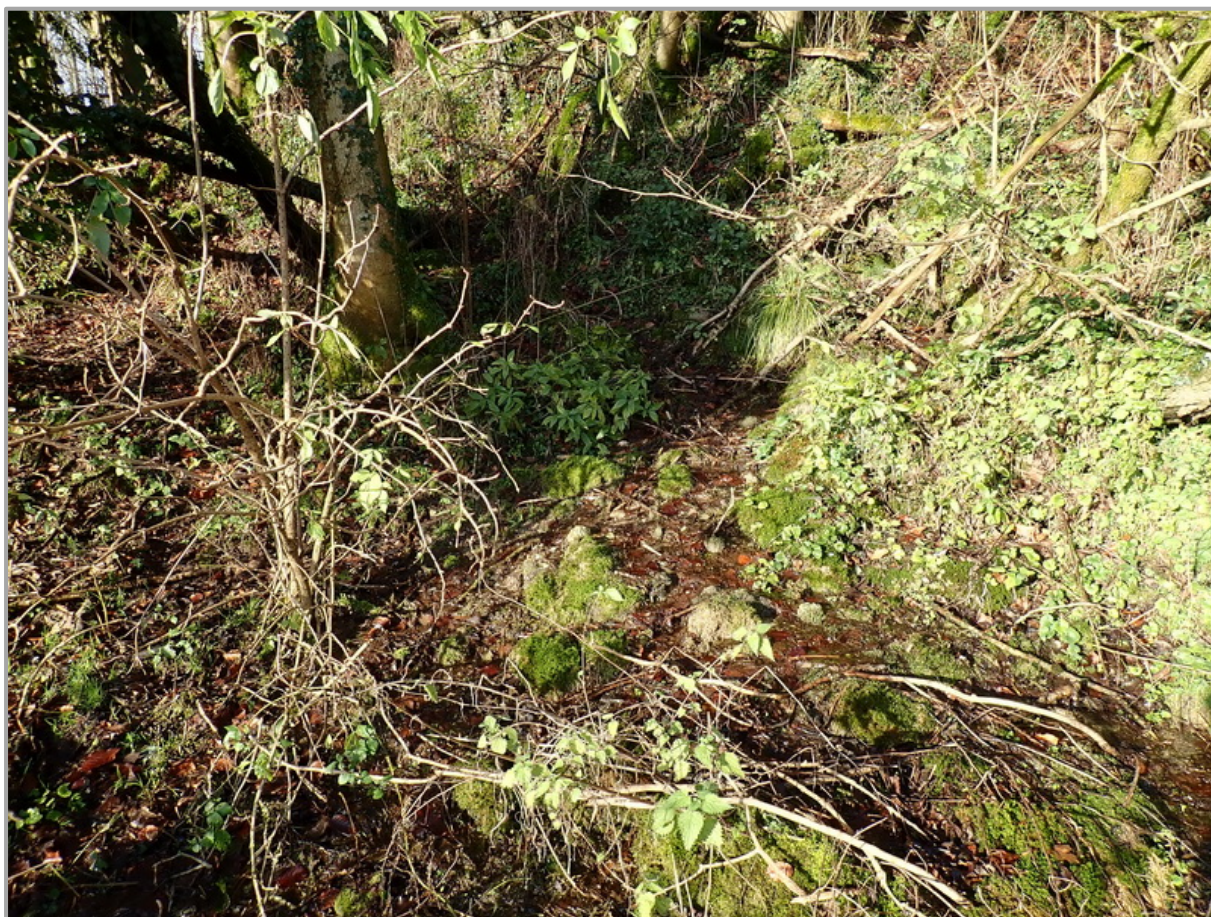
Its vegetation is an intact example of the M37 *Palustriella commutata* - *Festuca rubra* spring community. Tufa is actively forming, and the lack of disturbance has promoted accretion.

Plate 2. Tufaceous spring at SO 94251 13391

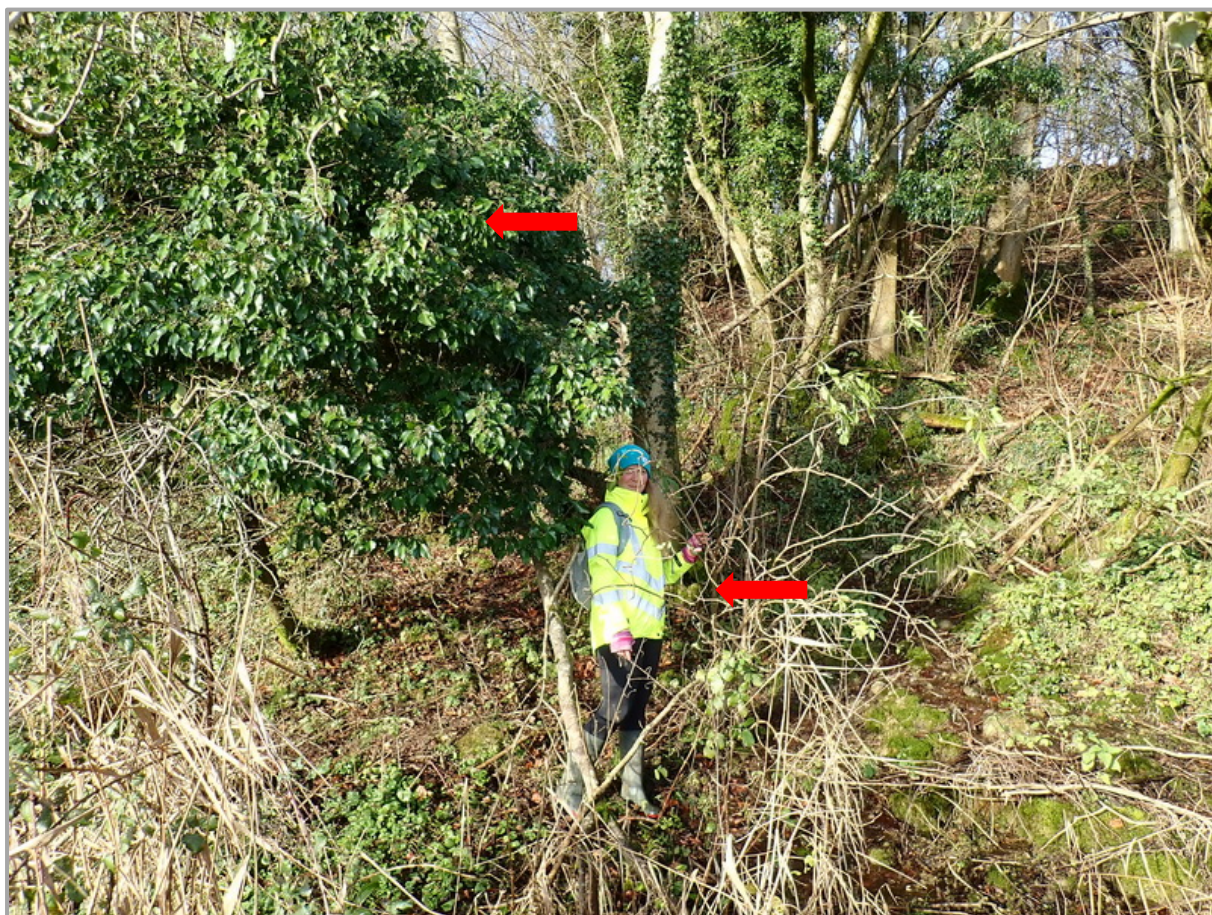
Plate 3. Locations of Elder and Common Ivy to prune back (arrowed)

- As the spring is on the edge of the wood and faces south-east, it receives quite a lot of light which is important to certain tufa-forming bryophytes especially *P. commutata*. Hard pruning of a small

Elder *Sambucus nigra* bush that is growing in the tufa (lower arrow, Plate 3) would help to prevent any increase of shading.

- A substantial colony of Common Ivy *Hedera helix* is growing on a near-horizontal branch a few metres to the south of the tufa (upper arrow, Plate 3) and this will to some extent block daylight. It is recommended that the ivy is pruned back as much as possible. However, no cutting back of any trees, shrubs or climbers immediately to the north or east of the tufaceous spring should be undertaken; a Field Maple *Acer campestre* a few metres away supports a small population of *Pylaisia polyantha*, which is a Nationally Scarce epiphytic moss.

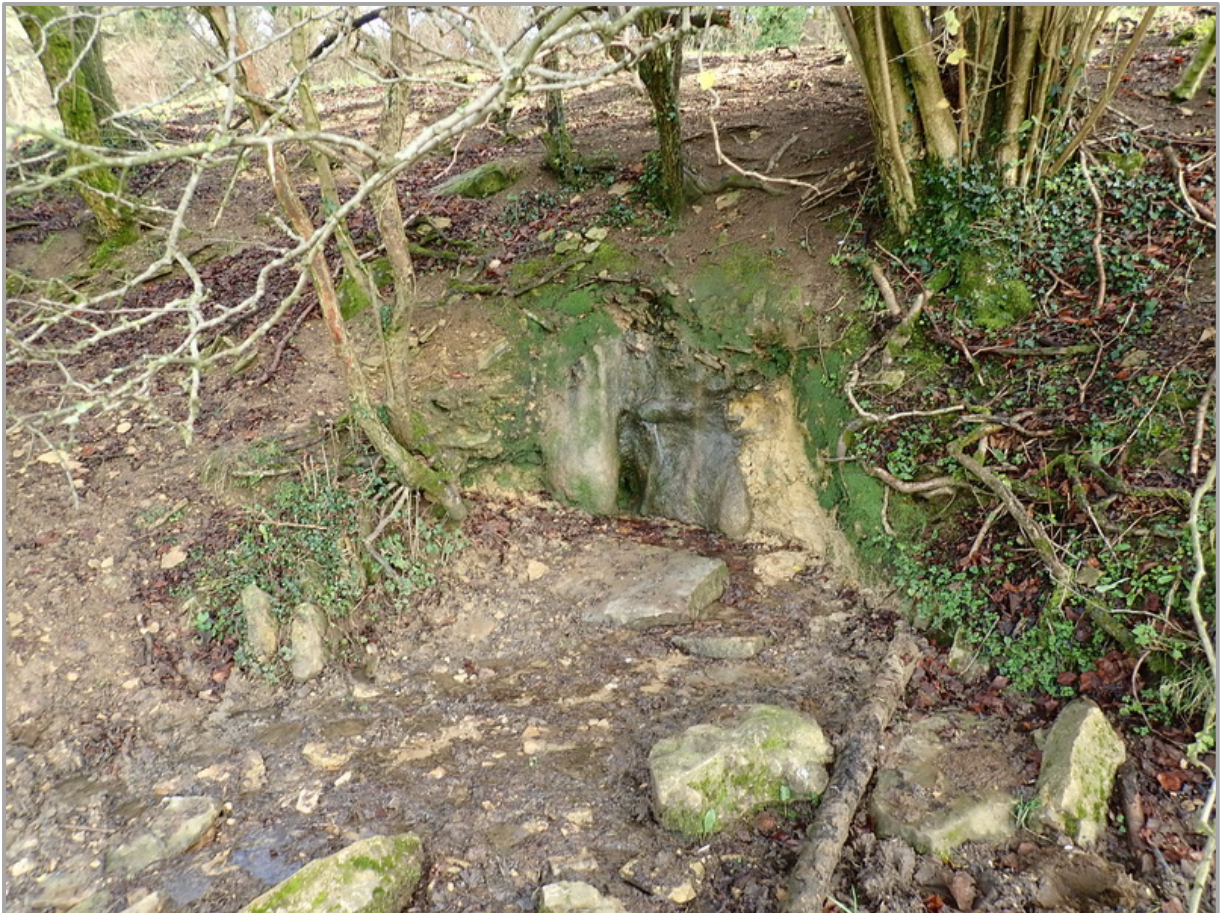
Feature G is situated at the base of a west-facing scrubby bank in grazed pasture. A single spring with low flow rises within a consolidated block of tufa and trickles out a few metres into the pasture before disappearing below ground (Plate 4). The spring is open to livestock and the tufa block and surrounds are poached and eroded. The feature lacks *P. commutata* but does support a strong population of *Eucladium verticillatum*, a small moss also often found in tufa-depositing springs. *C. filicinum* and *P. endiviifolia* are also present.

Although it is clear that this spring has actively accreted tufa in the past, it currently appears to be vulnerable to seasonal drying and may no longer be actively depositing. It is also in shade below scrub and damaged by livestock which visit it to drink and perhaps shelter so its condition is currently poor.

Plate 4. Tufaceous spring at SO 94491 13510

- Feature G would benefit primarily from exclusion of livestock by fencing to prevent further damage.
- Furthermore, cutting back of the mature Hawthorn *Crataegus monogyna* on the bank just to the south would allow much more light to the spring and encourage more diverse vegetation.

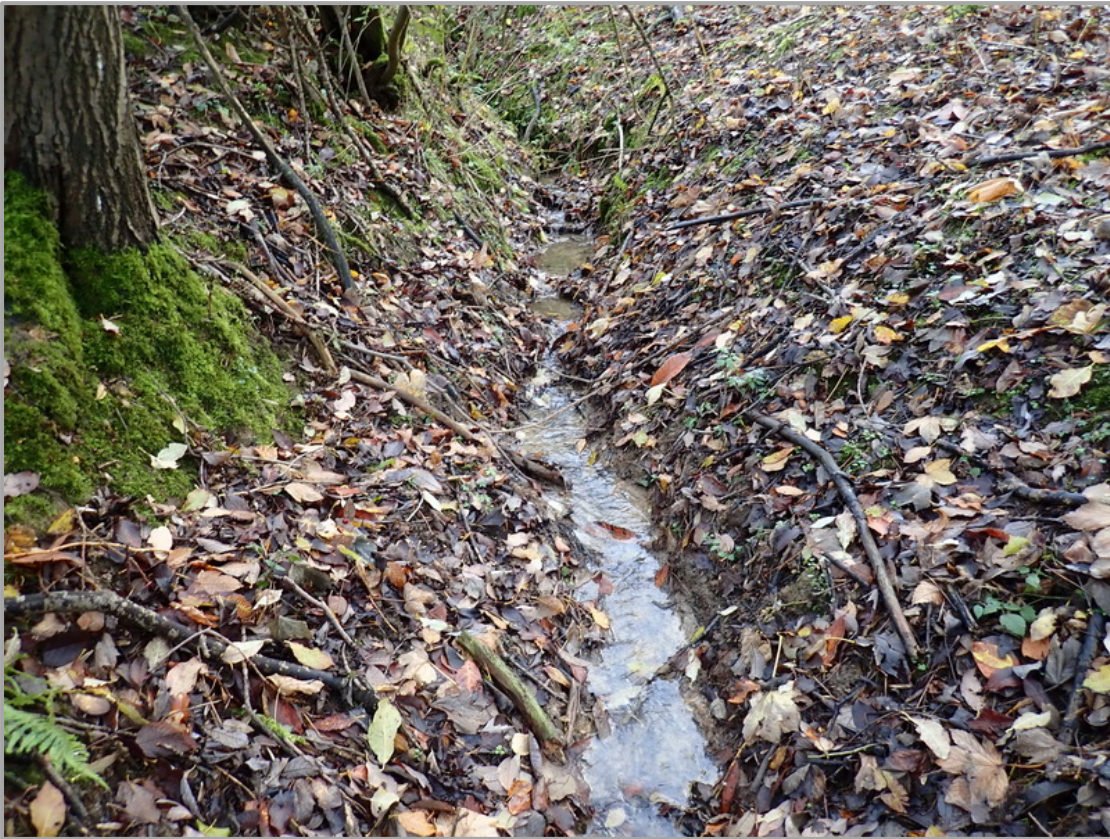
Plate A1 – Feature A

A small spring rises in scrub to form a small headwater stream which flows downhill and northward in a small deepening gully to join Norman's Brook near the farm buildings. Its channel is deeply shaded by topography and overhanging trees and it lacks tufa deposits.

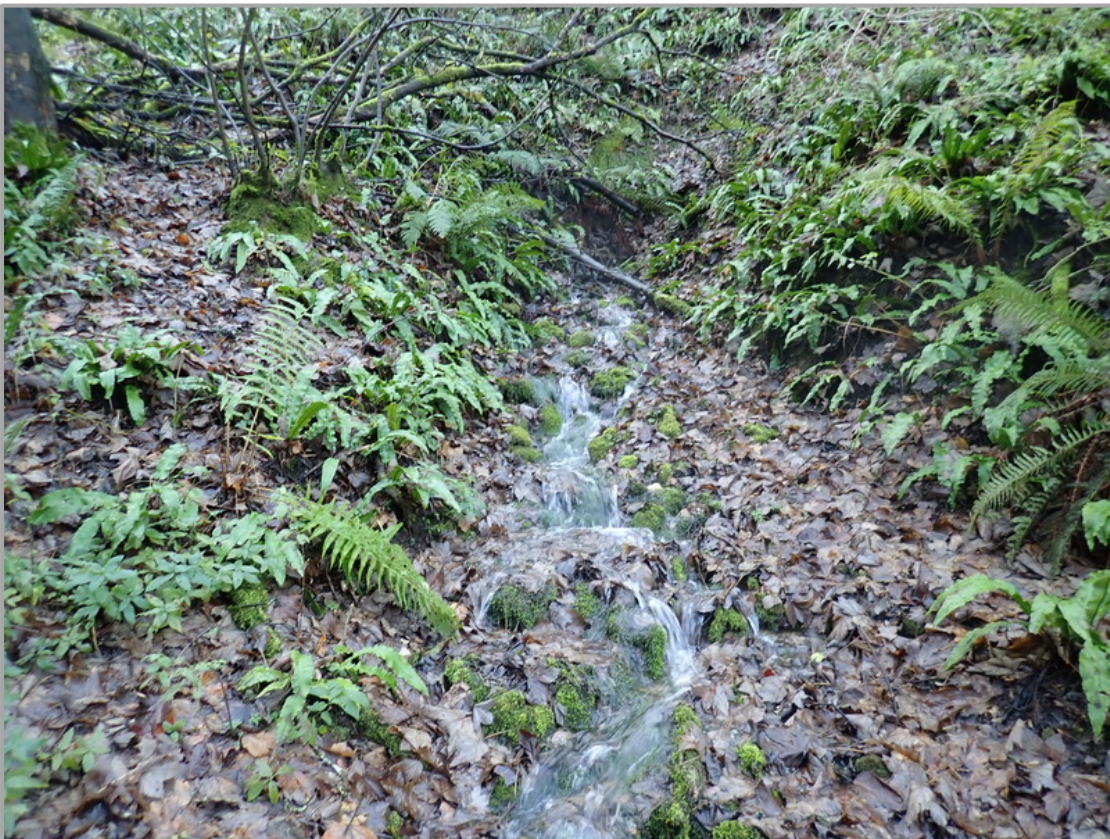
Feature C comprises two small springs (C1 and C2) rising at the lower end of a small Ash-dominated valley. The springs are approximately 20m apart and feed the same small stream. The larger spring (C2) has a strong flow of water and supports populations of bryophytes on stones in the water. The community is dominated by *Platyhypnidium riparioides*, *B. rivulare* and small amounts of *C. filicinum*, suggesting the water is moderately basic and nutrient-enriched. There are no tufa deposits in the spring or the stream below.

Plate A2.1 – active spring at SO 93178 I5830 (Feature C2)

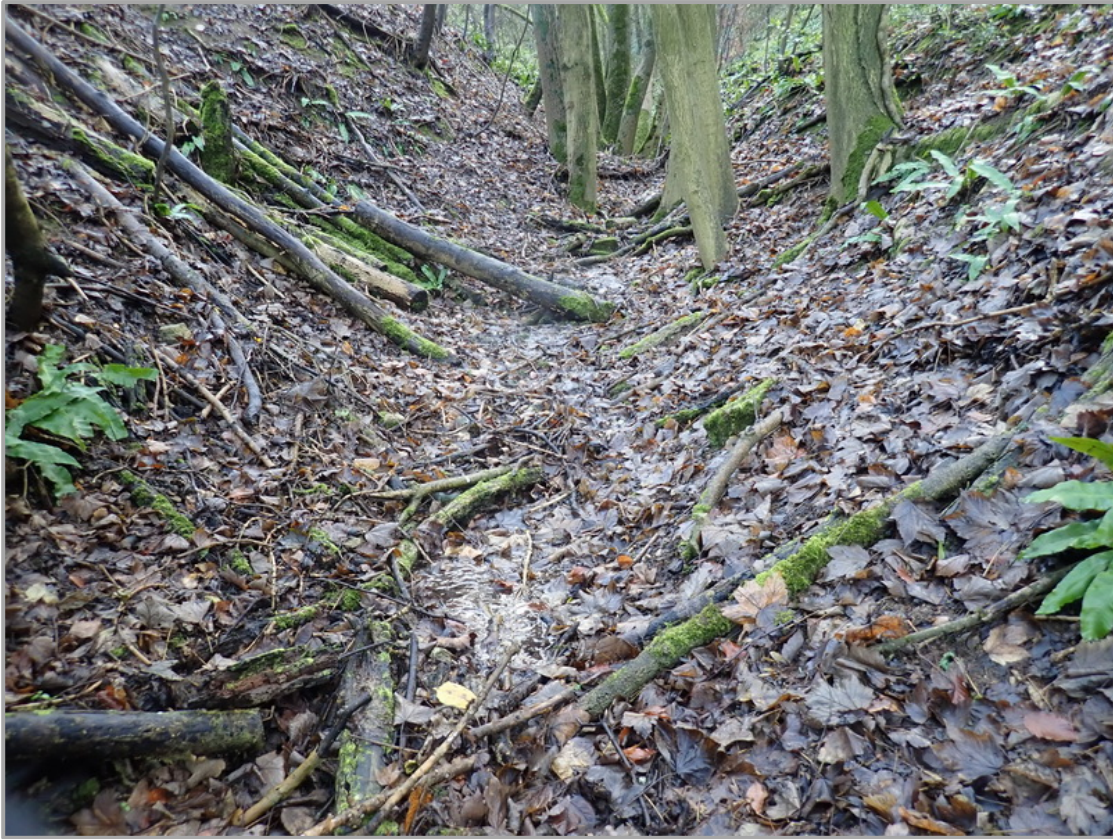
The second spring (C1) rises in the valley bottom in an intermittently wet and leaf-choked channel. It has low bryophyte cover of the same species as C2. Both springs are deeply shaded by the tree canopy above.

Plate A2.2 – intermittent spring at SO 93186 15831 (Feature C1)

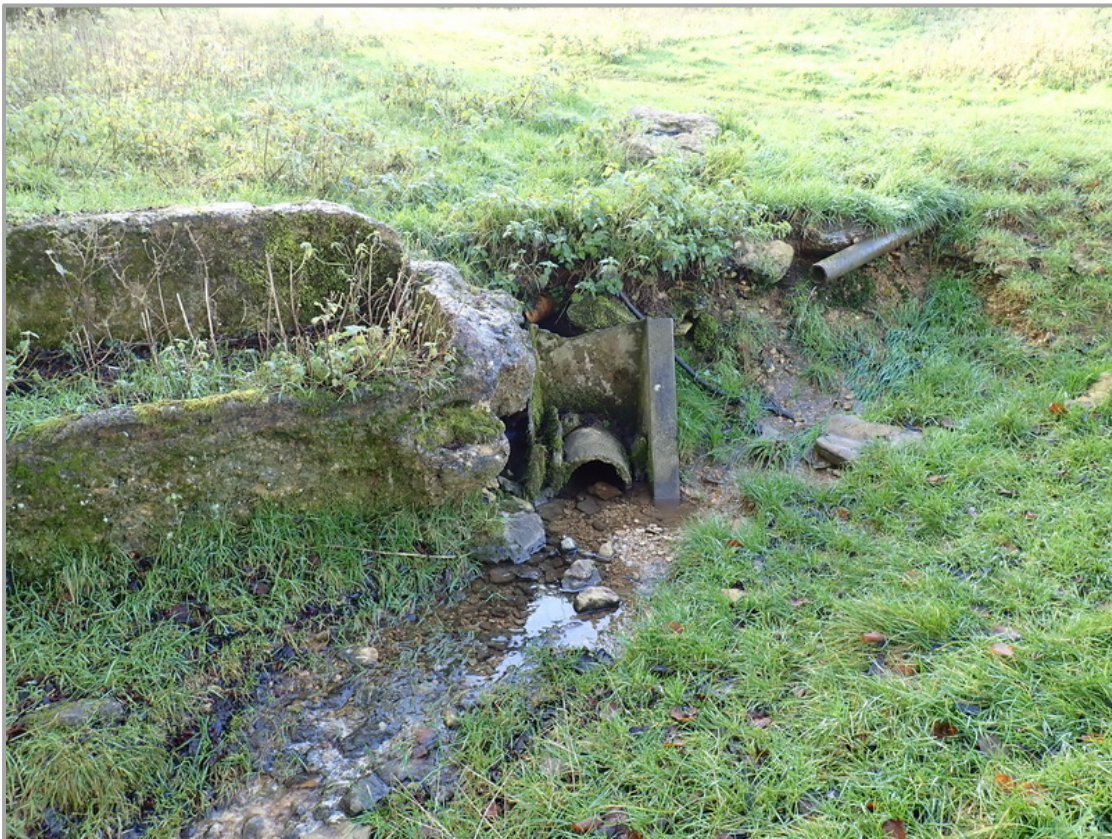
In the valley bottom, there is scant evidence of the two springs shown on 1:25000 Ordnance Survey maps except for an indistinct seepage in a small ditch. There is also a pipe carrying water that discharges into a small stream channel (Plate A3) and this may come from a hidden capped spring nearby.

Plate A3 – outflow from potentially hidden capped spring (Feature D)

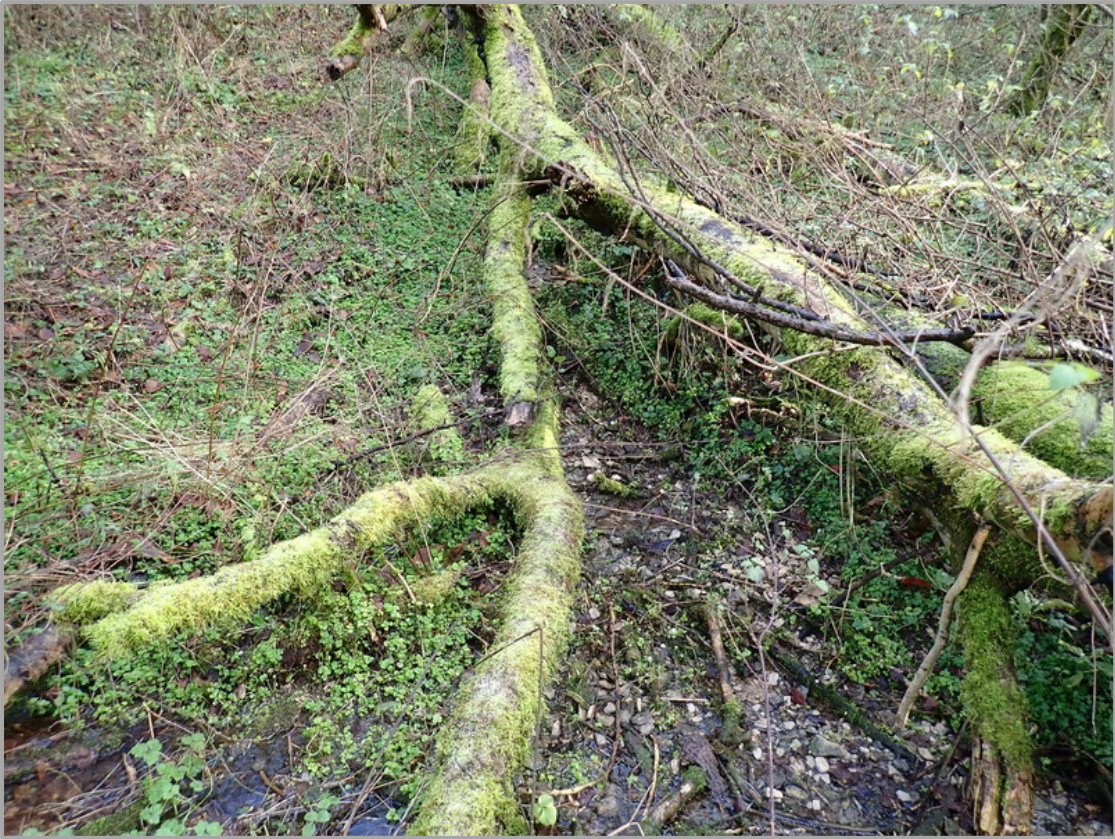
This feature comprises two small springs (F1 and F2) approximately 10m apart in deeply shaded secondary Ash woodland. They join to form a small seasonally flowing stream that runs down through pasture into the valley below. Despite rising only 80m from a tufa-depositing spring (Feature G), only a few ooids occur on stones and twigs in the streambed below F1. Surrounding vegetation indicates that soils in this area are quite enriched; it is characterised by abundant Opposite-leaved Golden-saxifrage *Chrysosplenium oppositifolium*, Common Nettle *Urtica dioica* and Yellow Archangel *Lamium galeobdolon* subsp. *montanum*.

Plate A4 – woodland spring at SO 94523 13585 (Feature F1)
