A1 in Northumberland: Morpeth to Ellingham

6.7 Environmental Statement – Appendix 11.1 Preliminary Sources Study Report

Preliminary Sources Study Report

Document Title	A1 North of Northumberland – Morpeth to Felton – Preliminary Sources Study Report
Author	Simon Berry
Owner	Jacobs
Distribution	Highways England
Document Status	Draft For Comment

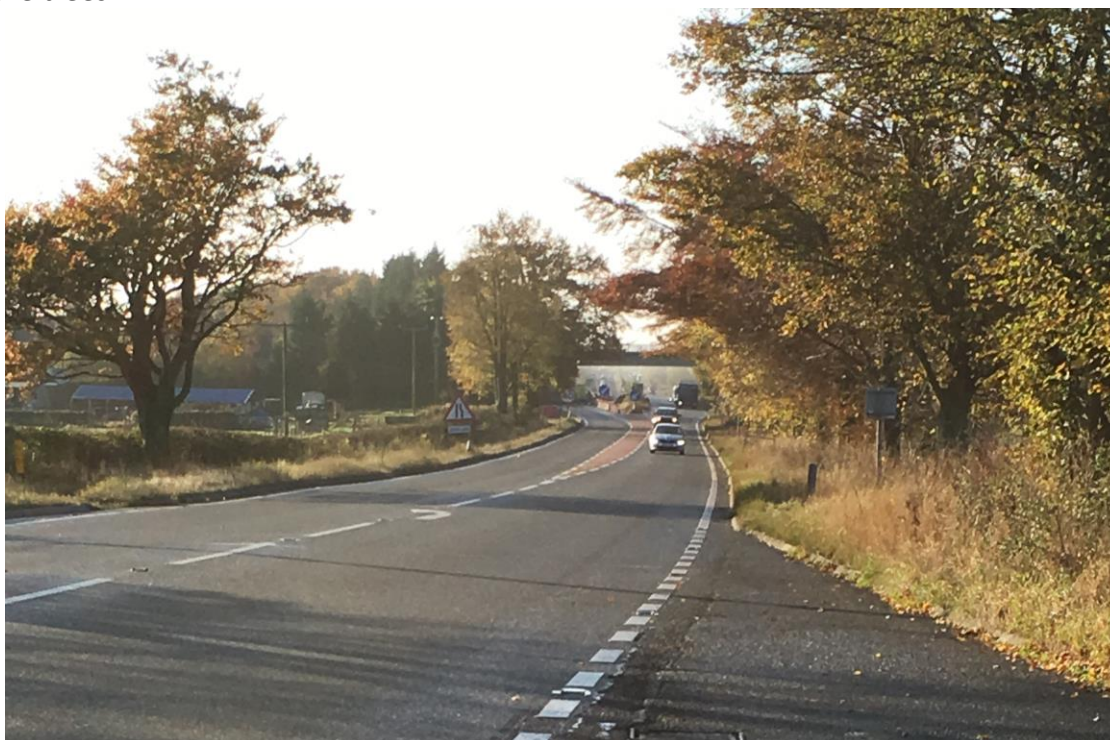
Plate 3.1 Stop 1 (approx. Ch. 1500m) looking south from a lay-by on the west of the road.

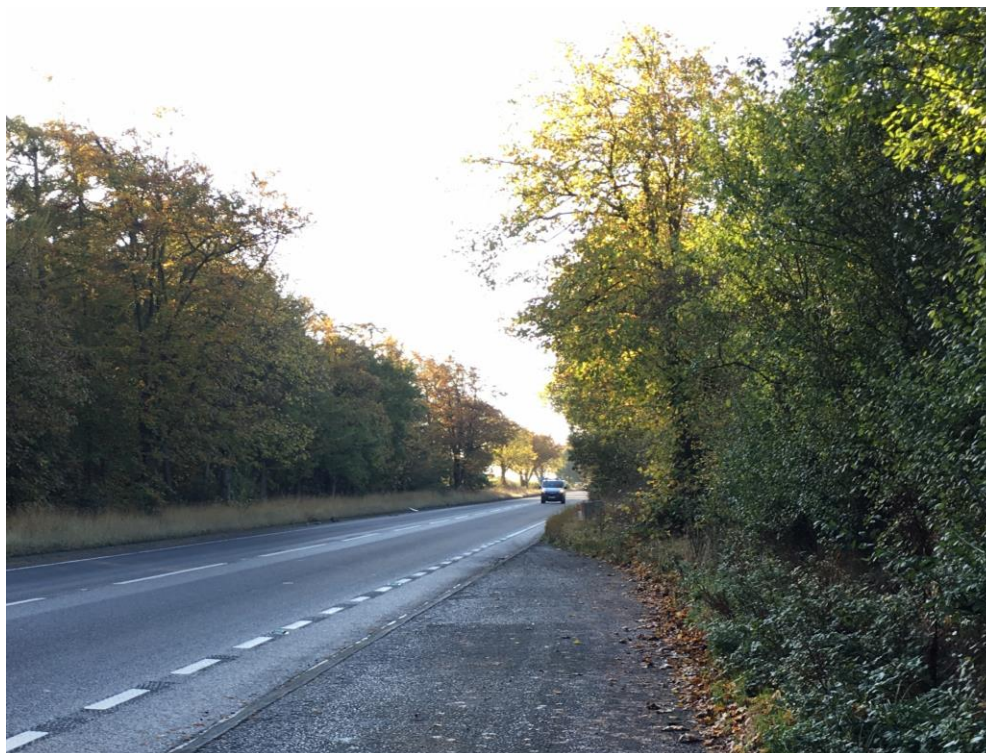
Plate 3.2 Stop 3 (approx. Ch. 3600m) looking south the lay-by on the west on the carriageway.

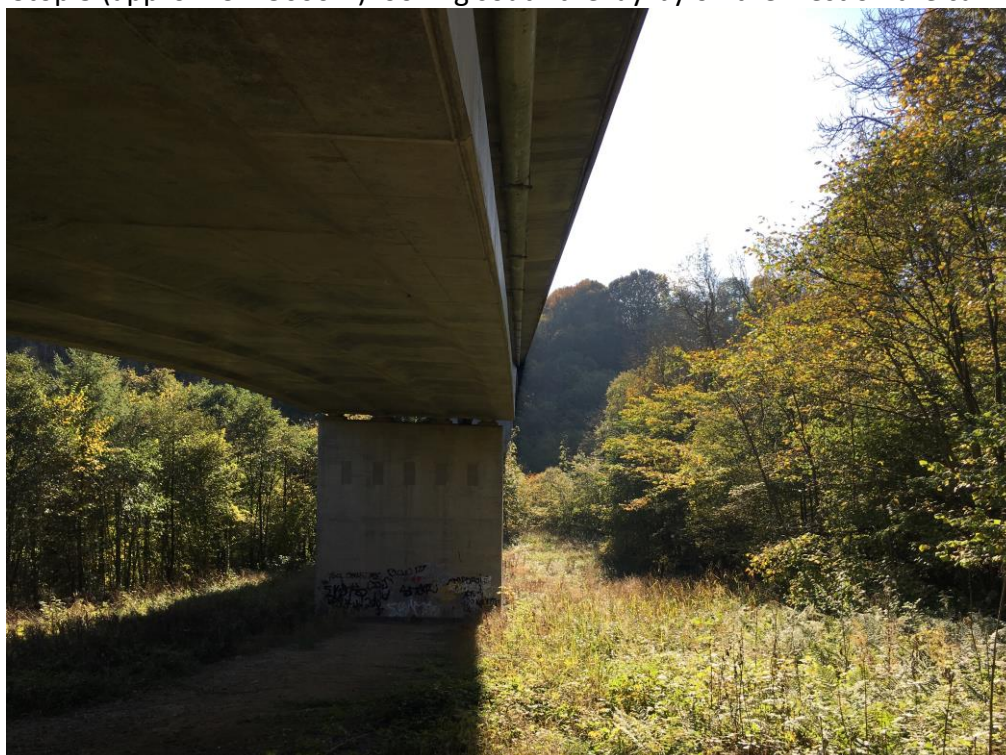
Plate 3.3 Stop 11 (approx. Ch. 12800m) View from the footpath north bank, River Coquet looking south underneath the bridge.

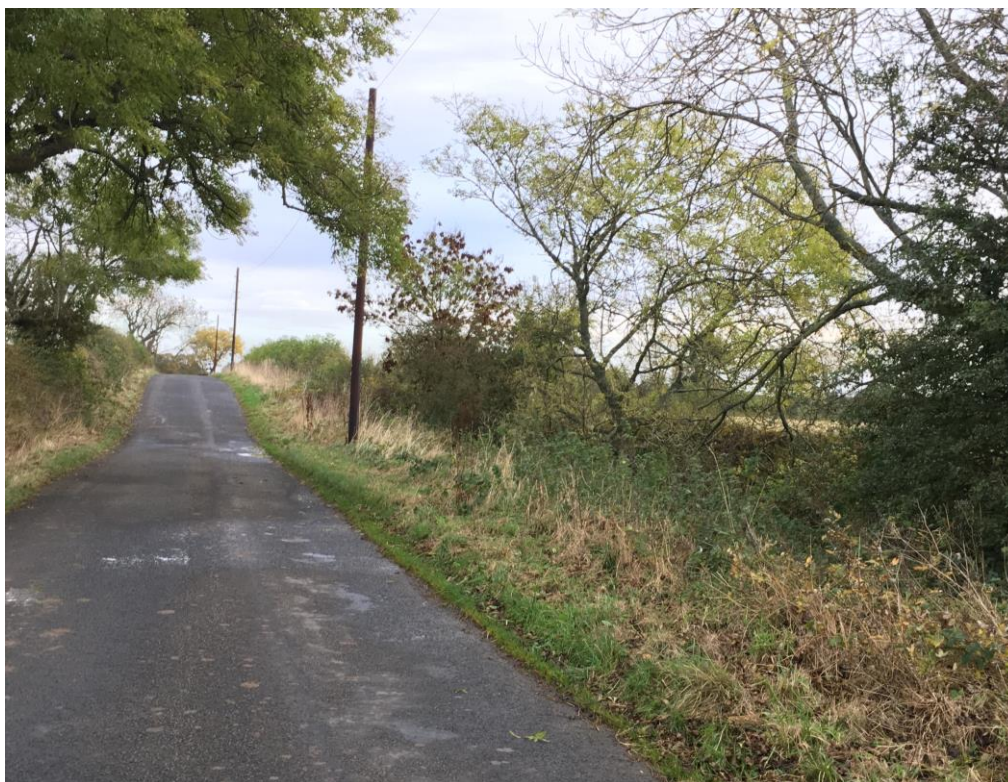
Stop 5 is located on Fenrother Lane at the location of the proposed offline option, approximately 0.5km west of the A1. The topography is undulating and falls to the south (Plate 3.4). The proposed junction between the offline option and Fenrother Lane will require earthworks to accommodate the overbridge.

Plate 3.4 Stop 5 (approx. Ch. 5000m) looking east on Fenrother Lane. Topography is undulating and falls to the south.

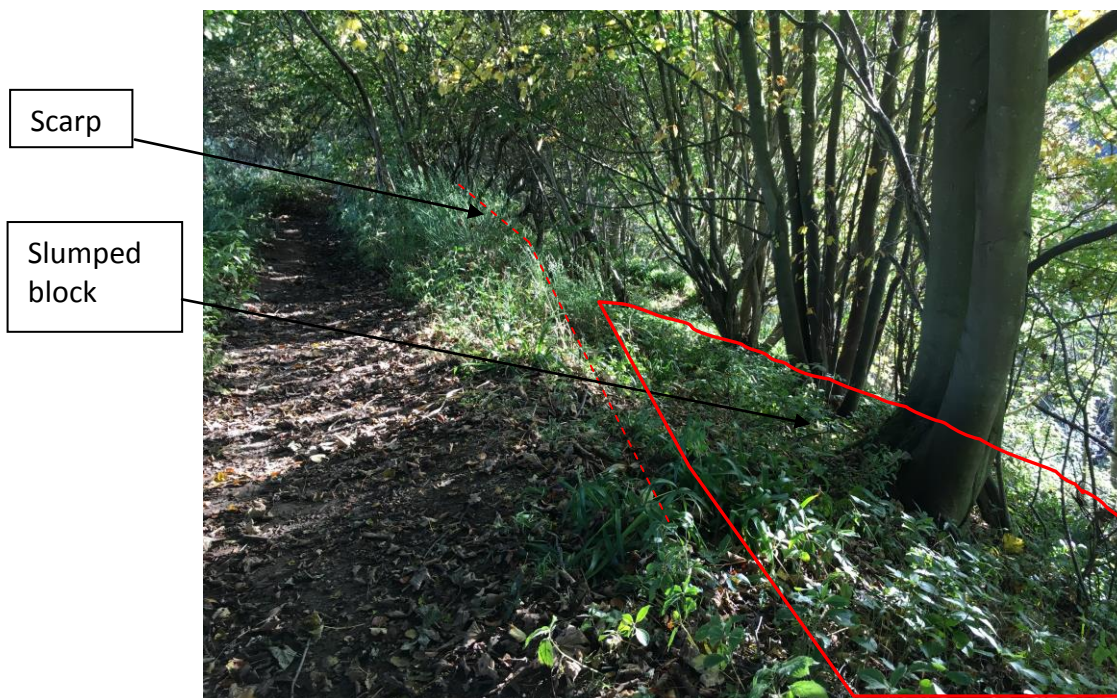
Slopes are densely vegetated which limits the inspection area to the slopes close to the footpath. Several slips were observed parallel to the footpath at the top of the valley in the superficial glacial deposits. Scarp features and slumped blocks are observed on the southern edge of the footpath (Plate 3.5).

Plate 3.5 Stop 11 (approx. Ch. 12800m) View from the footpath on the north side of the River Coquet looking south east.

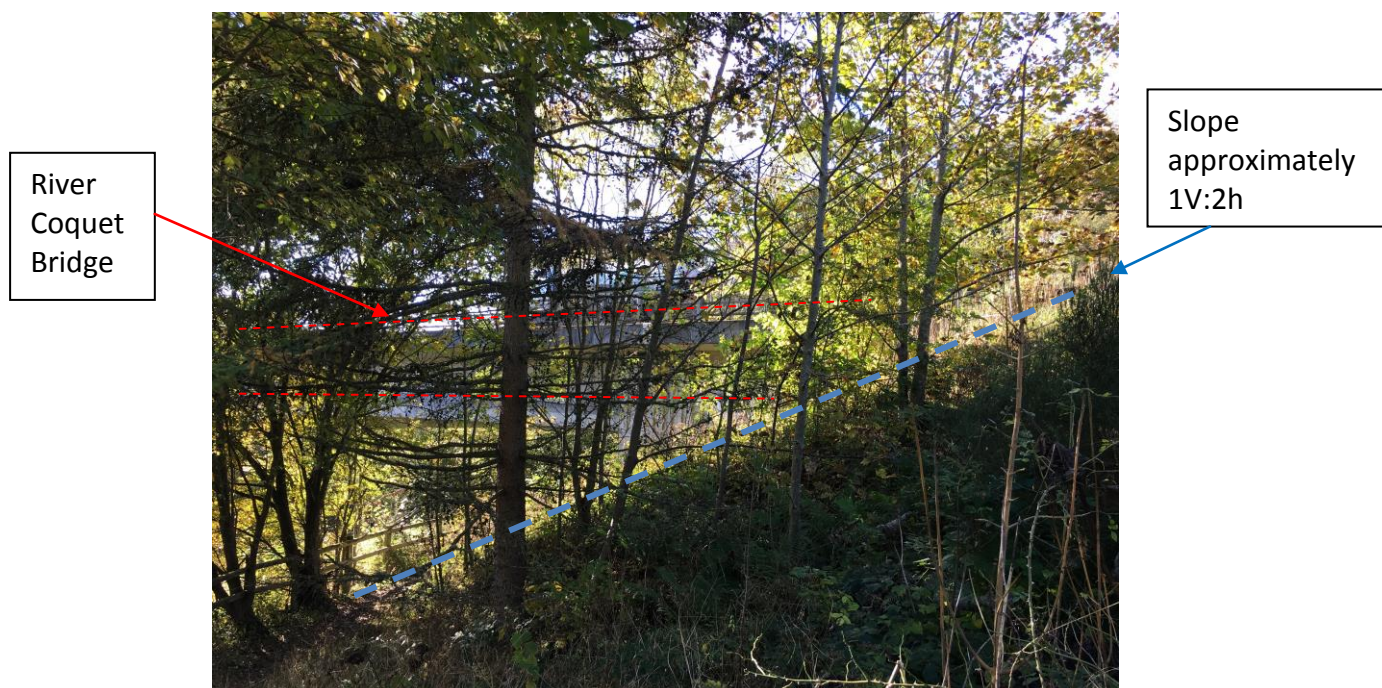
The gradient of the northern slope is approximately 1V:2H about 100m east of the River Coquet Bridge, as shown in Plate 3.6.

Plate 3.6 Stop 11 (approx. Ch. 12800m) View from the footpath on the north side of the River Coquet looking west to the River Coquet bridge.

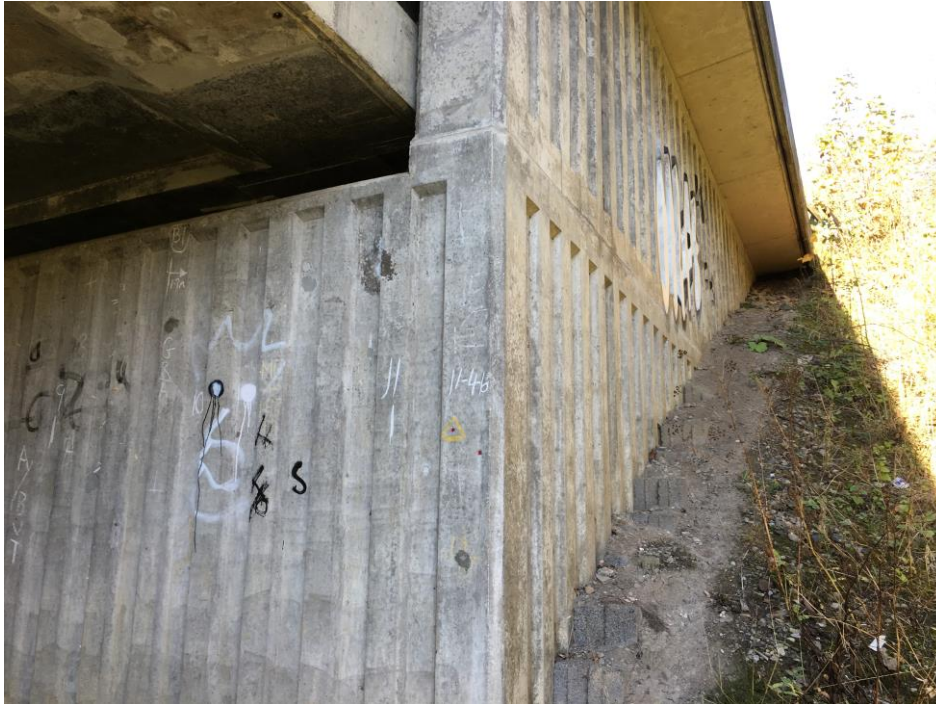
Slopes have been re-graded and dense vegetation has been removed to accommodate the existing bridge piers and abutments (Plate 3.7). No signs of instability were observed on the slopes next to the bridge.

Plate 3.7 Stop 11 (approx. Ch. 12800m) View of the east side of River Coquet Bridge abutment on the north slope.

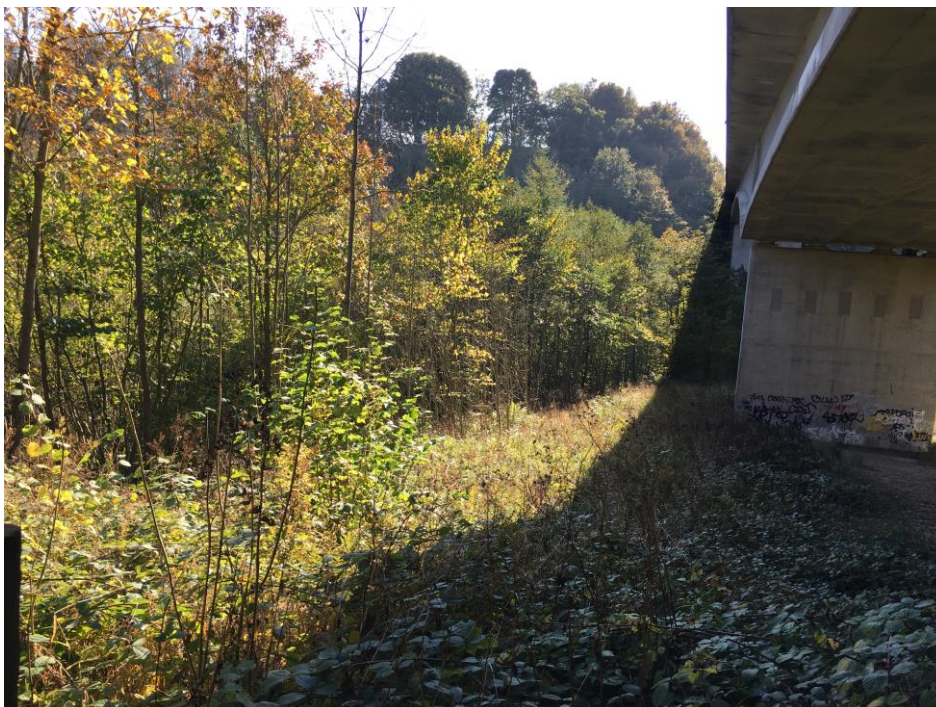
Plate 3.8 Stop 11 (approx. Ch. 12800m) View south of the River Coquet Bridge piers from the footpath on the North Slope.
