A1 in Northumberland: Morpeth to Ellingham

6.7 Environmental Statement – Appendix 11.2 Ground Investigation Report

A1 IN NORTHUMBERLAND: MORPETH TO FELTON SCHEME

Ground Investigation Report

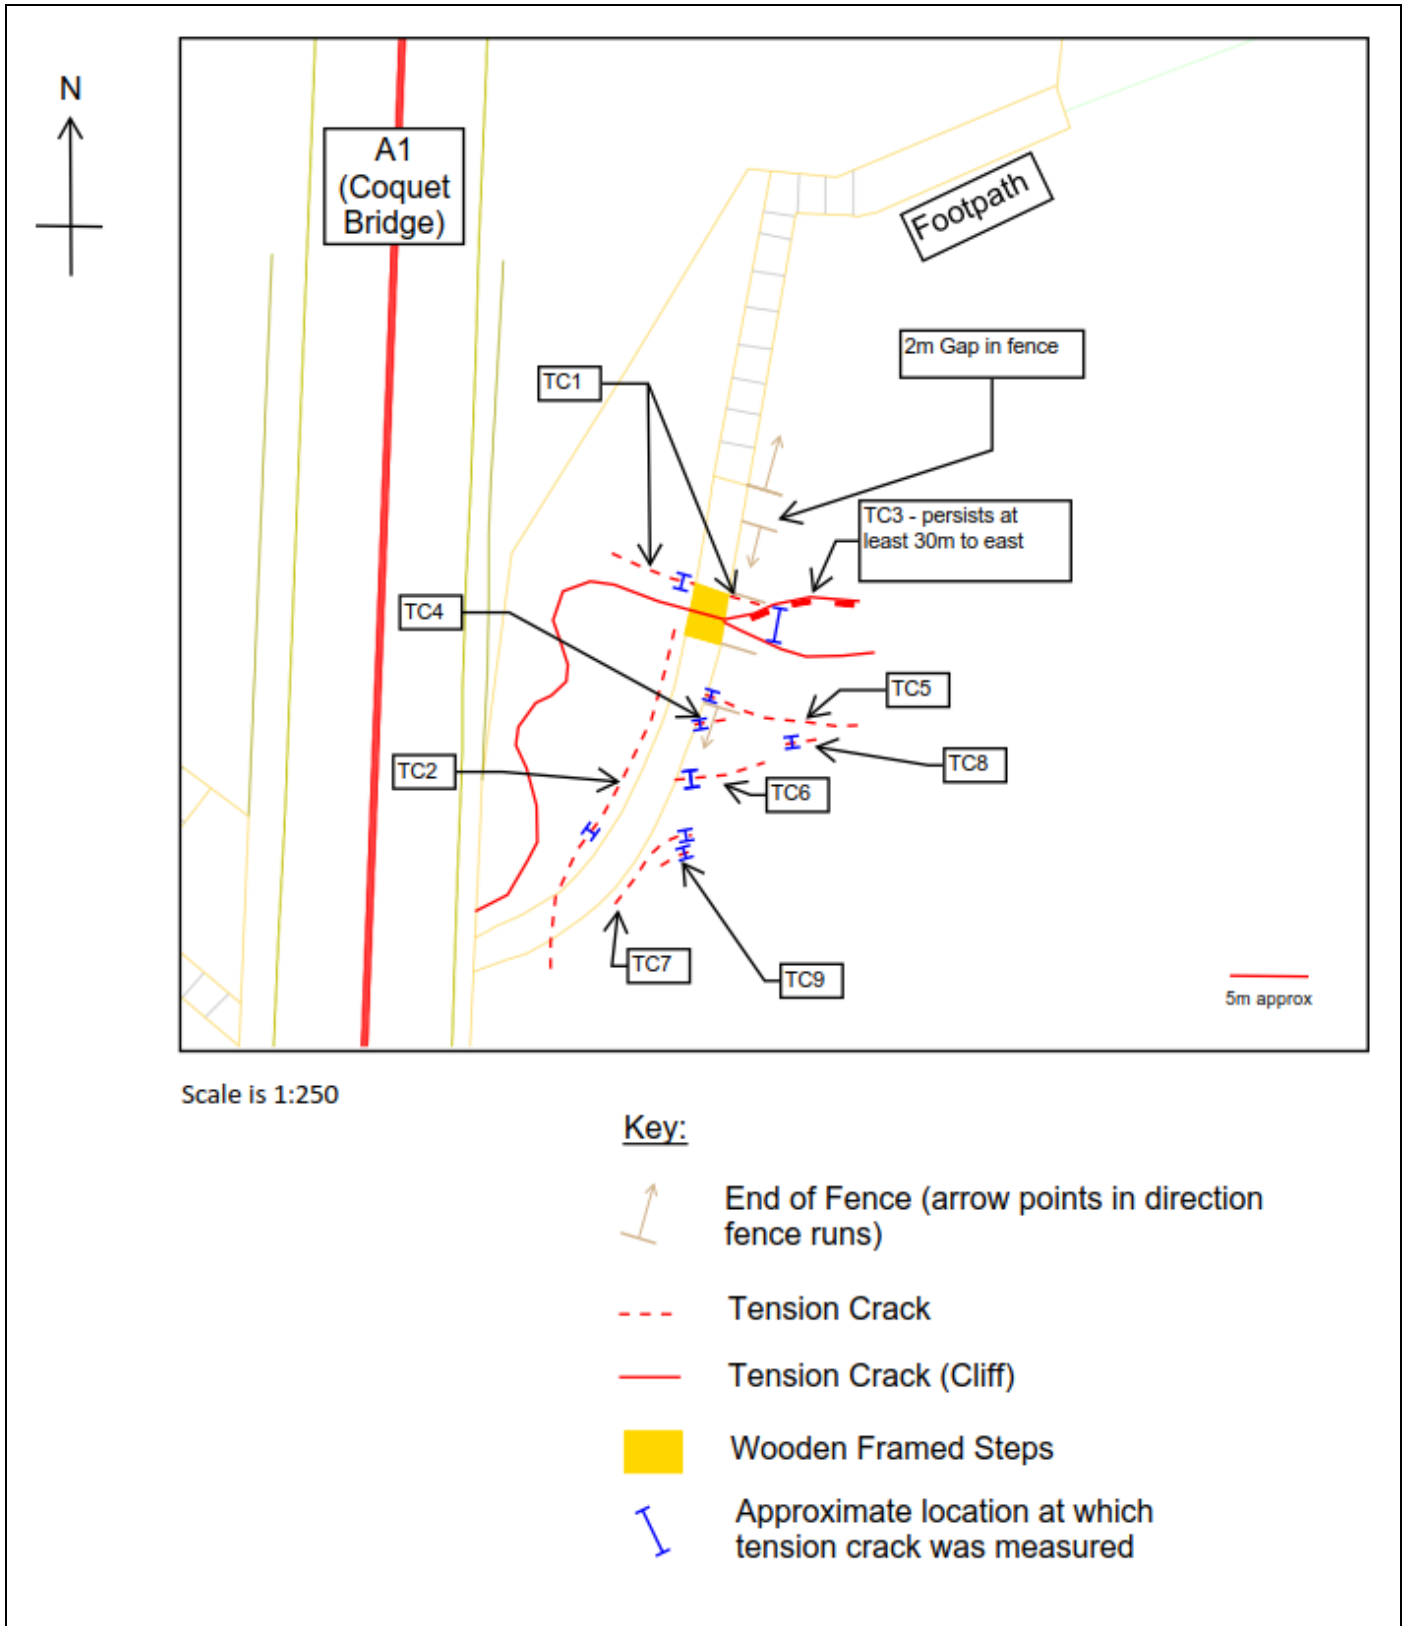
Figure 3 – Detailed plan of the observed tension cracking to the eastern side of the north abutment of the existing bridge.

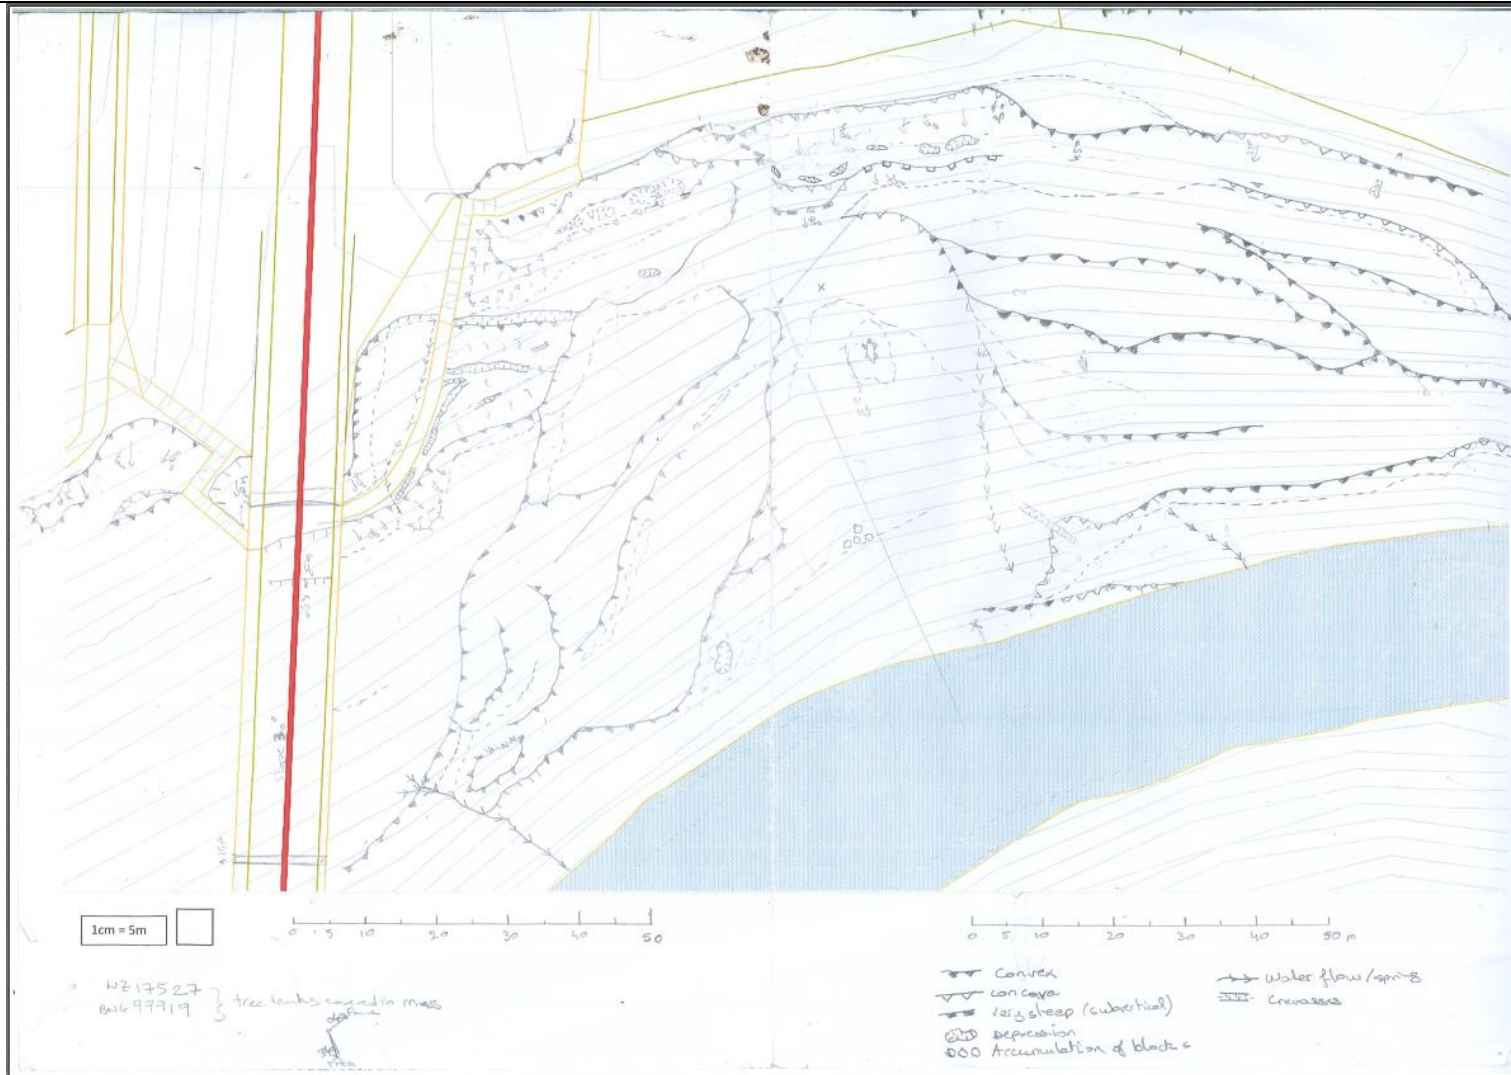
Figure 4 – Geomorphological map of the area to the east of the existing A1 overbridge.

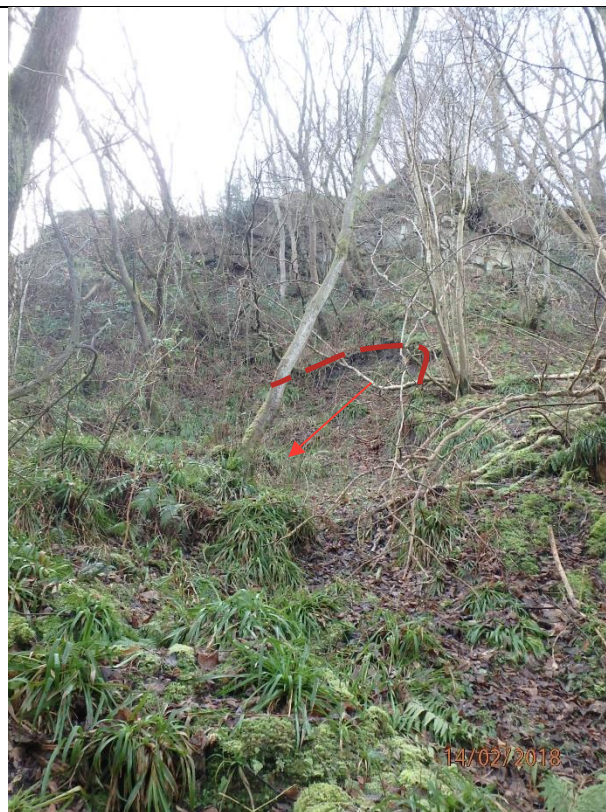
Photograph 10 – Arcuate scarp noted to the west of the southern embankment. This feature appeared to be fairly recent, with exposed soil within the back scarp.

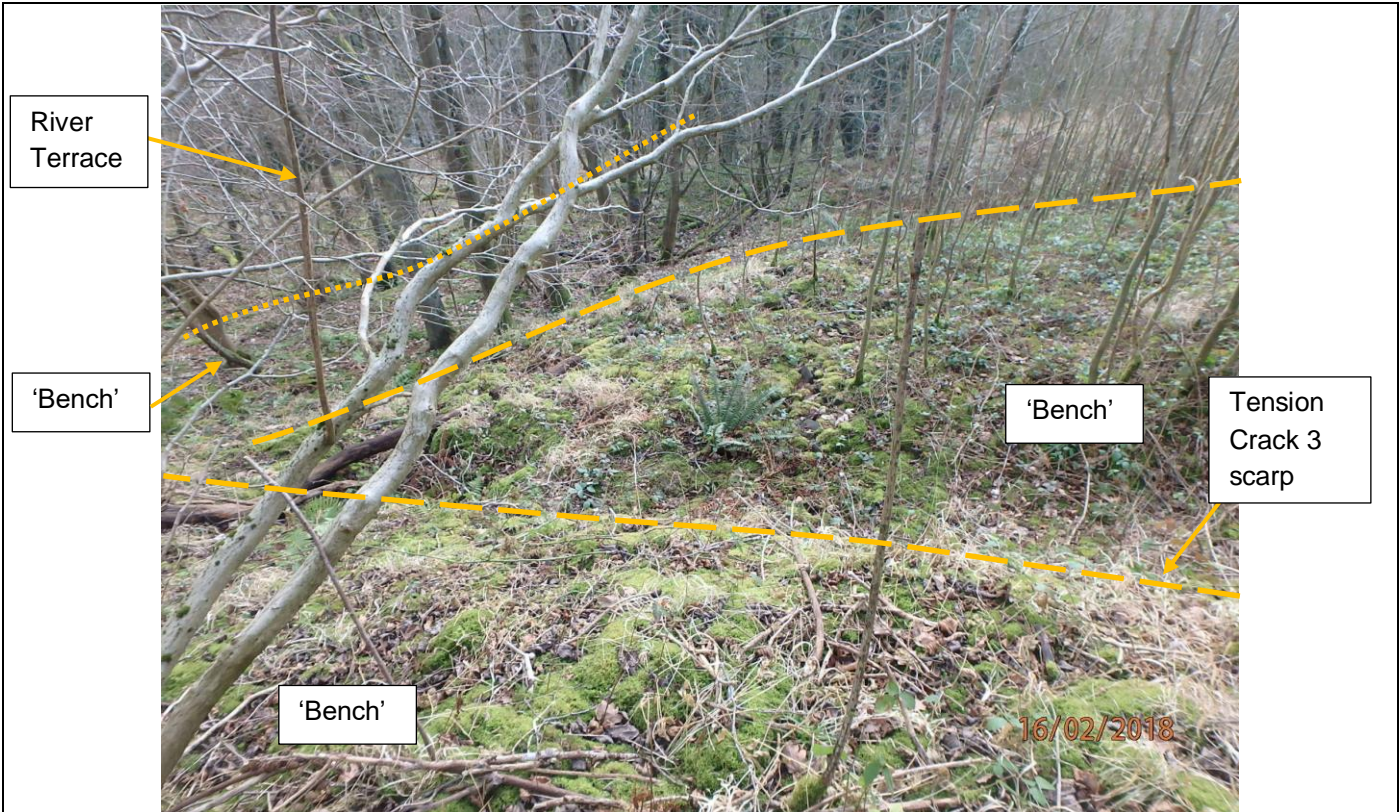
Photograph 11 – View south showing the terrain system of benches and slopes, potentially indicating failure within the area. At this point tension crack 3 has widened into a slope unit. Photograph taken at NZ 17485 99925.

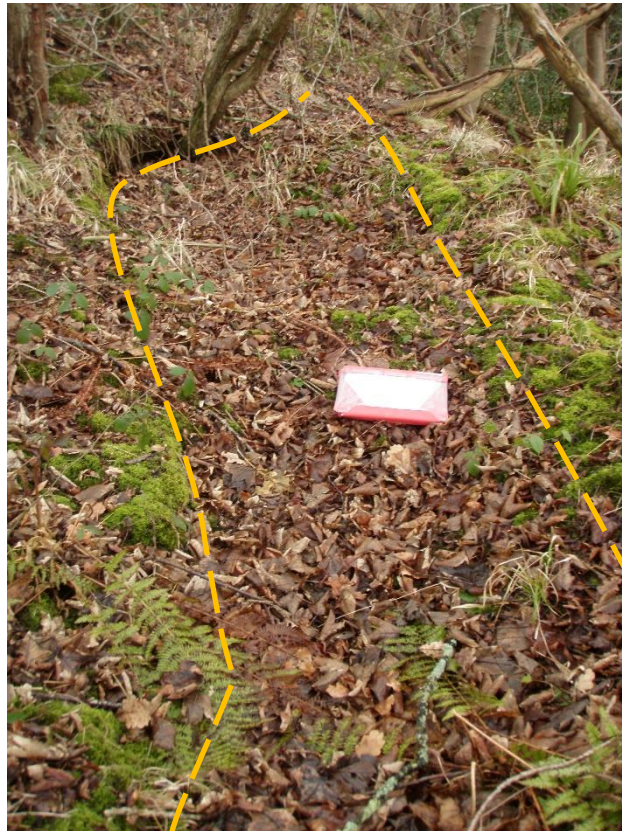
Photograph 12 – View east of a tension crack within a failed block. This structure is located to the south of the public footpath. The clipboard within the photograph is A4 sized.

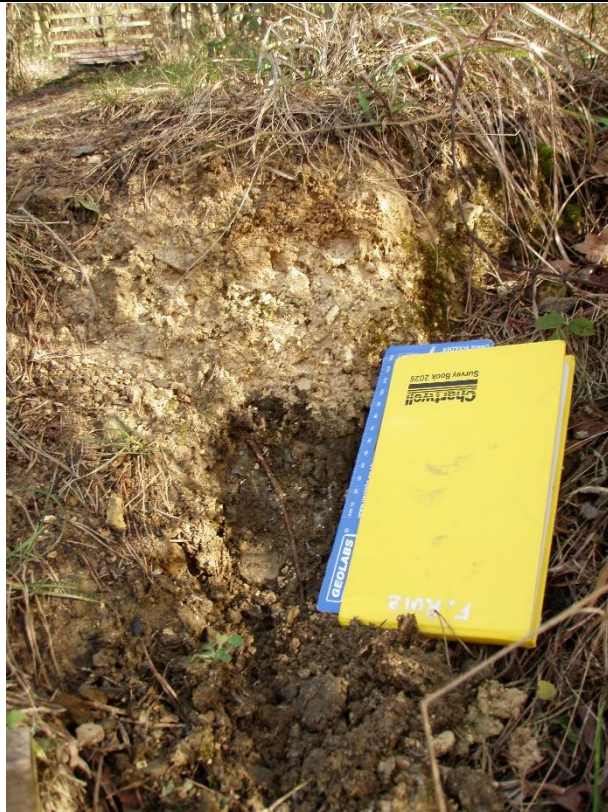
Photograph 14 – Made Ground materials described within tension crack 3 adjacent to the footpath steps. The major divisions on the blue card are 1cm wide. The thickness of the upper unit is approximately 20cm.

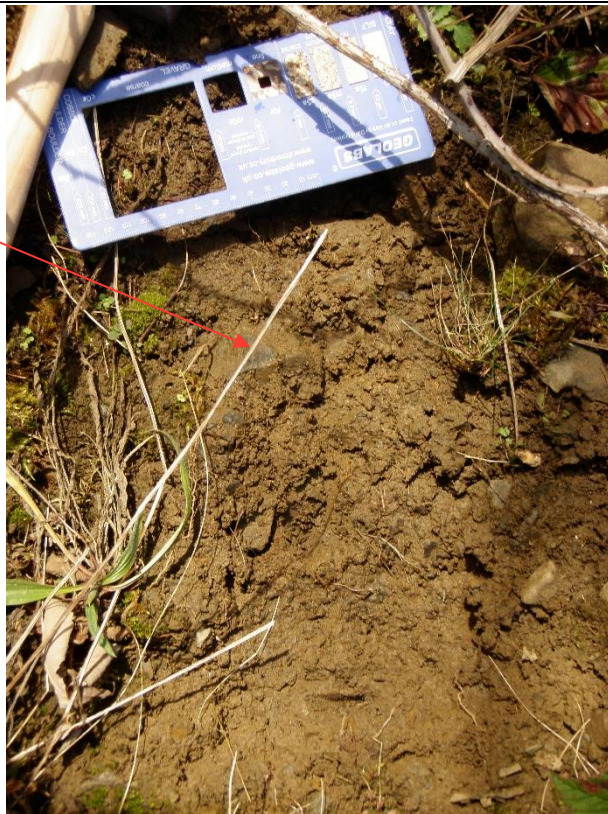
Photograph 15 – Detail of the lower Made Ground as seen within the scarp of tension crack 3.

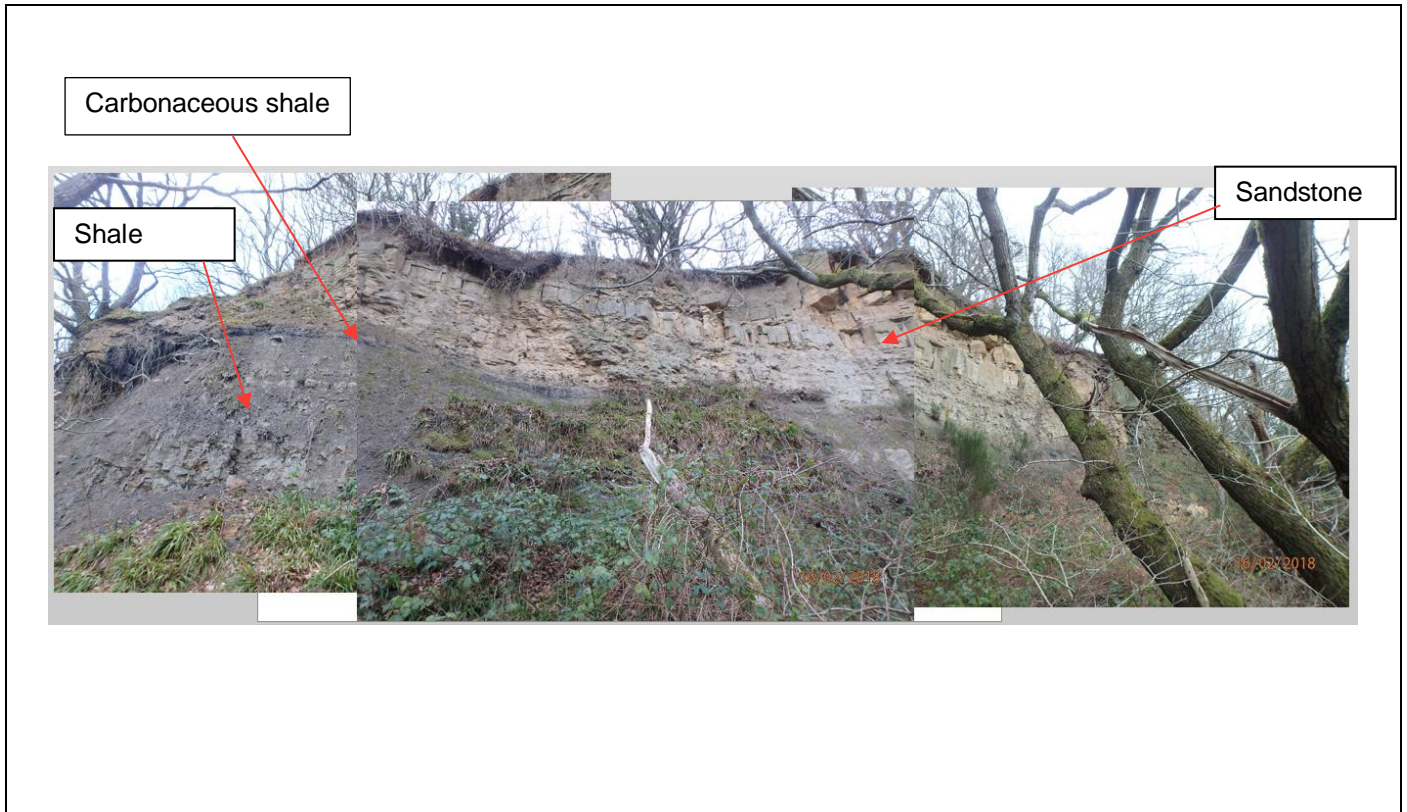
Photograph 16 – Bed rock geological succession observed to the east of the study area (photograph mosaic). This photograph demonstrates the change from the underlying shales to the overlying sandstones which thicken upwards. Photograph taken at NZ 17670 99895, 200m east of the existing bridge (location shown on Figure 5). Thought to represent an exposed failure plane.

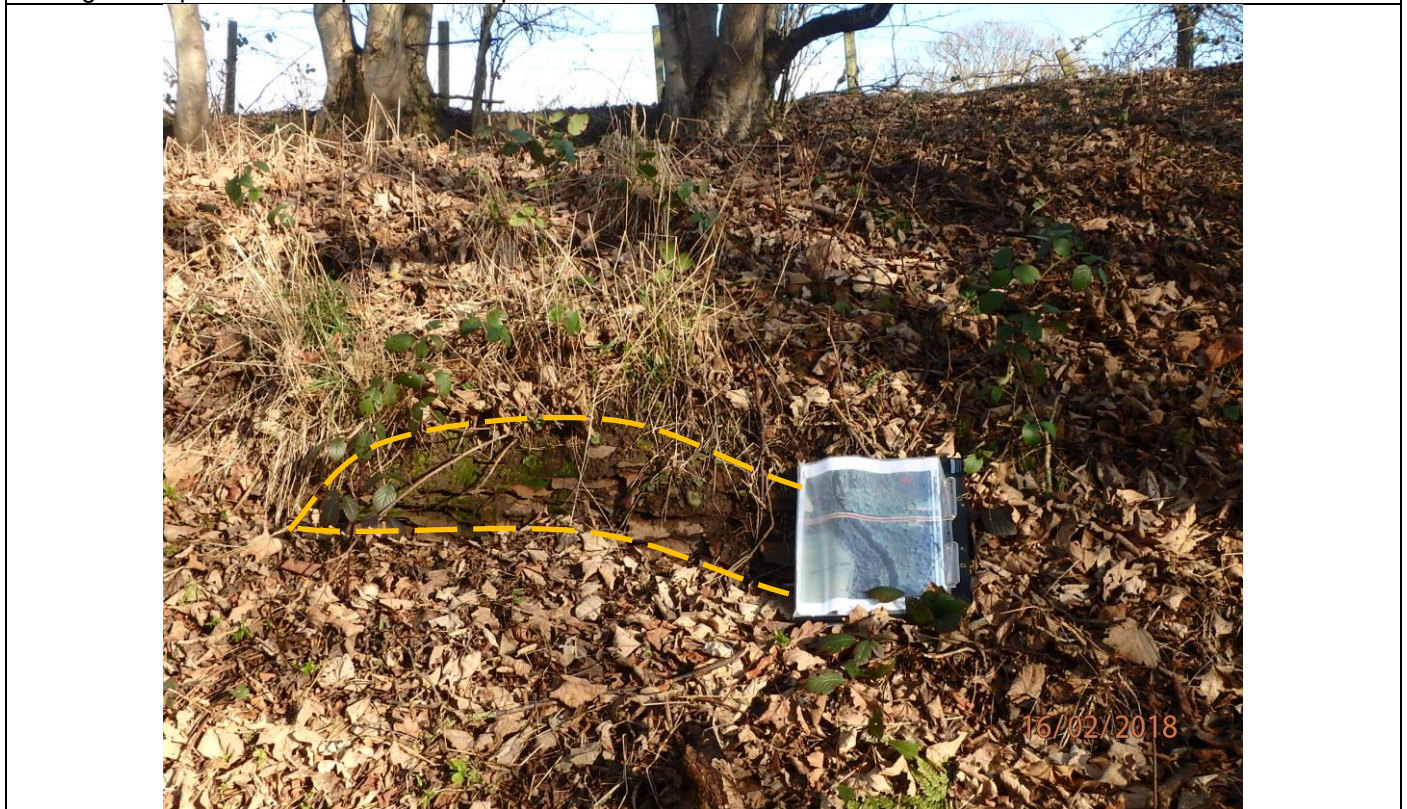
Photograph 17 – Exposed corrugated metal sheets, below the level of the footpath, exposed within the backscarp of one of the failed blocks. Photograph taken at NZ 17545 99955. Clipboard is A3 sized.

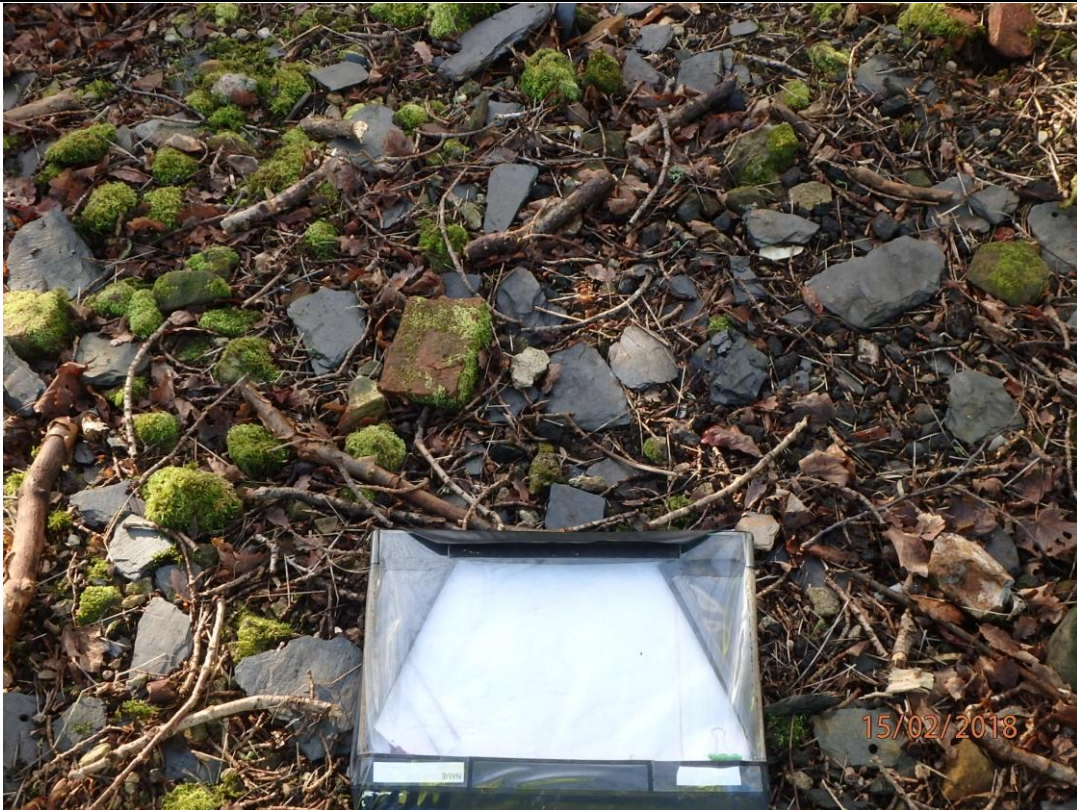
Photograph 18 – Apparent colliery spoil noted at the surface at NZ 17570 99959. Note the presence of cobble/boulder sized fragments of slate, clinker and brick. Clipboard is A3 sized.

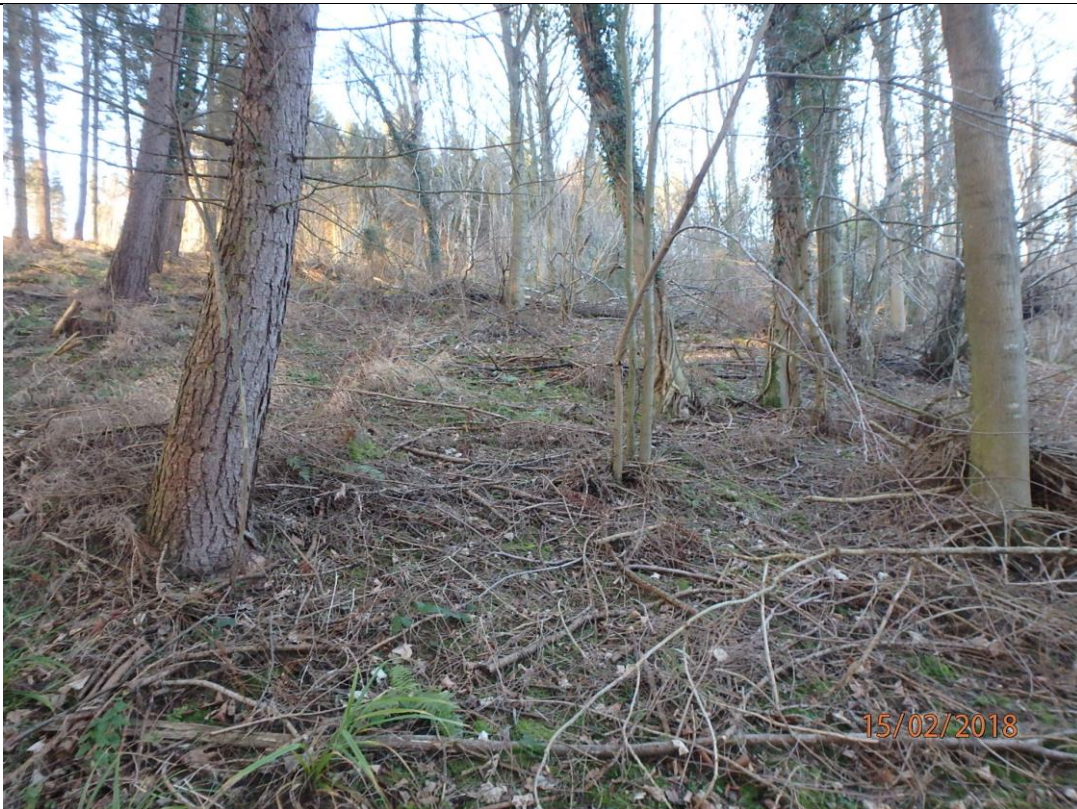
Photograph 19 – Proposed western extent of the zone of instability to the west of the existing A1 bridge northern abutment. Note the change in land use to coniferous forestry to the west.

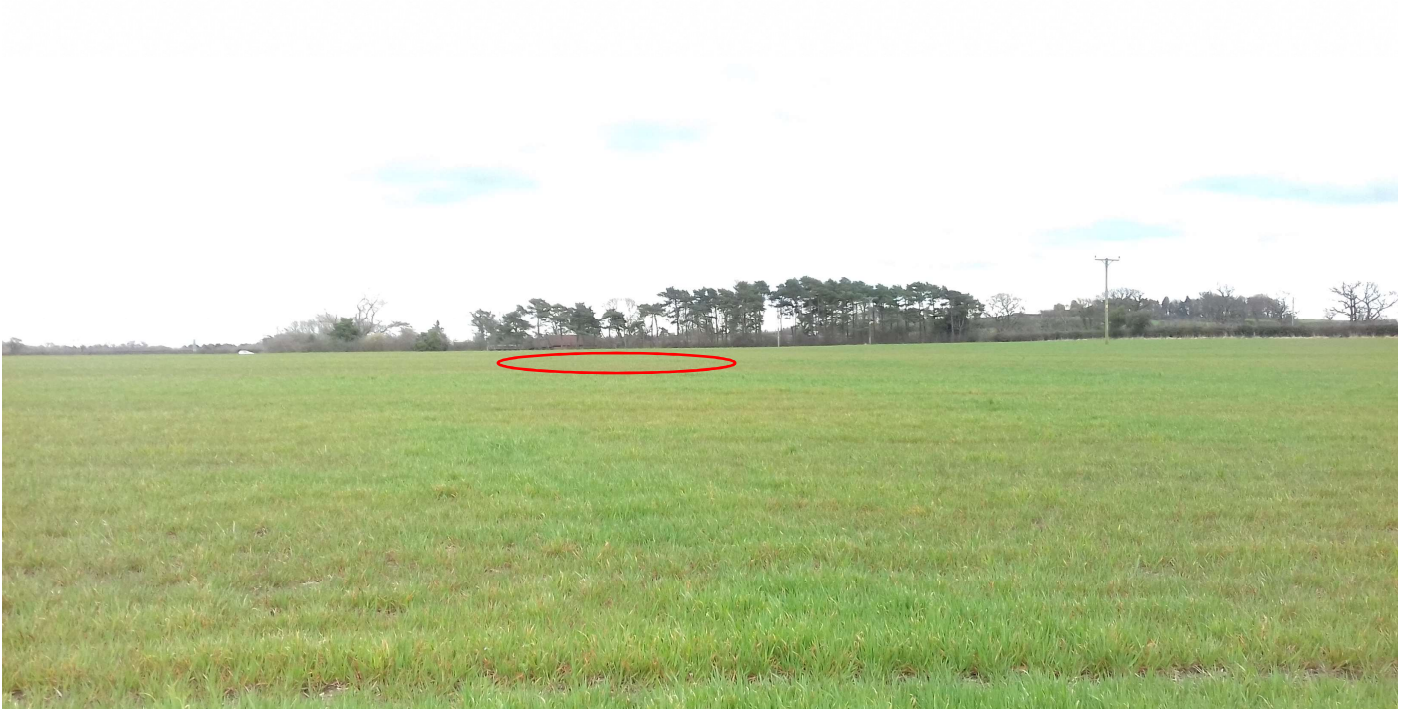
Figure 1-6 Looking east from L3. Undulations in the field may indicate locations of possible historic mining voids
