# **A12 Chelmsford to A120 widening scheme**

**TR010060**

## **9.18 Supplementary Riparian Mammal Survey Report**

**Supplementary Riparian Mammal Survey Report**

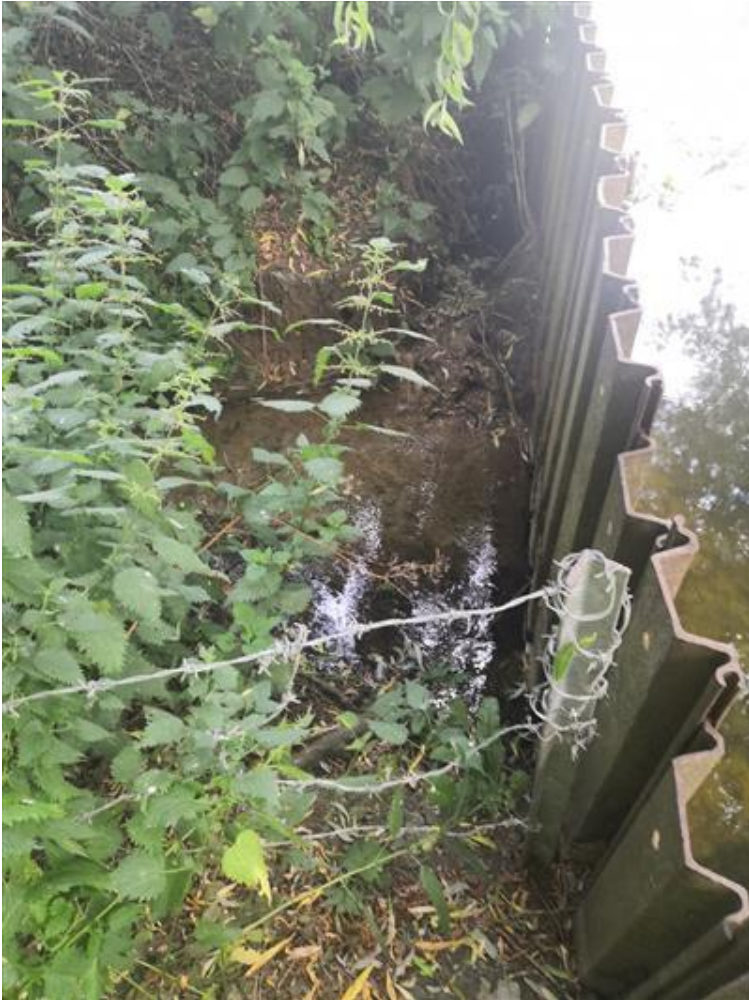
Description	Photograph
<p>Photograph 5: Potential otter slide, claw marks on bankside</p>

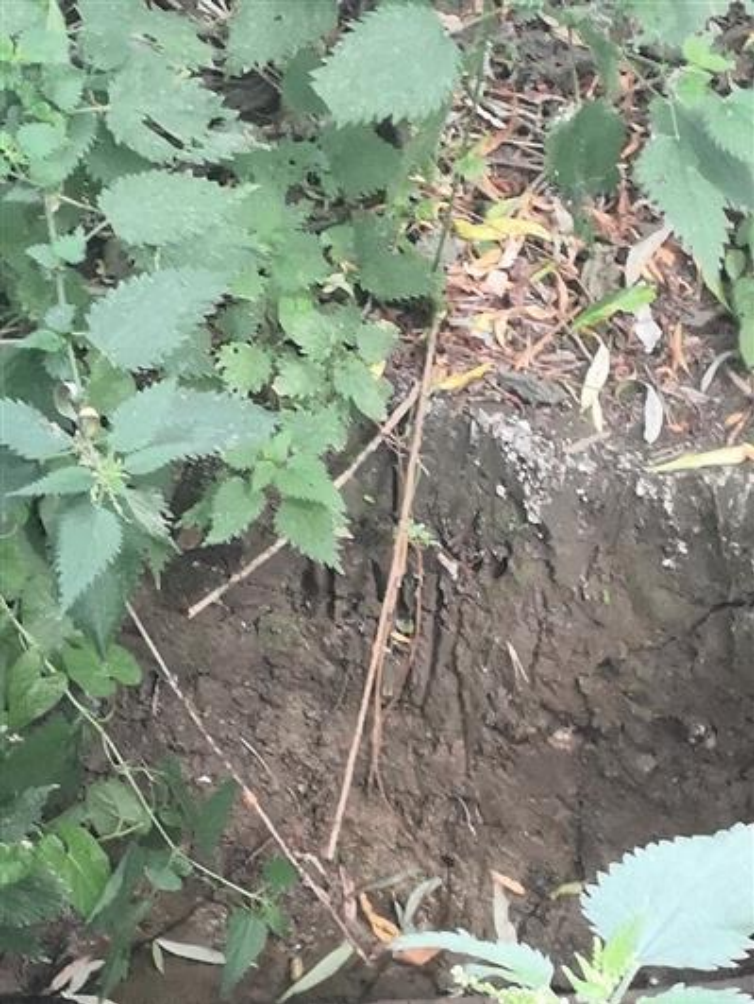
Description	Photograph
Photograph 6: Potential otter couch

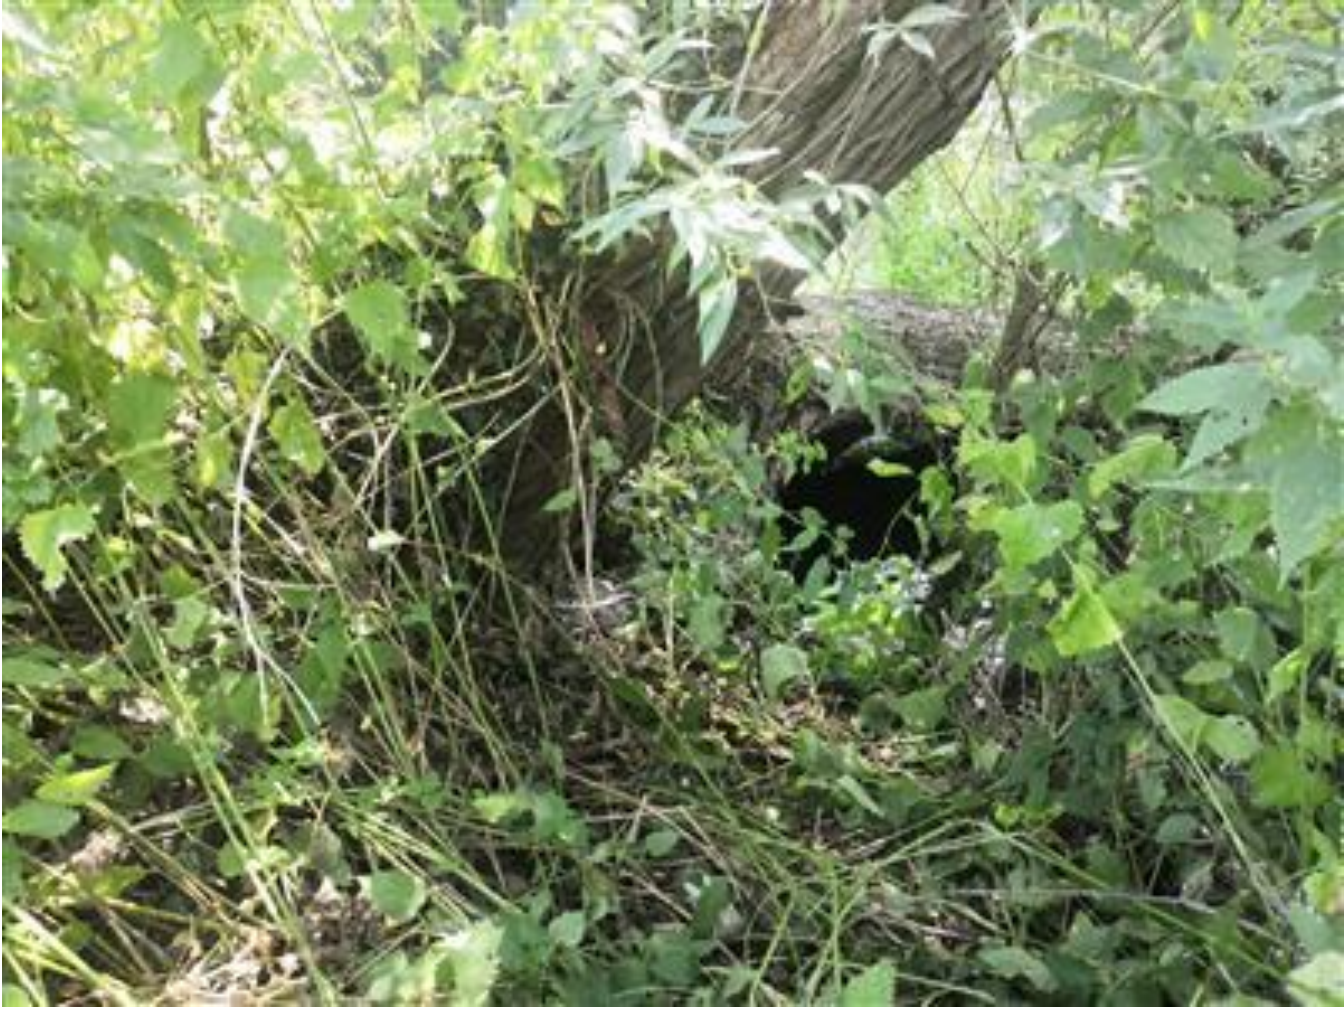
Description	Photograph
Photograph 7: Potential otter couch, debris present	  A photograph showing a potential otter couch. The image depicts a dark, hollowed-out space within a log or a pile of debris, surrounded by green vegetation and sunlight filtering through the leaves.

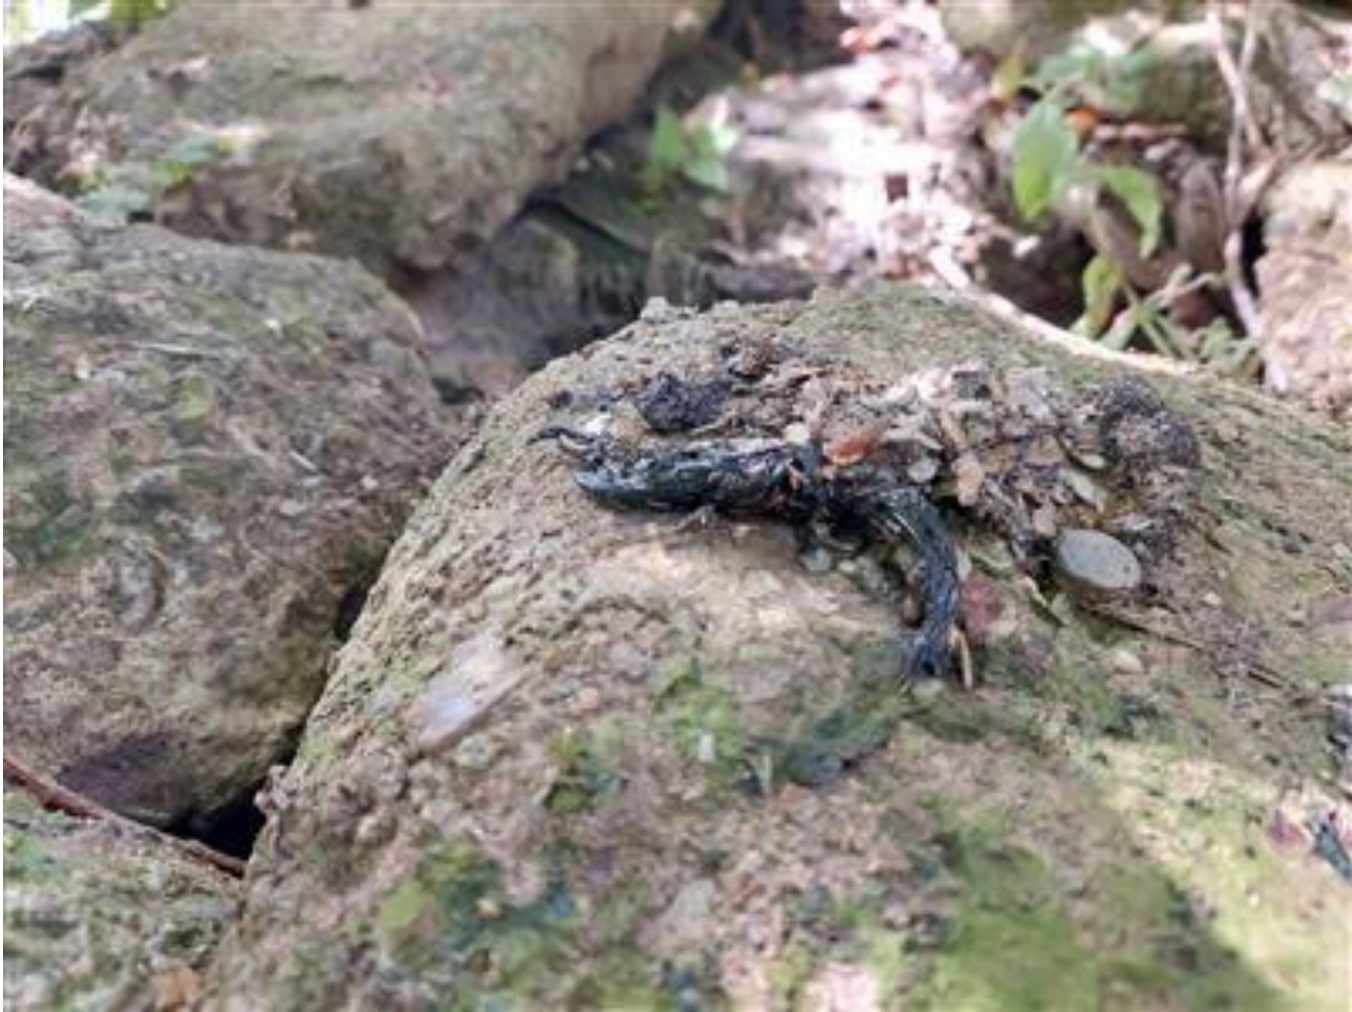
Description	Photograph
<p>Photograph 13: Otter spraint on log nearby to potential otter holt</p>	  A photograph showing a fallen log in a wooded area. The log is covered in green vegetation and has a dark, irregular mark on its surface, identified as an otter spraint. The surrounding area is filled with green leaves and branches, suggesting a dense forest environment.

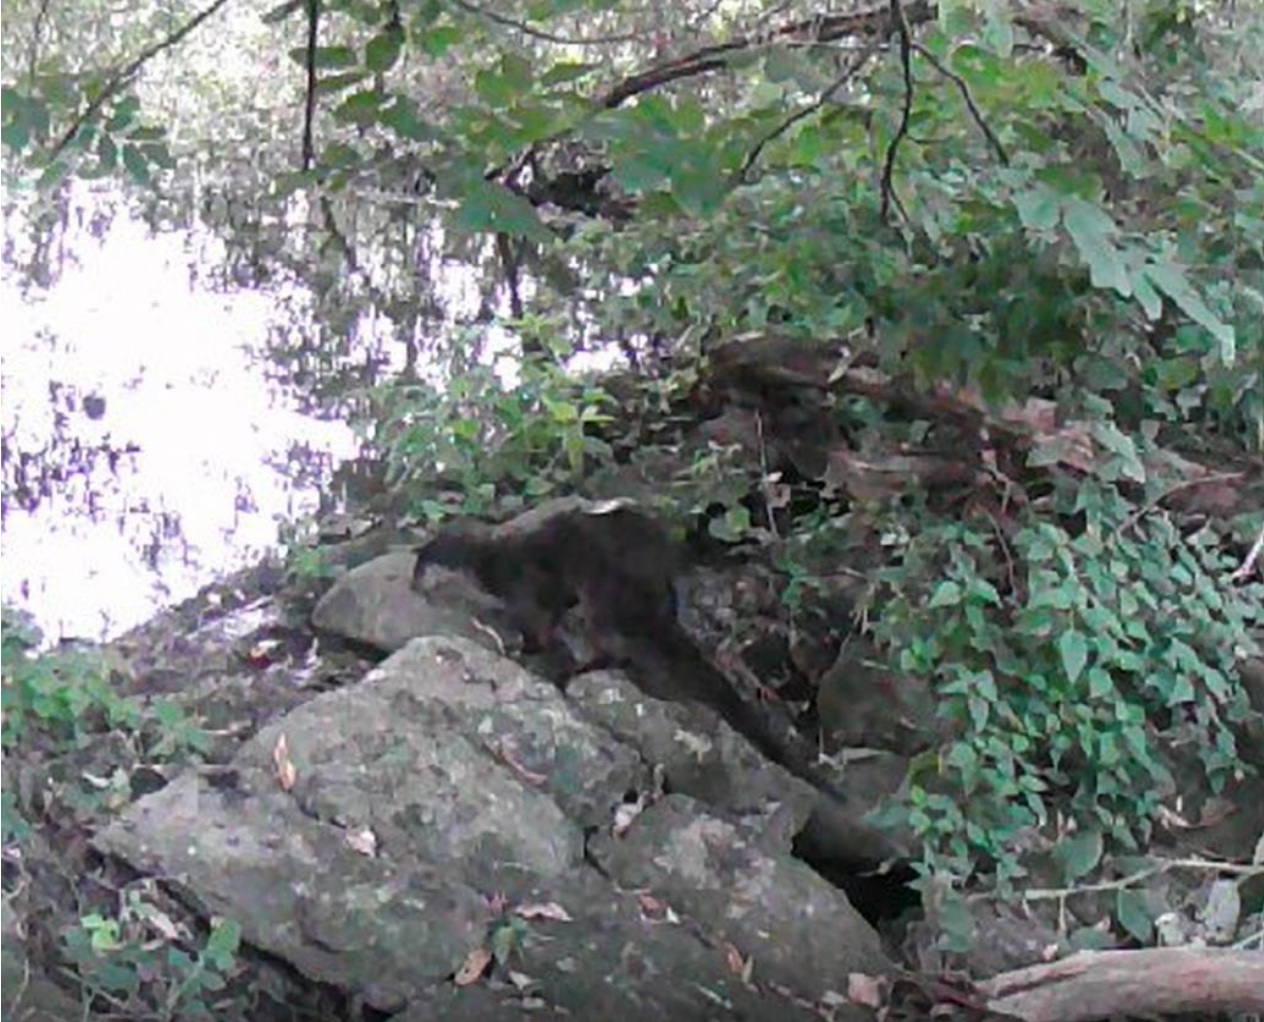
Description	Photograph
Photograph 16: Otter on C1, defecating at night	  A black and white photograph showing an otter on a rocky bank at night. The otter is positioned in the center-right of the frame, facing left. It appears to be defecating, with a small, bright spot visible on the ground. The background is filled with dense foliage and trees, illuminated by a light source, possibly a camera flash, creating a high-contrast scene. The rocks are large and irregularly shaped, forming a natural bank.
