M5 Junction 10 Improvements Scheme

Environmental Statement Appendix 7.7 Water Vole surveys TR010063 – APP 6.15

6.15 Environmental Statement: Appendix 7.7 Water Vole surveys

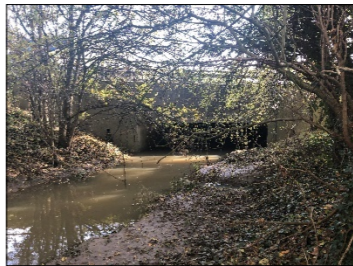
Habitat Feature	Date surveyed	Survey Limitations	Habitat Description	Water Vole Survey Results	Site Photographs	Further surveys proposed?
River Swilgate	-06/09/2019 (east of M5) -04/11/2019 (west of M5)	Access into the River Swilgate channel was restricted along sections of this watercourse due to steep banks, high water levels and dense vegetation. Where possible, these habitats were surveyed using binoculars from safe, accessible locations, and this is therefore not considered to be a significant limitation.	<p>The River Swilgate is a river which flows in a north-westerly direction through agricultural fields and beneath the M5. The channel width varies within the survey area, and moderate water levels (slow-moving) were recorded during the September and November 2019 surveys. The riverbanks comprise stone walls on both approaches to the M5 culvert. There are some gaps in the stonework although these could not be inspected in more detail. The remaining earth banks are mostly steep, although these become shallower at the meanders.</p> <p>The river passes beneath the M5 through a large box culvert which is at an angle (resulting in poor visibility through the culvert).</p> <p>To the east of the M5 and on the western approach to the M5, the river channel is mostly heavily shaded by areas of woodland and dense scrub vegetation along both banks of the river. There are short sections of open unshaded banks further east and west from the M5 which are vegetated with grasses and tall ruderal species including nettles, willowherb, teasel, cow parsley, and extensive Himalayan balsam. No emergent vegetation was recorded within the channel.</p> <p>Adjacent land use comprises open fields (pasture and arable). Poor water quality was recorded within the river.</p>	<p>Possible presence (surveys incomplete).</p> <p>No water vole signs were recorded during the 2019 survey. The earth banks provide suitable substrate for burrow creation. One burrow was seen in the northern bank to the east of the M5, however, this was very high above the water level on a steep bank and is considered more likely that this is a kingfisher burrow. The majority of the channel is considered to provide poor foraging habitat for water vole, although the sections of open unshaded banks offer higher suitability.</p>

N/A – no longer within survey area.

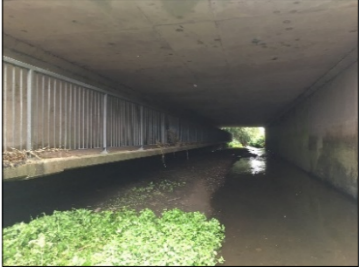
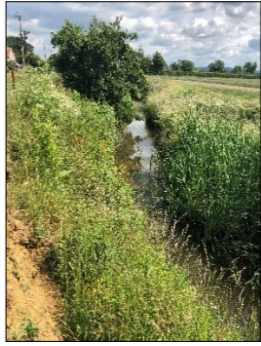
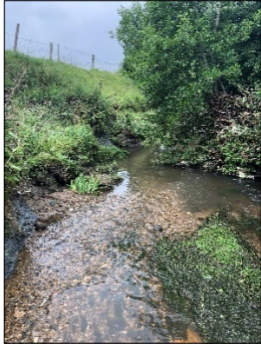
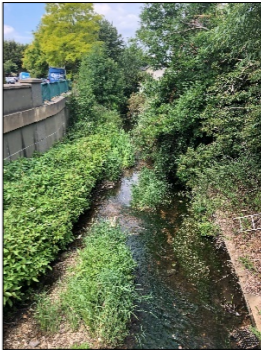
River Chelt	-11/09/2019 (east of M5 to Withybridge lane, east of Withybridge lane) -12/09/2019 (west of M5) -20/09/2019 (east of M5 within Cheltenham) -15/06/2020 (M5 east to Withybridge lane, east of Withybridge lane including sections within Cheltenham) -16/06/2020 (west of M5 and section	Access into the River Chelt channel was restricted along sections of this watercourse due to steep banks, high water levels and dense vegetation. Where possible, these sections were surveyed using binoculars from safe, accessible locations, and this is therefore not considered to be a significant limitation.	<p>The River Chelt is a river which flows in a westerly direction through Cheltenham, agricultural fields (pasture and arable) and beneath the M5. The channel varied significantly across the sections within the survey area:</p> <ul style="list-style-type: none"> West of M5 – high and fast-flowing water levels were recorded along this section in 2019 and 2020. The earth and clay banks are tall and steep facing, and generally open and unshaded. The banks are vegetated with grasses and tall ruderal species including extensive Himalayan balsam, with scattered scrub and trees. There are patches of emergent vegetation along the toe of the bank including yellow flag iris, reeds, and sedges. There are areas of woodland adjacent to this section of the River Chelt. The River Chelt passes beneath the M5 in a westerly direction through a large straight-sided 	<p>Likely absent.</p> <p>No water vole signs were recorded during the 2019 or 2020 survey. The River Chelt provides good foraging opportunities for water vole (in channel and on the banks), although these areas are patchy due to areas of heavy shading. The bank substrate varies and there are stretches of steep earth banks which provide suitable substrate for burrow creation. However, there are sections of the bank where the riverbed and bank toe are formed of clay which</p>

Habitat Feature	Date surveyed	Survey Limitations	Habitat Description	Water Vole Survey Results	Site Photographs	Further surveys proposed?
	east of Withybridge lane) -17/06/2020 (section east of Withybridge lane)		<p>box culvert. It should be noted that an additional box culvert is located south of the M5 culvert and very fast-flowing water was recorded being dispelled into the River Chelt during the 2019 and 2020 surveys. The source of this water is not known, and no watercourse is shown on OS mapping at this location.</p> <ul style="list-style-type: none"> • East of M5 (M5 to Withybridge Lane) – moderate and slower-moving water levels were recorded along this section in 2019 and 2020. The earth and clay banks are tall and steep facing and generally open and unshaded. The banks are vegetated with grasses and tall ruderal species including extensive Himalayan balsam, with scattered scrub and trees. There are dense areas of emergent vegetation along the toe of the bank including sedges, reeds, yellow flag iris, and watercress. There are areas of woodland on either side of the River Chelt on the approach to the M5 crossing. • East of M5 (east of Withybridge Lane) – low and slower-moving water levels were recorded along this section in 2019 and 2020. The earth and clay banks are tall and steep facing with increased tree/ scrub cover which increases shading within the channel. The banks are largely vegetated with grasses. The river meanders in several places, leaving stony and mud beaches within the channel. Emergent vegetation is sparse within the channel but there are patches including sedges and common water crowfoot. On the approach towards Cheltenham, a section of the river has tall and steep artificial stone banks. • East of M5 (within Cheltenham) – water levels varied along this section but were mostly low and fast-flowing in 2019 and 2020. Sections of the banks and adjacent embankments are modified where the river passes beneath several roads and runs alongside residential and commercial properties. The banks are mostly heavily vegetated with trees and scrub, resulting in heavy shading and a sparse vegetation present within the channel. There are patches of emergent vegetation including reeds, yellow flag-iris, and common water crowfoot. 	would not be suitable for burrow creation. It is noted that the River Chelt floods regularly and water levels and velocity were noted to increase significantly during spate conditions, which is considered to reduce the suitability of the habitat for water vole. Surveys have been completed and it is considered that water vole are likely absent along this watercourse.

No further surveys proposed.

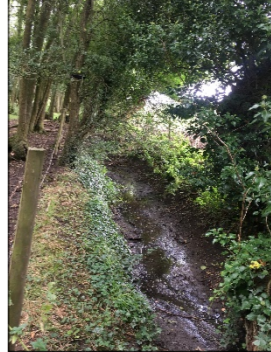
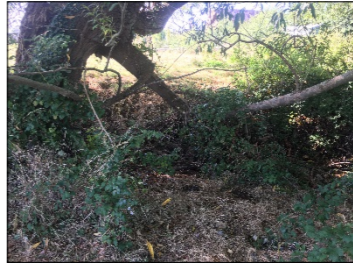
Habitat Feature	Date surveyed	Survey Limitations	Habitat Description	Water Vole Survey Results	Site Photographs	Further surveys proposed?
Leigh Brook	-02/09/2019 (west of M5) -06/09/2019 (section east of M5) -18/09/2019 (section east of M5)	Dense scrub vegetation restricted access along short sections of the banks of this watercourse (to the east and west of the M5). Where possible, these sections were surveyed using binoculars from safe, accessible locations, and this is therefore not considered to be a significant limitation.	<p>Leigh Brook comprises a minor watercourse/ stream which flows in a north-westerly direction through agricultural fields (pasture and arable) and passes beneath the M5.</p> <p>To the east of the M5, the channel comprises a field-side ditch which was found to be largely dry during the 2019 survey. The earth banks are mostly shallow, although there is a short section where the banks are taller and steeper. The channel is heavily shaded by adjacent hedgerows and trees. The channel and banks are densely vegetated by ruderal species including nettle and willowherb; however, no aquatic species were recorded.</p> <p>To the west of the M5, the stream channel is heavily shaded by adjacent dense scrub and woodland. The earth banks are shallow sloping and sparsely vegetated, and no vegetation was recorded within the channel. The channel was almost dry with some pools of standing water.</p> <p>The area of woodland adjacent to the stream to the west of the M5 is heavily cattle-poached with sparse understory vegetation.</p>	Likely absent. This watercourse is not considered to be suitable to support water vole.

No further surveys proposed.

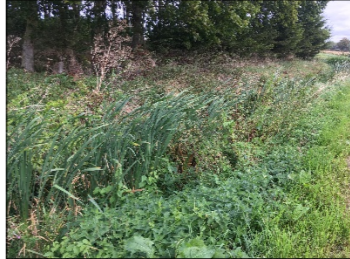
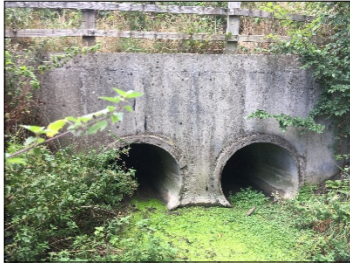
No further surveys proposed.
Unnamed minor watercourse 4 (MW4)	-11/09/2019 (east of M5) -12/09/2019 (west of M5) 16/06/2020 (east and west of M5)	N/A	<p>This is a minor watercourse which runs in a north-westerly direction through agricultural fields (arable) and passes underneath the M5 carriageway through two small tunnel culverts (approximately 1 m in width). The watercourse joins the River Chelt approximately 420 m to the north-west of the M5.</p> <p>To the east of the M5, the channel comprises a field-side ditch with short but steep earth banks. The channel is partially shaded by the adjacent woodland and hedgerow, and it was found to be mostly dry during the 2019 and 2020 survey. There are reeds present within the channel and the banks are vegetated with grasses, nettles, hemlock, and docks.</p> <p>To the west of the M5, the channel widens, and the earth banks are steeper. There was no water present at the time of the 2019 survey and shallow water was present during the 2020 survey. There are reeds and bulrush present within the channel and the banks are largely vegetated by grasses and nettles. This section of</p>	Likely absent. No water vole signs were recorded during the 2019 or 2020 survey. The channel provides good foraging habitat for water vole. In addition, the banks are considered to provide a suitable substrate for burrow creation. However, the low water levels are considered to reduce the likelihood of this watercourse supporting a water vole population. Surveys have been completed and it is considered that water vole are likely absent along this watercourse.

No further surveys proposed.

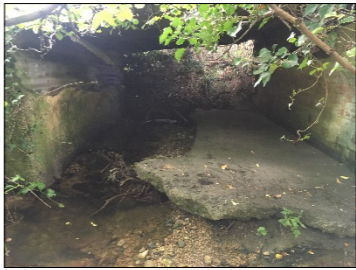
Unnamed minor watercourse 5 (MW5)	11/09/2019	Dense scrub vegetation restricted access along short sections of the banks. Where possible, these sections were surveyed using binoculars from safe, accessible locations, and this is therefore not considered to be a significant limitation.	This is a minor watercourse which runs in a northerly direction to join the River Chelt. There is a small farm access bridge which crosses this stream. The stream had low water levels (no obvious flow) at the time of the 2019 survey. The channel is heavily shaded by adjacent scrub vegetation and trees with no aquatic vegetation recorded and sparse vegetation on the earth banks (which are steeply sloping).	Likely absent. This watercourse is not considered to be suitable to support water vole.

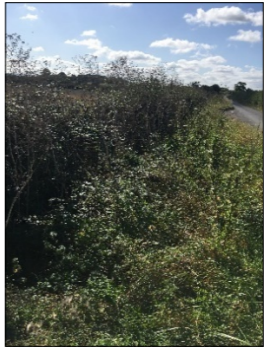
No further surveys proposed.
Drain 3	17/09/2019	N/A	This comprises a road-side drainage ditch which was found to be largely dry with pools of shallow water (likely surface run-off) during the 2019 survey. Poor water quality (pollution) was noted. It is shaded by an adjacent field boundary hedgerow. The shallow earth banks and the channel are vegetated with grasses and tall ruderal species including nettles, with no aquatic species recorded.	Likely absent. This ditch is not considered to be suitable to support water vole.

No further surveys proposed.

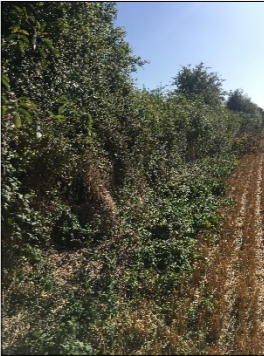
Habitat Feature	Date surveyed	Survey Limitations	Habitat Description	Water Vole Survey Results	Site Photographs	Further surveys proposed?
Drain 14	09/09/2019	N/A	This comprises a road-side drainage ditch which runs alongside Hayden Lane, beneath the B4634 road and continues north alongside Withybridge Lane. The ditch was found to be completely dry during the 2019 survey. It is shaded by adjacent field boundary hedgerows. The shallow earth banks and channel are vegetated with grasses and tall ruderal species including nettles and no aquatic species were recorded.	Likely absent. This ditch is not considered to be suitable to support water vole.	No photograph available.	No further surveys proposed.
Drain 15	18/09/2019 19/09/2019	N/A	This comprises a ditch with very shallow earth banks which runs alongside Hayden Lane, beneath a hedgerow at the boundary of an arable field, beneath the B4634 (culverted) and north beneath a hedgerow at the boundary of agricultural fields (pasture). The ditch has very shallow earth banks and it was completely dry during the 2019 survey. The channel is heavily shaded and there is sparse vegetation on the banks, with no aquatic vegetation recorded.	Likely absent. This ditch is not considered to be suitable to support water vole.

No further surveys proposed.

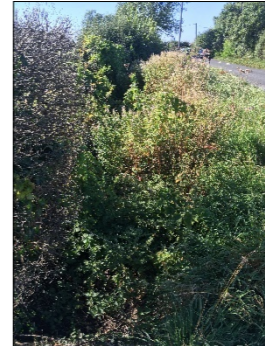
Habitat Feature	Date surveyed	Survey Limitations	Habitat Description	Water Vole Survey Results	Site Photographs	Further surveys proposed?
Drain 17	18/09/2019	N/A	This comprises a road-side drainage ditch which was found to be completely dry during the 2019 survey. It is shaded by an adjacent field boundary hedgerow. The road-side earth bank is steep and vegetated with grasses and tall ruderal species including nettles, thistles, and cow parsley, with no aquatic vegetation recorded.	Likely absent. This ditch is not considered to be suitable to support water vole.

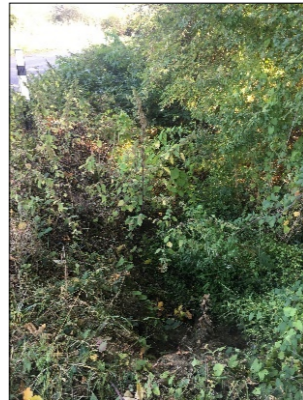
No further surveys proposed.
Drain 19	18/09/2019	N/A	This comprises a road-side drainage ditch which was found to be completely dry during the 2019 survey. It is shaded by an adjacent field boundary hedgerow and trees. The road-side earth bank is steep and vegetated with grasses and tall ruderal species including nettles, with no aquatic vegetation recorded.	Likely absent. This ditch is not considered to be suitable to support water vole.

No further surveys proposed.

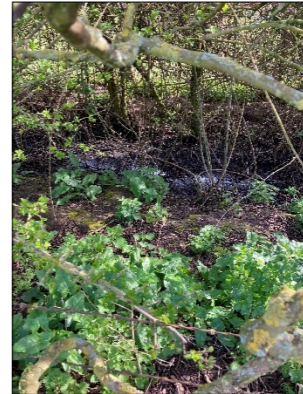
Drain 20	18/09/2019	N/A	This comprises a ditch with very shallow earth banks which runs beneath a hedgerow at the boundary of agricultural fields (pasture and arable). The ditch was completely dry during the 2019 survey. The channel is heavily shaded and there is sparse vegetation on the banks, with no aquatic vegetation recorded.	Likely absent. This ditch is not considered to be suitable to support water vole.	No photograph available.	No further surveys proposed.
Drain 21	30/03/2021	N/A	This comprises a ditch with very shallow earth banks which runs beneath a hedgerow at the boundary of agricultural fields (pasture). The ditch was almost dry with patches of shallow standing water. The channel is heavily shaded and there is sparse vegetation on the banks, with no aquatic vegetation recorded.	Likely absent. This ditch is not considered to be suitable to support water vole.

No further surveys proposed.

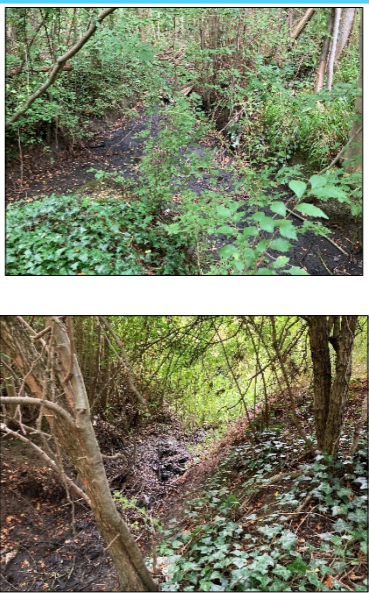
Habitat Feature	Date surveyed	Survey Limitations	Habitat Description	Water Vole Survey Results	Site Photographs	Further surveys proposed?
Drain 22 (Piffs Elm)	28/07/2021	No survey access to ditch on eastern side of M5 (landowner permission not agreed)	<p>This comprises a ditch which passes beneath the M5 through a corrugated metal culvert just south of Junction 10. On the western side of the M5, the ditch runs parallel to the A4019 before passing through an area of woodland alongside the M5 J10 northbound on-slip. The channel was found to be almost dry with pools of standing water. There is dense duckweed covering the pools of water, however, no other aquatic vegetation was recorded in the channel. The earth banks are steep in places which provide some opportunity for burrow creation. The woodland provides heavy shading and there is limited suitable vegetation on the banks to provide foraging habitat for water vole. The ditch has connectivity to Drain 9 which was assessed as providing poor habitat for water vole and has been scoped out of further assessments.</p> <p>There was no permitted access to survey Piffs Elm to the east of the M5. The ditch does not appear on OS mapping, however, from a review of online mapping and aerial imagery, the ditch likely continues through an area of woodland and residential gardens. The ditch also does not appear to be connected to other suitable habitat for water vole. Drain 10 and Drain 11 are located in close proximity to the likely route of Piffs Elm ditch on the eastern side of the M5, however, these ditches were assessed as providing poor habitat for water vole and have been scoped out of further assessments.</p>	<p>Likely absent.</p> <p>This ditch is not considered to be suitable to support water vole.</p>

No further surveys proposed.

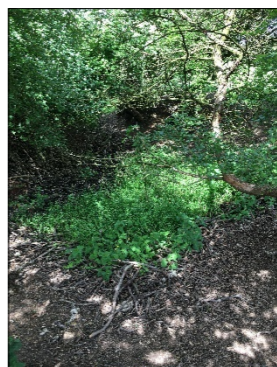
Pond 11	02/09/2019	N/A	This pond comprises a shallow ground depression which was completely dry at the time of the 2019 survey. The pond is heavily shaded by adjacent scrub and trees, and no aquatic species were present within the pond. Adjacent land use comprises open grassland fields (pasture).	Likely absent. This pond is not considered to be suitable to support water vole.

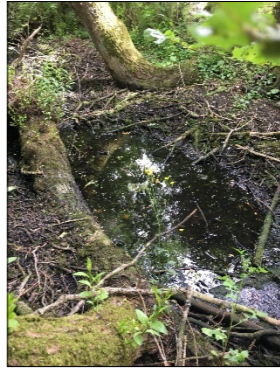
Habitat Feature	Date surveyed	Survey Limitations	Habitat Description	Water Vole Survey Results	Site Photographs	Further surveys proposed?
Pond 12	02/09/2019	N/A	This pond comprises a shallow ground depression which had shallow water present during the 2019 survey. The pond is heavily shaded by adjacent scrub and trees, and no aquatic species were present within the pond. Adjacent land use comprises open grassland fields (pasture).	Likely absent. This pond is not considered to be suitable to support water vole.

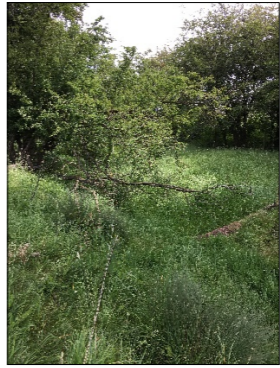
Pond 14	02/09/2019	N/A	This pond comprises a shallow ground depression which was completely dry at the time of the 2019 survey. The pond is heavily shaded by adjacent trees, and no aquatic species were present within the pond. Adjacent land use comprises open grassland fields (pasture).	Likely absent. This pond is not considered to be suitable to support water vole.

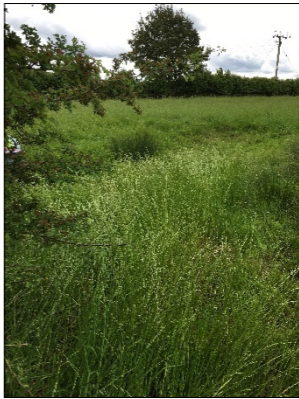
Habitat Feature	Date surveyed	Survey Limitations	Habitat Description	Water Vole Survey Results	Site Photographs	Further surveys proposed?
Pond 15	02/09/2019	N/A	This pond comprises a shallow ground depression within an open grassland field (pasture) which was completely dry at the time of the 2019 survey. The pond is partially shaded by an adjacent hedgerow, and no aquatic species were present within the pond.	Likely absent. This pond is not considered to be suitable to support water vole.

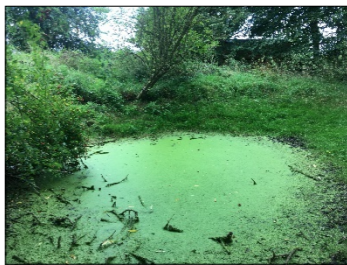
No further surveys proposed.
Pond 17a	02/09/2019	N/A	This pond is located within the corner of an open rough grassland field. The earth banks are tall although shallow-sloping and vegetated with grasses and scattered scrub/trees, which results in partial shading of the pond. There is extensive duckweed within the pond with a lack of other aquatic vegetation.	Likely absent. This pond is not considered to be suitable to support water vole.

No further surveys proposed.

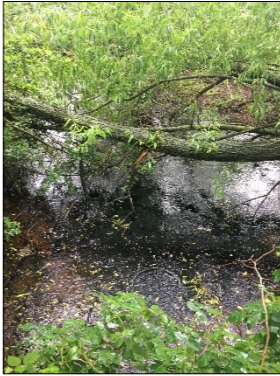
Habitat Feature	Date surveyed	Survey Limitations	Habitat Description	Water Vole Survey Results	Site Photographs	Further surveys proposed?
Pond 21	06/09/2019	Access around the banks of this pond was restricted by dense bankside scrub, however, binoculars were used to aid the survey.	This pond is located at the corner of open grassland fields (pasture) and there was shallow water present during the 2019 survey. The pond is heavily shaded by adjacent scrub and trees, and no aquatic species were present within the pond. The earth banks are shallow.	Likely absent. This pond is not considered to be suitable to support water vole.

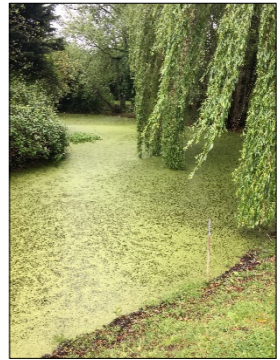
No further surveys proposed.
Pond 24	04/11/2019	Access around the banks of this pond was restricted by fencing, however, binoculars were used to aid the survey from adjacent land.	This is a large pond located at the corner of open grassland fields (pasture) and residential housing/gardens. The earth banks are very shallow sloping. There are trees and scrub vegetation on the banks resulting in sparse vegetation on the banks. There is a high coverage of duckweed within this pond and a lack of other aquatic species.	Likely absent. This pond is not considered to be suitable to support water vole.

No further surveys proposed.

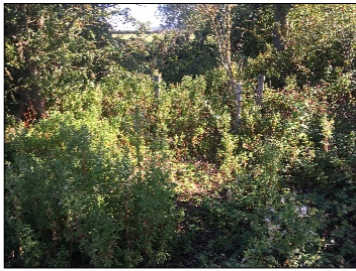
Habitat Feature	Date surveyed	Survey Limitations	Habitat Description	Water Vole Survey Results	Site Photographs	Further surveys proposed?
Pond 26	18/09/2019	N/A	This pond comprises a shallow ground depression adjacent to a hedgerow and area of dense scrub adjacent to open grassland fields. The pond was completely dry at the time of the 2019 survey. The pond is heavily shaded, and no aquatic species were present within the pond.	Likely absent. This pond is not considered to be suitable to support water vole.

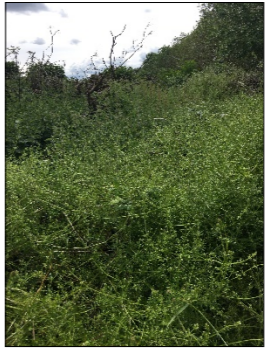
Pond 28	N/A	No survey access (landowner permission not agreed).	N/A	N/A	N/A	No further surveys proposed.
Pond 29	N/A	No survey access (landowner permission not agreed).	N/A	N/A	N/A	No further surveys proposed.
Pond 30	18/09/2019	Access around the banks of this pond was restricted by dense bankside scrub.	This pond was found to be surrounded and covered by dense bramble scrub and therefore it could not be accessed to survey. However, it is assumed that the pond has sparse vegetation due to the heavy shading.	Likely absent. This pond is not considered to be suitable to support water vole.

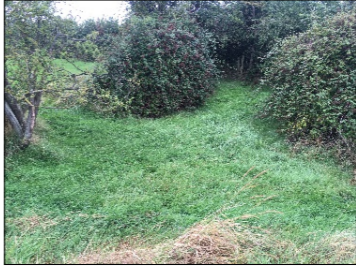
No further surveys proposed.
Pond 31	09/09/2019	N/A	This pond comprises a shallow ground depression within an open grassland field (pasture) which was completely dry at the time of the 2019 survey. The pond is partially shaded by an adjacent bramble scrub and no aquatic species were present within the pond.	Likely absent. This pond is not considered to be suitable to support water vole.

No further surveys proposed.
