A46 Newark Bypass

6.3 Environmental Statement

Appendix 8.13 River Physical Habitat Technical Report

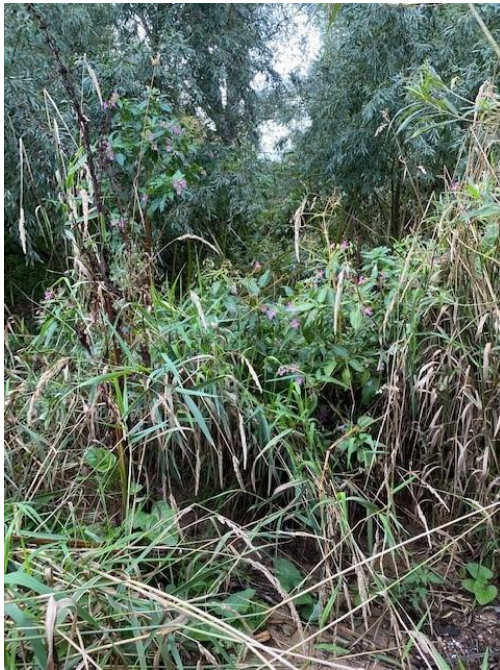
Photo 4-1: KC2 module 5 bank top

- The bank top non-native invasive plant species (NNIPS) cover indicator score was lowest in sub-reach KC1 as Himalayan balsam *Impatiens glandulifera* was recorded extensively on the bank top. Himalayan balsam was also recorded on the bank top of KC2. No NNIPS were recorded in KC3.
- The bank top managed ground cover indicator score was lowest in sub-reach KC3 as transport infrastructure was extensive on the right bank top (see Photo 4-2).

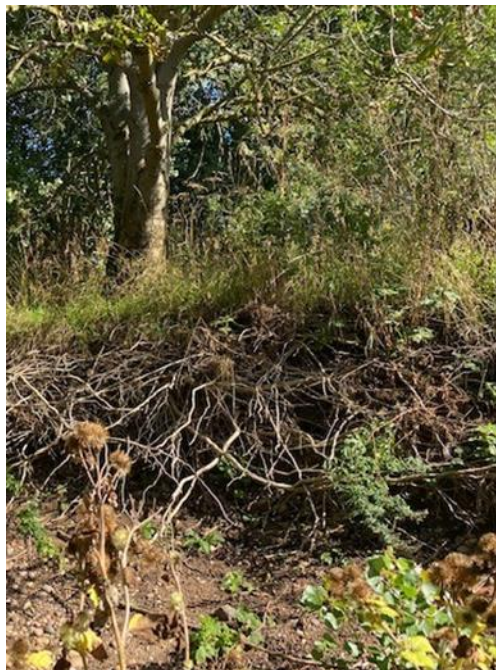
Photo 4-3: KC1 module 1 bank face

- The bank face artificial profile extent indicator score was only negative in the sub-reach KC1 as the artificial bank profile 'obviously reshaped' was recorded as extensive on the left bank face.
- The bank face reinforcement extent indicator scores were lowest for the sub-reaches KC1 and KC3 which both had a score of -2 (see Photo 4-4). Reinforcement was also recorded in the sub-reach KC2.
- The bank face reinforcement material severity indicator scores were consistent for all 3 of the sub-reaches with -2 recorded due to the presence of concrete, rip-rap and brick.
- The bank face NNIPS cover indicator scores were -3 for all sub-reaches on the Kelham channel as Himalayan balsam was recorded.

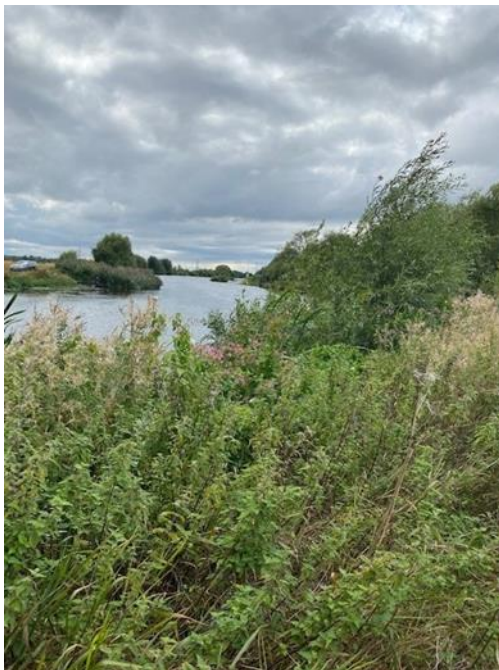
Photo 4-9: MC1 module 2 facing upstream

- The bank top NNIPS cover indicator score was -3 for all 3 sub-reaches as Himalayan balsam was recorded on the bank tops in all sub-reaches.
- The bank top managed ground cover indicator score was lowest for the sub-reach MC3 with a score of -4. Extensive transport infrastructure was recorded on both bank tops in module 2 which has the highest severity weighting (Photo 4-10).

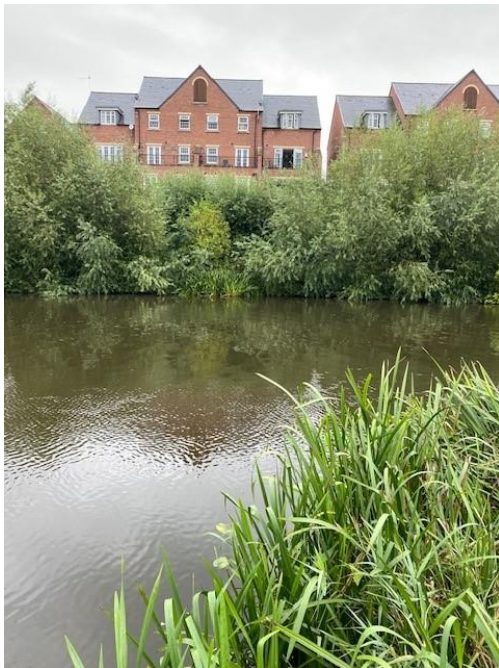
Photo 4-17: MC4 module 5 midpoint

- The bank top NNIPS cover indicator scores were both 0 as none were present on the bank tops of both sub-reaches.
- The bank top managed ground cover indicator score was -4 for both sub-reaches as building infrastructure was present on the bank top (Photo 4-17 and Photo 4-18).

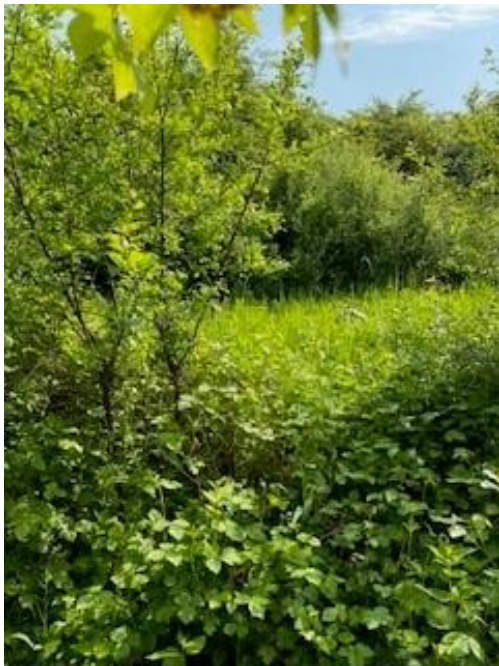
Photo 4-25: SD1 module 2 right bank top

- There were no non-native invasive plant species observed in the 3 sub-reaches.
- The bank top managed ground cover was negative for all 3 of the sub-reaches. The watercourse ran alongside the A1 road on the right bank top and the left bank top was a arable field. (See Photo 4-25 and Photo 4-26).

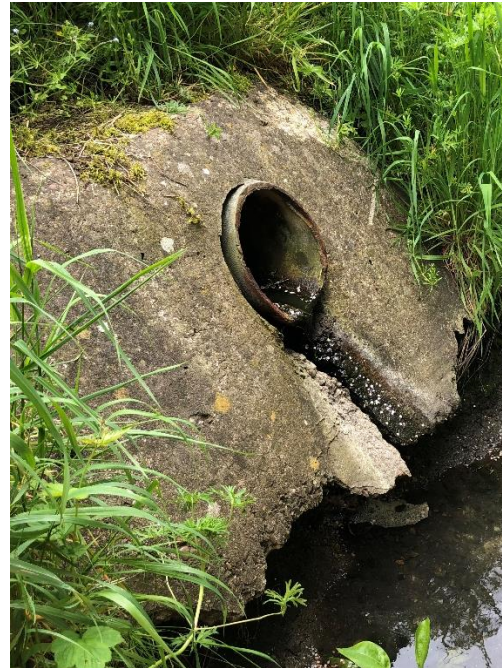
Photo 4-28: SD2 module 1 outfall

- The sub-reach SD2 was observed to have 1 outfall present in module 1 and had an indicator score of -1. No artificial channel margin features were recorded in the other 2 sub-reaches.

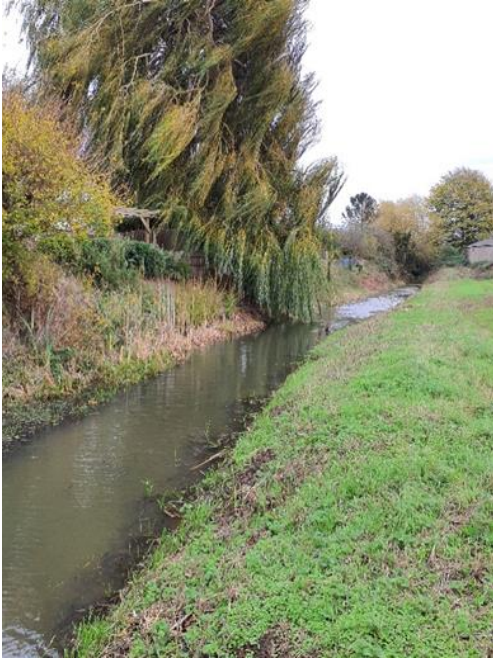
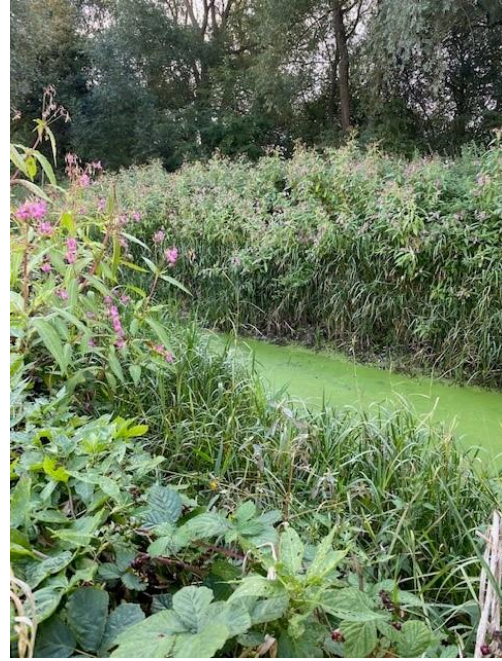
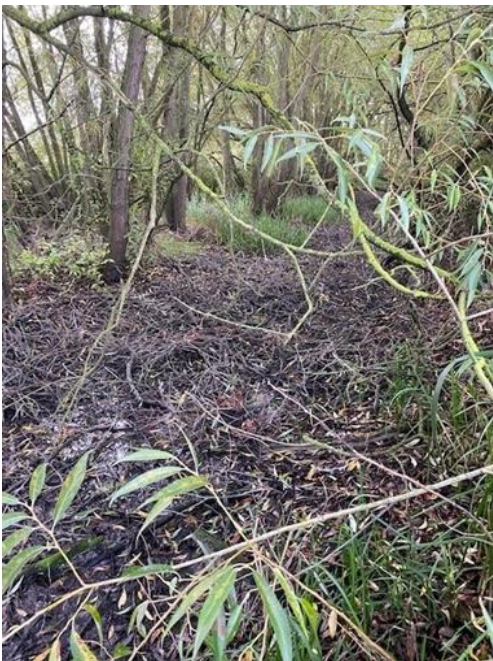
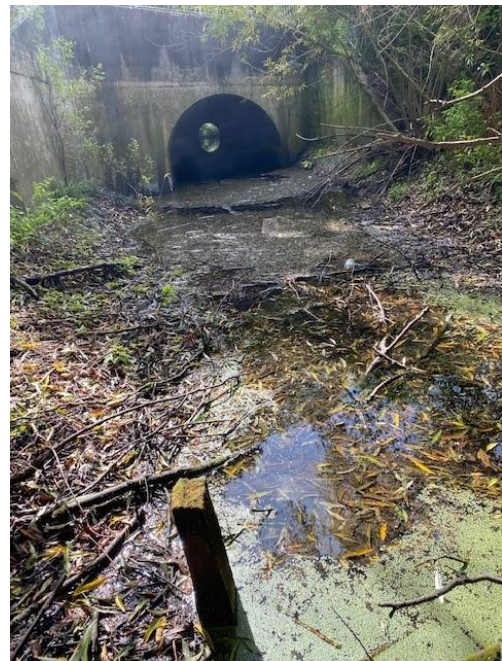
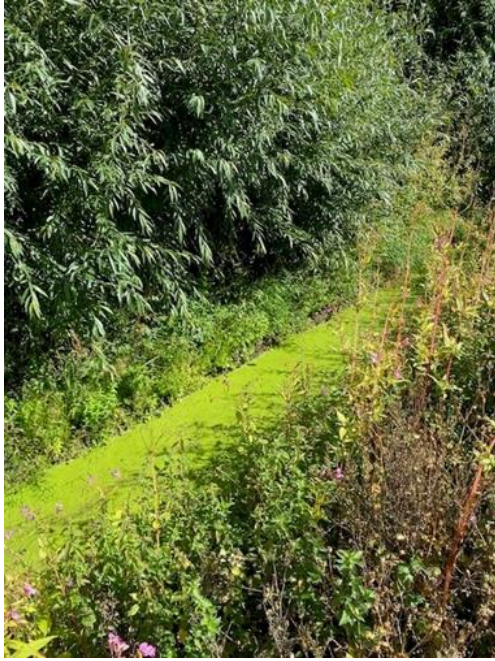
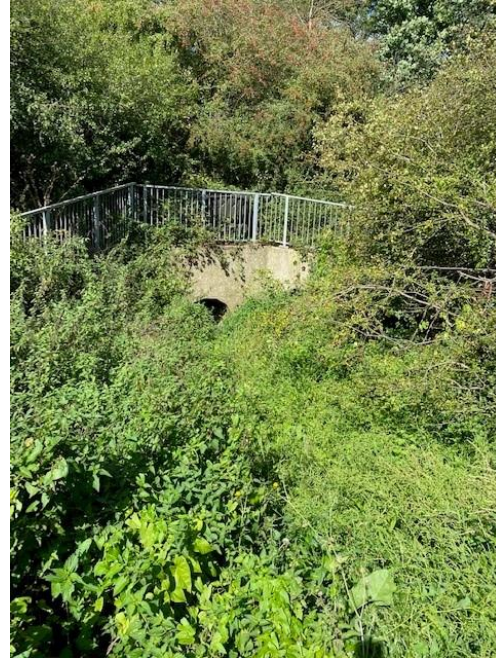
- 4.3.5 Two reaches (Old Trent Dyke A46 culvert and Old Trent Dyke Kelham Road area) were also impacted by shading which was above the 10% threshold. Insufficient water levels were also observed for 4 of the reaches (Old Trent Dyke to A46, Old Trent Dyke A46 to Railway, Old Trent Dyke A46 culvert and Old Trent Dyke Kelham Road area). The presence of INNS in 4 of the 5 reaches (Old Trent Dyke to A46, Old Trent Dyke A46 to Railway, Old Trent Dyke A46 culvert and Old Trent Dyke Kelham Road area) also contributed to the Poor overall condition. The reaches are shown below in Table 4-39 to Photo 4-44.

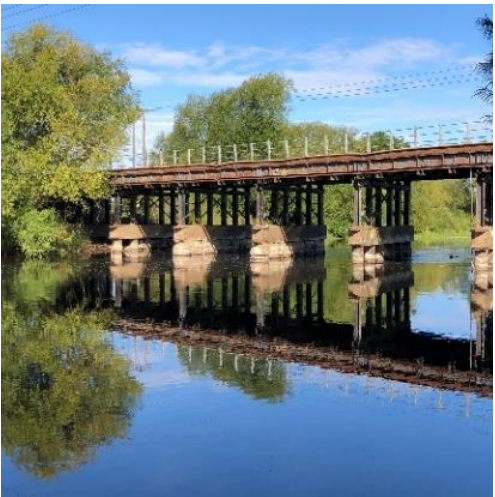
10	Feature	SK 77103 53884	Flow diversity influenced by bridge supports, creating conditions to support a variety of fish species and life stages. Likely to be a pool at this location, as deposited material was visible further downstream.

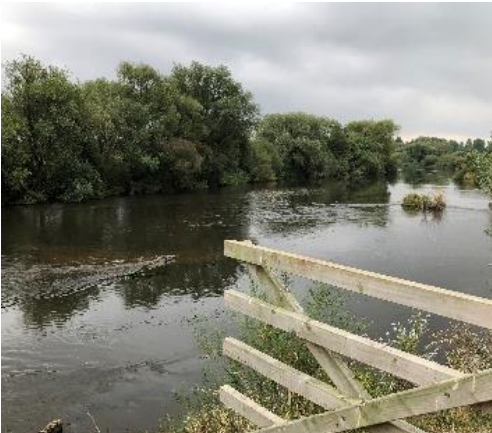
2	Modification	SK 76927 54559	Failed structure in water.

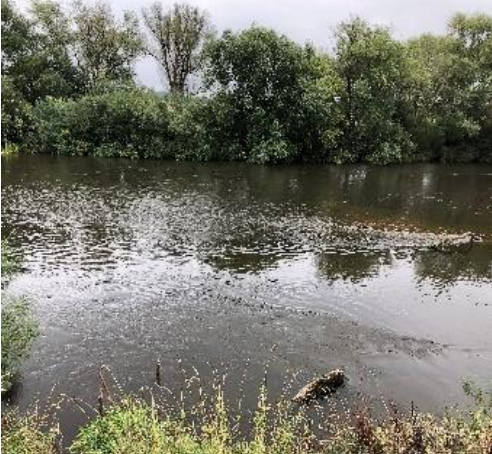
Feature number	Feature type	NGR	Description of ecological significance	Photograph
3	Modification	SK 77073 54642	Groyne in water - partially collapsed.

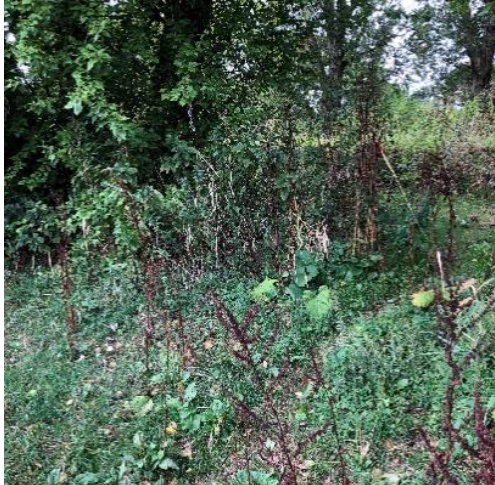
17	Feature/modification	SK 77657 55469 to SK 77637 55651	Right bank rip-rap toe and other failed reinforcements present. Right bank possibly historically resectioned. Completely colonised by trees at the time of survey, with branches overhanging or trailing into the water providing important marginal cover for fish.

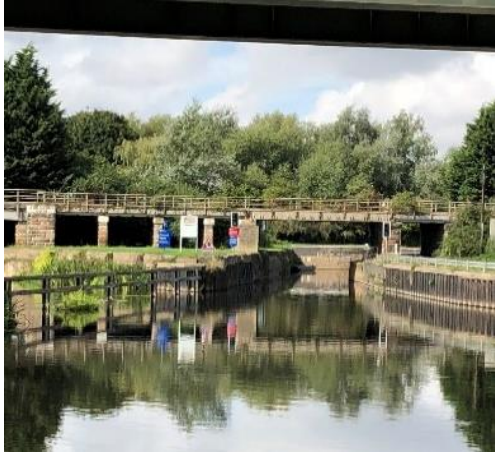
15	Modification	SK 80076 55317	Weir, likely inhibiting fish passage during most conditions; however providing localised flow diversity and oxygenation of water.
