Preliminary Arboricultural Assessment

**PRELIMINARY ARBORICULTURAL ASSESSMENT
ABLE MARINE ENERGY PARK
KILLINGHOLME**

Prepared by:
COLIN WHITE NDArb. SCC M.Arb.A

July 2010

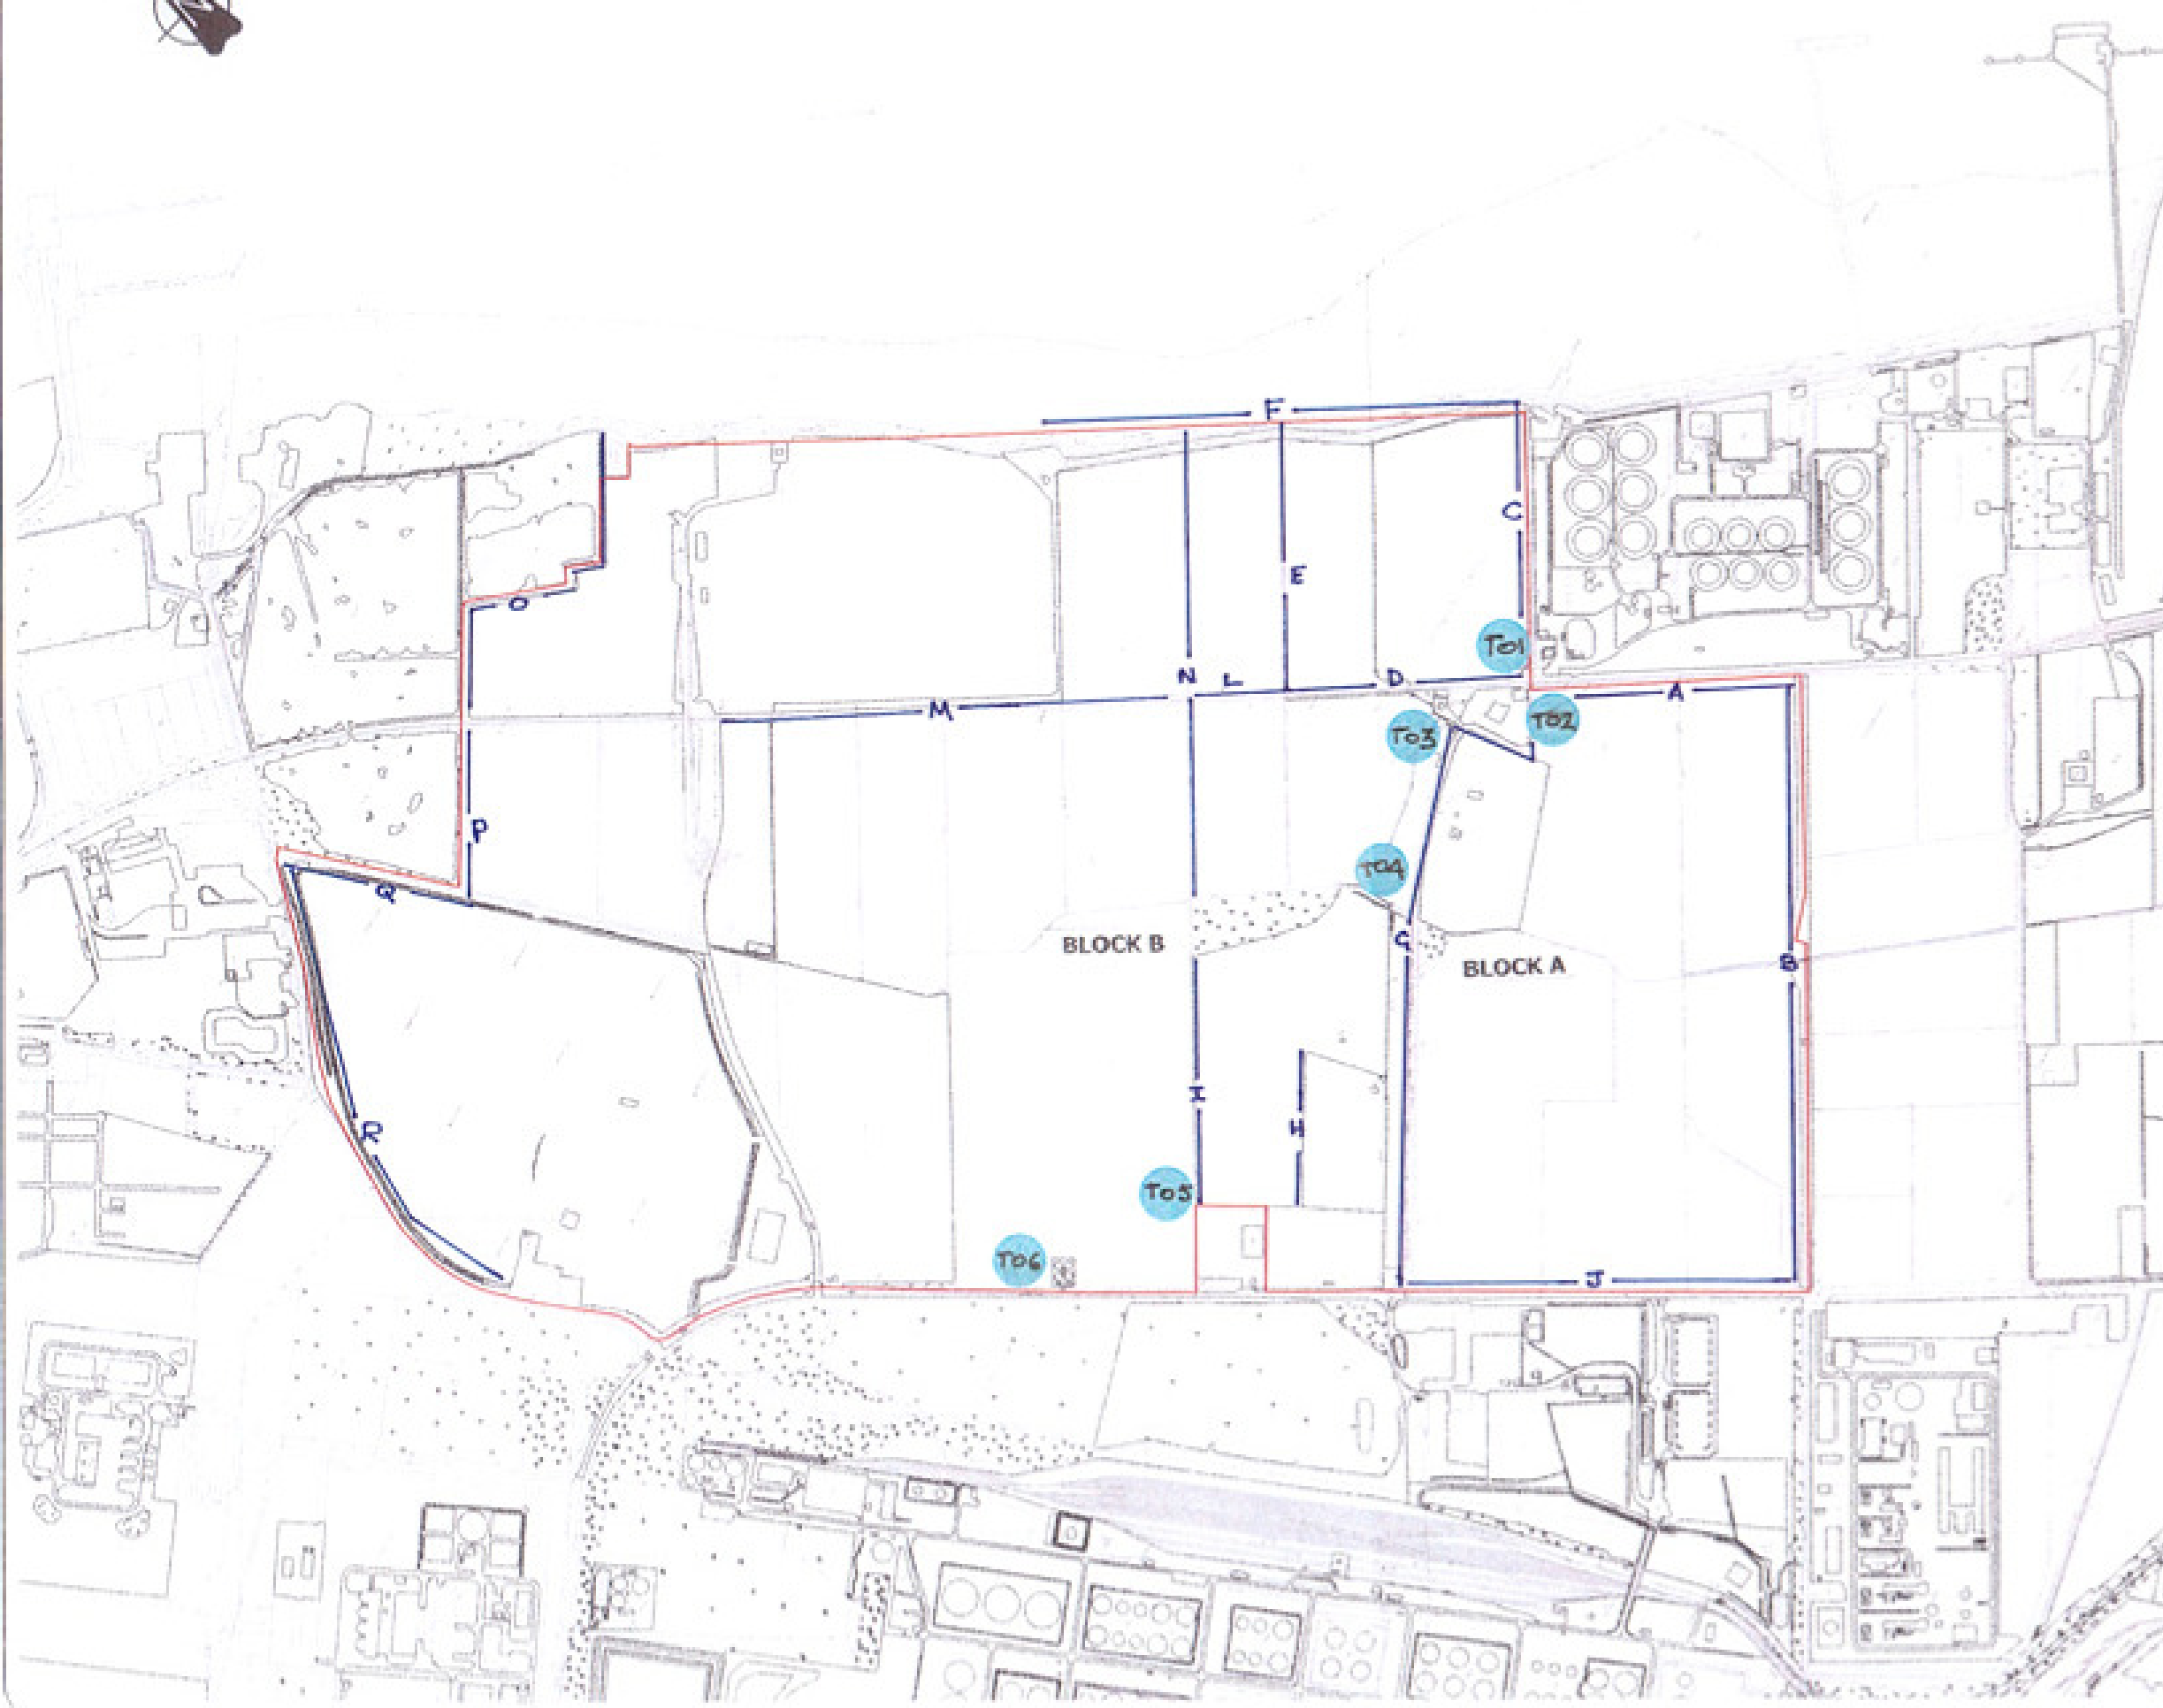
Existing Conditions

INDIVIDUAL TREE DETAIL				
TREES	SPECIES	AGE/CLASS	COND	DETAIL
T01	AH	SM	Fair	Individual hedgerow tree at field gate. Leaf size and frequency normal for species. Branch systems complete. Retention category C1
T02	AH	SM	Fair-Poor	Group of 2No trees within hedging adjacent to old railway line and access road to part of refinery site. Branch systems complete. Leaf size and frequency reduced for species. Significant deadwood. Retention category C1
T03	CY AH	SM	Fair	Group of Cypress (CY) and intermittent Ash (AH) as screening around a property adjacent to a haulage contractors vehicle storage area. The property is currently for sale. Retention category C1

T04	EL	SM	Poor	Group of 3No multistem trees associated with the remains of Hawthorn (Ha) hedging. Advanced infection by Ophiostoma ulmi (Dutch Elm Disease) Category R
T05	WI	SM	Poor	Group of 4No Multistem trees on field margin and industrial compound boundary. Branch systems incomplete. Leaf size and frequency normal for species. Historic inappropriate pruning. Significant deadwood. Retention category C1
T06	AH NM SY	Early SM	Fair	Linear group of Multistem trees 11No Ash (AH) 2No Norway Maple (NM) and 1No Sycamore (SY) Planted as screen around Northerly perimeter fence of treatment plant. Branch systems complete. Leaf size and frequency normal for species. Retention category C1

Species: AH EL OK PO SY	Age/class: SM-M	Cond: FAIR
<p>Block A: A monoculture block of Elm. As a consequence of Dutch Elm Disease only a group of 8No multistem trees in the North-West corner still present with the remaining area colonized by scrub, principally Hawthorn including a boundary hedge of that species. Those trees remaining are all in an advanced state of decline as a consequence of the cycle of Dutch Elm Disease infestation.</p>		
<p>Block B: Mixed broadleaf group comprising principal trees of 29No Ash 51No Black poplar 4No Elm 20No Oak and 10No Sycamore. Trees average 12.6m in height with some Poplar beyond the general canopy at 14.9m. An understorey of Hawthorn Elder and Blackthorn (BL) is present including some immature trees self-sown from the principal trees present.</p> <p>A significant number of trees present are twin or multistems as a consequence of historic coppicing. There is little evidence of more recent management although some drainage has been introduced to control waterlogging and further traumatic failure. General tree condition is fair although Included Bark is present on some. The Elm is reduced as a consequence of Dutch Elm Disease and some Sycamore are infected by a butt rot POPLYPORUS squamosus.</p>

A	Incomplete Hawthorn hedging adjacent to old railway line. Some intermittent Ash present. Average 3.5-4.5m in height. Unmanaged.
B	Unmanaged Hawthorn monoculture forming the South-East boundary of the Site. Comparable to Hedge A
C	Unmanaged Hawthorn adjacent to access track completing South-East boundary
DE	Hawthorn monoculture forming field boundary and old railway screen. Currently upto 4.5m in height. Unmanaged.
F	Intermittent Hawthorn low-growing adjacent to sea-wall.
G	Double hedge on both sides of access road to haulage depot and part of refinery site. Intermittent Elm and Ash present along hedge runs. All Elm infested by Dutch Elm Disease. Mainly unmanaged with some lower flail-mower pruning to improve access to haulage depot.
H	Unmanaged Hawthorn as field margin. Poor condition
I	Unmanaged Hawthorn as field margin upto Woodland Block B from industrial compound. T05 located at Westerly termination.

J	Roadside boundary. Hawthorn monoculture with intermittent Elm. All Elm present are dead. Maintained at approximately 1.4m.
K	Continuation of Hedge J as roadside boundary. Hawthorn monoculture with intermittent Ash of a semi-mature age classification. Unlike Hedge J this continuation is unmanaged currently upto 5.3m in height.
L	Unmanaged Hawthorn bordering seaward side of old railway lime.
M	Incomplete Hawthorn hedging located on seaward side of old railway line. Unmanaged.
N	Field margin Hawthorn monoculture providing boundary between Woodland Block B and sea-wall. Although complete currently unmanaged.
O	Hawthorn and Dog Rose forming Site North boundary. Recently planted on mounding around reed-beds. Some remnants of earlier Hawthorn hedge present beyond new planting. Vigorous immature hedging.
P	Recently planted Hawthorn monoculture on reed-bed mound. Vigorous immature hedging with tree protection still in place.

Q	Unmanaged Hawthorn. Incomplete, forming boundary beyond drainage ditch which parallels metalled access road.
R	Recently planted hedging whips with tree protection. Incomplete with poor establishment forming significant part of North and North-West Site boundary.

Some remedial pruning to T05 including deadwooding would extend their potential life span and improve their contribution to the amenity signature of the whole Site which is currently poor. T04 a group of Elm is irreversibly infected by Dutch Elm disease and should be removed. T06 which is a screening group has been historically managed by coppicing which has resulted in multi-stem regrowth. If retention as a screen is desirable some removals are necessary to re-space the group and encourage more appropriate development as individual trees. The group of trees T03 providing screening for a private dwelling is beyond the scope of this Assessment.

Management: Removal of dead Elm and other traumatic failures would present an opportunity for re-planting to create an uneven-aged stand. Further thinning would reduce a potential for windthrow and some understorey clearance and replacement with evergreen subjects would enhance the amenity signature and improve the potential as a wildlife habitat. Remaining trees in Block A should be felled and replaced.

Management: Those peripheral hedges on the North and North-West boundaries should be subjected to establishment maintenance to ensure their potential as screening to that aspect of the Site is achieved. More mature hedging which borders the unclassified road boundary connecting with the A160 although only partially managed is important as screening and an appropriate management regime needs to be implemented. Internal hedging, a significant proportion of which is suffering from
