**Able Humber Ports Ltd
Marine Energy Park
Proposal to build a quay and associated development on
the south bank of the River Humber**

**Comments on other parties' responses to
The Examining Authority's 2nd Written Questions**

Technical Note – Embankment Stability Analysis

Project	Halton Marshes	Date	28 August 2003
Note	Embankment Stability Analysis	Ref	KMLHBF/22
Author	ELC

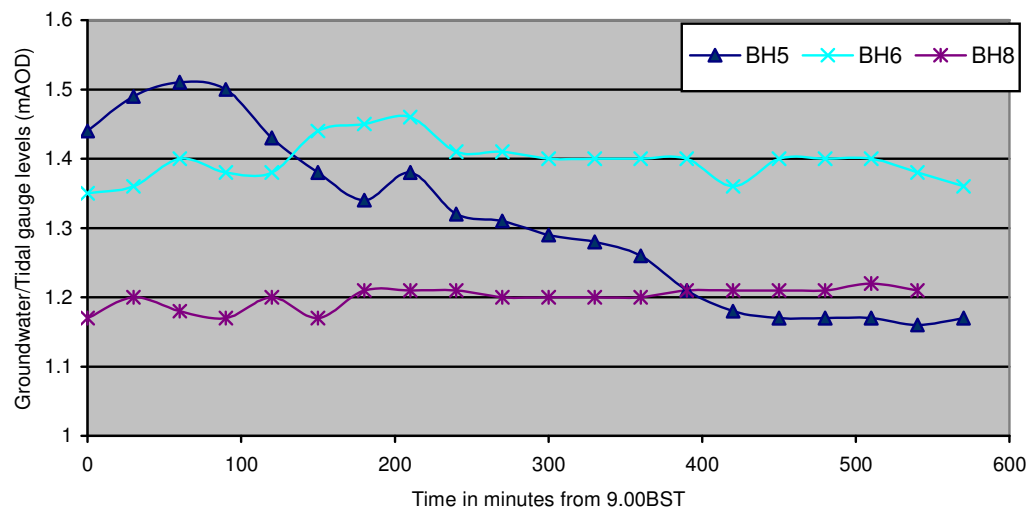
Figure 1: Groundwater levels recorded in boreholes on the 3rd of July 2003

- 6.5 Figure 1 indicates that high groundwater levels in the summer months could be expected to be around 1.2 to 1.5mAOD across the site.
- 6.6 Groundwater monitoring undertaken on the 27th and 30th of June coincided with reducing tide levels, not with the time of day at which the lowest tidal point occurred. Therefore the groundwater levels would be expected to reach lower levels than those measured during the monitoring period.

- 6.7 The groundwater levels recorded in boreholes BH5 and BH6 show a time lag response to the tidal levels recorded by the Environment Agency of approximately one hour at borehole BH5 and three and a half hours at BH6.
- 6.8 Borehole BH8 did not record such a marked peak groundwater level in response to the tidal fluctuation as boreholes BH5 and BH6.
- 6.9 The groundwater levels recorded in BH2, however, recorded a level of 0m below ground level throughout the monitoring on the 3rd of July, indicating that the borehole was possibly flooded during this day. Levels recorded in this borehole on the 27th and 30th of June recorded levels of 3.8 and 3.68m below ground level respectively.

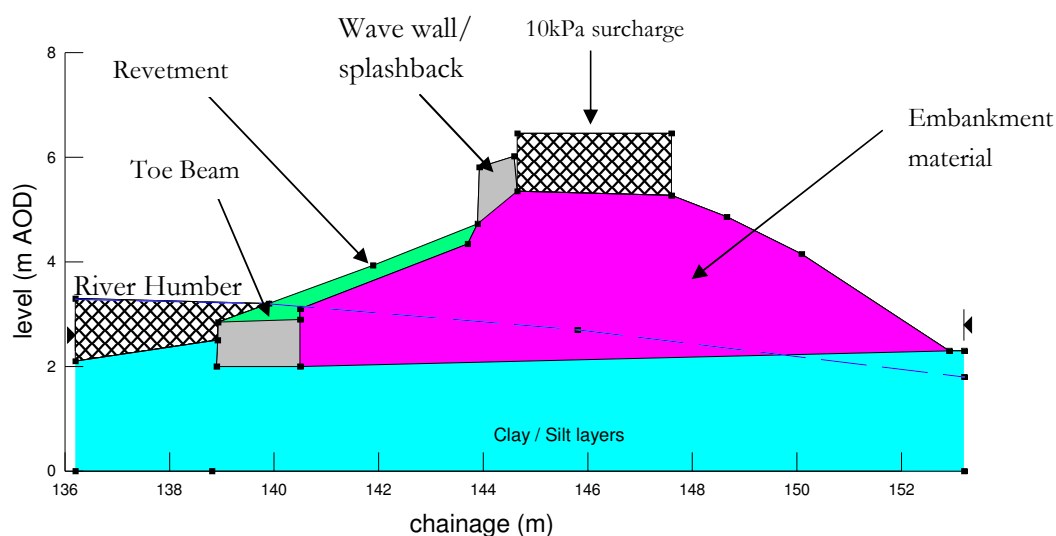
Figure 1: Basic Embankment Geometry

- 7.4 A surcharge of 10kPa was applied to the crest of the embankment to allow for any vehicular movement across it.

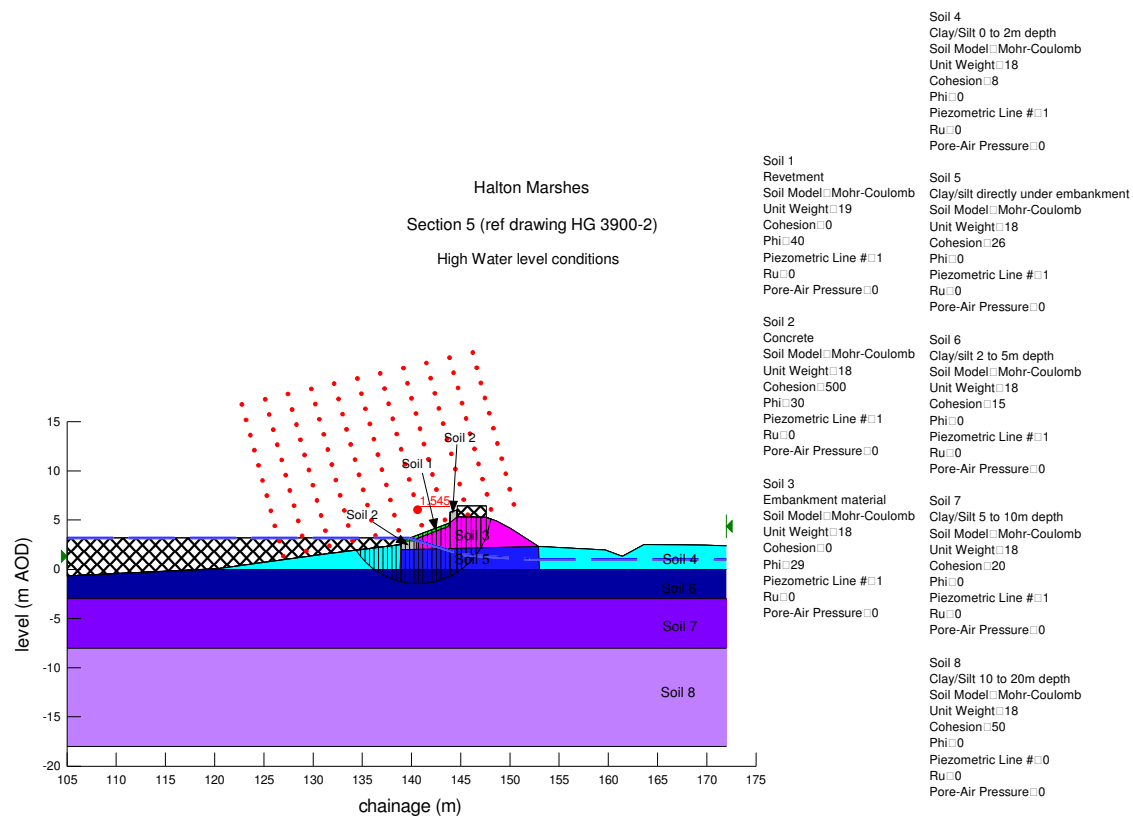
For high tide water levels (based on Environment Agency recorded levels for June and July), the minimum factor of safety recorded was 1.55, which is above the recommended factor of 1.3, indicating the slope to be stable in its current condition (as shown below).

River levels could be expected to reach higher levels than those illustrated above, however this would only be expected to increase the stability due to the increase toe weighting from the water.

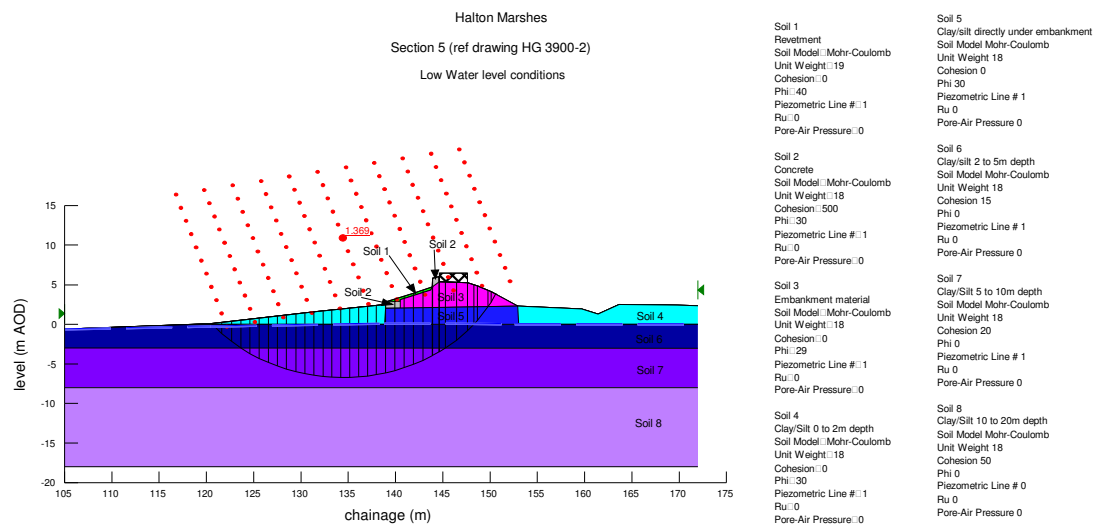
For low tide levels, the minimum factor of safety recorded for the embankment was 1.37 (as detailed below), also above the recommended factor of 1.3, indicating the embankment to be stable at low tides under current conditions.

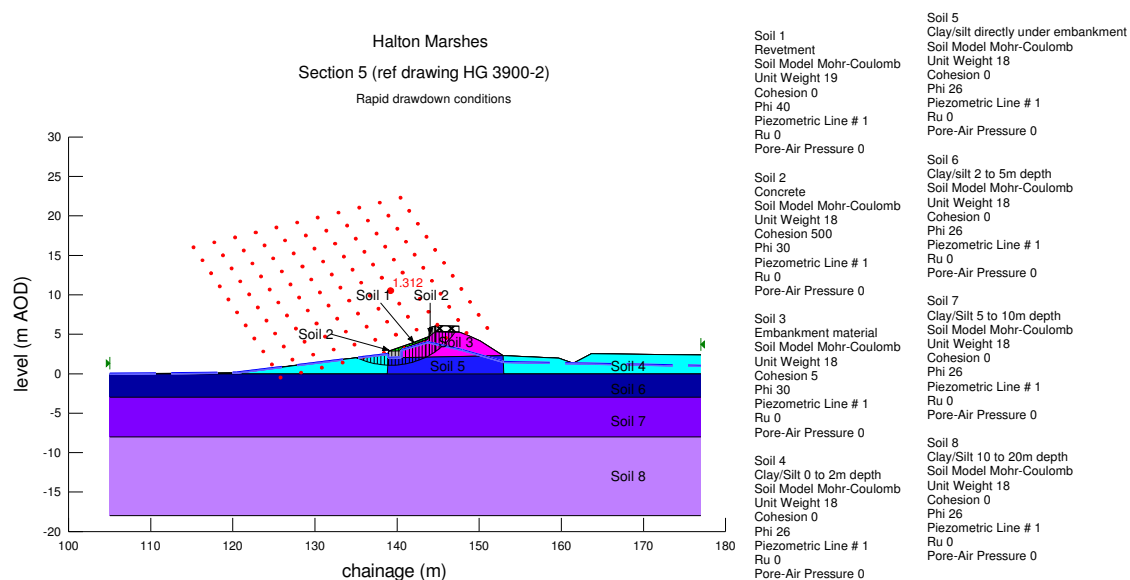
For the critical case conditions of rapid draw-down (allowing for pore-water pressure effects), the minimum factor of safety recorded was 1.31 (as detailed below), indicating the slope to be on the limits of stable conditions.

The highest groundwater levels as part of the rapid draw-down scenario have been estimated due to a lack of groundwater monitoring.

- 9.2 For conditions of rapid draw-down, the factor of safety achieved is close to 1.3, indicating that the slope is on the limit of stability in it's current state and any changes in geometry (i.e. erosion, loading at the crest, extreme climatic conditions) could result in a reduction in this stability.

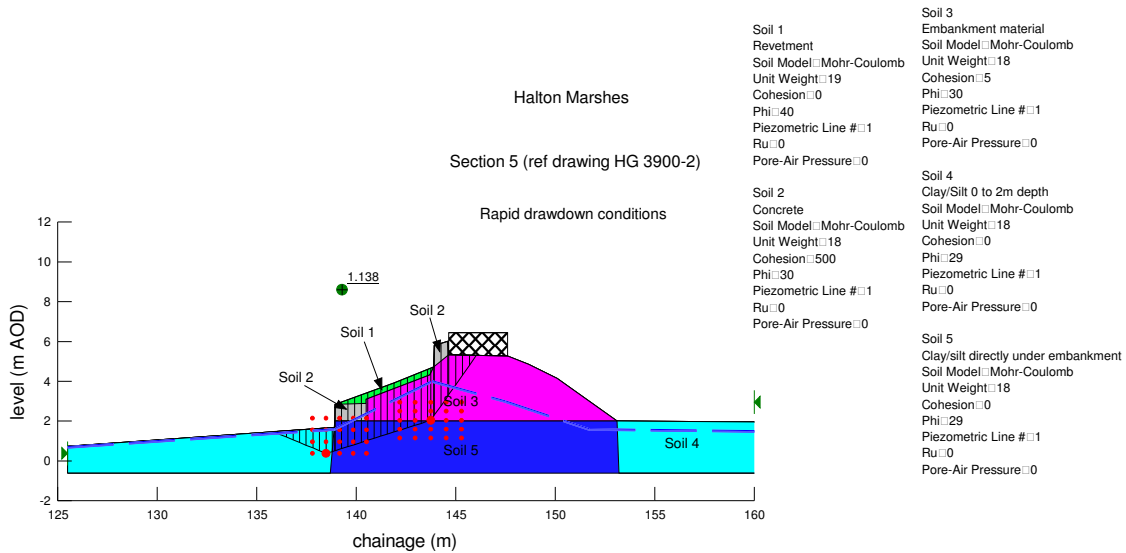
The figure below shows an example of the minimum factor of safety achieved if 0.8m of erosion were to occur at the site. As shown the minimum factor of safety is 1.14, indicating that the slope would become unstable if such erosion were to occur. Similar analyses were carried out for stages of 0.2m of erosion at the foreshore face of the toe beam in order to ascertain the level of erosion at which the beam would become unstable (i.e. the factor of safety drops below 1.3). The results are detailed in Table 2 below.

Amount of erosion at the foreshore	Minimum factor of safety for block failure
No erosion	1.3
0.2m	1.27
0.4m	1.21
0.6m*	1.16
0.8m	1.14
1m	1.07

* point at which foreshore drops to a level below the base of the toe beam (i.e. toe beam is completely eroded out)

- 9.3 The erosion analysis indicates that if erosion of material from the face of the toe beam structure continues at the site, the toe beam is at risk of sliding failure where if the foreshore is eroded even by relatively small amounts (approximately 0.2m).

- 9.4 Erosion along the toe of the embankment would also be expected to reduce the rotational stability of the embankment as a whole to less than 1.3, as erosion would reduce the stabilising toe weight.

- 9.7 Therefore based on this analysis, measures to reduce the risk of continued erosion at the toe of the embankment would be required in order to maintain its stability in the long term as erosion of the foreshore below the base of the toe beam will potentially lead to slope failure by either block or rotational modes.
