# Appendix 11

## Future Rail Connectivity Plan

# WEST MIDLANDS INTERCHANGE

Stage 1 Road Safety Audit

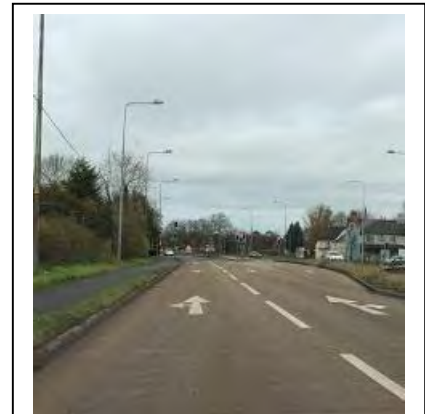
**Summary:** Restricted manoeuvres may cause driver confusion and hesitation resulting in shunt type collisions.

**Detail:** As part of this scheme, the northbound right turn manoeuvre from the A449 into Station Drive is to be prevented (see Photo1). Also several central reserve gaps are to be closed. Without adequate advance signing and subsequent directional signing, drivers may become confused, resulting in hesitation and subsequent collisions.

Also once the central reserve gaps are closed and agricultural vehicles can no longer turn right into and out of their fields, there is likely to be a number of slow agricultural vehicles looking for alternative opportunities to U-turn.

**Photo 1:** A449 Northbound approach to Station Drive junction

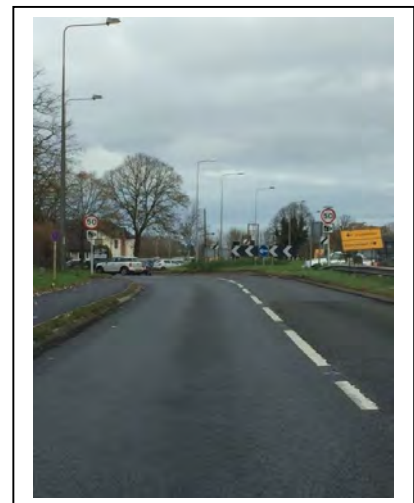
**Summary:** Proposed development of the WMI site has the potential to increase the risk of collisions on the A5, especially at Gailey Roundabout.

**Detail:** Collisions data provided to the audit team as part of the RSA1 showed high numbers of collisions, including serious injury collisions, on the A5 at Gailey roundabout (see Photo 2) and along the A5 between Gaily Roundabout and its junction with Vicarage Road. The proposed development of the WMI is likely to increase traffic flows, especially HGVs, on the surrounding road network. The A5 is a major feeder road for traffic into and out of the WMI development and is likely to encounter increases in flows. However, improvement works are not proposed to the Gaily Roundabout to help mitigate the potential risk attributed to higher traffic flows and there is a risk that the already poor collision record, will get worse.

**Photo 2 :** Gailey Roundabout

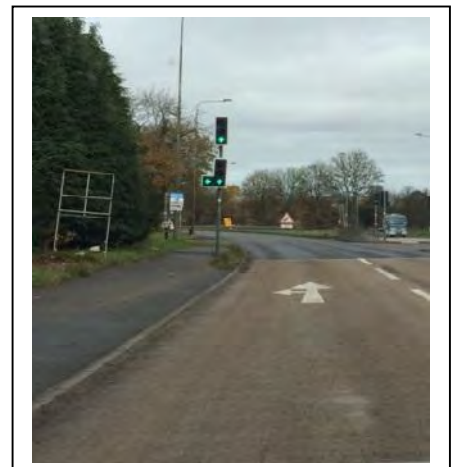
**Detail:** On the southbound carriageway of the A449 there is a pedestrian and cyclist facility which runs adjacent to the carriageway (see Photo 3). A majority of this facility is set away from the edge of the carriageway with a strip of verge between the facility and the edge of carriageway. However, there is a section of the facility on the A449 southbound carriageway, to the north of its junction with Station Drive, where a 'buffer' zone between the facility and the edge of carriageway does not appear to exist.

The construction of the new West Midlands Interchange is likely to increase pedestrian and cyclist usage of the facilities. The A449 is subject to 60mph speed limit along this section of carriageway. The lack of a 'buffer' zone may increase the risk of a vehicle colliding with a cyclist or pedestrian using the facility and/or deterring cyclists or pedestrians from using the facilities.

**Photo 3 :** Footway alongside the A449

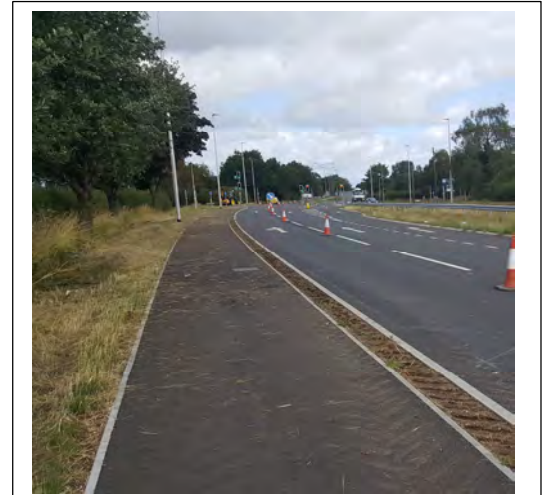
**Summary:** Lack of cycle facilities on the western verge of the A449 may increase risk of collisions between cyclists and pedestrians and/or vehicles.

**Detail:** The proposed pedestrian/cyclist facilities in the vicinity of the new roundabout include a combined cycle and pedestrian facility on the A449 eastern verge and also into Gravelly Way. However, the crossing facility over the A449 to the south the roundabout and the facility on the A449 western verge is intended for pedestrians only. The existing provision includes a combined cycle/pedestrian facility on the A449 western verge (see Photo 4) and the signalised crossings have cycle provision to allow the safe crossing of cyclists. Failing to provide adequate provision for cyclists could increase the risk of a cyclist colliding with a pedestrian when using the pedestrian facilities or with a vehicle due to the cyclist being forced onto the carriageway.

**Photo 4** – Existing combined facility alongside the A449

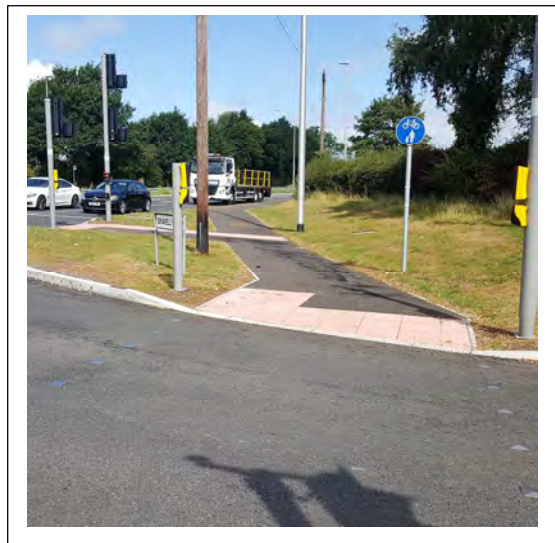
**Summary:** Proposed removal of controlled crossing over A449 and Gravelly Way could increase risk of collisions between pedestrians/cyclists and vehicles.

**Detail:** The existing layout of the A449/Gravelly Way junction includes controlled crossing facilities over the A449 and Gravelly Way (see Photo 5). The proposed roundabout layout removes the controlled crossing facilities and provides uncontrolled crossing facilities for cyclists and pedestrians over Gravelly Way and for pedestrians only over the A449. The risk of a pedestrian/cyclist crossing into the path of an approaching vehicle is therefore increased. Also, once the West Midlands Rail Freight Interchange is completed, traffic flows are likely to increase therefore reducing the potential gaps in traffic to allow pedestrians and cyclists to safely cross A449/Gravelly way. Should a collision occur between a cyclist or pedestrian and a vehicle, the severity of any injuries suffered is likely to be high.

**Photo 5** – Existing controlled pedestrian/cycle facility over Gravelly Way
