Cambridge Waste Water Treatment Plant Relocation Project
Anglian Water Services Limited

Appendix 8.19: Waterbeach Pipeline Arboricultural Impact Assessment

Arboricultural Impact Assessment & Method Statement

Waterbeach CWWTPR – WBRM

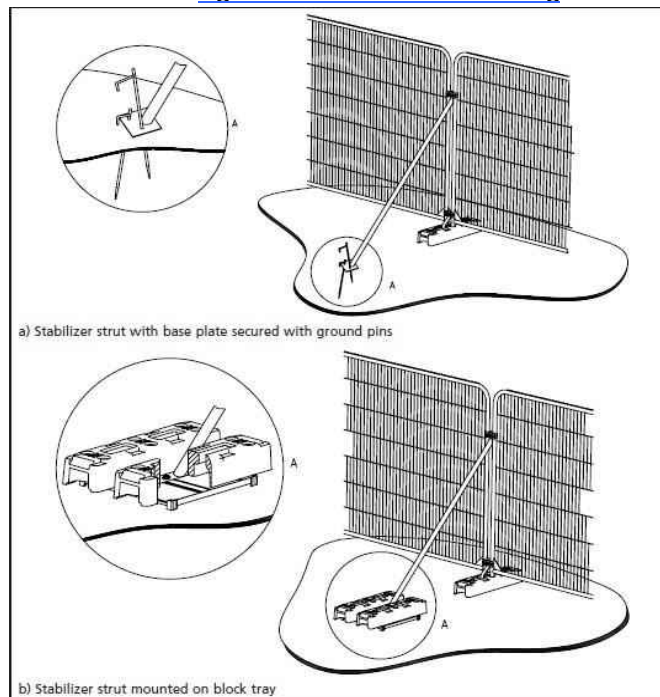
Figure 1: Tree Protective Fencing

- 8.1.4 Trees T180 – T185 (refer to drawing [TPP WATERBEACH 10 2](#)) have a reduced rooting area available due to the compacted ground within the existing field access. To ensure that there is no damage to the soil structure it is recommended that the higher specification Heras fencing (refer to [Figure 1](#) below).

The barrier will comprise 2m tall, welded mesh panels on rubber or concrete feet, the fence panels should be joined together using a minimum of two anti-tamper couplers, installed so that they can only be removed from inside the fence. The distance between the fence couplers should be at least 1 m and should be uniform throughout the fence. The panels should be supported on the inner side by stabilizer struts, which should normally be attached to a base plate secured with ground pins.
