The London Resort Development Consent Order

Appendix 18.1 – Phase 1 Geo-environmental and Geotechnical Risk Assessment (December 2014)

Paramount Park Entertainment Resort

Phase I Geo-environmental and Geotechnical Risk Assessment

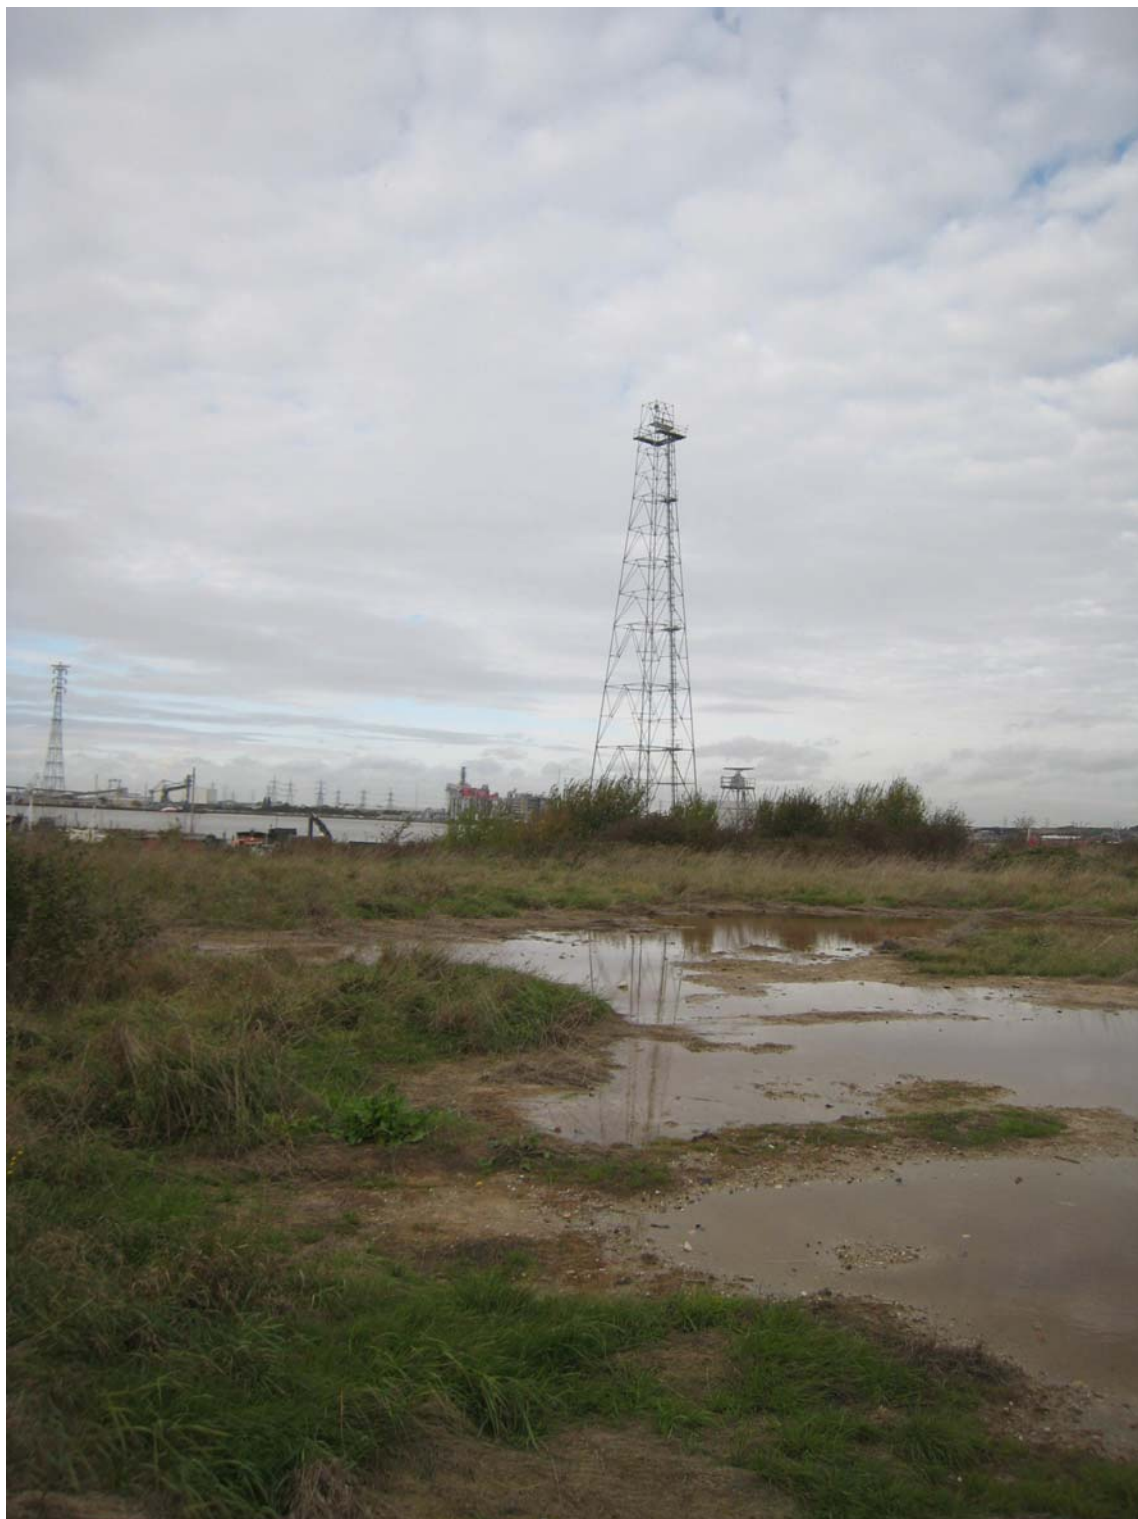
Photo 6. Looking at Broadness Lighthouse and radar station at the very northern part of the site. Surface water ponding is evident.

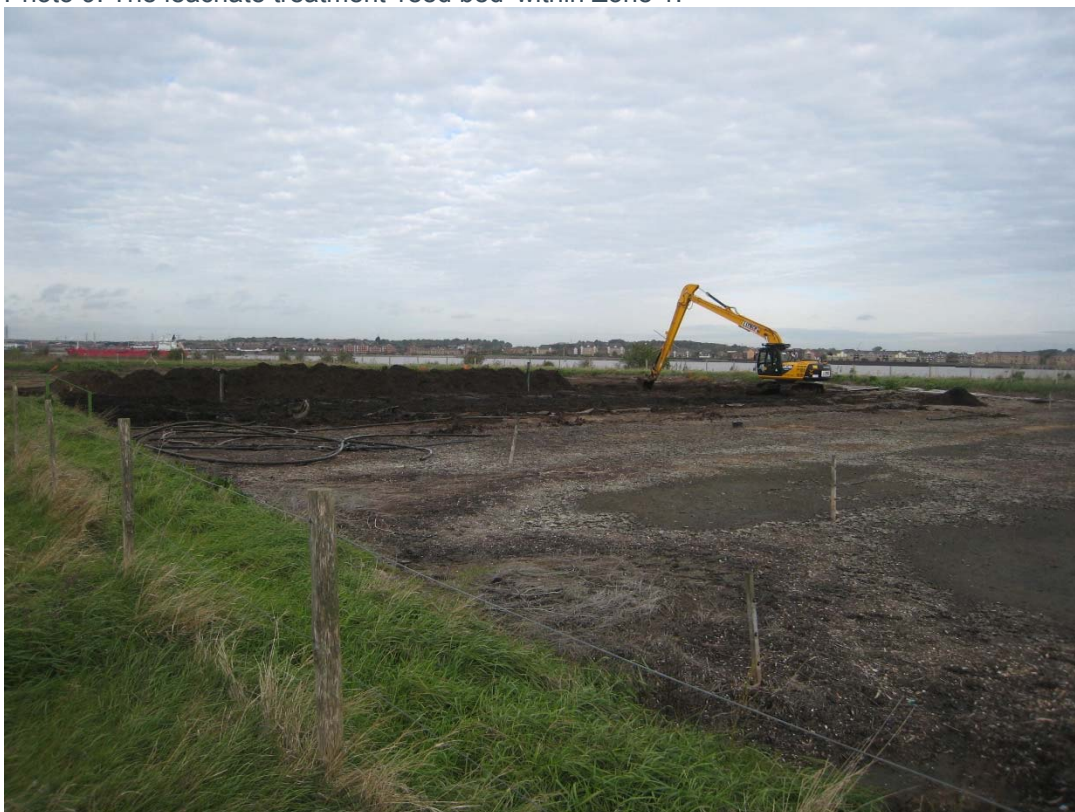
Photo 9. The leachate treatment 'reed bed' within Zone 1.

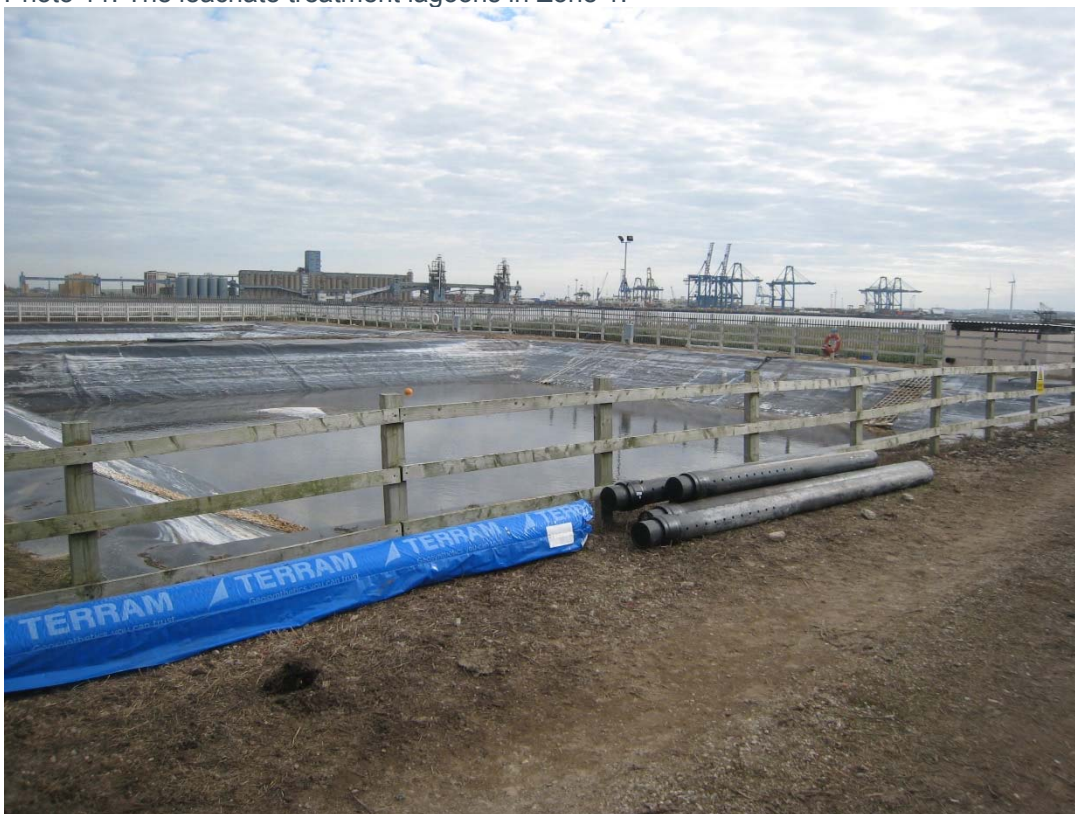
Photo 11. The leachate treatment lagoons in Zone 1.

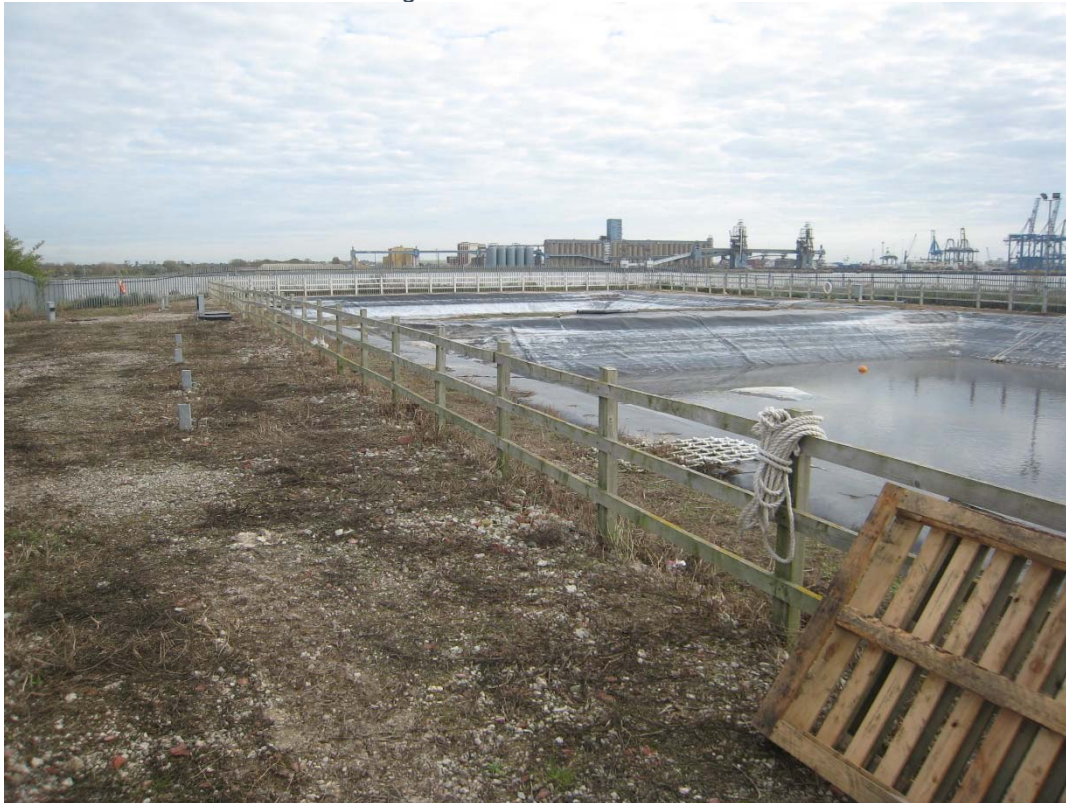
Photo 13. Leachate Treatment Lagoon in Zone 1.

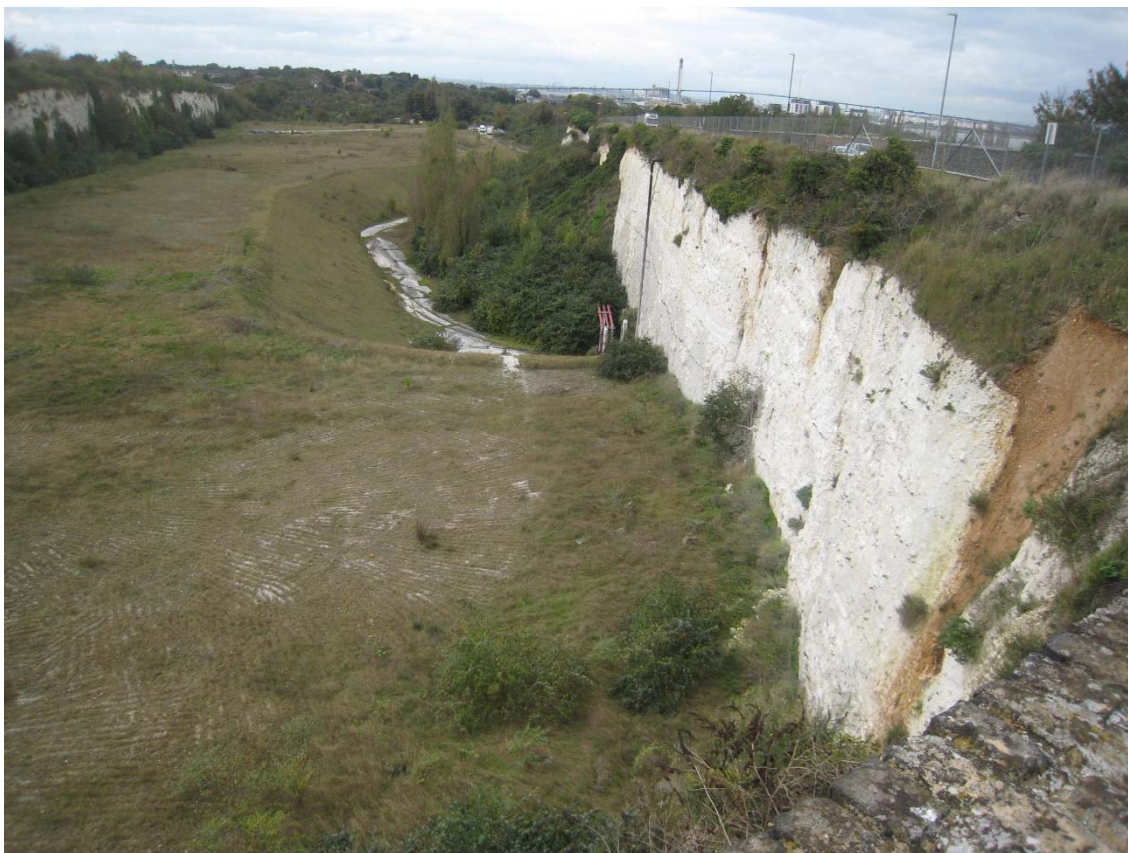
Photo 3. A possible tunnel running through the chalk spine of London Road to the southern part of Zone 5. A solution features in the Chalk can be seen on the right.

Medium constraints are likely to include chalk dissolution features within the chalk spines. There is also at least one tunnel present underneath the railway spine, which as previously noted could create a preferential water path leading to more dissolution features. The spines also pose a risk of rockfall, although they are

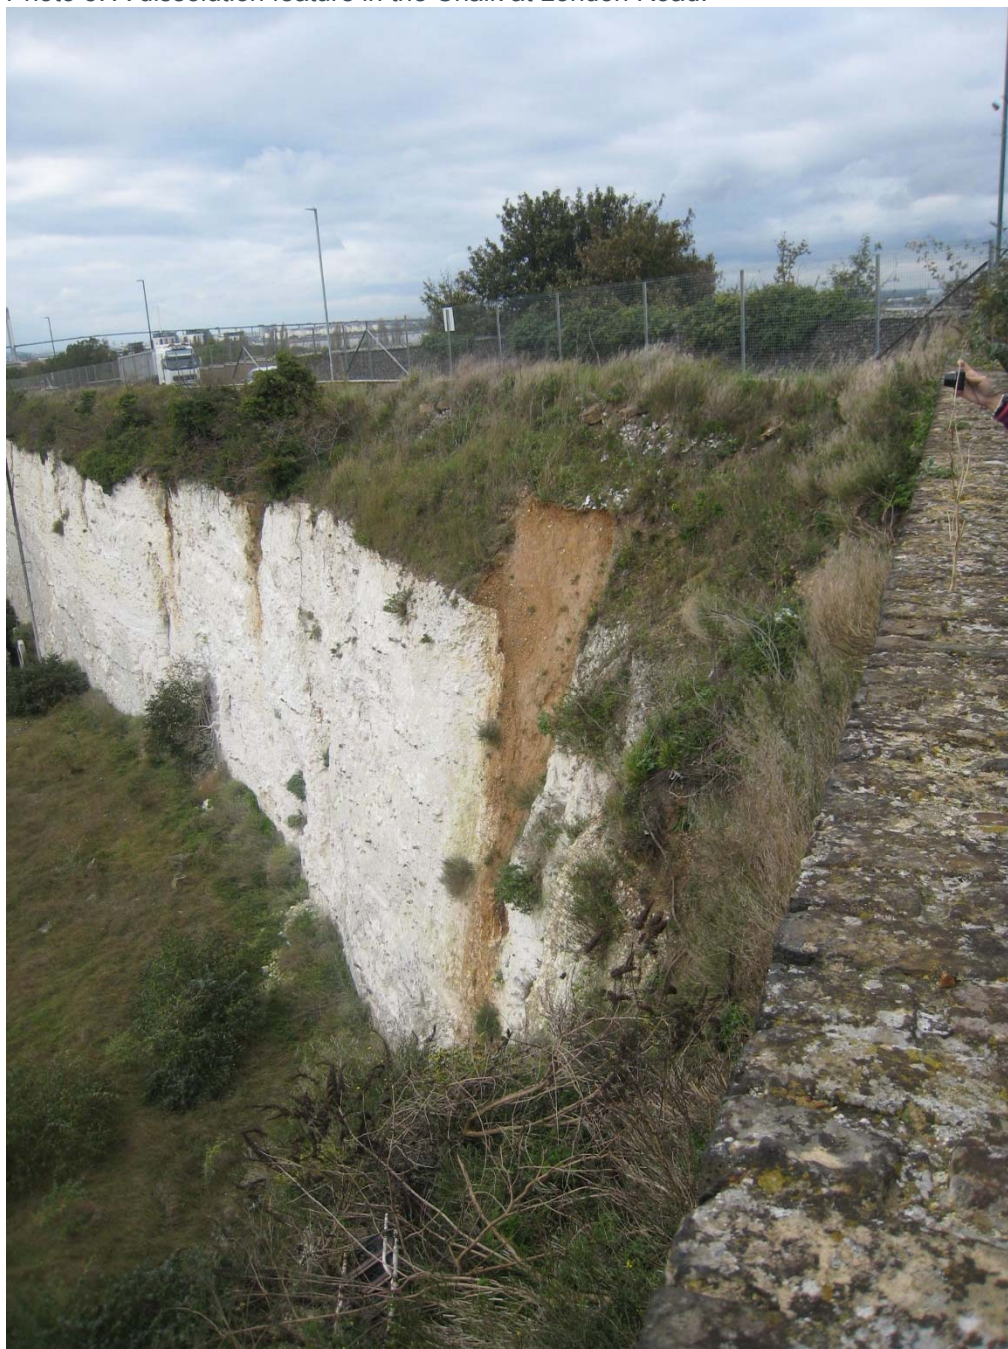
Photo 5. A dissolution feature in the Chalk at London Road.
