The London Resort Development Consent Order

Appendix 18.1 – Phase 1 Geo-environmental and Geotechnical Risk Assessment (December 2014)

Paramount Park Entertainment Resort

Phase I Geo-environmental and Geotechnical Risk Assessment

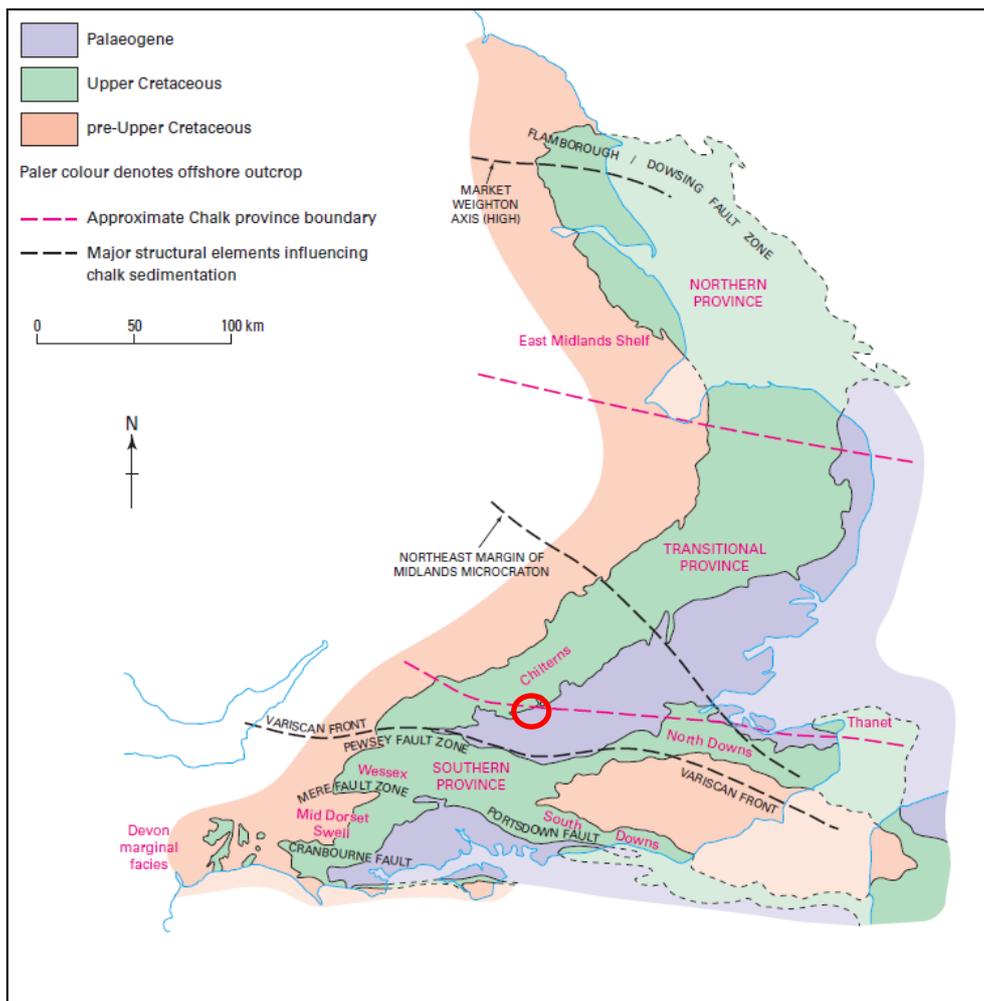
Figure 1. Chalk Group Provinces of England (31)

Note: The red circle shows the approximate location of the site.

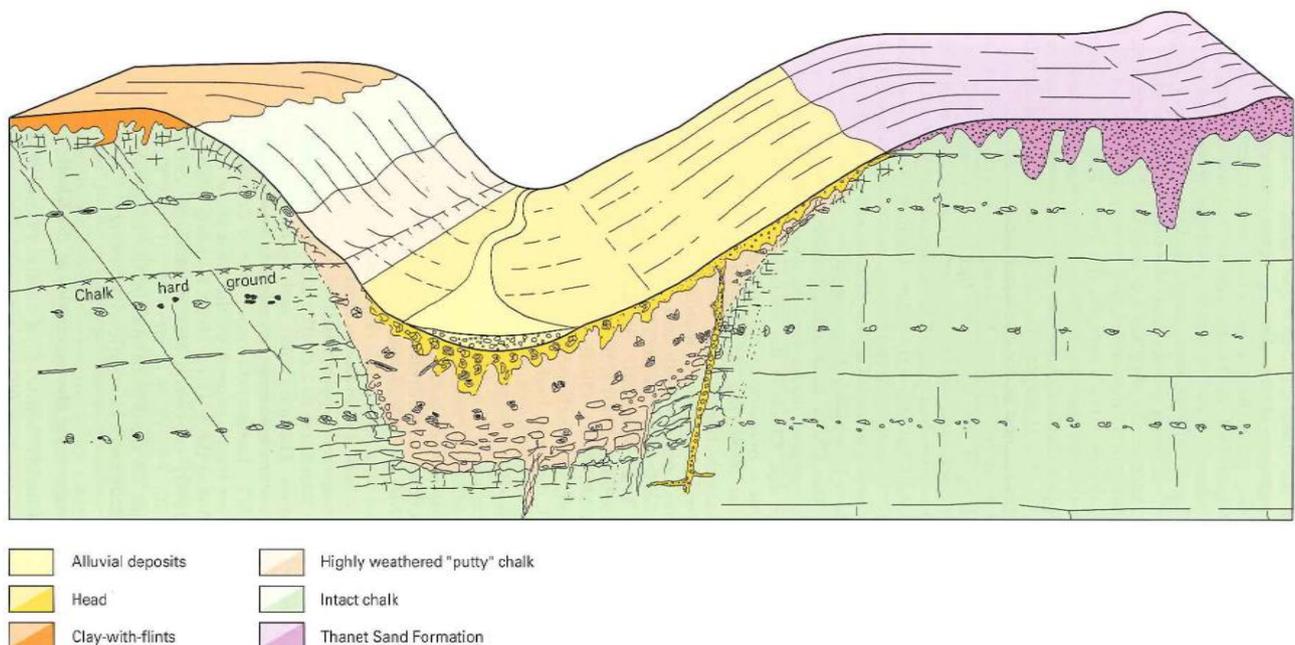
Figure A - Idealised ground model for a section along of the course of the Thames in east London (BGS, 2004)

The BGS idealised ground model for section along the course of the River Thames is general, but enables the key stratigraphic relationships to be considered for the site and the implications to geotechnical engineering design. The site is located adjacent to the River Thames and is likely to have a similar ground model.

The primary observation is the depth of the weathering profile expected beneath the areas close to the Thames and how the structure of the chalk will dictate the lateral variability of this. Another characteristic is the dissolution features which will form along joint sets and zones of preferential flow, this may be hollows or in filled with superficial material.

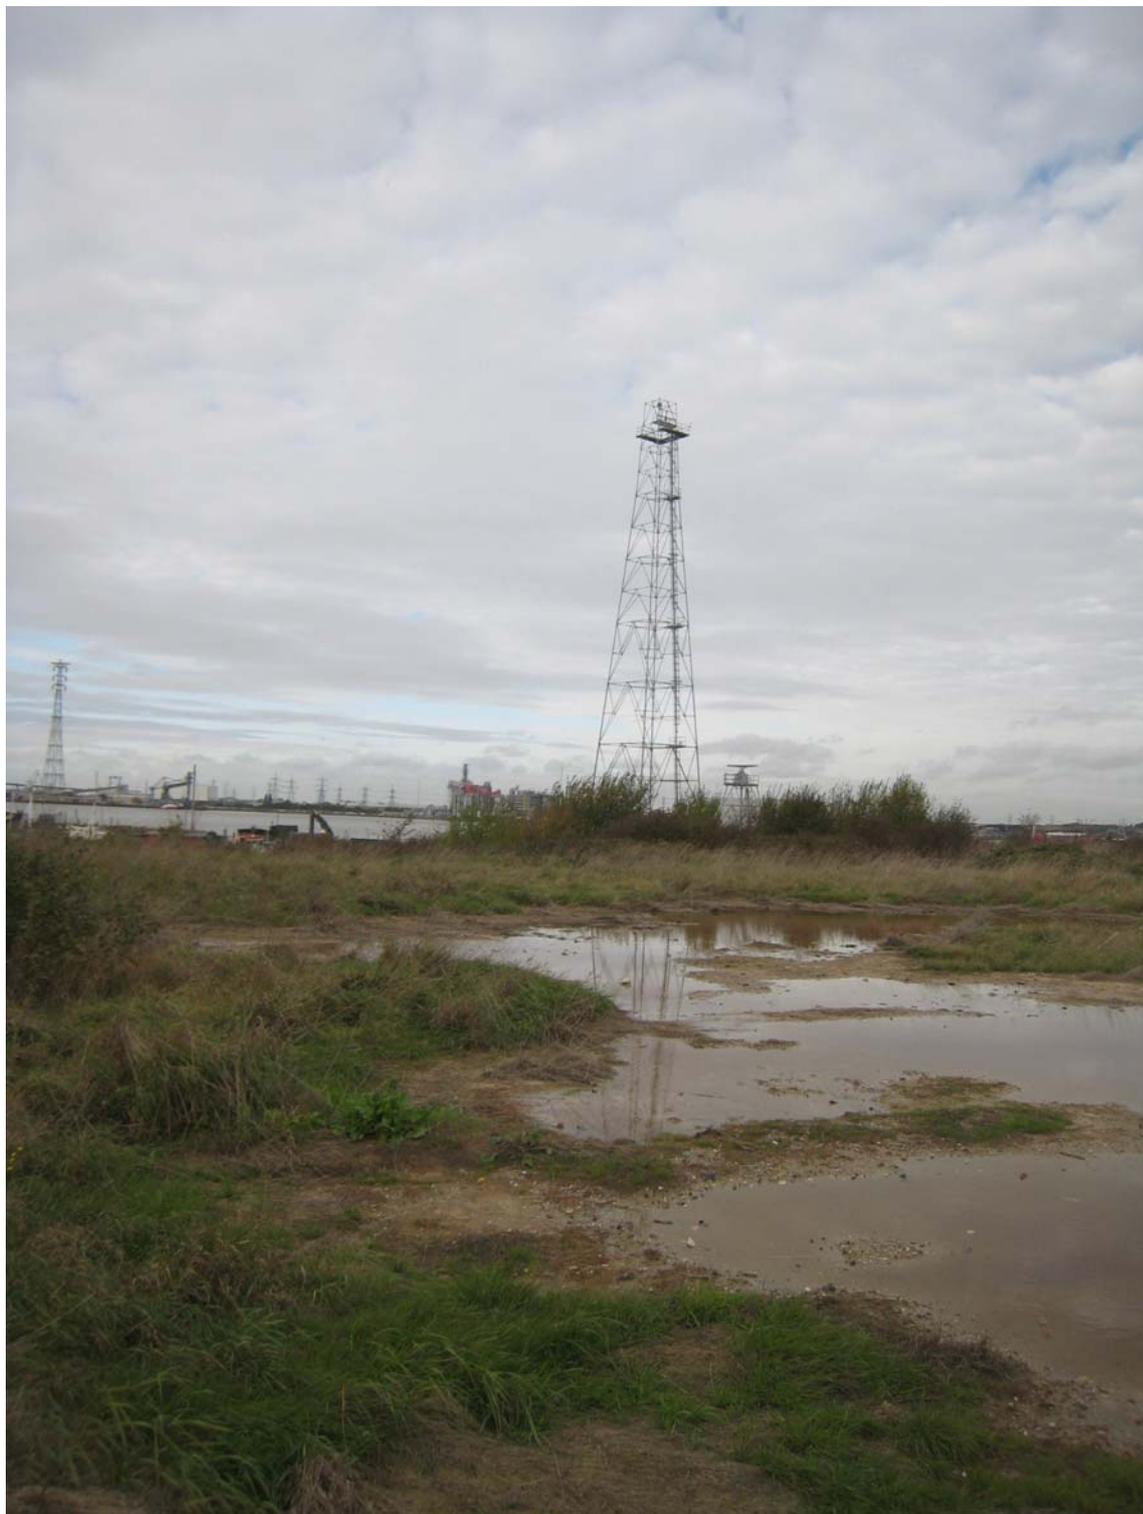
Photo 6. Looking at Broadness Lighthouse and radar station at the very northern part of the site. Surface water ponding is evident.

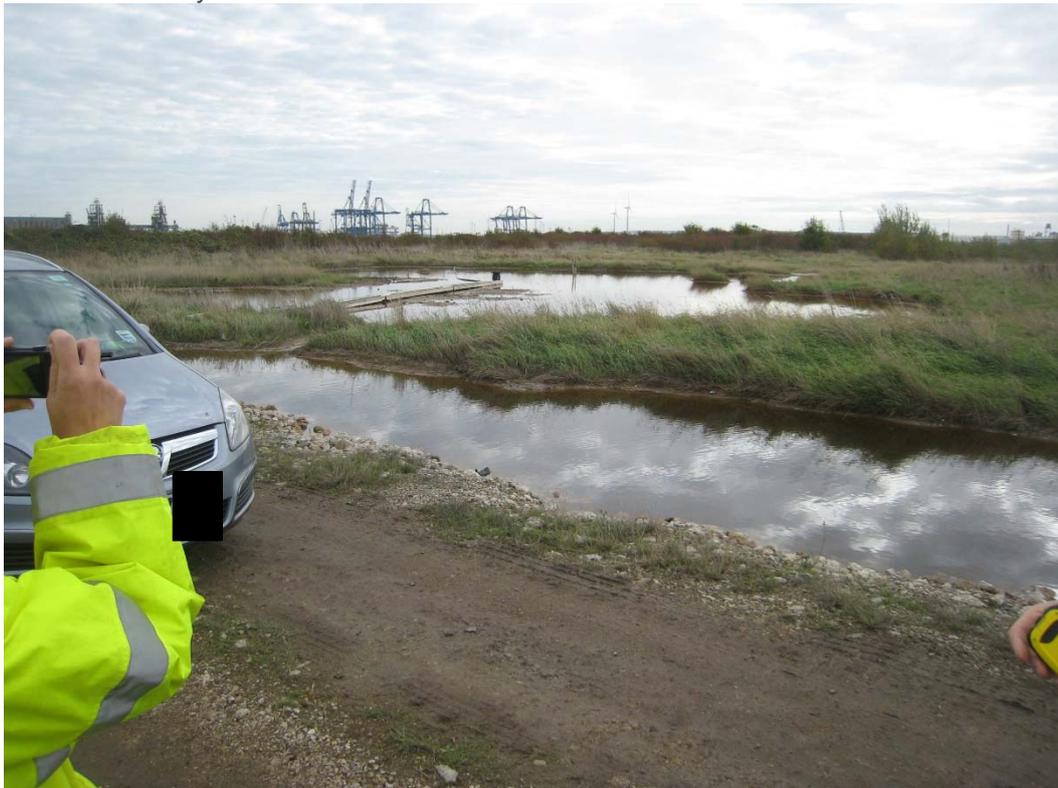
Photo 7. Looking towards the centre of the site from the northern part of Zone 1. Surface water ponding is evident in the 'soakaway' created in the CKD.

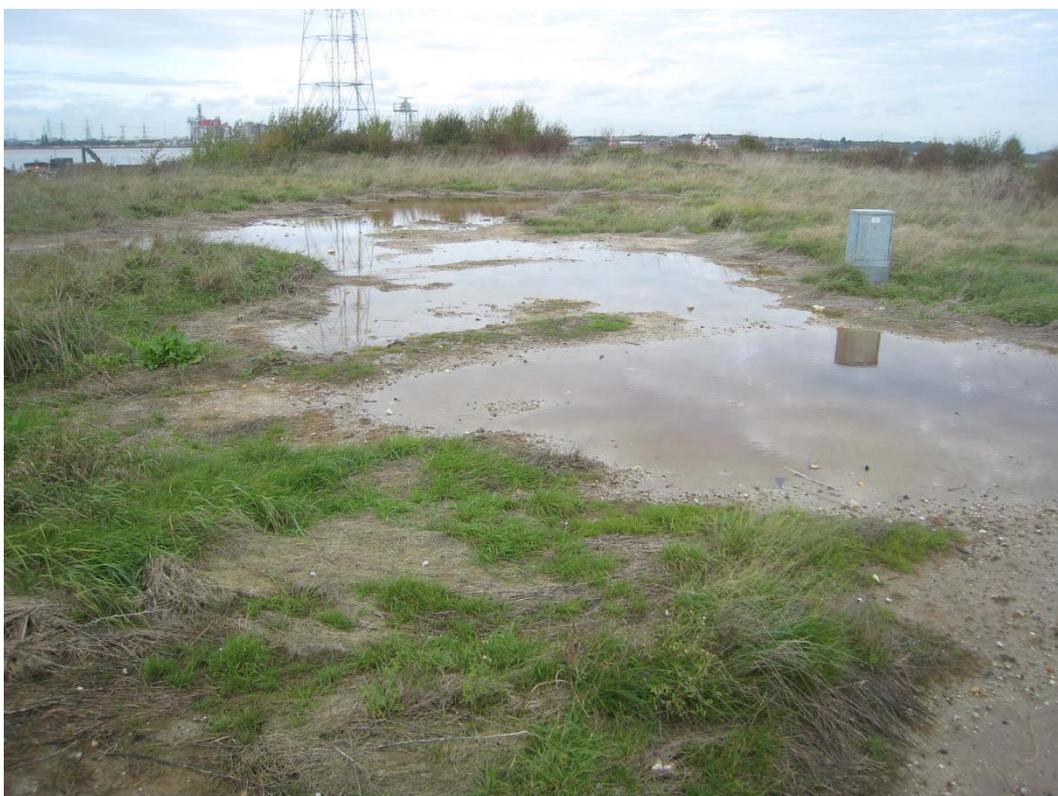
Photo 8. Visible ponding water on the surface near the northern part of the Zone 1, the 'soakway', by Broadness Lighthouse.

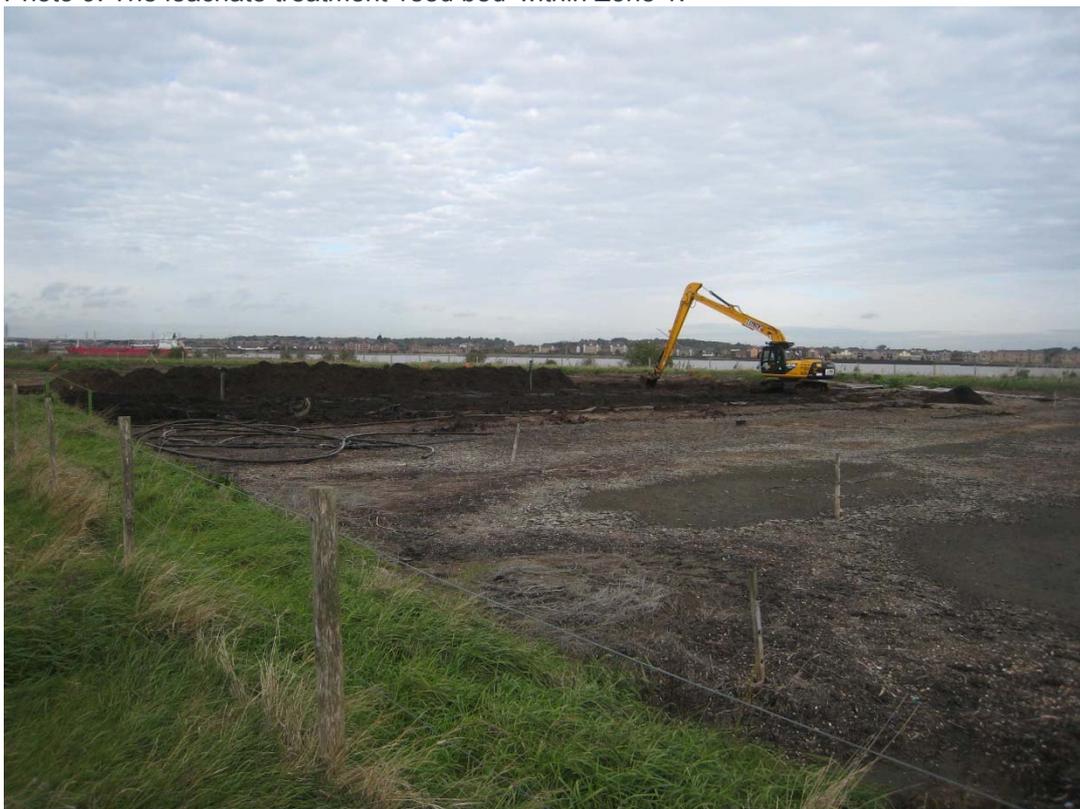
Photo 9. The leachate treatment 'reed bed' within Zone 1.

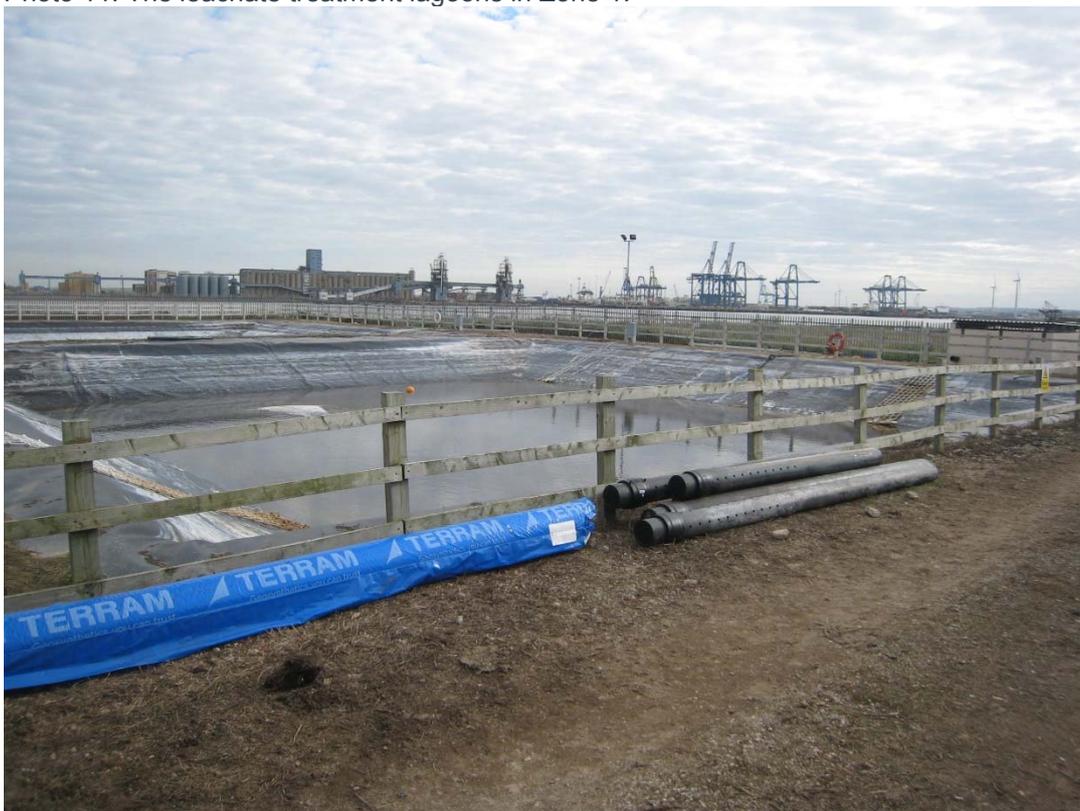
Photo 11. The leachate treatment lagoons in Zone 1.

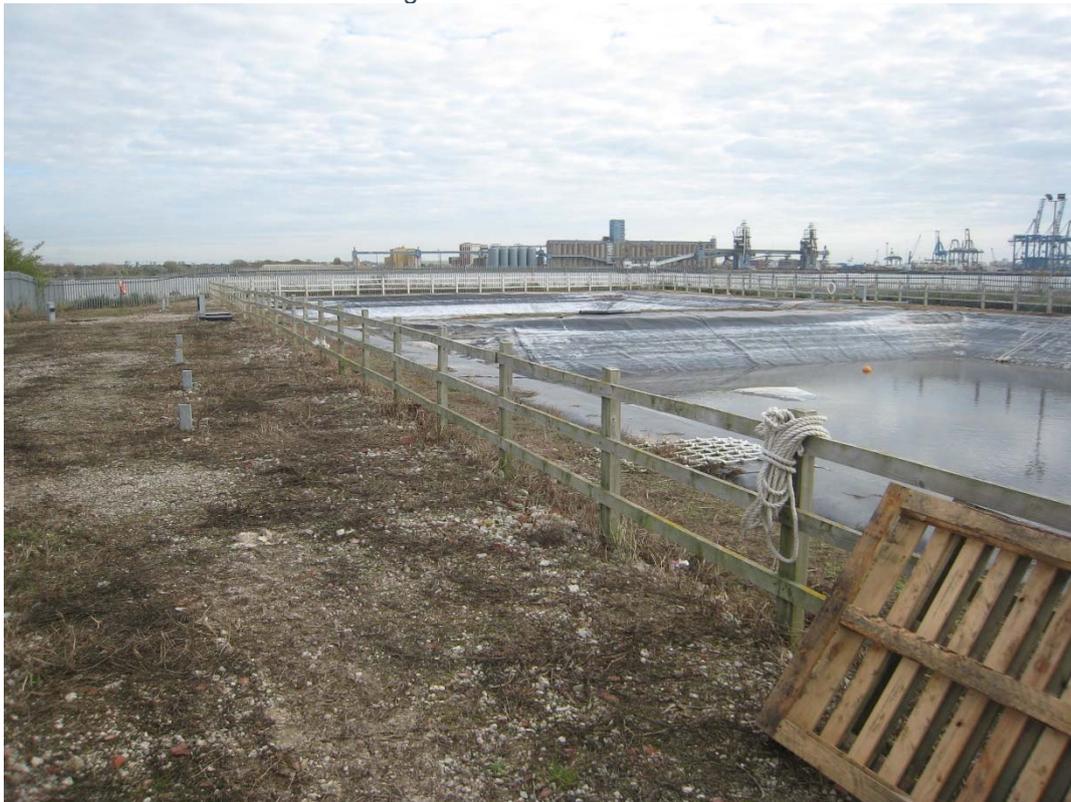
Photo 13. Leachate Treatment Lagoon in Zone 1.

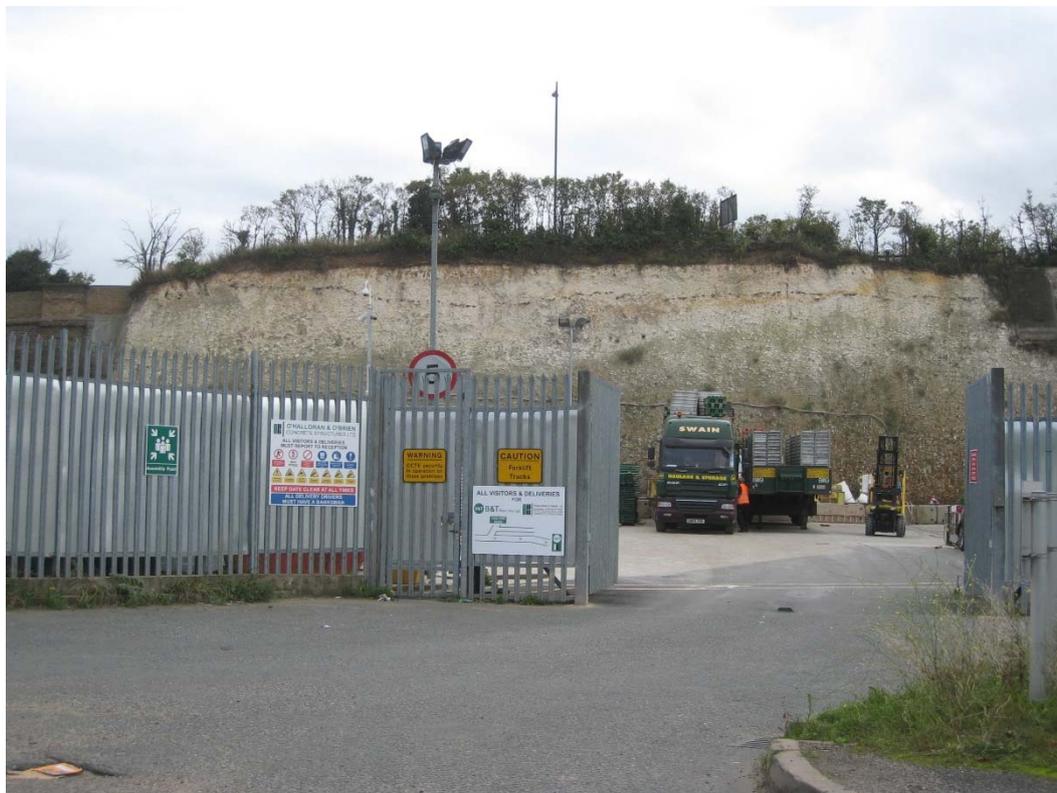
Photo 1. Part of Northfleet Industrial Estates. Development has occurred up to the near-vertical chalk spines.

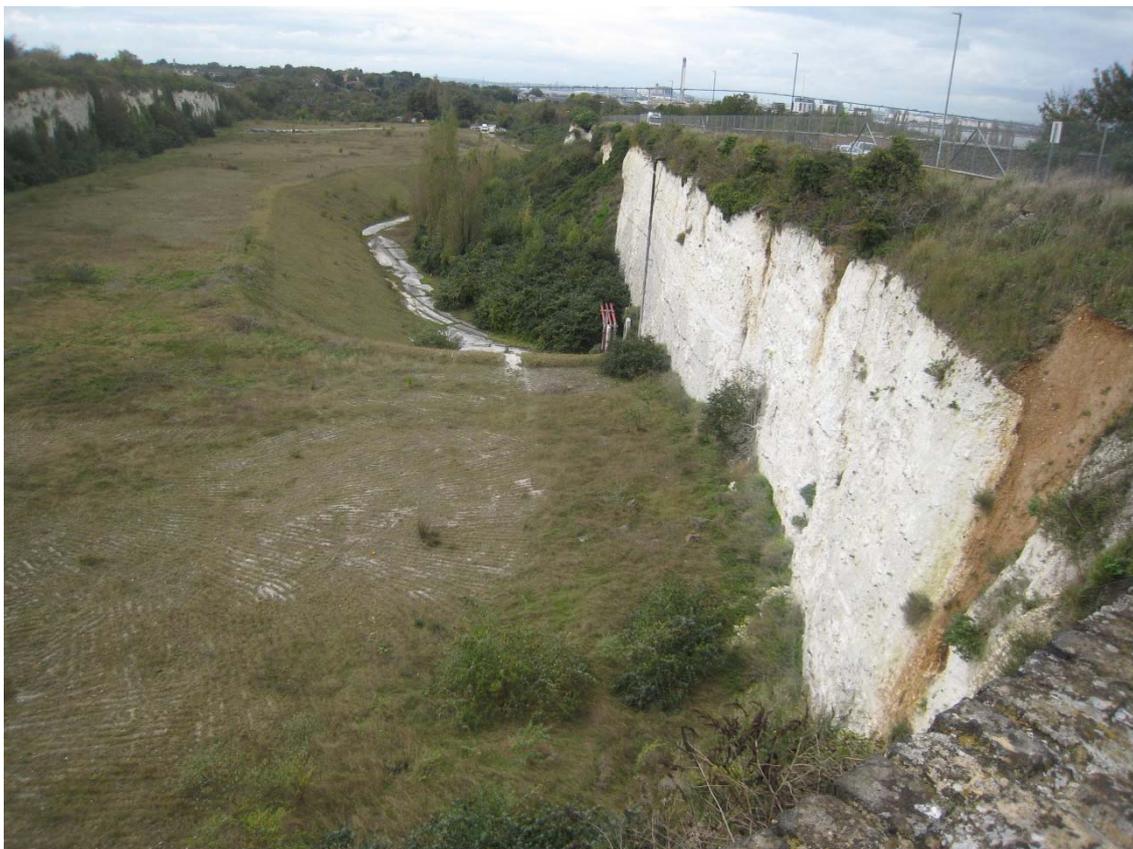
Photo 3. A possible tunnel running through the chalk spine of London Road to the southern part of Zone 5. A solution features in the Chalk can be seen on the right.

Medium constraints are likely to include chalk dissolution features within the chalk spines. There is also at least one tunnel present underneath the railway spine, which as previously noted could create a preferential water path leading to more dissolution features. The spines also pose a risk of rockfall, although they are

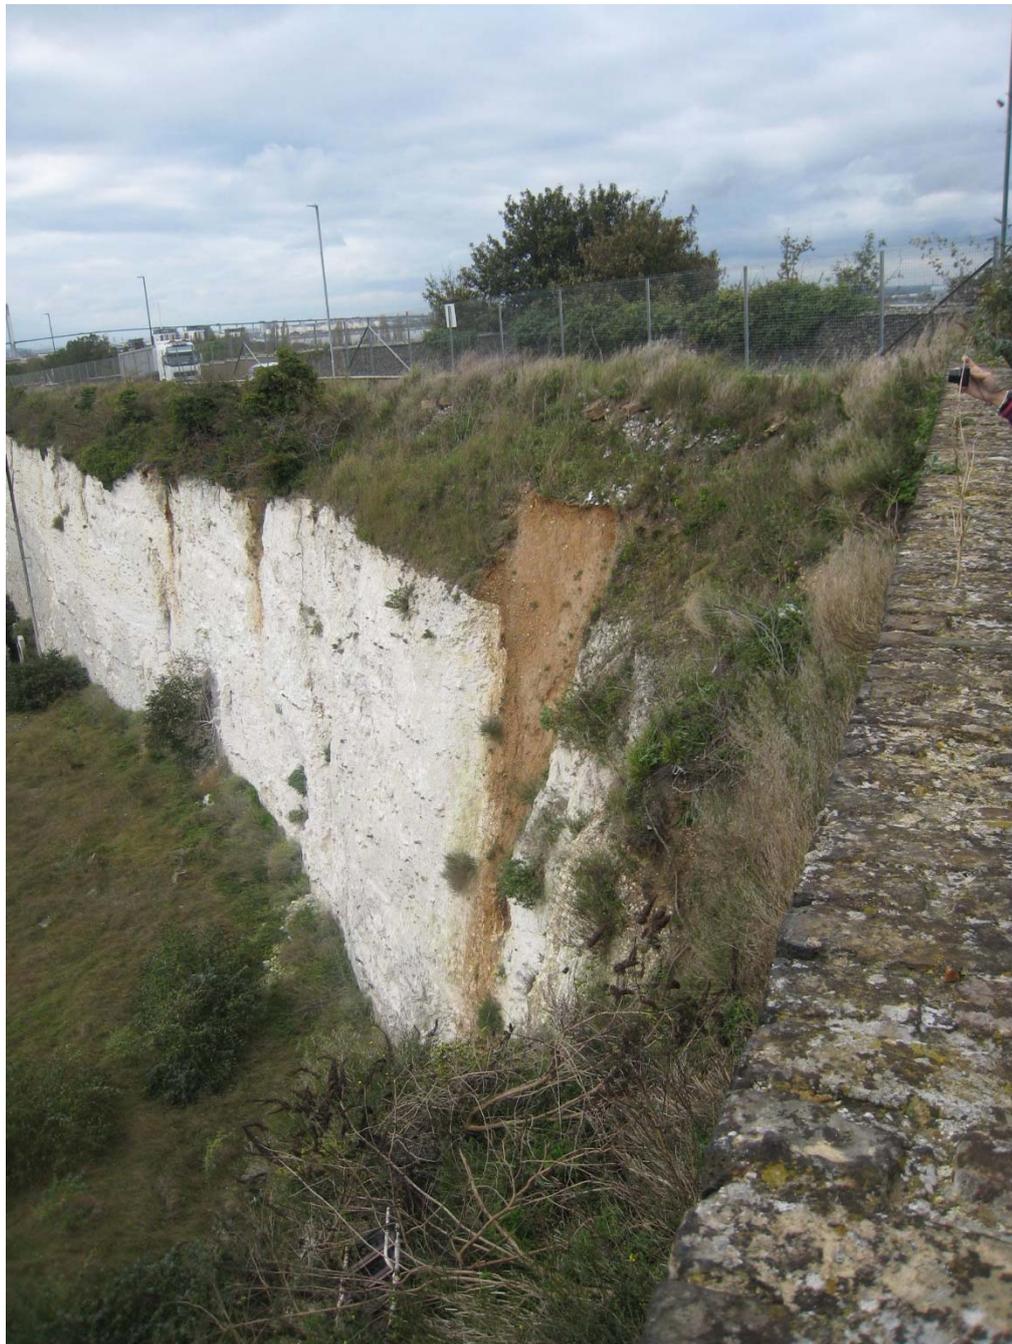
Photo 5. A dissolution feature in the Chalk at London Road.

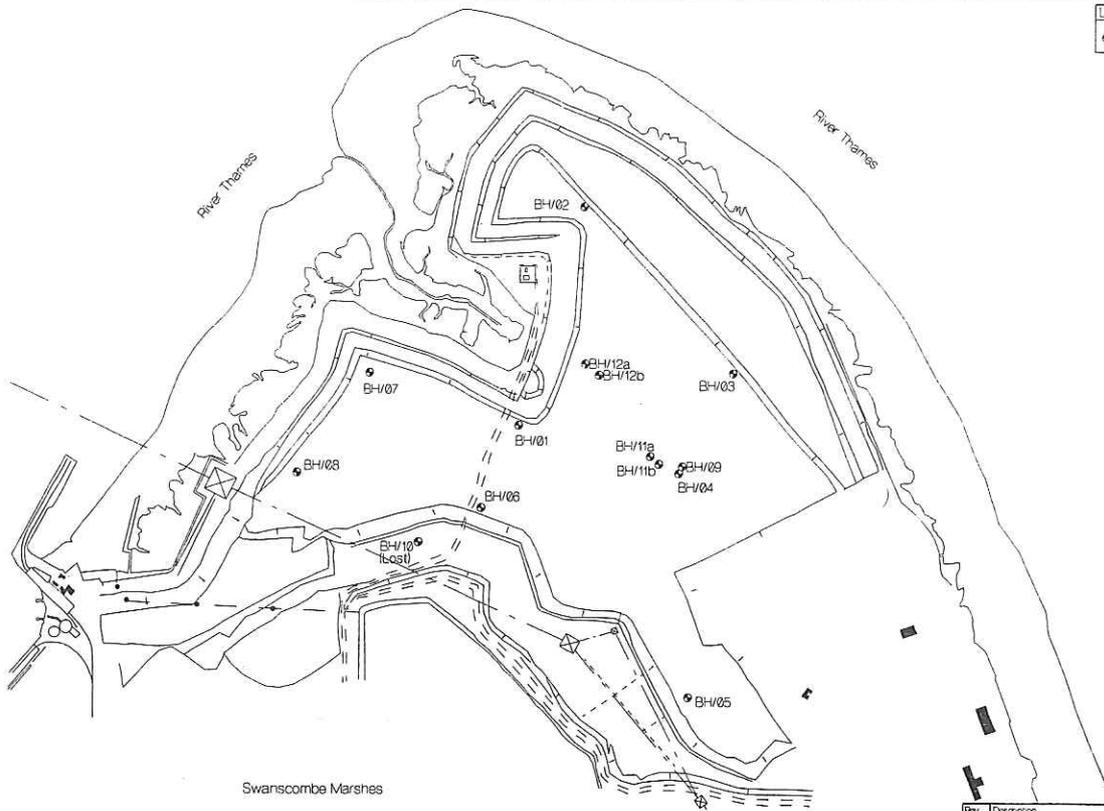
C.2. Borehole Map for Zone 1

Legend:
 BH-1/09 Borehole Location

Project: Broadness Marsh CKD Tip
 Title: Borehole Location Plan
