# THE LONDON RESORT

#### **Appendix 18.2 – Phase 1 Geo-environmental and Geotechnical Risk Assessment A2(T) Corridor and Access Roadway**

## **Phase I Geo-environmental and Geotechnical Risk Assessment (A2 Corridor and Access Roadway)**

London Resort Company Holdings

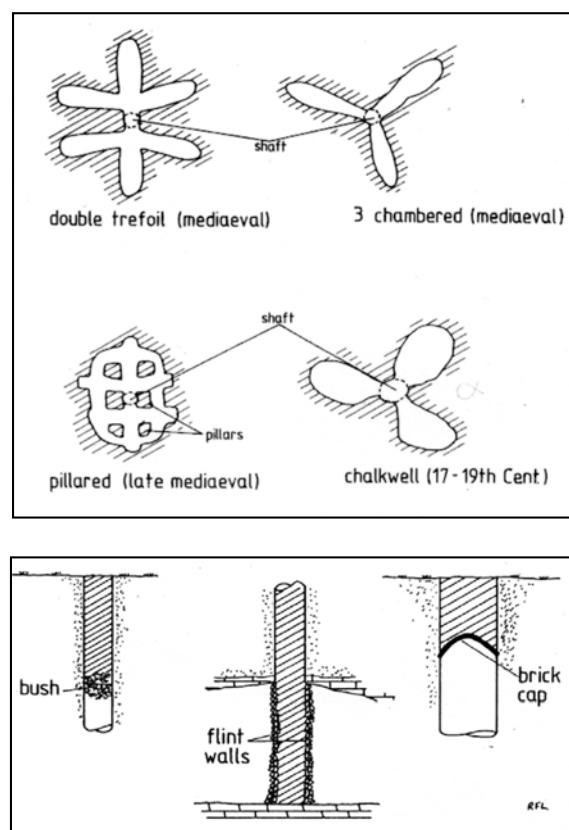
Figure 2. Denehole Types and Examples of Shaft Filling Taken from CIRIA 574 (32)

The shafts of these excavations are known to be sunk as close as possible to the field boundary so any future subsidence would not interfere with ploughing activities. Most deneholes are found singly and in distinct association with ancient field boundaries; however, some are found in groups where less than 0.9 m (3 ft) of chalk can separate the structures. The entrances to the mines were commonly blocked, often intentionally with tree stumps and vegetation. Many denehole sites are now in woods or long narrow copses (known locally as 'Shaves' or 'Shaws') where farmers have planted trees in the past to isolate the area.

Alternatively Chalkwells (or draw wells) were sunk in areas where the chalk was overlain by a heavy clay soil during the 17<sup>th</sup> Century. According to Edmonds, Green and Higgingbottom (31), Chalkwells were typically above the water table. The shafts of these excavations are wider than that of deneholes, often 0.5 to 2 m in diameter, where miners were lowered down by rope, often the diameter of the shaft increased with depth to prevent rope friction. Approximately two to four roughly cut caves radiating from the base of the shaft were excavated; when enough chalk had been removed the chalkwell was sealed by installing a brick dome about 1.8 m (6 ft) down the shaft and backfilling to the surface. A later development was to widen the shaft from part way down into a beehive arrangement. The main use was for agriculture and their location as such is associated with field boundaries. In addition Chalkwell deposits were occasionally used to supplement the chalk required for brickmaking rather than the larger scale brickfields.

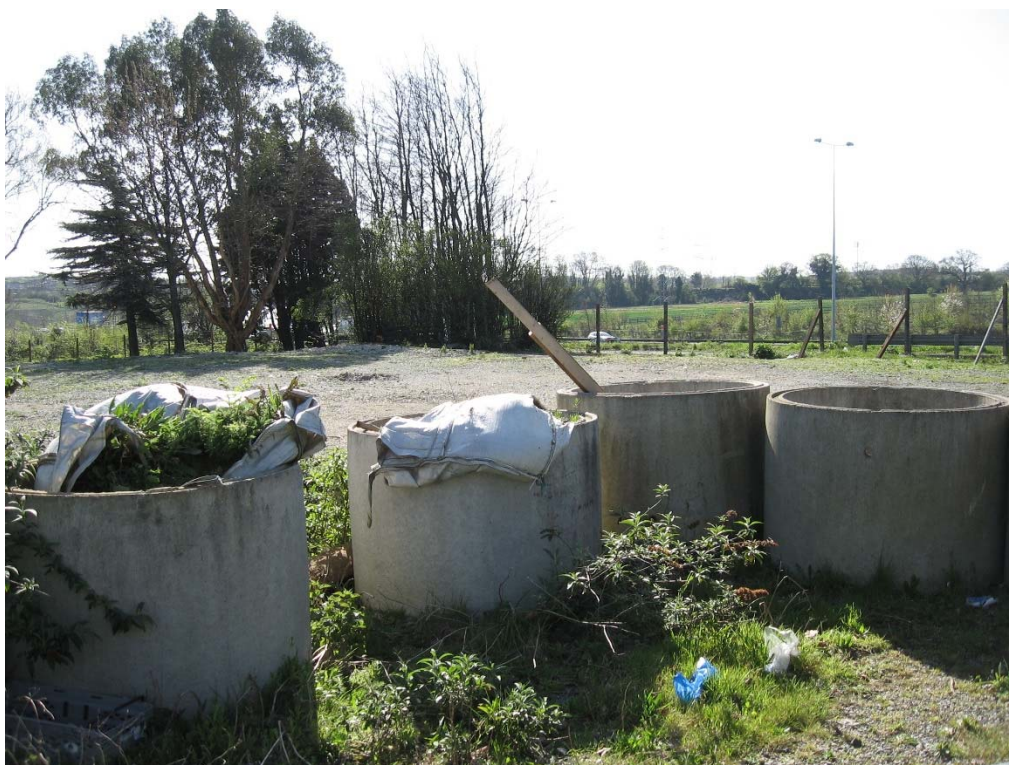
Photo 2. Photo showing location of former petrol station, showing site clearance and remaining materials.

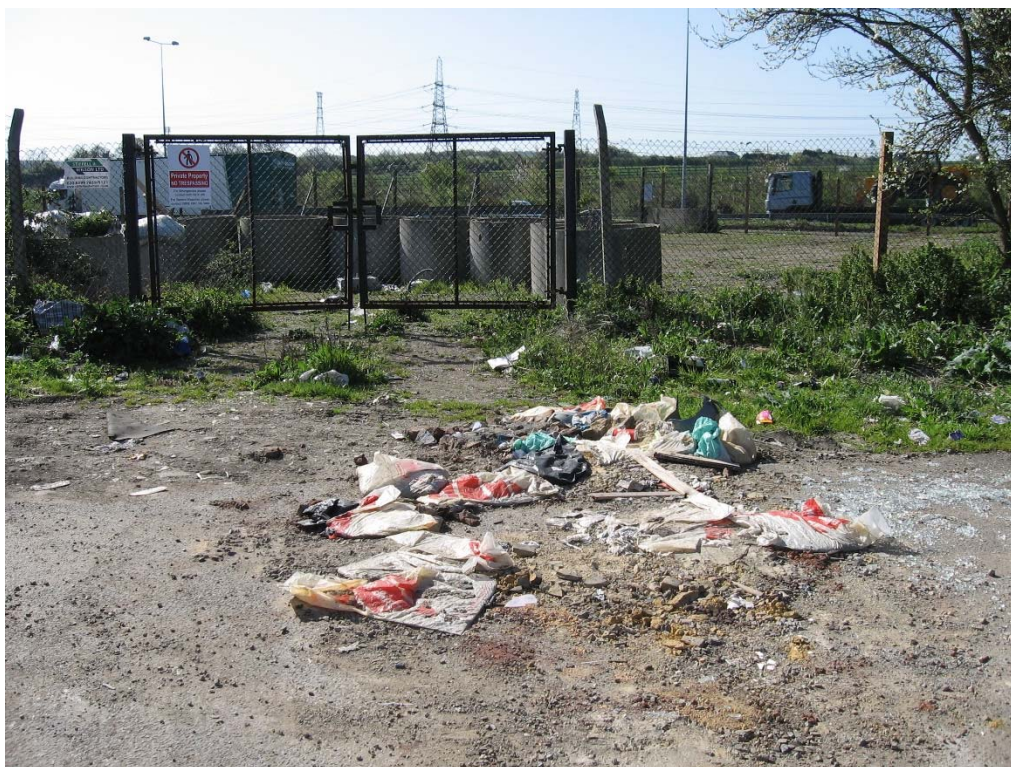
Photo 3. Photo showing minor flytipping in front of former petrol station gates.

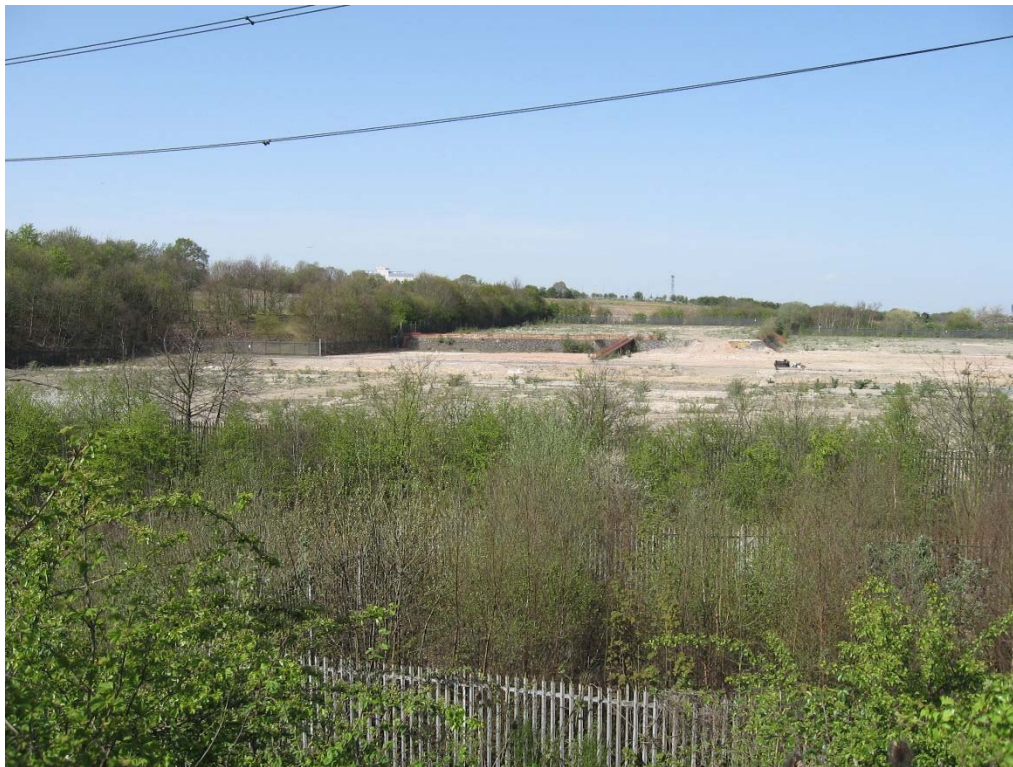
Photo 5. Photo showing demolished Northfleet West Grid Substation adjacent to Zones 7 and 9, looking northwest.

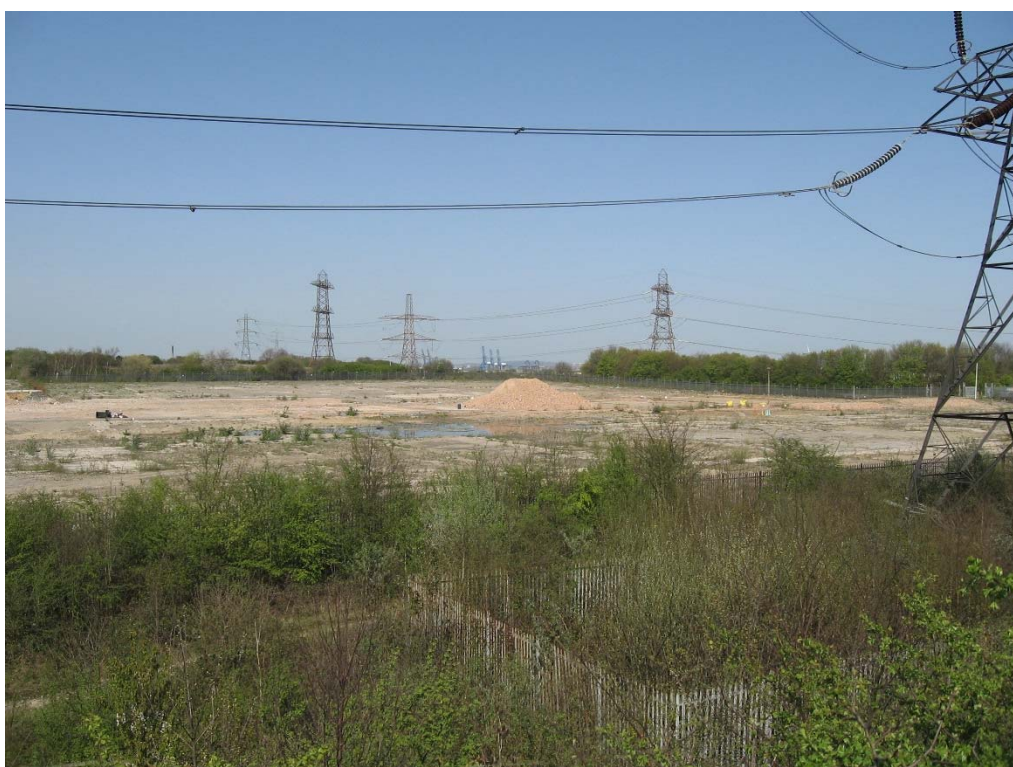
Photo 6. Photo showing demolished Northfleet West Grid Substation adjacent to Zones 7 and 9, looking northeast.

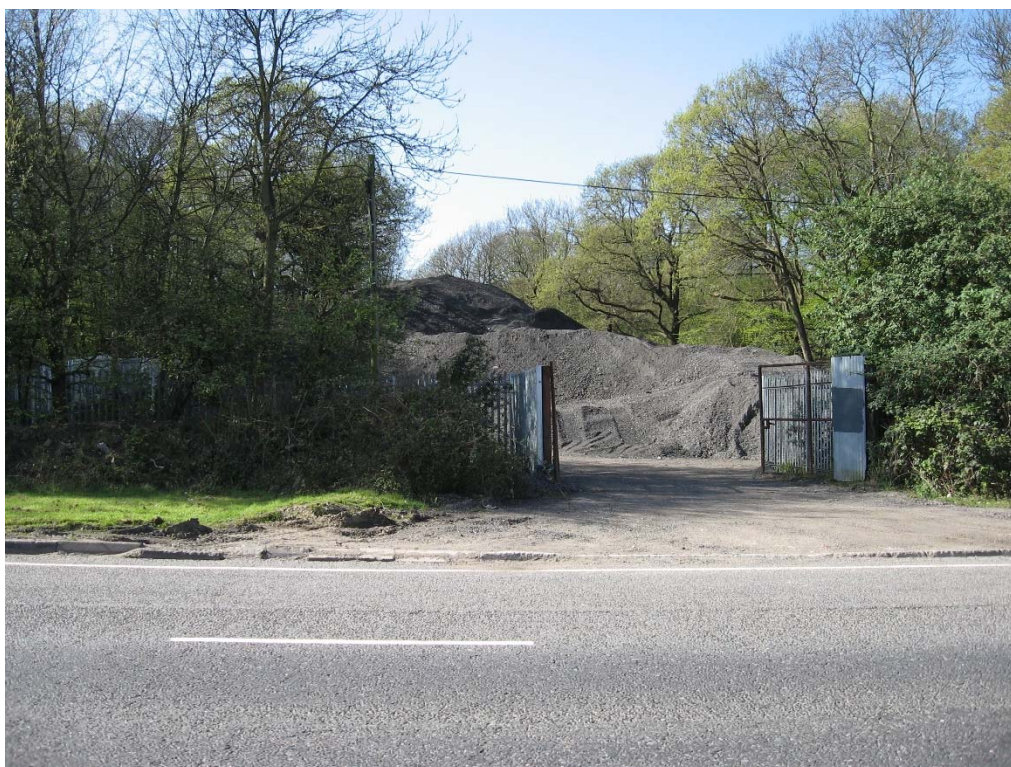
Photo 14. Photo showing stockpile of aggregate material located in the western portion of Zone 9.

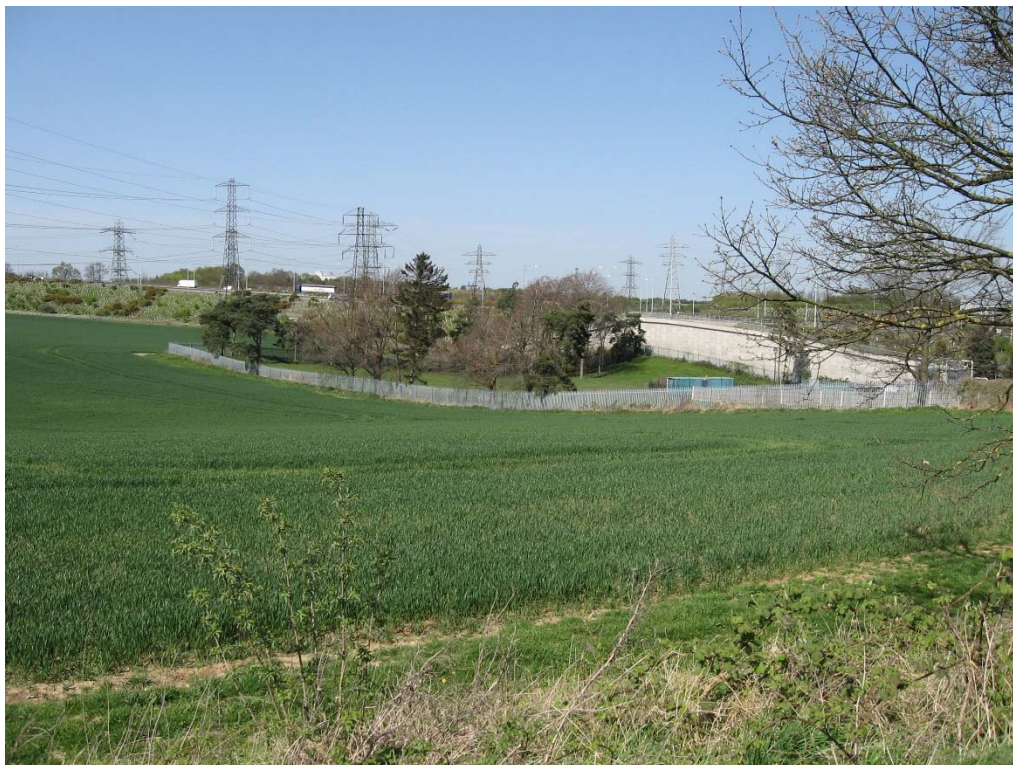
Photo 15. Photo looking north showing water treatment works located in the eastern portion of Zone 9.
