# The London Resort Development Consent Order

Appendix 18.15 – Specification for groundwater and surface water monitoring

Document reference: 6.2.18.15

Subject Initial Water Quality Surveys Required

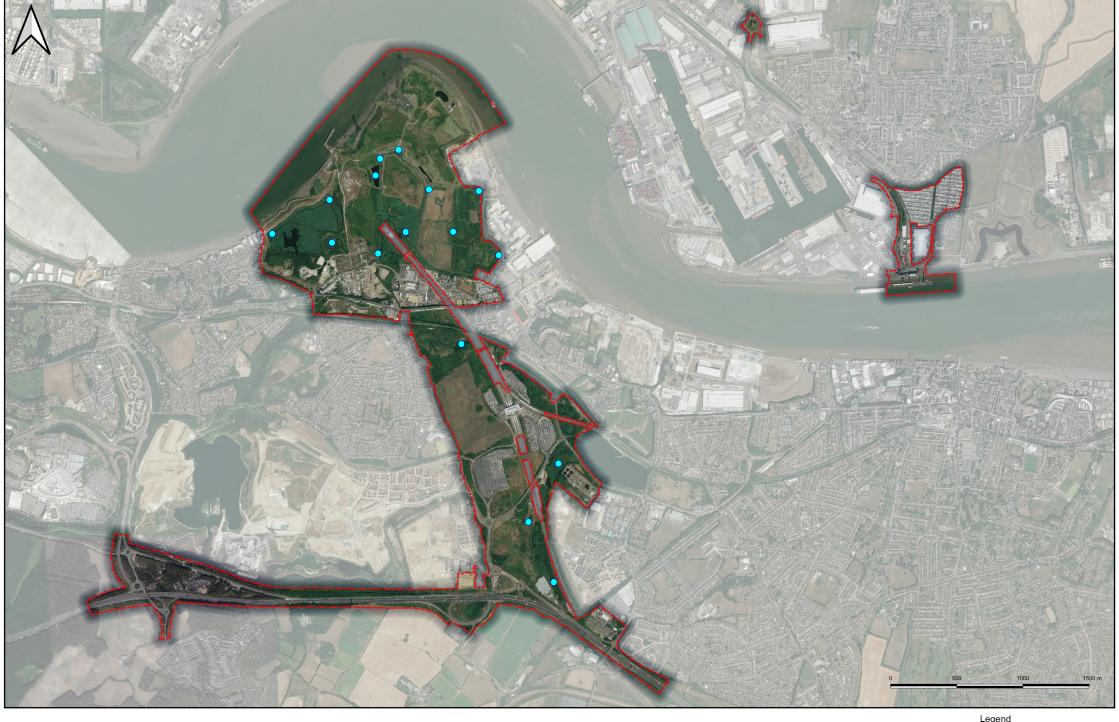
## **Appendix B: Surface water monitoring locations**

These locations can be seen in Appendix B.

London Resort Overall Site Plan - Outer Limits Boundary

- 1. 3 no. locations in or adjacent to the River Ebbsfleet
- 2. 3 no. locations in Black Duck Marsh
- 3. 3 no. locations in Botany Marsh
- 4. 2 no. locations within the main river
- 5. 2 no. locations in the Broadness Landfill perimeter channel
- 6. 1 no. location in the surface water body in the centre of the peninsula
- 7. 1 no. location in the surface water body adjacent to the HS1 tunnel box
- 8. 1 no. location in the surface water body in Bamber Pit
