The Sizewell C Project

6.6 Volume 5 Two Village Bypass Chapter 12 Groundwater and Surface Water Appendix 12A Two Village Bypass River Corridor Survey

May 2020

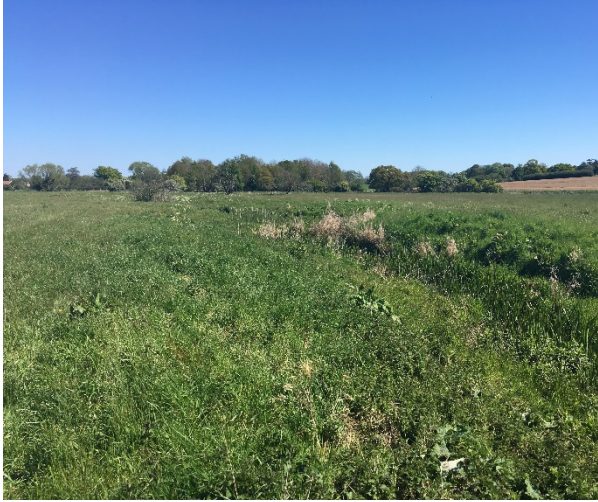
<p>Photo 1 – Looking upstream, open banks, channel choked with vegetation.</p>

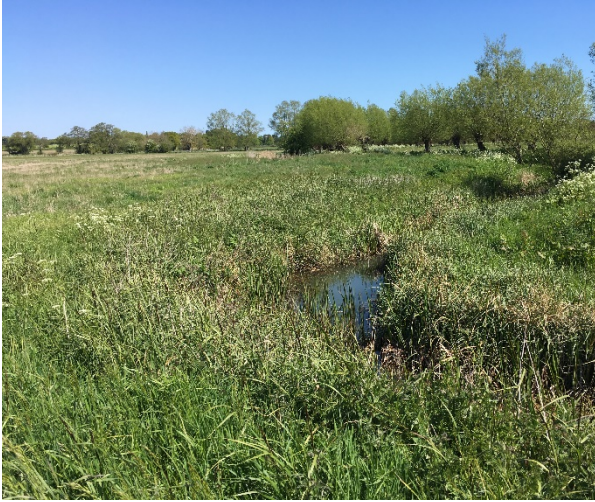
<p>Photo 2 – Looking upstream, pollarded willow trees on left bank, vegetation choking channel.</p>

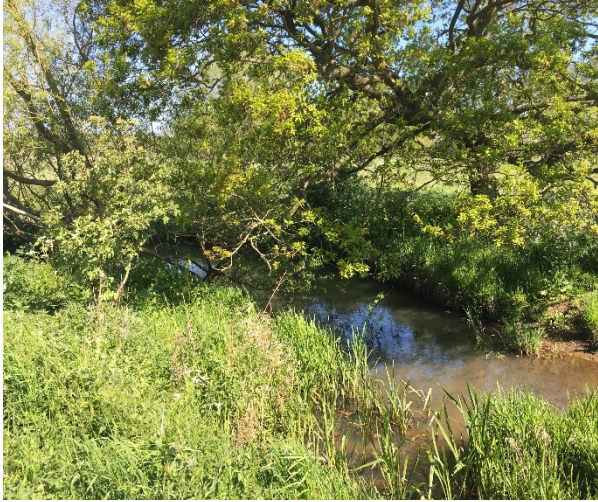
<p>Photo 3 – From downstream end, looking across turbid channel with marginal vegetation.</p>

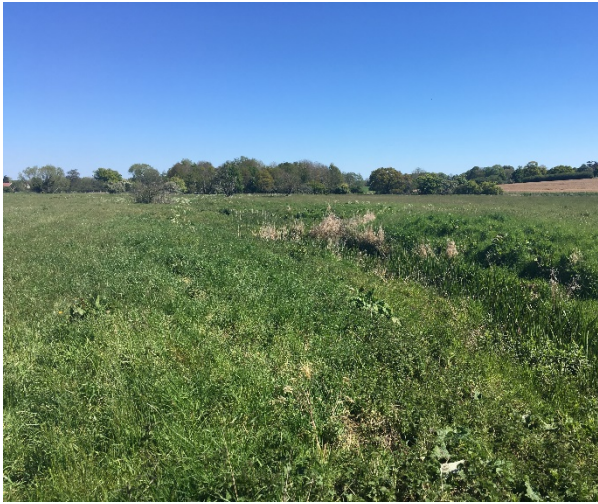
<p>Photo 1 – Taken from upstream, looking downstream, Various species of aquatic macrophytes present in wet channel.</p>

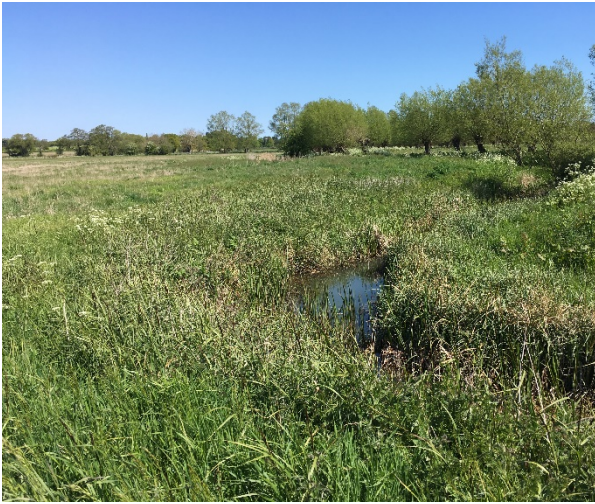
<p>Photo 2 – Mid-channel, looking downstream. Channel dry here and choked with greater pond sedge and common reed.</p>

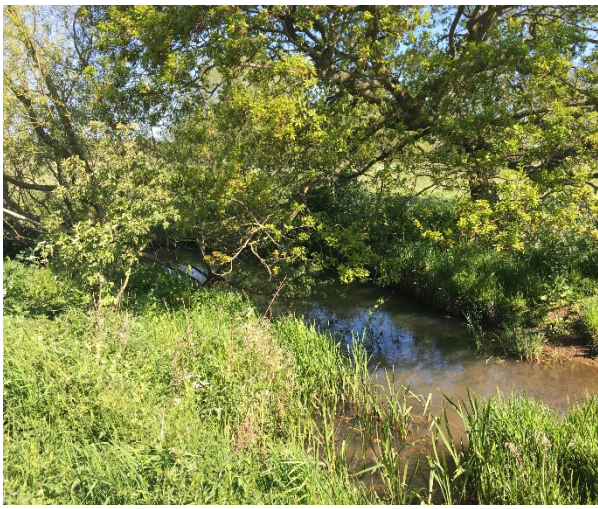
<p>Photo 3 – Dense woodland/scrub at downstream end, preventing access to channel/confluence with River Alde.</p>
