Proposed location for Planning Inspectors' site visit in relation to DCO for Sizewell C

Thorpeness sea defences/cliffs

OS Map reference: TM 47640 60167

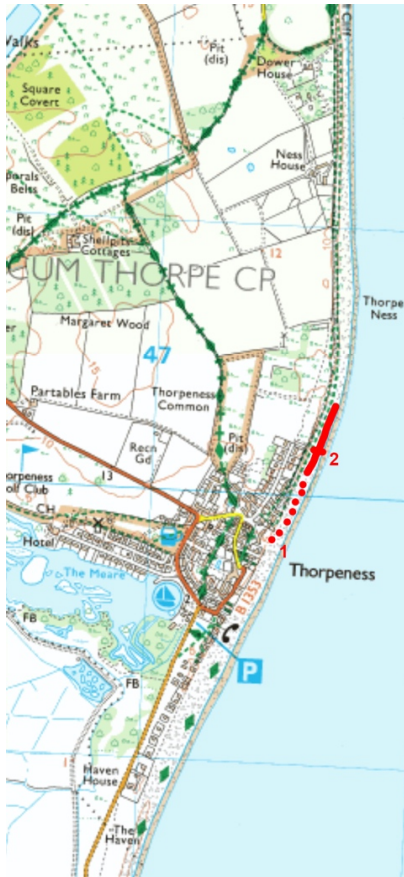
Appendix I. Map of proposed location and access to beach.

Solid red line = area to be examined

Dotted line = walking access (shingle beach)

1 = access to beach - footpath at end of Old Homes Road

2 = main site to be visited (major breach of sea defences)

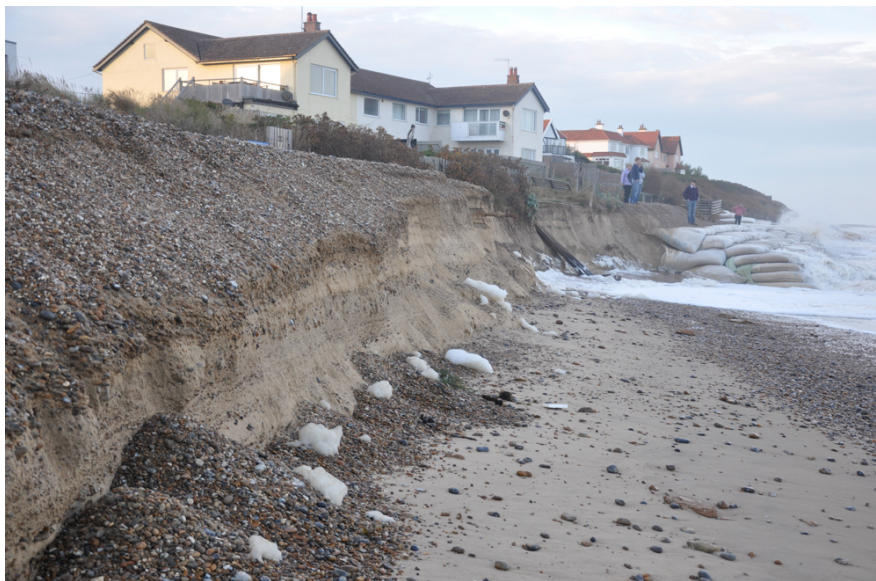
Appendix 2. Photo of erosion at Thorpeness, October 2013
(site shown is Pt 1 on map in Appendix 1)

Significant damage was caused to the south end of these defences (pt 1 on map in Appendix 1) by a single day storm event on 12th October 2013 as a result of an unusually corrosive sea/wind which particularly impacted Thorpeness. This resulted in a 3 meter loss of beach height at the footpath from Old Homes Road - image attached (Appendix 2). The damage was subsequently repaired.

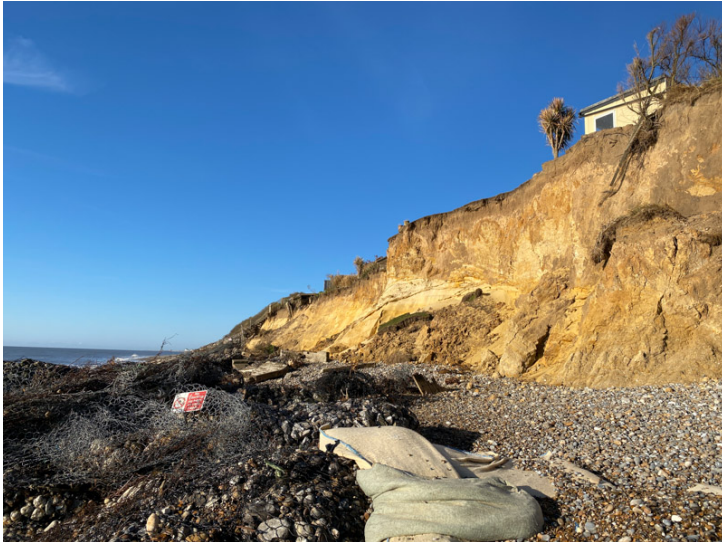
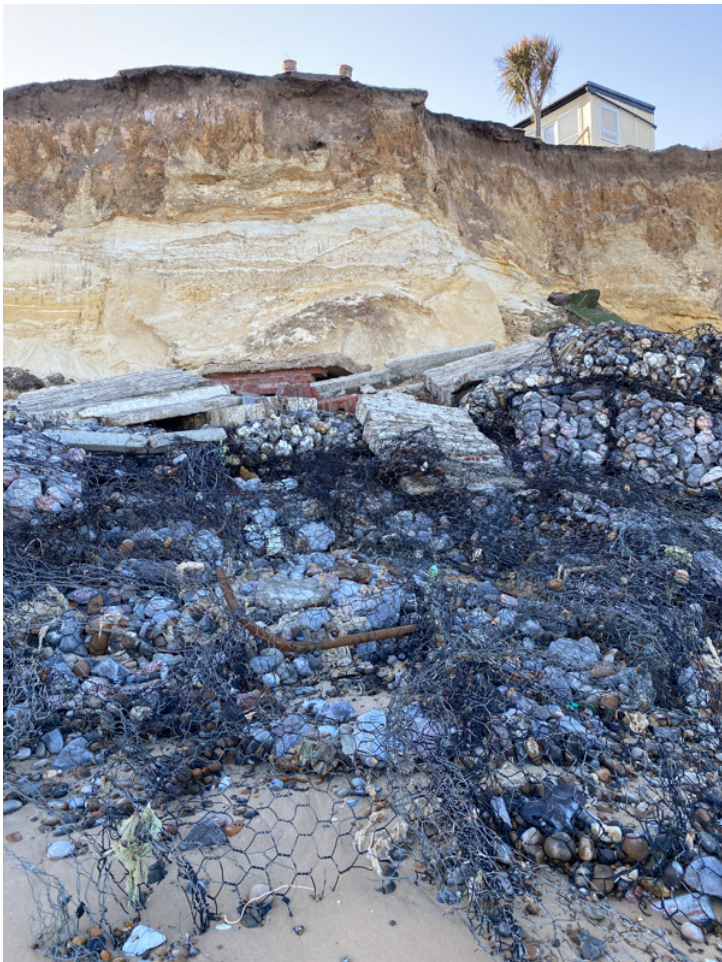
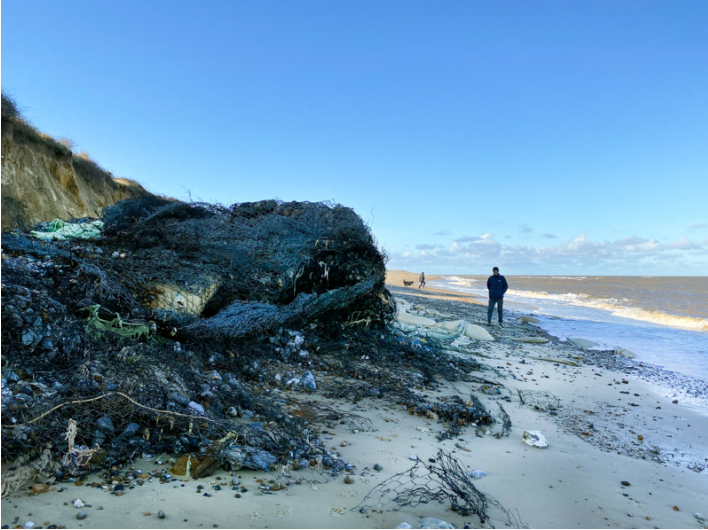
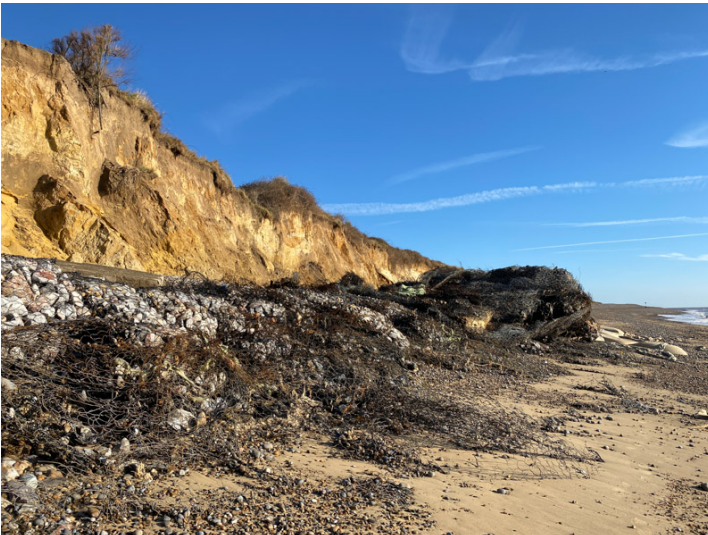
Appendix 3. Photos of current sea defence damage and erosion at Thorpeness (2021)
(site shown is Pt 2 on the map)

However, in recent months significant erosion has occurred at the northern end of the sea defences (Pt 2 on the map below), causing major loss of the cliff behind - images attached (Appendix 3).

- There is major damage to the sea defences in this location. This has led to a huge breach at the northern end (pt 2 on the map), leading to a significant loss of cliff (and gardens of two houses on North End Avenue).

- This site illustrates the unpredictability of sea defence failure. The decimation of the sea defences here (especially the north end) has happened after only around 10 years of their life despite this being expected to be an estimated 25 years. The damage was not the result of any storm surge but just 'normal' attrition, especially over the winter months of 2020/21.

Footnote: on my visit to this location today, contractors were on site for the day shoring up the northern end of the sea defences (a very temporary fix as it is beyond repair without a spend of several £million) and adding rock to the southern/middle part of the defences for reinforcement. I understand there is unlikely to be any further works in forthcoming weeks as there no budget at present.

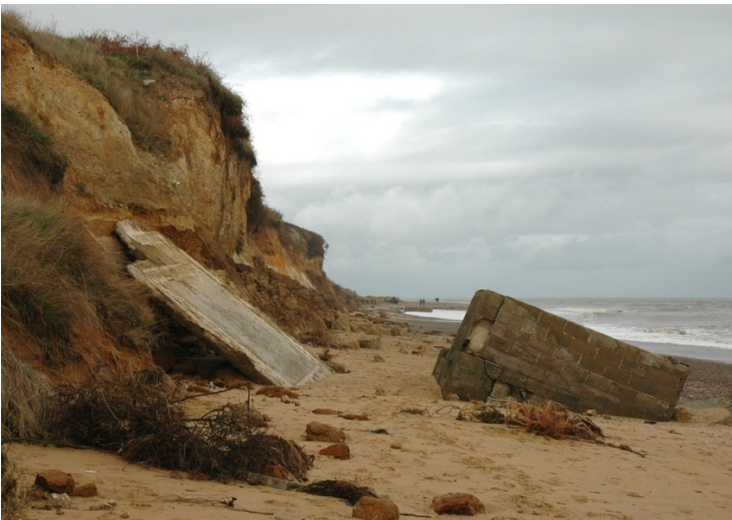
Pillbox 1 (approx. 50 meters north of pt 2 on map) - photo taken in 2007, soon after it was bulldozed off the cliffs.

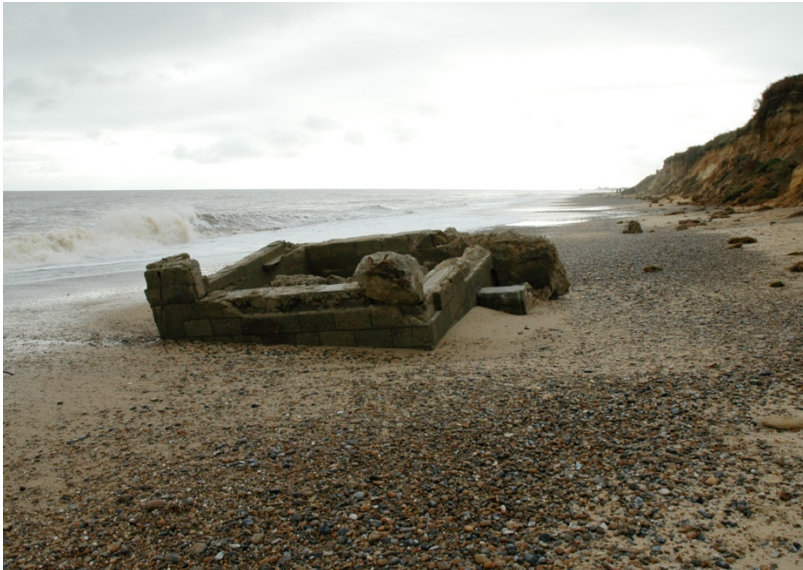
Pillbox 2 (located at the northernmost end of the red line on map) - photo taken in 2007.

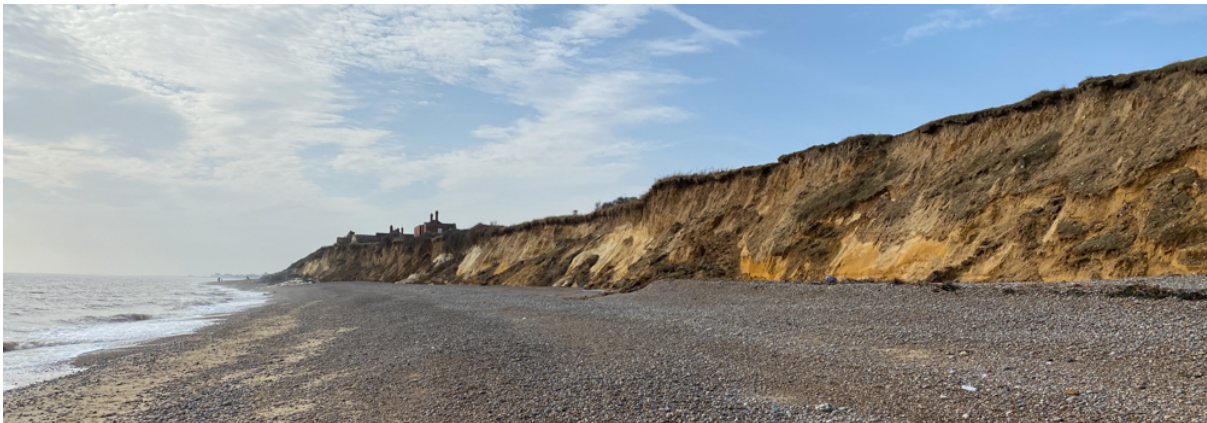
Pillbox 1, just visible on the tideline before the houses on the cliff, is now an estimated 25 meters from the base of the cliff - photo taken in 2021. NB photo taken just south of the site of Pillbox 2.

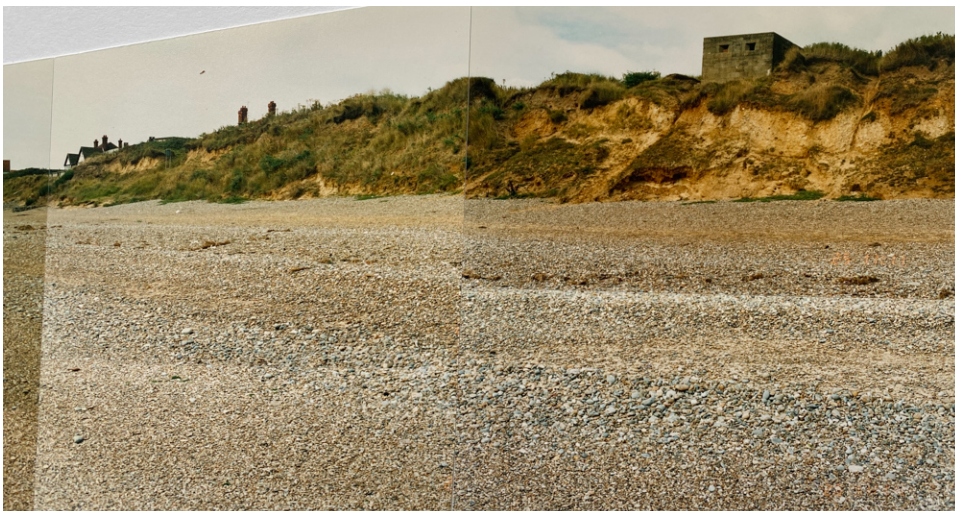
- The cliff erosion north of the defences demonstrate the 'embayment' effect that occurs on land at either end of a significant hard sea defence. The larger the sea defence, the greater this embayment is likely to be. For comparison, see the last photo in Appendix 4 taken in 1993, showing no signs of embayment before the construction of these sea defences. The embayment impact of the proposed Sizewell C sea defences could be highly significant, given their size.

Photos taken in 1993, showing Pillbox 1.
