# The Sizewell C Project

## 9.34 Fen Meadow Plan Report - Baseline Report Part 1 of 2

Fen Meadow Compensation  
Sites: Benhall Site 10\_11  
Baseline Ecology Report

Fen Meadow Compensation  
Site: Benhall Site 10 & 11  
Baseline Hydrogeological Report

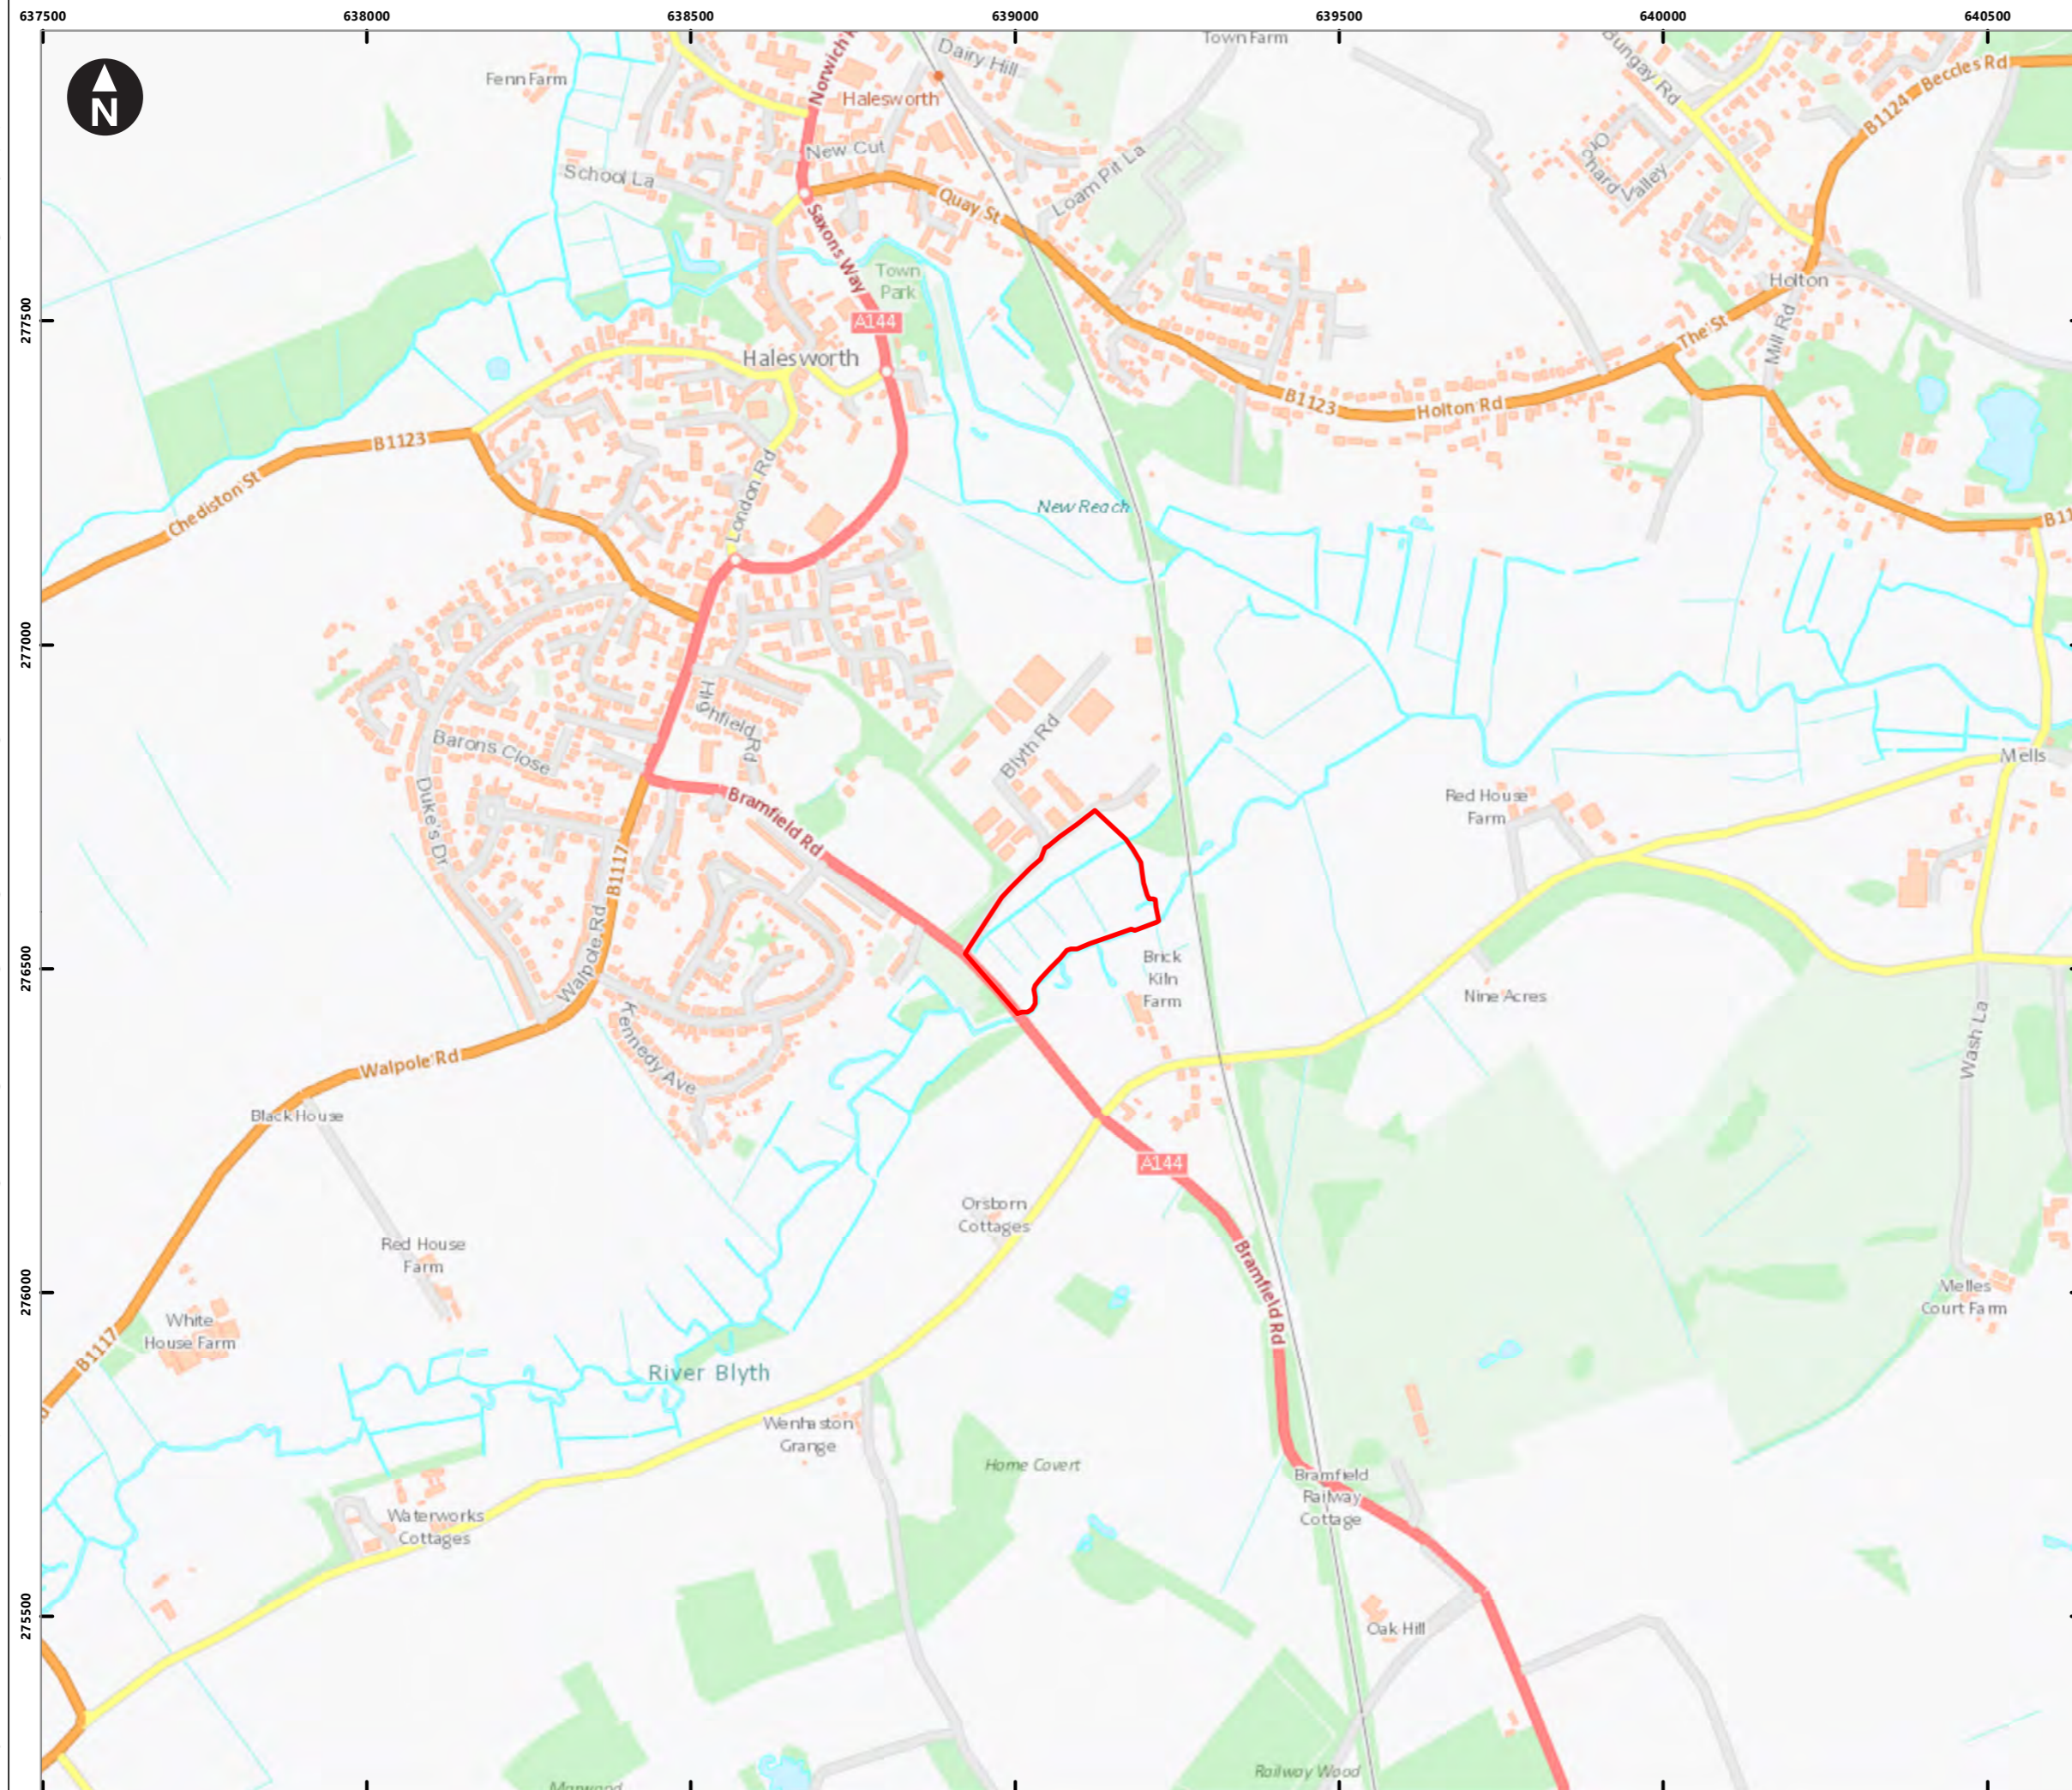
Key  
Site 28 boundary

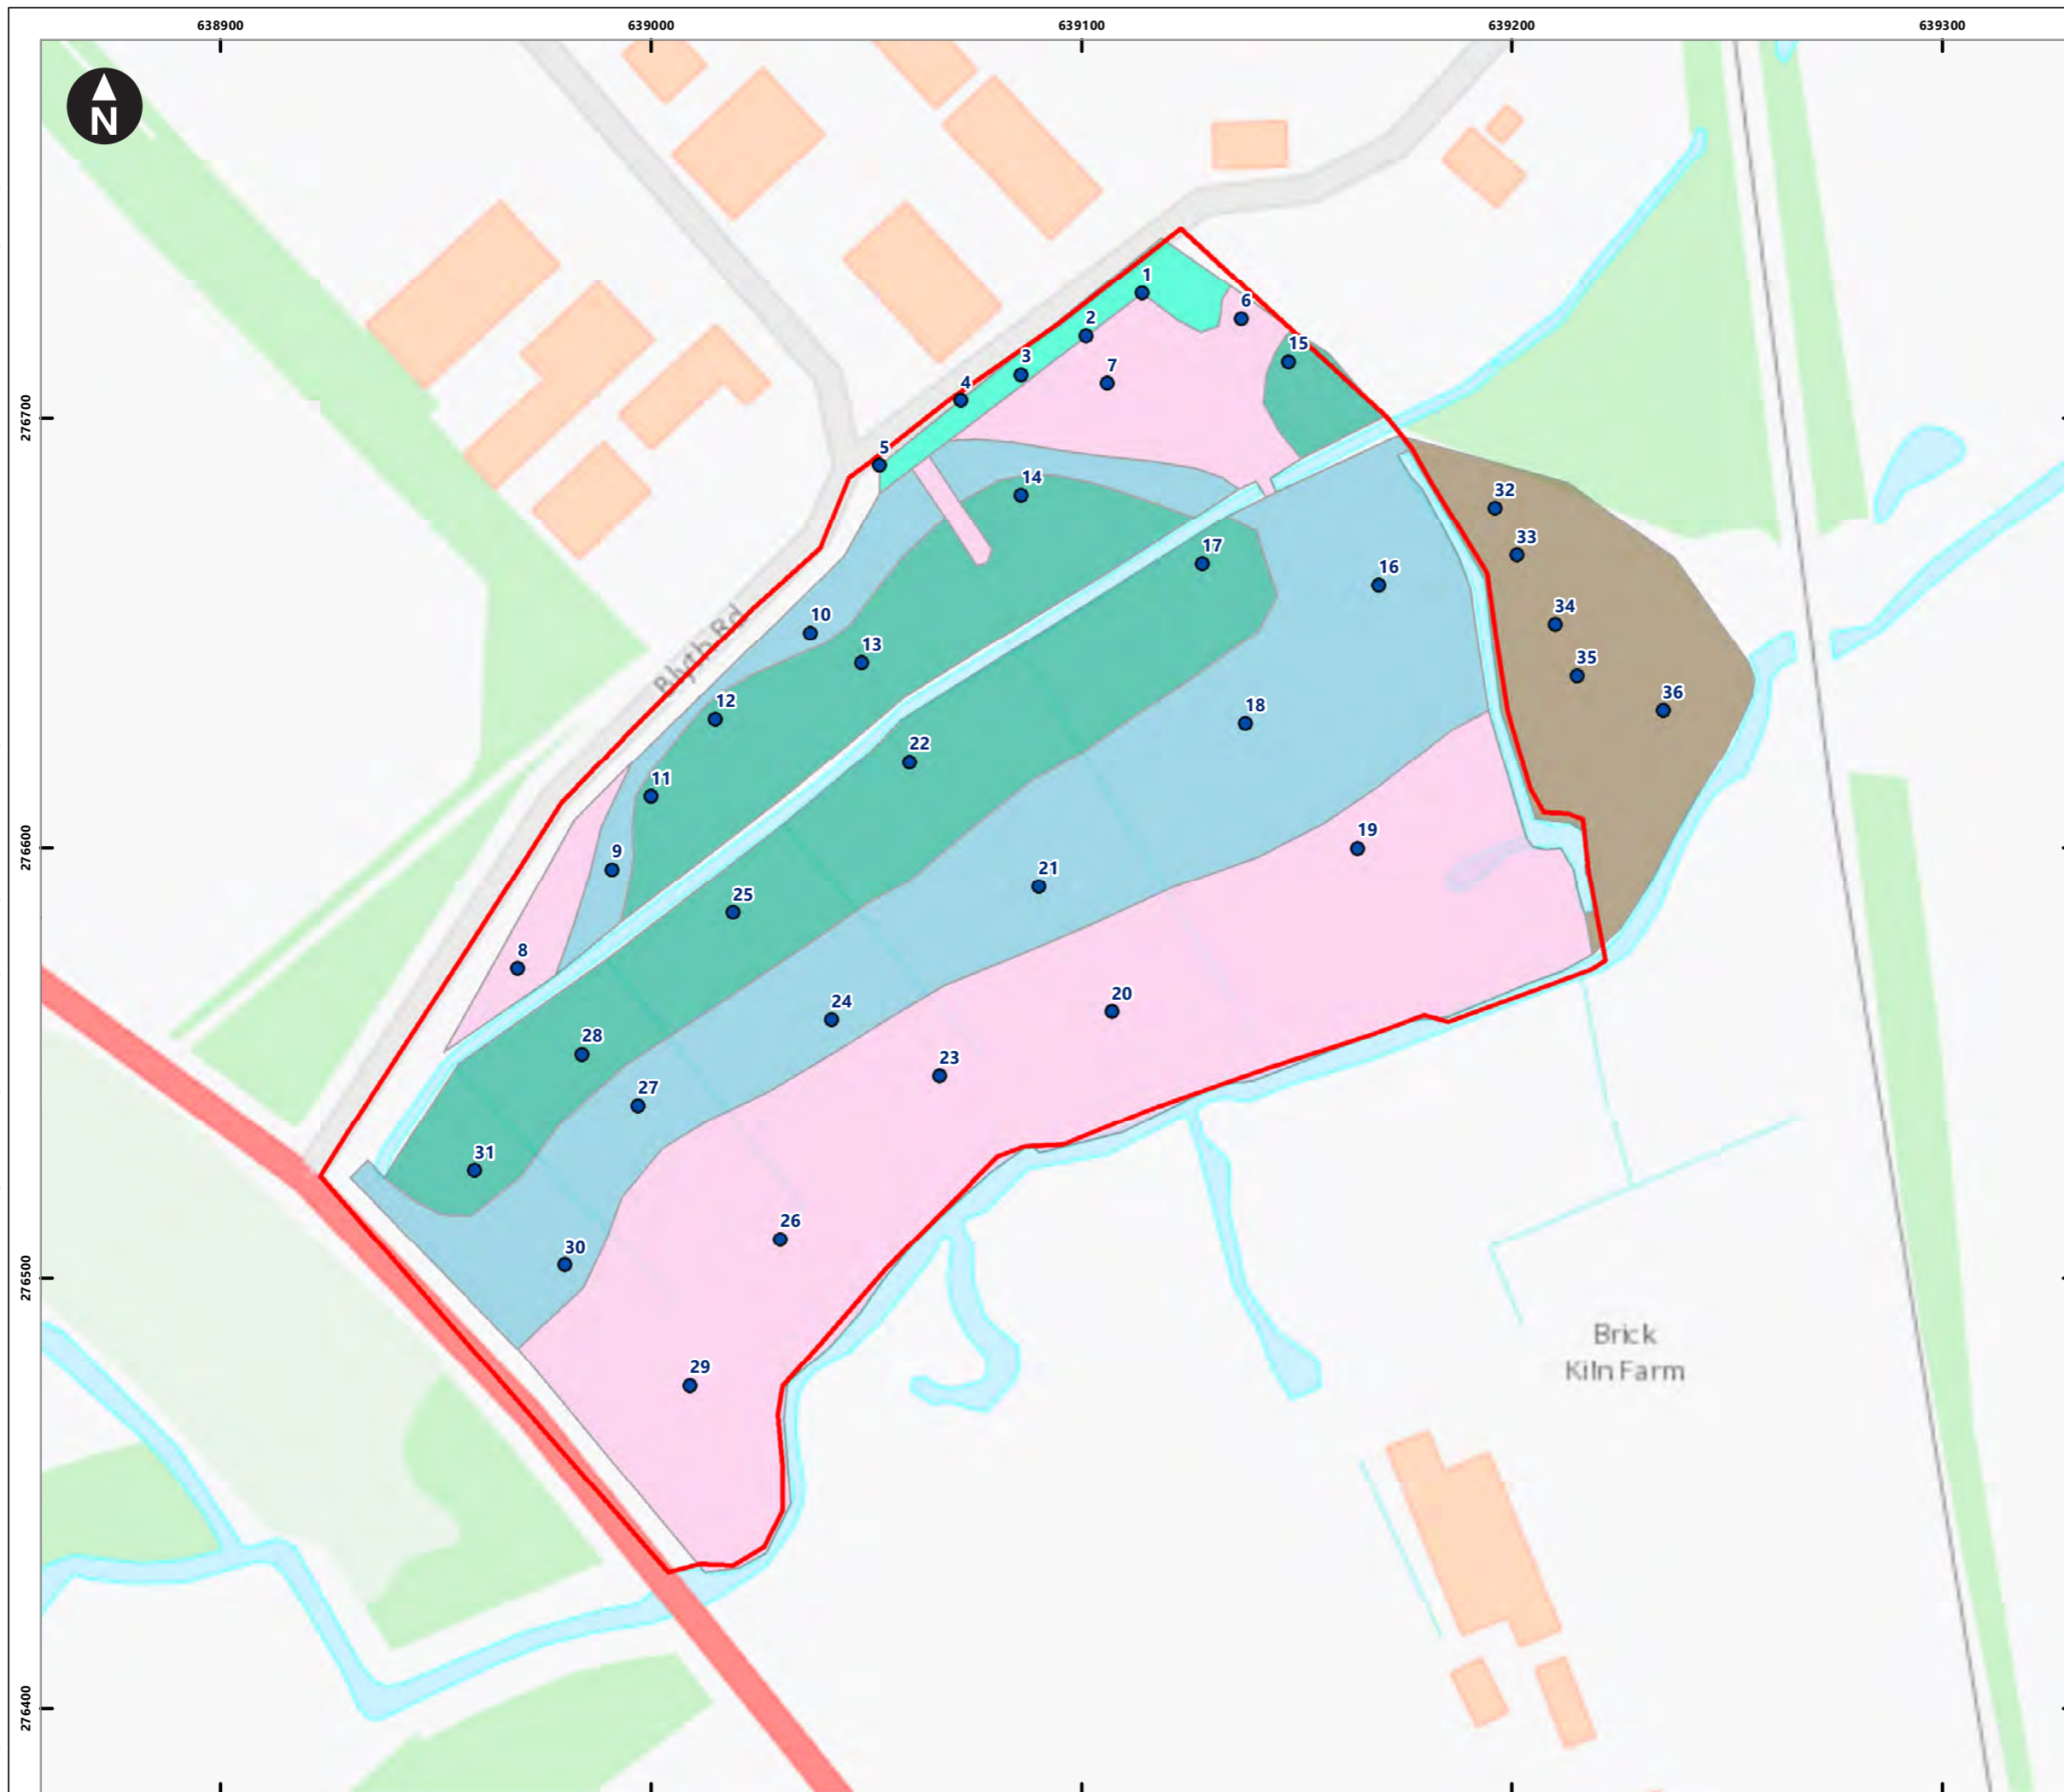
- Site 28 boundary
- NVC sample plot

Table 4.1 lists twelve phreatophyte species (*sensu* Londo, 1988). While representing nearly one-fifth of species recorded in the sample plots, only the hybrid jointed rush is common, though the group of species is clustered in the *Holco-Juncetum* stands. This is indicative of weak, localised groundwater seepage. The presence of another obligate' phreatophyte - blunt-flowered rush - on the side of one ditch near its junction with the catch dyke may be interpreted as a relic of a more distinctive fen meadow flora that persists in association with the ditch network.

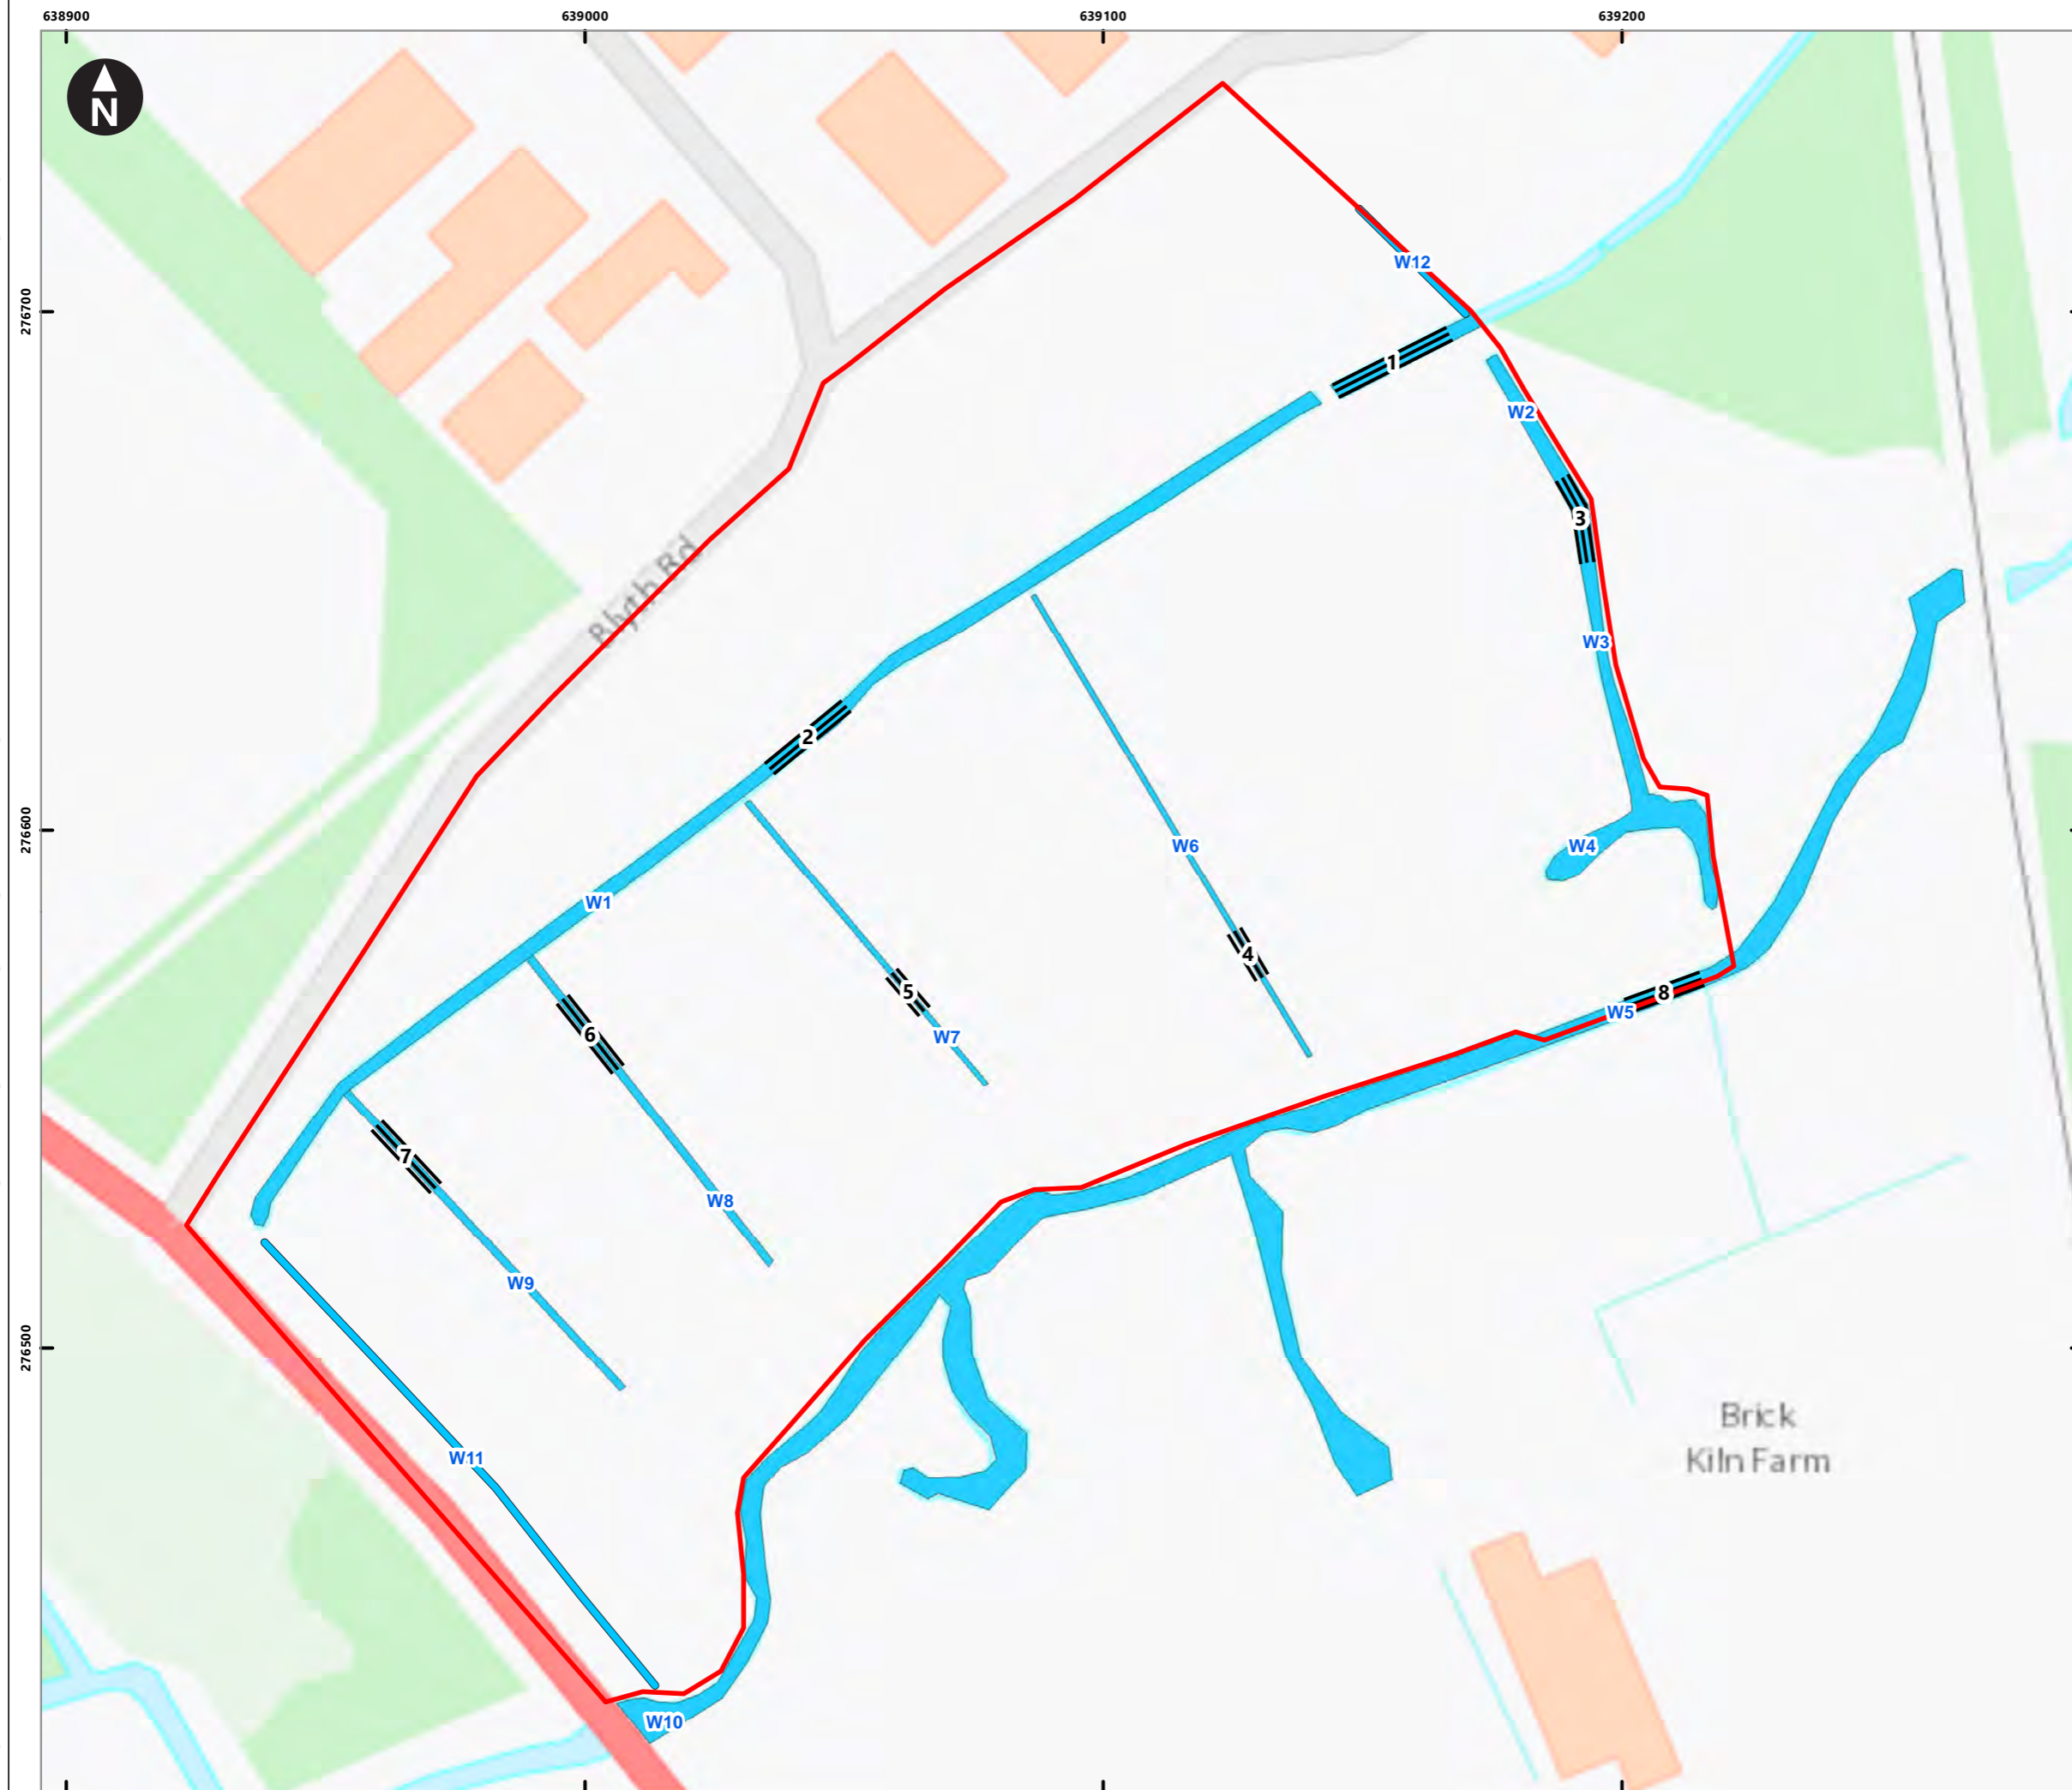
- Site 28 boundary
- Running water
- W1 Ditch number
- Aquatic invertibrate survey location

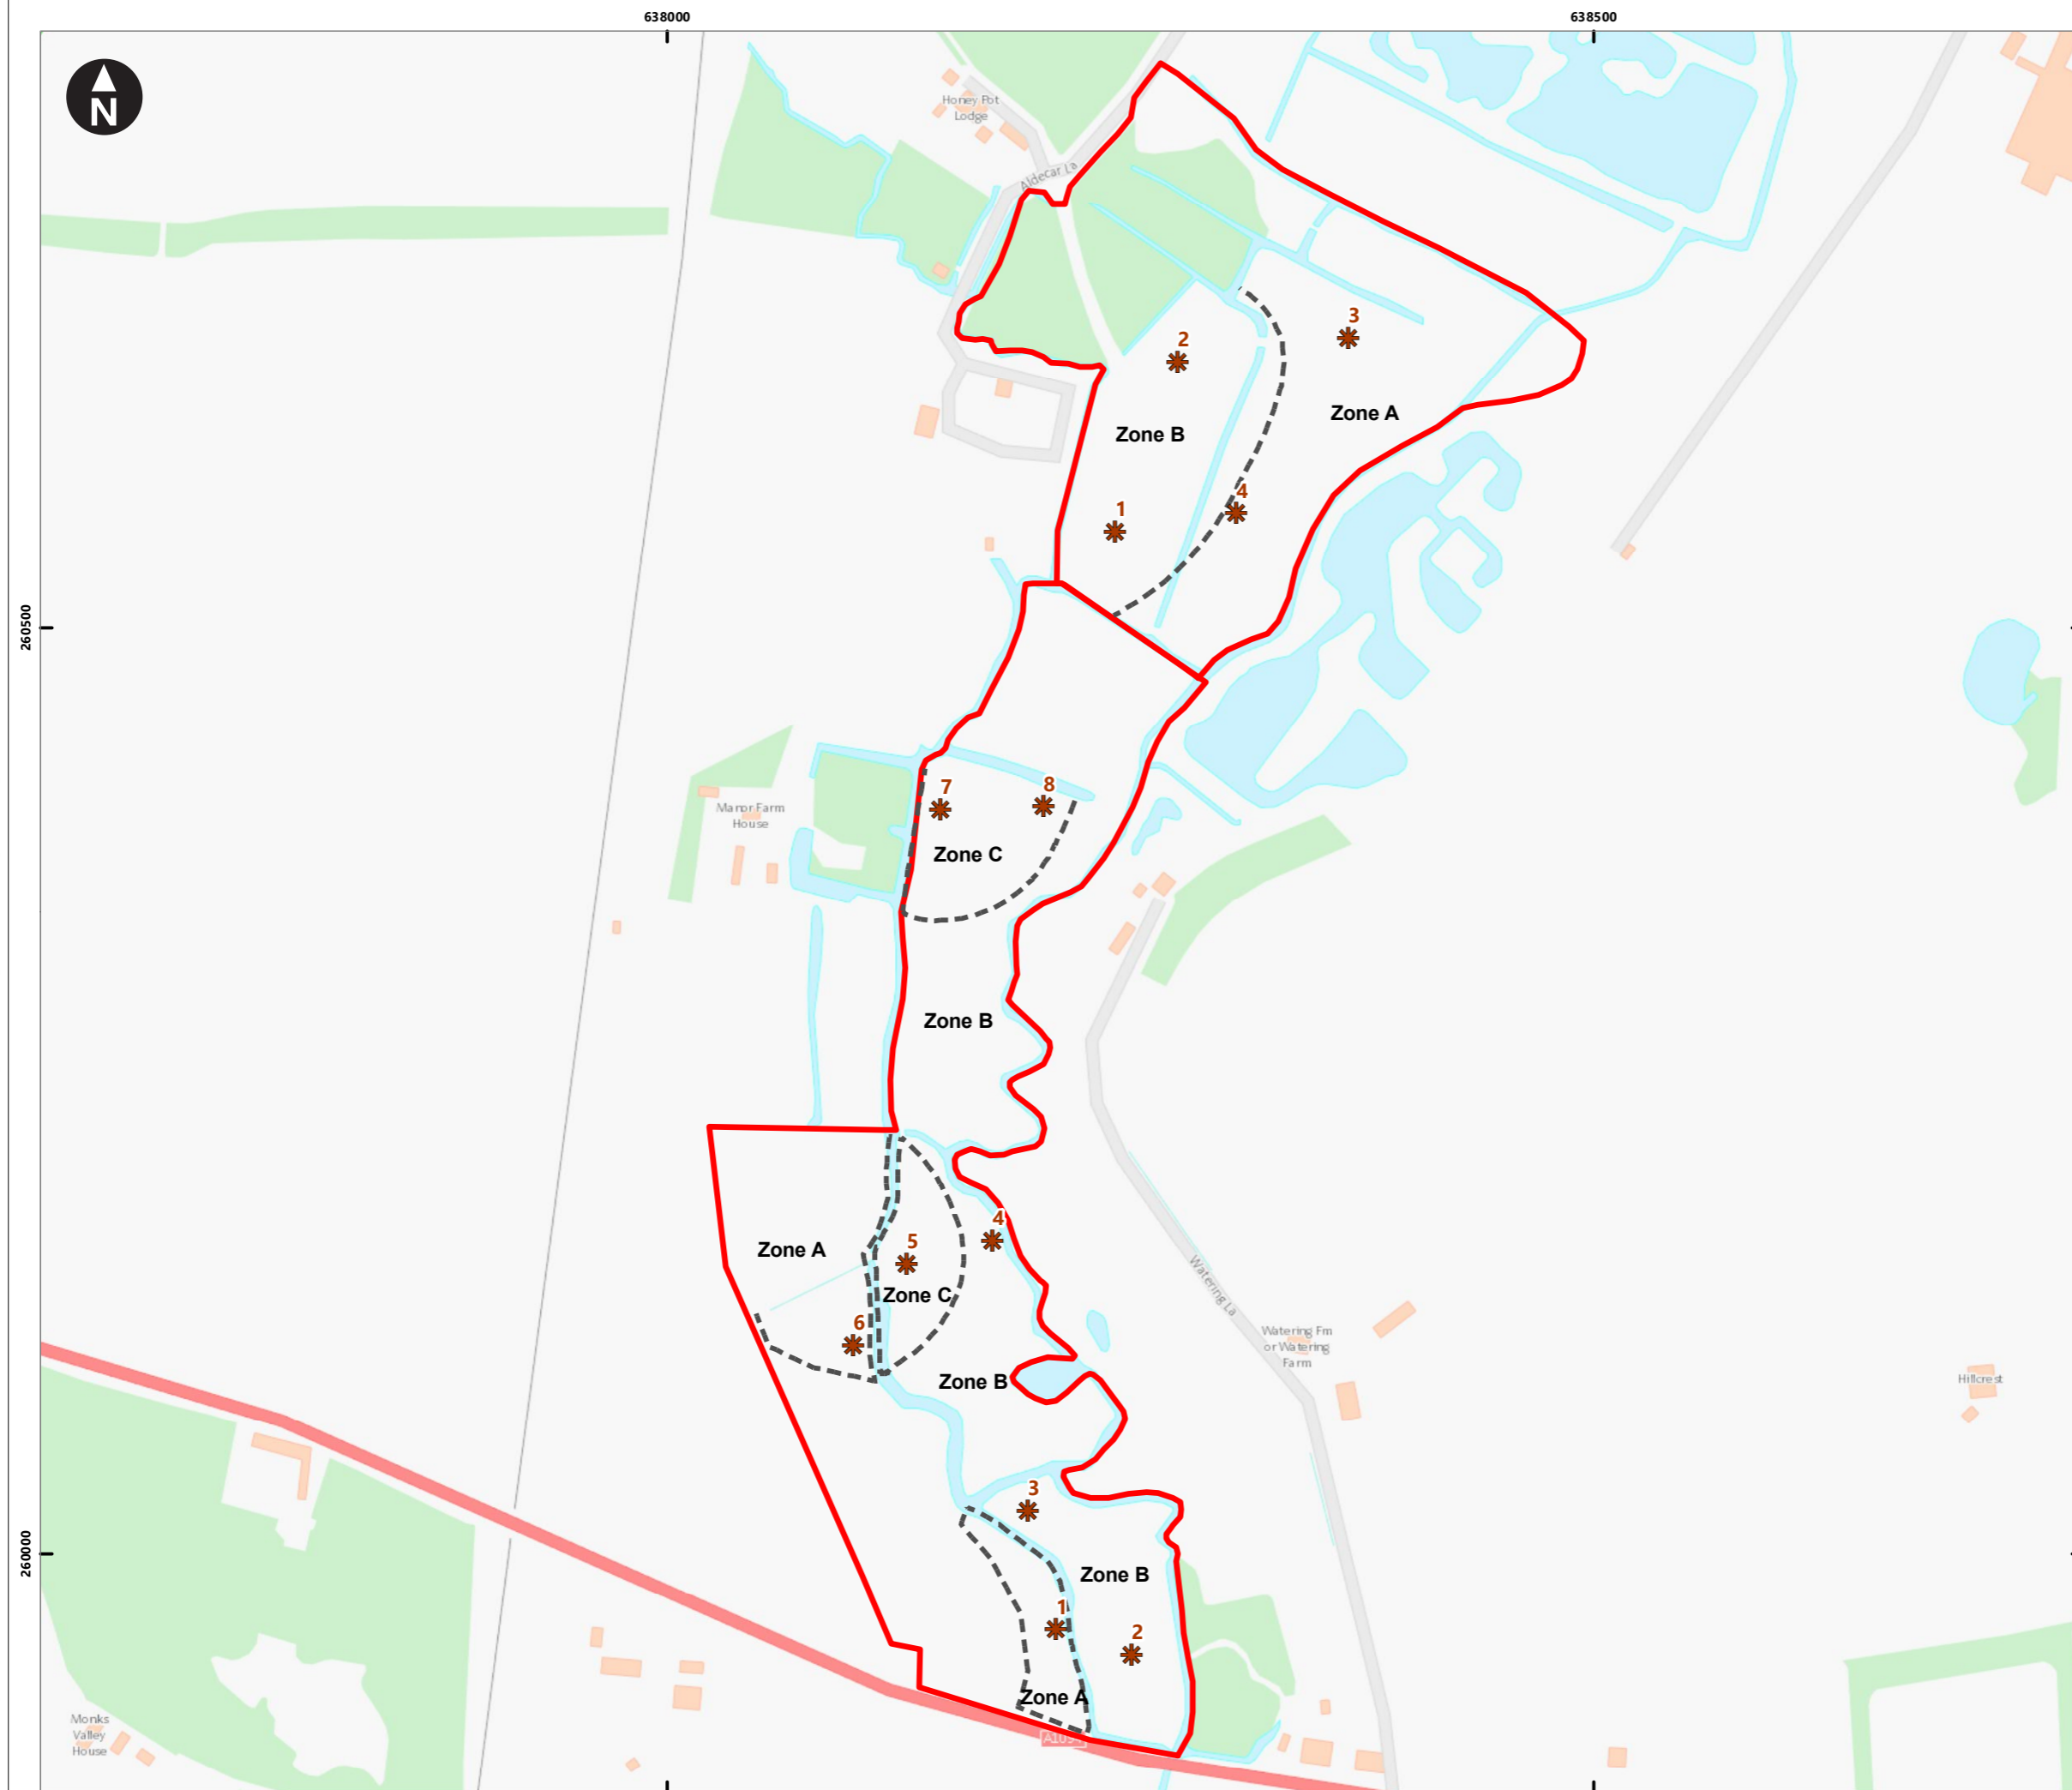
- Site 10\_11 boundary
- Zone boundary
- ✱ Soil core sample location

- The soils core surveys carried out in April 2019 indicated that the initial water table was generally between 0.5m and 1m below ground level, rising to 0.4 and 0.1m below ground level at two locations after rest. The rising groundwater levels indicates that water in the peat and sands and gravels beneath the silty clay layer near the surface has a positive hydrostatic pressure in some locations. The October 2020 drilling programme recorded similar rest ground water levels (0.48 to 0.84m). General groundwater flow is thought to be towards the River Fromus (west to east) but collected data from the surveys suggest a relatively flat water table at the Benhall site.

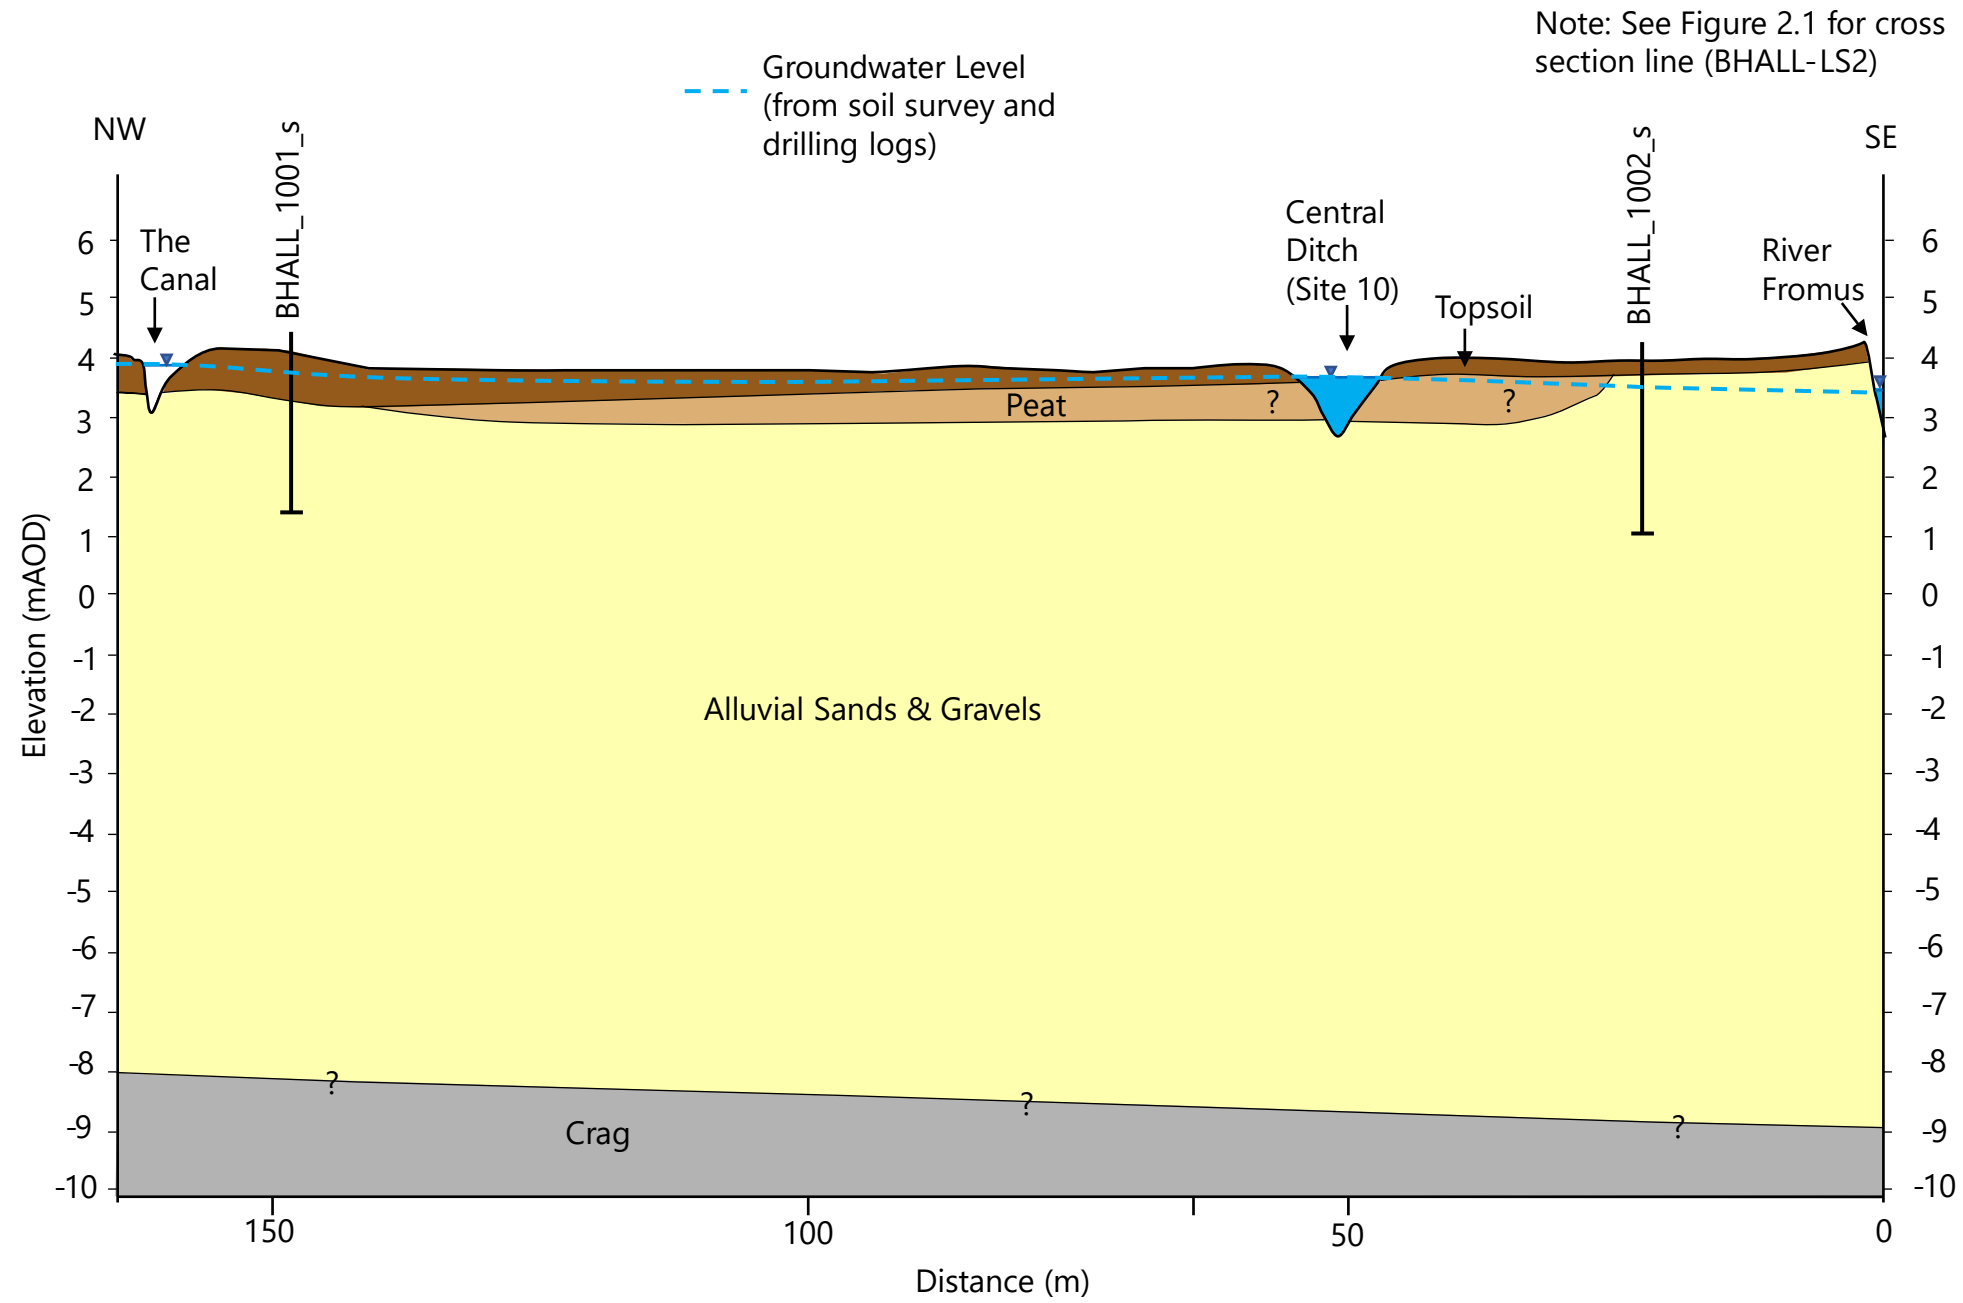
- Key
- Topsoil
  - Peat
  - Alluvial sand and gravels
  - Crag
  - Groundwater level

- Development of Peat has occurred in the northern half of Site 11 and in Site 10 and is encountered between 0.4 and 2.5 m below ground surface. The borehole logs indicate a peat thicknesses of up to 4 m thick in places. Soils cores show that a silty clay layer is often present above the Peat which may hold a higher water level than that of the underlying sands and gravels. The basal part of the peat was more degraded than the upper part in some areas which may indicate that the groundwater level is fluctuating through the lower part, though it may rise through the peat during periods of heavier rainfall.

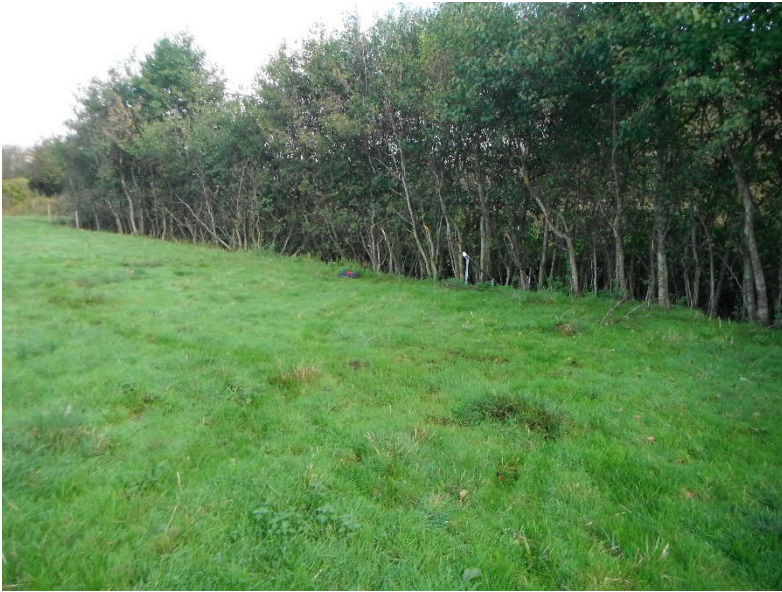
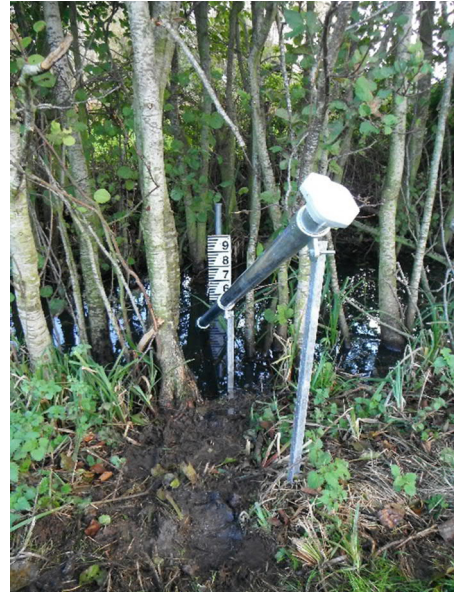
## SITE 28 HALESWORTH – HAL-GB02

<b>Installation Name:</b> HAL-GB02		
<b>Equipment Installed:</b> OTT Orpheus Mini - OM-453491	<b>Logging Interval:</b> 15 minutes	<b>OS Grid Reference:</b> TM 39185 76674
<b>Datum Level:</b> Awaiting Survey	<b>Datum:</b> Base of Gaugeboard	<b>Gaugeboard Length:</b> 1m

**Installation Notes:** Deep sediment.

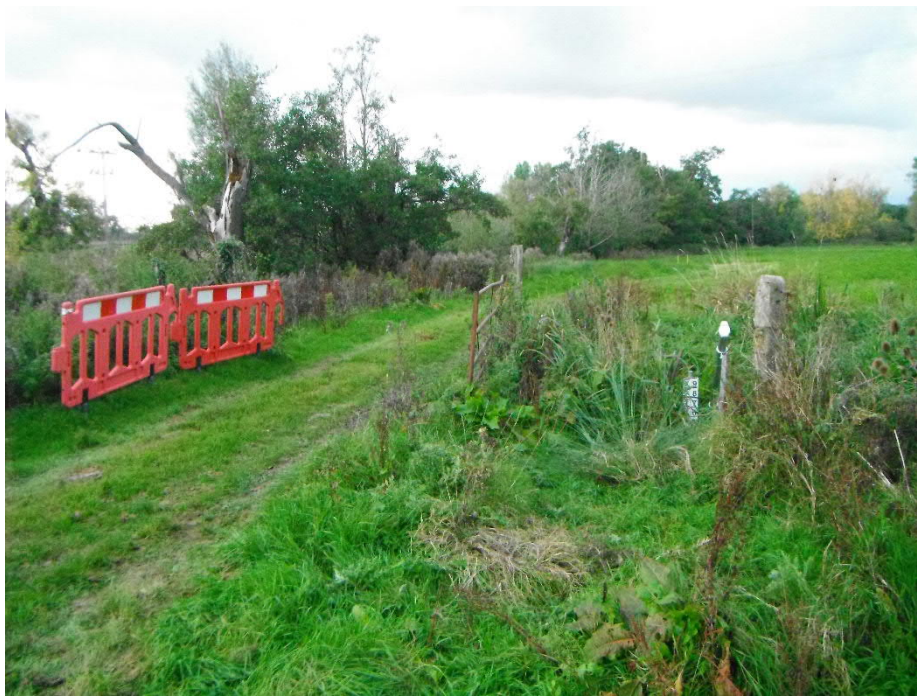
## SITES 10/11 SNAPE – SNP-GB01

<b>Installation Name:</b> SNP-GB01		
<b>Equipment Installed:</b> OTT Orpheus Mini - OM-453493	<b>Logging Interval:</b> 15 minutes	<b>OS Grid Reference:</b> TM 38130 60235
<b>Datum Level:</b> Awaiting Survey	<b>Datum:</b> Base of Gaugeboard	<b>Gaugeboard Length:</b> 1m

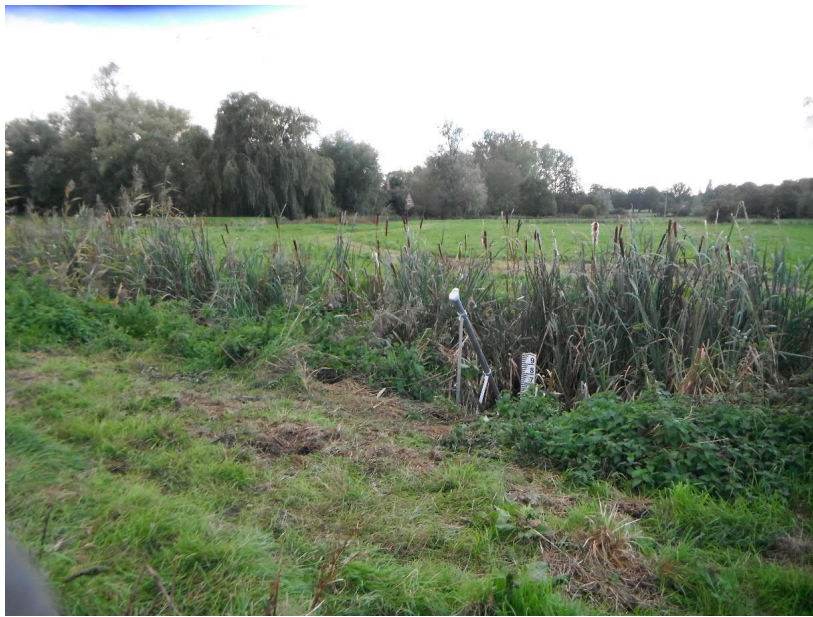
## SITES 10/11 SNAPE – SNP-GB02

<b>Installation Name:</b> SNP-GB02		
<b>Equipment Installed:</b> OTT Orpheus Mini - OM-453492	<b>Logging Interval:</b> 15 minutes	<b>OS Grid Reference:</b> TM 38249 60509
<b>Datum Level:</b> Awaiting Survey	<b>Datum:</b> Base of Gaugeboard	<b>Gaugeboard Length:</b> 1m

**Installation Notes:** Deep ditch.
