# The Sizewell C Project

## 9.34 Fen Meadow Plan Report - Baseline Report Part 1 of 2

Fen Meadow Compensation  
Sites: Benhall Site 10\_11  
Baseline Ecology Report

Fen Meadow Compensation  
Site: Benhall Site 10 & 11  
Baseline Hydrogeological Report

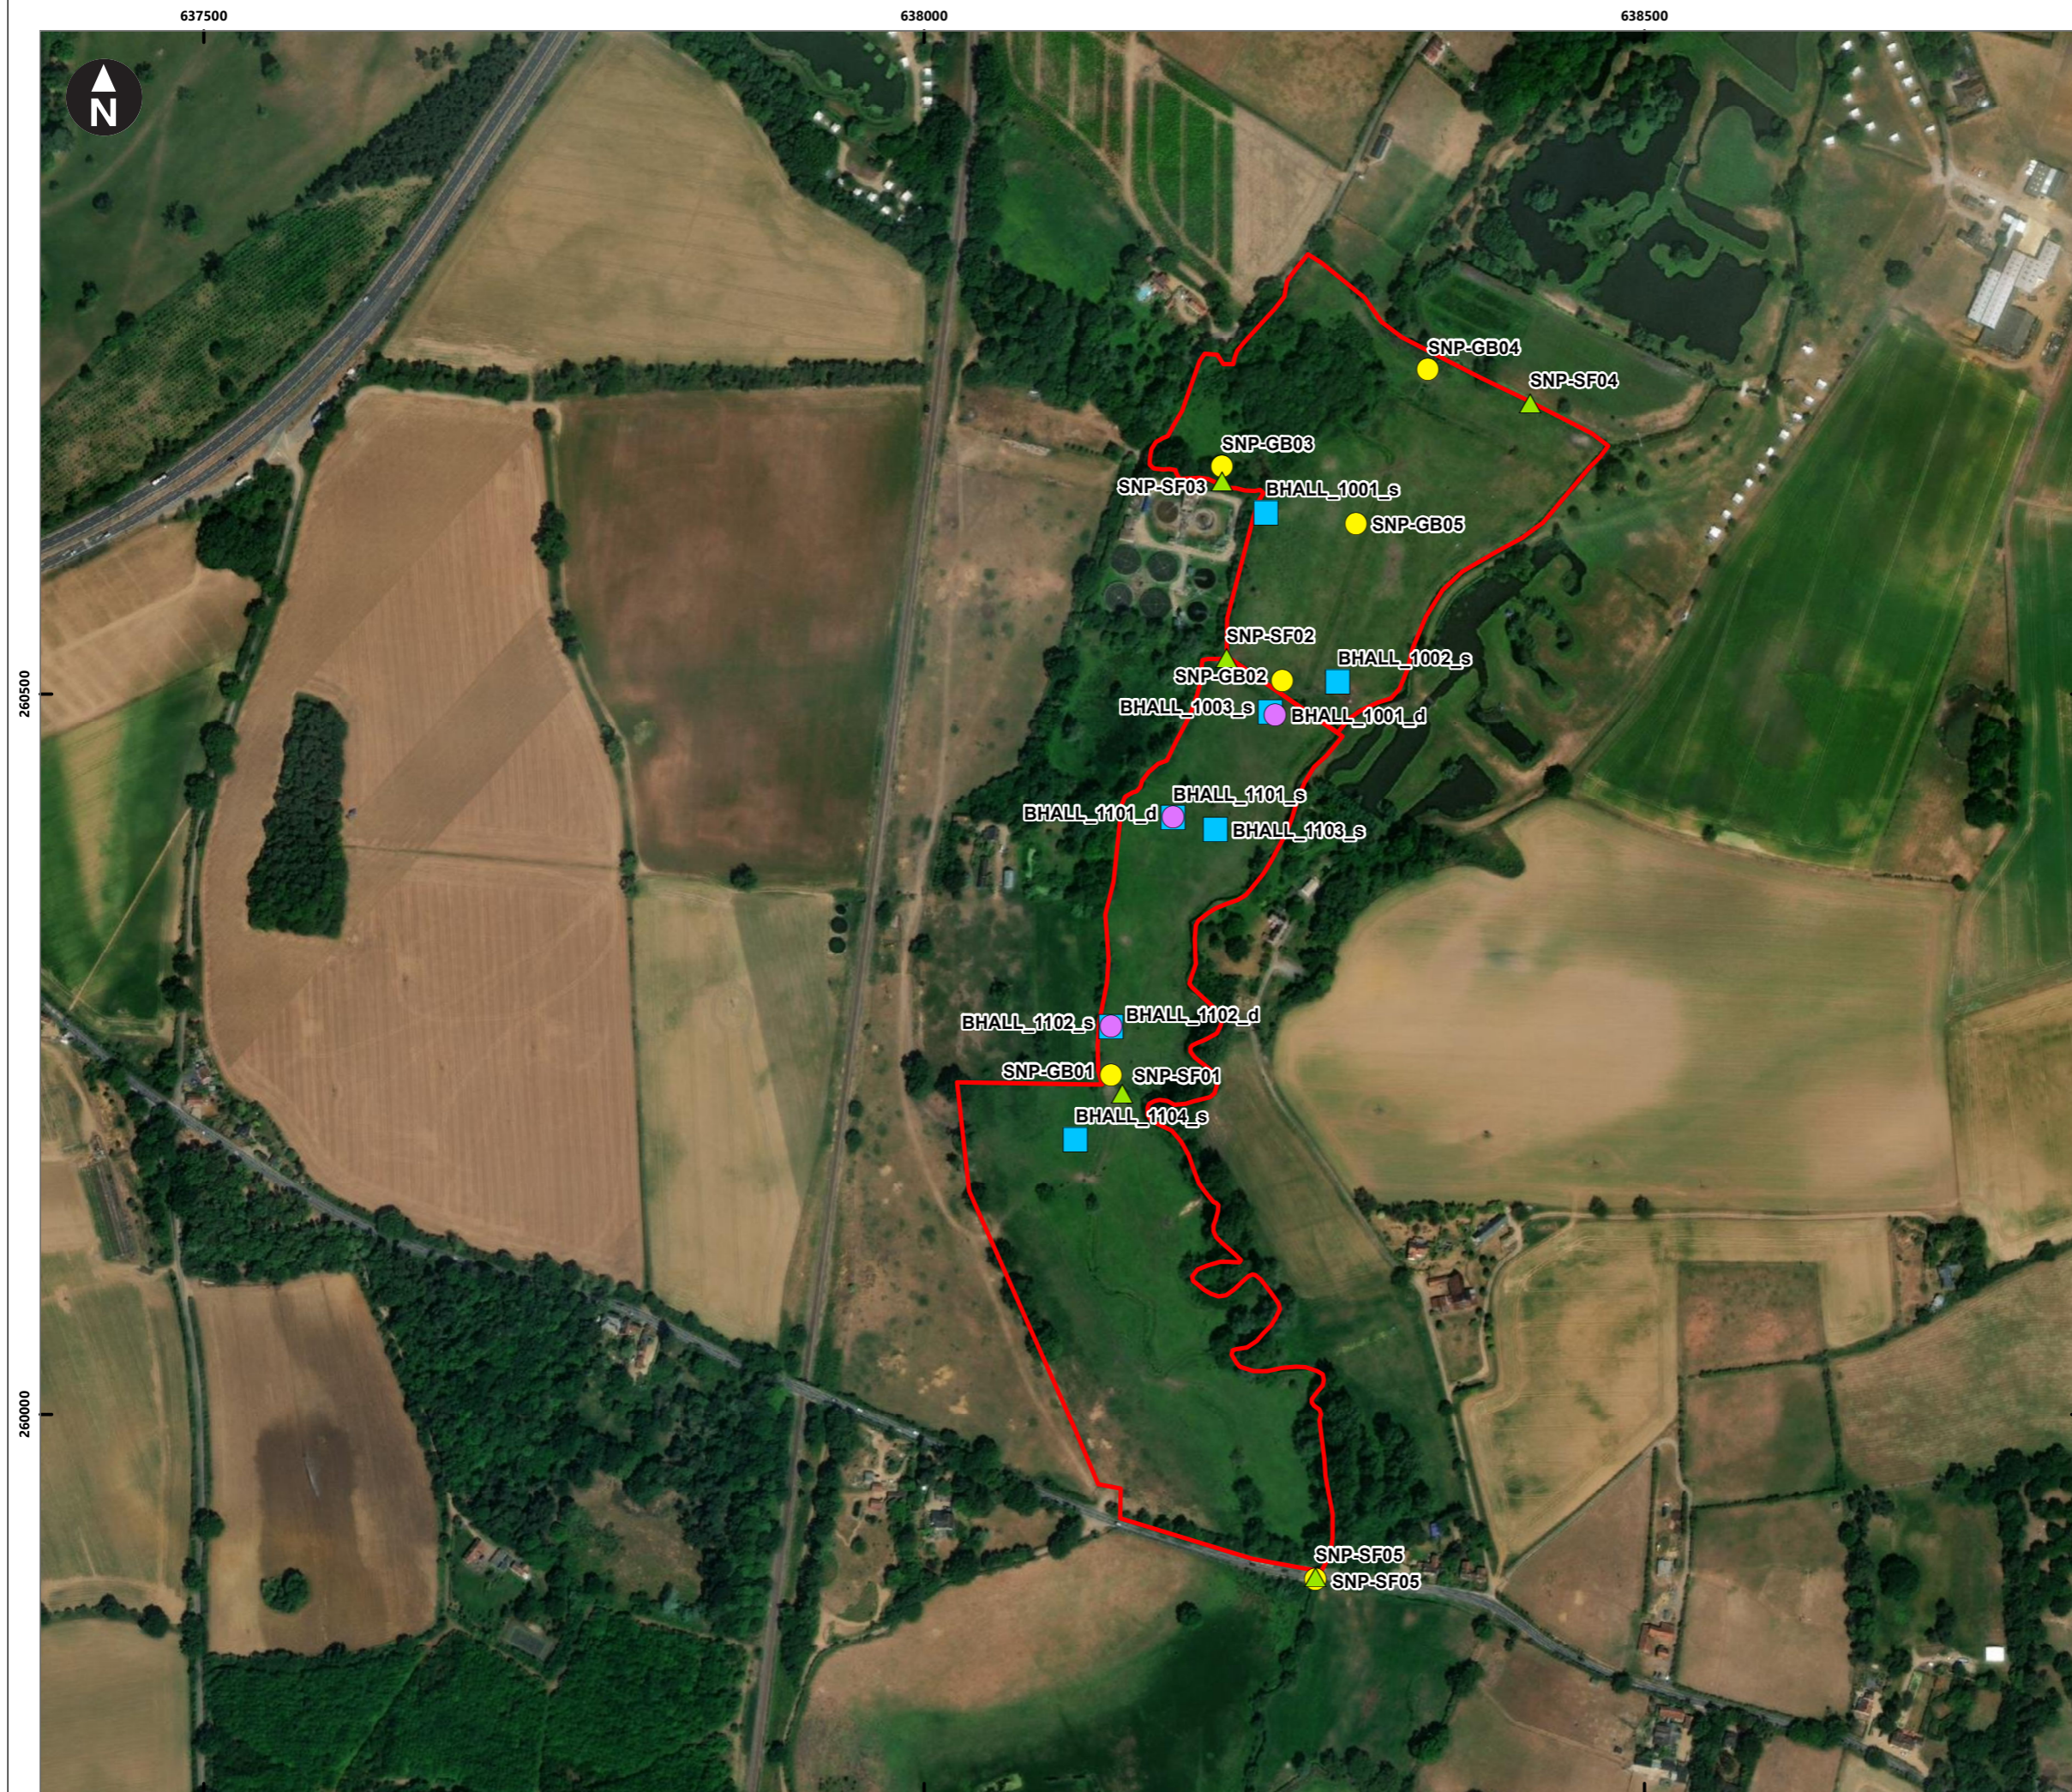
- Site boundary
- Gaugeboard
- Piezometer
- Dipwell
- ▲ Flow gauging

- Installation of gaugeboards to monitor surface water levels in site watercourses / drains;
  - Monitoring of deep and shallow groundwater conditions via piezometers and shallow dipwells. Each installation is visited monthly with water levels recorded manually as a spot check, but each is also fitted with a water level logger that records at 15 minute intervals and is downloaded on a quarterly basis.
