# The Sizewell C Project

## 9.34 Fen Meadow Plan Report - Baseline Report Part 2 of 2

## Fen Meadow Plan Report 1 – Baseline Report

APPENDIX F: HALESWORTH SITE 28 - BASELINE HYDROGEOLOGICAL REPORT

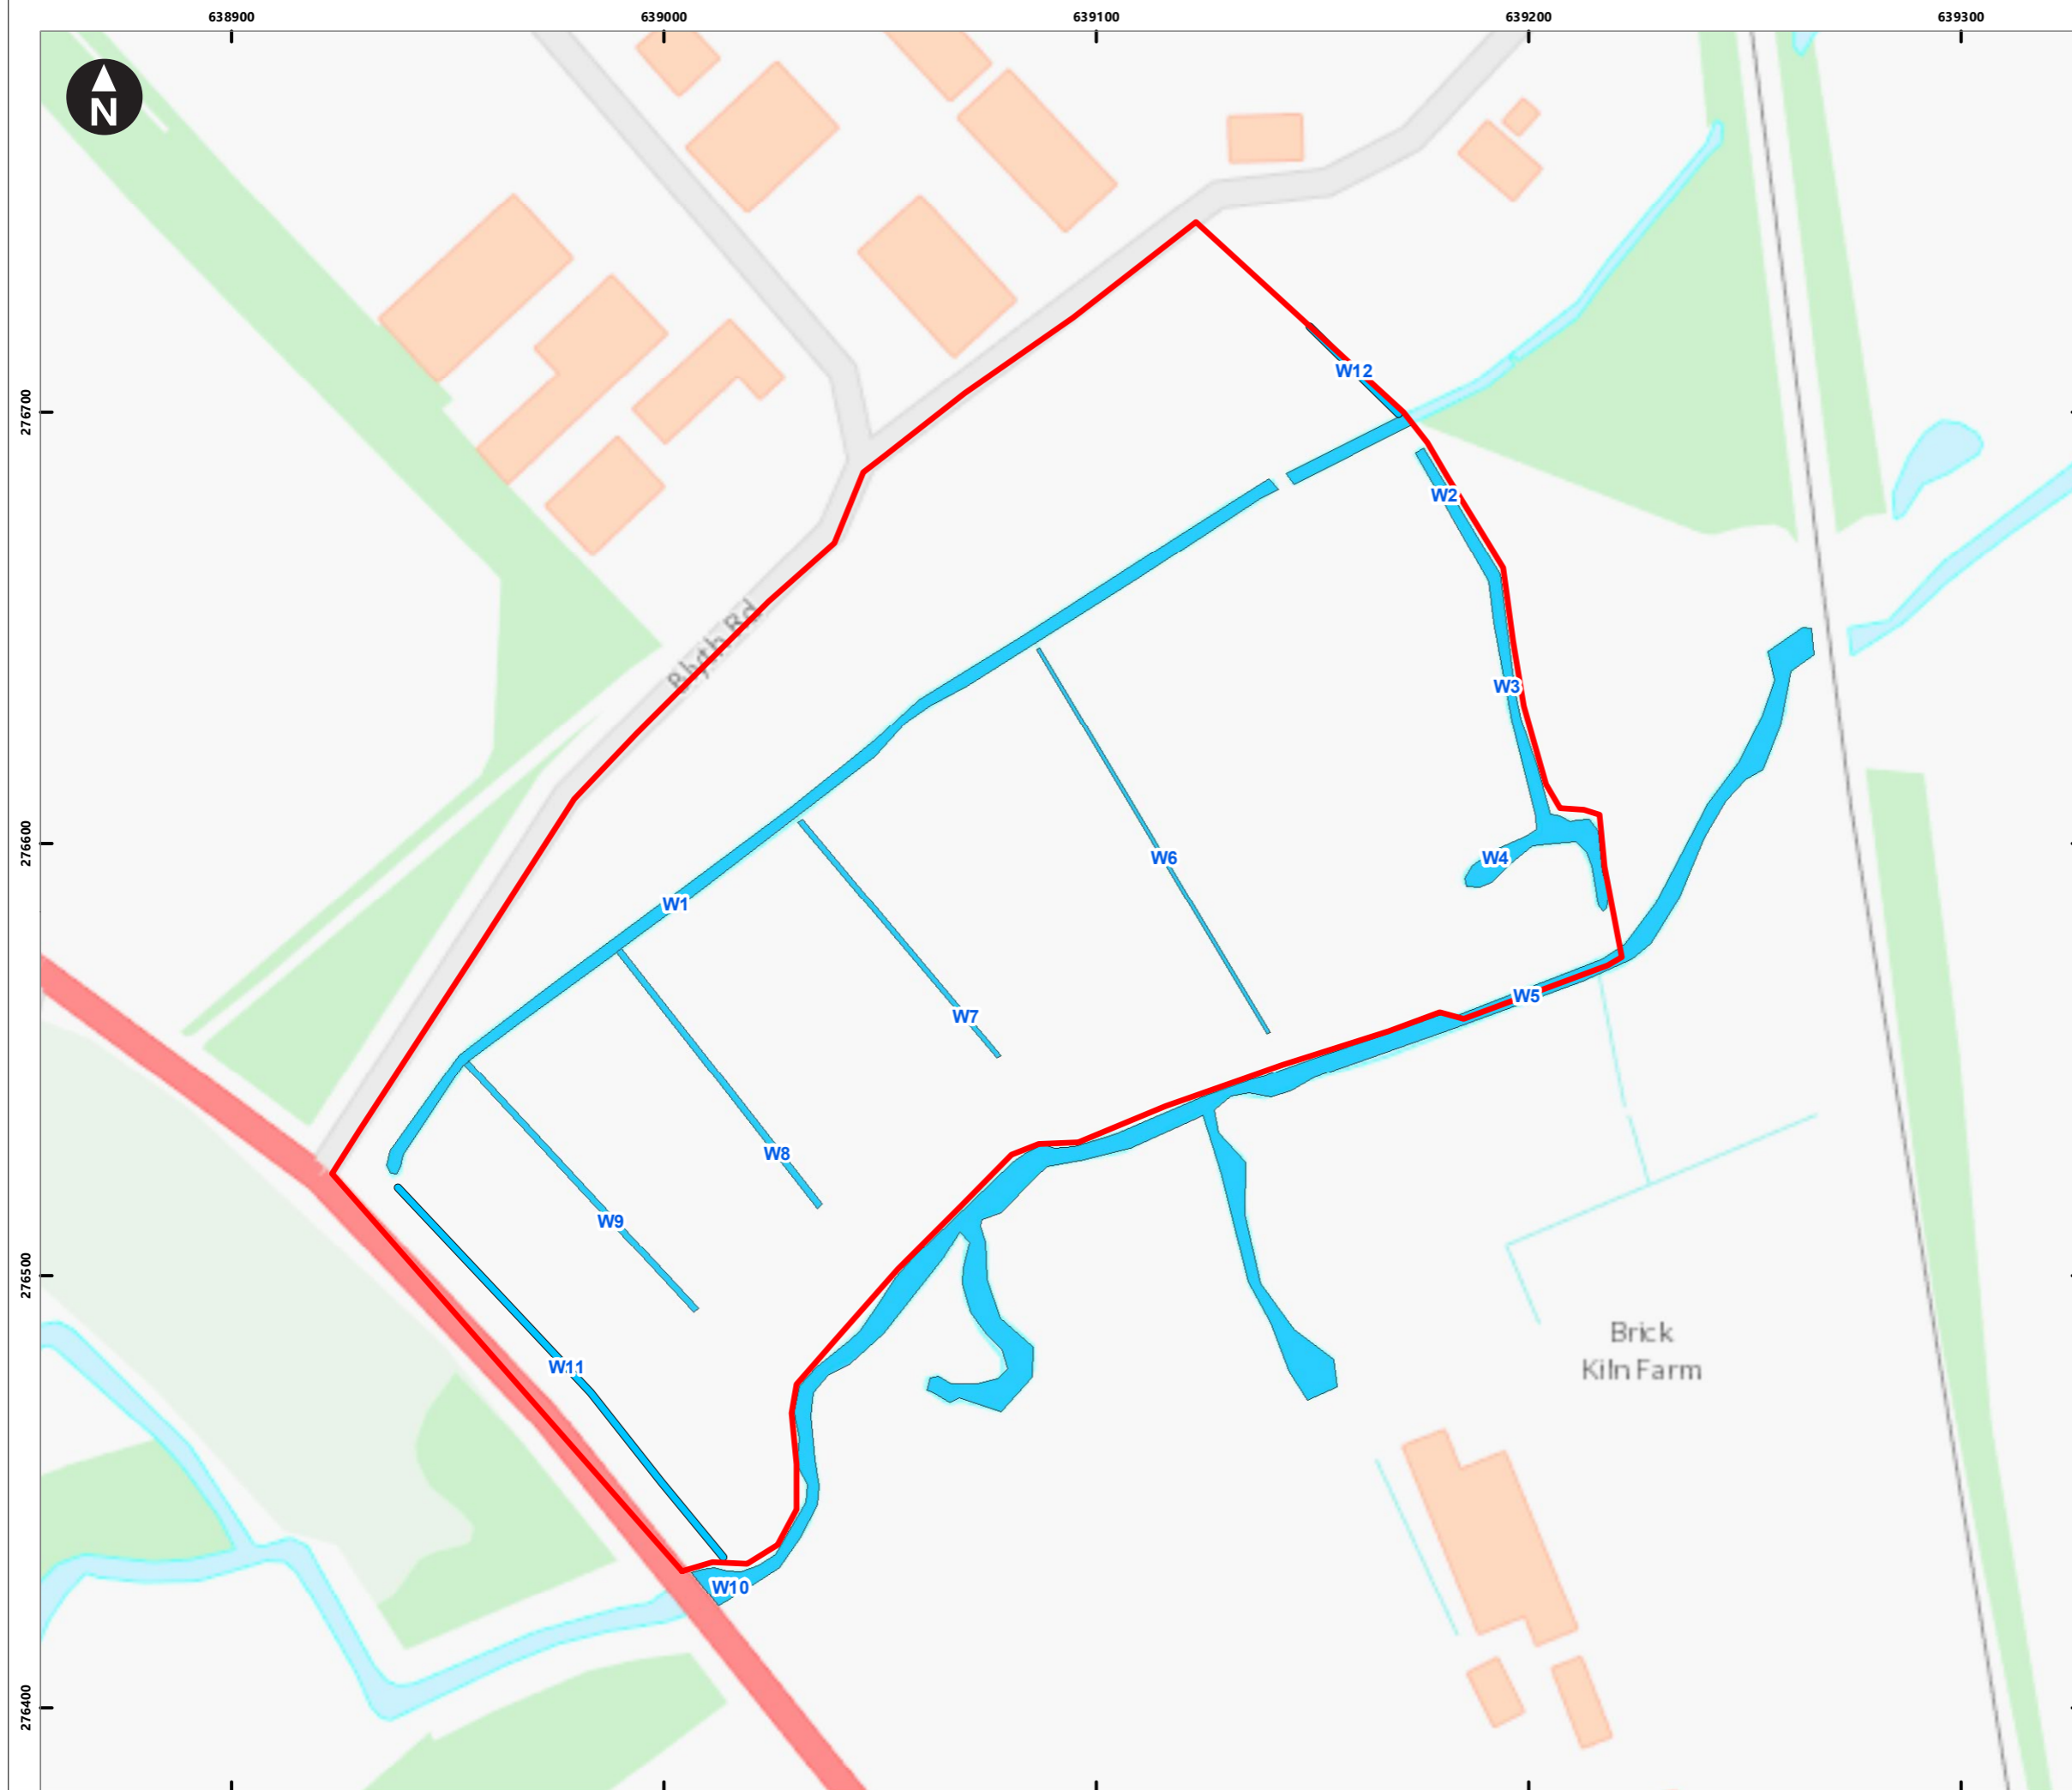
**Figure 3.2**  
**Hydrology - rain and flow gauges, rivers, ponds**

- Site 28 boundary
- Water
- W1 Ditch number

Daily rainfall data have been supplied by the EA for the nearest raingauge located at Benhall TBR c. 16 km north of the Site for the period 1991 to 2019 (see inset on Figure 3.2 for location). There are quite a few years with missing or suspect data but from the years with a full dataset the long-term average (LTA) rainfall is calculated to be 574 mm/a.

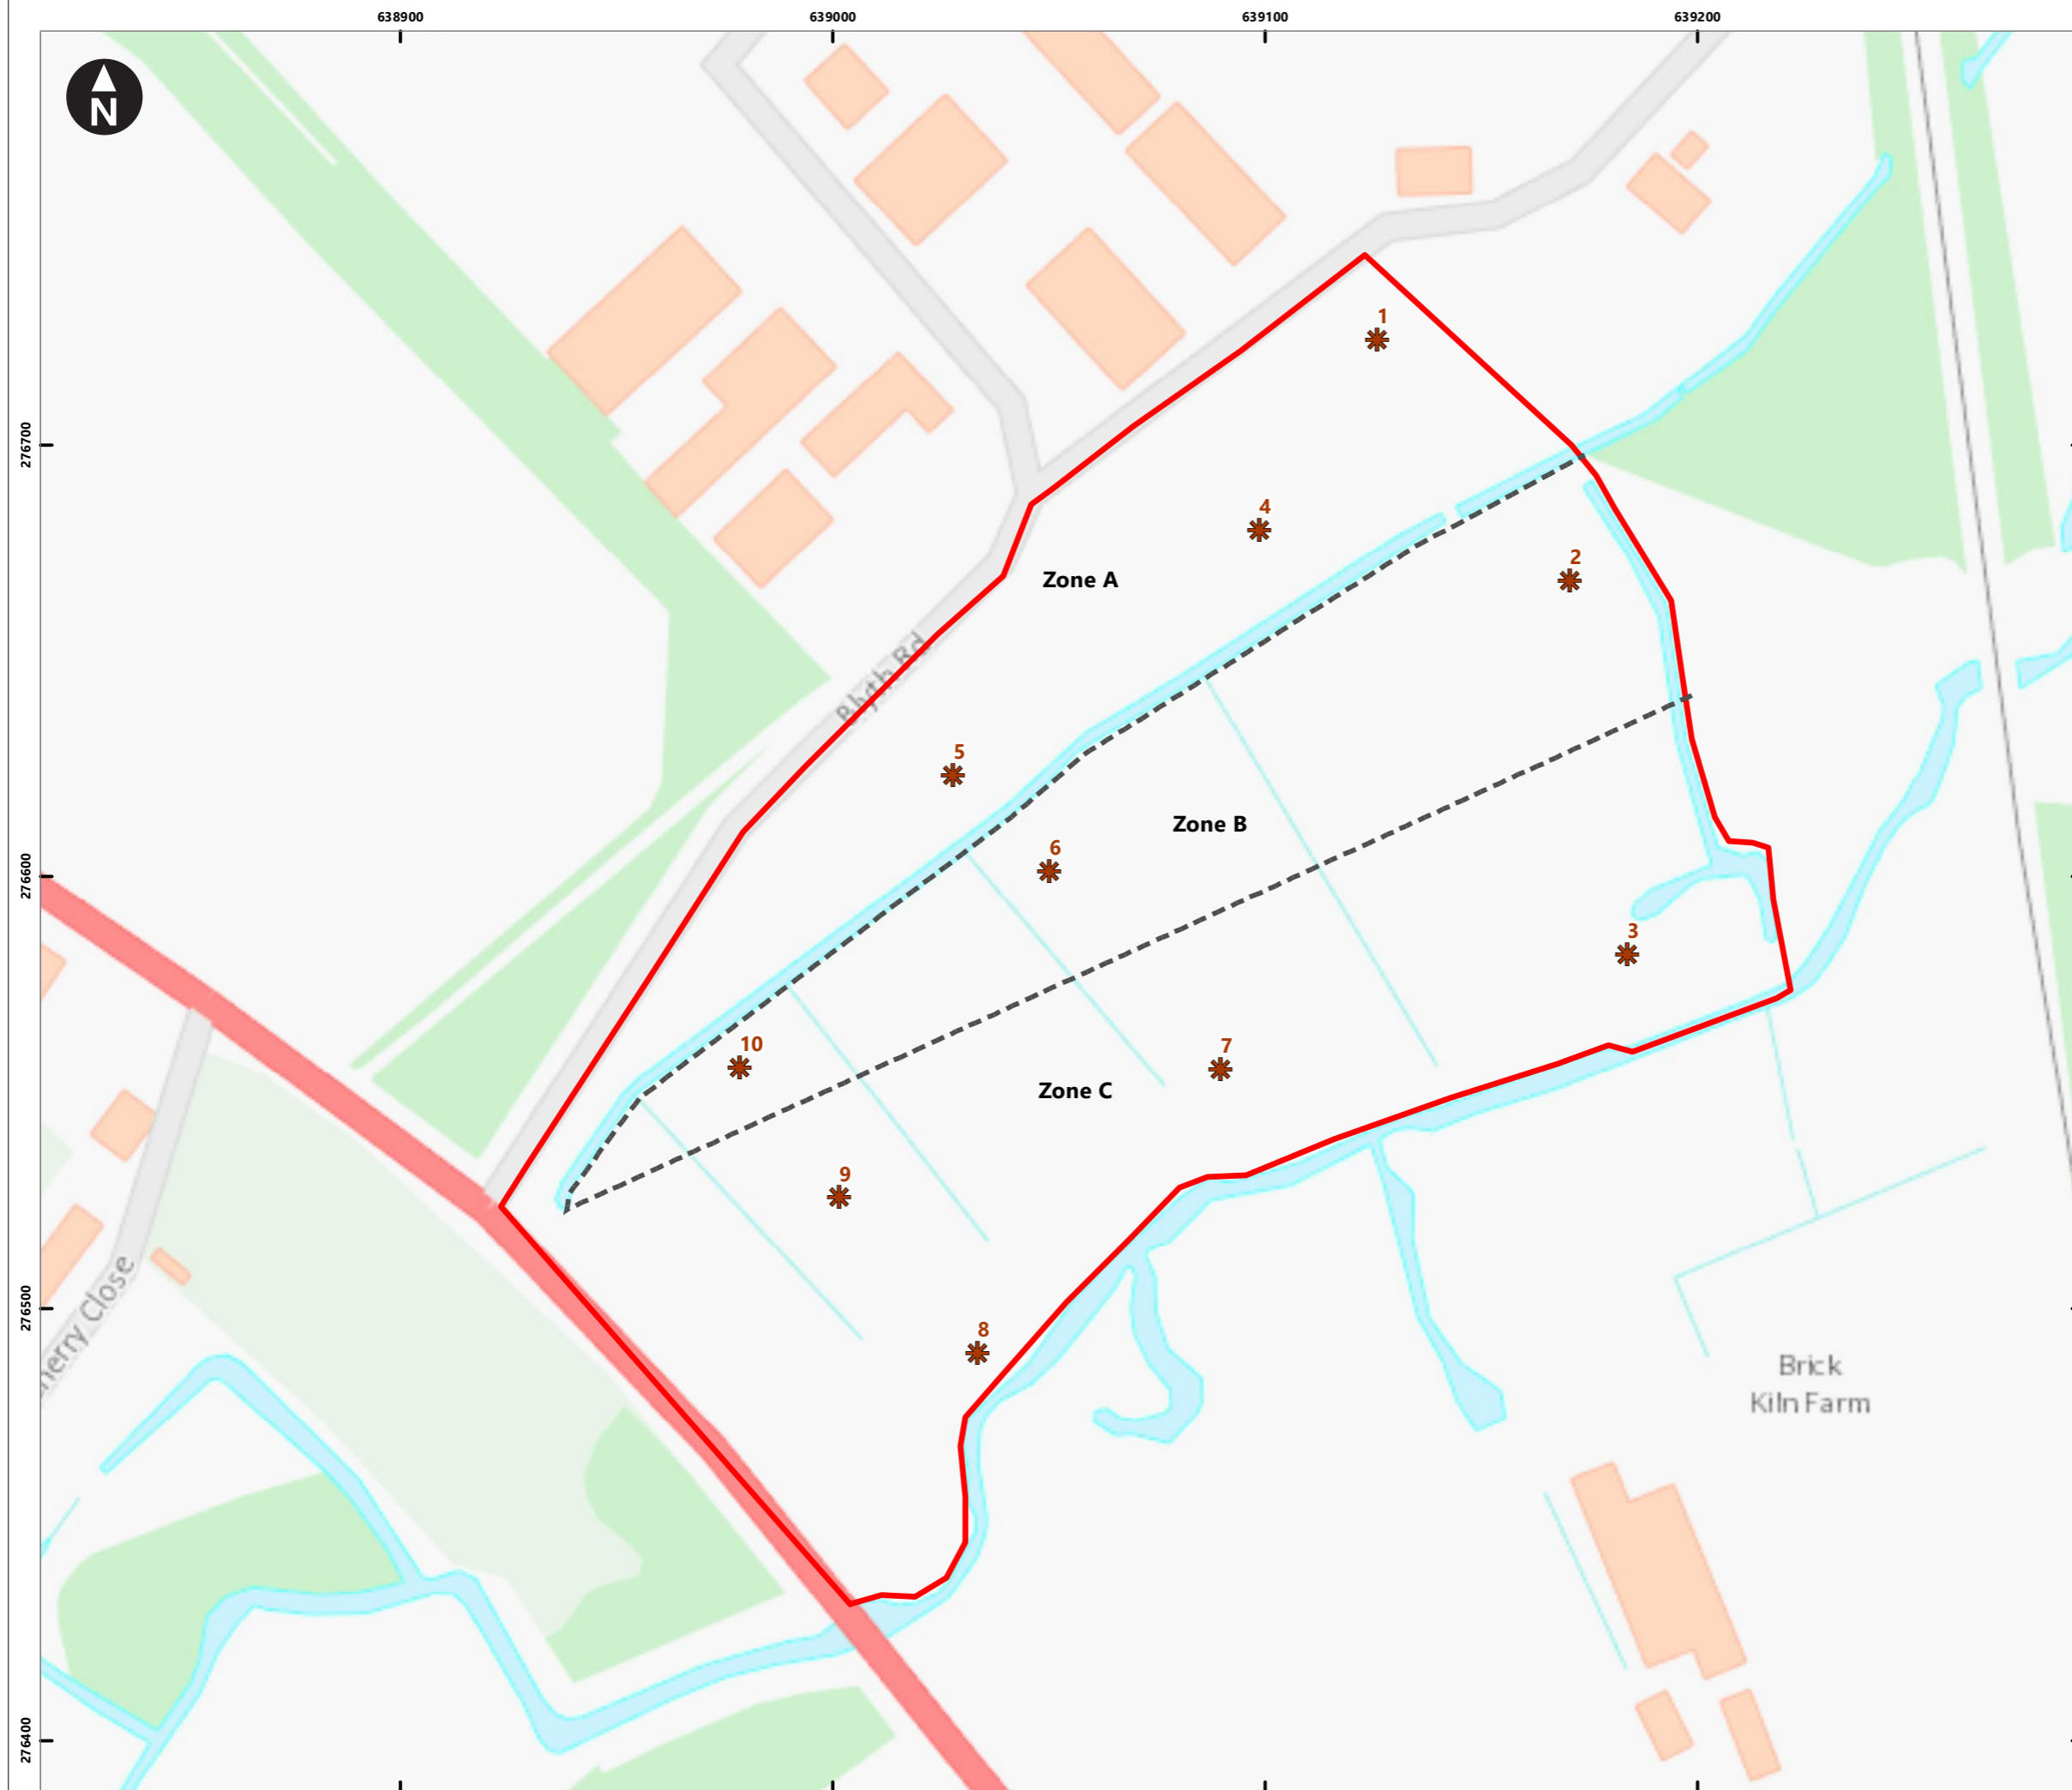
- Key
- Site 28 boundary
  - Zone boundary
  - ✱ Soil core sample location

Zone A represents the small area of upland in the northeast corner of the Site, and the fringes of the floodplain where the upland sediments are near the ground surface. Manganiferous streaks (in cores 1 and 4) provide evidence for the depth in each core where the water table has typically fluctuated; the streaks are also associated with evidence for periodic wetting and drying where ferrous iron has been mobilised within a high water table and precipitated out as ferric (rust-coloured) iron in soil voids when the water table falls. The occurrence of streaks, in particular, is evidence for relatively high groundwater levels along the valley margin. Core 5, on the margin of this zone, confirms the relative dispositions of the floodplain sediments. In the past, groundwater seepage through the sands and freshwater river incursions have led to the development of reed-carr peats except along the valley edge. These have subsequently been buried by a layer of brackish clay. The subsequent deposition of a silt loam alluvium has also extended to the valley margin.

Zone C covers much of the floodplain and demonstrates that the silt-clay-peat sequence is widespread. Cores 7 and 9 lack the peaty top found in Zone B but are otherwise similar; Core 8 demonstrates that the peat thins in the southwest and overlies sand, while Core 3 records a local deposit of dark-grey (probably sulphidic) silty clay beneath the spread of silt clay recorded across the floodplain.

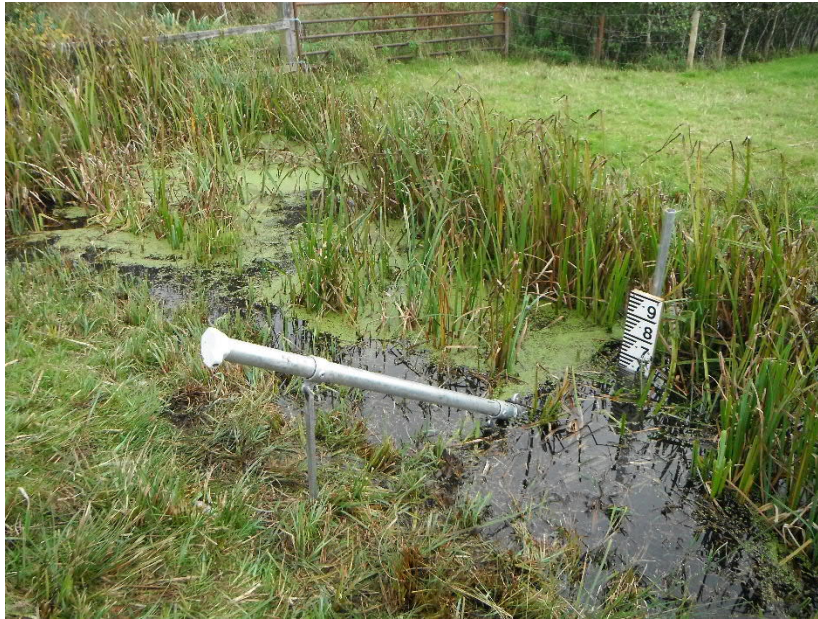
## SITE 28 HALESWORTH – HAL-GB01

<b>Installation Name:</b> HAL-GB01		
<b>Equipment Installed:</b> OTT Orpheus Mini - OM-453494	<b>Logging Interval:</b> 15 minutes	<b>OS Grid Reference:</b> TM 39161 76703
<b>Datum Level:</b> Awaiting Survey	<b>Datum:</b> Base of Gaugeboard	<b>Gaugeboard Length:</b> 1m

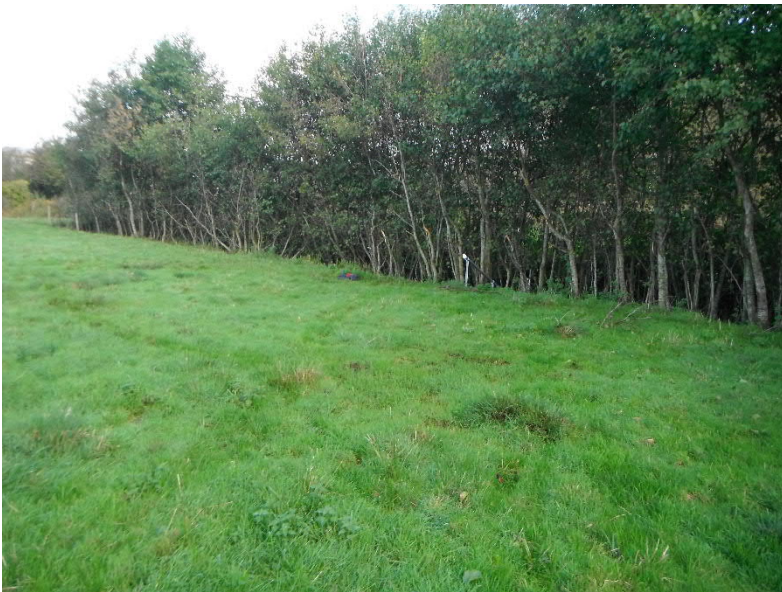
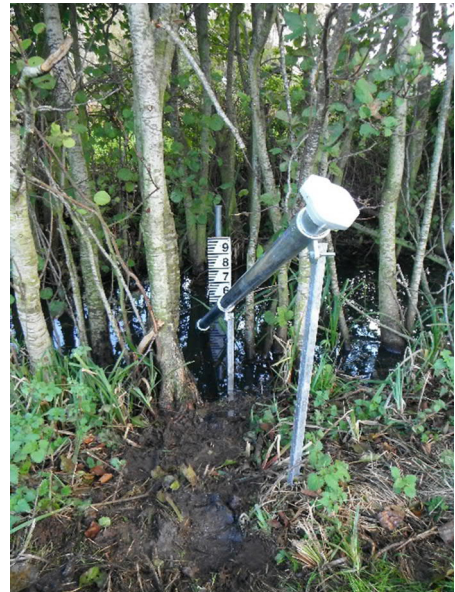
## SITE 28 HALESWORTH – HAL-GB02

<b>Installation Name:</b> HAL-GB02		
<b>Equipment Installed:</b> OTT Orpheus Mini - OM-453491	<b>Logging Interval:</b> 15 minutes	<b>OS Grid Reference:</b> TM 39185 76674
<b>Datum Level:</b> Awaiting Survey	<b>Datum:</b> Base of Gaugeboard	<b>Gaugeboard Length:</b> 1m

**Installation Notes:** Deep sediment.

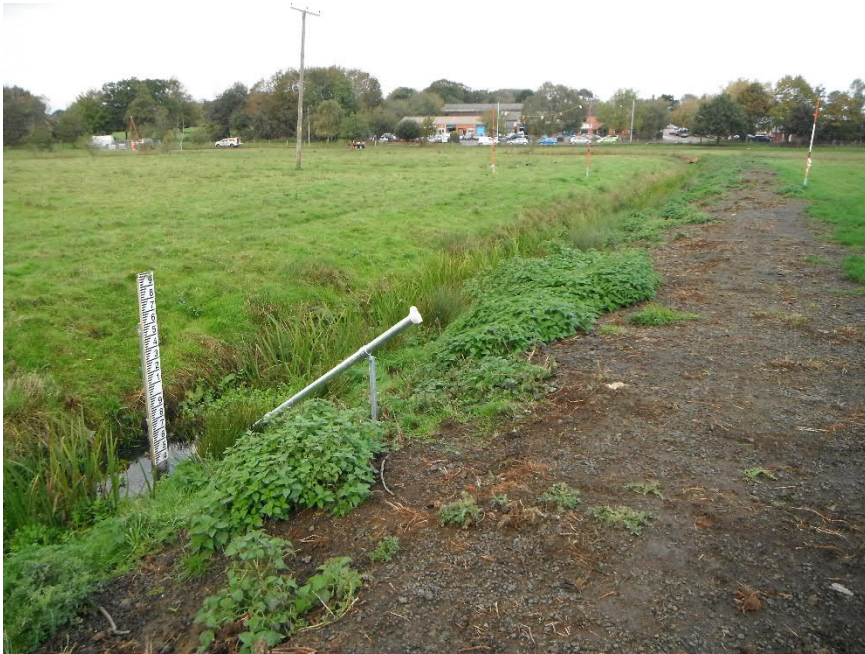
## SITE 28 HALESWORTH – HAL-GB03

<b>Installation Name:</b> HAL-GB03		
<b>Equipment Installed:</b> OTT Orpheus Mini - OM-453497	<b>Logging Interval:</b> 15 minutes	<b>OS Grid Reference:</b> TM 39132 76581
<b>Datum Level:</b> Awaiting Survey	<b>Datum:</b> Base of Gaugeboard	<b>Gaugeboard Length:</b> 2m

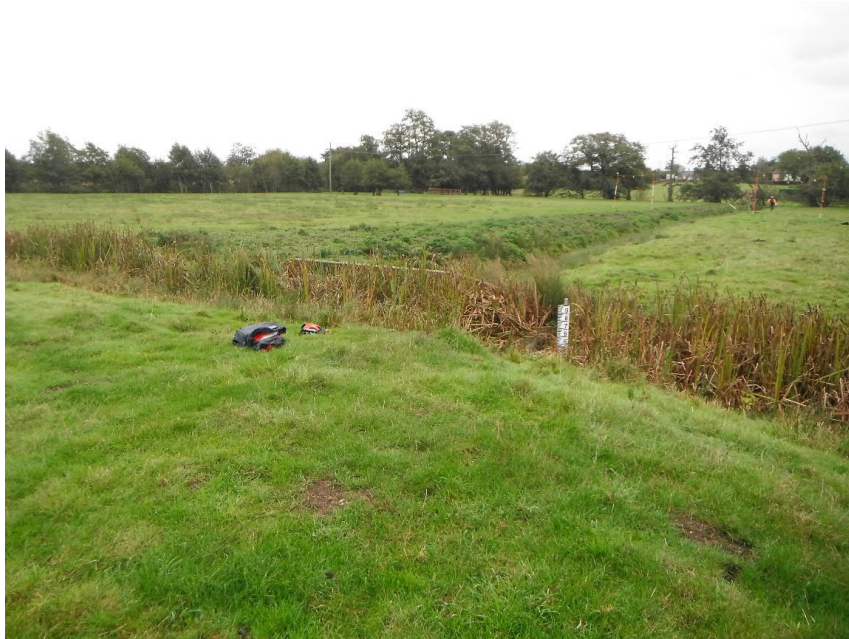
## SITE 28 HALESWORTH – HAL-GB04

<b>Installation Name:</b> HAL-GB04		
<b>Equipment Installed:</b> N/A	<b>Logging Interval:</b> N/A	<b>OS Grid Reference:</b> TM 39080 76655
<b>Datum Level:</b> Awaiting Survey	<b>Datum:</b> Base of Gaugeboard	<b>Gaugeboard Length:</b> 1m

**Installation Notes:** Not logged.

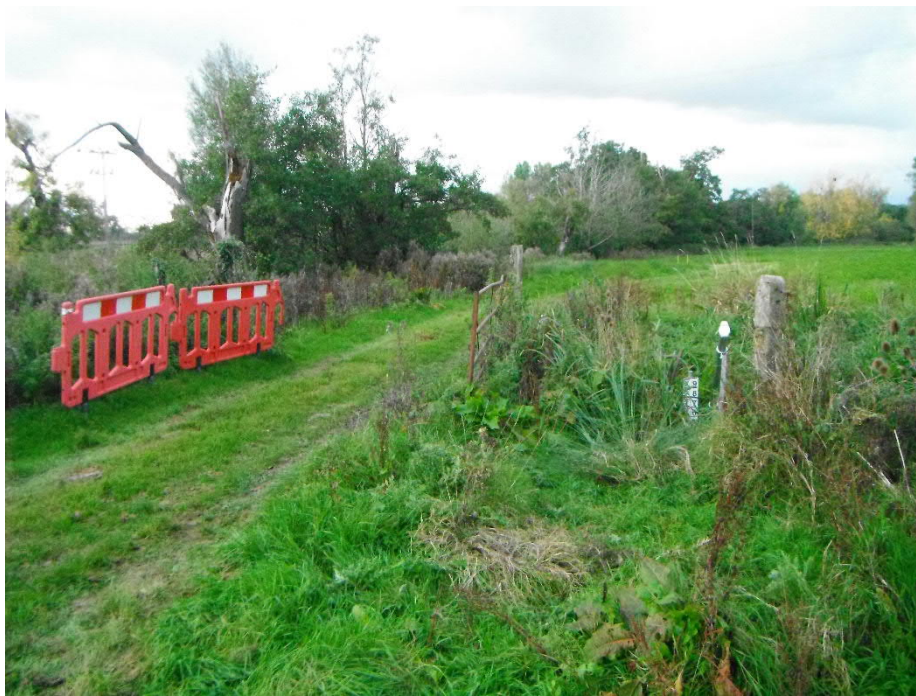
## SITES 10/11 SNAPE – SNP-GB01

<b>Installation Name:</b> SNP-GB01		
<b>Equipment Installed:</b> OTT Orpheus Mini - OM-453493	<b>Logging Interval:</b> 15 minutes	<b>OS Grid Reference:</b> TM 38130 60235
<b>Datum Level:</b> Awaiting Survey	<b>Datum:</b> Base of Gaugeboard	<b>Gaugeboard Length:</b> 1m

**Installation Notes:** Watch barbed wire at ankle level.

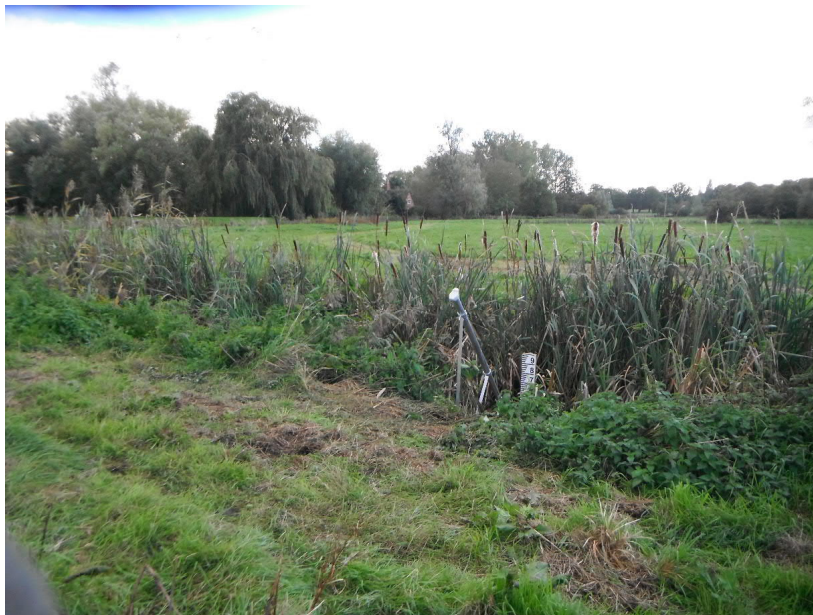
## SITES 10/11 SNAPE – SNP-GB02

<b>Installation Name:</b> SNP-GB02		
<b>Equipment Installed:</b> OTT Orpheus Mini - OM-453492	<b>Logging Interval:</b> 15 minutes	<b>OS Grid Reference:</b> TM 38249 60509
<b>Datum Level:</b> Awaiting Survey	<b>Datum:</b> Base of Gaugeboard	<b>Gaugeboard Length:</b> 1m

**Installation Notes:** Deep ditch.

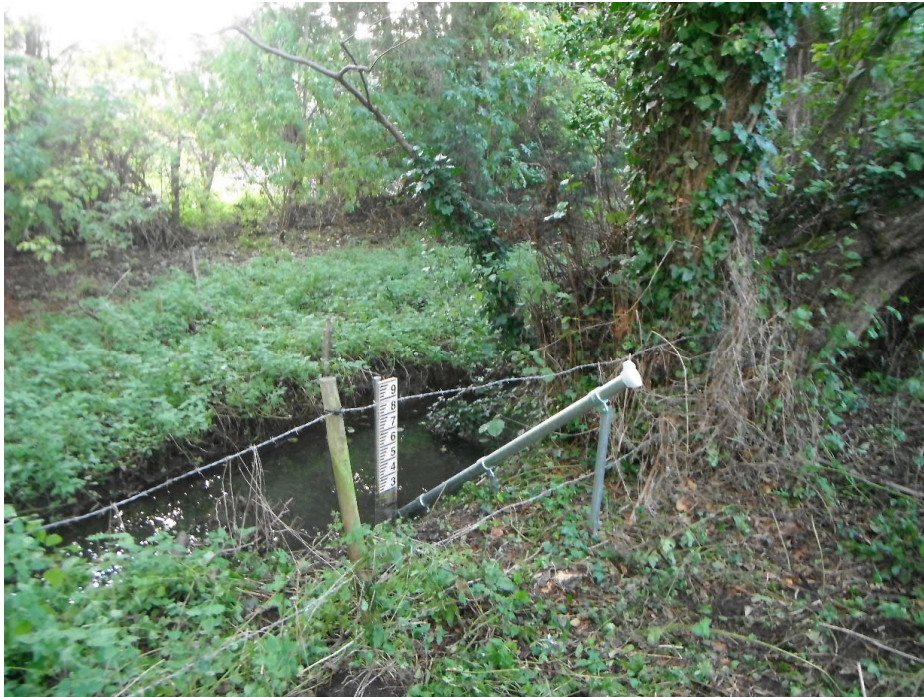
## SITES 10/11 SNAPE – SNP-GB03

<b>Installation Name:</b> SNP-GB03		
<b>Equipment Installed:</b> OTT Orpheus Mini - OM-453498	<b>Logging Interval:</b> 15 minutes	<b>OS Grid Reference:</b> TM 38207 60658
<b>Datum Level:</b> Awaiting Survey	<b>Datum:</b> Base of Gaugeboard	<b>Gaugeboard Length:</b> 1m

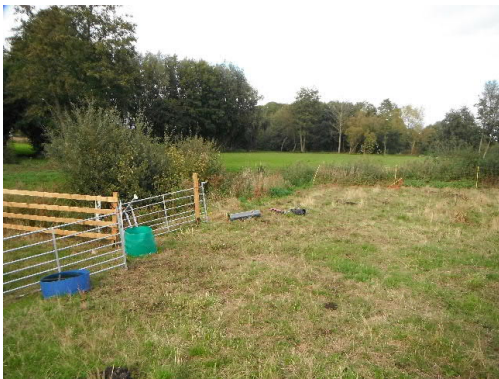
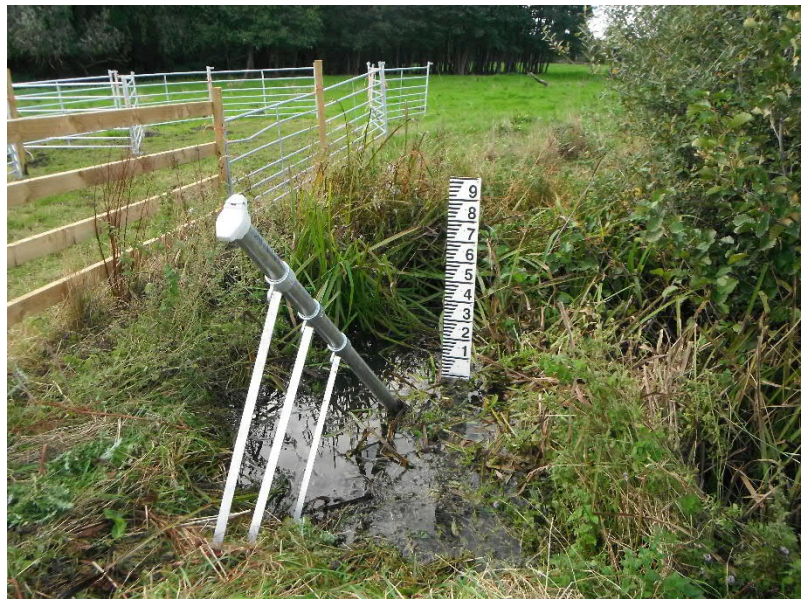
## SITES 10/11 SNAPE – SNP-GB04

<b>Installation Name:</b> SNP-GB04		
<b>Equipment Installed:</b> OTT Orpheus Mini - OM-453495	<b>Logging Interval:</b> 15 minutes	<b>OS Grid Reference:</b> TM 38350 60725
<b>Datum Level:</b> Awaiting Survey	<b>Datum:</b> Base of Gaugeboard	<b>Gaugeboard Length:</b> 2m

**Installation Notes:** Moved due to Water Voles at original location. Very deep water.

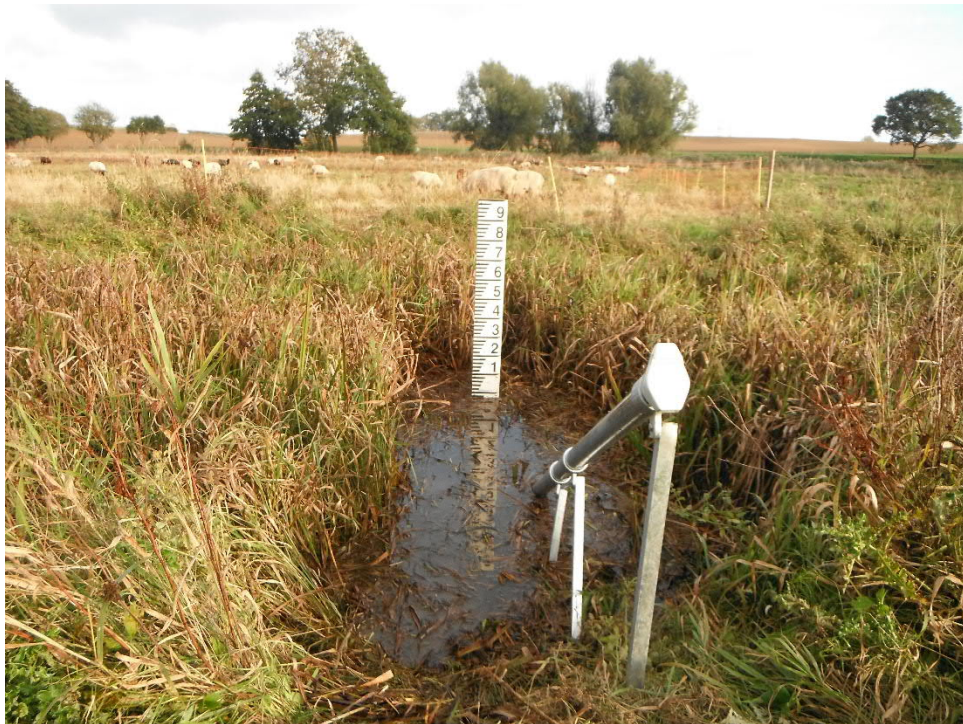
## SITES 10/11 SNAPE – SNP-GB05

<b>Installation Name:</b> SNP-GB05		
<b>Equipment Installed:</b> OTT Orpheus Mini - OM-453496	<b>Logging Interval:</b> 15 minutes	<b>OS Grid Reference:</b> TM 38300 60618
<b>Datum Level:</b> Awaiting Survey	<b>Datum:</b> Base of Gaugeboard	<b>Gaugeboard Length:</b> 2m

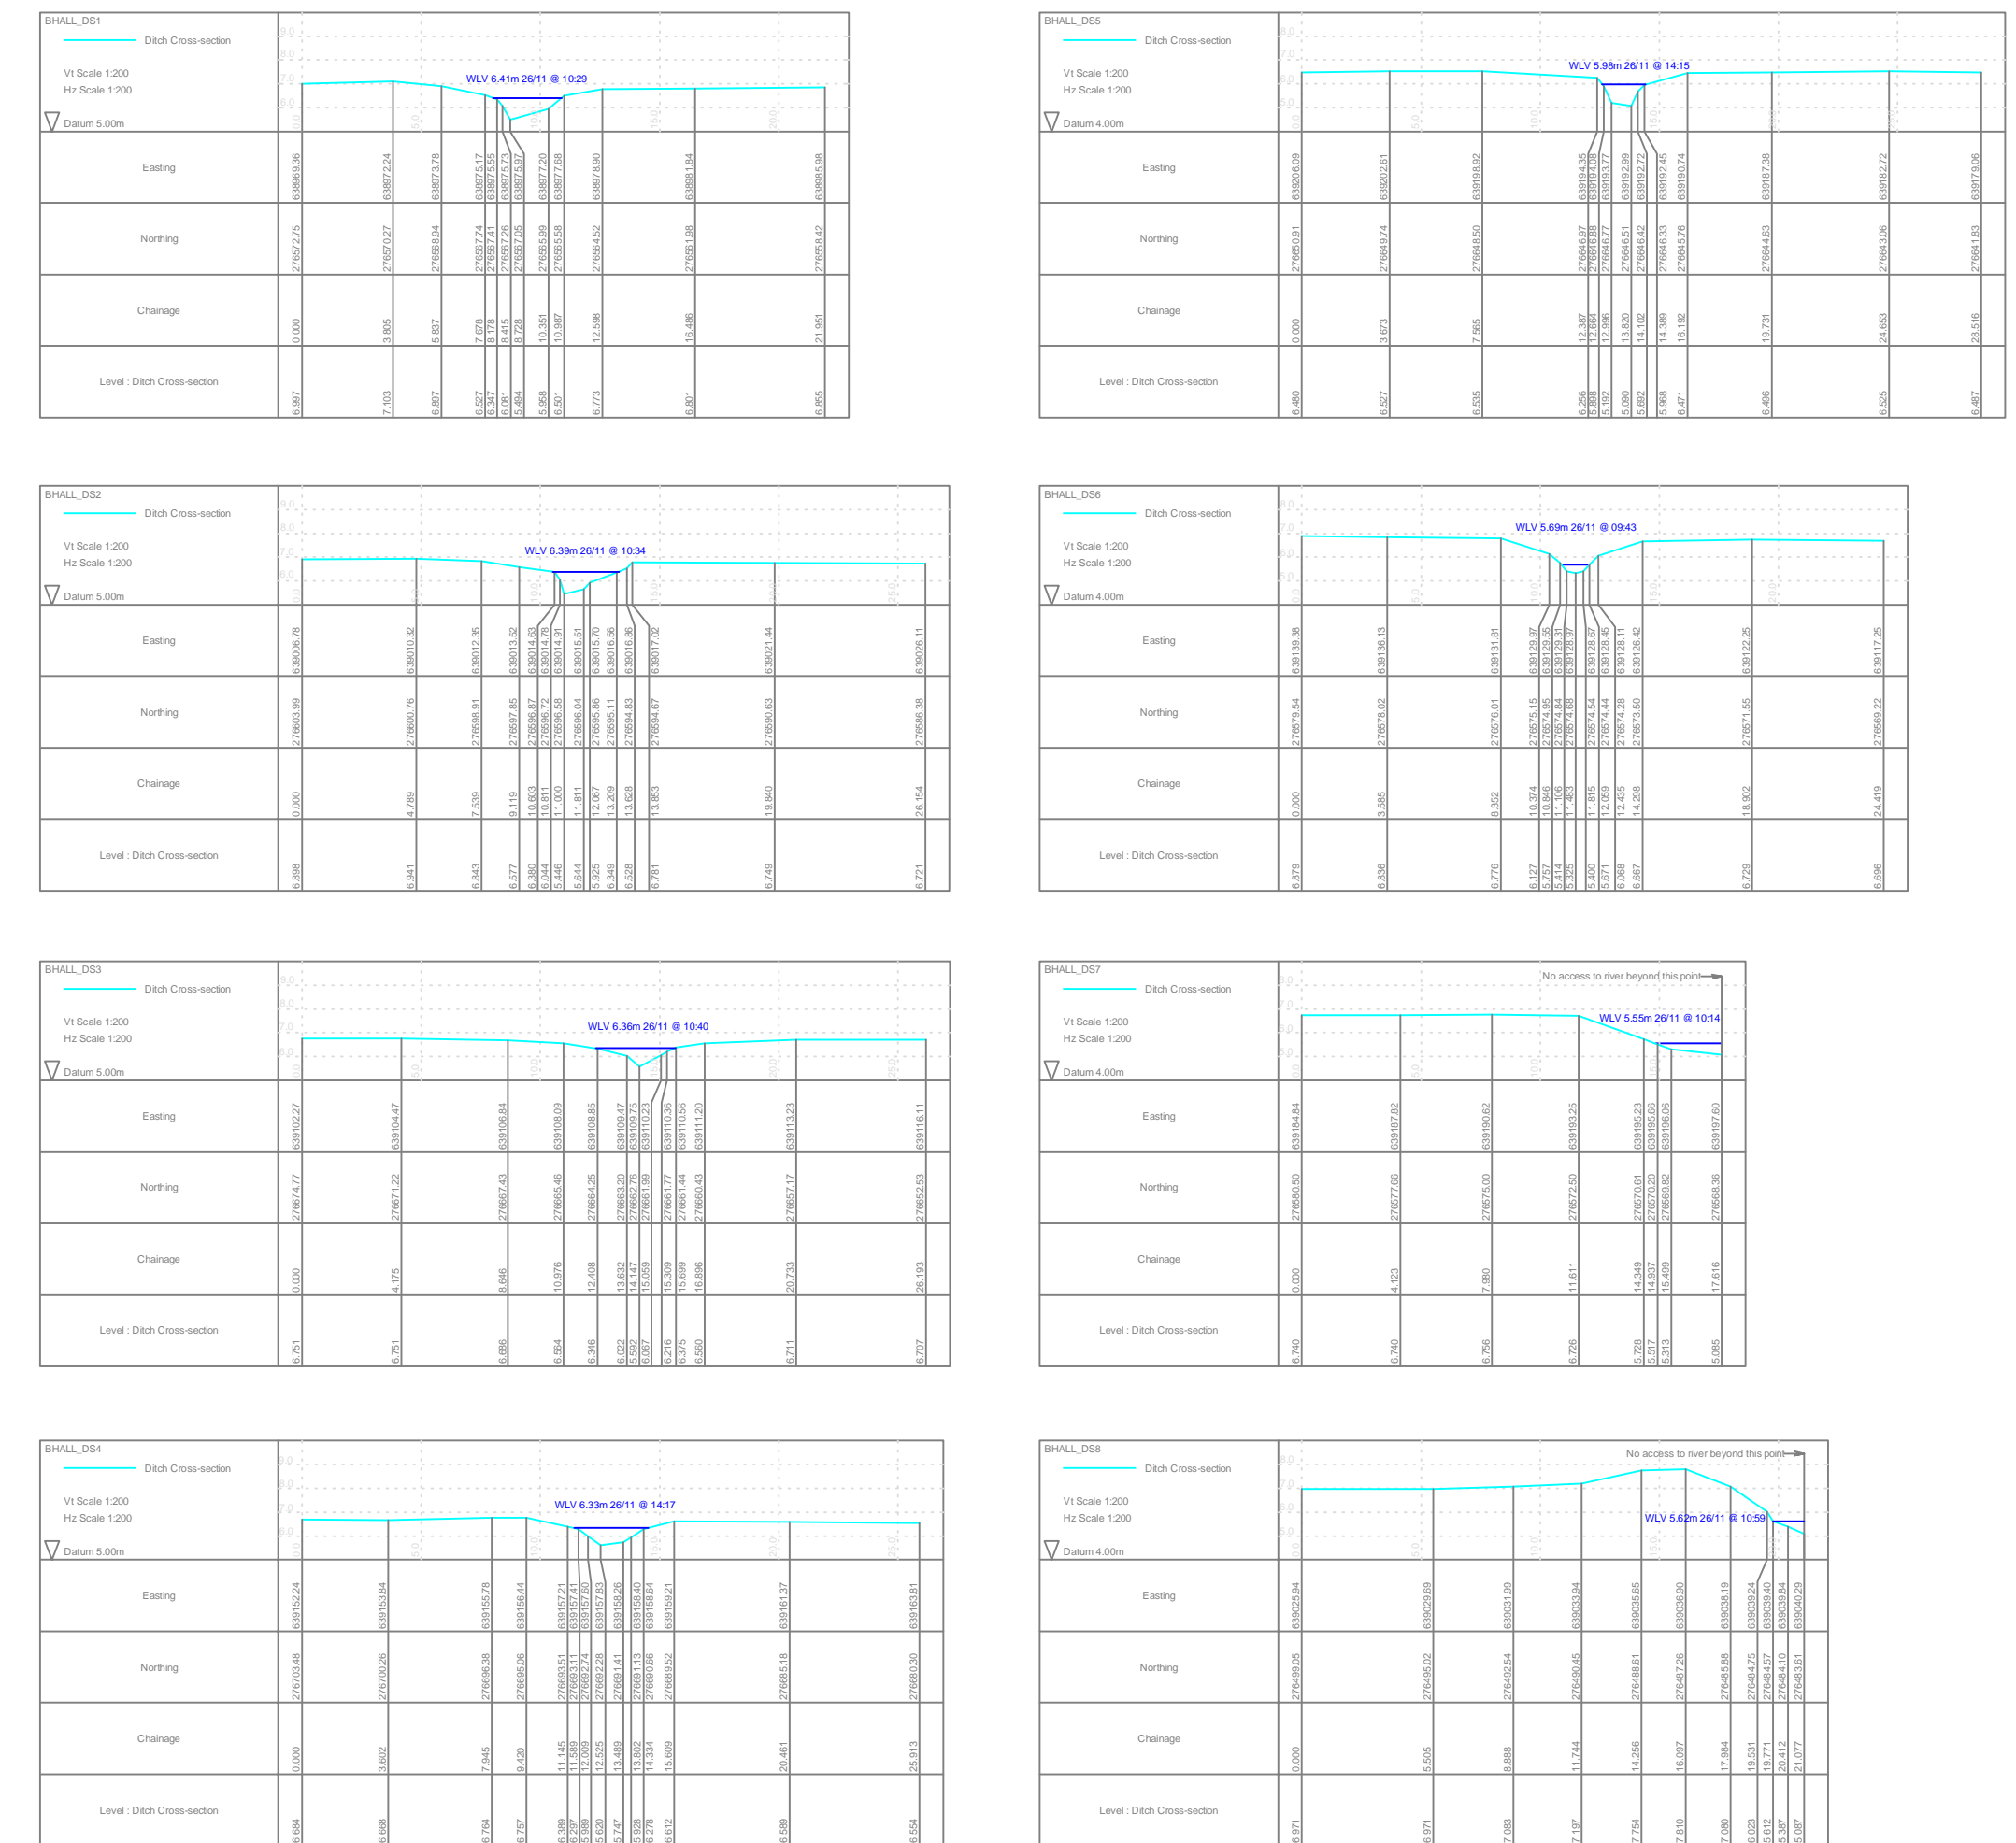
Ditch Cross-sections

Sizewell C Hydro Survey  
Site 28, Halesworth  
Transects and Sections

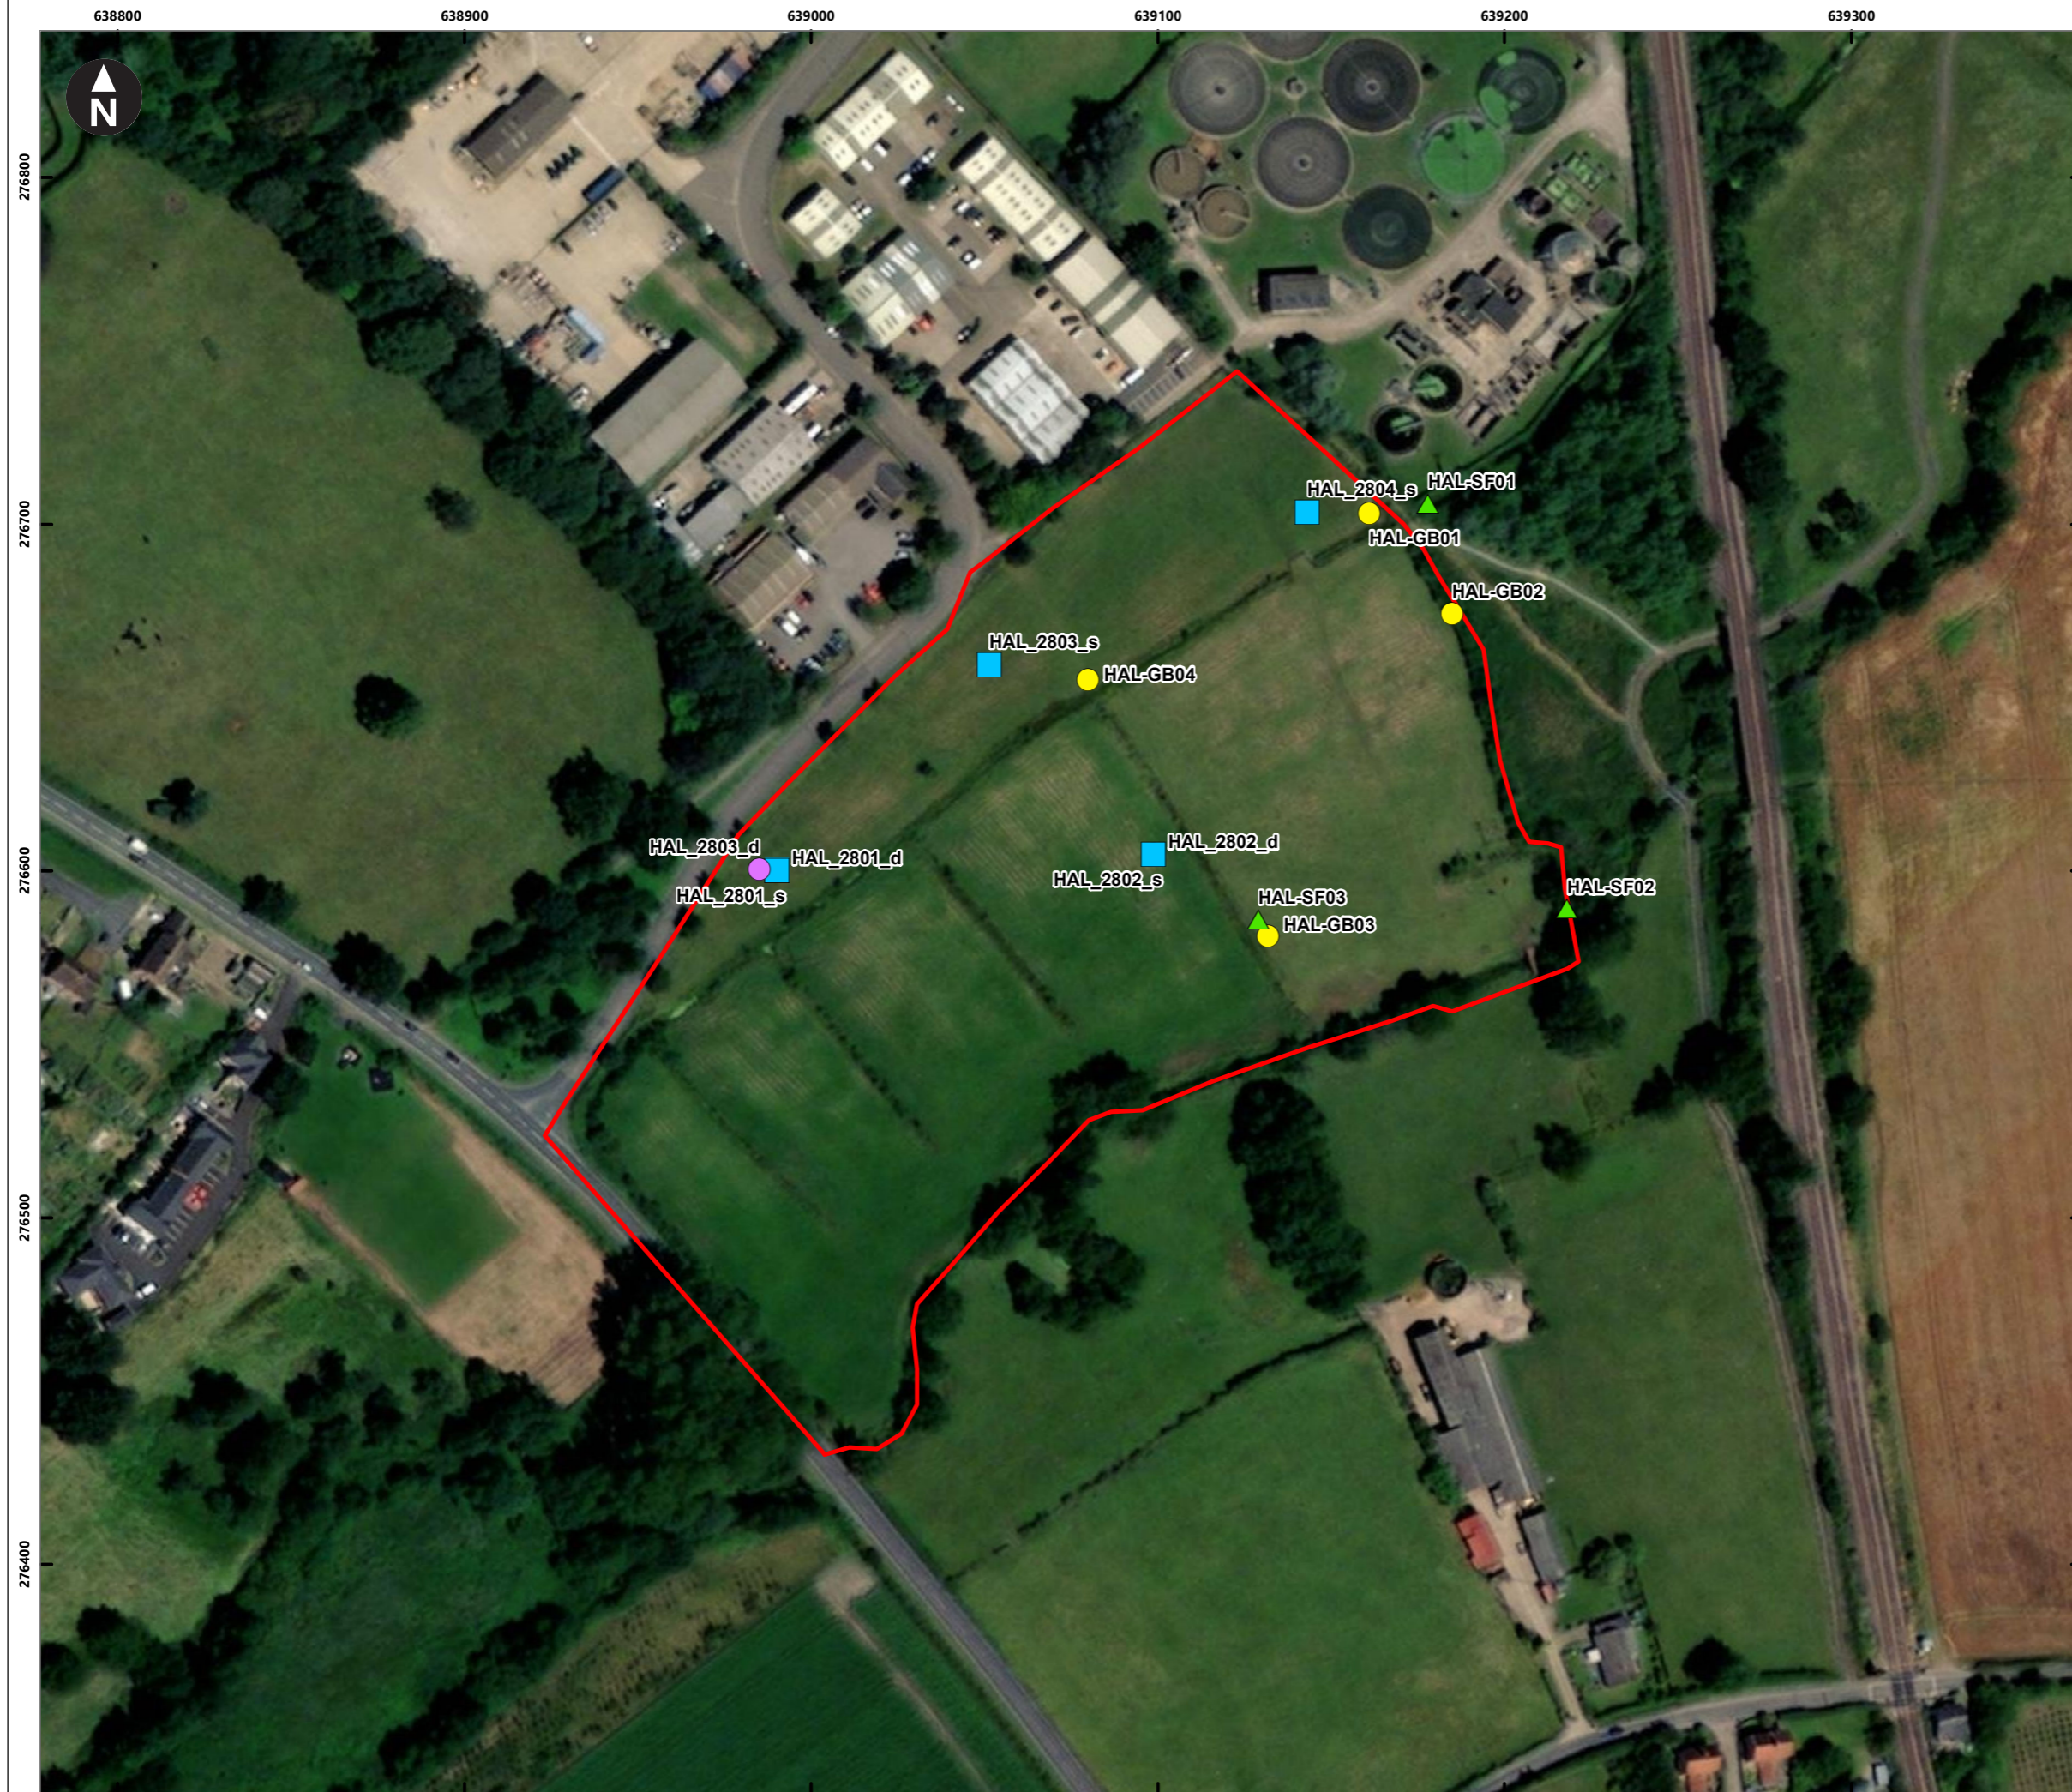
- Site boundary
- Gaugeboard
- Piezometer
- Dipwell
- ▲ Flow gauging

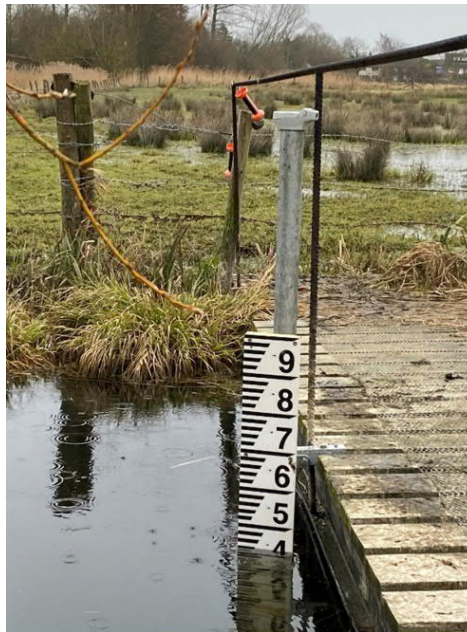
# PAKENHAM FEN – PAK-GB01

<b>Installation Name:</b> PAK-GB01		
<b>Equipment Installed:</b> OTT Orpheus Mini	<b>Logging Interval:</b> 15 minutes	<b>OS Grid Reference:</b> TL 93239 68817
<b>Datum Level:</b> 29.027mAOD	<b>Datum:</b> Base of Gaugeboard	<b>Gaugeboard Length:</b> 2m

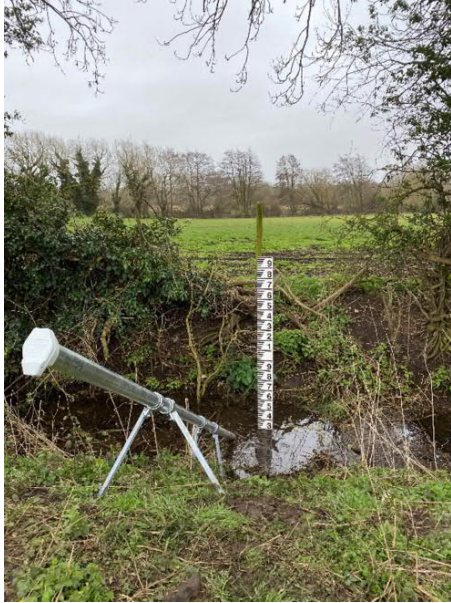
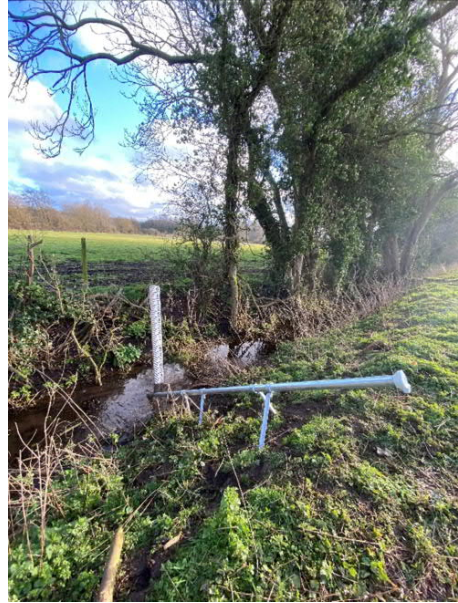
# PAKENHAM FEN – PAK-GB02

<b>Installation Name:</b> PAK-GB02		
<b>Equipment Installed:</b> OTT Orpheus Mini	<b>Logging Interval:</b> 15 minutes	<b>OS Grid Reference:</b> TL 93064 68381
<b>Datum Level:</b> 31.2mAOD	<b>Datum:</b> Base of Gaugeboard	<b>Gaugeboard Length:</b> 2m

**Installation Notes:** Stilling well secured to channel bank.
