# The Sizewell C Project

## 9.34 Fen Meadow Plan Report - Baseline Report Part 2 of 2

## Fen Meadow Plan Report 1 – Baseline Report

APPENDIX F: HALESWORTH SITE 28 - BASELINE HYDROGEOLOGICAL REPORT

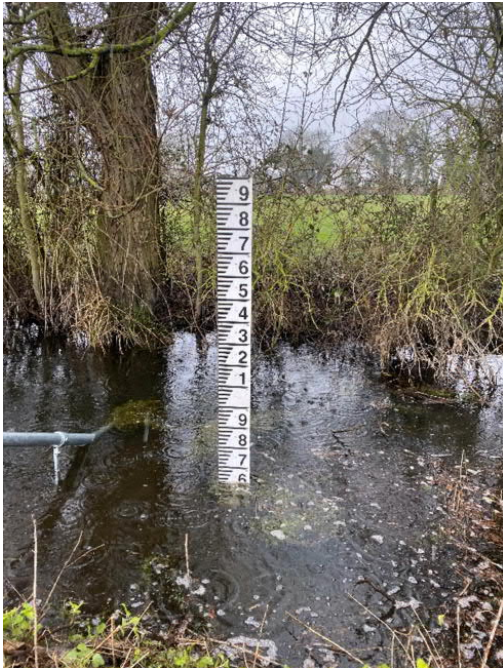
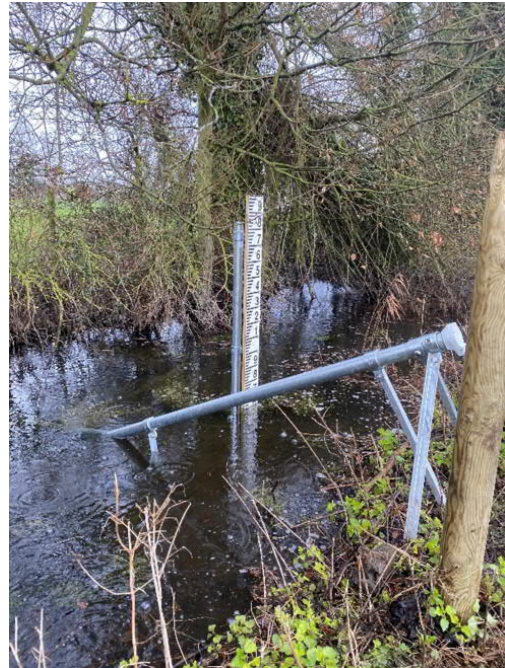
# PAKENHAM FEN – PAK-GB03

<b>Installation Name:</b> PAK-GB03		
<b>Equipment Installed:</b> OTT Orpheus Mini	<b>Logging Interval:</b> 15 minutes	<b>OS Grid Reference:</b> TL 93175 68400
<b>Datum Level:</b> 29.917mAOD	<b>Datum:</b> Base of Gaugeboard	<b>Gaugeboard Length:</b> 2m

**Installation Notes:** Deep water, silty bed.

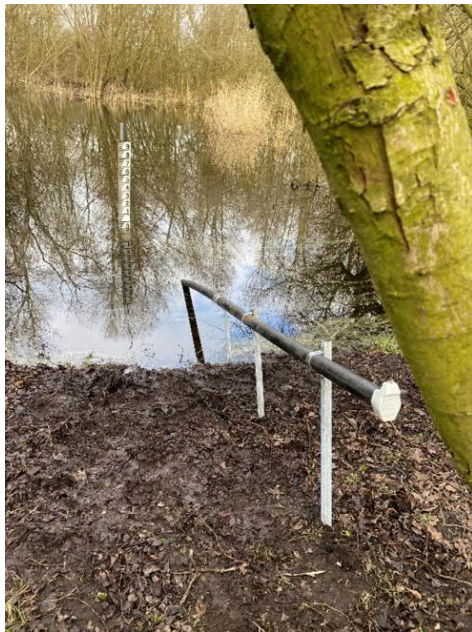
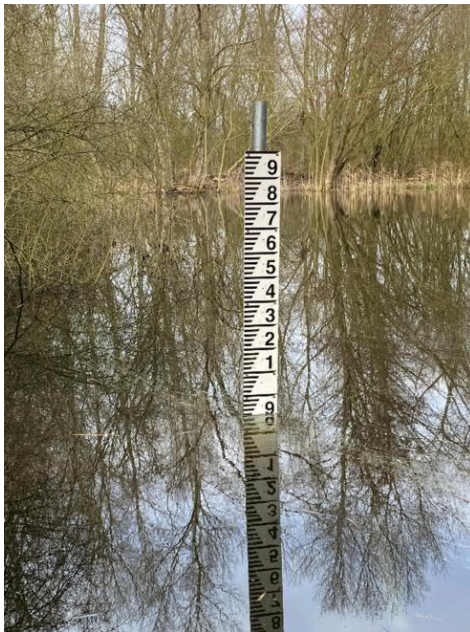
# PAKENHAM FEN – PAK-GB04

<b>Installation Name:</b> PAK-GB04		
<b>Equipment Installed:</b> OTT Orpheus Mini	<b>Logging Interval:</b> 15 minutes	<b>OS Grid Reference:</b> TL 92873 67891
<b>Datum Level:</b> 31.084mAOD	<b>Datum:</b> Base of Gaugeboard	<b>Gaugeboard Length:</b> 2m

**Installation Notes:** 8.5m stilling well secured into the bank.

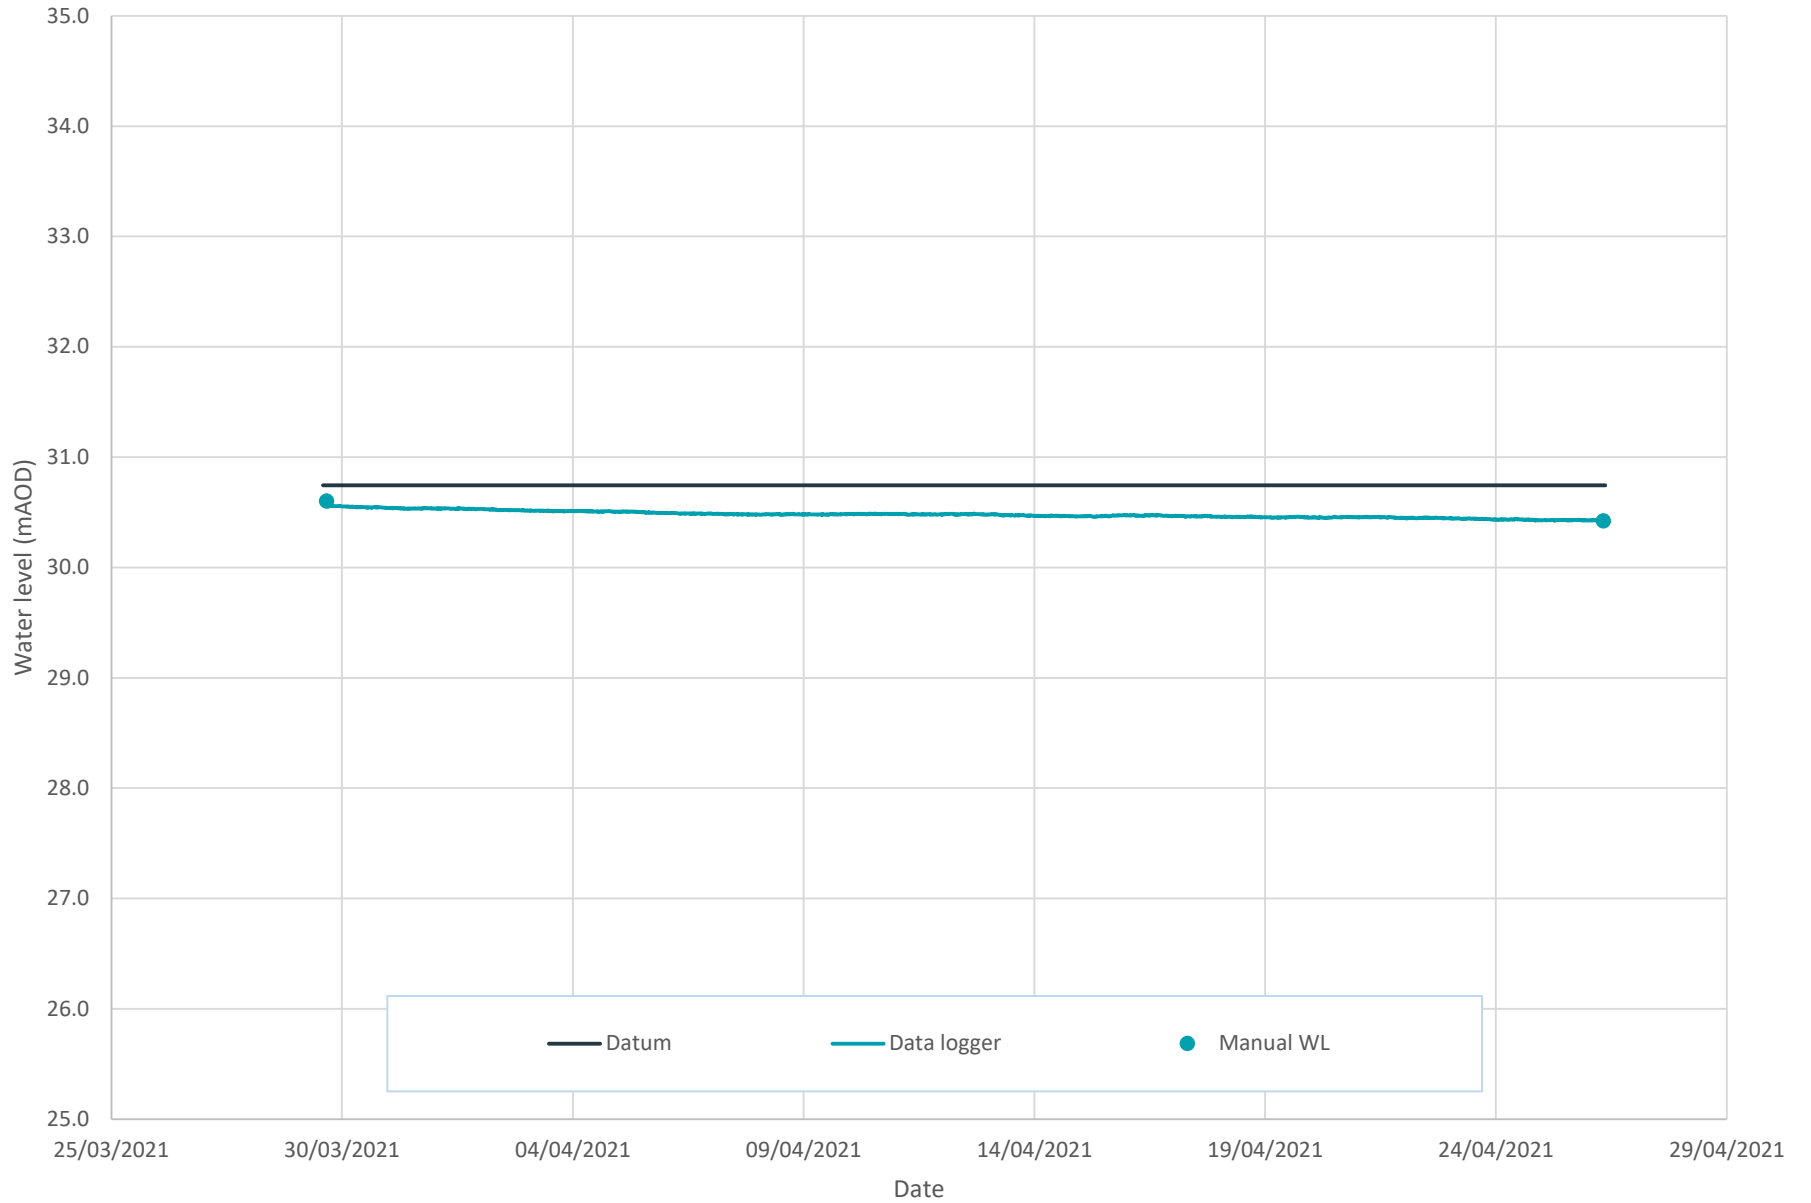
# PAK-HA-6 Hydrograph

Note: negative m bgl value indicates positive hydrostatic pressure
