**References
to
Deadline 3 Submissions

**Application by NNB Generation Company (SZC) Limited for an Order
Granting Development Consent for
The Sizewell C Project**

Recovering the Little Tern colony at Chesil Beach, Dorset

Assessing the dynamics of vegetated shingle Hurst Spit case study 2013-2017.

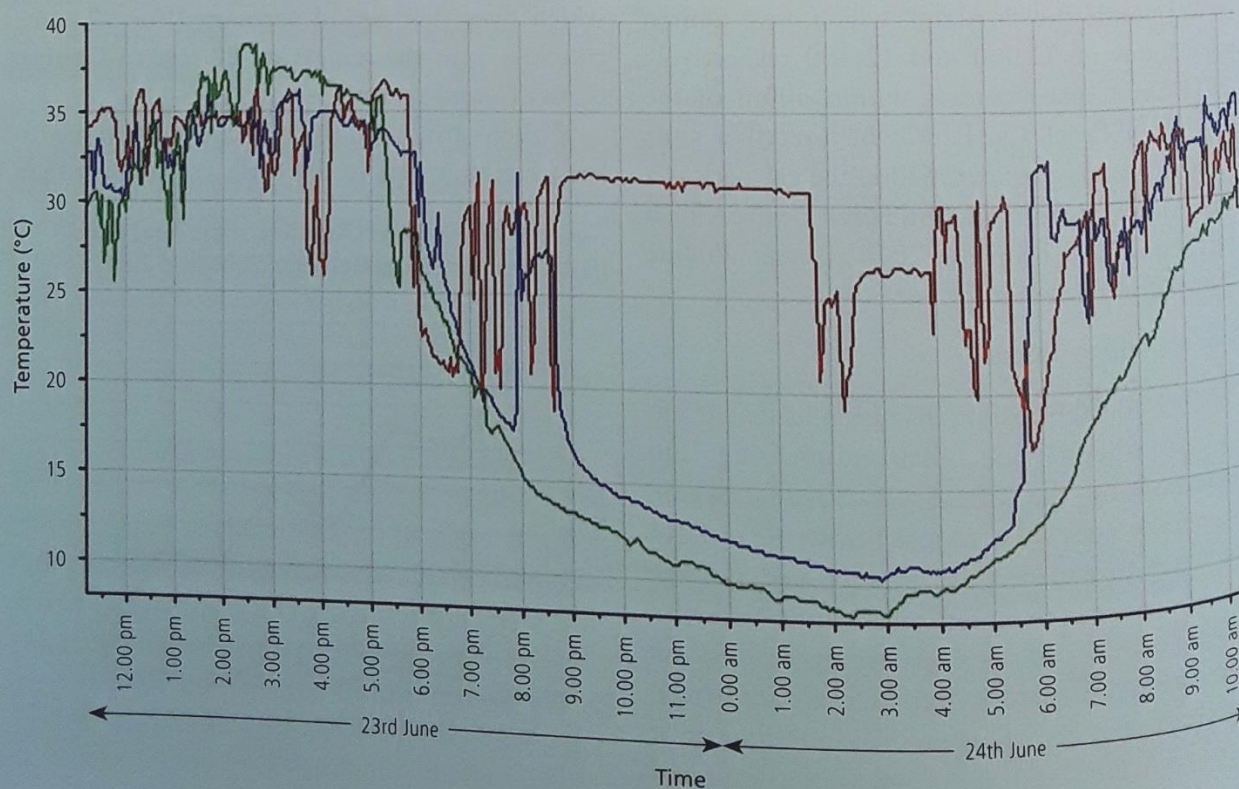
Figure 2. Data-logger graph showing temperature traces of two nests (blue and red) against the ambient temperature (green) on the night of 23rd June and the morning of 24th June 2001.

Of all monitored incubation attempts by the Little Terns in nine seasons during 2000–2008, 149 (33% of the total) failed to hatch. Nearly 6,000 hours of temperature data-logging carried out on 26 incubation attempts from 2000 to 2004 showed that some terns were leaving their eggs at night, its being assumed that they were being disturbed by Foxes. On 71 occasions terns returned to their nests within the hour, but in 60 instances an incubating bird left at dusk and did not return until first light. With early-morning ambient temperatures (usually the coldest time) dipping to as low as 6°C, these absences were exposing the

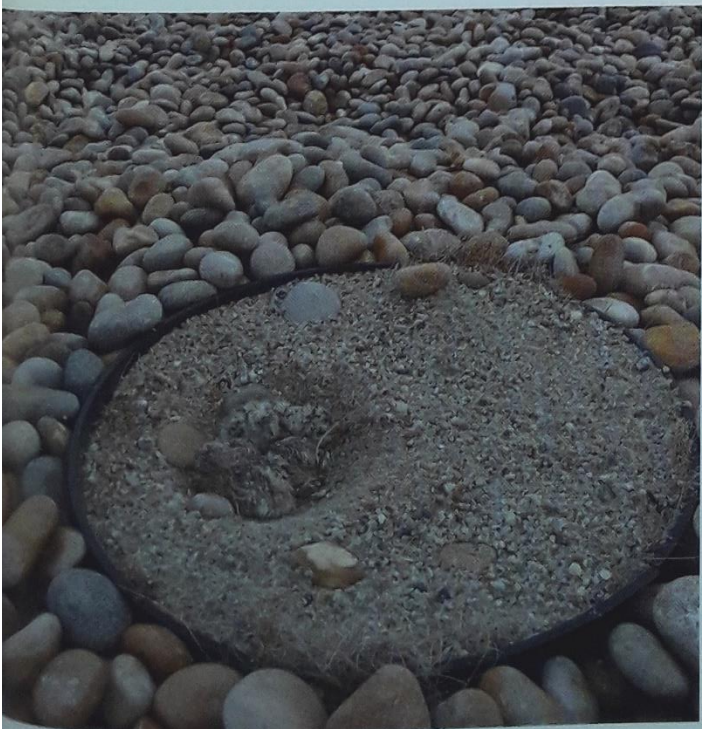
Modified sand patch in 2016 with newly hatched chicks and showing nest scrapes. Ali Quinney

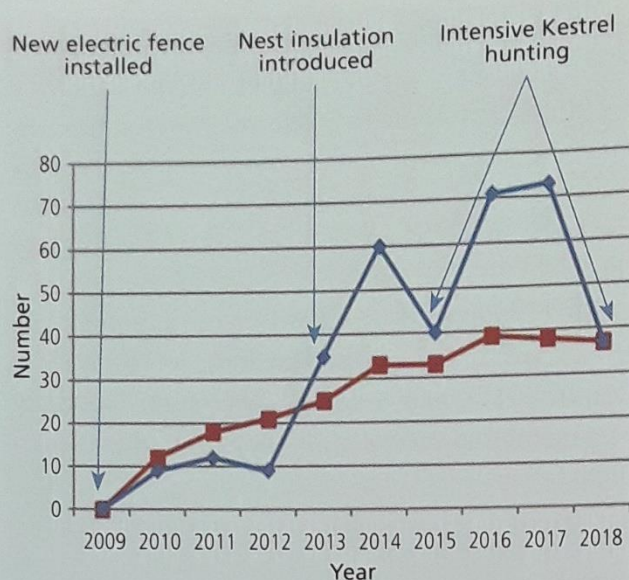
Figure 3. The Chesil Beach Little Tern population 2009–2018, showing the increase in breeding pairs (red) and fledged chicks (blue) following interventions from 2009. The impact of intensive hunting by Kestrels is clear in 2015 and 2018.

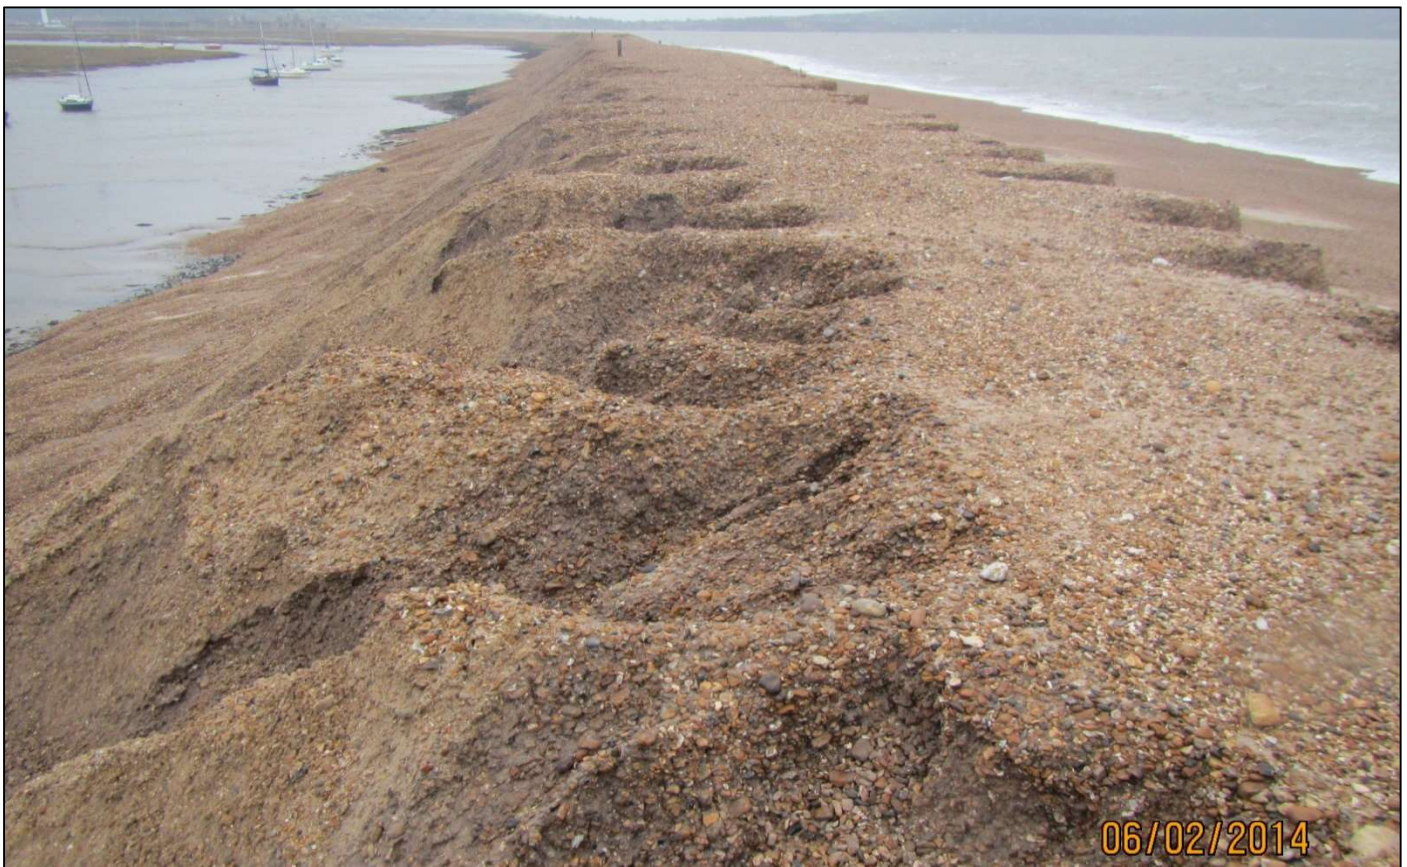
Figure 3- Image looking southeast along Hurst Spit showing damage caused during winter storms 2013/14 (NFDC).

The severe storm events of winter 2013/14 caused significant natural disruption and damage to vegetated shingle communities at Hurst Spit much, so much that it can be assumed that the majority of vegetation was destroyed or damaged during this period within the study area by March 2014 (**Figure 3**). Wide spread (post-storm) emergency beach management and recycling operations were conducted to repair the crest, further impacting the vegetated shingle extent (Recycling from HU5-6 in front of the breakwater, North Point and crest trimming were all carried out as part of emergency works).

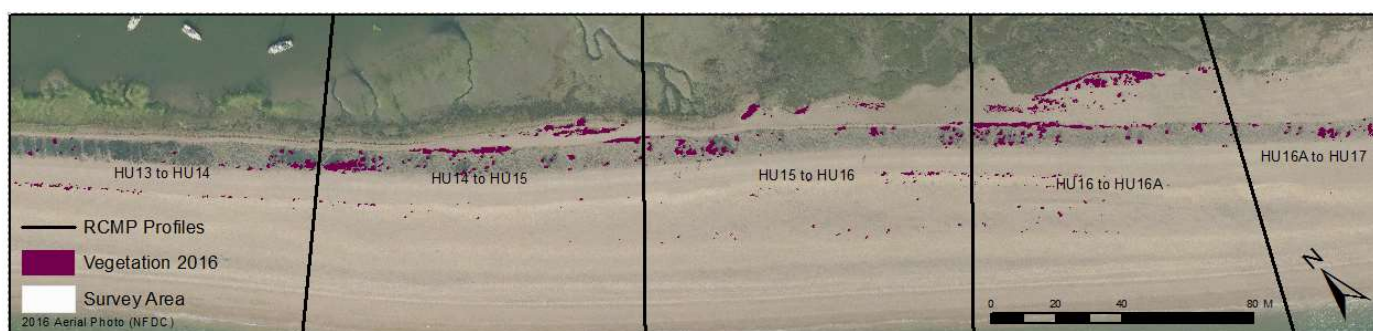
Figure 4b- Digitised extent of vegetated shingle- a snapshot.

Appendix B shows the digitised shapefile of vegetation extent for each year.
