# The Sizewell C Project

## 9.40 Fen Meadow Compensation Study 2018 Phase 1 Report

Fen Meadow Compensation  
Study - Approach and site  
Screen Report 2018

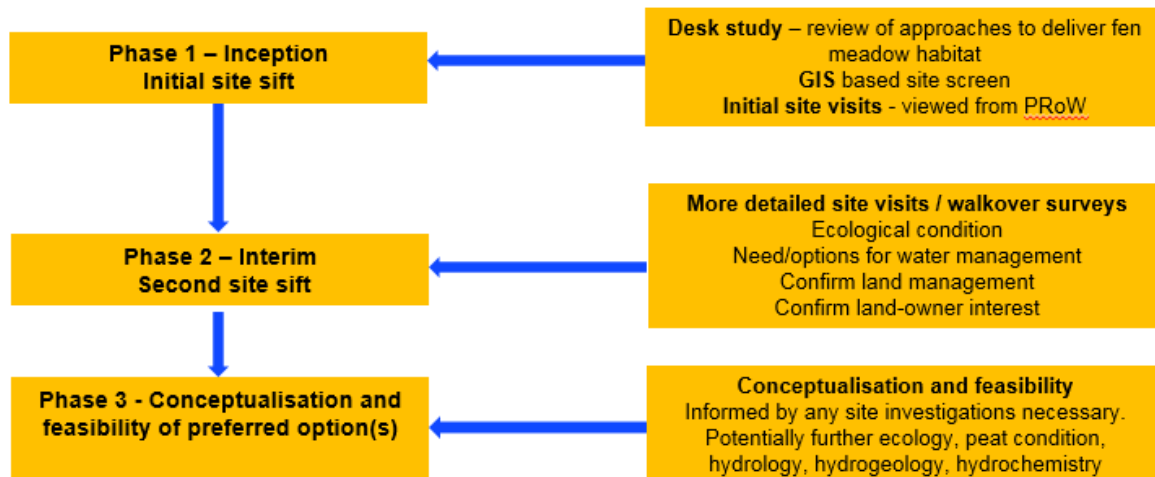
Figure 1.1 Project Outline

The project comprises 3 phases and associated tasks as detailed in Figure 1.1.

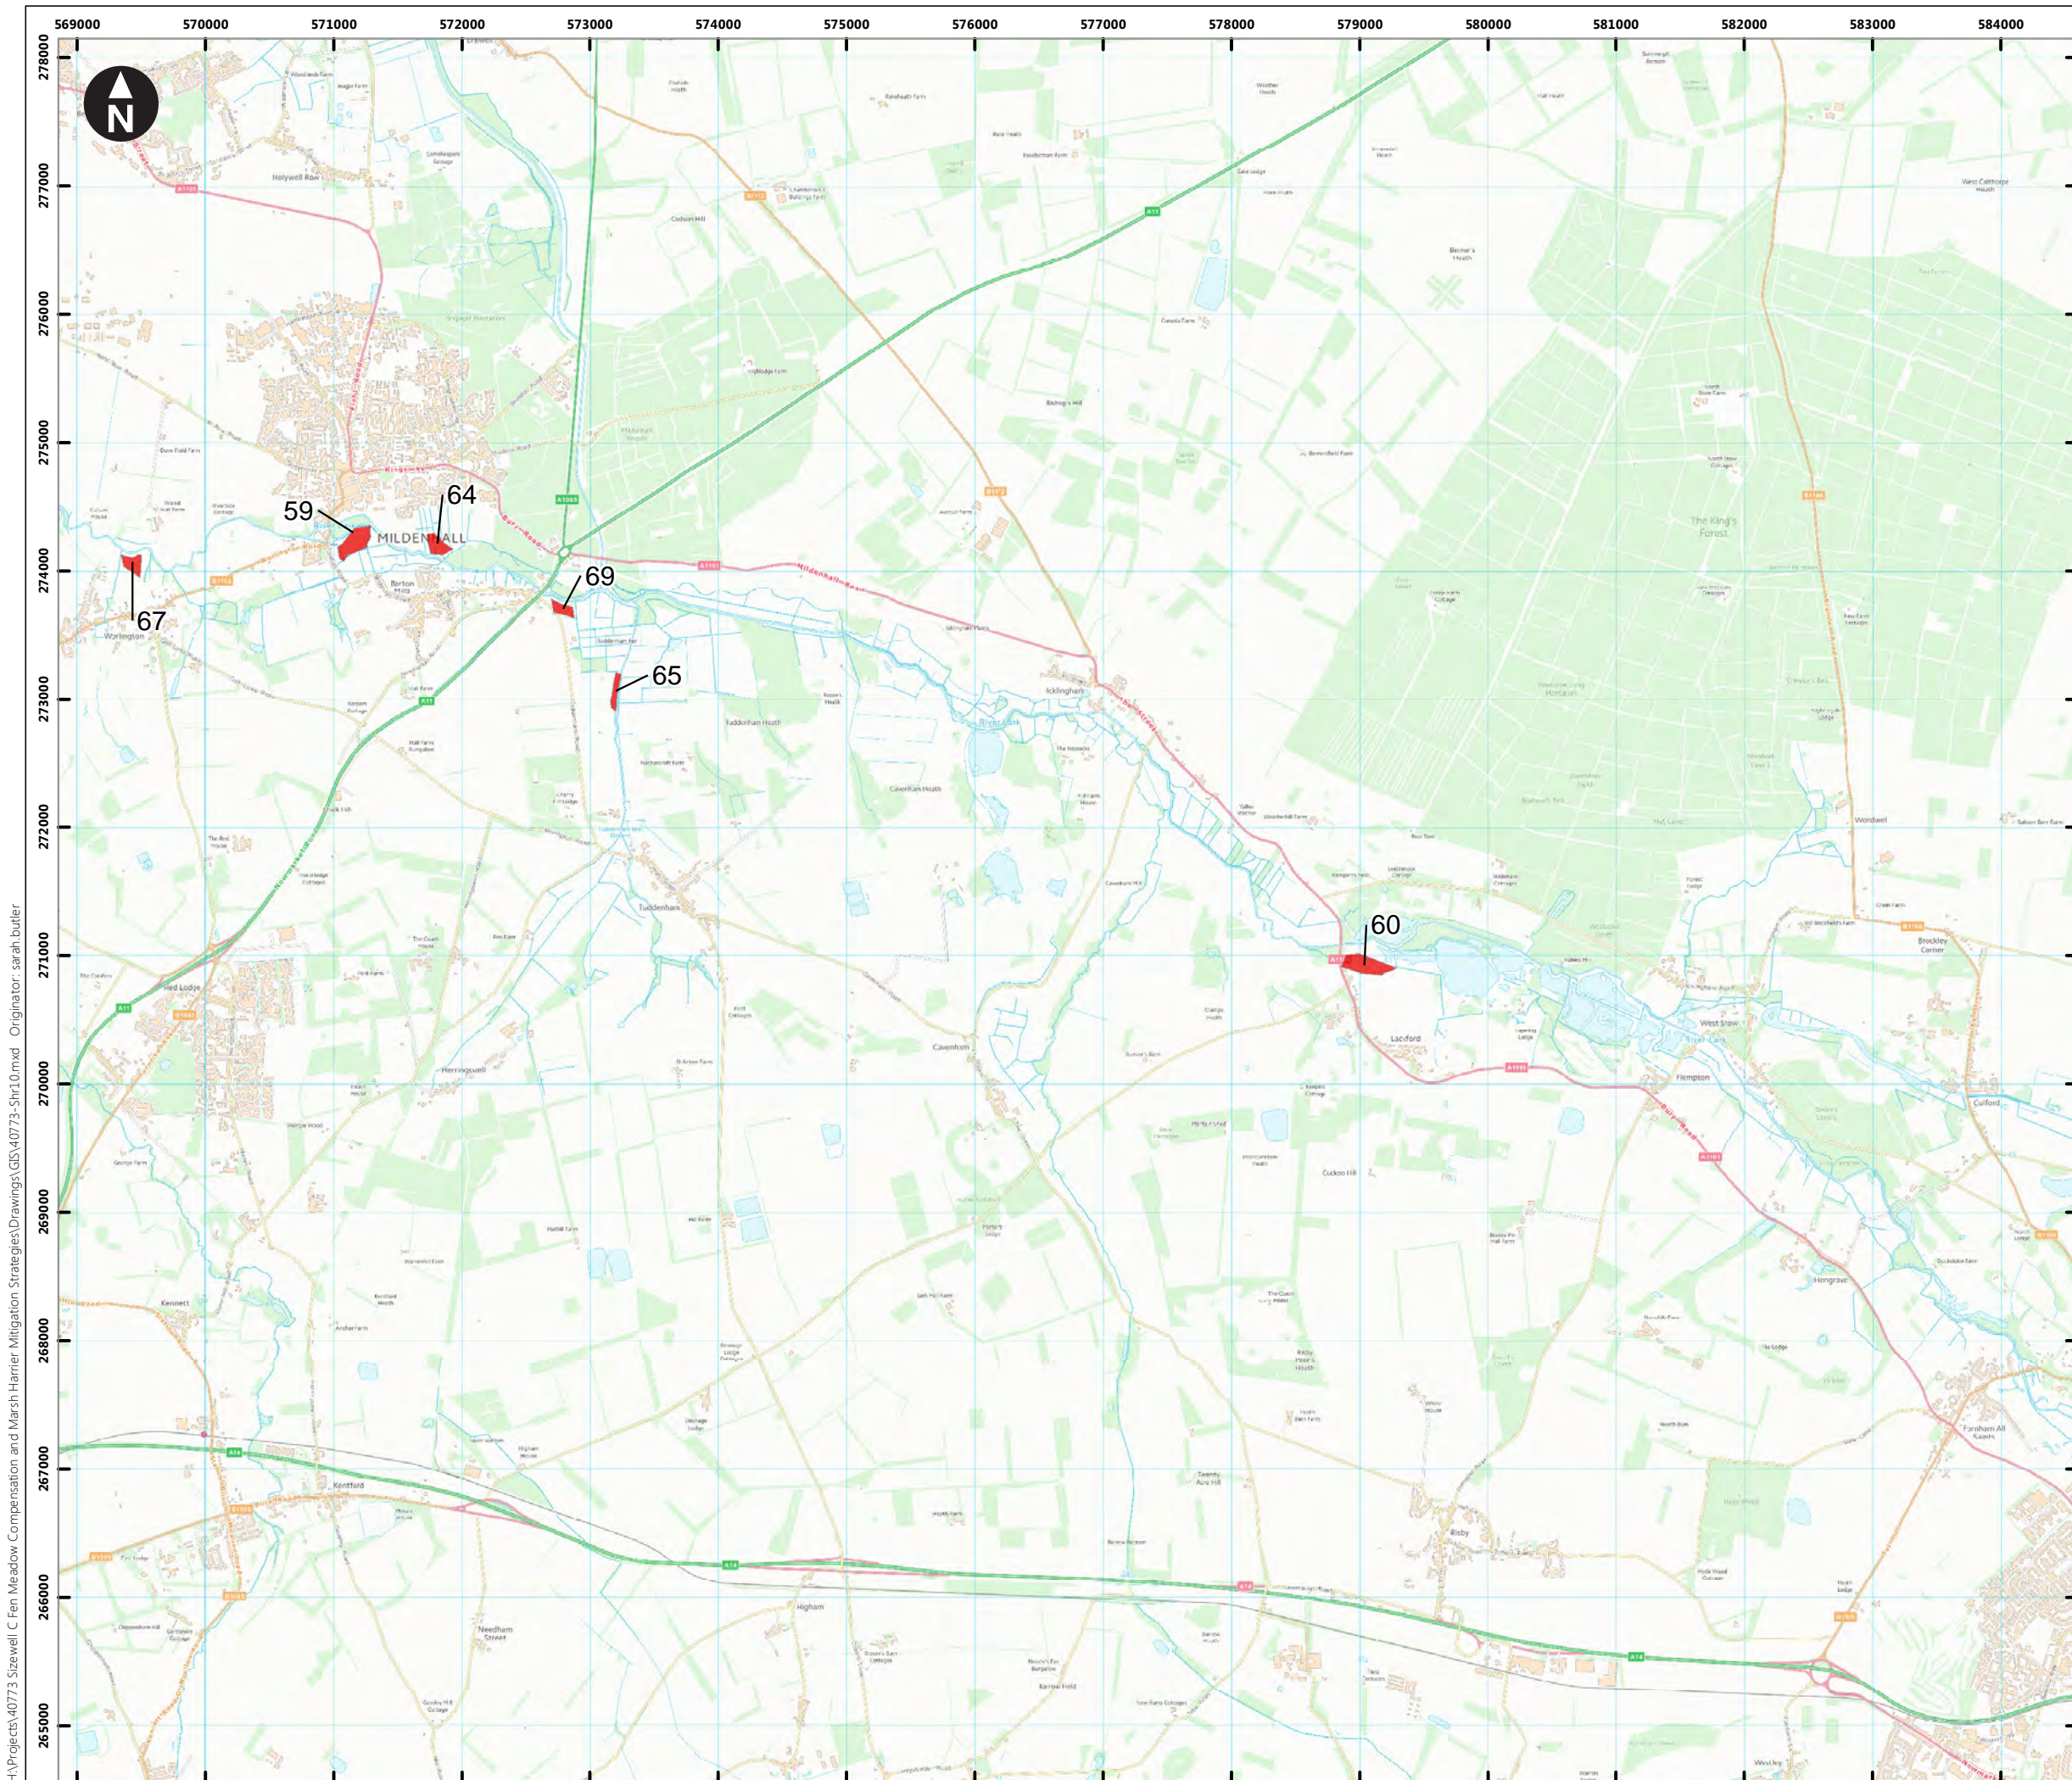
**Figure 2.3g**  
RAG rating of land parcels with potential to support fen meadow

- Take forward to next phase
- On hold
- Unlikely to proceed
