“Coastal erosion at Thorpeness and lessons for the Sizewell C Project”

- written representation by Frances Crowe to the Planning Inspectorate in respect of the DCO for Sizewell C, June 2021.

A chronological visual account of erosion at Thorpeness

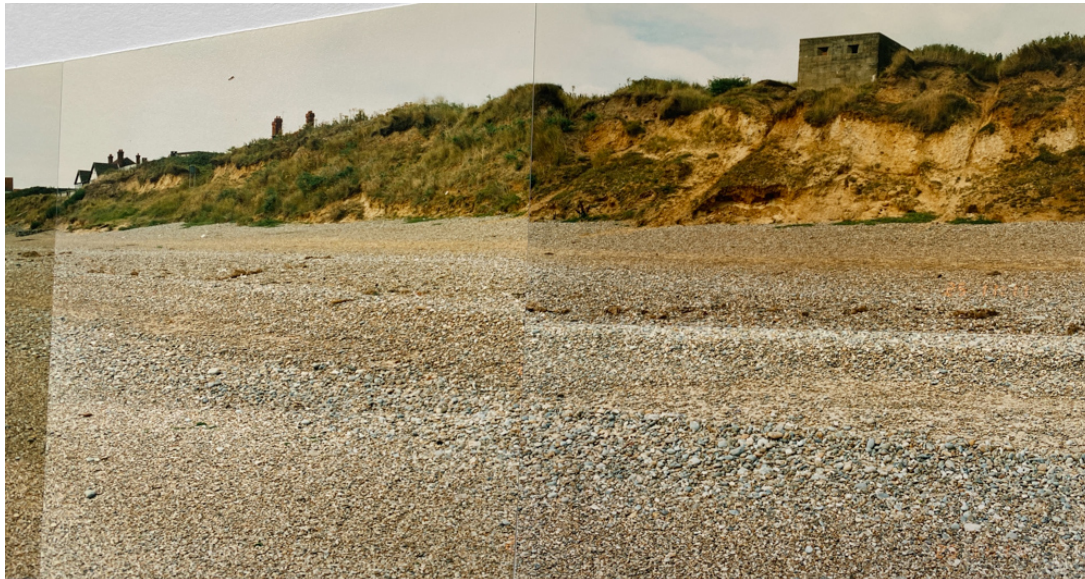
1. Collaged photos taken in 1993, showing Pillbox I and the chimneys of the Red House on North End Avenue. No embayment noticeable and access to the beach was still possible from the cliffs at this time by the footpath just north of The Red House.

- The cliff erosion north of the defences demonstrate the 'embayment' effect that occurs on land at either end of a significant hard sea defence. (Photos 10 & 18). The larger the sea defence, the greater this embayment is likely to be. For comparison, see the last Photo 1 taken in 1993, showing no signs of embayment before the construction of these sea defences. The embayment impact of the proposed Sizewell C sea defences could be highly significant and affect large distances, given their size.

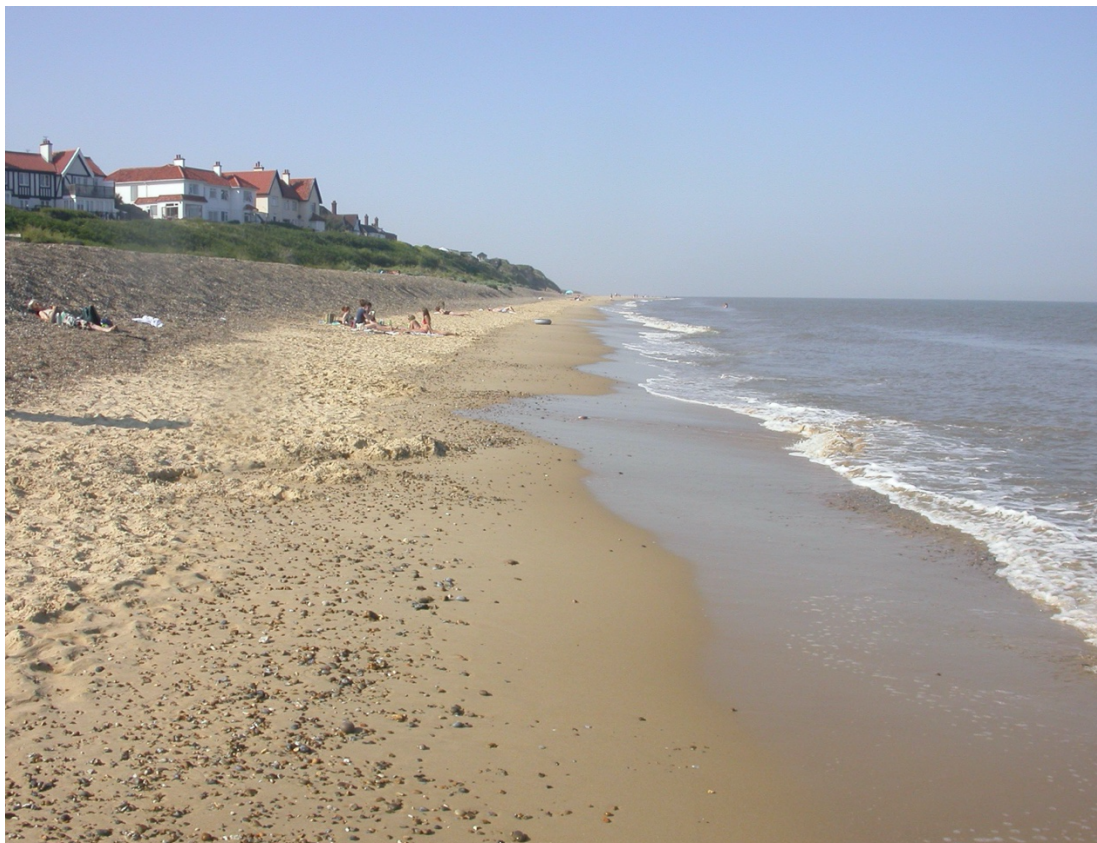
2. Thorpeness beach, July 2006. Note vegetated cliffs beyond last houses and prominent summer house on clifftop (in the garden of The Red House) - now lost to the sea. No embayment at this time.

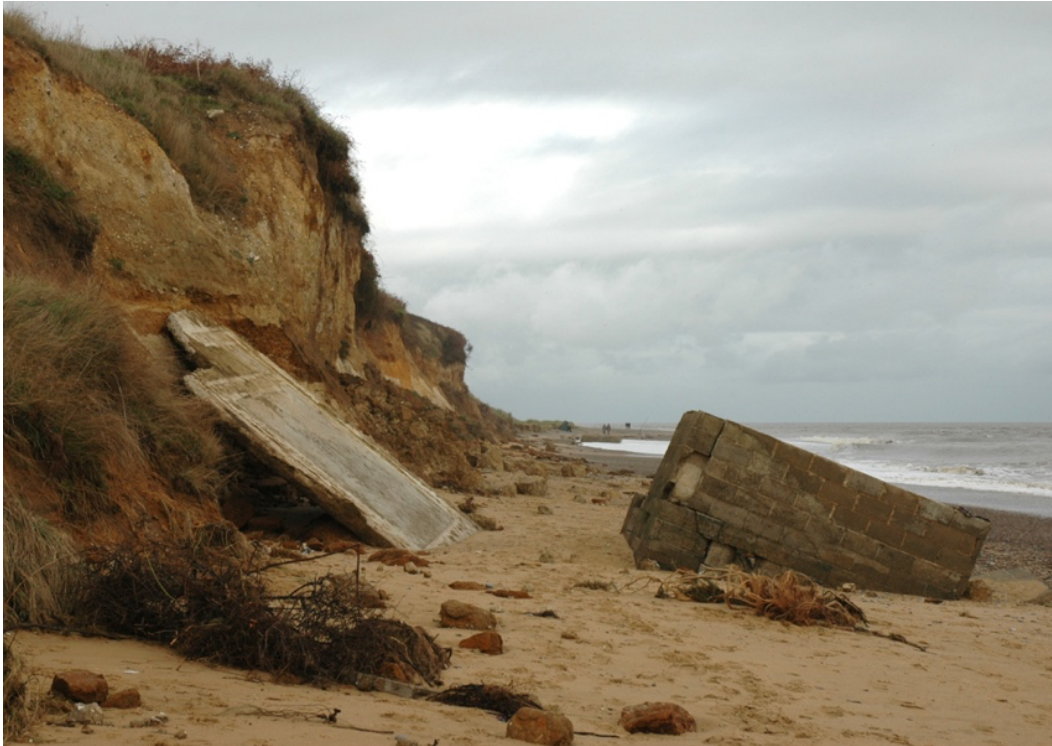
3. The southernmost World War II pillbox (approx. 50 meters north of pt 2 on map in appendix 1) - photo taken in 2007, soon after it was bulldozed off the cliffs.

- The pillbox offers a useful indication of the extent to which the cliff has receded in the last 15 years. It now lies an estimated 25 meters seaward of the cliff face. (Photos 3 & 18).

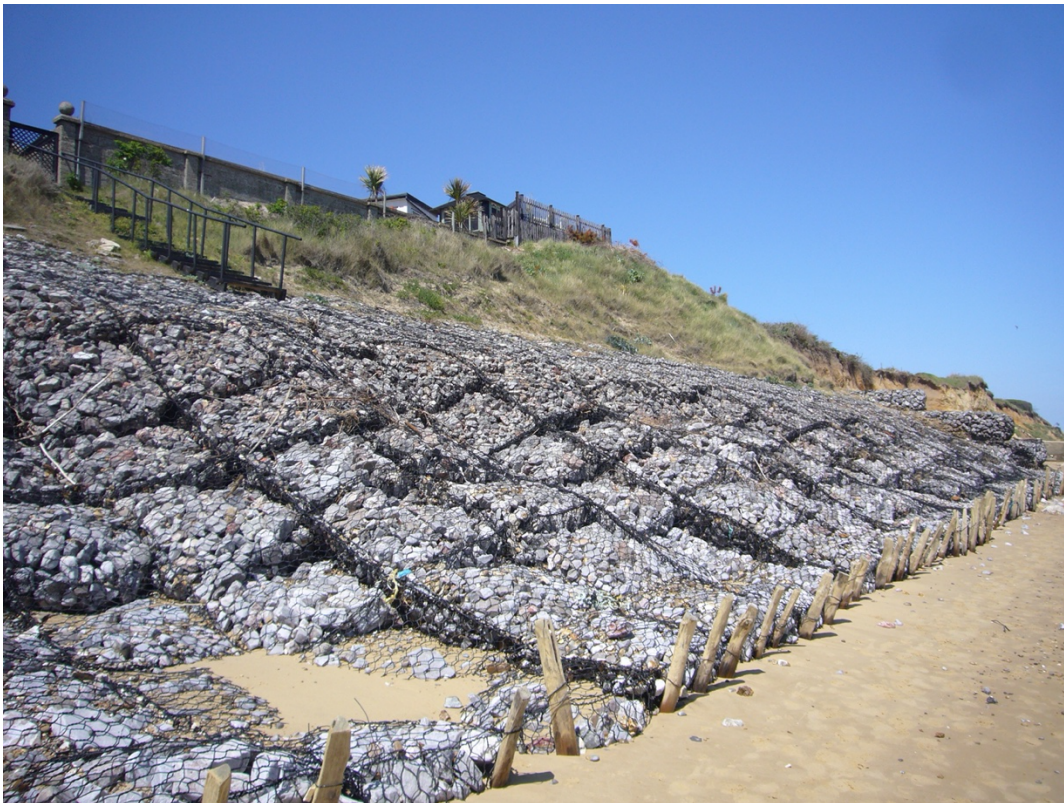
4. Recently constructed sea defences (stone filled gabions), May 2010.

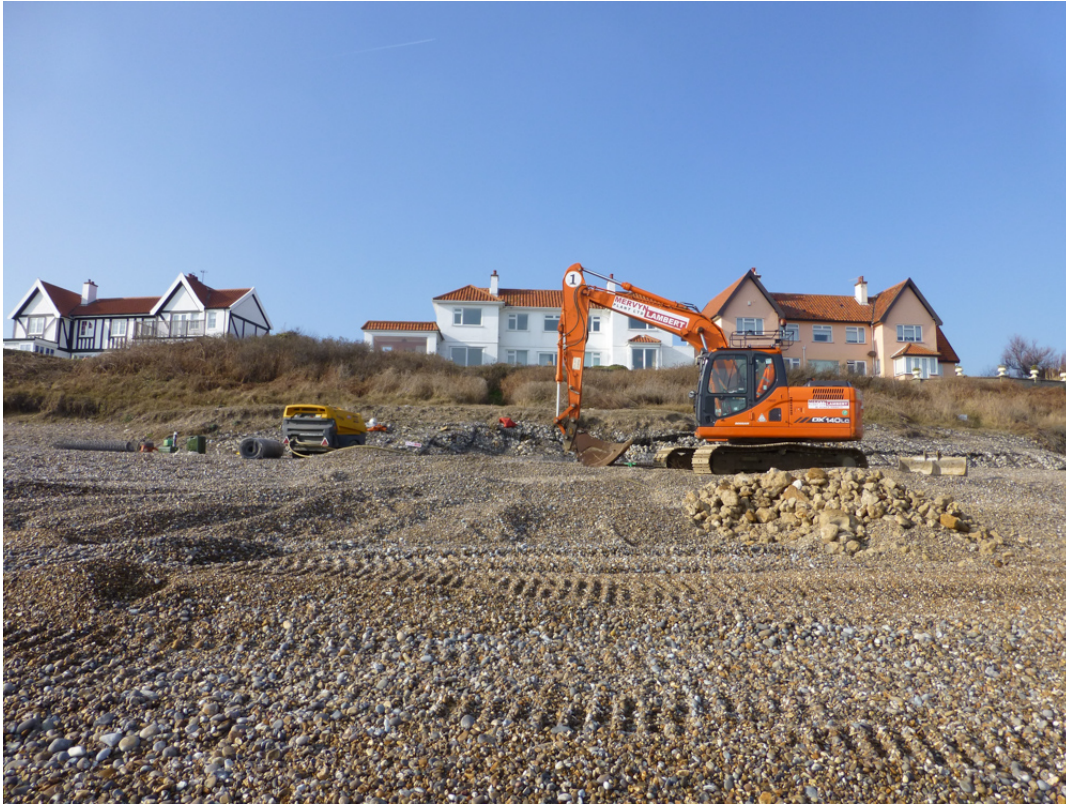
5. Reinforcement of sea defences, including addition of geo-textile bags, 19th February, 2013

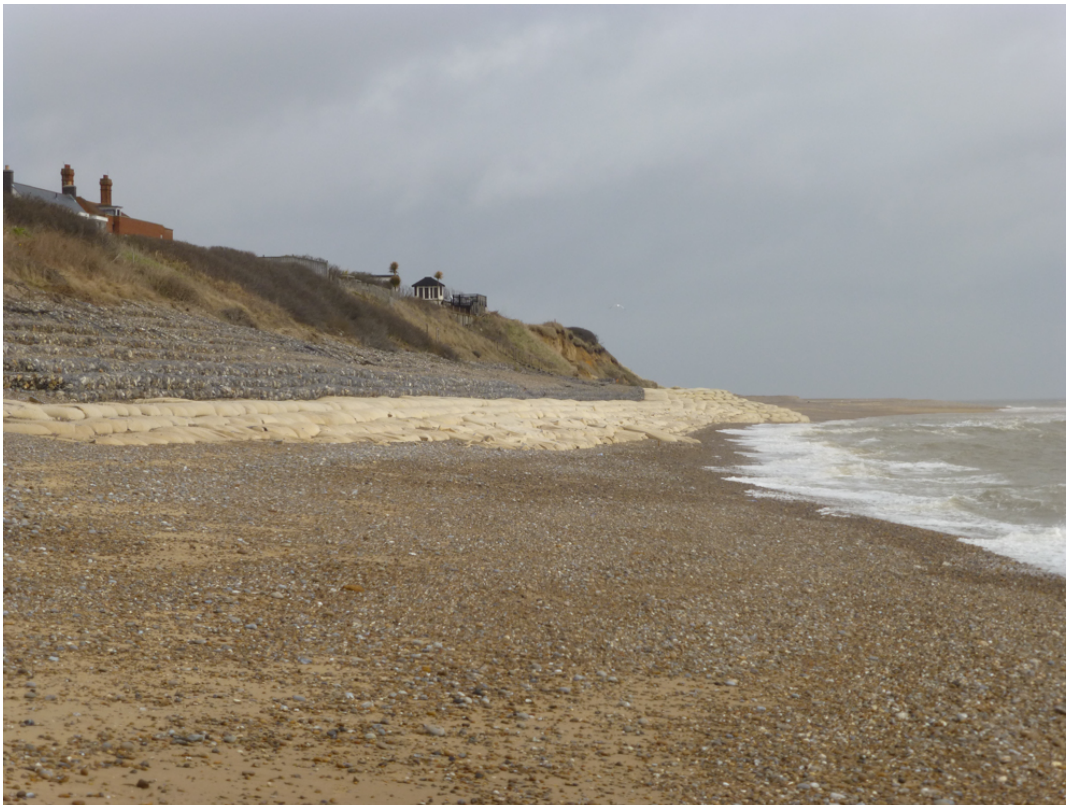
6. New geotextile sea defences in place -16th April 2013.

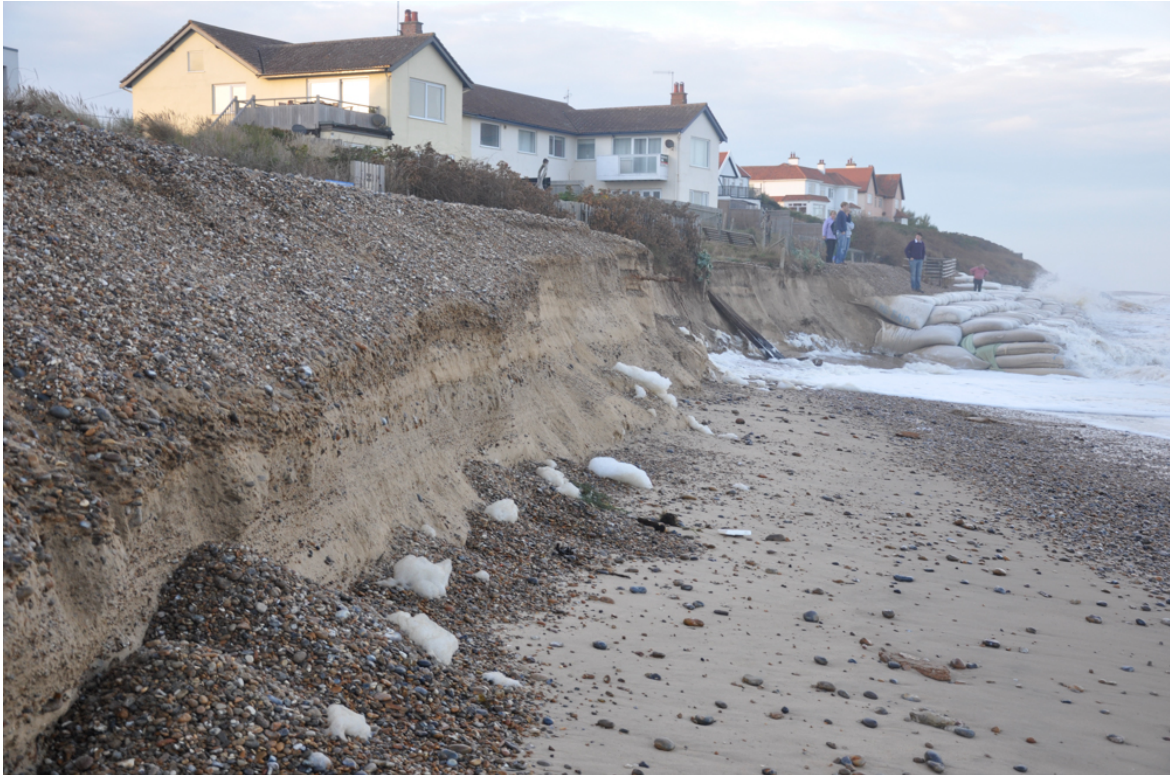
7. Erosion at Thorpeness, October 2013, in front of Tinkers End at the end of Old Homes Road - unusual sea conditions led to the loss of 3 meters of beach overnight.

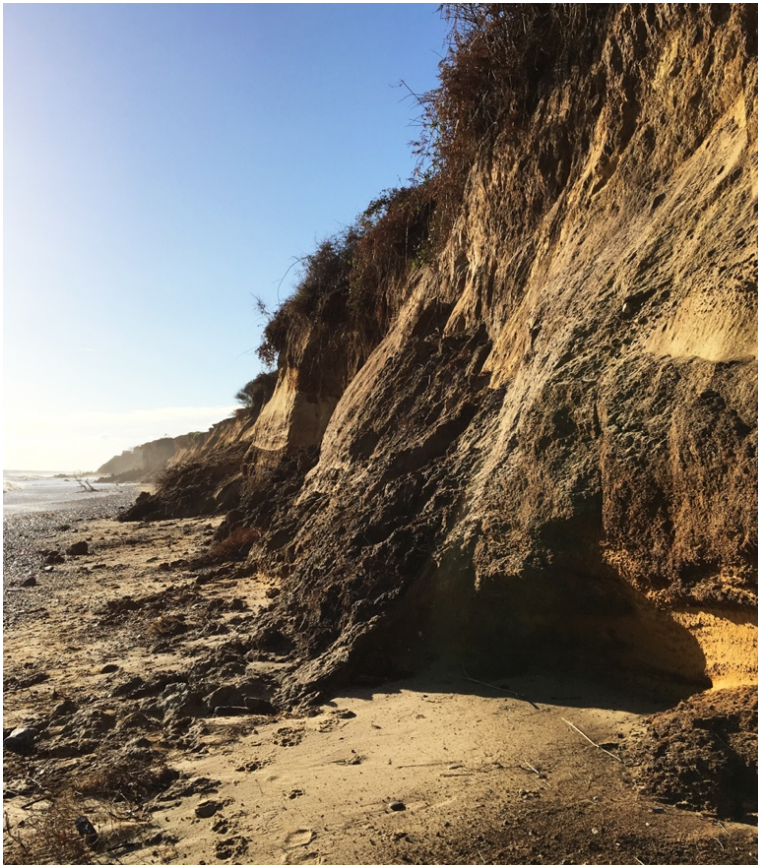
8. Typical winter cliff erosion, cliffs between Thorpeness and Sizewell, 14th January, 2014.

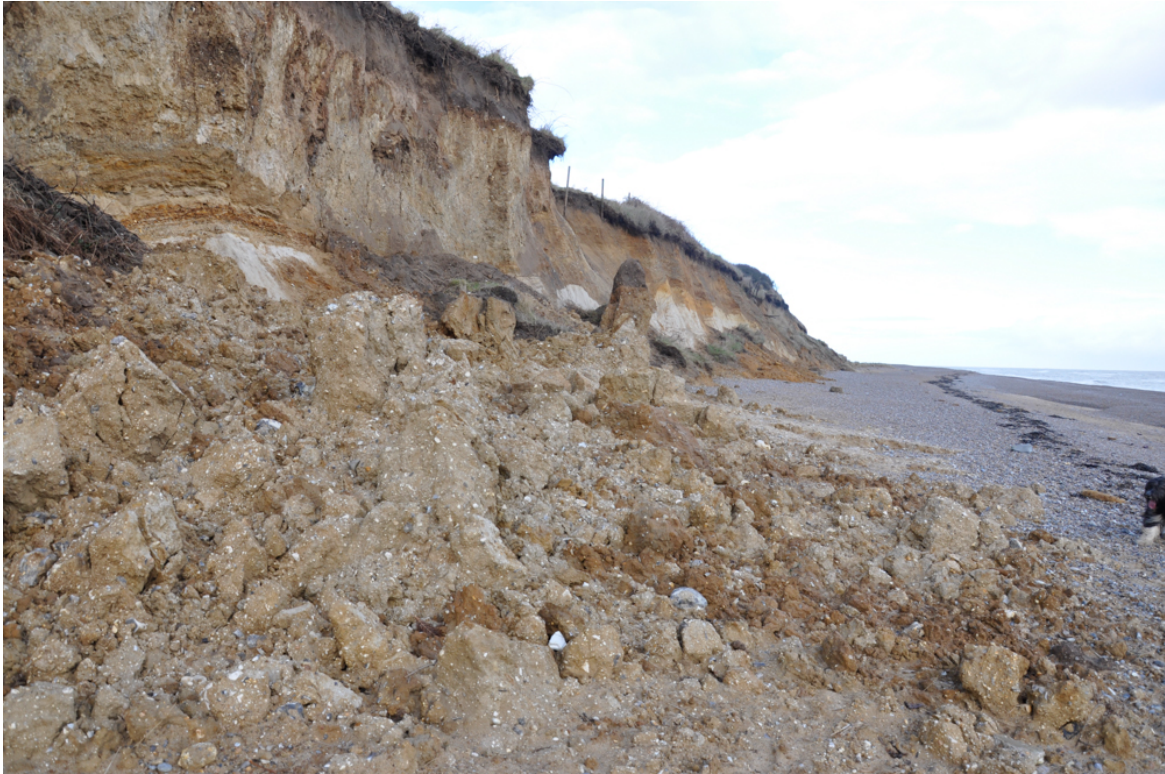
9. Winter cliff erosion, looking north towards Sizewell - 17th January, 2014

- The cliffs north of Thorpeness (north of Pt 2 on the map in Appendix 1) clearly indicate the friability of this coast and why it is one of the fastest eroding coastlines in Europe. (Photos 9-12). This site is only 2 - 3 km from the reactors and waste storage at Sizewell, which has very similar coastal geology to Thorpeness. Similar erosion is happening in places all along the East Anglian coast - for example, Felixstowe, Bawdsey, Orford Ness, Dunwich, Easton Bavents and Covehythe.

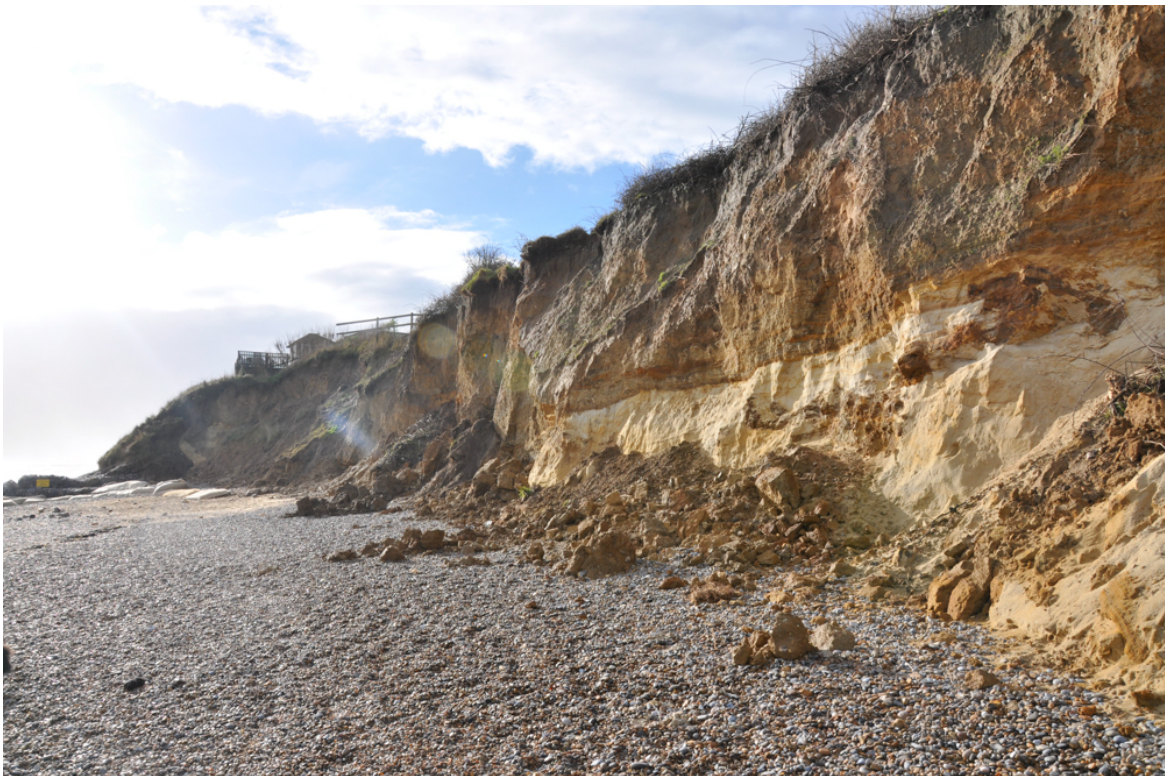
10. The cliffs immediately north of the gabion sea defences and The Red House. Embayment is now visible in the area, as well evidence of extensive ongoing cliff erosion. 17th January 2014.

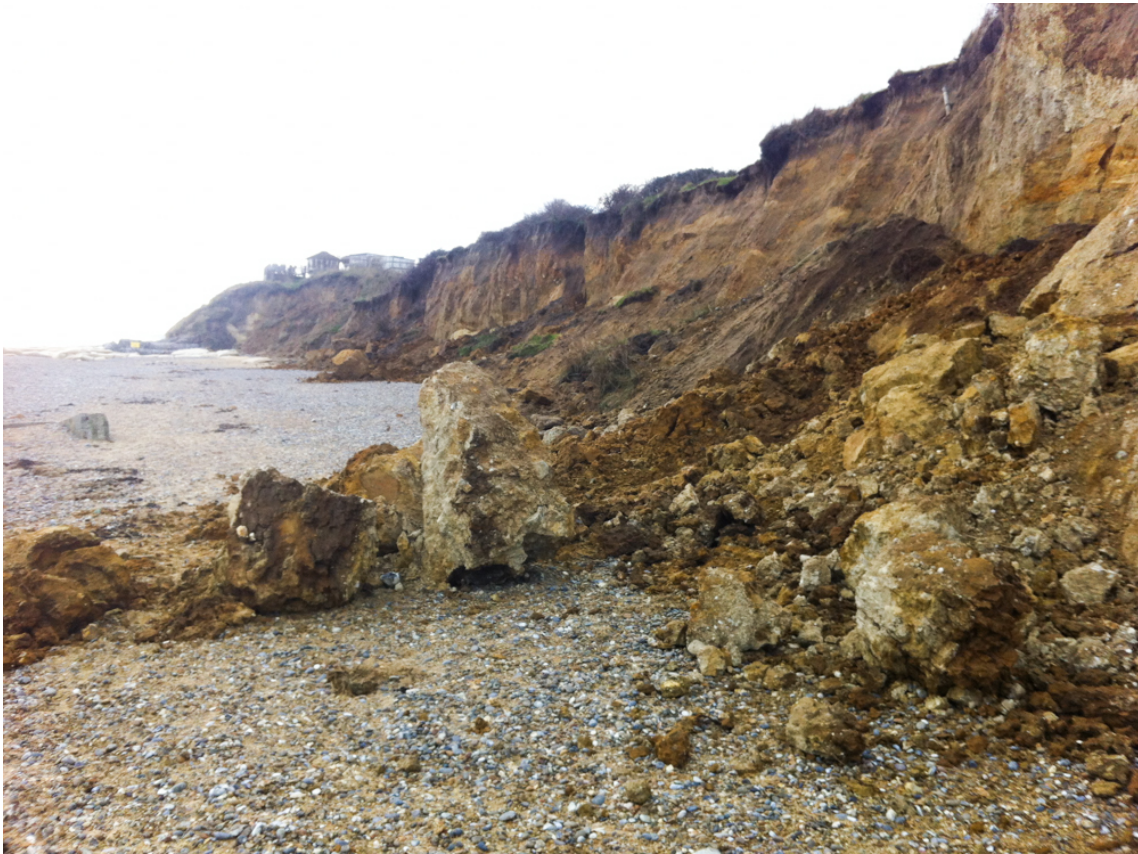
11. Cliffs north of Thorpeness, 19th Feb 2014.

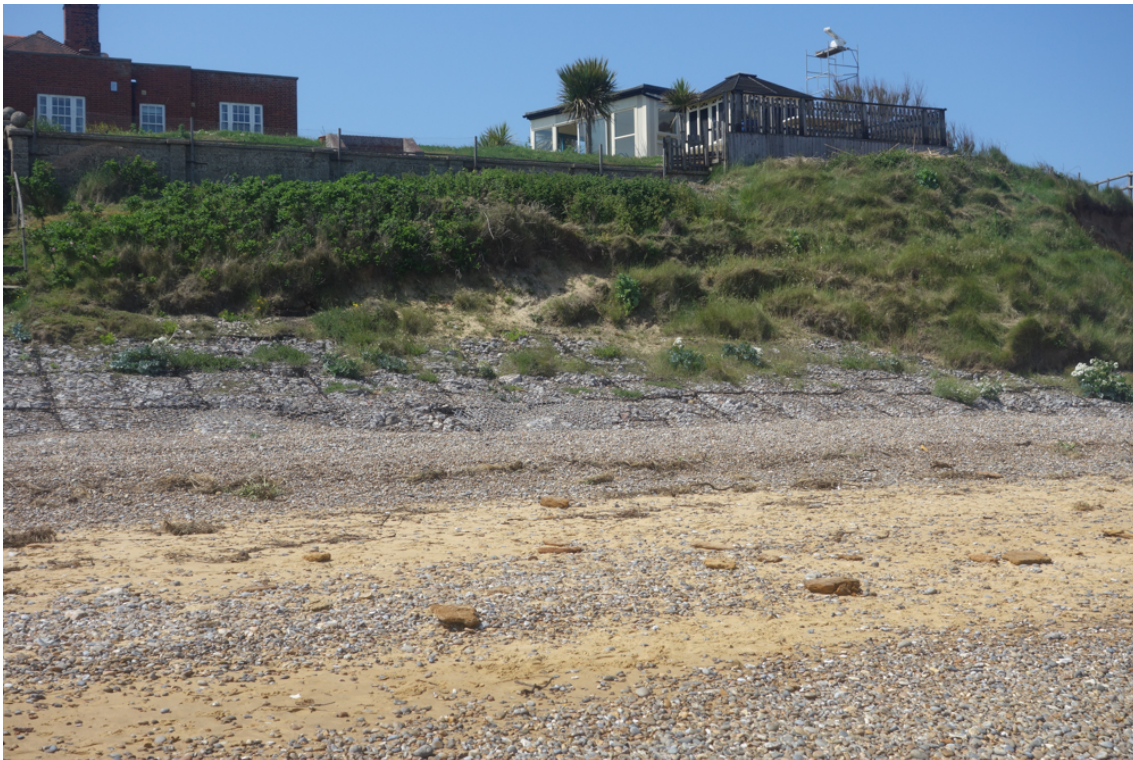
12. The cliff and beach in front of The Red House, 5th June, 2016. Notice that the cliff above the gabions is well-vegetated, in theory offering greater protection.

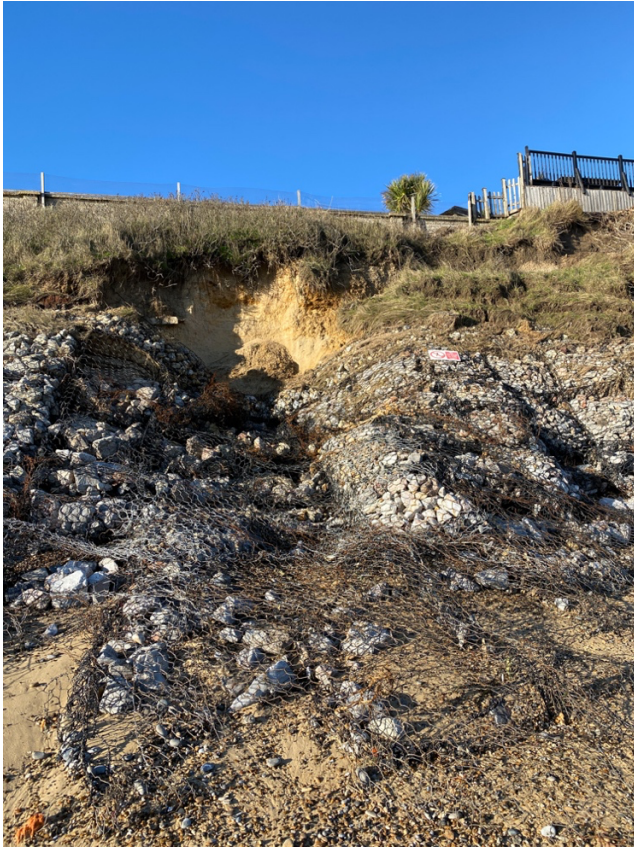
13. Initial breakdown of the gabion sea defences in front of the Red House with erosion beginning in the sandy cliff behind - 9th Jan 2021.

- This site illustrates the unpredictability of sea defence failure. The decimation of the sea defences here (especially the north end) has happened after only 8-11 years of their life despite this being expected to be an estimated 25 years. The damage was not the result of any storm surge but just 'normal' attrition, especially over the winter months of 2020/21. (Photos 13-16 & 18-19).

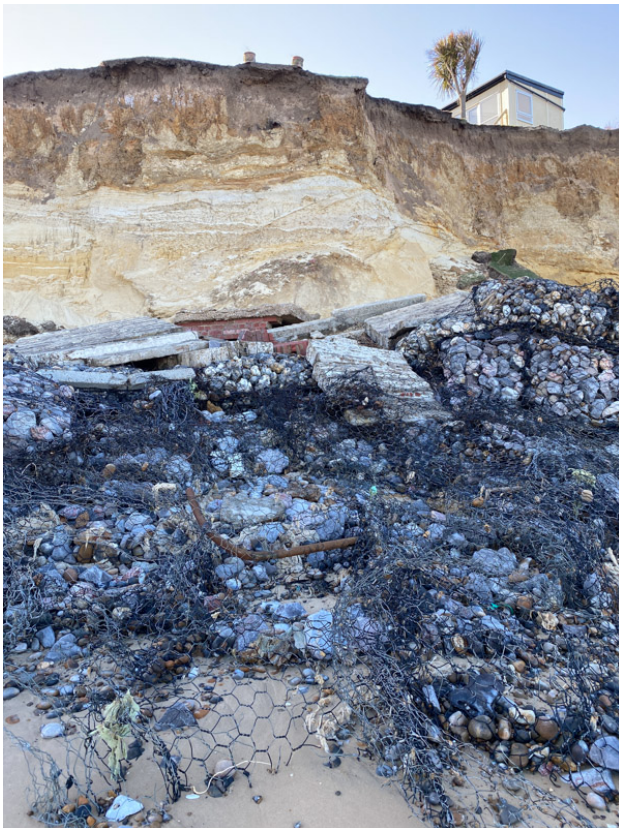
14. The cliffs in front of The Red House - 6th March 2021.

- The site also highlights the difficulty in remediating failed defences and illustrates their impact on visitors and residents. The failed defences now are restricting valuable access along the beach and represent a significant hazard and eyesore to beach visitors. (Photos 14-17). Additionally, they are now partially ineffective in defending residential properties. Significant cost and disruption will result, regardless of whether the sea defences are repaired, replaced or left to retreat.

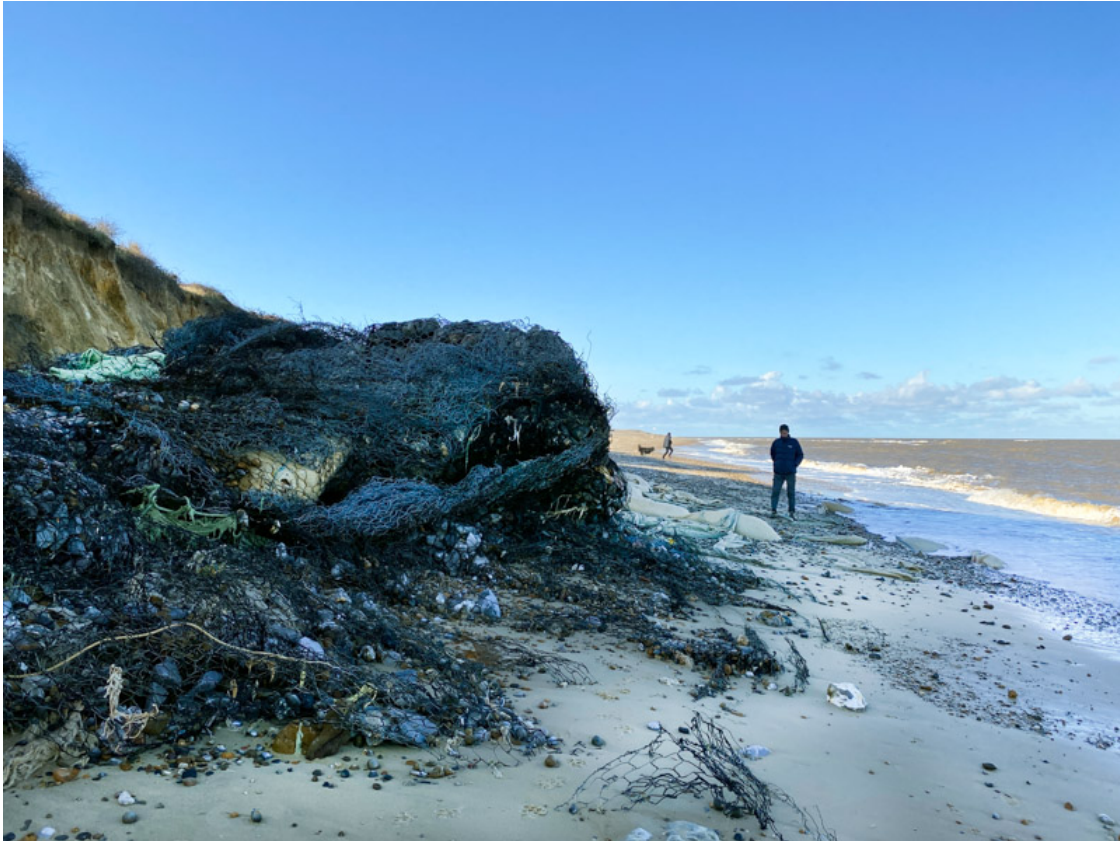
15. Destroyed gabions at the northern end of the sea defences - 6th March, 2021.

- There is major damage to the sea defences in this location. This has led to a huge breach at the northern end (pt 2 on the map), leading to a significant loss of cliff (and gardens of two houses on North End Avenue).

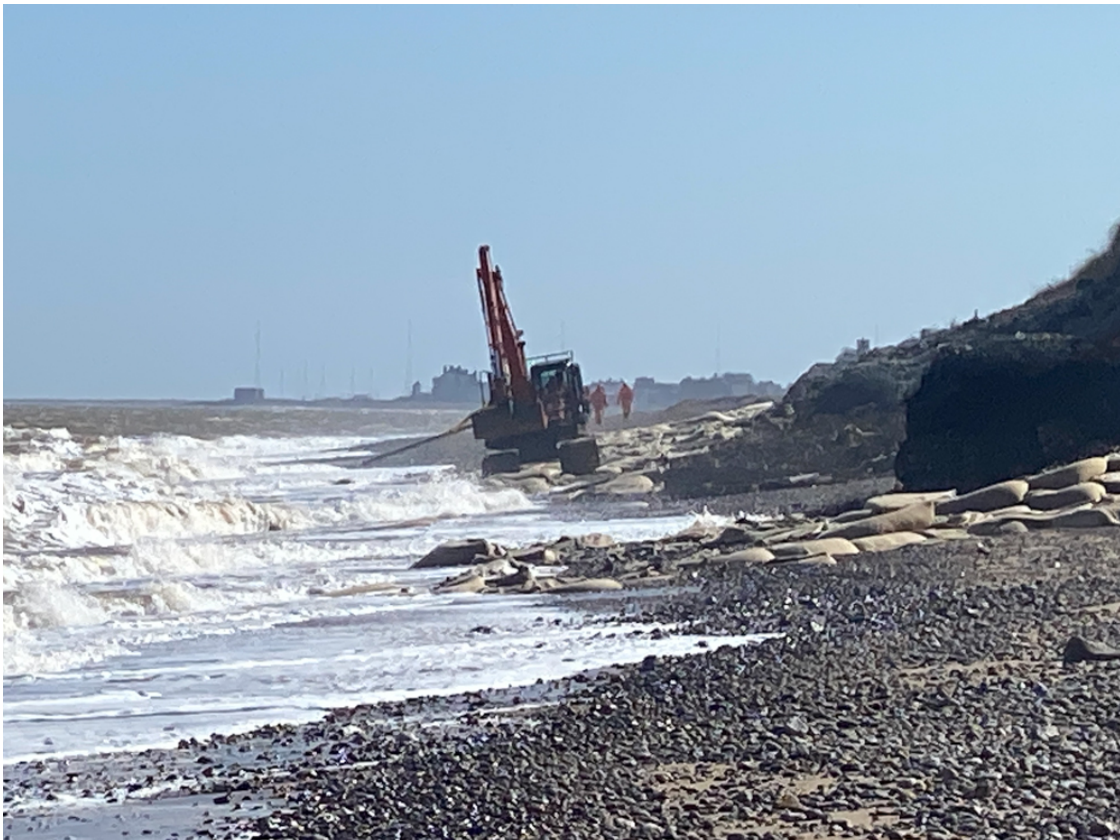
16. Beach at low tide. One day works to shore up defences and add rock to the least damaged defences at the southern end - 10th May 2021.

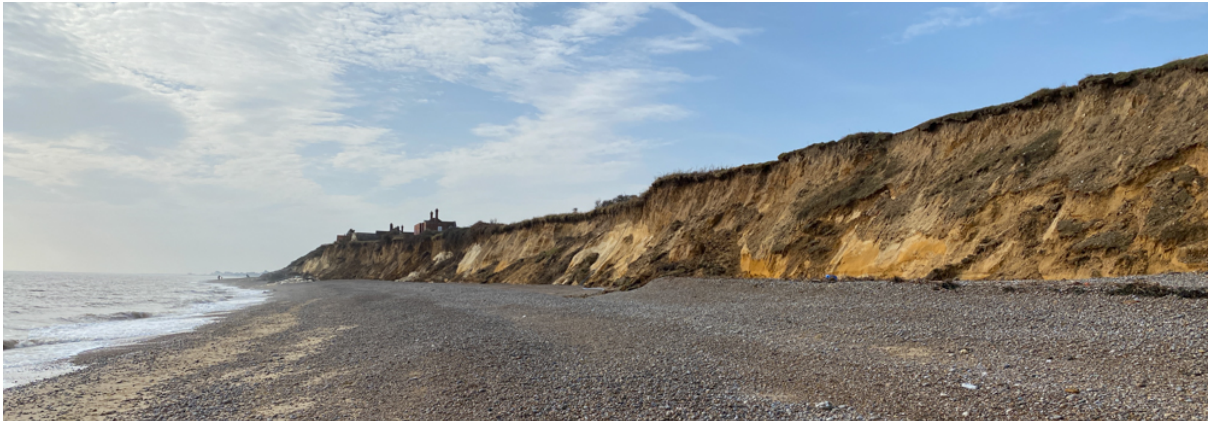
17. Pillbox, just visible on the tideline before the houses on the cliff, is now an estimated 25 meters from the base of the cliff - May 2021.

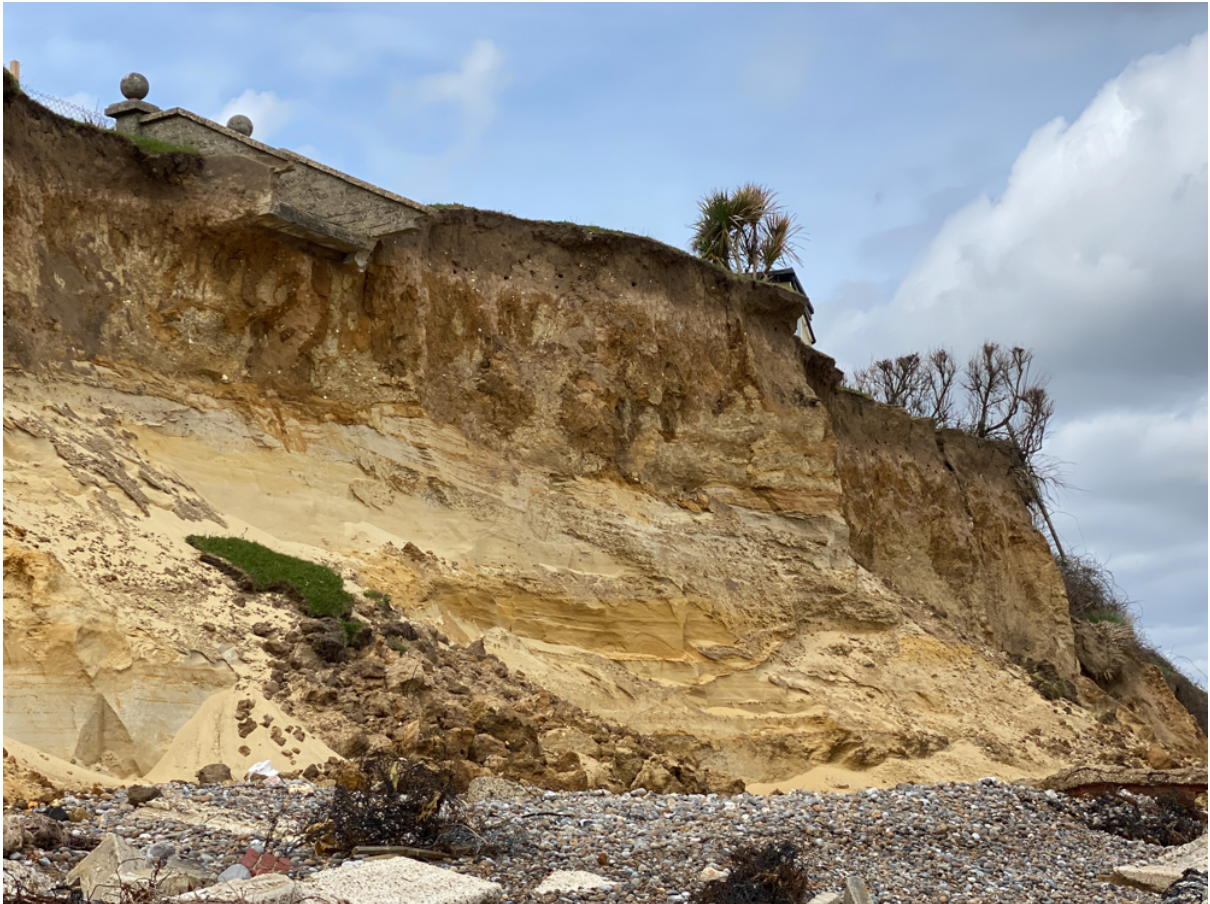
18. The cliff and beach in front of The Red House, 23rd May 2021 (note loss of garden wall, fenced decking area, palm tree and summer house, further garden outbuilding now at risk)

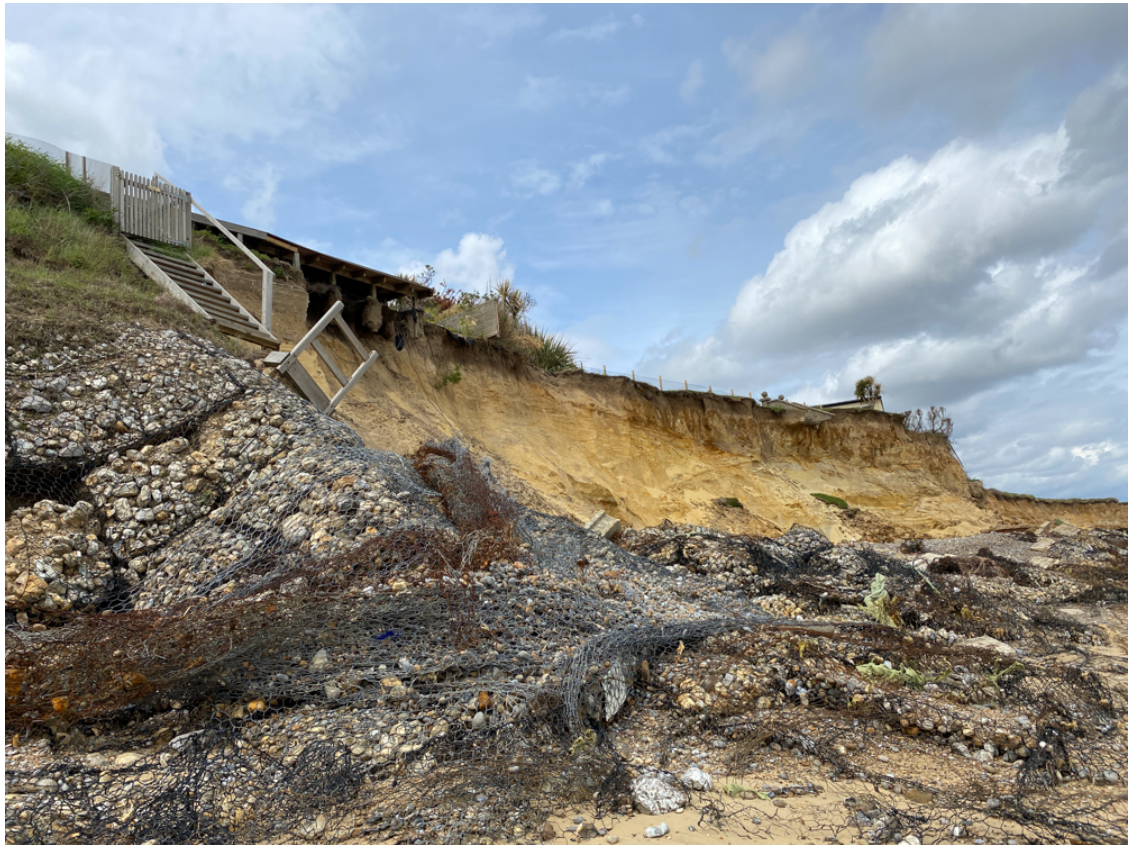
19. 23rd May 2021 - further view of the cliff decimation in front of The Red House

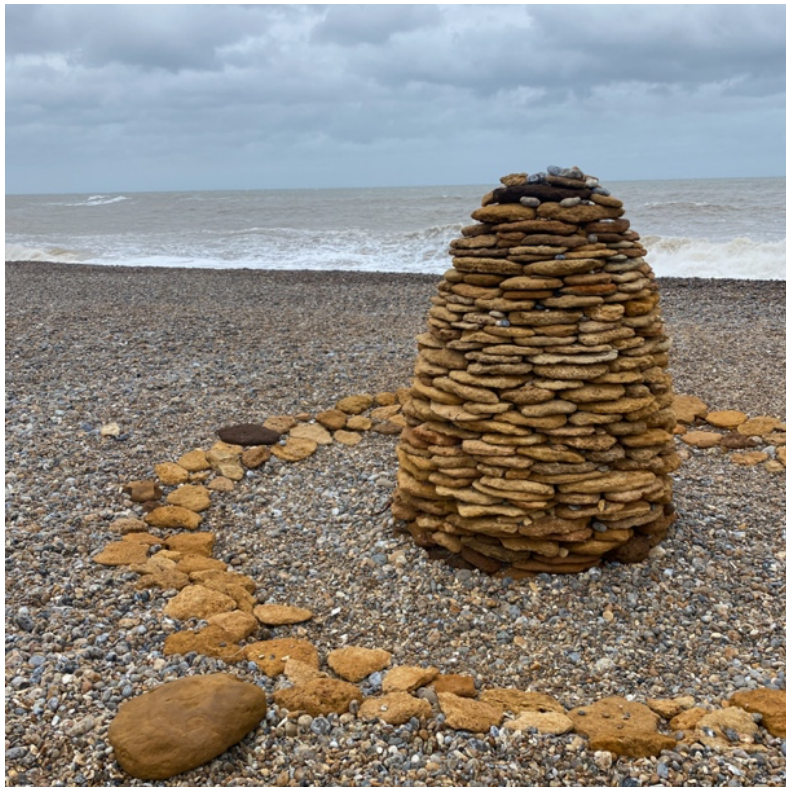
20.

May 2021, 2-meter-high cairn built on beach from coralline crag that washed up in winter storms - evidence of the fragility of the offshore reef that protects Thorpeness and Sizewell.

- The large amounts of coralline crag washed up on the beach last winter may be indicative of increased vulnerability of the offshore reef that helps protect Thorpeness and Sizewell, possibly due to ocean acidification, increased sea temperatures and/or greater storm activity. Analysis needs to be undertaken by the applicant to establish how robust this reef is and the degree of loss/damage.
