# The Sizewell C Project

## 9.64 Draft Fen Meadow Plan - Clean Version

Revision: 2.0  
Applicable Regulation: Regulation 5(2)(q)  
PINS Reference Number: EN010012

September 2021

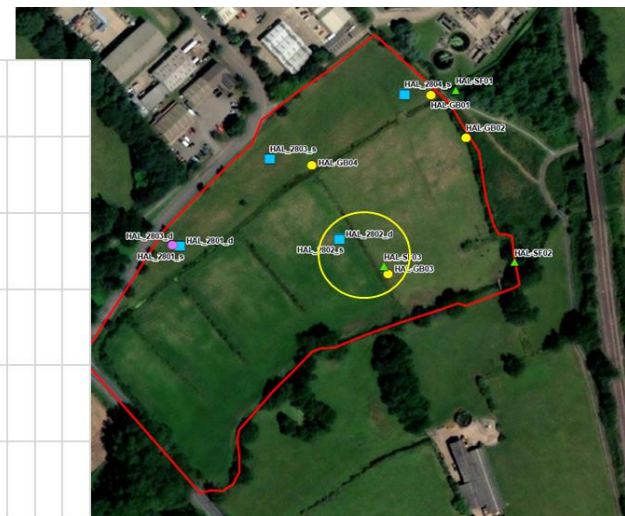
A2

Groundwater levels to the north above those observed in the drainage ditch. Peaks in SW levels also seen in GWL.

Generally declining trend over the spring months matched with low SW levels.
