The Sizewell C Project

9.92 Sizewell C Project Draft Bat Method Statement Part 1 of 6

Revision: 2.0
Applicable Regulation: Regulation 5(2)(q)
PINS Reference Number: EN010012

Bats – Method Statement template to support a licence application

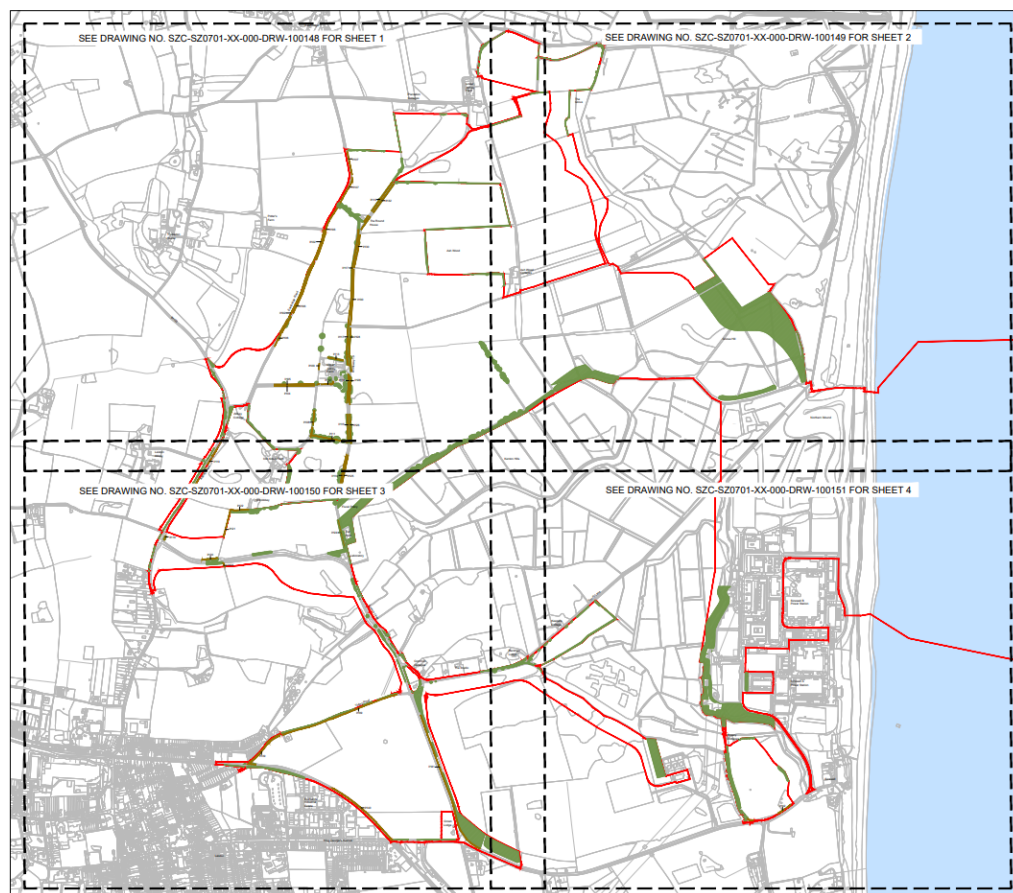
Habitat fragmentation also has the potential to indirectly impact roosts at UAF by isolating the identified bat roosts from surrounding habitat. This may cause a reduction in the use (and/or abandonment) and reduction of success of these roosting sites e.g. the long-term success of the maternity roost in UAF B10. Identified mitigation would be appropriately situated to minimise any impacts from fragmentation. This would involve retaining key habitat links between UAF to the wider landscape, as shown below.
