# **East Anglia ONE North and East Anglia TWO Offshore Windfarms**

## **Infiltration Test Results (May 2021)**

Applicants: East Anglia TWO and East Anglia ONE North Limited  
Document Reference: EA1N\_EA2-DWF-ENV-REP-IBR-001104  
SPR Reference: ExA.AS-2.D11.5.V5

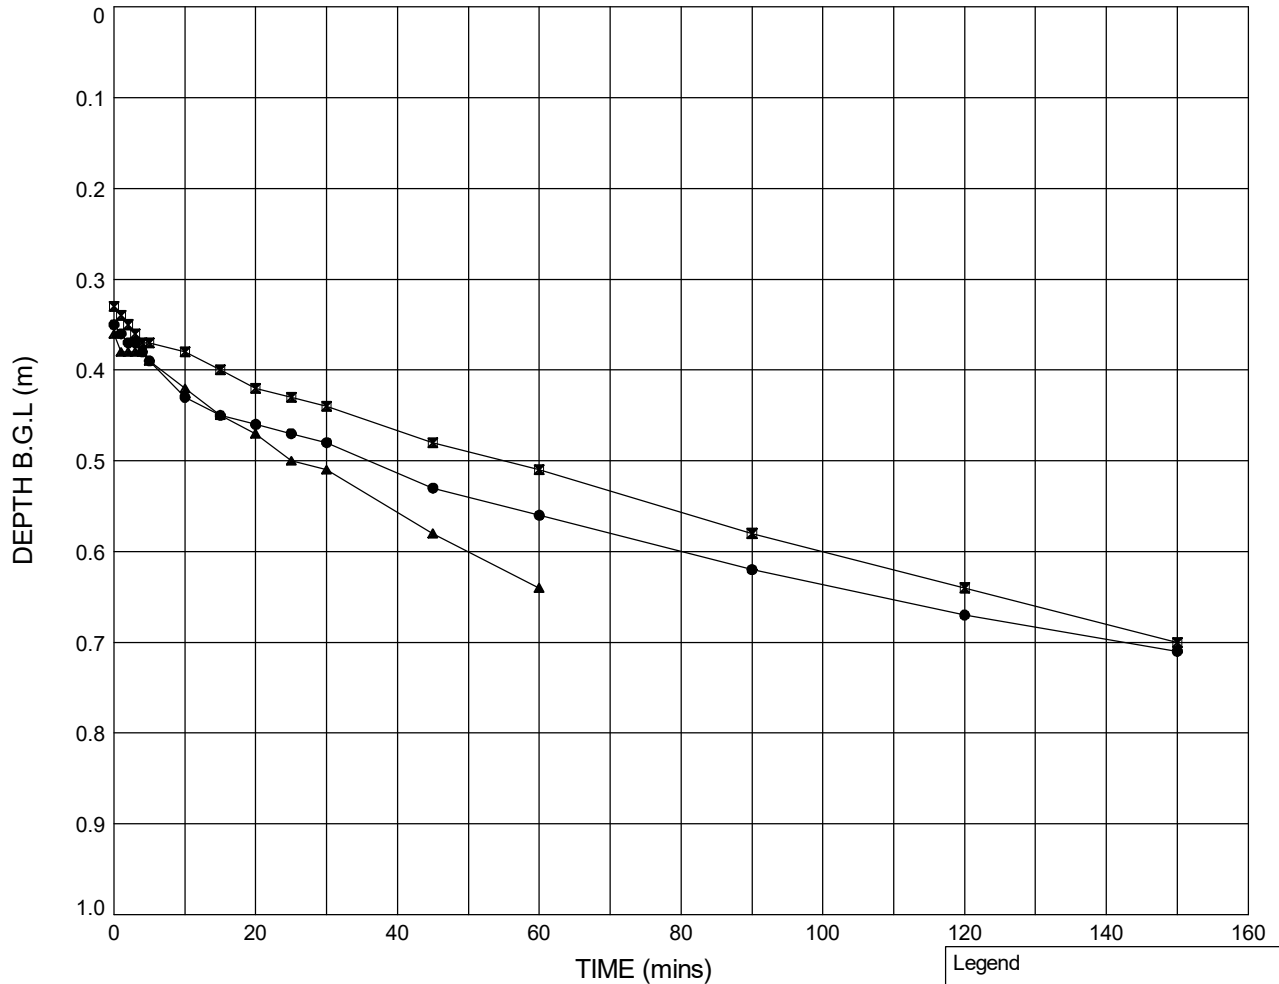
Soakaway Test - Position ID : **TP012B**

## PLOT OF DEPTH OF WATER BELOW GROUND LEVEL AGAINST TIME

Test 1	Test 2	Test 3	
Pit start depth:	= 1.00	1.00	1.00	m
Pit final depth:	= 1.00	1.00	1.00	m
Effective depth, $D_e$	= 0.65	0.67	0.64	m
Effective storage volume, $V_{p75-25}$	= 0.3250	0.3350	0.3200	m <sup>3</sup>
Surface area, $a_{p50}$	= 2.6250	2.6750	2.6000	m <sup>2</sup>
Time, $t_{p75-25}$	= 12353	9750	4671	secs
Infiltration rate, $f$	= $1.00 \times 10^{-5}$	$1.28 \times 10^{-5}$	$2.63 \times 10^{-5}$	m/s

Please note test data was extrapolated to obtain  $t_{p75-tp25}$ . Notes: Test 3 - Soakaway Terminated at 6:10pm.

Test pit*	SuDS Basin	Infiltration rate (mm/hr)			
		Test 1	Test 2	Test 3	Average
TP012B	National Grid Substation	36	46	95	59
TP013B	National Grid Substation	12	10	7	10
TP014C	National Grid Substation	34	29	26	30
TP015B	Onshore Substations	75	63	91	76
TP016B	Onshore Substations	46	35	36	39
TP017B	Onshore Substations	98	66	50	71
TP330B	Between the National Grid and Onshore Substations	8	-	-	8
* TP014B was abandoned after one test due to time constraints and was replaced the next working day with TP014C.

15. The above results show a range of infiltration rates at seven different locations. Observations identified that the results at TP012B improved as the tests took place. This mirrors the results achieved at the adjacent TP012A pit (April 2021 infiltration tests), which demonstrates consistency in the soil characteristics. Although this is unusual, as typically the results reduce as the tests progress at that location, it is possible and may be due to the silt washing away in clusters of more gravely soils, therefore creating more favourable conditions in the infiltration pathway as the three tests progress.

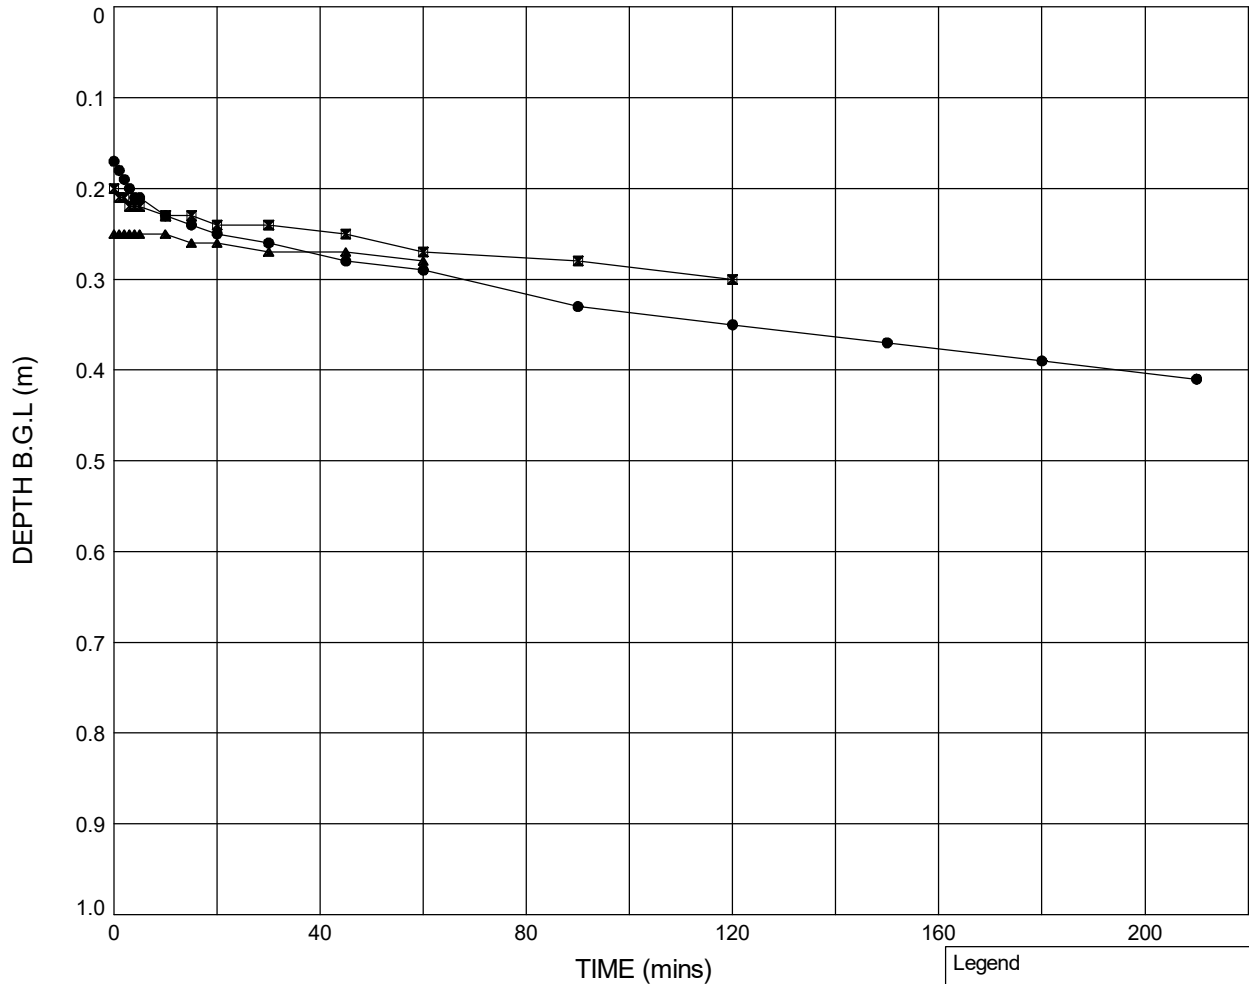
Soakaway Test - Position ID : **TP013B**

## PLOT OF DEPTH OF WATER BELOW GROUND LEVEL AGAINST TIME

Test 1	Test 2	Test 3	
Pit start depth:	= 1.00	1.00	1.00	m
Pit final depth:	= 1.00	1.00	1.00	m
Effective depth, $D_e$	= 0.83	0.80	0.75	m
Effective storage volume, $V_{p75-25}$	= 0.3113	0.3000	0.2813	m <sup>3</sup>
Surface area, $a_{p50}$	= 2.4100	2.3500	2.2500	m <sup>2</sup>
Time, $t_{p75-25}$	= 37350	48000	67500	secs
Infiltration rate, $f$	= $3.46 \times 10^{-6}$	$2.66 \times 10^{-6}$	$1.85 \times 10^{-6}$	m/s

Please note test data was extrapolated to obtain  $t_{p75-tp25}$ .

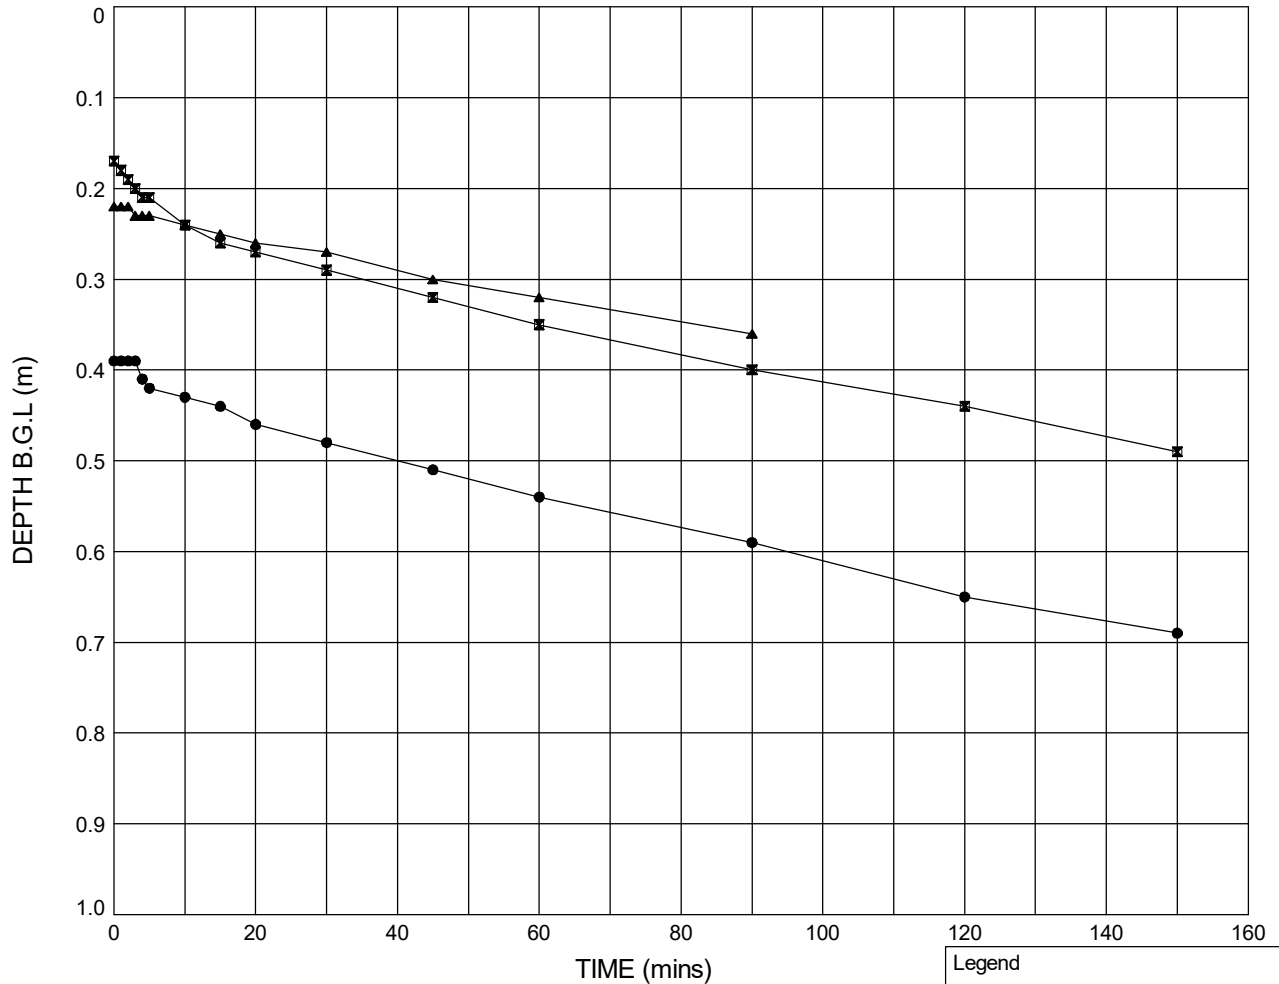
Soakaway Test - Position ID : **TP014C**

## PLOT OF DEPTH OF WATER BELOW GROUND LEVEL AGAINST TIME

Test 1	Test 2	Test 3	
Pit start depth:	= 1.00	1.00	1.00	m
Pit final depth:	= 1.00	1.00	1.00	m
Effective depth, $D_e$	= 0.61	0.83	0.78	m
Effective storage volume, $V_{p75-25}$	= 0.2593	0.3528	0.3315	$m^3$
Surface area, $a_{p50}$	= 2.1920	2.6760	2.5660	$m^2$
Time, $t_{p75-25}$	= 12397	16510	17550	secs
Infiltration rate, $f$	= $9.54 \times 10^{-6}$	$7.98 \times 10^{-6}$	$7.36 \times 10^{-6}$	m/s

Please note test data was extrapolated to obtain  $t_{p75-tp25}$ . Notes: Test 1 - Partial collapse of trial pit during test., Test 3 - Soakaway Terminated at 6:04pm.

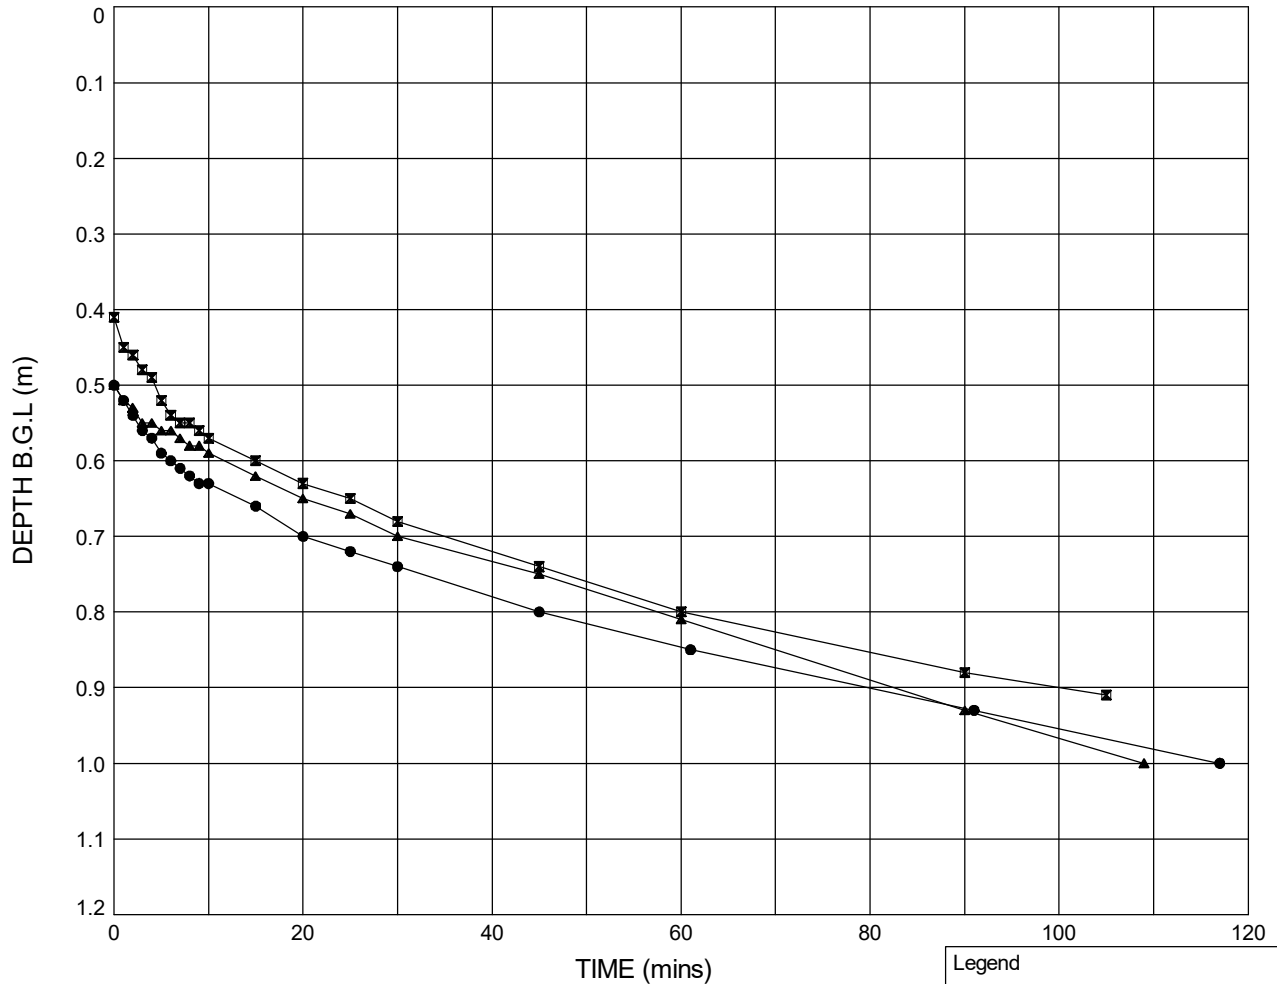
Soakaway Test - Position ID : **TP015B**

## PLOT OF DEPTH OF WATER BELOW GROUND LEVEL AGAINST TIME

Test 1	Test 2	Test 3	
Pit start depth:	= 1.20	1.20	1.20	m
Pit final depth:	= 1.20	1.20	1.20	m
Effective depth, $D_e$	= 0.70	0.79	0.70	m
Effective storage volume, $V_{p75-25}$	= 0.2800	0.3160	0.2800	$m^3$
Surface area, $a_{p50}$	= 2.0600	2.2220	2.0600	$m^2$
Time, $t_{p75-25}$	= 6567	8100	5397	secs
Infiltration rate, $f$	= $2.07 \times 10^{-5}$	$1.76 \times 10^{-5}$	$2.52 \times 10^{-5}$	m/s

Please note test data was extrapolated to obtain  $t_{p75-tp25}$ .

17. For the onshore substations' basin, the average infiltration rate of the lowest test result for TP015B, TP016B and TP017B is 49.3mm/hr. In order to take a conservative approach at this location, the Applicants have agreed a 40mm/hr infiltration rate with the LLFA for drainage calculations at this outline design stage of the Projects, and agreed with the LLFA to progress a hybrid SuDS basin (i.e. a combination of infiltration and attenuation) at this location.

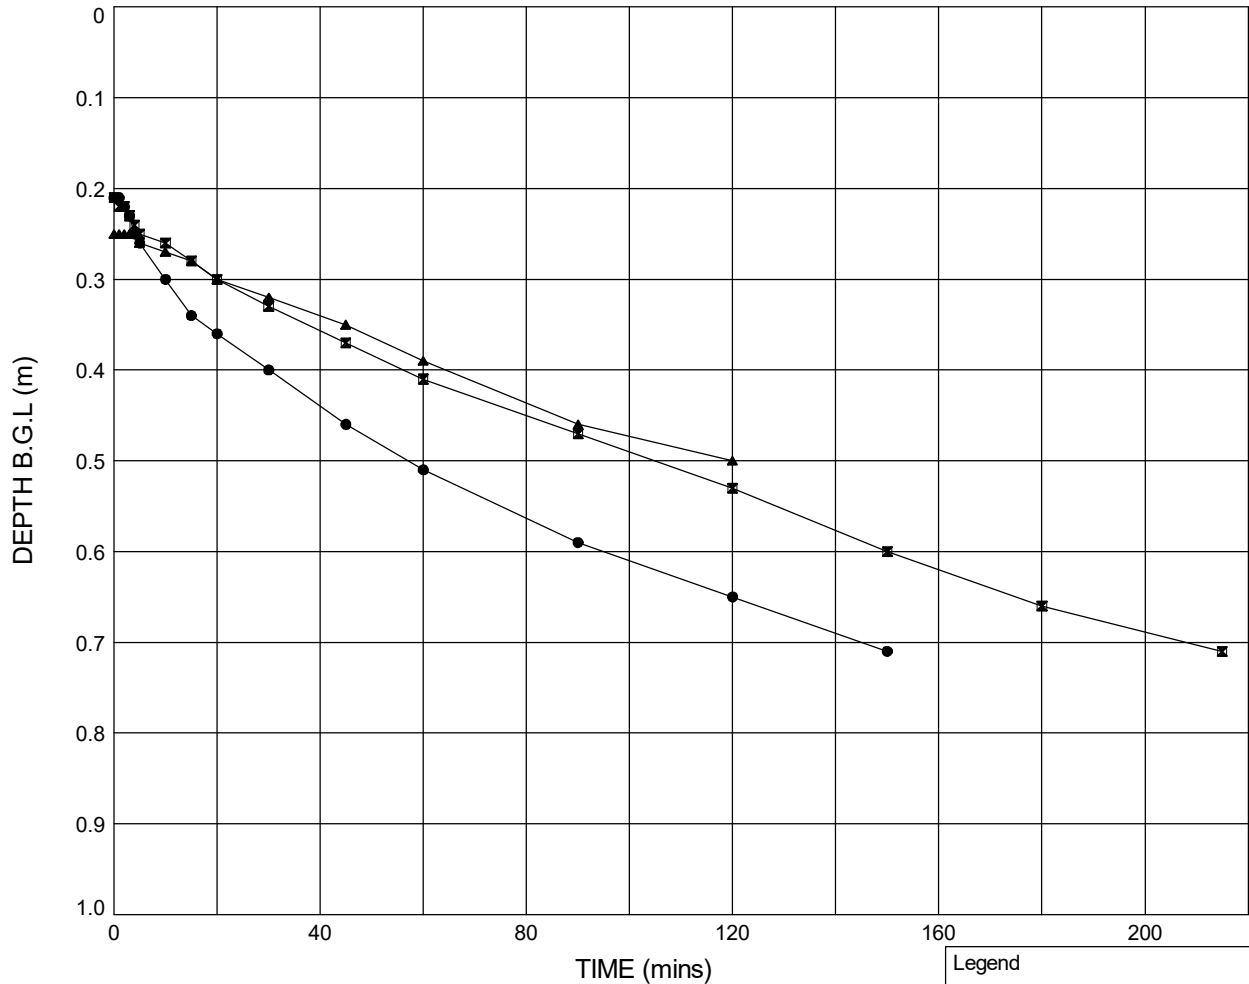
Soakaway Test - Position ID : **TP016b**

## PLOT OF DEPTH OF WATER BELOW GROUND LEVEL AGAINST TIME

Test 1	Test 2	Test 3	
Pit start depth:	= 1.00	1.00	1.00	m
Pit final depth:	= 1.00	1.00	1.00	m
Effective depth, $D_e$	= 0.79	0.79	0.75	m
Effective storage volume, $V_{p75-25}$	= 0.4938	0.4938	0.4688	$m^3$
Surface area, $a_{p50}$	= 3.6200	3.6200	3.5000	$m^2$
Time, $t_{p75-25}$	= 9863	13241	12606	secs
Infiltration rate, $f$	= $1.29 \times 10^{-5}$	$9.60 \times 10^{-6}$	$9.92 \times 10^{-6}$	m/s

Please note test data was extrapolated to obtain  $t_{p75-tp25}$ .

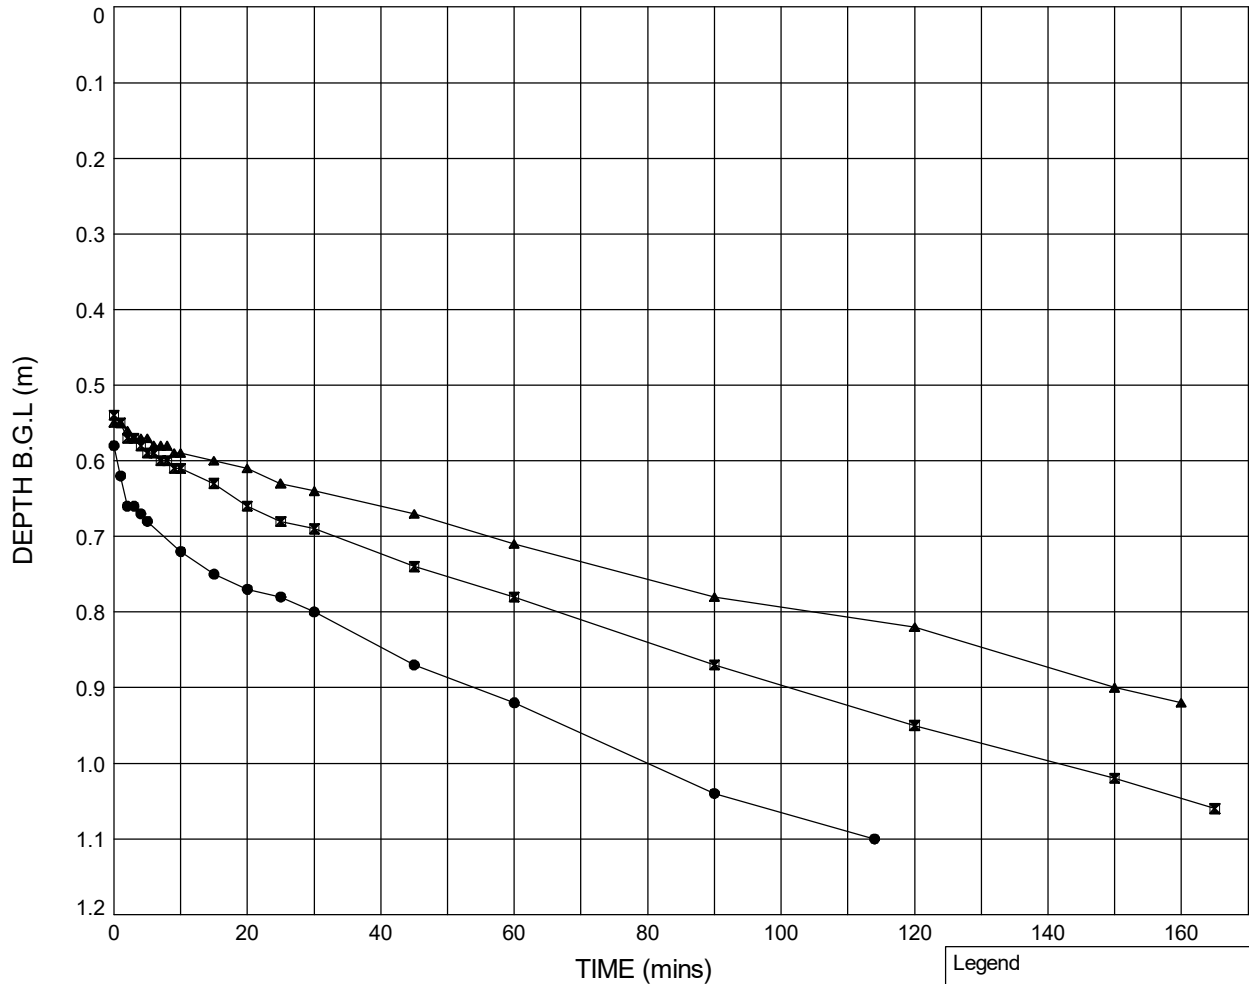
Soakaway Test - Position ID : TP017B

## PLOT OF DEPTH OF WATER BELOW GROUND LEVEL AGAINST TIME

Test 1	Test 2	Test 3	
Pit start depth:	= 1.20	1.20	1.20	m
Pit final depth:	= 1.20	1.20	1.20	m
Effective depth, $D_e$	= 0.62	0.66	0.65	m
Effective storage volume, $V_{p75-25}$	= 0.2480	0.2640	0.2600	$m^3$
Surface area, $a_{p50}$	= 1.9160	1.9880	1.9700	$m^2$
Time, $t_{p75-25}$	= 4770	7267	9461	secs
Infiltration rate, $f$	= $2.71 \times 10^{-5}$	$1.83 \times 10^{-5}$	$1.39 \times 10^{-5}$	m/s

Please note test data was extrapolated to obtain  $t_{p75-tp25}$ .

14. With the exception of TP017B (Test 1 and Test 2), all test results were extrapolated to calculated  $t_{25}$  (the time for the water level to fall to 25% effective storage depth) to aid with the calculation of the infiltration rates at each test location. The real-time recording of water depths at each test pit are illustrated on the graphs within **Appendix 1**, which were recorded from onsite readings.

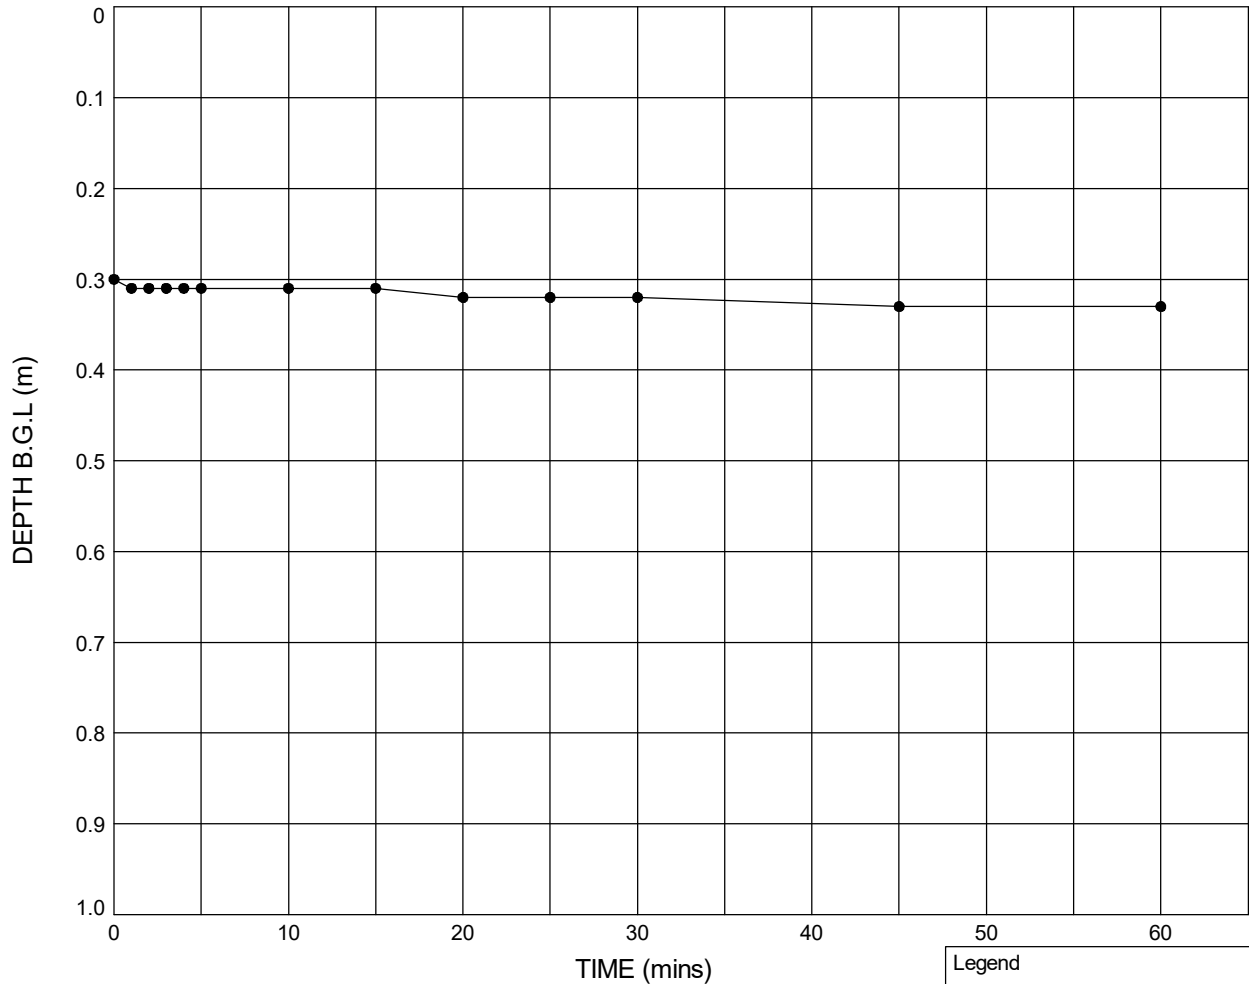
Soakaway Test - Position ID : **TP330B**

## PLOT OF DEPTH OF WATER BELOW GROUND LEVEL AGAINST TIME

Pit start depth: = **1.00** m  
Pit final depth: = **1.00** m  
Effective depth,  $D_e$  = **0.70** m  
Effective storage volume,  $V_{p75-25}$  = **0.2800** m<sup>3</sup>  
Surface area,  $a_{p50}$  = **2.0600** m<sup>2</sup>  
Time,  $t_{p75-25}$  = **63000** secs  
Infiltration rate,  $f$  =  **$2.16 \times 10^{-6}$**  m/s

Please note test data was extrapolated to obtain tp75-tp25.

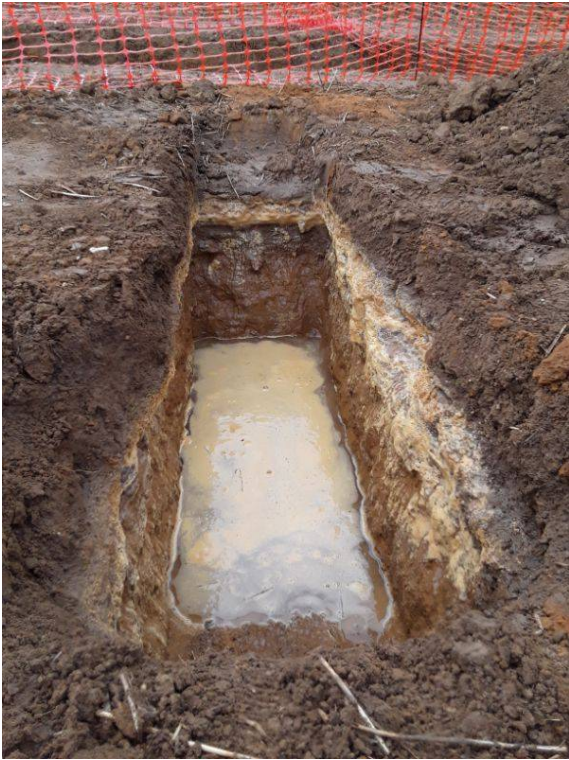
TP013B - Pit

Samples and In-situ Tests				Water	Backfill	Description of Strata	Reduced Level	Depth (Thickness)	Material Graphic Legend
Depth	No	Type	Results						
						Dark brown slightly gravelly silty fine to coarse SAND. Gravel is subangular to rounded fine to coarse flint. (TOPSOIL)	15.43	0.30

Orange silty fine to medium SAND. (LOWESTOFT FORMATION)		(0.70)

14.73	1.00	
						Trial pit completed at 1.00m depth.

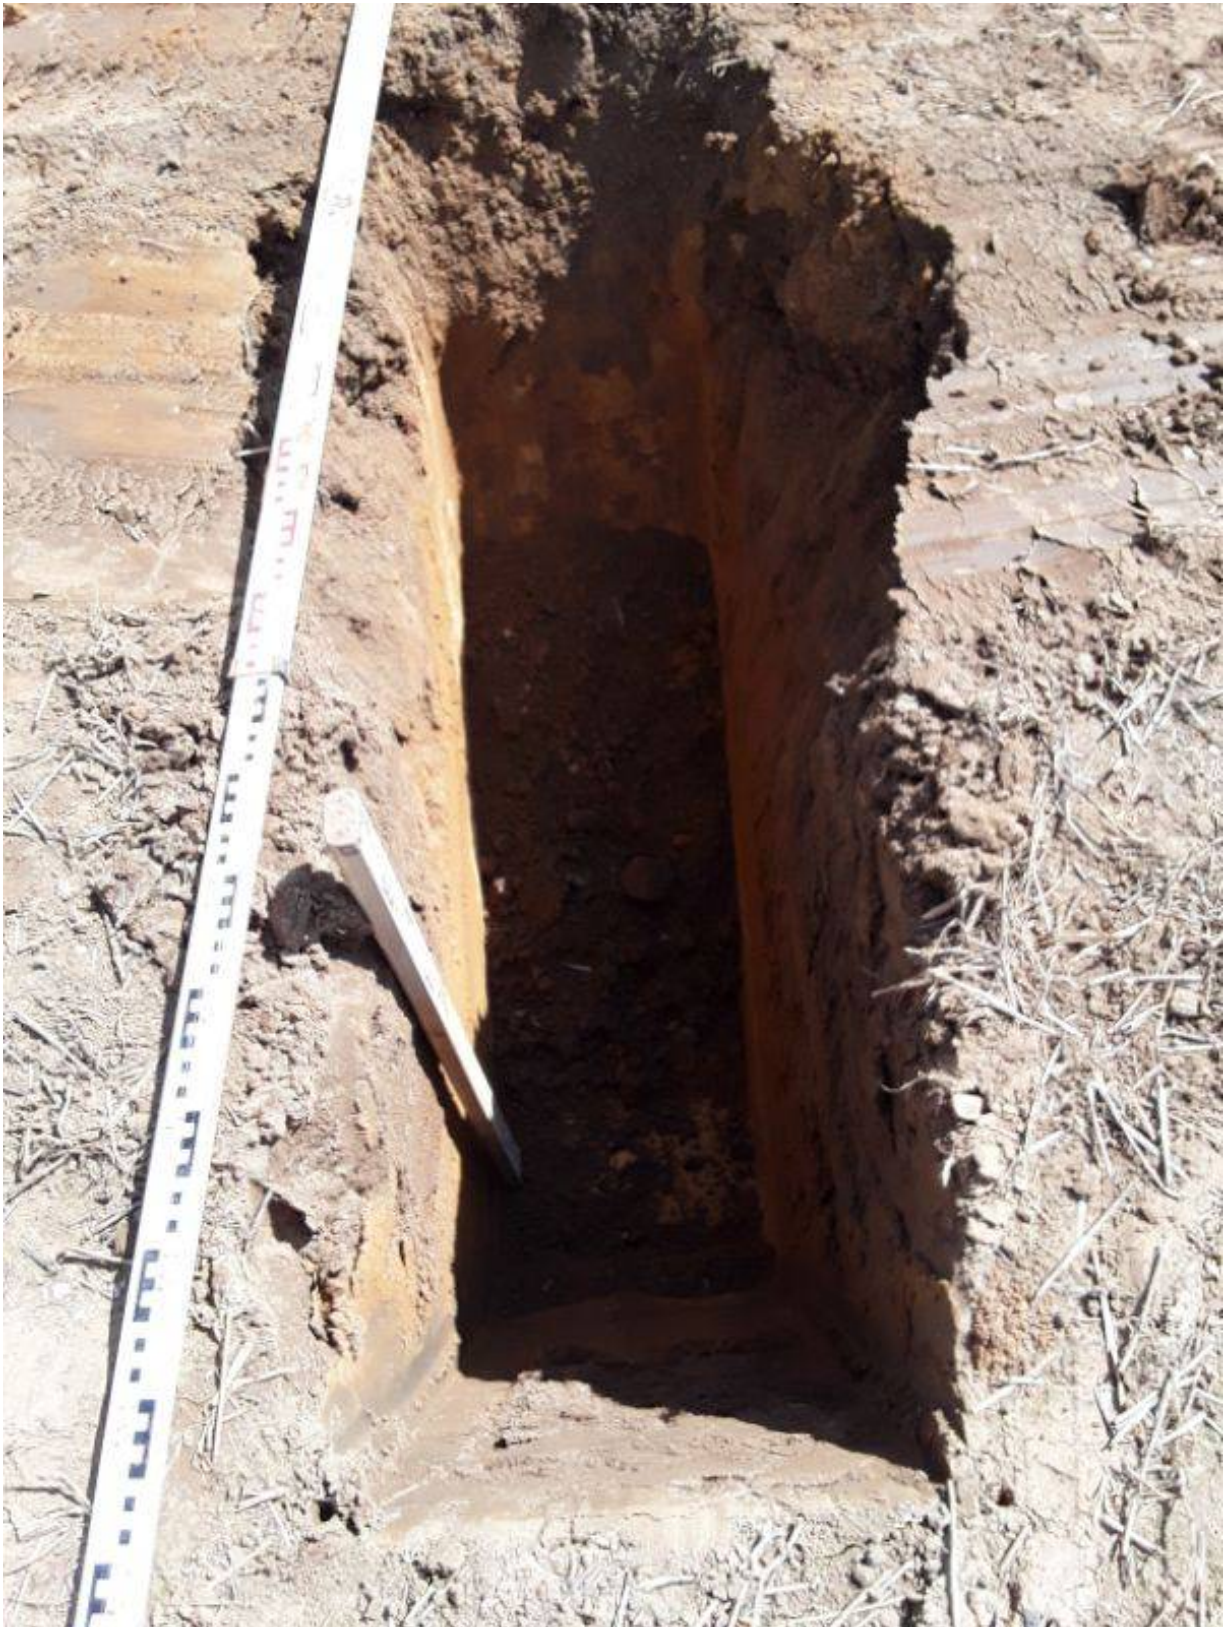
TP014C - Pit - Photo 1

Samples and In-situ Tests				Water	Backfill	Description of Strata	Reduced Level	Depth (Thickness)	Material Graphic Legend
Depth	No	Type	Results						
						Dark brown slightly gravelly silty fine to coarse SAND. Gravel is subangular to rounded fine to coarse flint. (TOPSOIL)	15.24	(0.40)	
						Orange slightly silty gravelly fine to coarse SAND. Gravel is subangular to rounded fine to coarse flint. (LOWESTOFT FORMATION)	14.64	(0.60)	
						Trial pit terminated at 1.00m depth.		1.00
