History of Friston Flooding

Friston Surface Water Study - Technical Report

Synopsis: This report details the Surface Water Study for Friston, Suffolk. The document includes the baseline modelling assessment, assessment of an observed flooding event and validation of the hydraulic model and economic appraisal of flood damages.

Friston Flood Study Report

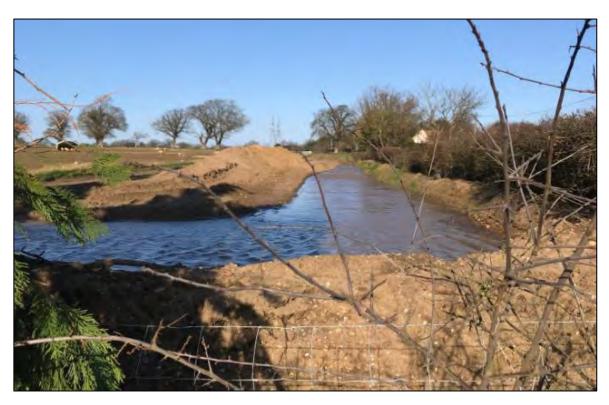
Figure 3-5 - Site visit Photograph of Pig Farm Bund and Basin

Since the flooding event observed in October 2019 a bund and basin within the pig farm off Saxmundham Road proximal to the village has been constructed by the landowner. This informal bund and basin have been added to the current baseline hydraulic model, it has not, however, been added to the validation event as it was not in place at that time. Its purpose is to capture flow coming off the field before it impacts the properties downstream. It was also reported by residents in October 2019 that a large amount of sediment ran off the farmland towards the residential properties downstream. The bund and basin also aim to reduce this.

This feature has been added to the current baseline model for design event analysis from site photographs and sketches from the site visit (Figure 3-5). The height of the bund and depth of the basin have been estimated from the photographs. The location which they have been added to within the model is shown in Figure 3-6.

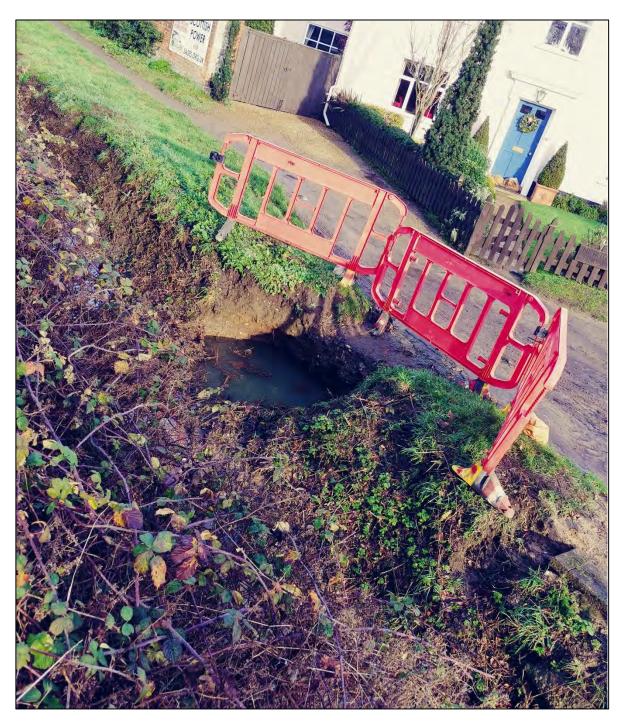
Figure 4-8 - Remnants of attempted remedial works to channel
