Hornsea Project Three Offshore Wind Farm

Environmental Statement:
Volume 6, Annex 5.5 – Screening Assessment – Onshore HVAC Booster Station

PINS Document Reference: A6.6.5.5
APFP Regulation 5(2)(a)

Date: May 2018

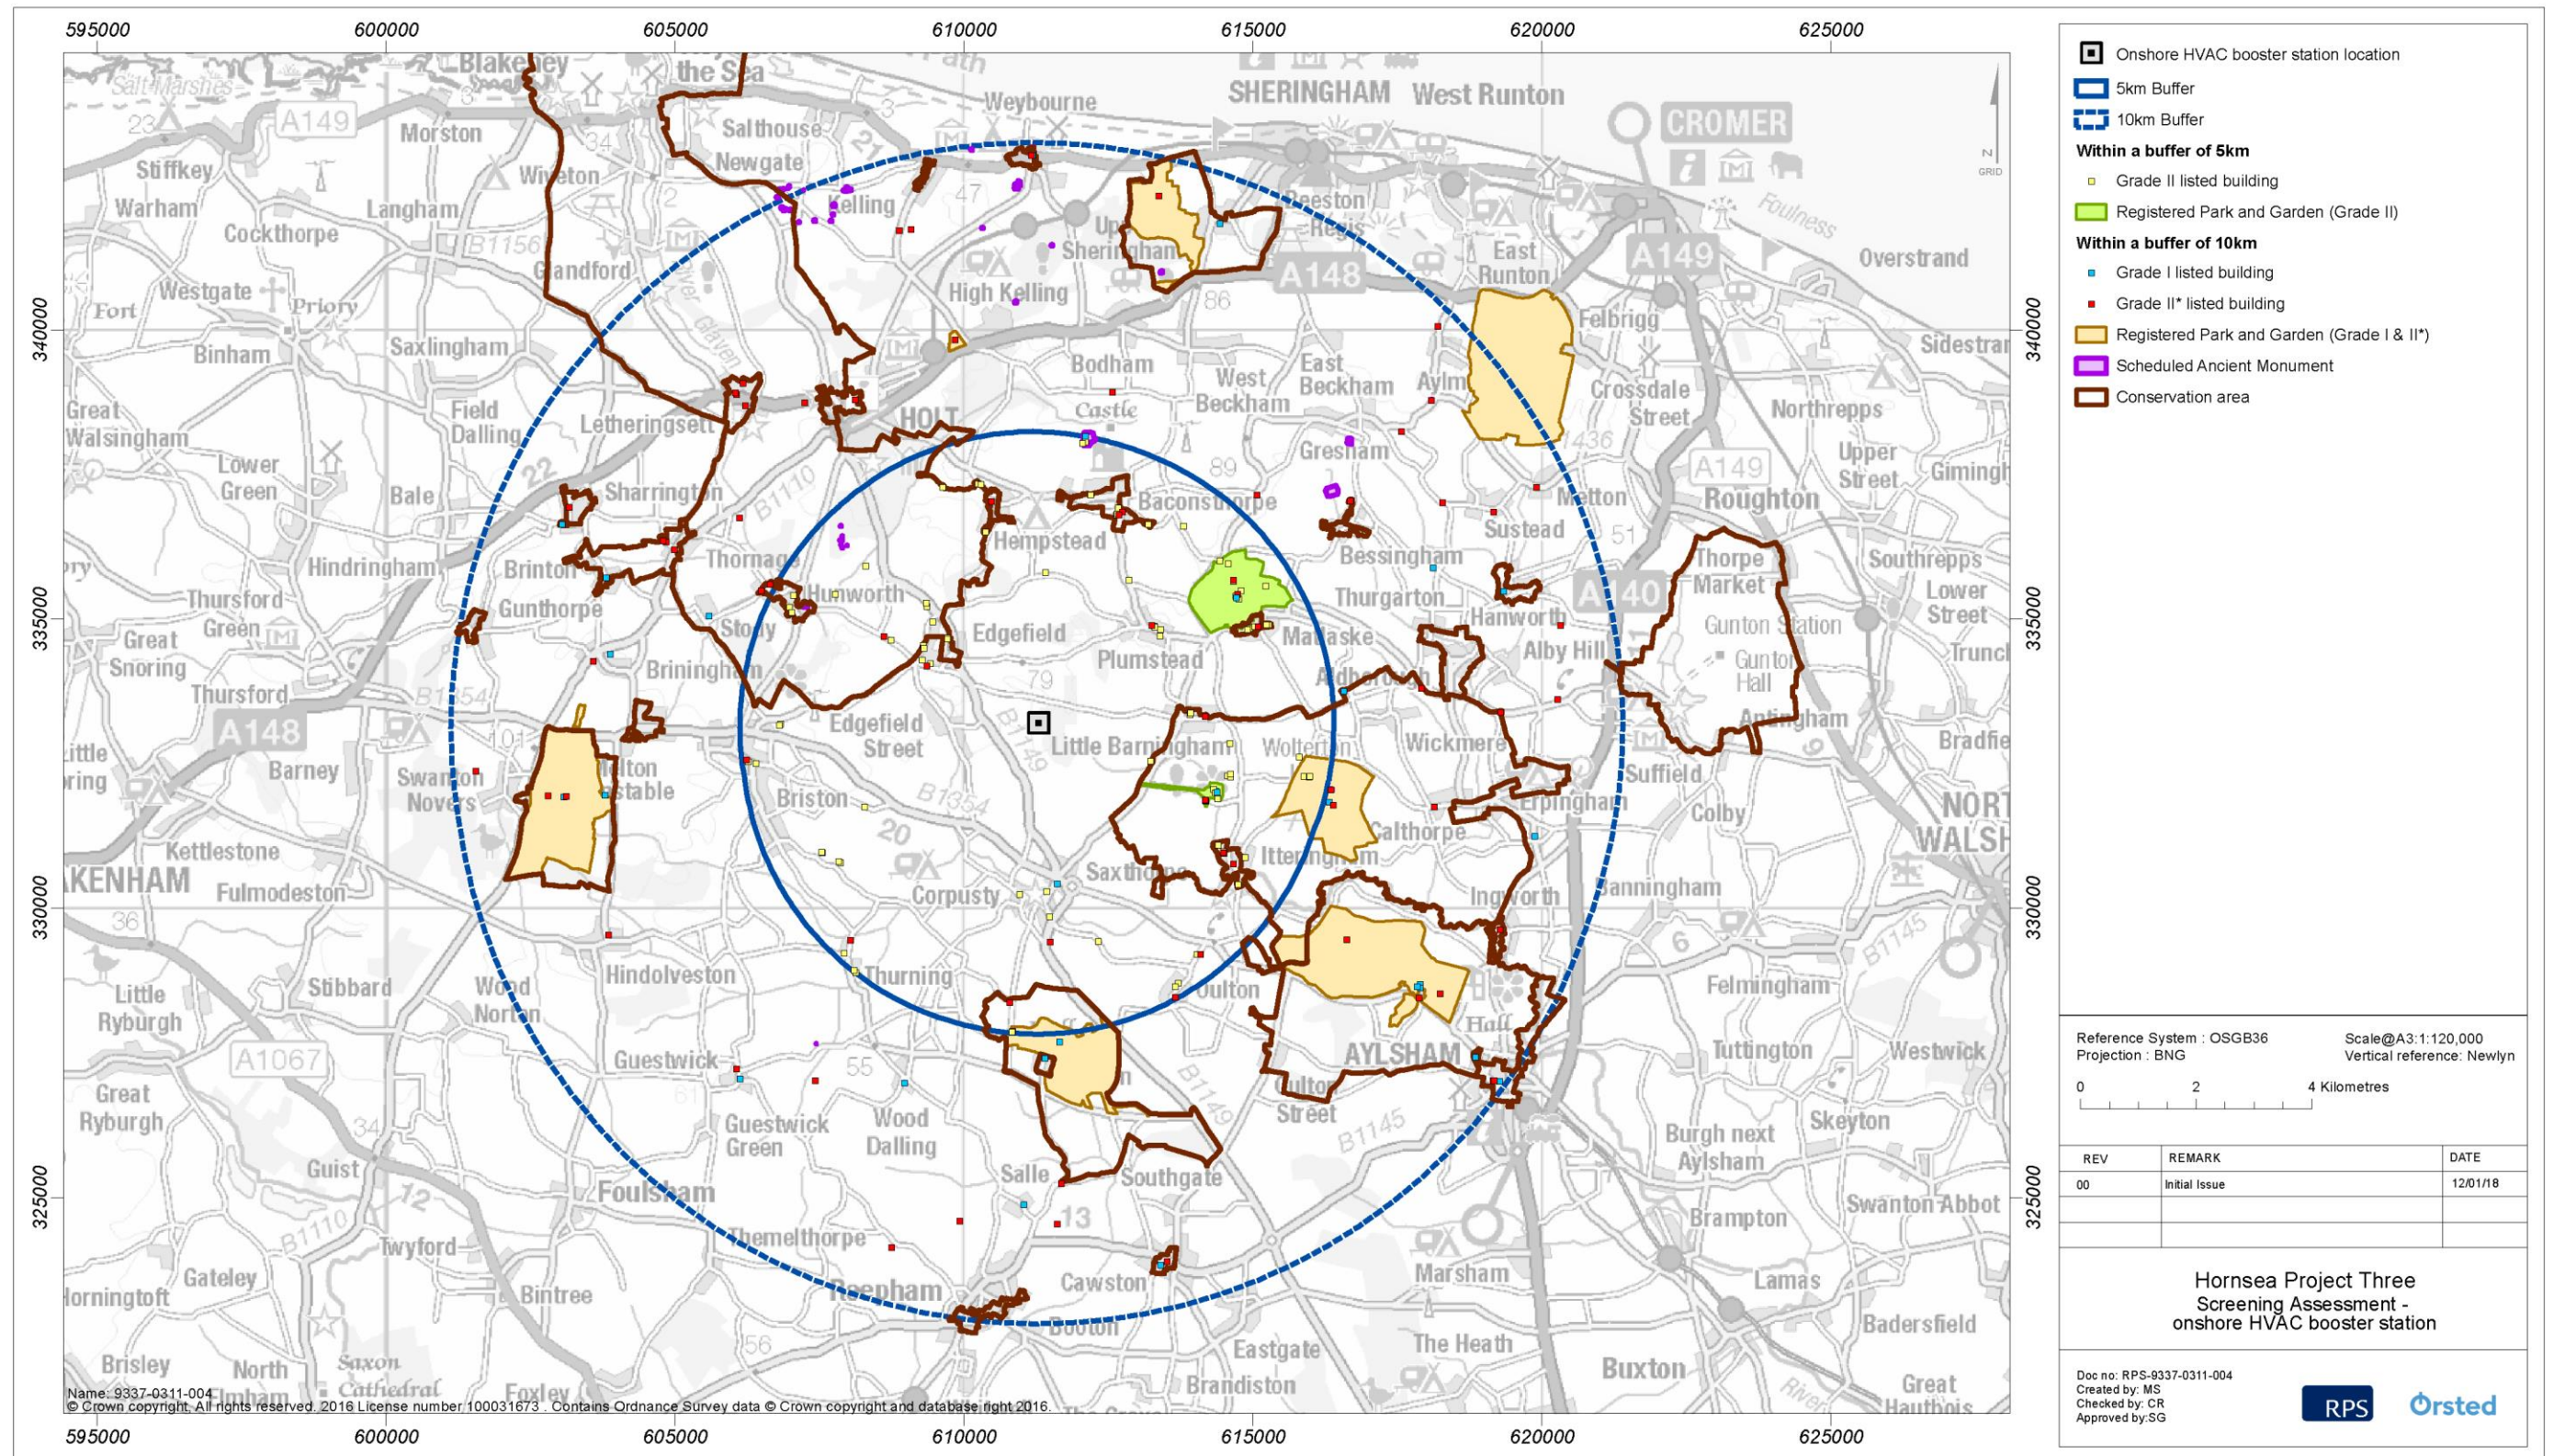
Figure 1.1: Screening Assessment – Onshore HVAC Booster Station.

1.2.1.4 Figure 1.1 at the end of this document shows the locations of the assets listed in Table 1.1 to Table 1.4.
