Hornsea Project Three  
Offshore Wind Farm

### Appendix 25 to Deadline I submission – Onshore HVAC Booster Station Infiltration Report

Date: 7<sup>th</sup> November 2018

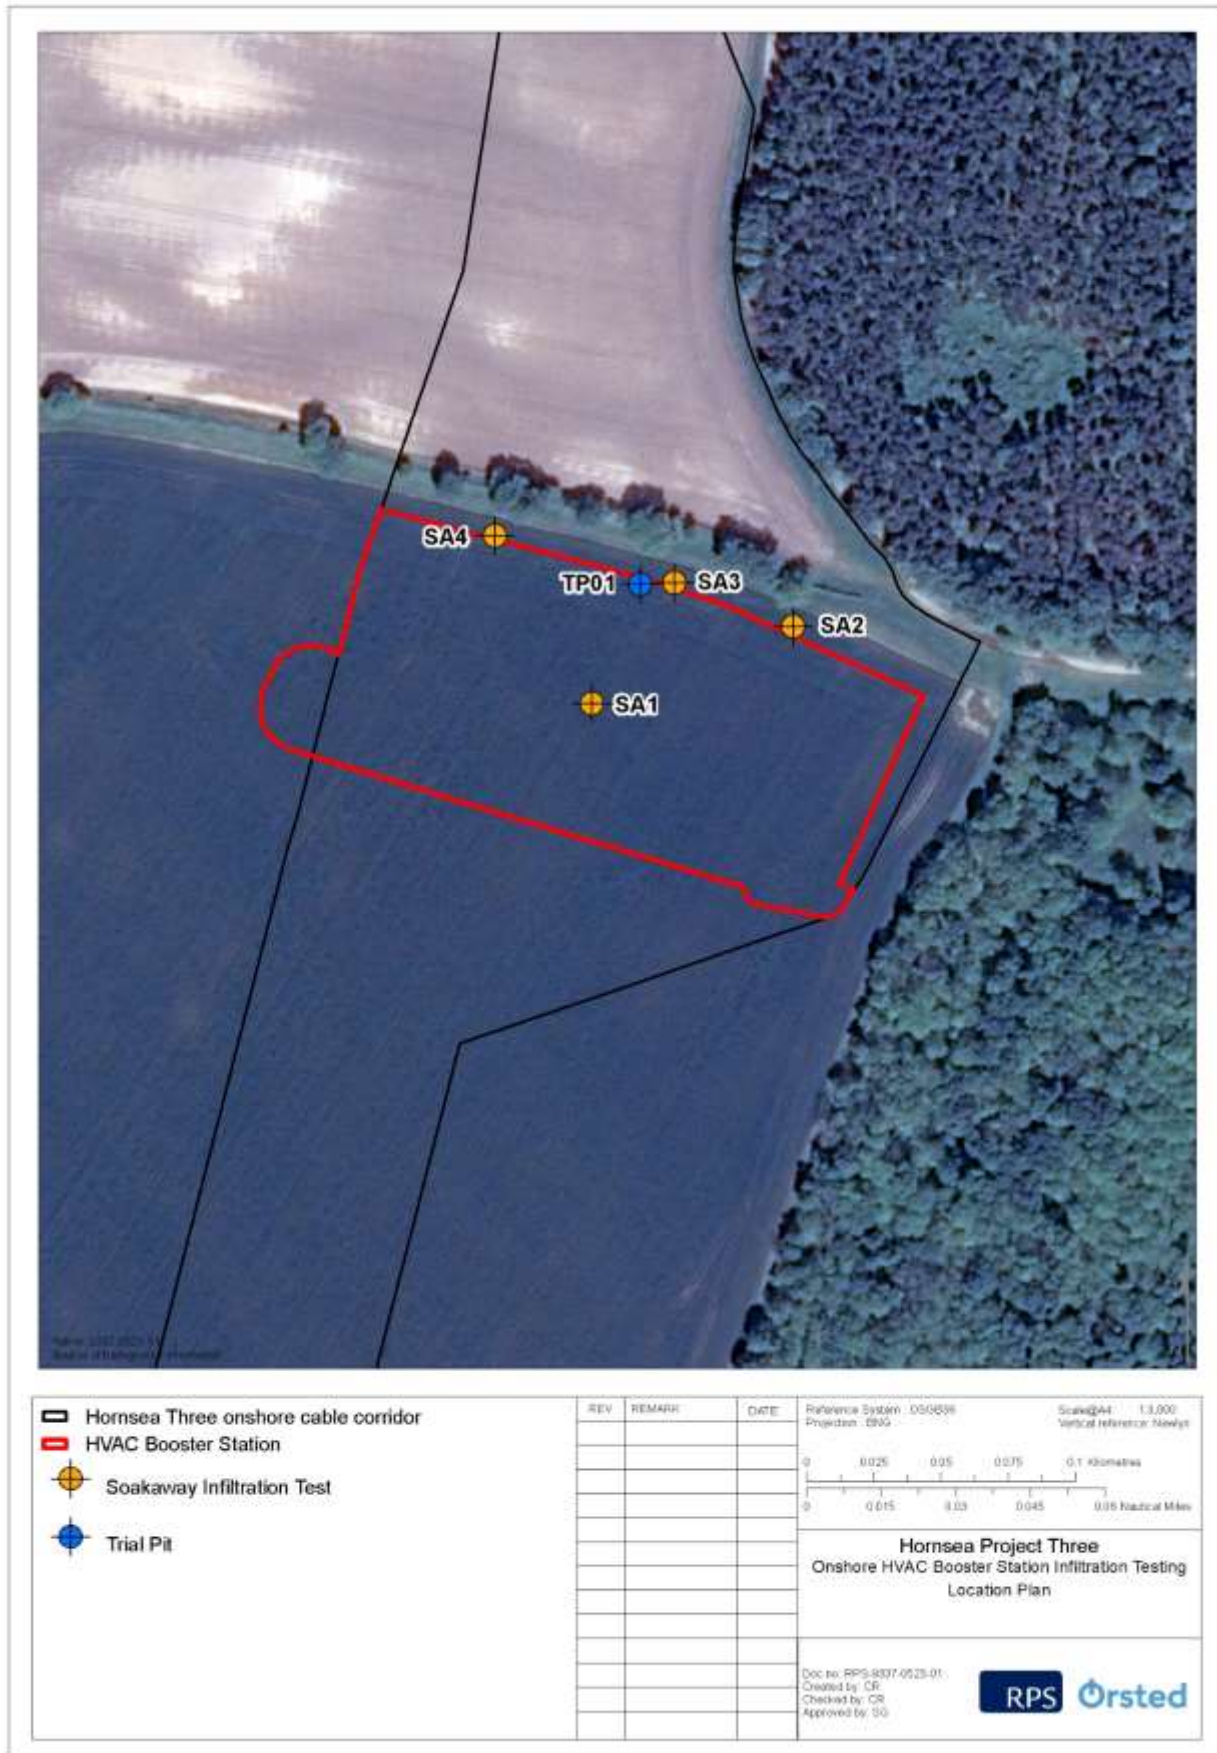
Figure 2.2: Onshore HVAC Booster Station Infiltration Testing Location Plan.

- 2.5 A total of four pits were excavated for the purpose of undertaking infiltration testing between the 23 August 2018 and 24 August 2018. The location of the infiltration test pits was based on the indicative layout of the onshore HVAC booster station (as shown in Appendix A of Volume 6, Annex 2.1: Onshore Infrastructure Flood Risk Assessments (Document Reference A6.6.2.1)) and the potential location of soakaways.

- 2.6 Infiltration test pits were excavated to a maximum depth of 2.6 m bgl: two pits were excavated to 2.6 m bgl, one pit was 2.5 m bgl deep and the remaining pit was excavated to 1.3 m bgl. A shallower depth had been selected in this location (SA3) to assess the feasibility of shallower infiltration. This was based on the strata encountered with the shallower soils containing a lower percentage of fines (indicating a high infiltration potential), compared to the deeper soils which became increasingly cohesive in nature (i.e. indicating a low infiltration potential). In addition, a single trial pit was excavated to a depth of 3.6 m bgl to confirm the geological sequence.

- 2.7 On completion of the testing, the pits were backfilled with the excavation arisings.
- 2.8 The location of the onshore HVAC booster station area, and the infiltration test pits/trial pit are shown in Figure 2.1 and Figure 2.2 respectively. Test and trial pit logs are included in Appendix A.

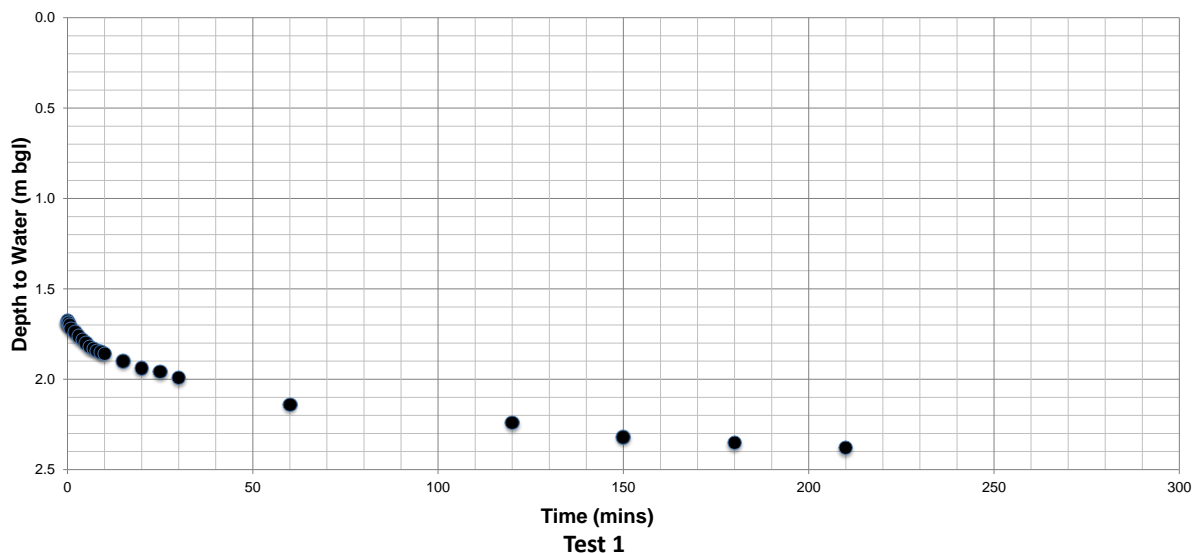
Client:	Orsted	Report Ref:	RCEI64177.003	<b>SA4</b>
Site:	Hornsea 3 HVAC Booster Station	Date:	30 August 2018

Remarks: Test 1 recorded an infiltration rate, however, the second test failed to drain to a 25% effective depth over the period of the test

Test 1	Test 2	Test 3
Dimensions of Trial Pit:	Depth (m)	2.60	2.60	2.60
	Width (m)	0.45	0.45	0.45
	Length (m)	2.00	2.00	2.00
Effective Depth (m)		0.92	0.92	0.92
$V_{p75-25}$ : volume of the trial pit between 75% and 25% of the effective depth (m <sup>3</sup> )		0.41	0.41	0.41
$a_{p50}$ : internal surface area of trial pit up to 50% effective depth (m <sup>2</sup> )		3.15	3.15	3.15
$t_{p75-25}$ : time for water to fall from 75% to 25% effective depth (secs)		86625	Not achieved	
$f$ : Soil Infiltration Rate (ms <sup>-1</sup> )		1.52E-06

3.6 Test pit SA4 located in the north west of the onshore HVAC booster station area achieved infiltration between the 75% and 25% fill level, however the second run of the test recorded significantly reduced drainage with the test draining to the 75% level over the course of four hours, whereas the first test run had completely drained within three and a half hours. A third test was not undertaken due to the limited the infiltration rate recorded during the second run. The results of the testing undertaken indicates that limited infiltration is likely in this area.
