Hornsea Project Three Offshore Wind Farm

Appendix 5 to Deadline 1 submission - The Wash and North
Norfolk Coast SAC - Baseline and impacts of cable installation
Clarification Note

Date: 7th November 2018

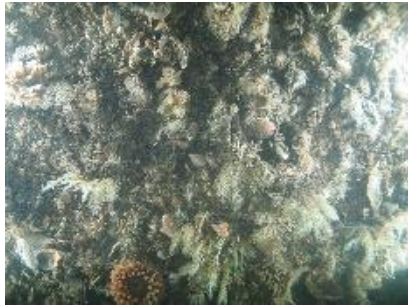
Site	Sediment Description	Elevation (mm)	Composition (%)	Biota present	Representative photo	Reef definitions		Reefiness
						Elevation	Composition	
1	msG (mixed sediment) Muddy sandy gravel with shell fragments	<64mm	0%	<i>A. diaphanum</i> , <i>F. foliacea</i> , <i>Actinaria</i> spp., <i>Trochoidea</i> spp., <i>Brachyura</i> spp., <i>Inachidae</i> spp., <i>Caridea</i> spp., <i>C. papposus</i> , <i>A. rubens</i> and hydroids.

2.27 Sediments at Site 1, the most southernly location sampled during the 2018 survey within the Hornsea Three offshore cable corridor (Figure 2.1), were a mix of sands and gravels, with shell fragments and varying proportions of finer sediments (e.g. fine sand and mud). The sediments at Site 1 were considered as broadly comprising muddy sandy gravel (msG) and overall as mixed sediments according to the simplified Folk sediment classification (from Long, 2006). The epifaunal community recorded included hydroids, bryozoans *A. diaphanum* and *F. foliacea*, sea anemones *Actiniaria* spp. and mobile species including top shell *Trochoidea* spp. crustaceans *Brachyura* spp., *Inachidae* spp. and *Caridea* spp. and starfish *C. papposus* and *A. rubens*. Although pebbles and cobbles were recorded at this site, the elevation of the seabed was less than 64 mm. As outlined in Table 2.3, Site 1 was scored as 'not a reef' in all the relevant characteristic assessments (i.e. elevation and composition) and, therefore according to the guidelines set out by Irving, 2009 and the criteria in Table 2.2, the seabed at Site 1 was not considered to constitute an Annex I stony reef.

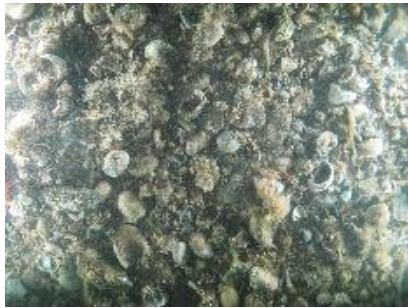
Not a reef	Not a reef	Not a reef
2	msG (mixed sediment) Muddy sandy gravel with shell fragments and occasional cobbles	<64mm	6.80%	<i>A. diaphanum</i> , <i>F. foliacea</i> , <i>Actinaria</i> spp., <i>Sagartiidae</i> spp., <i>Brachyura</i> spp., <i>Caridea</i> spp., <i>C. papposus</i> , <i>A. cataphractus</i> and hydroids.

- 2.28 The sediments recorded at Site 2 (see Figure 2.1) were also predominately characterised by a mix of sands and gravels with shell fragments and occasional cobbles; the composition of cobbles was estimated at approximately 6.8%. Finer sediments were present and the sediments were considered as broadly comprising msG or mixed sediments according to the simplified Folk sediment classification. The epifaunal community recorded was characterised by hydroids, bryozoans *A. diaphanum* and *F. foliacea*, anemones *Actiniaria* spp. and *Sagartiidae* spp. and mobile species including crustaceans *Brachyura* spp. and *Caridea* spp., starfish *C. papposus* and one recorded fish species, pogue *Agonus cataphractus*. Whilst there were cobbles present at this site, they were not present in high enough quantities (i.e. >10%; see Table 2.2) or with sufficient elevation (i.e. > 64 mm; see Table 2.2) to constitute Annex I reef. As outlined in Table 2.3, Site 2 was scored as 'not a reef' in all the relevant characteristic assessments (i.e. elevation and composition) and, therefore, according to the guidelines set out by Irving, 2009 and Jenkins *et al.* (2015) and the criteria in Table 2.2, the seabed at Site 2 was not considered to constitute an Annex I stony reef.

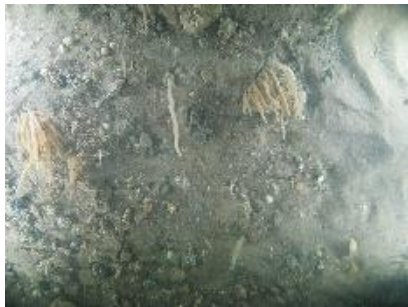
Not a reef	Not a reef	Not a reef
3	gmS (mixed sediment) Gravelly muddy sand with shell fragments and few cobbles	<64mm	2.60%	<i>Actinaria</i> spp., <i>F. foliacea</i> , <i>Actinaria</i> spp., <i>A. rubens</i> and hydroids.

- 2.29 A review of the photographic stills and video footage for Site 3 indicated a homogenous area of gravelly muddy sand sediment with shell fragments and few cobbles (approximately 2.6%). The site was classified as mixed sediment according to the simplified Folk sediment classification. The sediments at Site 3 had a higher sand content and reduced gravel content, compared to Sites 1 and 2, and as such also had reduced epifaunal communities (i.e. fewer species recorded and in lower abundances) associated with the sediment. The epifaunal communities present were characterised by hydroids and bryozoans *A. diaphanum* and *F. foliacea* and anemones *Actiniaria* spp. all typically recorded as Rare according to the SACFOR scale. Due to the low composition of cobbles at this site, and in line with the guidance described in paragraph 2.19 and Table 2.2, Site 3 was scored as 'not a reef' in all the relevant characteristic assessments (Table 2.3) and, therefore, does not constitute Annex I stony reef.

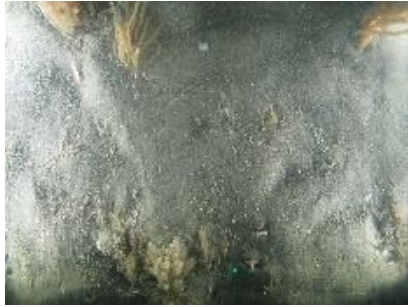
Site	Sediment Description	Elevation (mm)	Composition (%)	Biota present	Representative photo	Reef definitions		Reefiness
						Elevation	Composition	
4	(g)mS (Mixed sediment) Slightly gravelly muddy sand with ripples and few shell fragments	<64mm	2.40%	<i>A. diaphanum</i> , <i>F. foliacea</i> , <i>Actiniaria</i> spp., <i>Inachidae</i> spp. and hydroids.

- 2.30 The sediments at Site 4 comprised predominantly gravelly muddy sands (gmS) with ripples and a few shell fragments. According to the simplified Folk classification, Site 4 was broadly classified as mixed sediment. The epifaunal community recorded in the DDV stills and video footage comprised hydroids and the bryozoans *A. diaphanum* and *F. foliacea*, as well as anemones *Actiniaria* spp. and crustaceans *Inachidae* spp. No reef features were identified, as a result Site 4 does not constitute as an Annex I stony reef. As outlined in Table 2.3, Site 4 was scored as 'not a reef' in all the relevant characteristic assessments (i.e. elevation and composition) and, therefore, according to the guidelines set out by Irving, 2009 and Jenkins *et al.* (2015) and the criteria in Table 2.2, the seabed at Site 4 was not considered to constitute an Annex I stony reef.

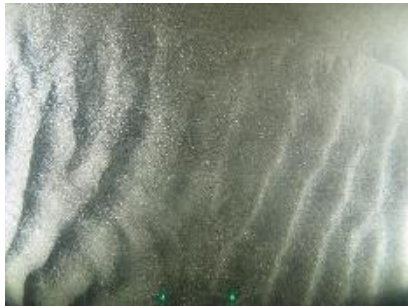
Not a reef	Not a reef	Not a reef
5	(g)S (coarse sediment) Slightly gravelly sand with ripples	<64mm	0%	No infauna or epifauna visible.

- 2.31 Site 5, the most northerly location sampled in the Hornsea Three 2018 DDV survey (see Figure 2.1), was characterised by coarse sediments, predominantly gravelly sand gS with ripples. Following a review of the photographs and video records, no infauna or epifauna was recorded at this site. As outlined in Table 2.3, Site 5 was scored as 'not a reef' in all the relevant characteristic assessments (i.e. elevation and composition) and, therefore, according to the guidelines set out by Irving, 2009 and Jenkins *et al.* (2015) and the criteria in Table 2.2, the seabed at Site 5 was not considered to constitute an Annex I stony reef.

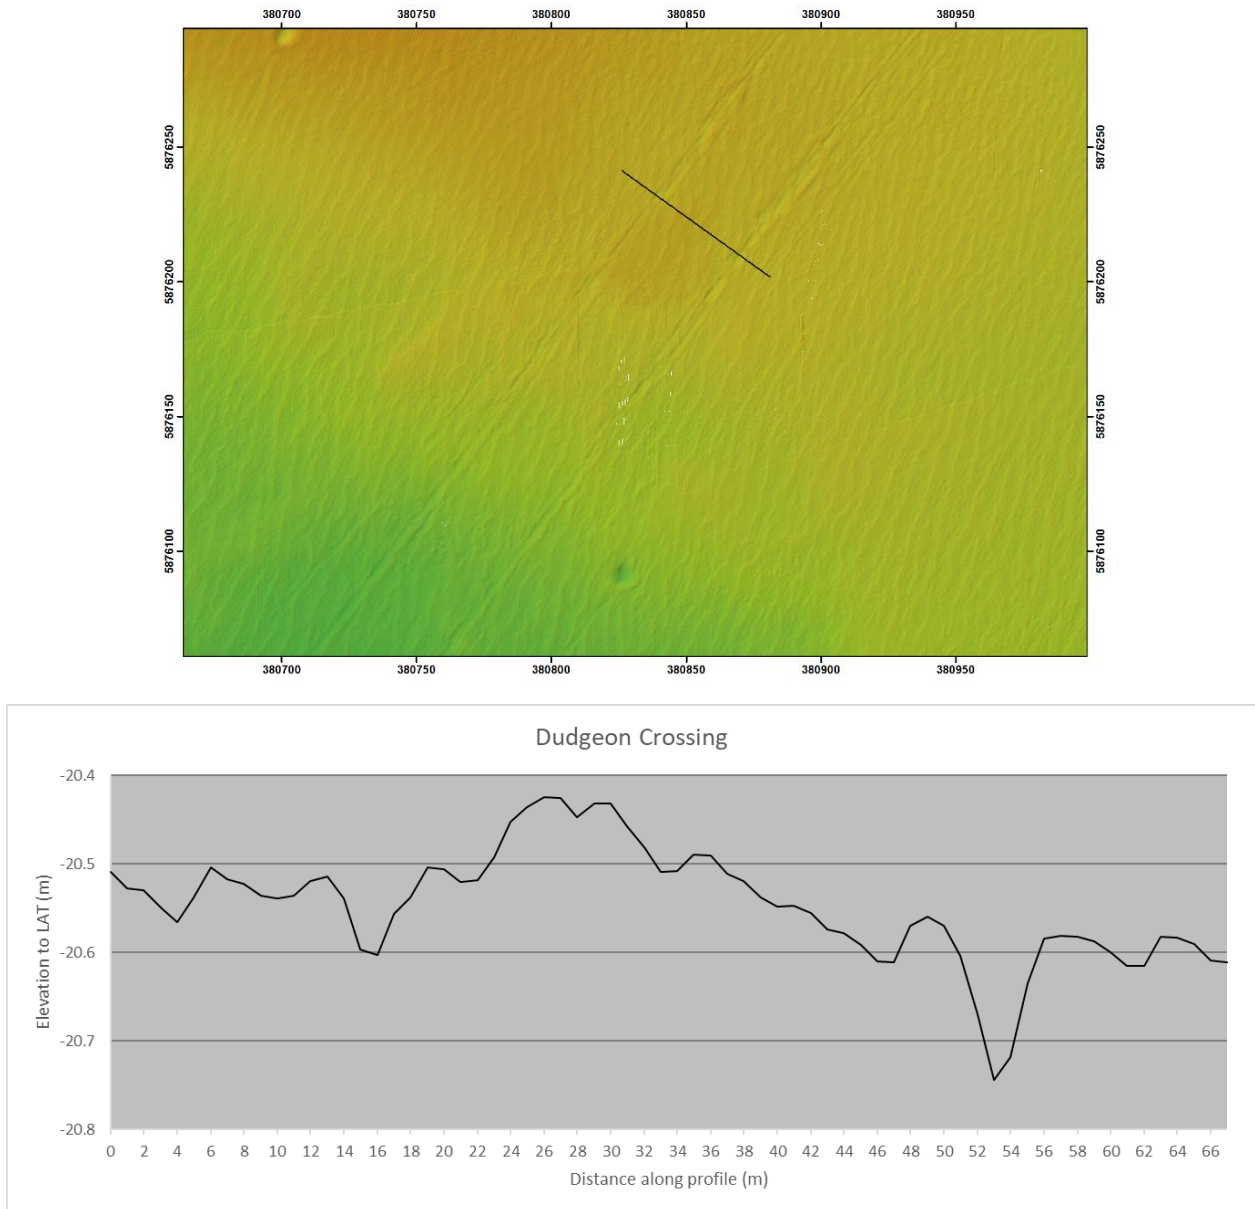
Figure 3.6: Bathymetry (top) and profile (bottom; distance along seabed in metres (x-axis) and depth of seabed in metres (y-axis)) over Dudgeon offshore wind farm export cables approximately 8.5 km offshore (see Profile E in Figure 3.1).

3.17 Figure 3.6 presents the bathymetry and profiles across remnant trenches from the installation of the Dudgeon offshore wind farm export cables in 2016 (Profile E on Figure 3.1). The geophysical data indicates that that the width of each area affected by trenching is approximately 10 m within which the profile of the sediment is only marginally reduced, relative to the surrounding sediment (i.e. by approximately 10 to 20 cm). Given that the geophysical data shown in Figure 3.6 was collected in 2016, the situation shown represents the state of the seabed less than one year following cable installation. On this basis, rapid recovery of the topography of the seabed has occurred within a matter of months.

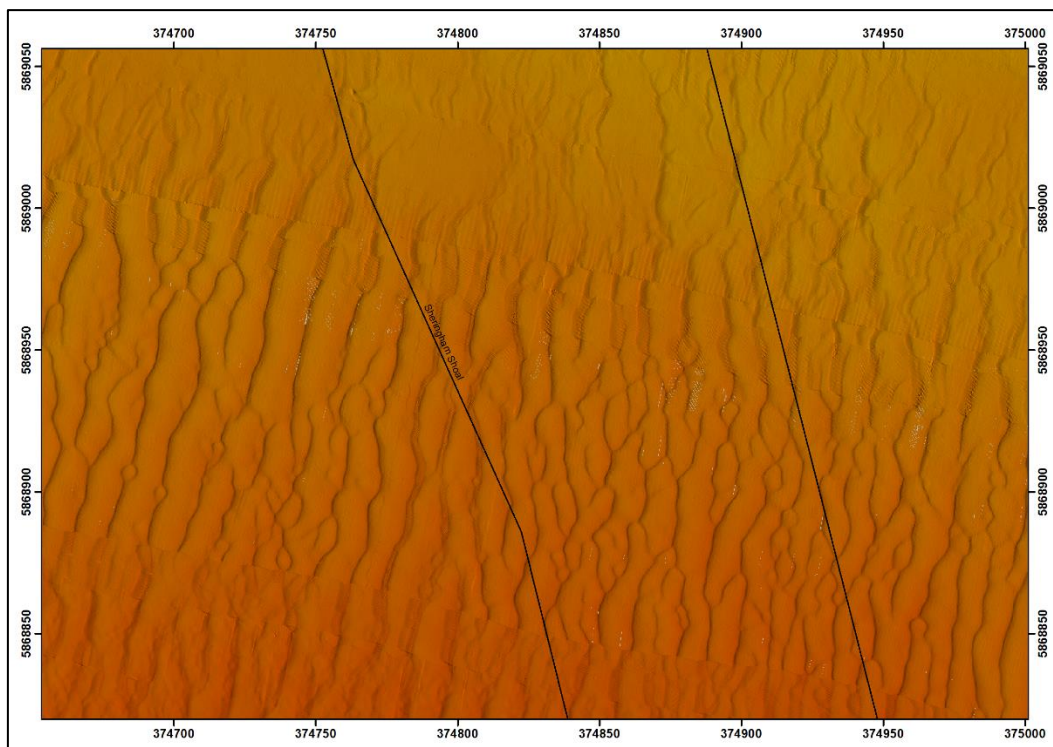
Figure 3.8: Bathymetry over Sheringham Shoal offshore wind farm export cables in the nearshore (see Area G in Figure 3.1 approximately 500 m offshore).

3.18 Figure 3.7, Figure 3.8, Figure 3.9 and Figure 3.10 present the bathymetry over the Sheringham Shoal offshore wind farm export cables at various distances offshore (see Figure 3.1). Interrogation of the geophysical data indicates complete burial of these cables beneath the bedforms and no change in bedform pattern as a result of cable trenching. Furthermore, there is no evidence of any wider alteration to seabed features beyond the very small immediate area, within which cables have been installed.
