HORNSEA PROJECT THREE OFFSHORE WIND FARM

Planning Inspectorate Reference: EN010080

**Annex D7: Natural England detailed comments on ES benthic
characterisation of the nearshore cable corridor.**

7 November 2018

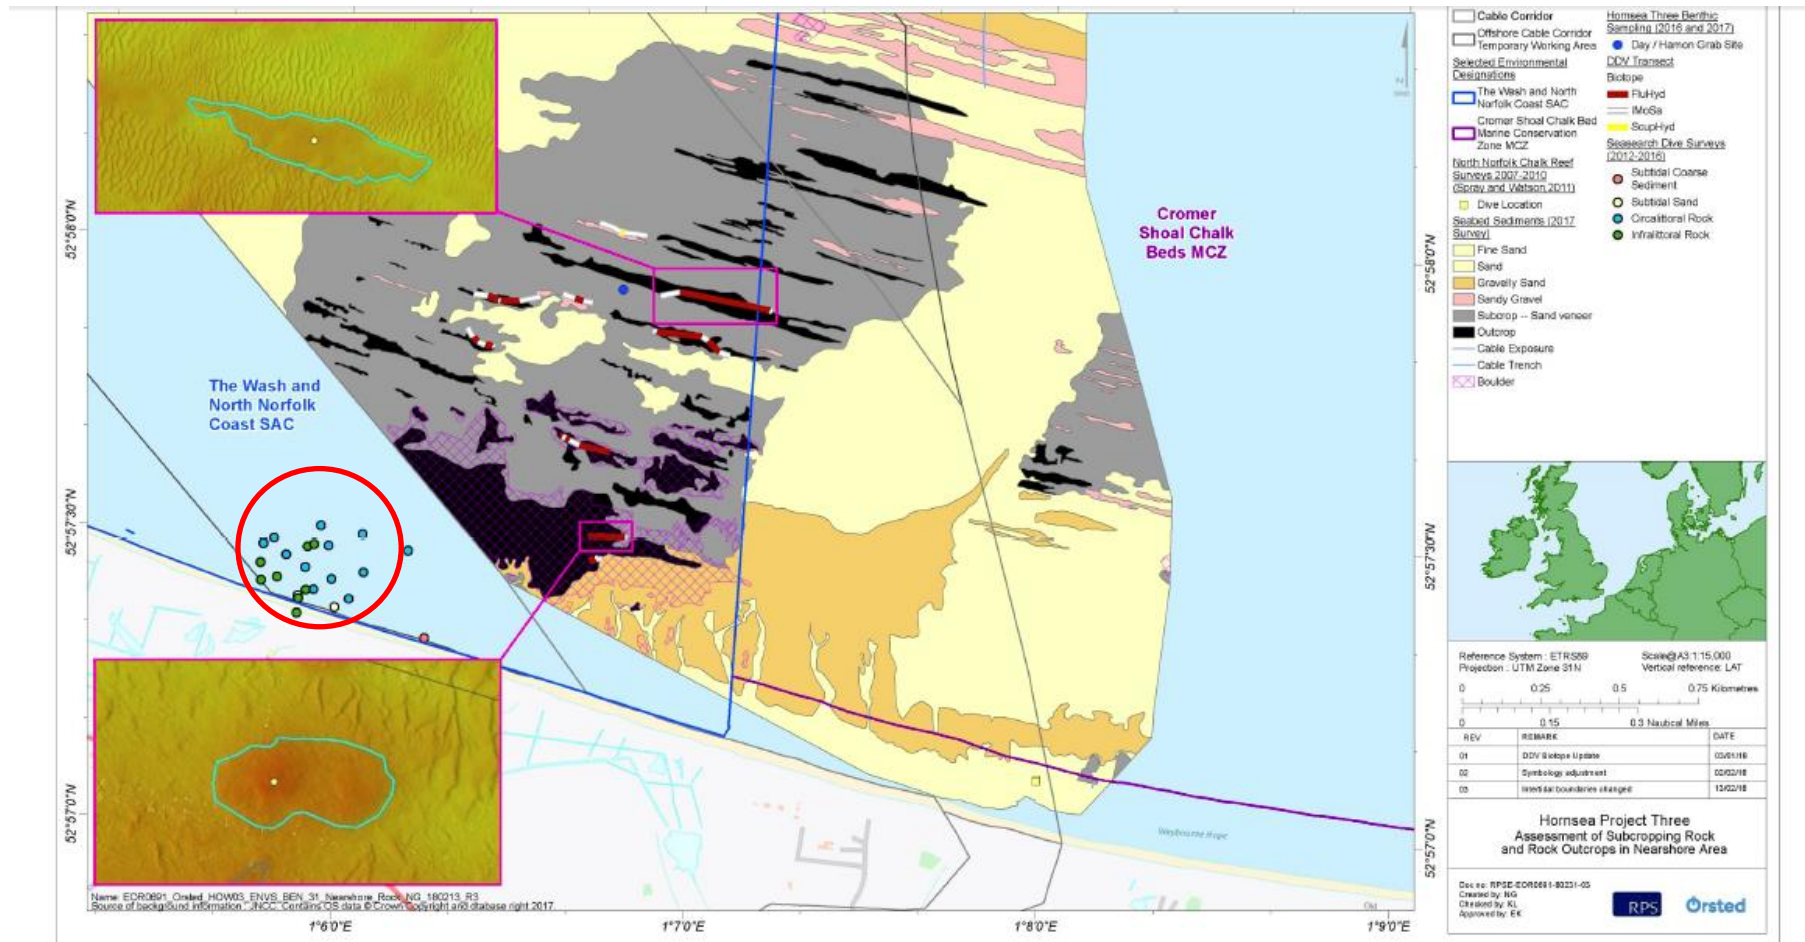
4.1 Reproduced Figure 4.29 from Hornsea Project 3 Offshore windfarm Environmental Statement: Volume 5, Annex 2.1 - Benthic Ecology Technical Report.

Figure 4.29: Hornsea Three nearshore geophysical seabed interpretation showing subcropping rock (grey) and areas of potential outcrop (black), DDV ground truthing transects with epifaunal biotopes identified and historic records of infralittoral and circalittoral rock in the nearshore area.

2.2.2. There are contradictions in figures 4.28 and 4.29; the geophysical data available does not support the extrapolation and extensions of the biotopes. In some cases these habitats contradict each other. **See Section 4.**

2.2.3. The underlying geophysical data provided in Figure 4.29 does not extend into the cable corridor 'buffer/margin' on the west side, yet the biotopes from individual grab samples some from the Dudgeon and Sheringham OWF cable routes (located considerably further around the coast) have been extended in to this. The lack of geophysical and ground truthed data along the actual cable route means we have little confidence in the biotope map provided.

The areas circled in red show 2 different habitats in the same location. Figure 2.29 shows circalittoral rock and infralittoral rock from seasearch samples and rock outcrops with sand veneers. In addition Figure 4.29 has data from the 2017 seabed sediments survey which shows subcrop and outcropping rock as well as some sand and fine sand. In contrast in the same location Figure 2.28 shows subtidal sand. These obviously contradict each other and need to be resolved to understand the impacts and feasibility of installing a cable in this location.
