Appendix 32 to Deadline 7 submission – Dudgeon Offshore  
Wind Farm Cable Route Geophysical Survey

**DUDGEON OFFSHORE WIND FARM**

**EXPORT CABLE ROUTE**

**SURVEY REPORT**

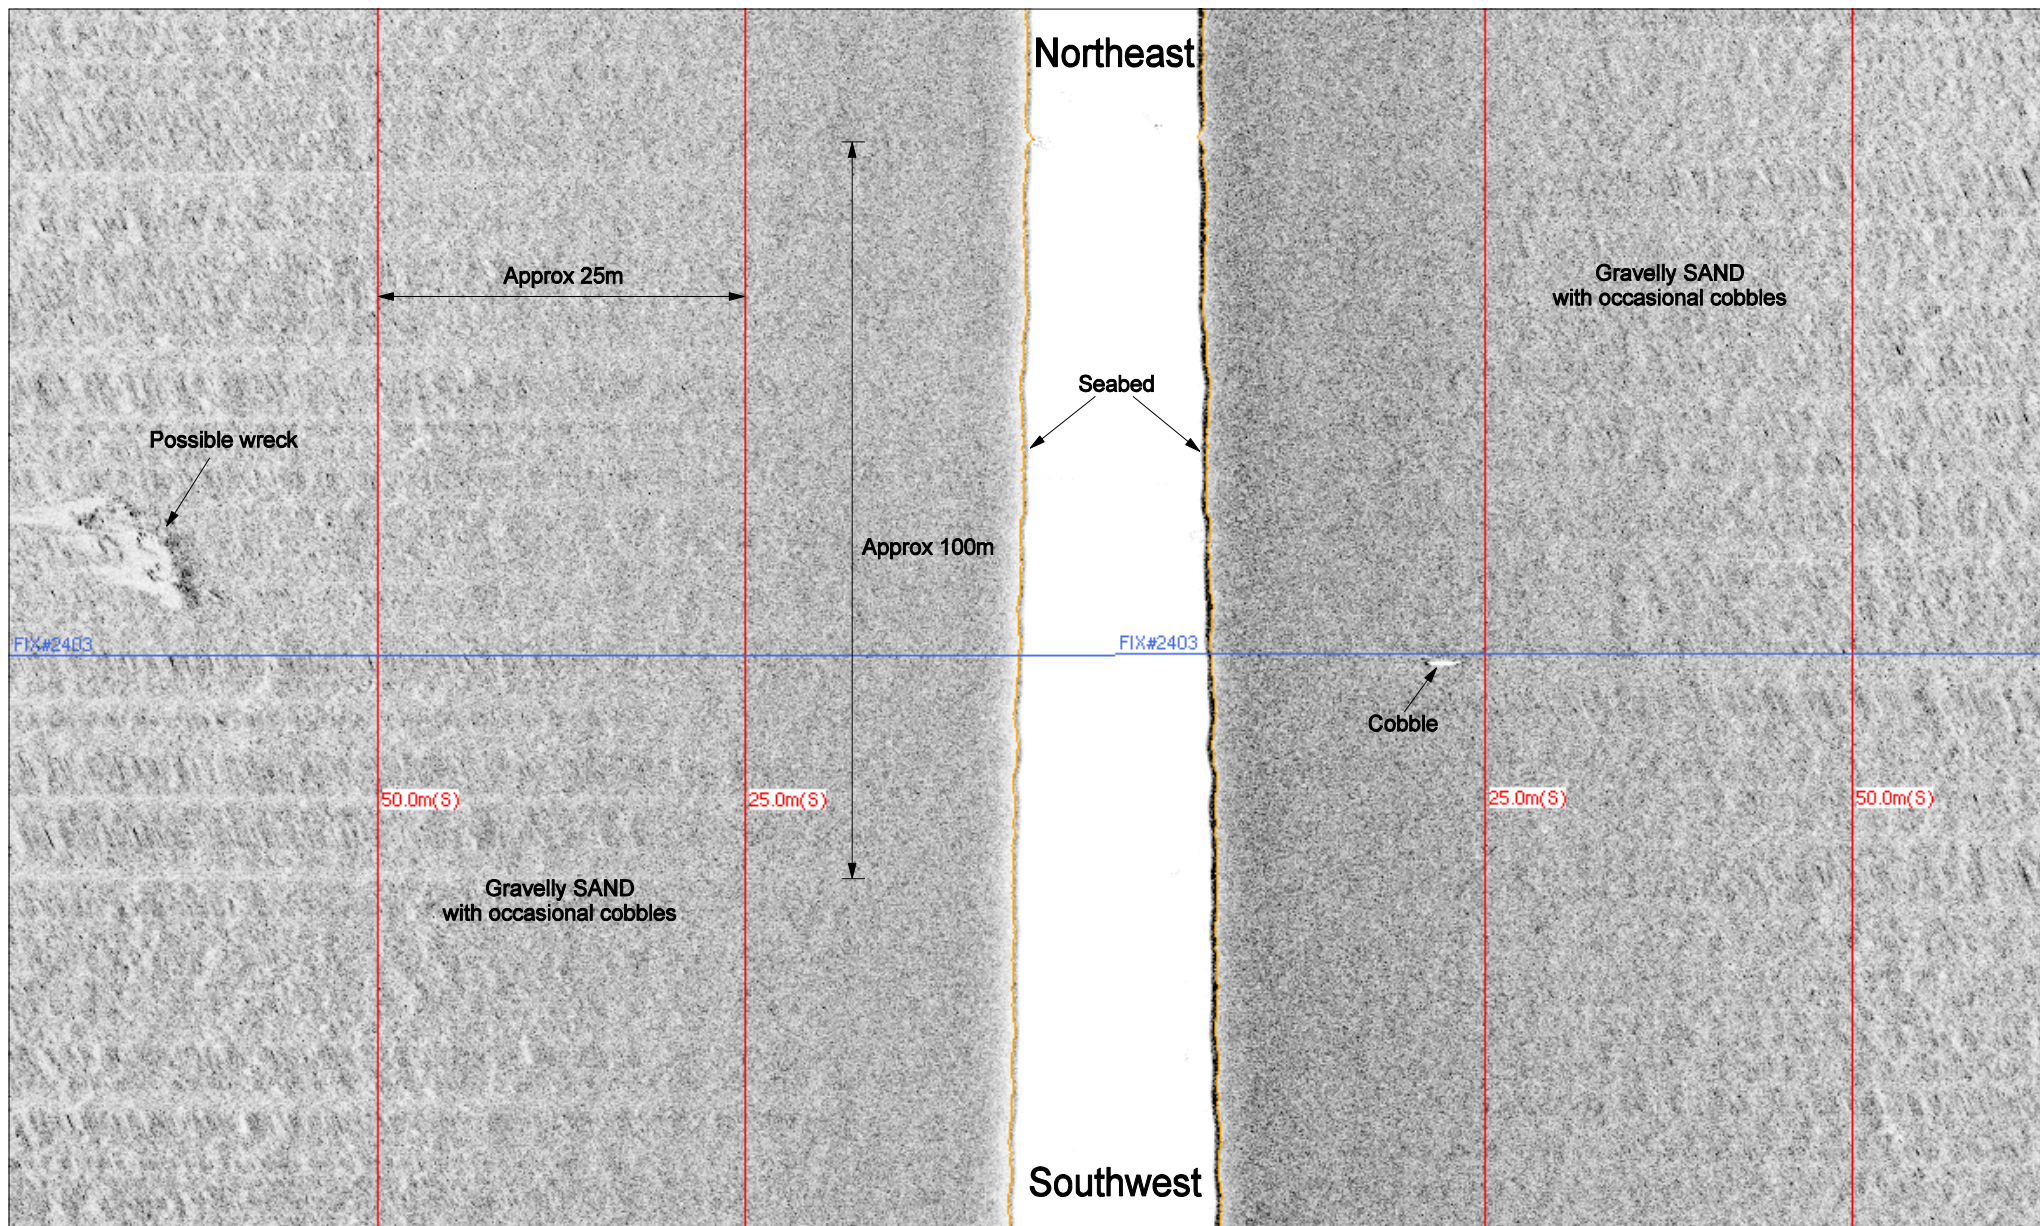
Fig. 3.5

Line L150A

SIDESCAN SONAR  
Illustrating possible wreck

90m ENE of KP17.34 is a large contact measuring 19.6x2.7x0.6. It has a magnetic anomaly of 55nT associated with it and is possibly a fishing boat (see [figure 3.5](#)).

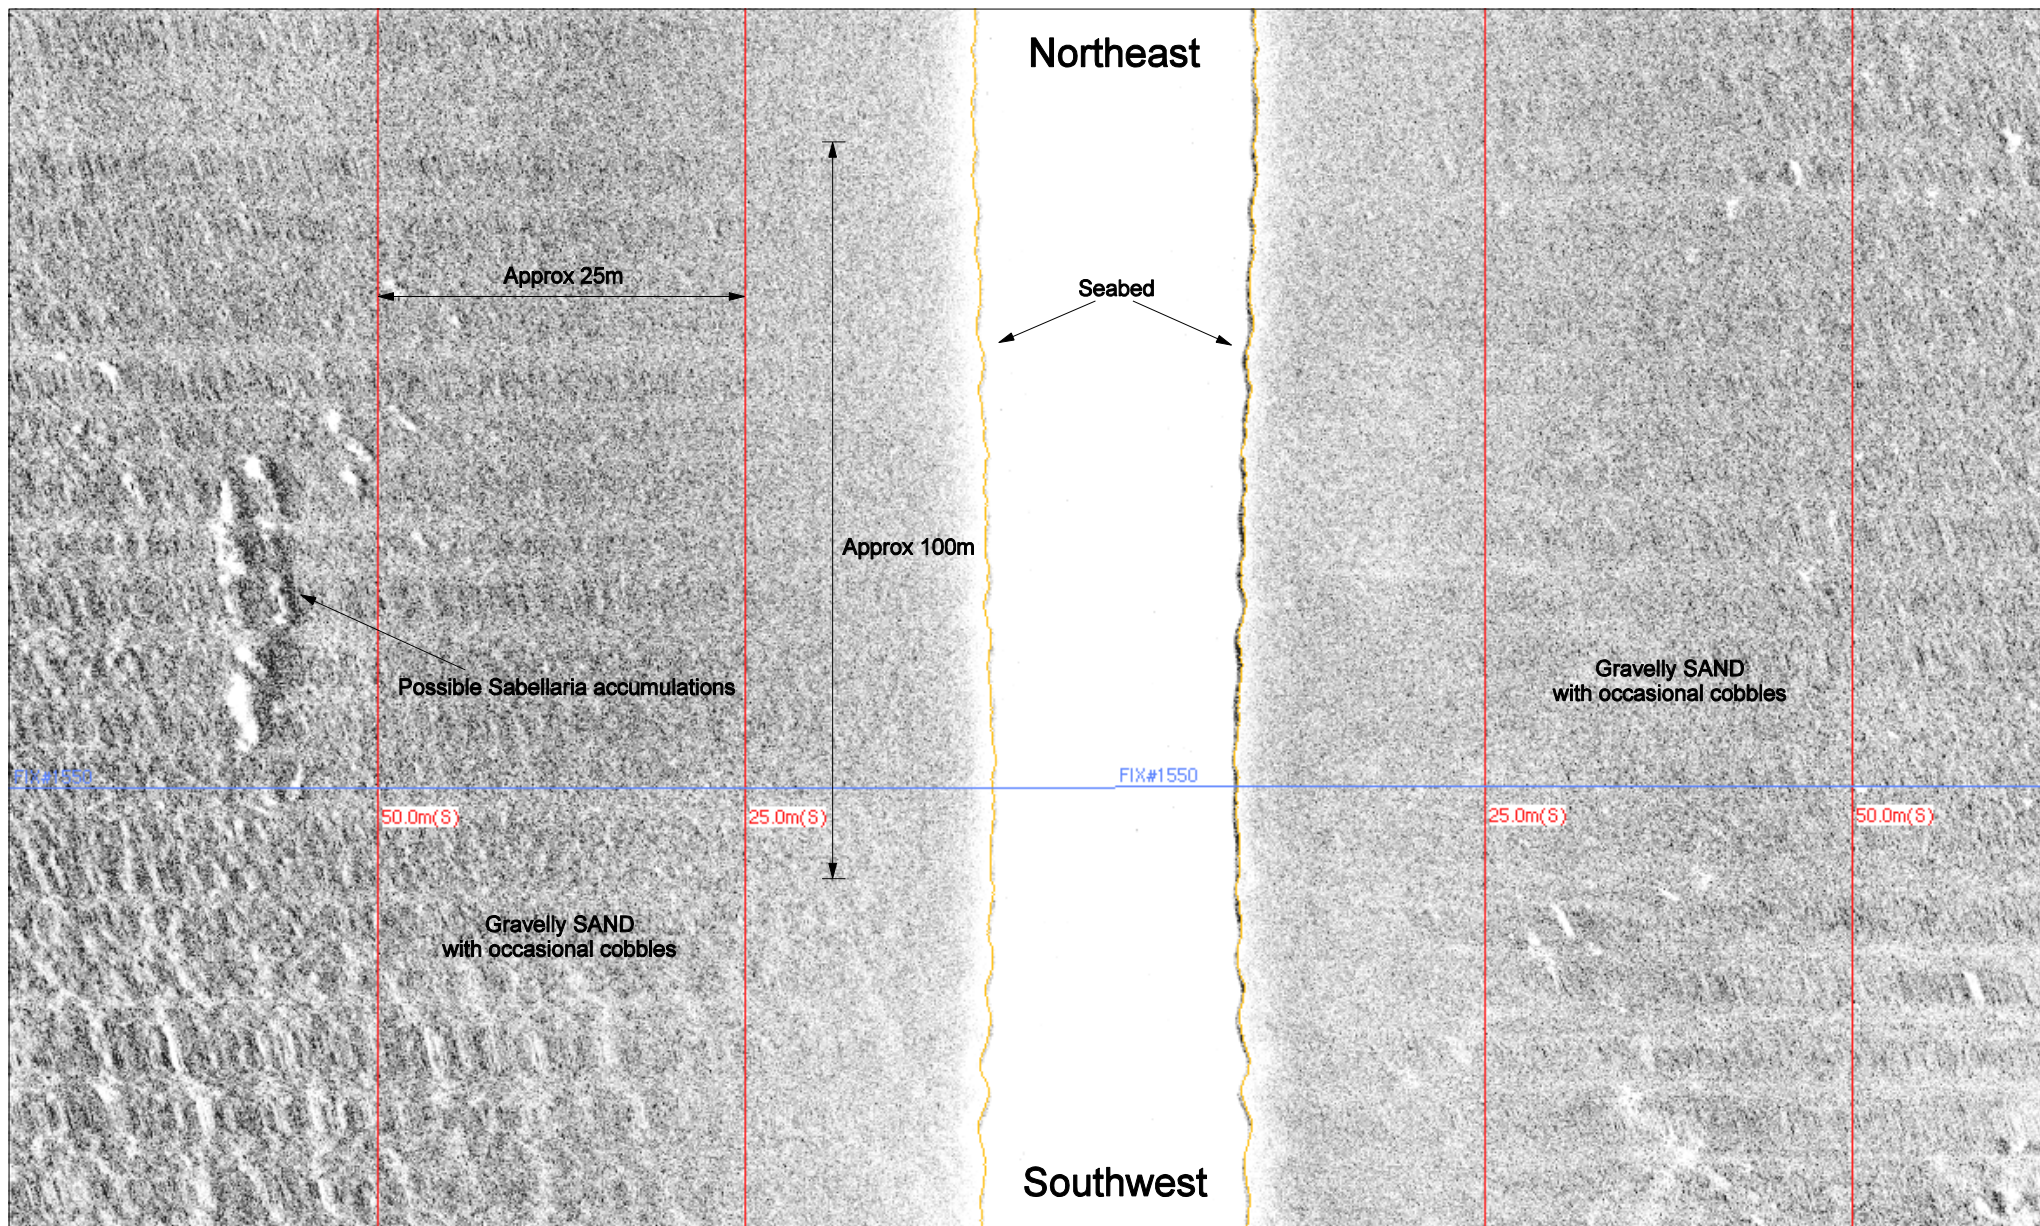
Fig. 3.7

Line R150A

SIDESCAN SONAR  
Illustrating possible Sabellaria accumulations

150 - 250m to the WNW of the centre line between KP18.32 and KP18.55 are a number of contacts that may represent possible *Sabellaria* accumulations (see figures 3.6 and 3.7). The seabed around KP18 exhibits slightly larger rippled sands, which can be an indication of patchy *Sabellaria* accretions.

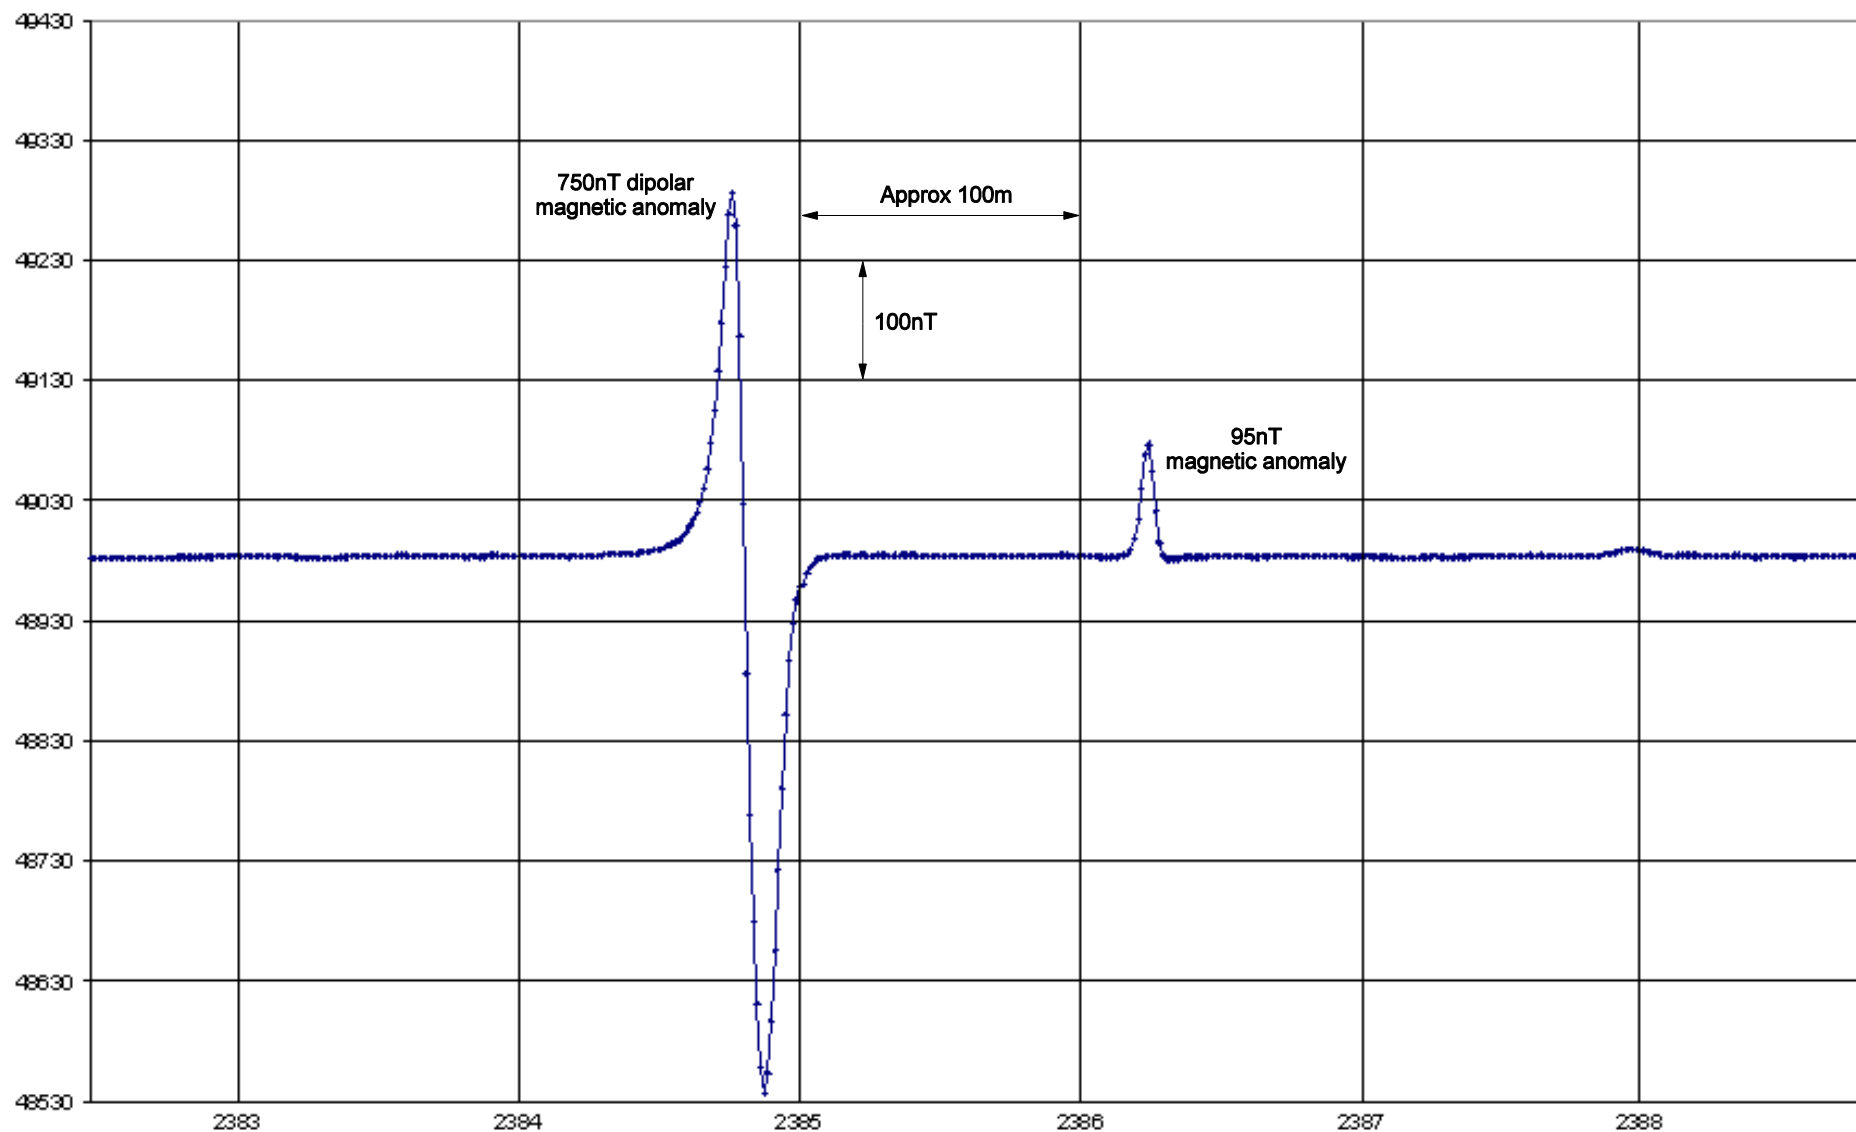
Fig. 3.8

Line L150A

MAGNETOMETER  
Illustrating two magnetic anomalies

- There were a number of magnetic anomalies that had no associated sonar contacts, so caution is urged in these areas.

130m to ESE of the centre line, between KP19.03 and KP19.19 two large magnetic anomalies are noted, of 95nT and 750nT respectively (see figure 3.8). However, there are no associated contacts noted on the sonar records (see figure 3.9) and for such large anomalies this is unusual. A possible explanation is that this is a buried feature.

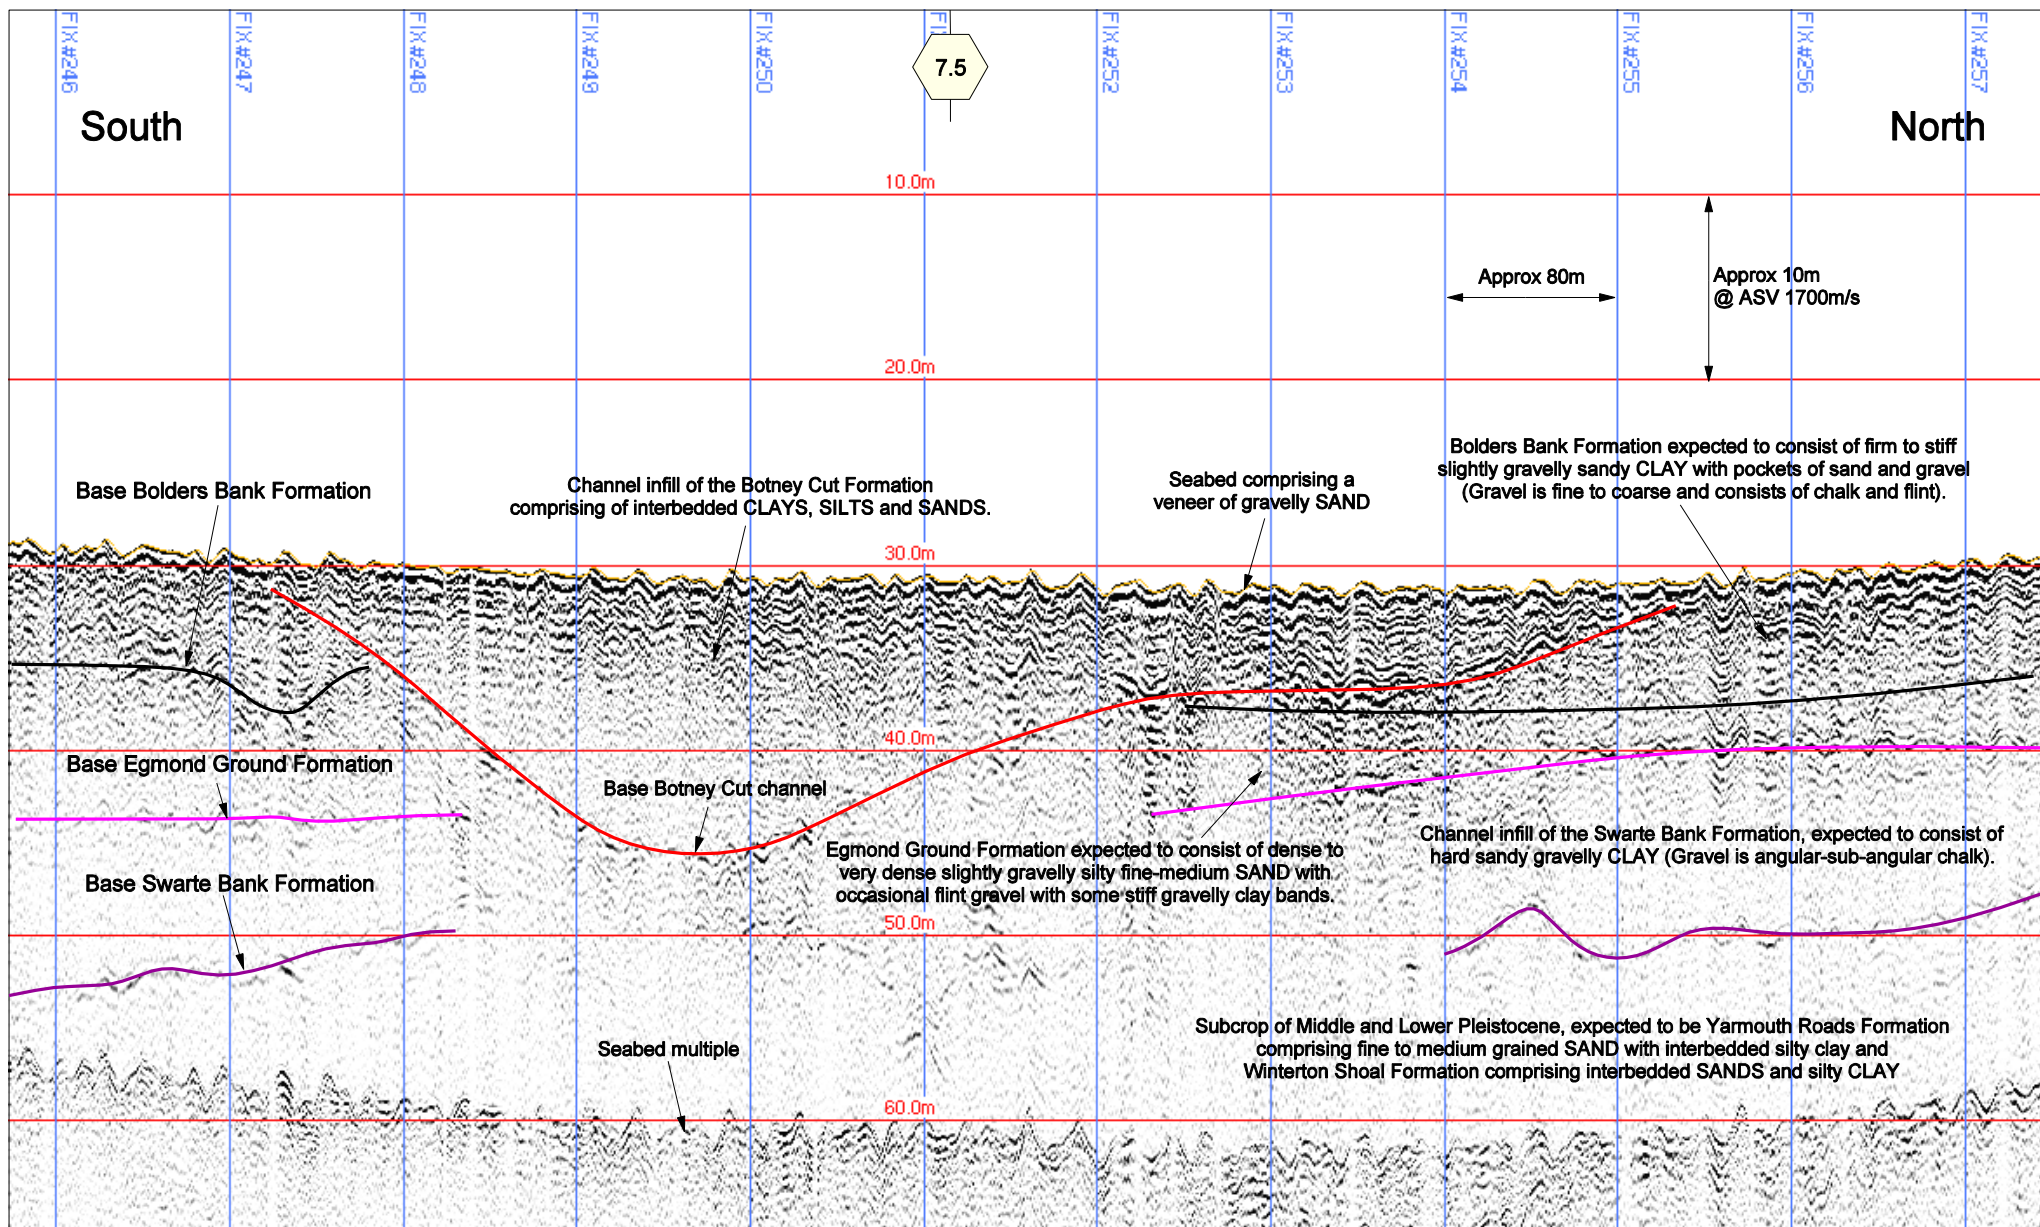
Fig. 3.10

Line CL

**BOOMER**  
Illustrating Botney Cut channel

As the route heads towards the coast, the Bolders Bank Formation thins gradually but is generally expected between 5 and 8m, where it is encountered beneath the veneer of gravelly sand. There are also a number of occasions when the channel infill of the Botney Cut Formation comprising of interbedded clays, silts and sands are seen to incise into the Bolders Bank Formation (see [figure 3.10](#)). These Botney Cut channels intersect the route at the following locations:
