Appendix 13.1: WKN Desk Based Heritage Assessment

Wheelabrator Kemsley (K3 Generating Station) and Wheelabrator Kemsley North  
(WKN) Waste to Energy Facility DCO

**WHEELABRATOR KEMSLEY NORTH  
WASTE-TO-ENERGY PLANT**

**DESK-BASED BASELINE HERITAGE  
ASSESSMENT**

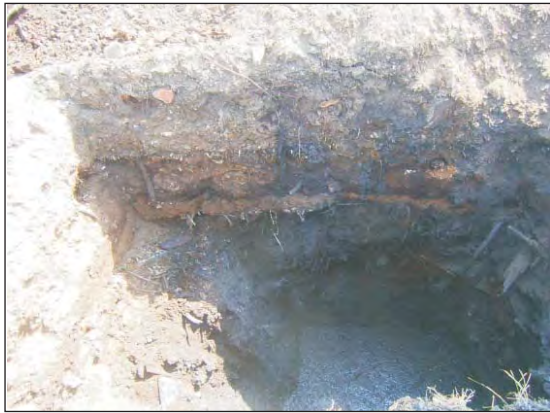
TP 17 viewed from the south

5.2.2 A black sandy gravel containing clinker was recorded in Trial Pits 17, 20-23, 25 and Window Samples 10, 14 and 17, and a thick deposit of coal dust was noted in TP 26.

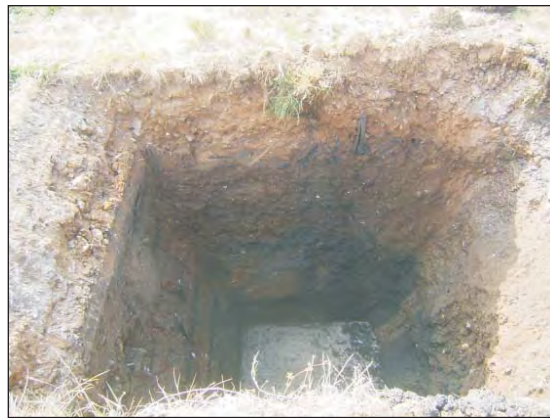
TP 18 viewed from the south-west

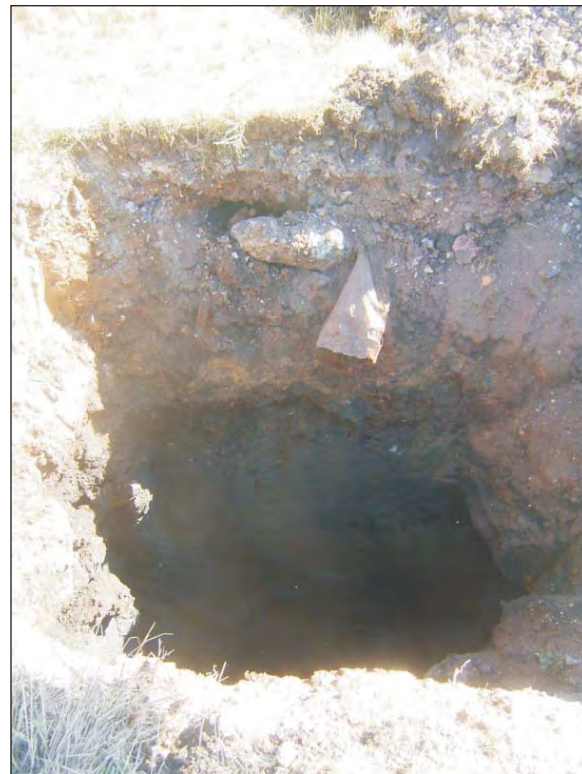
TP 19 viewed from the south

- 8.1.1 The Trial Pits and Window Samples revealed a significant amount of made ground across the Site with a minimum depth of 1.4m (TP 19) down to a maximum depth of 4.6m below ground level (WS 10). Some of the earlier made ground deposits consisted of degraded wood and paper (TP 17, 19 and 21 and WS 11 and 17), with even earlier deposits consisting of black gravels with clinker (TP 17, 20-23 and 25 and WS 10, 14 and 17).
- 8.1.2 Window Sample 10 produced a thin layer of peaty topsoil overlying the alluvium at 4.6-4.7m below ground level. This buried topsoil can only be dated from the deposition of the made ground above.
- 8.1.3 No features, deposits or artefacts of archaeological or palaeo-environmental significance were encountered and no further works are recommended.

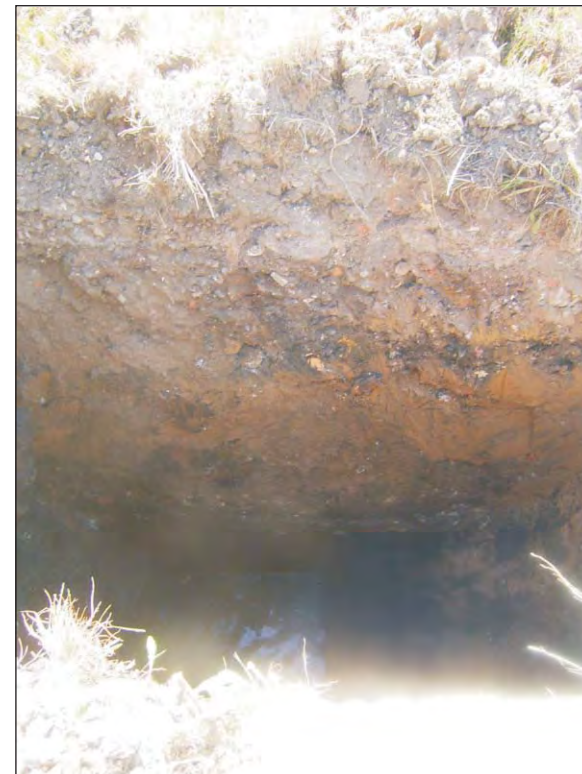
TP 20 viewed from the west

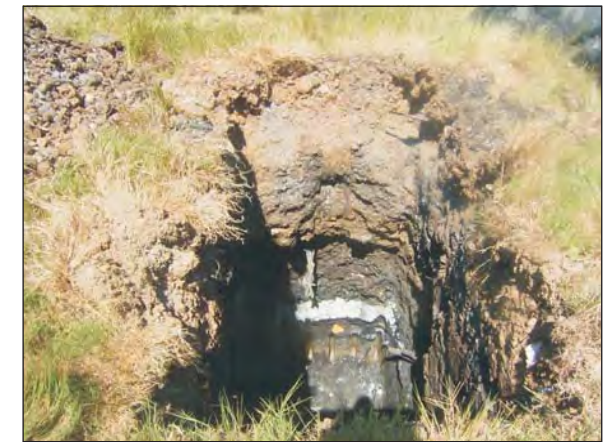
TP 21 viewed from the south

<b>Trial Pit 21</b> Depth: 4.2m (abandoned due to rising ground water)			
<b>Context</b>	<b>Category</b>	<b>Description</b>	<b>Depth</b>
2101	Layer	Topsoil – Mid brown sandy silt	0.00-0.15m
2102	Layer	Made Ground – Mid orange brown silty clay with common brick, concrete rubble, wood and plastic	0.15-0.8m
2103	Layer	Made Ground – Dark grey brown silty clay with orange brown clay lumps with moderate brick, flint nodules, degraded wood, plastic and metal. Layer contaminated with hydro-carbons	0.8-2.8m
2104	Layer	Made Ground – Light grey soft degraded paper – waste product from recycled paper	2.8-3.1m
2105	Layer	Made Ground – Black sandy gravels with grey brown clays lumps, clinker and occasional yellow brick	3.1-3.5m
2106	Layer	Alluvium – Mottled light orange grey clay	3.5m+

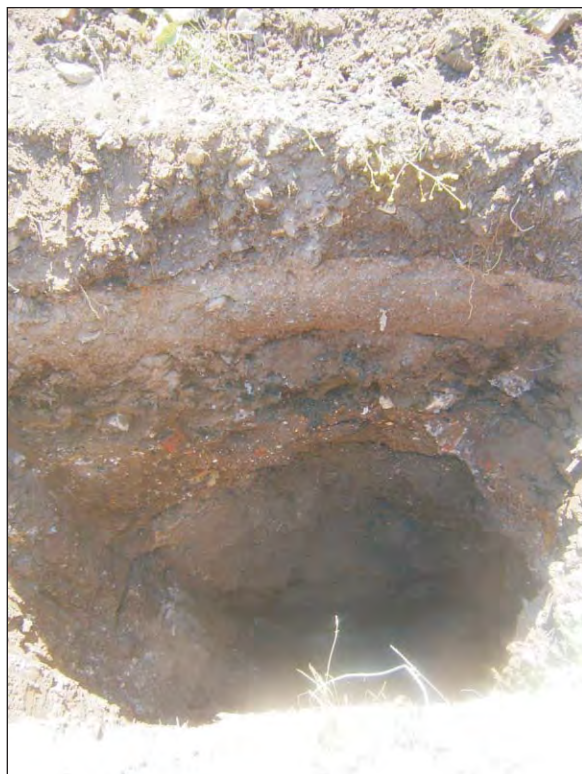
TP 22 viewed from the north-east

<b>Trial Pit 22</b> Depth: 4.3m			
<b>Context</b>	<b>Category</b>	<b>Description</b>	<b>Depth</b>
2201	Layer	Made Ground – Mid grey brown clayey silt with moderate brick and concrete lumps	0.00-0.6m
2202	Layer	Made Ground – Dark brown sandy silt with brick, wood, plastic and concrete rubble	0.6-1m
2203	Layer	Made Ground – Mid brown sandy silt with abundant broken and degraded wood	1-1.2m
2204	Layer	Made Ground – Grey clay with abundant brick and chalk	1.2-1.5m
2205	Layer	Made Ground – Mid brown clay with orange mottles, with abundant brick, plastic, concrete lumps, wood, metal pipes and chalk lumps	1.5-2.7m
2206	Layer	Made Ground – Mid brown grey silty clay with abundant chalk, common brick, plastic and concrete rubble. Layer tipped in from NW. Thin lens of black gravels with clinker towards base of horizon	1.6-3.6m
2207	Layer	Alluvium – Mottled dark and mid grey clay with orange mottles	3.6m+

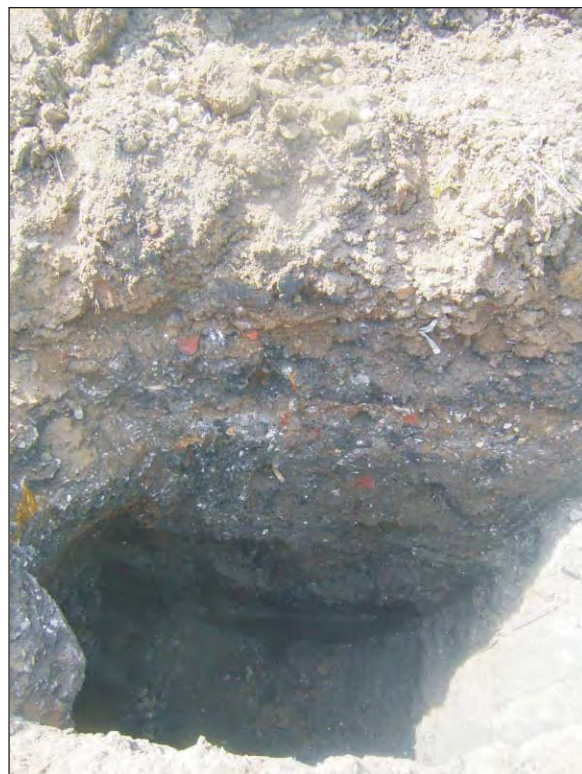
TP 23 viewed from the east

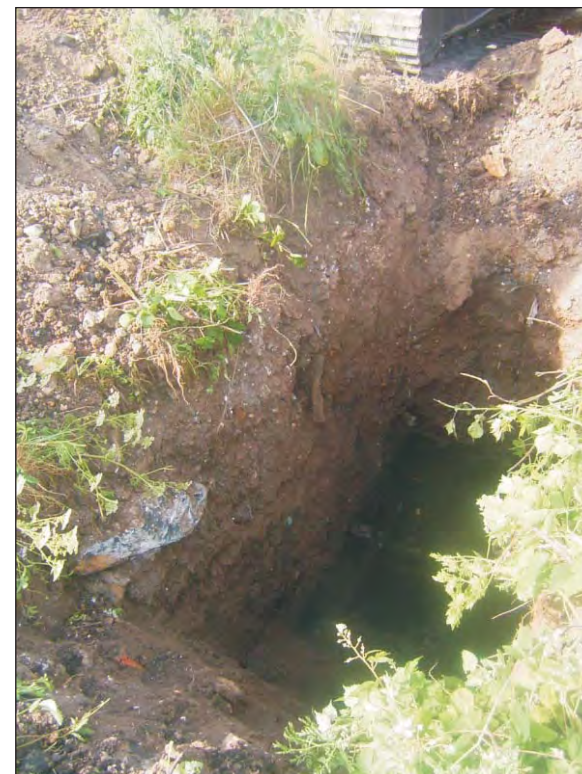
TP 25 viewed from the east

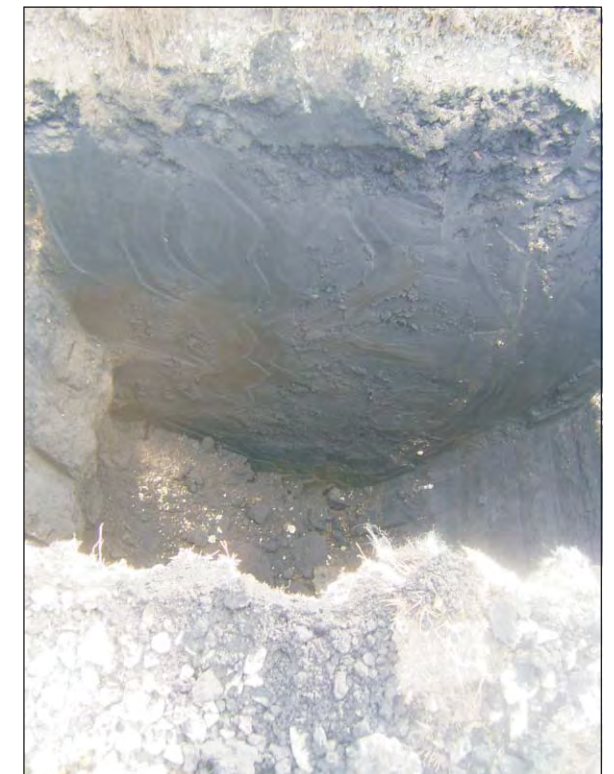
TP 26 viewed from the north

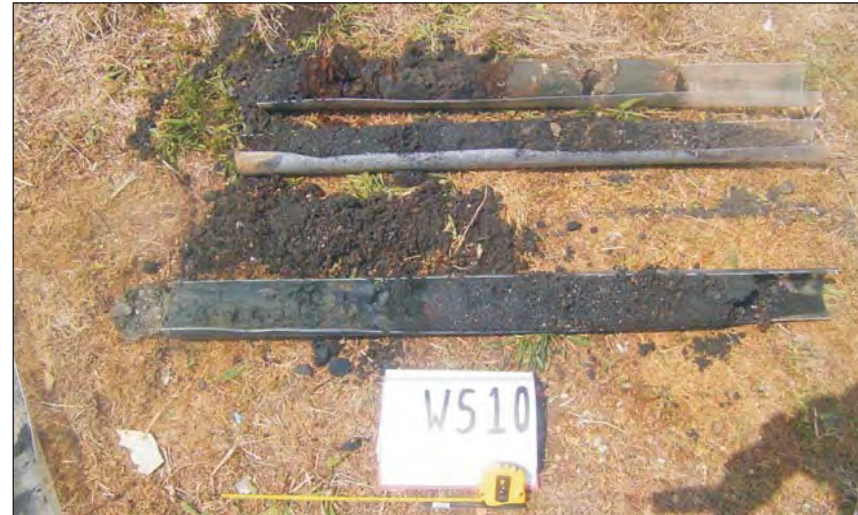
WS 10

Evidence for buried topsoil was encountered within WS10 at a depth of 4.6m below ground level but no features, deposits or artefacts of archaeological or palaeo-environmental significance were encountered within the trial pits or window samples. No further work is recommended.

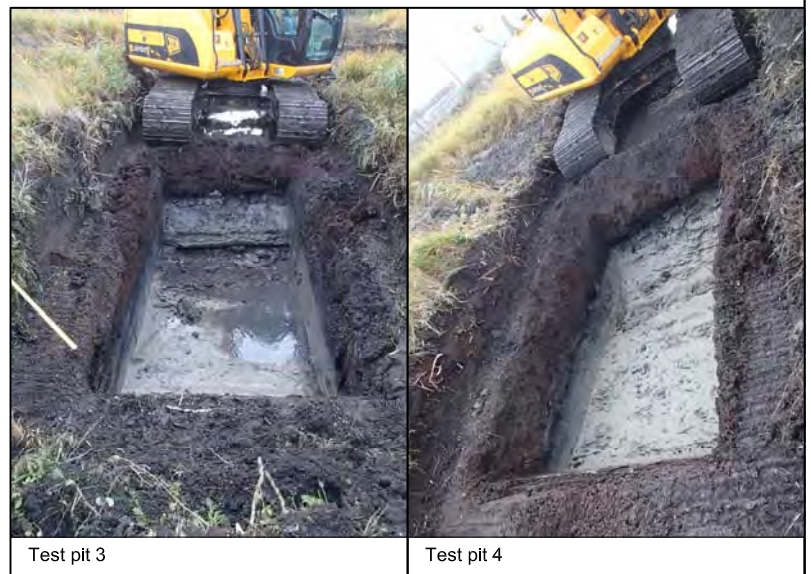
© Archaeology South-East		Kemsley Trailer Park, Swale District		Fig. 3
Project Ref: 7882	Nov 2015	Trench plan and photos		
Report Ref:	Drawn by: LG

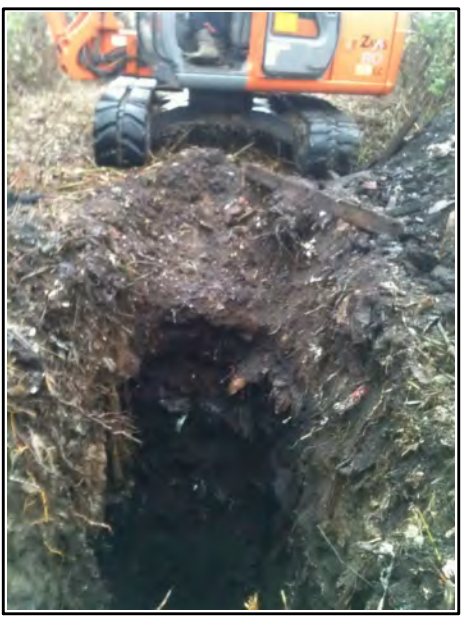
Record of Trial Pit  
**TP01**

Samples & in situ Tests					Strata			
Depth	Type/No.	Test Results	PID (ppm)	Water Level	Reduced Level m(AOD)	Legend	Depth (Thickness)	DESCRIPTION
1	1.15	B/TP1_1.2 D/TP1_1.2	<0.1			[Cross-hatch pattern]	(2.50)	MADE GROUND. Brown, silty, slightly gravelly sand. Sand is fine to coarse. Gravel is fine to coarse, sub-rounded to sub-angular. Abundant plastics, paper waste, metal guttering and polystyrene waste. Dry.
2	2.45	D/TP1_2.5	<0.1			[Cross-hatch pattern]	2.50 (0.30) 2.80	MADE GROUND. Dense, black, sandy gravel. Sand is fine to coarse. Gravel is of fine clinker. Dry. NVO.
3	2.95	B/TP1_3.0	<0.1			[Horizontal lines pattern]	(0.30) 3.10	Brown-grey, organic CLAY. Dry. Moderate organic odour.
Trial pit terminated at 3.1m bgl.								
4

NVO: No visual or olfactory evidence of contamination. Stability: Unstable. Backfilled on completion.

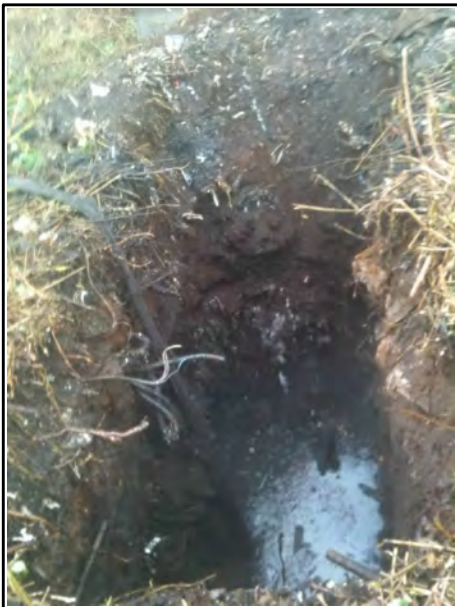
Record of Trial Pit  
**TP02**

Samples & in situ Tests					Strata			
Depth	Type/No.	Test Results	PID (ppm)	Water Level	Reduced Level m(AOD)	Legend	Depth (Thickness)	DESCRIPTION
1						[Cross-hatched pattern]	(1.80)	MADE GROUND. Silty, slightly gravelly sand. Sand is fine to coarse. Gravel is fine to coarse. Approximately 50% is waste, comprising plastic, rubber, wood, paper and chippings, increasing to 70% from 1.2m bgl. Dry.
1.45	D/TP2_1.5		<0.1				1.80	
1.75	B/TP2_1.8 D/TP2_1.8		<0.1				(0.50)	MADE GROUND. Black, sandy gravel of ash and clinker. Approximately 30-40% is waste comprising plastic, rubber, wood, paper and chippings. Dry.
2						[Horizontal dashed pattern]	2.30	Grey, organic CLAY.
2.45	B/TP2_2.5		<0.1				(0.30)	Wet. NVO.
3								<b>Trial pit terminated at 2.6m bgl.</b>
4

NVO: No visual or olfactory evidence of contamination. Stability: Highly unstable. Backfilled on completion

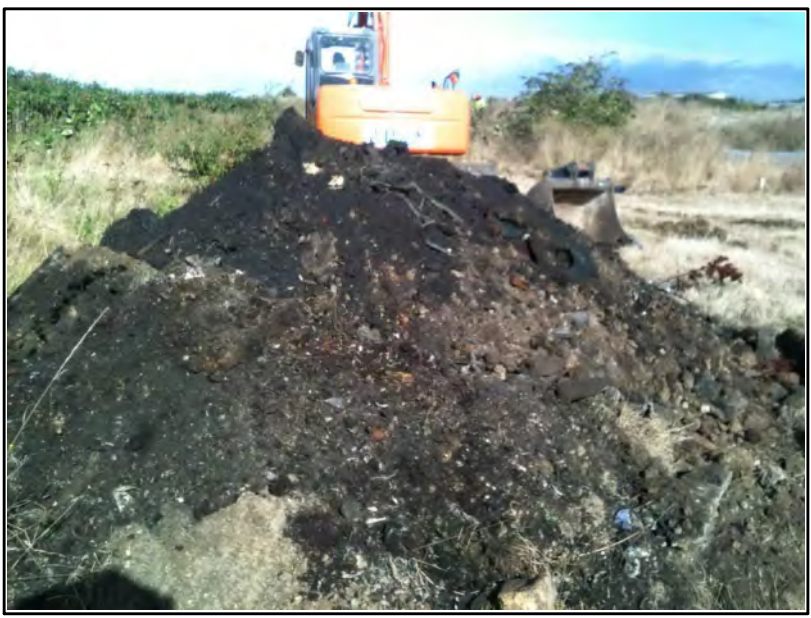
1.35	D/TP15_1.4		<0.1				(1.50)	
2.45	D/TP15_2.5		<0.1				2.50	MADE GROUND. Dark brown, sandy gravel. Sand is fine to coarse of ash. Gravel is fine to coarse, angular to sub-rounded of clinker. Dry.

3.40							(0.90)	
3.45	B/TP15_3.5		<0.1			[Cross-hatched pattern]	3.40 3.50	Grey, silty, slightly sandy CLAY with black organic fragments. Dry. Organic odour.
								Trial pit terminated at 3.5m bgl.

NVO: No visual or olfactory evidence of contamination. Stability: Moderately stable. Backfilled on completion.

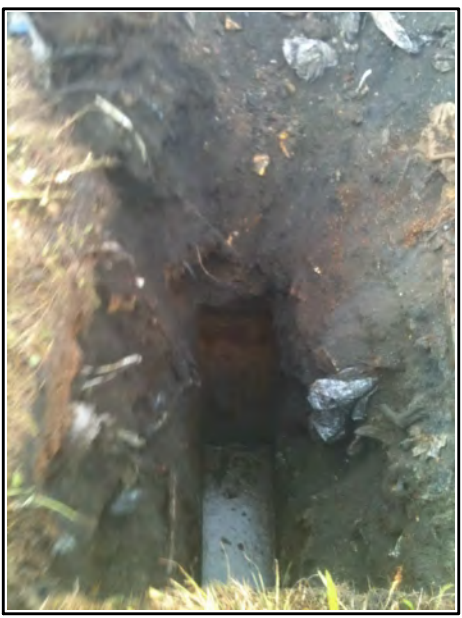
(0.50)	MADE GROUND. Black, sandy gravel. Sand is fine to coarse of ash. Gravel is fine to coarse of clinker. Wet.

3.00	
							(0.40)	Firm, organic CLAY. Wet. NVO.
							3.40	
Trial pit terminated at 3.4m bgl.

NVO: No visual or olfactory evidence of contamination. Stability: Unstable below 1.09m. Backfilled on completion.

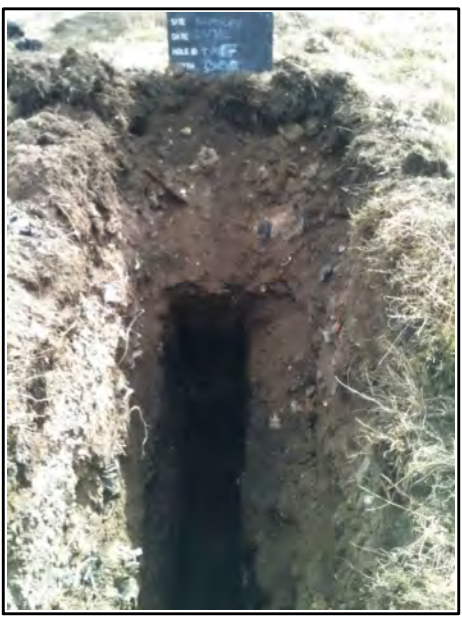
2.75	D/TP17_2.8		<0.1				2.80	
3.45	B/TP17_3.5		<0.1			[Cross-hatch pattern]	3.40	MADE GROUND: Grey, slightly silty, sandy gravel. Sand is fine to coarse of ash. Gravel is fine to coarse, angular to sub-angular. Dry.

3.55	
<b>Trial pit terminated at 3.55m bgl.</b>

NVO: No visual or olfactory evidence of contamination.

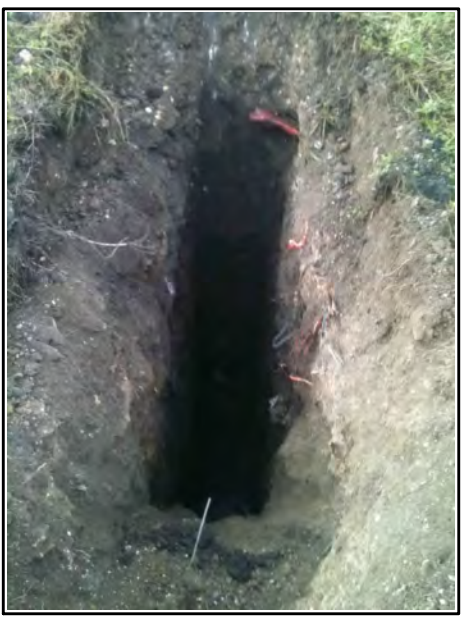
1.45	B/TP18_1.5 D/TP18_1.5		<0.1				1.10	MADE GROUND. Grey, sandy, clayey gravel. Sand is fine to coarse of ash. Gravel is fine to coarse, angular to sub-angular of clinker and slag. Occasional timber, plastic, glass, metal, rubber and ceramic fragments. Dry.

2.45	D/TP18_2.5		<0.1				1.90	
2.95	B/TP18_3.0		<0.1	3.00		[Horizontal line pattern]	3.00	Grey, organic CLAY. Wet. NVO.
							(0.55)	
							3.55	
Trial pit terminated at 3.55m bgl.

NVO: No visual or olfactory evidence of contamination. Stability: Moderately stable. Backfilled on completion.
