# Norfolk Boreas Offshore Wind Farm

## Appendix 3. Review of Cable Installation, Protection Mitigation and Habitat recoverability.

# REVIEW OF CABLE INSTALLATION, PROTECTION, MITIGATION AND HABITAT RECOVERABILITY

EOR0744  
Cable Installation, Protection,  
Mitigation and Habitat  
Recoverability  
Rev03  
12 November 2019

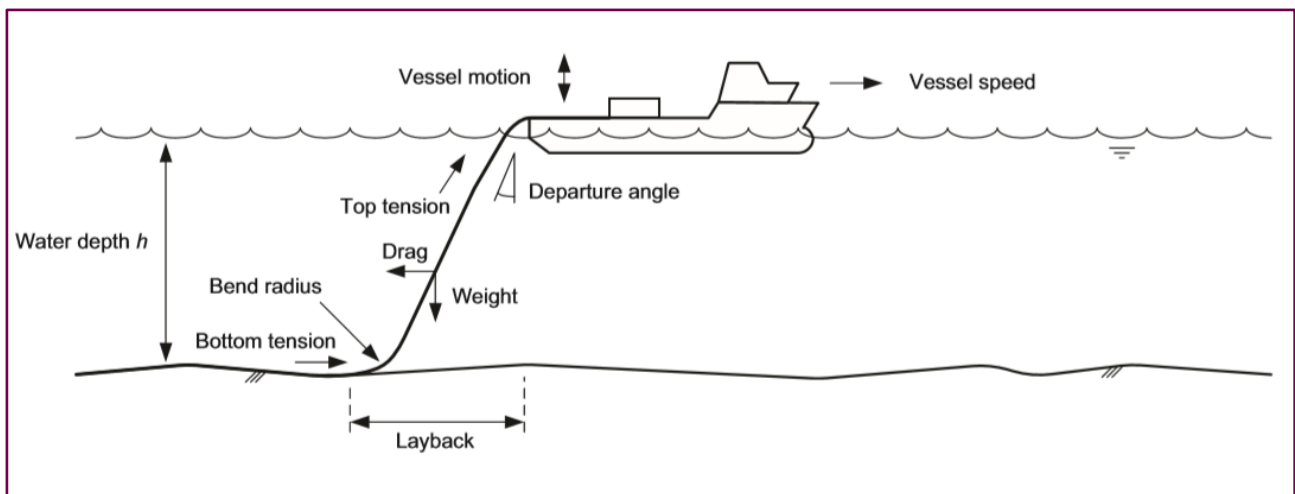
Figure 2.1: Cable laying process (DNV, 2016).

- 2.4.1.2 Cables are installed via Cable Lay Vessels (CLV; which may include cable lay barges), using a cable tracking system to monitor and maintain cable lay route, cable tension, configuration and load. Figure 2.1 provides a schematic of the cable installation process.

- 2.4.1.3 The CLV has one or two cable carousels on board and under controlled conditions allows the cable to be released off the back of the vessel. These vessels typically have dynamic positioning systems supporting these cable lay activities, although other vessel types (e.g. barges) may also be used in some areas. The vessel will have touch down monitoring ensuring the cable is laid where it is intended and within the margin of error.

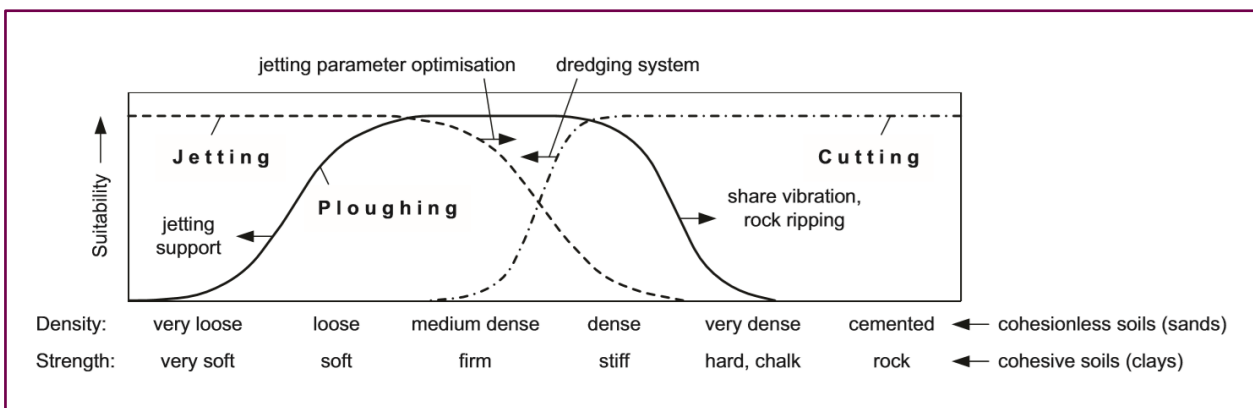
Figure 2.2: Indicative burial tool suitability in different ground conditions (DNV, 2016).

2.4.1.6 Figure 2.2, provides a high-level model and a basis to define which tool should be considered for installation in a range of sediment conditions. It should be noted that this is a simplified model and there are additional considerations to account for, such as gravel content, peat and boulders. Further discussion on which tool is suitable for which type of sediment can be found below, with specific discussion of the following installation methods:

- 3.3.5.6 A secondary finding is in relation to the scale of impact on burial success between different installation tool types. Where the assumed same changes in substrate shear strength between different Case Studies is seen, there are different levels of success between the tools. The jet trencher and the cable plough are more affected by the increase in substrate shear strength and burial success reduces by over 50% across the Case Studies. In comparison, the mechanical trenching equipment cable burial success is reduced by a smaller degree, with greater burial success in harder soil types (e.g. CS04; see Figure 3.11). This finding is again in line with the DNV (2016) guidance (see Figure 2.2).

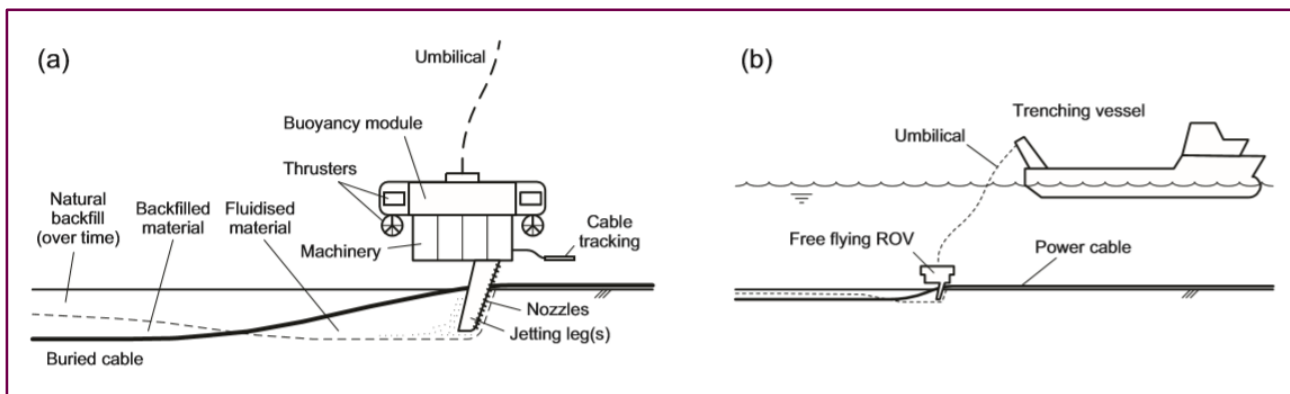
**Figure 2.3: ROV jet trencher. (a) Principal components, (b) Cable lay operation (DNV, 2016).**

2.4.2.1 Jet trenchers fluidise the soils by pumping seawater at high pressure through a series of small diameter nozzles arranged on opposing jet legs which locate either side of the cable. The legs are slowly lowered into the seabed until near vertical and the trencher, which is usually driven on tracks as opposed to free flying, moves forwards forming a trench. The cable lies between the jetting swords on the seabed and lowers into the trench, either under gravity or supported with a depressor, as the trencher progresses. Backwash nozzles are often located at the base of the legs to mobilise sediment along the trench and prevent it from settling out of suspension before the cable touches down (Figure 2.3).

2.4.2.2 Jet trenchers are best suited to fine to medium grained sands and soft clays, with the more powerful jet trenchers able to jet firm clays as well. They are less well suited to very stiff clays or areas of coarse sand and gravel although it is possible to achieve some lowering in the latter case by carrying out multiple passes or through adaptations of these tools.

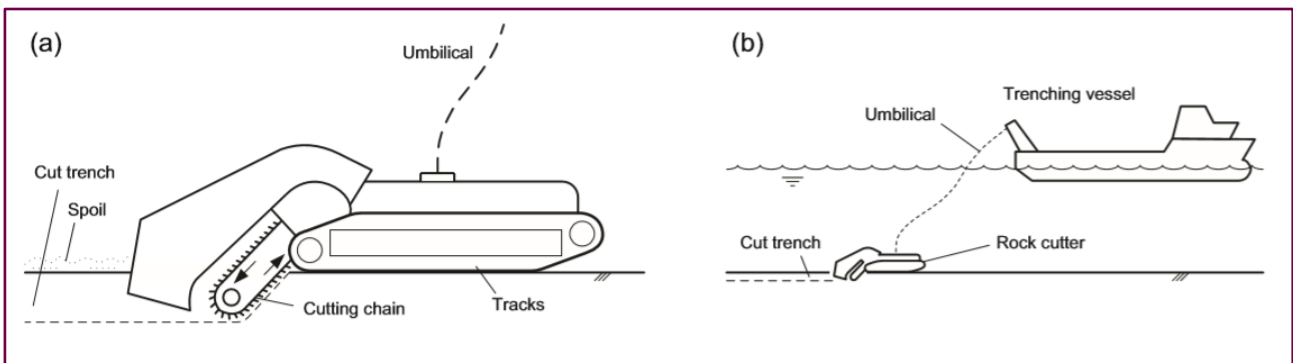
**Figure 2.4: Chain cutter. (a) Principal components, (b) Pre-lay rock cutting operations (DNV, 2016).**

2.4.3.1 Mechanical trenchers physically cut a trench, usually with a series of conical picks mounted on either a wheel or as a chain on a mechanical digging boom (Figure 2.4). The typical process is for the trencher to engage with and raise the cable whilst deploying the wheel or chain below and then for it to progress forward digging a trench.

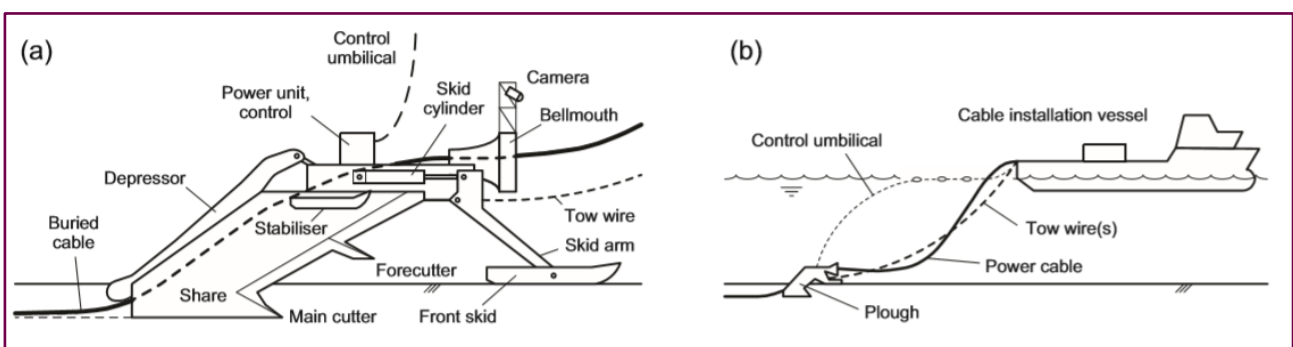
**Figure 2.5: Subsea cable plough. (a) Principal components, (a) Cable lay operations (DNV, 2016).**

2.4.4.1 Cable ploughs come in a variety of shapes and sizes and are designed specifically for different soil types and burial depths. All ploughs are towed from a vessel or barge which must be able to provide adequate tow force, or in the case of landfall approaches pulled in from a fixed anchor point. Some ploughs are designed to allow for simultaneous lay and burial as shown in Figure 2.5, where the cable is lowered and fed through the plough and into the trench. Other ploughs are used as a pre-lay activity to plough a large furrow for the cable to be lowered into.

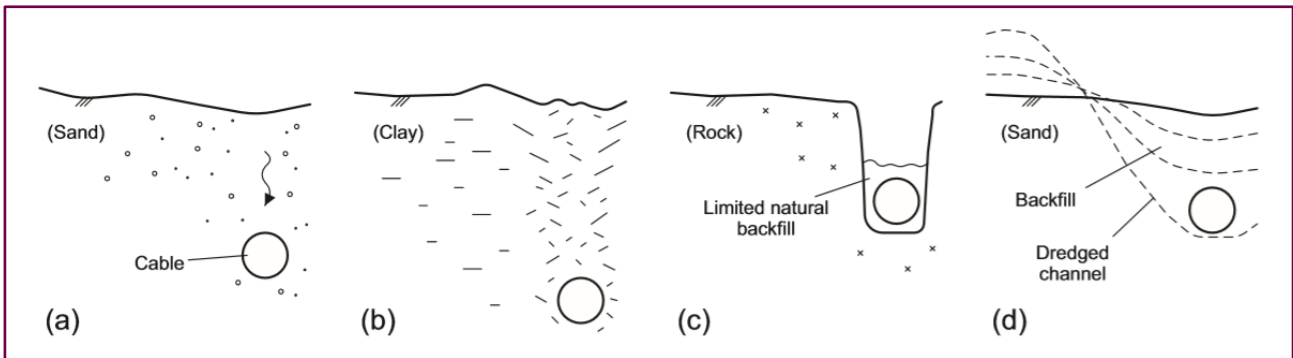
**Figure 2.6: Protection of cable through burial. (a) Jetting/fluidisation, (b) Ploughing, (c) Mechanical cutting, (d) Open trench dredging (DNV, 2016).**

of lowering beneath the surface of the substrate. This is usually considered within a Cable Burial Risk Assessment (CBRA), which also considers the risks to the cable given the prevailing conditions (e.g. shipping activity, fishing intensity and type of gear used, seabed mobility). Figure 2.6 indicates how the different sediment types can offer protection to cables installed using the installation methods summarised in Section 2.1. Note: no single burial technique will work in all ground conditions.

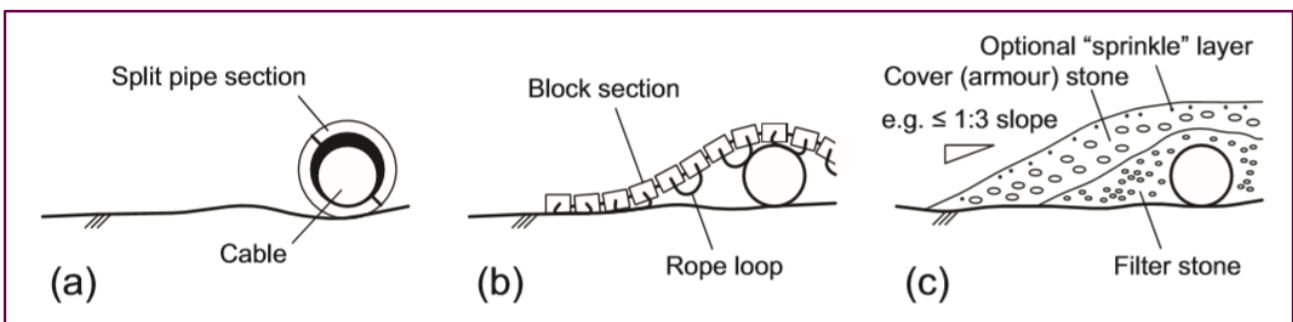
**Figure 2.7: Cable protection. (a) Tubular product, (b) Mattress, (c) Rock placement (DNV, 2016).**

2.5.4.1 Non-burial protection may be used where cable burial is not advisable/practicable or where additional/corrective measures may be required. This may be where subsea cables cross existing infrastructure (e.g. installed cables and pipelines), or perhaps subsea cables have not been sufficiently protected by burial beneath natural sediments (e.g. due to hard substrates / mobile sediments expose previously buried sections of cable), or where cable repairs have taken place and an omega joint cannot be reburied. Options for non-burial include the use of tubular products, concrete mattresses and rock placement, or a combination of these as per DNV guidelines ((DNV, 2016; Figure 2.7), though alternatives are also available including, but not limited to rock bags, grout bags, frond mattresses as well as surface protection measures such as marker buoys for exposed cables. Protection measures are site specific and will depend on the risk to electrical cables (e.g. fishing activity).

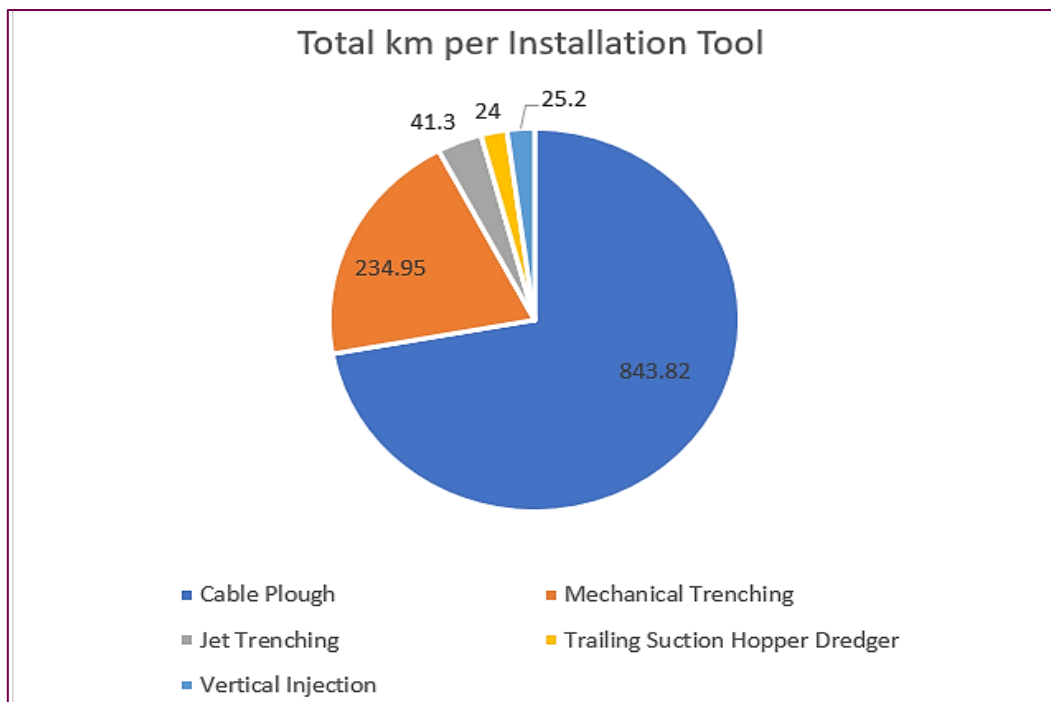
**Figure 3.5: Total Installation Lengths per Tool for all Case Studies.**

Installation Tool	Installed Cable Length (km)					Total
	CS01	CS02	CS03	CS04	CS05	
Cable Plough	137.31	137.31	285.3	19.2	264.7	843.82
Mechanical Trenching	78.35	0	0	20	136.6	234.95
Jet Trenching	35.5	0	0	5.8	0	41.3
Trailing Suction Hopper Dredger	0	0	0	0	24	24
Vertical Injection	0	0	0	0	25.2	25.2
<b>Total</b>	<b>251.16</b>	<b>137.31</b>	<b>285.3</b>	<b>45</b>	<b>450.5</b>	<b>1169.27</b>

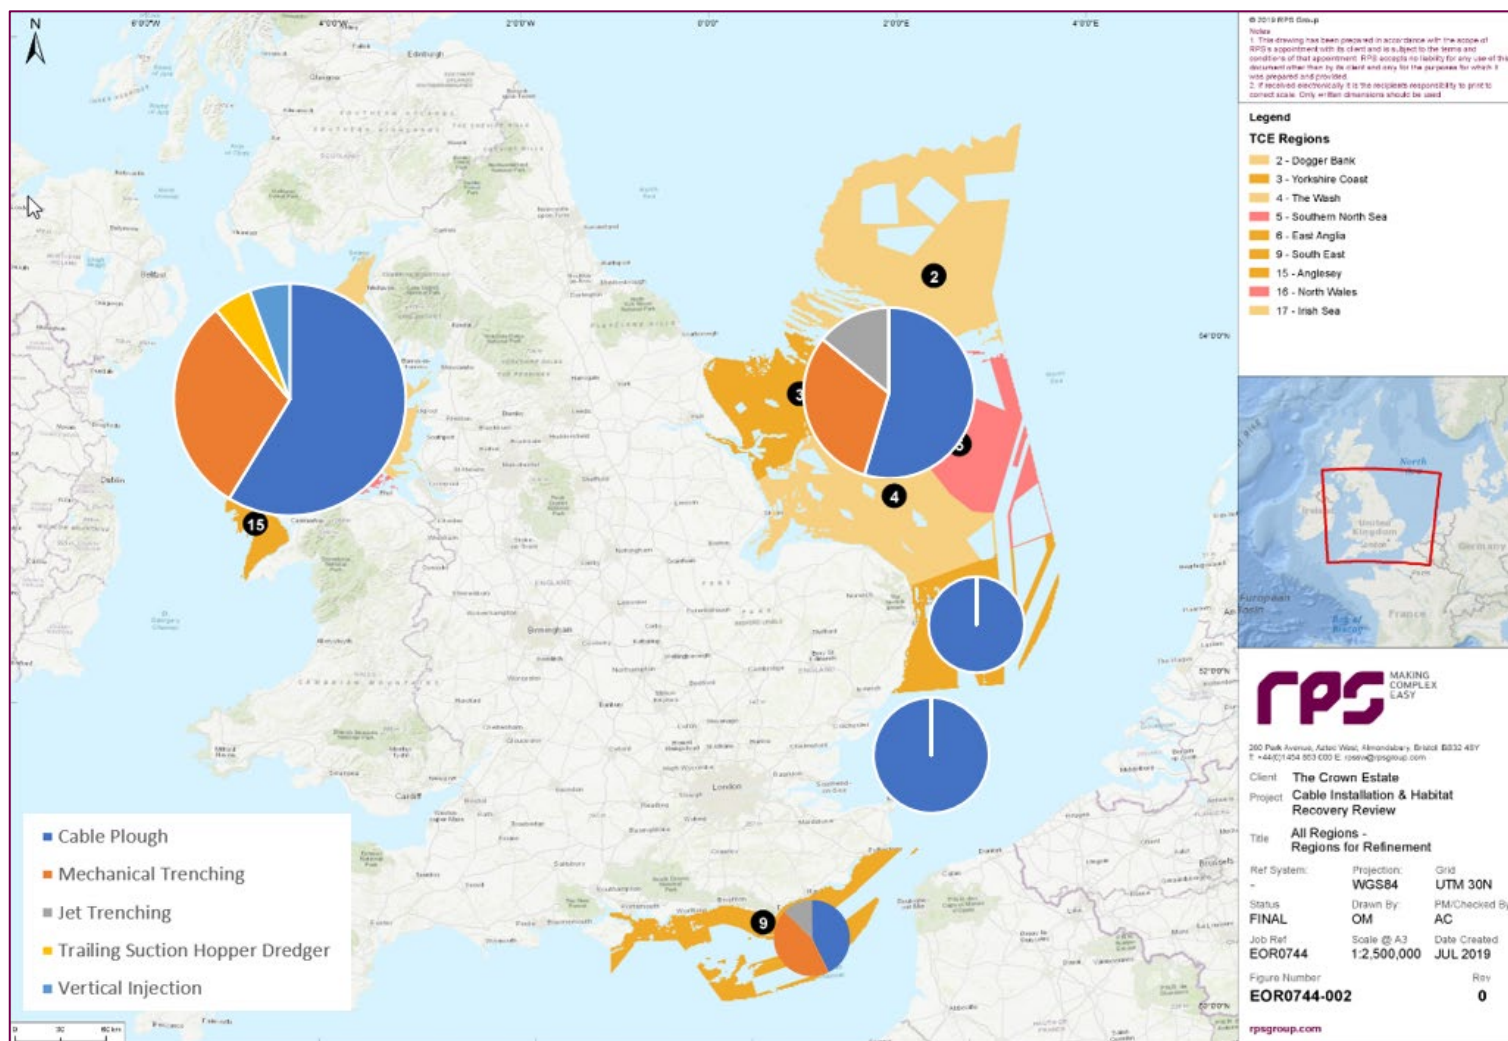
Figure 3.6: Summary Total Installation Lengths per Tool for each case study.

ground conditions, it is foreseeable that the right selection of tool from each group supports successful cable installation in the appropriate conditions.

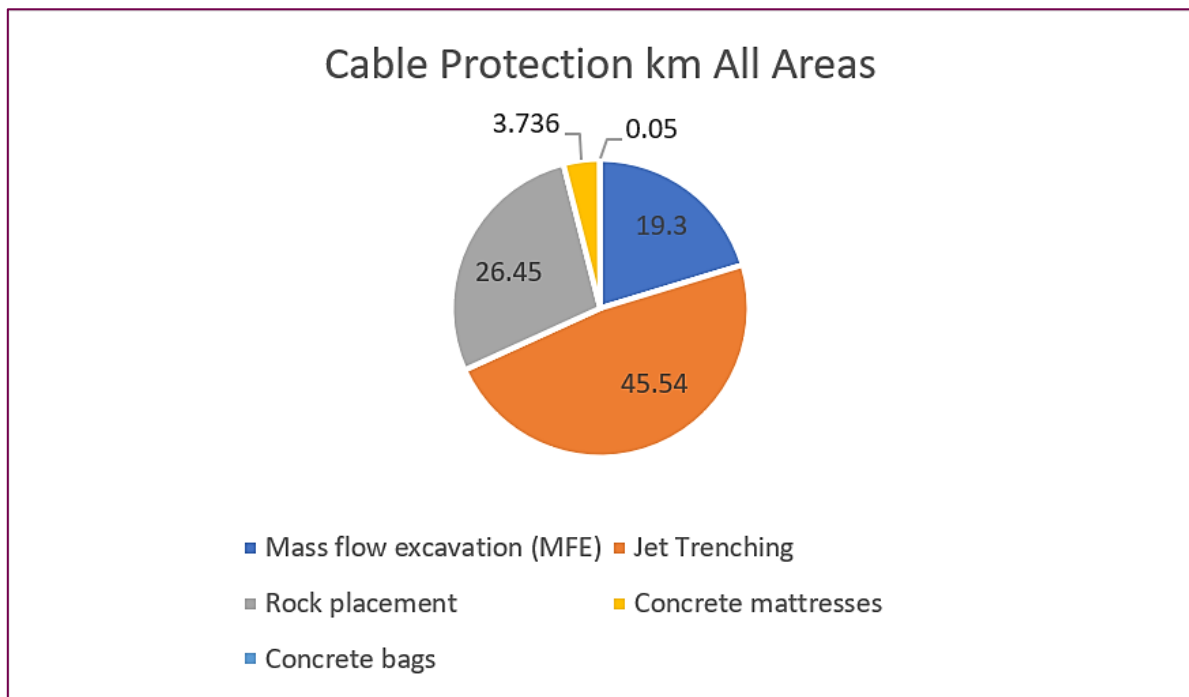
**Figure 3.7: Total Protection Lengths per Method for all Case Studies.**

Protection Measure	Installed Cable Length Protection Measure (km)					Total
	CS01	CS02	CS03	CS04	CS05	
Mass Flow Excavation (MFE)	19.3	0	0	0	0	19.3
Jet Trenching	0	0	0	4.54	41	45.54
Rock Placement	1.7	0	0.2	3.01	21.54	26.45
Concrete Mattresses	0.2	1.971	1.045	0	0.52	3.736
Concrete Bags	0.05	0	0	0	0	0.05
Total	21.25	1.971	1.245	3.01	63.06	95.076
Total Route length (km)	251.16	137.31	285.3	45	450.5	1169.27
Total Route length %	8.46%	1.44%	0.44%	16.78%	14.00%	8.13%
Total Non-burial Protection (km)	1.95	1.971	1.245	3.01	22.06	30.24
Total Non-burial Protection %	0.78%	1.44%	0.44%	6.7%	4.92%	2.59%

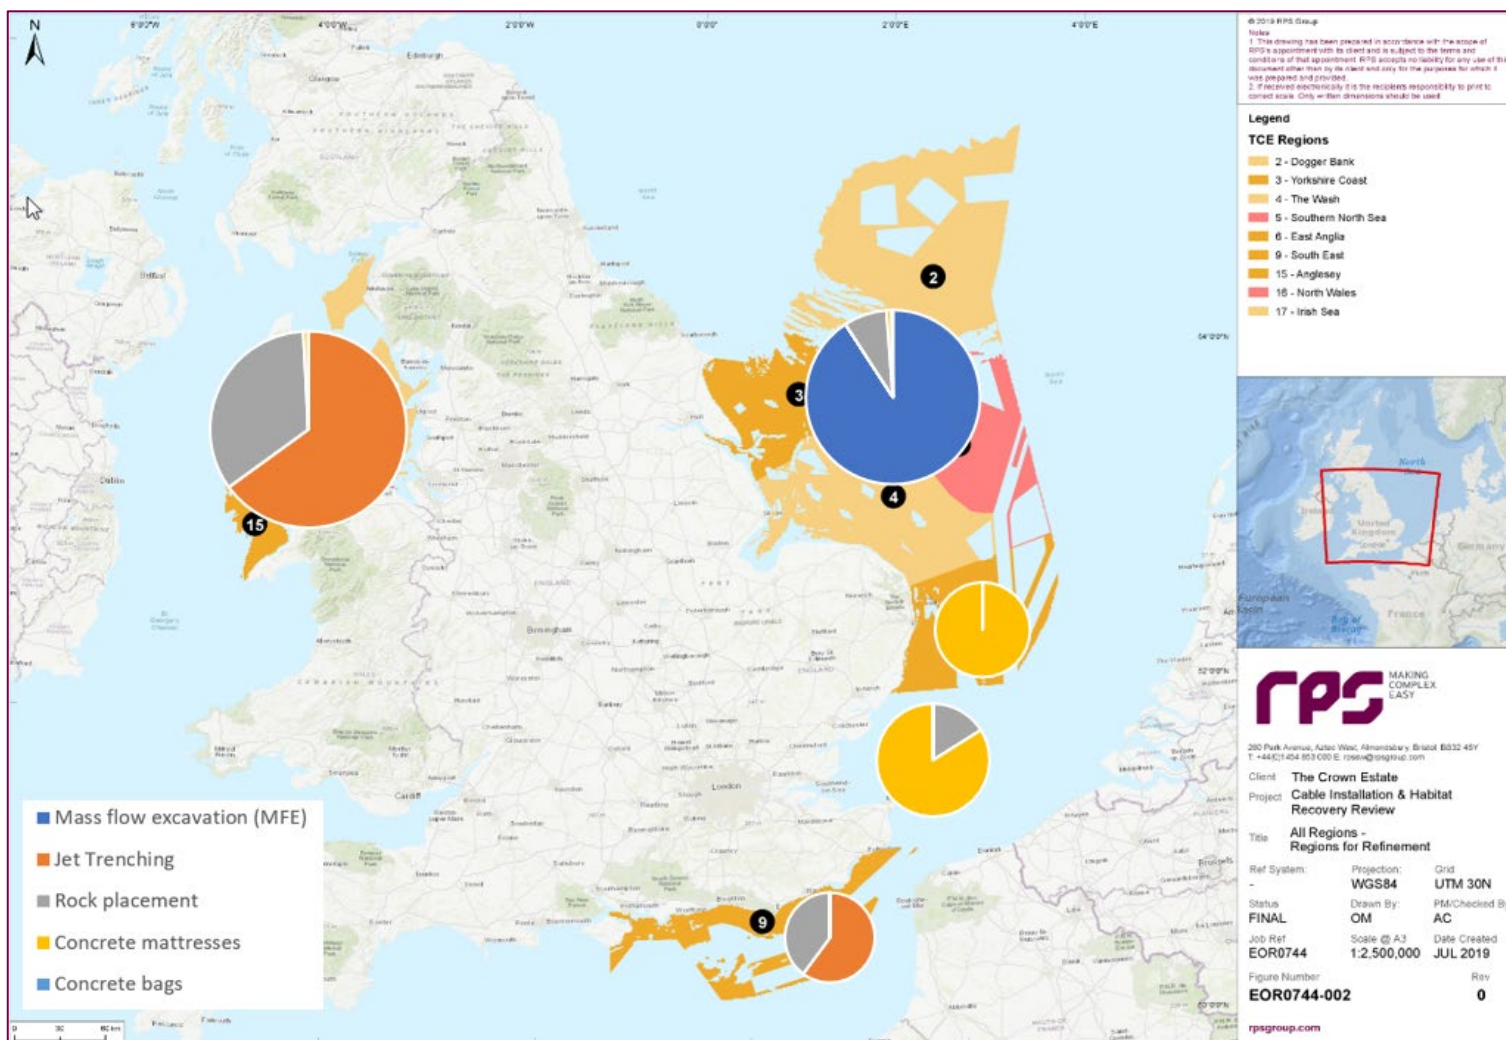
Figure 3.8: Summary Installation Protection Length per Method for each Case Study area.

- 3.3.4.6 Combining the data of installed cable lengths and protection lengths across each Case Study area (see Table 3.8), the percentage of installed cables requiring some form of mitigation reaches a maximum of 16.78% (Case Study 04 – South East). The average across all Case Studies is just over 8% of the route lengths requiring some form of remedial protection activities. However, placement of non-burial cable protection measures (i.e. rock or mattresses) accounted for <3% for all Case Study areas. This compares to recent consent applications where the non-burial cable protection parameters (e.g. rock or mattresses) are based on proportions of the overall export cables lengths of approximately 10% (e.g. Viking Link, Hornsea Three), but can be as high as 25% (e.g. Hornsea Projects One and Two).

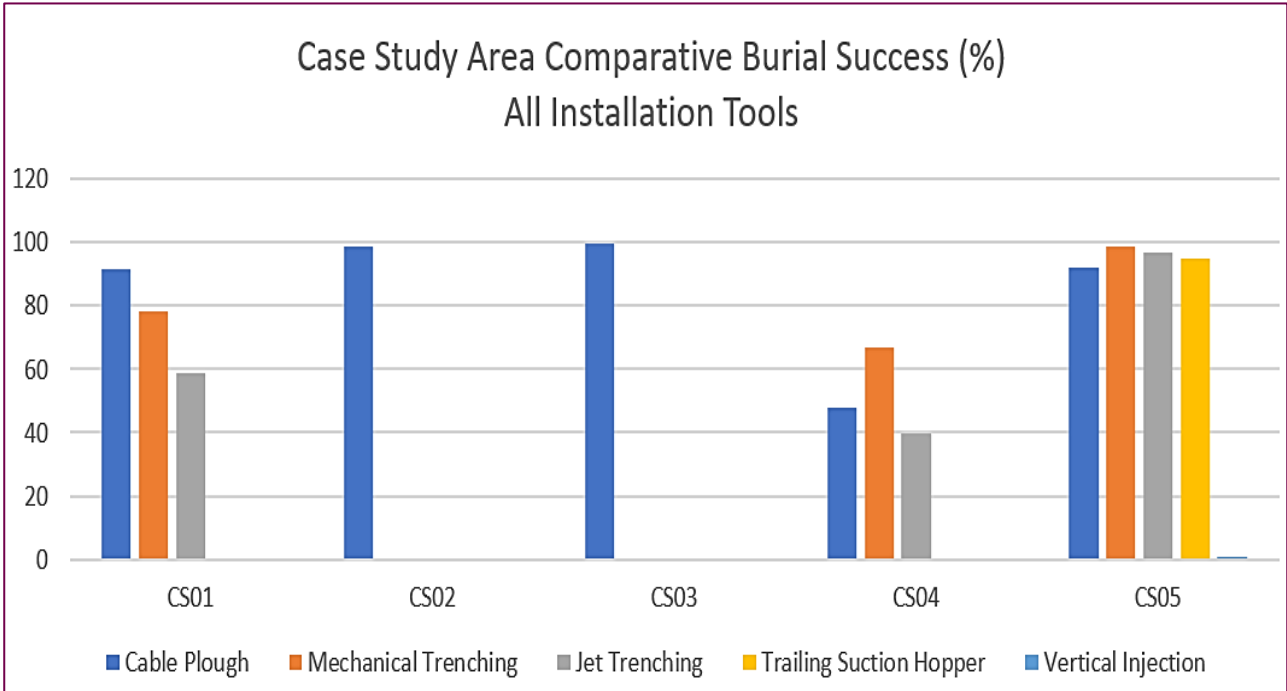
**Figure 3.9: Comparative Burial Success for all Installation Tools.**

3.3.5.1 Figure 3.9 below shows the percentage success for each installation tool type used in each of the case study areas. The installation tools/methods were used to different degrees across the five Case Studies, though three installation methods (i.e. plough, mechanical trenching and jet trenching) were used most commonly across the Case Studies, allowing for some comparison of the tools across regions.

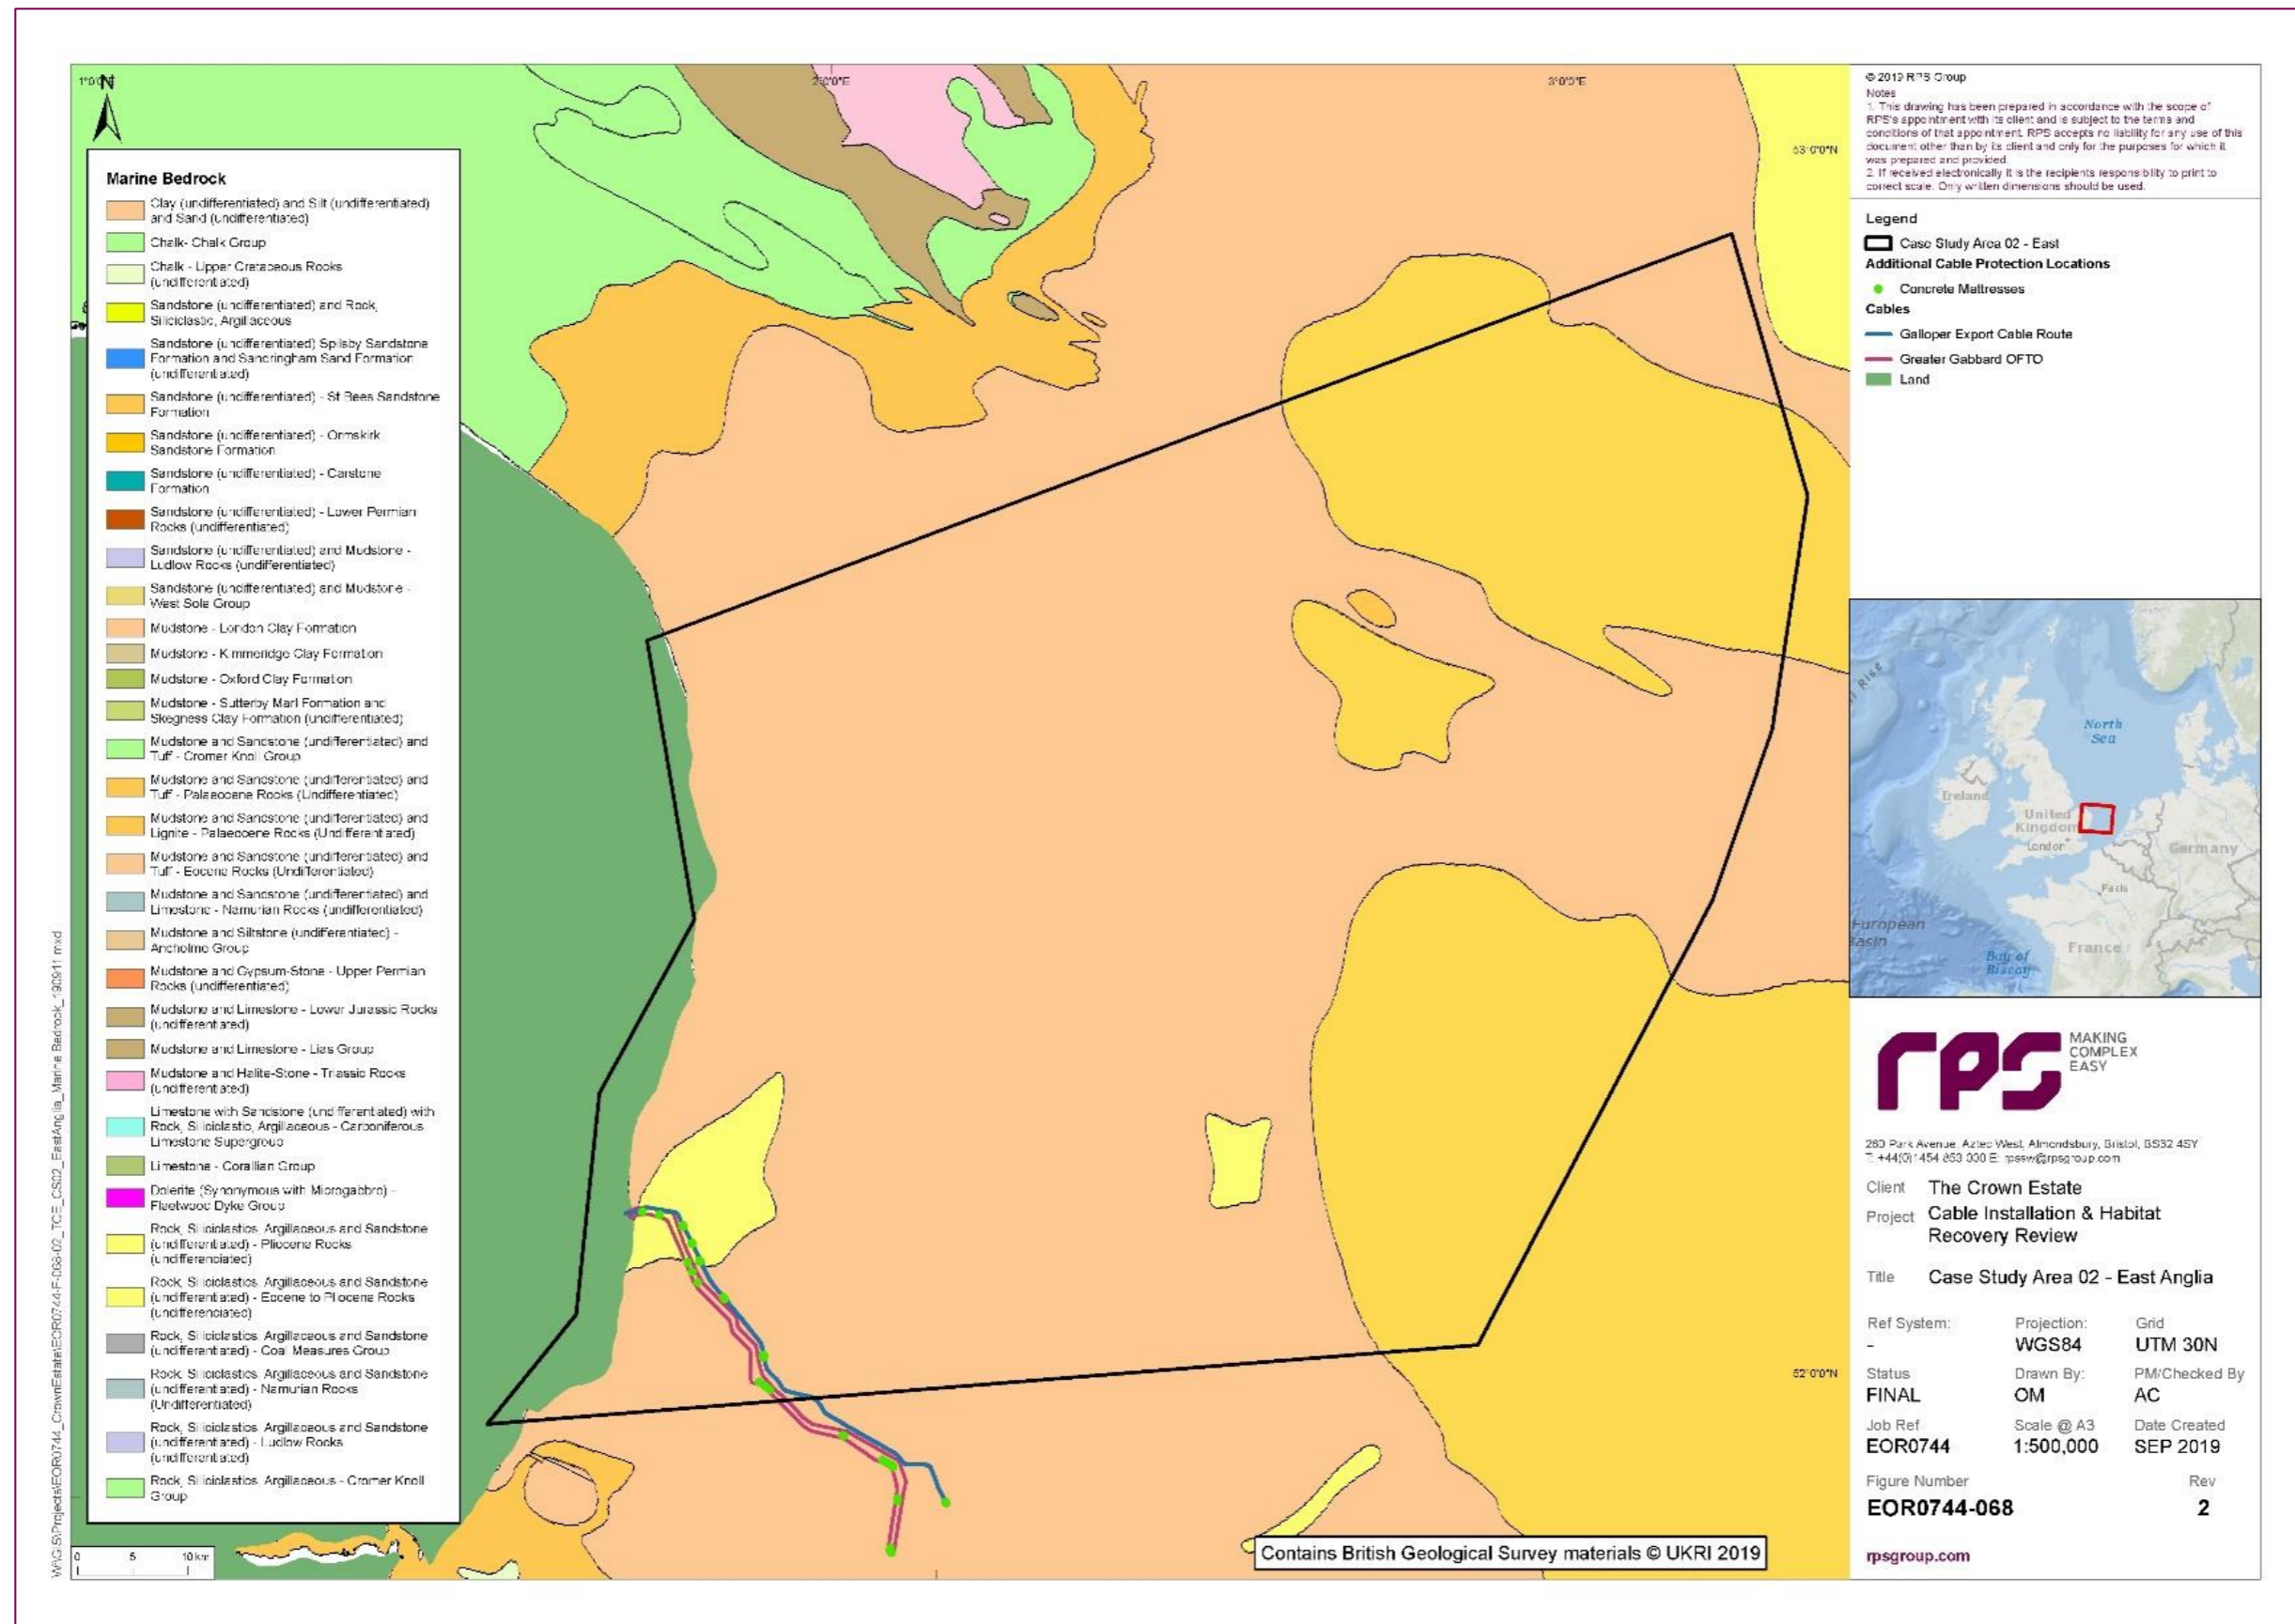
Figure 4: Case Study 02 – East Anglia – Marine Bedrock.

The summary bedrock profile for the East Anglia region (Region 6) in this Case Study is summarised in Table 6 below and are shown in Figure 4. The predominant areas are the areas near to shore of mudstone and sandstone.

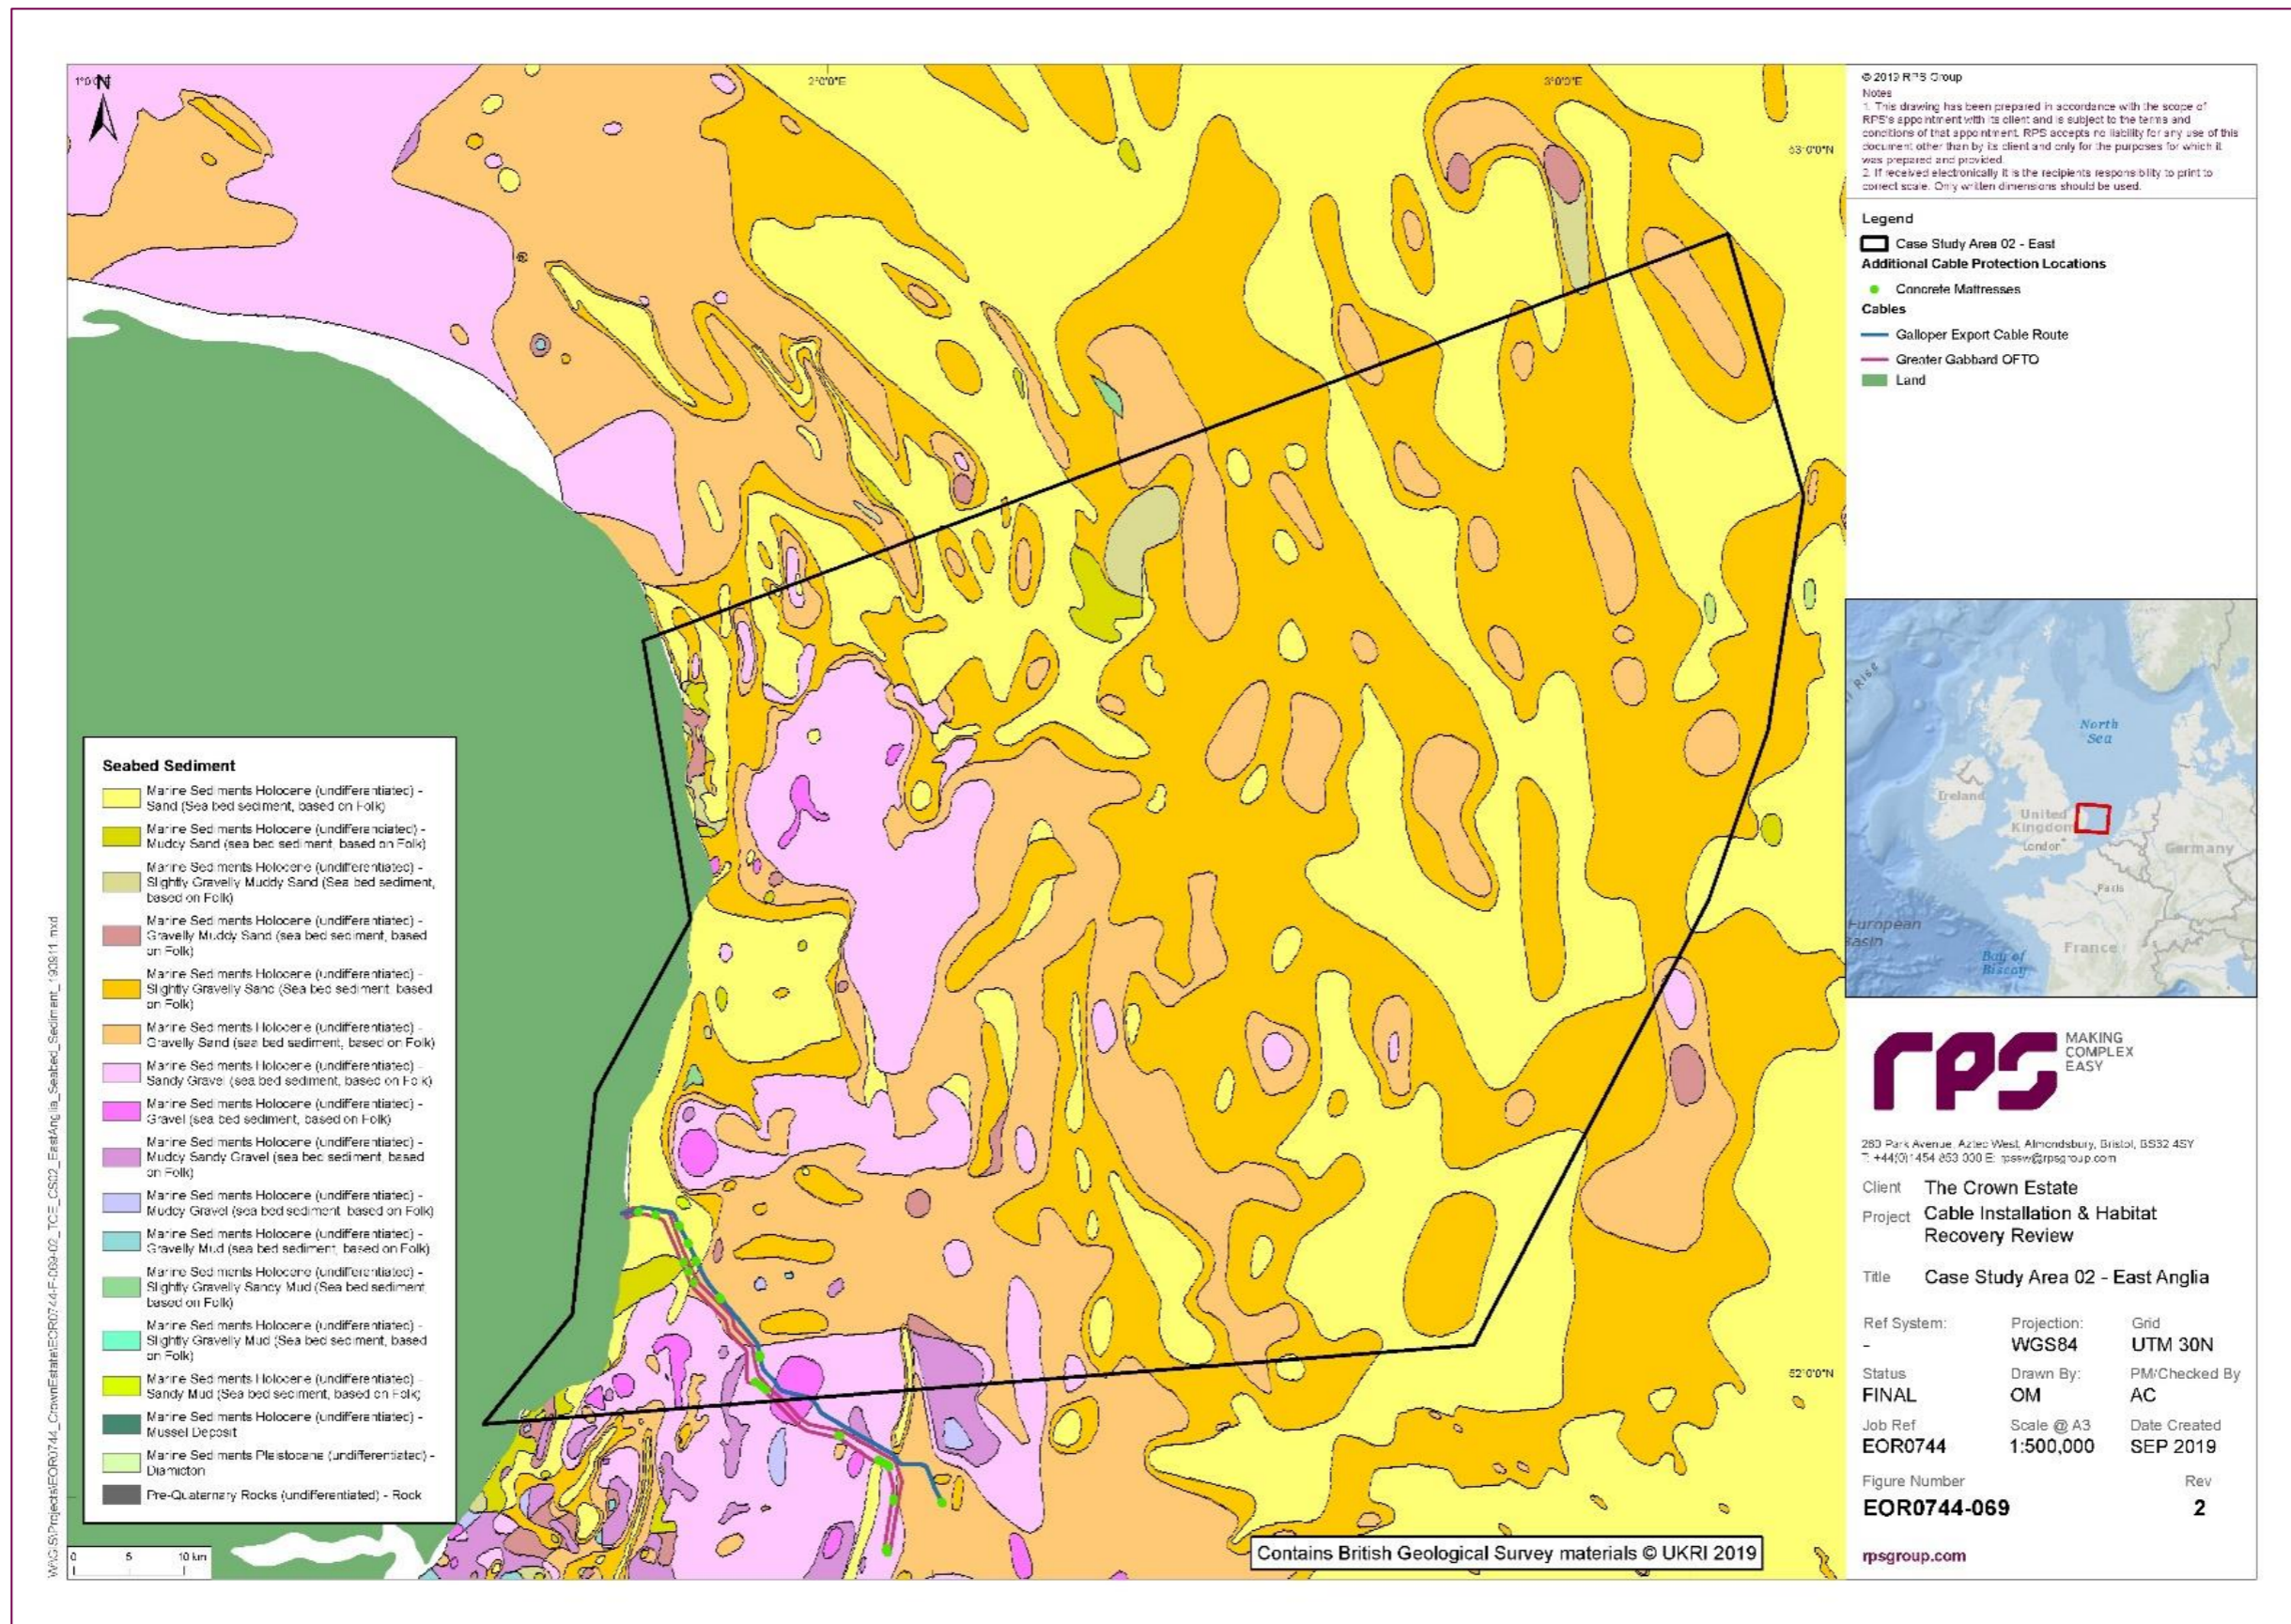
Figure 5: Case Study 02 – East Anglia – Marine Seabed Sediment.

The summary sediment types within the East Anglia region (Region 6) in this Case Study are summarised in Table 7 below and are visually represented in Figure 5. These sediments are to be taken into consideration in combination with the bedrock formations when evaluating cable installation scenarios.

In this Case Study area, the single installation tool used was the cable plough. This choice of tool has clearly been successful, with 98.6% of the cable length reaching the depth of burial (Table 8). The predominant sediment types were sandy gravel, gravelly sand and sand. The cable plough performed well, and the remedial protection was completed with concrete mattresses, with the total protection reported in this Case Study comprising a total of 1.5% of the total cable lengths.
