# Norfolk Boreas Offshore Wind Farm

## Appendix 3. Review of Cable Installation, Protection Mitigation and Habitat recoverability.

# REVIEW OF CABLE INSTALLATION, PROTECTION, MITIGATION AND HABITAT RECOVERABILITY

EOR0744  
Cable Installation, Protection,  
Mitigation and Habitat  
Recoverability  
Rev03  
12 November 2019

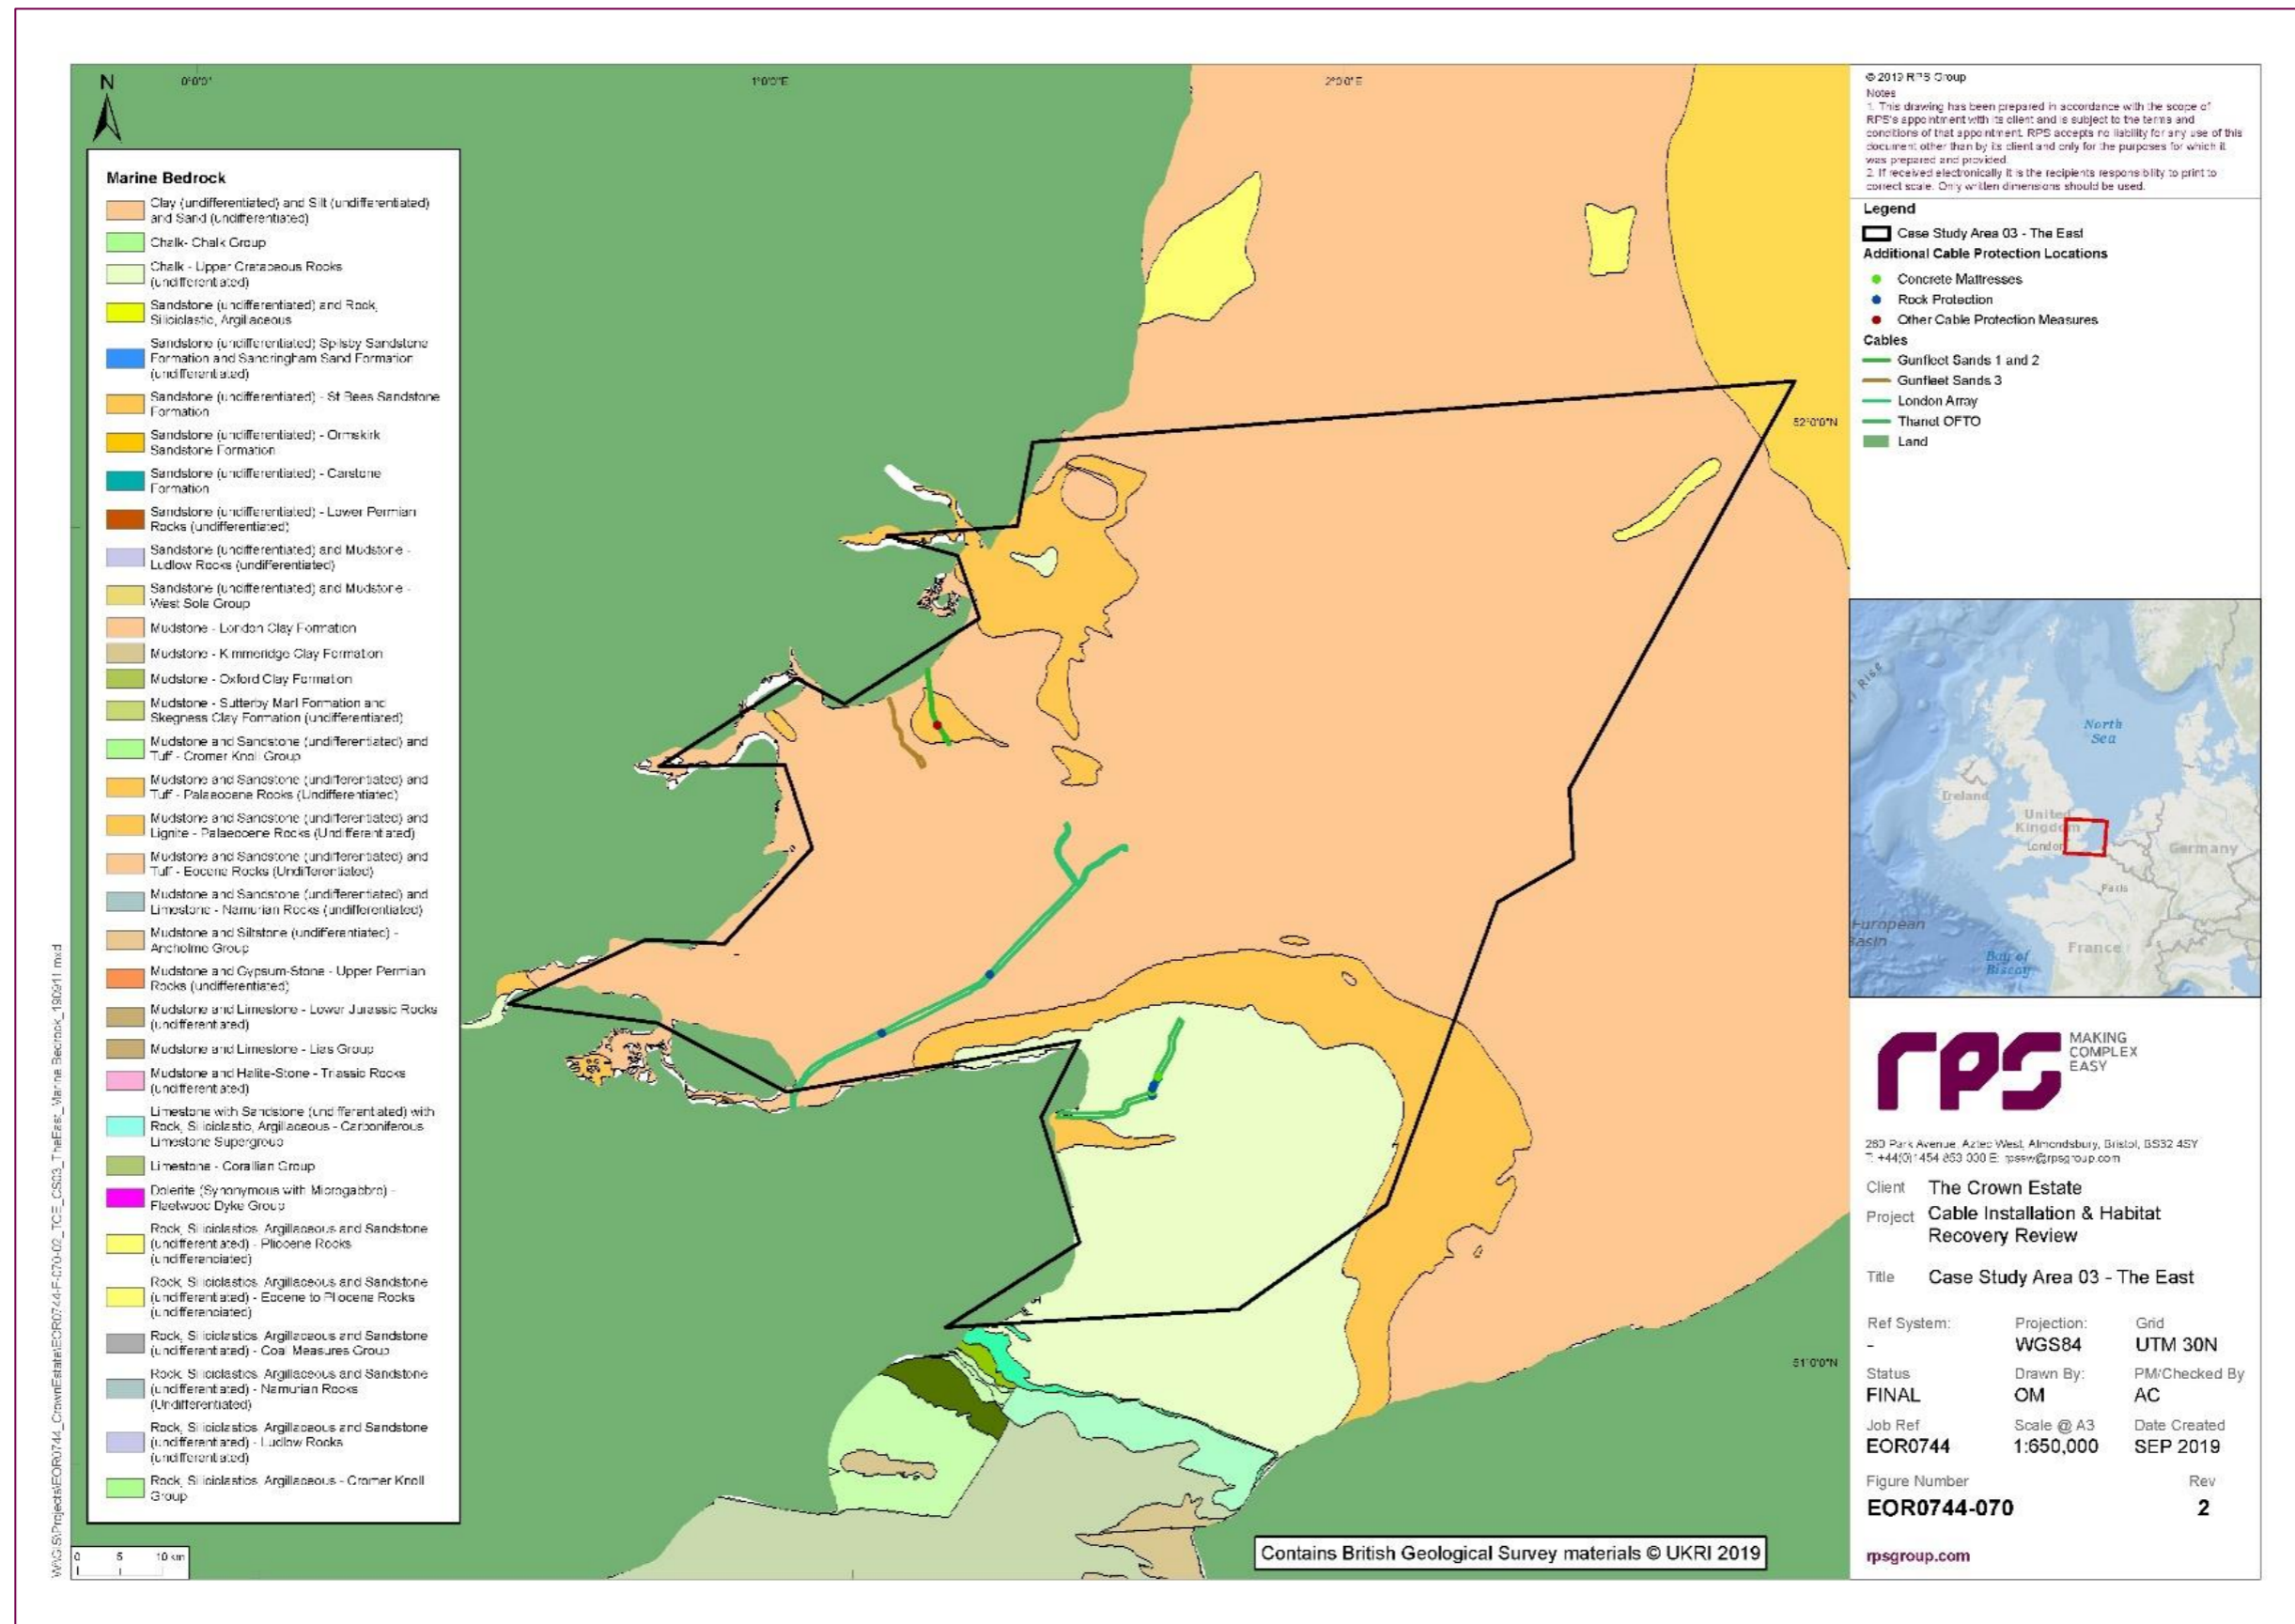
Figure 6: Case Study 03 – East – Marine Bedrock.

The summary bedrock profile for each of the regions within this Case Study are summarised in Table 10 below and are shown in Figure 6. Where site specific project information on ground conditions were available, these were primarily in areas to the south where chalk is the main bedrock for project in the area. Looking further north in the Case Study area, mudstone and sandstone are heavily featured.

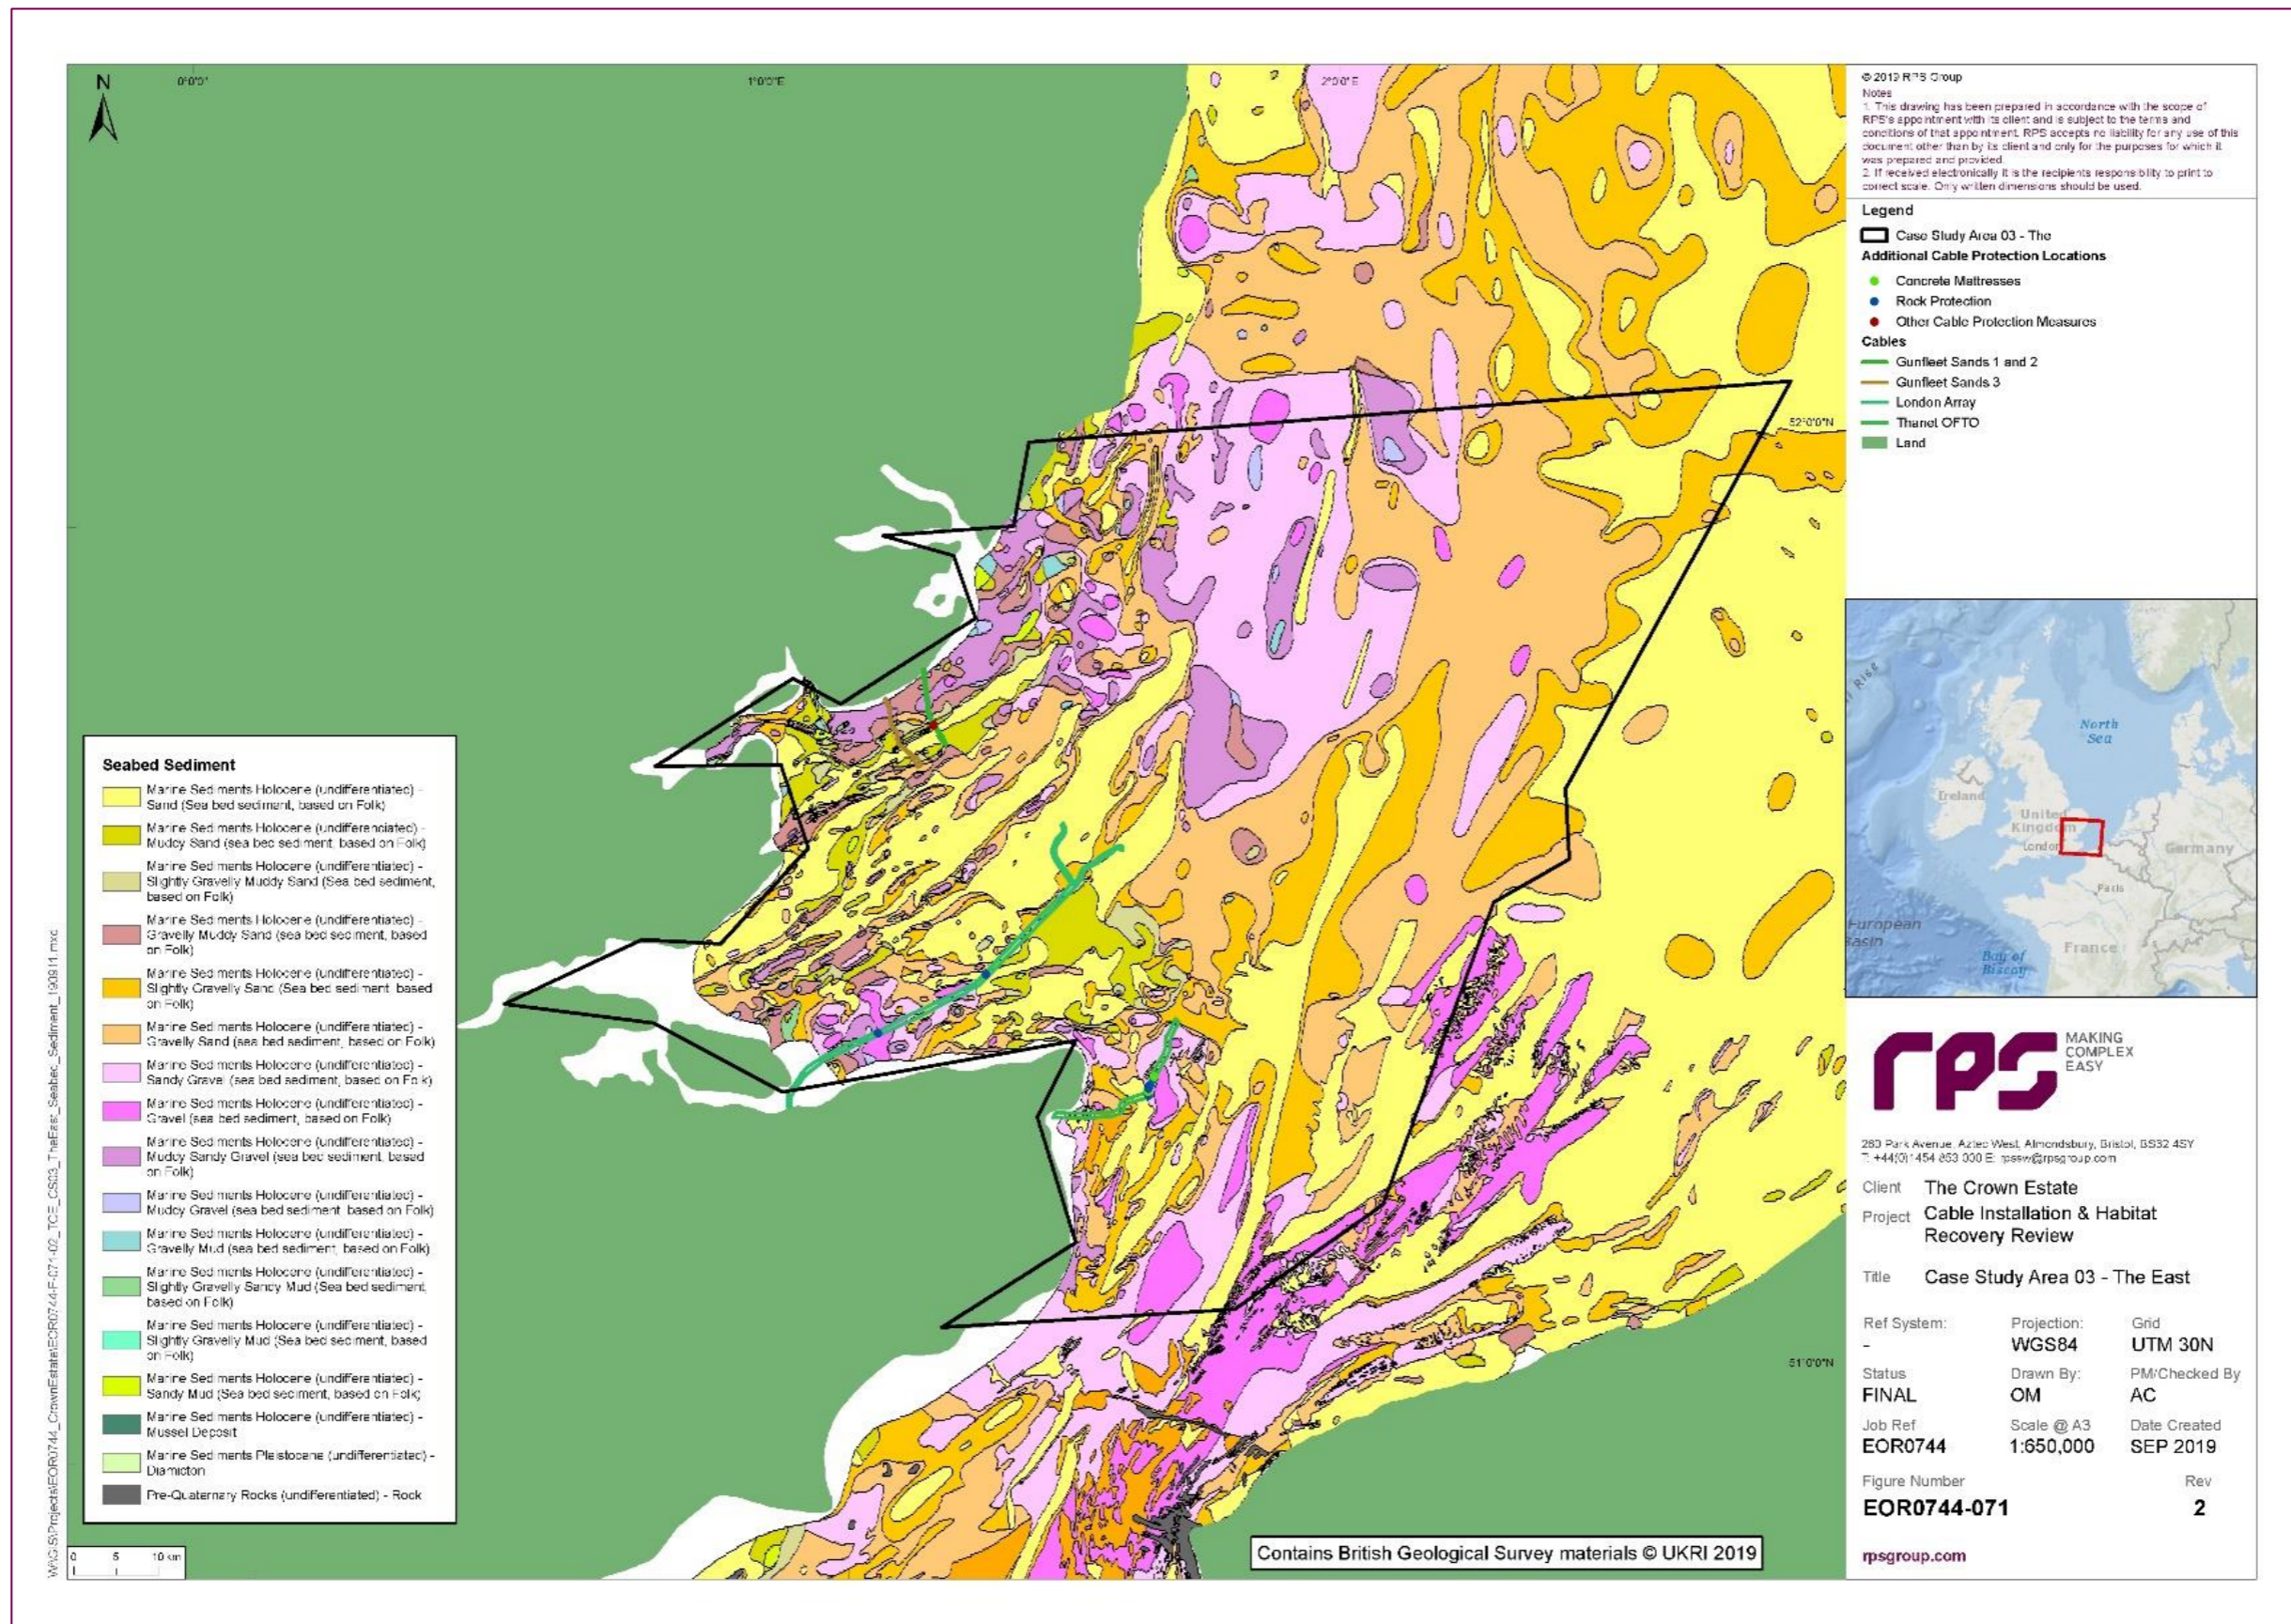
Figure 7: Case Study 03 – East – Marine Seabed Sediment.

The summary sediment types for each of the regions within this case study are summarised in Table 11 below and shown in Figure 7. These sediments are to be taken into consideration in combination with the bedrock formations when evaluating cable installation scenarios.

In this Case Study area, the single installation tool used was the cable plough. This choice of tool has clearly been successful, with 99.56% of the cable length reaching the depth of burial (Table 12). In the predominant sediment types of coarse sand and gravely sand, the cable plough performed well. Remedial protection represented only a small proportion of the overall length of export cables (i.e. <0.5%), with mainly concrete mattresses and some rock protection.

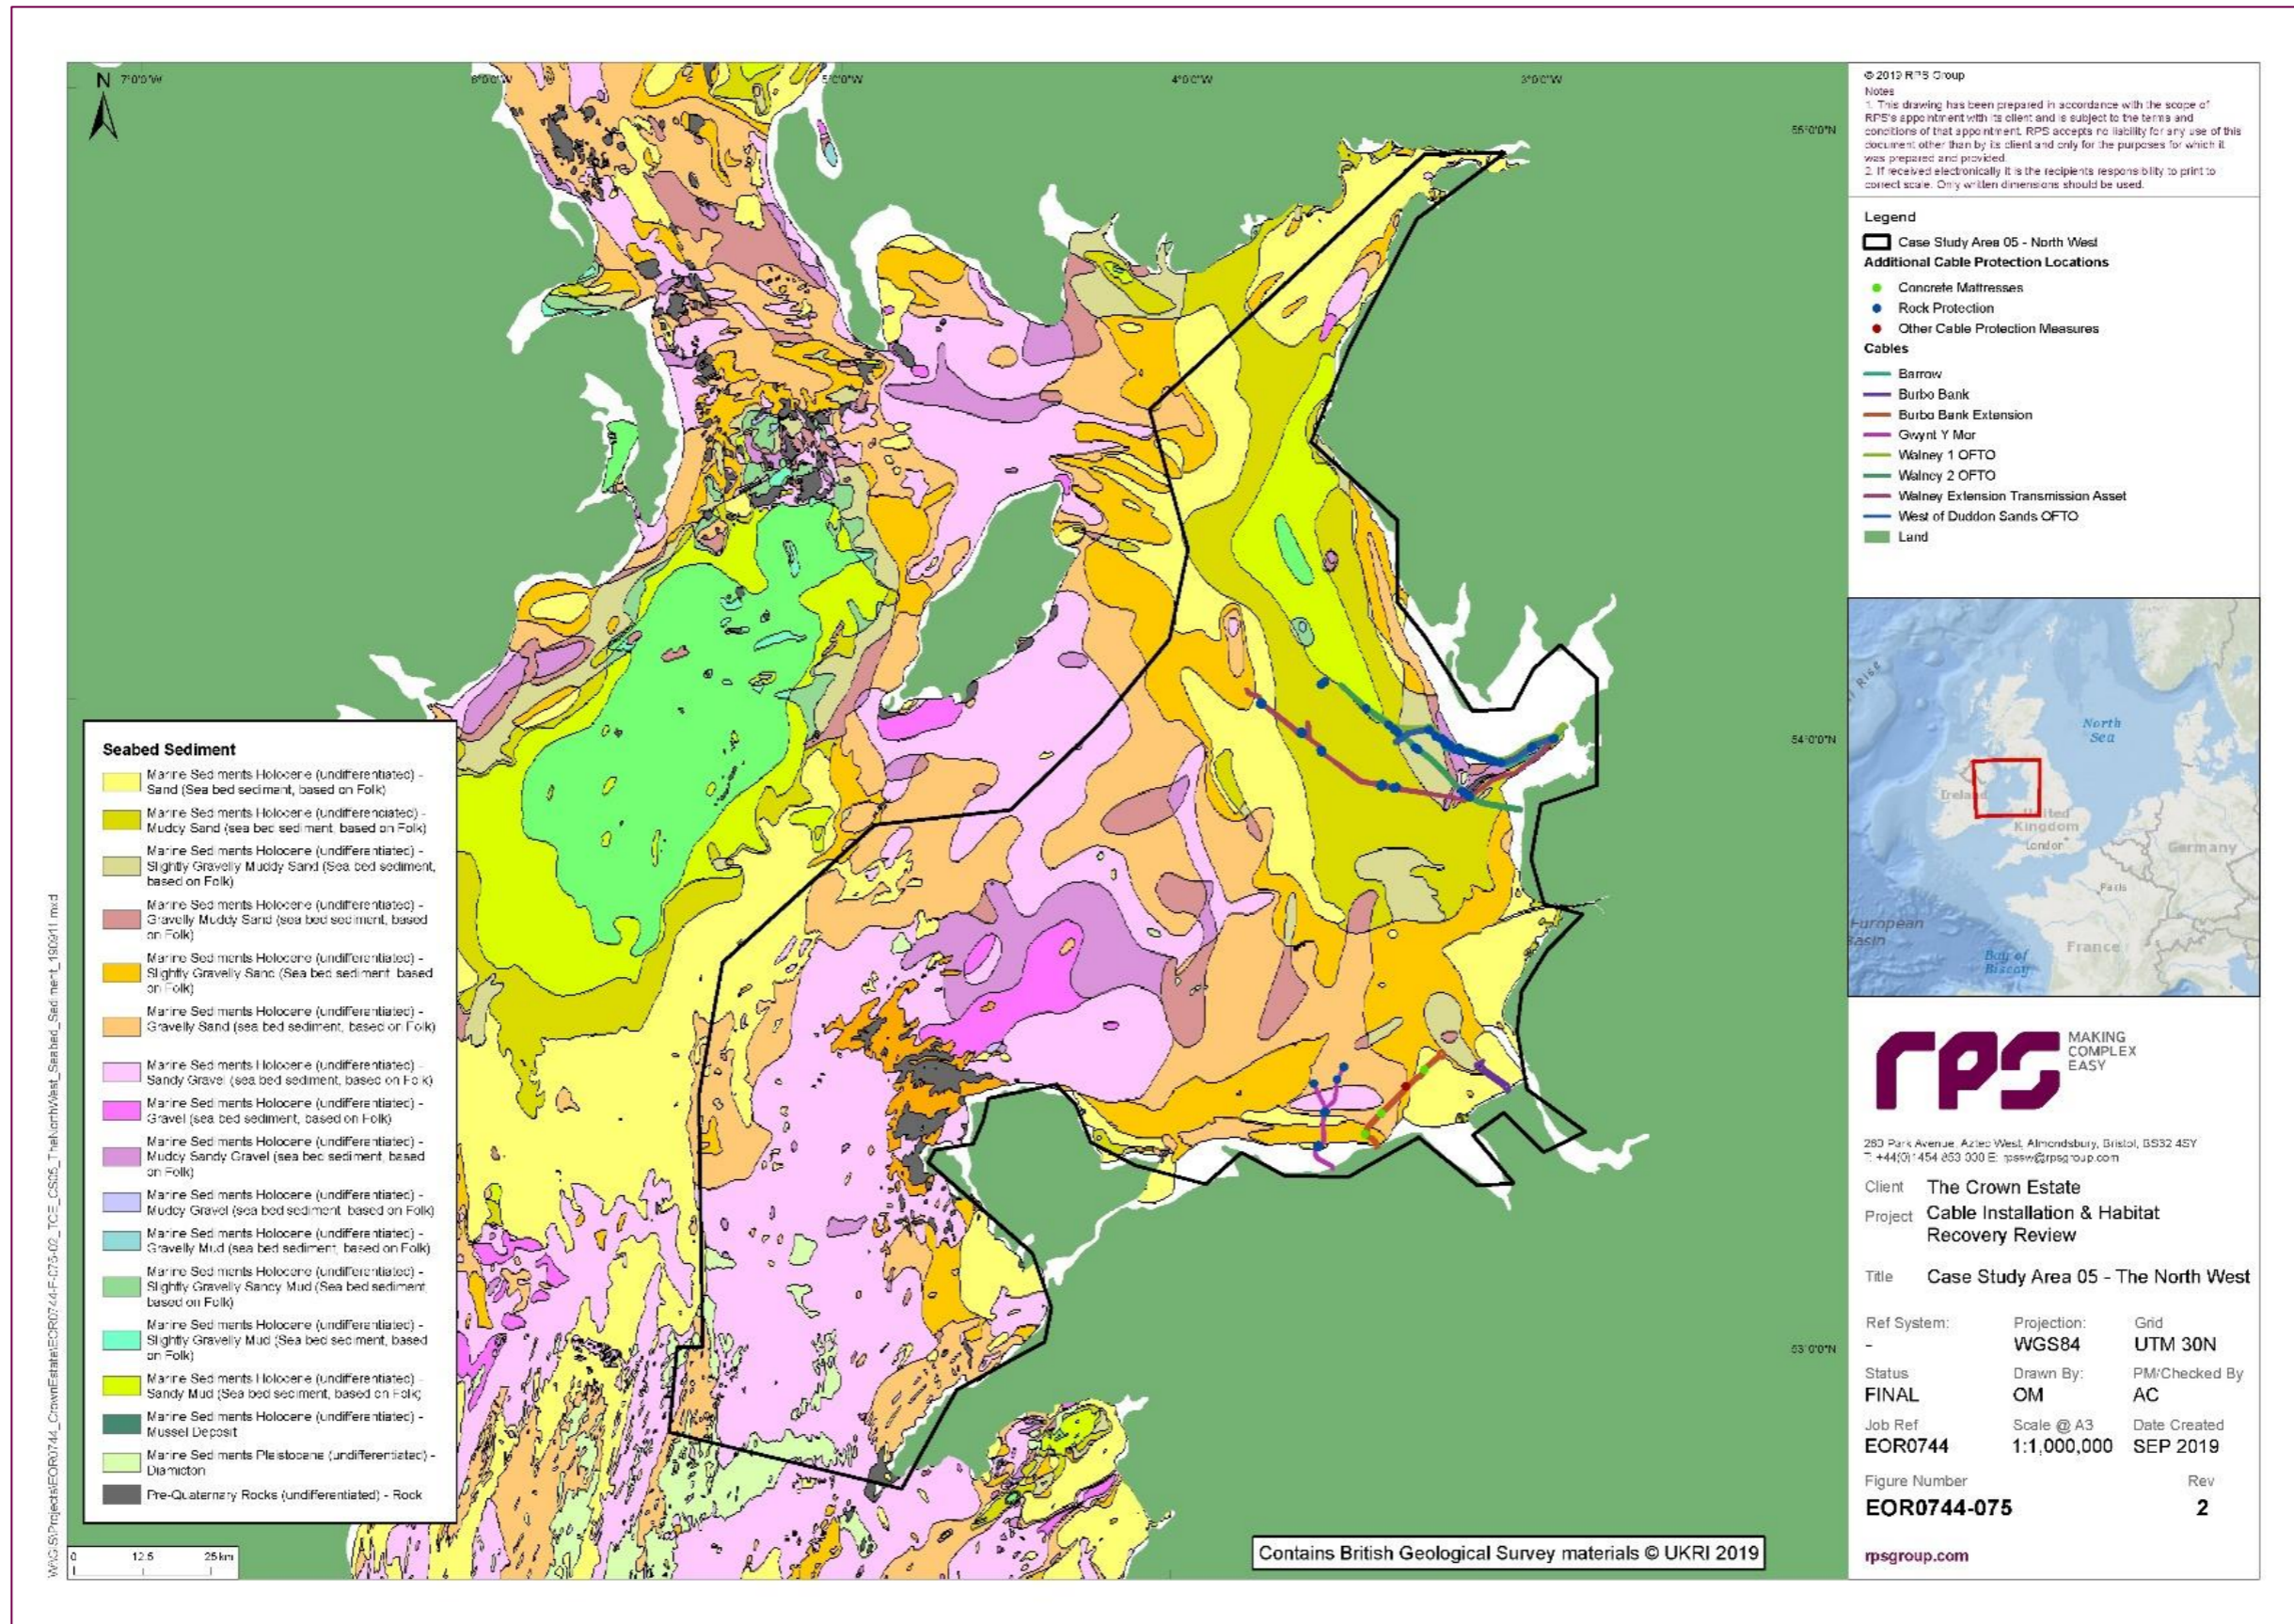
Figure 11: Case Study 05 – North West – Marine Seabed Sediment

The summary sediment types for each of the regions within this Case Study are summarised in Table 19 below, and presented in Figure 11. These sediments are to be taken into consideration in combination with the bedrock formations when evaluating cable installation scenarios.

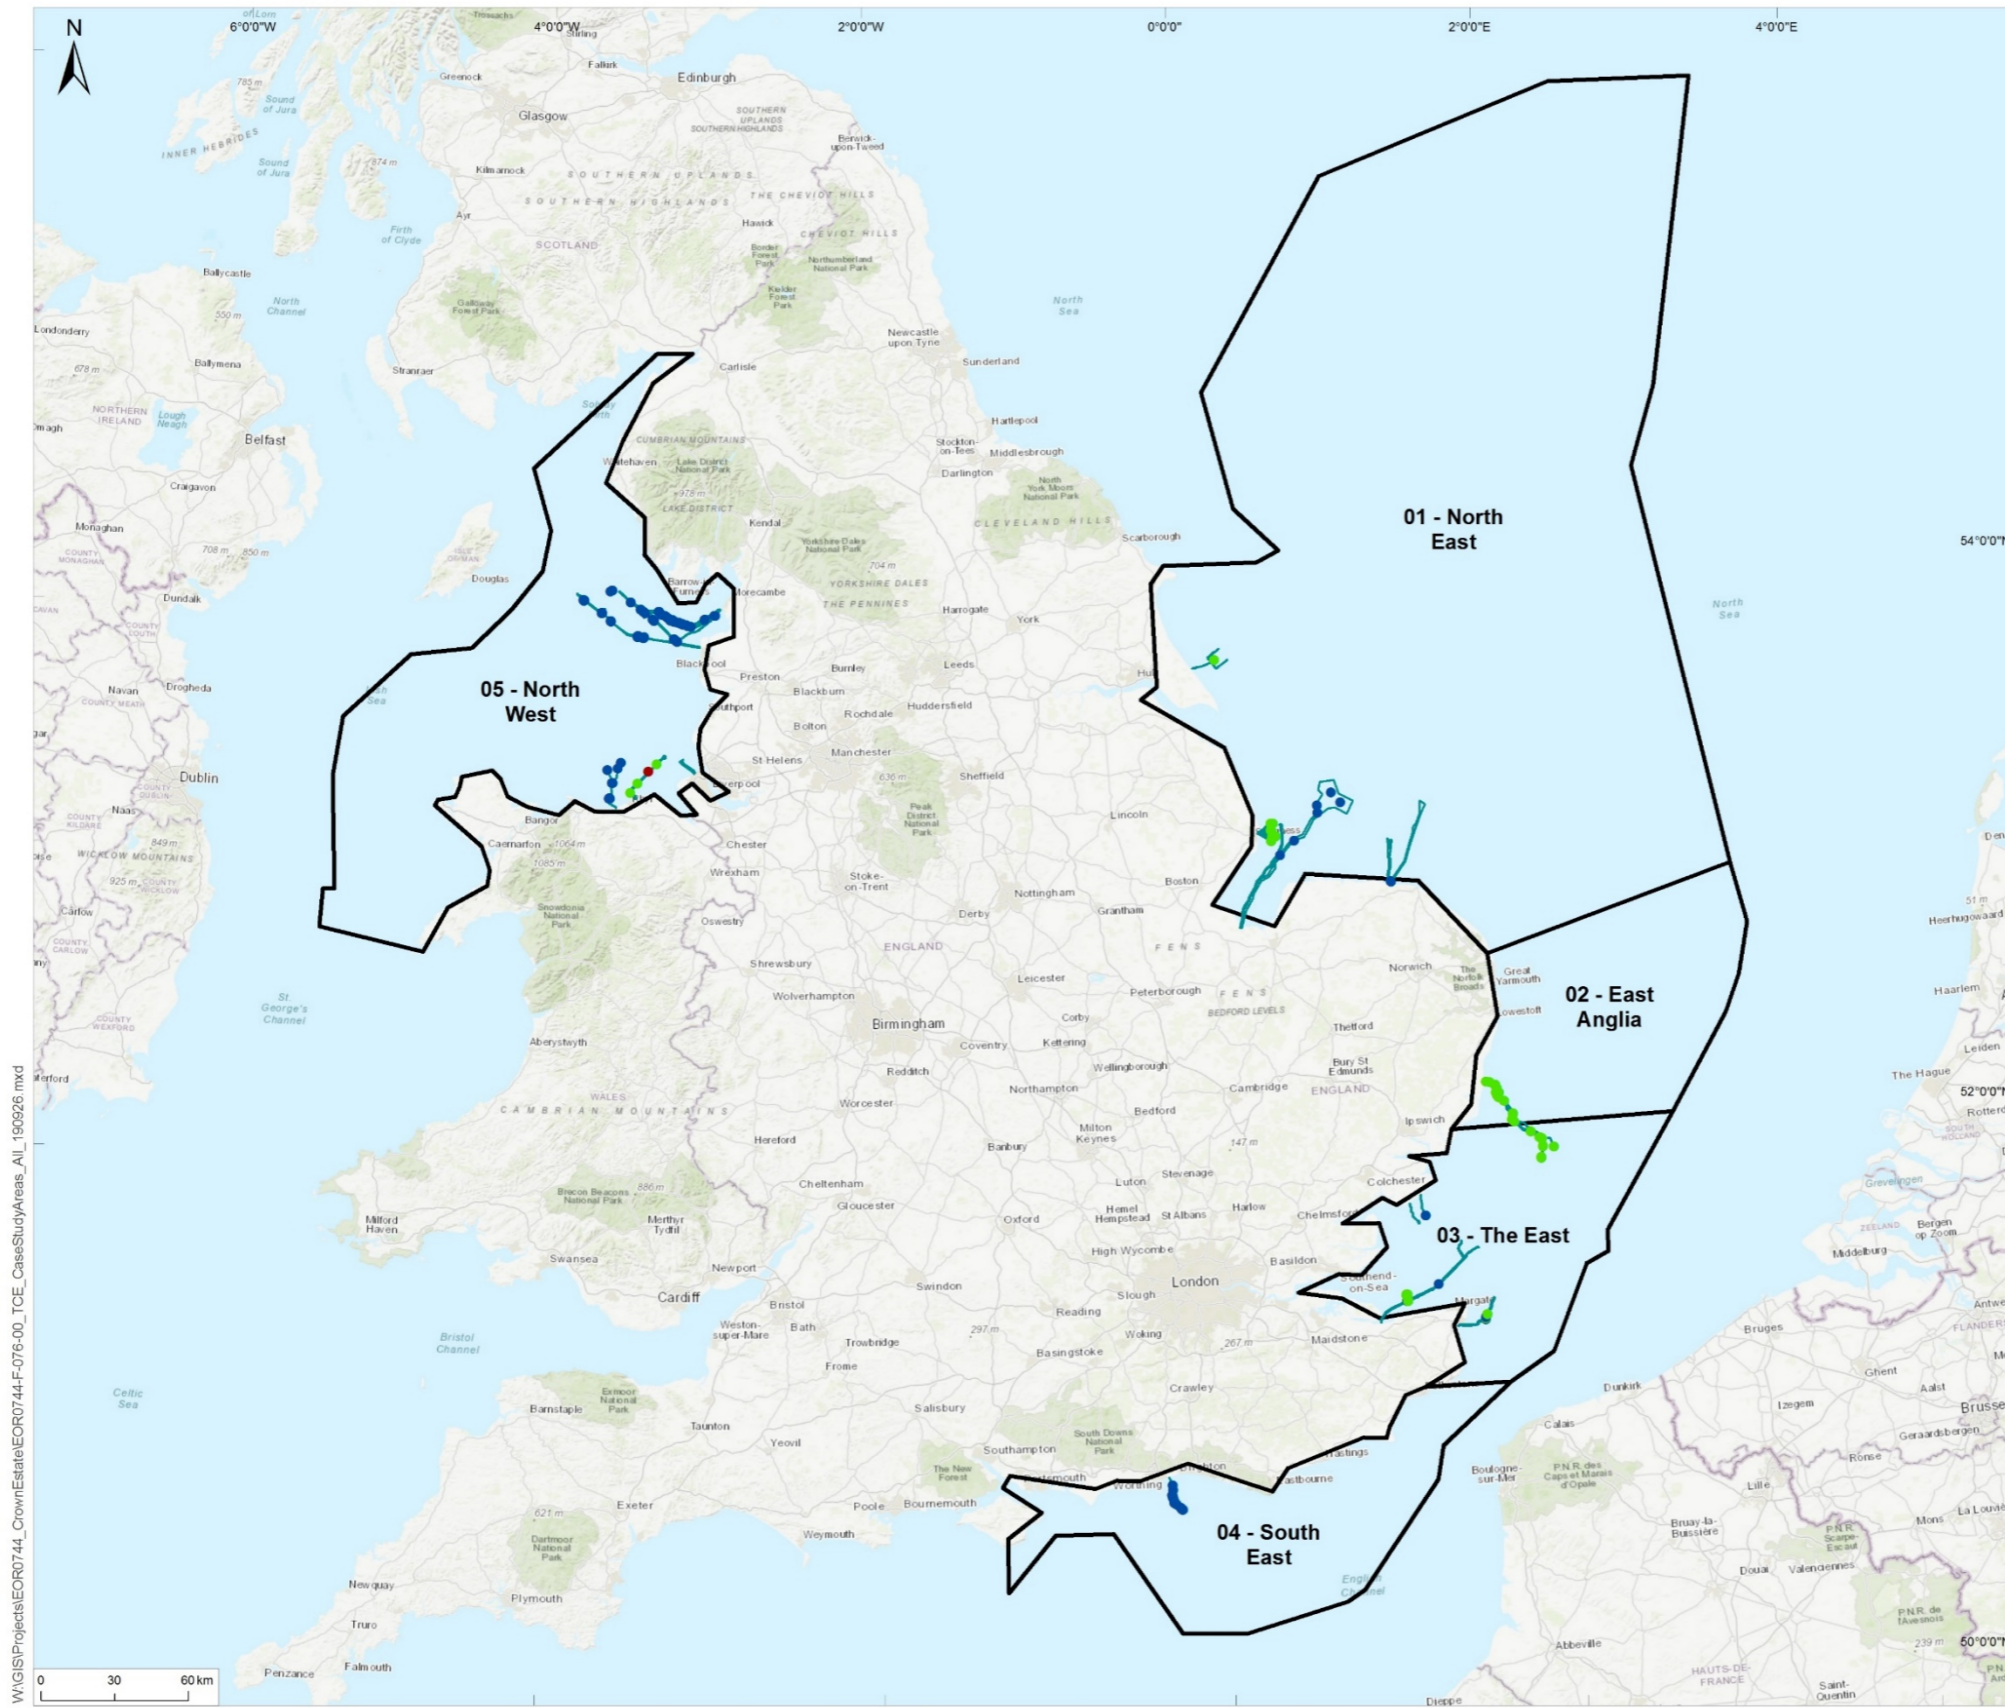
Client **The Crown Estate**  
 Project **Cable Installation & Habitat Recovery Review**  
 Title **Case Study Areas**

- Legend**
- Case Study Areas
  - Cables
  - Additional Cable Protection Locations**
    - Concrete Mattresses
    - Rock Protection
    - Other Cable Protection Measures

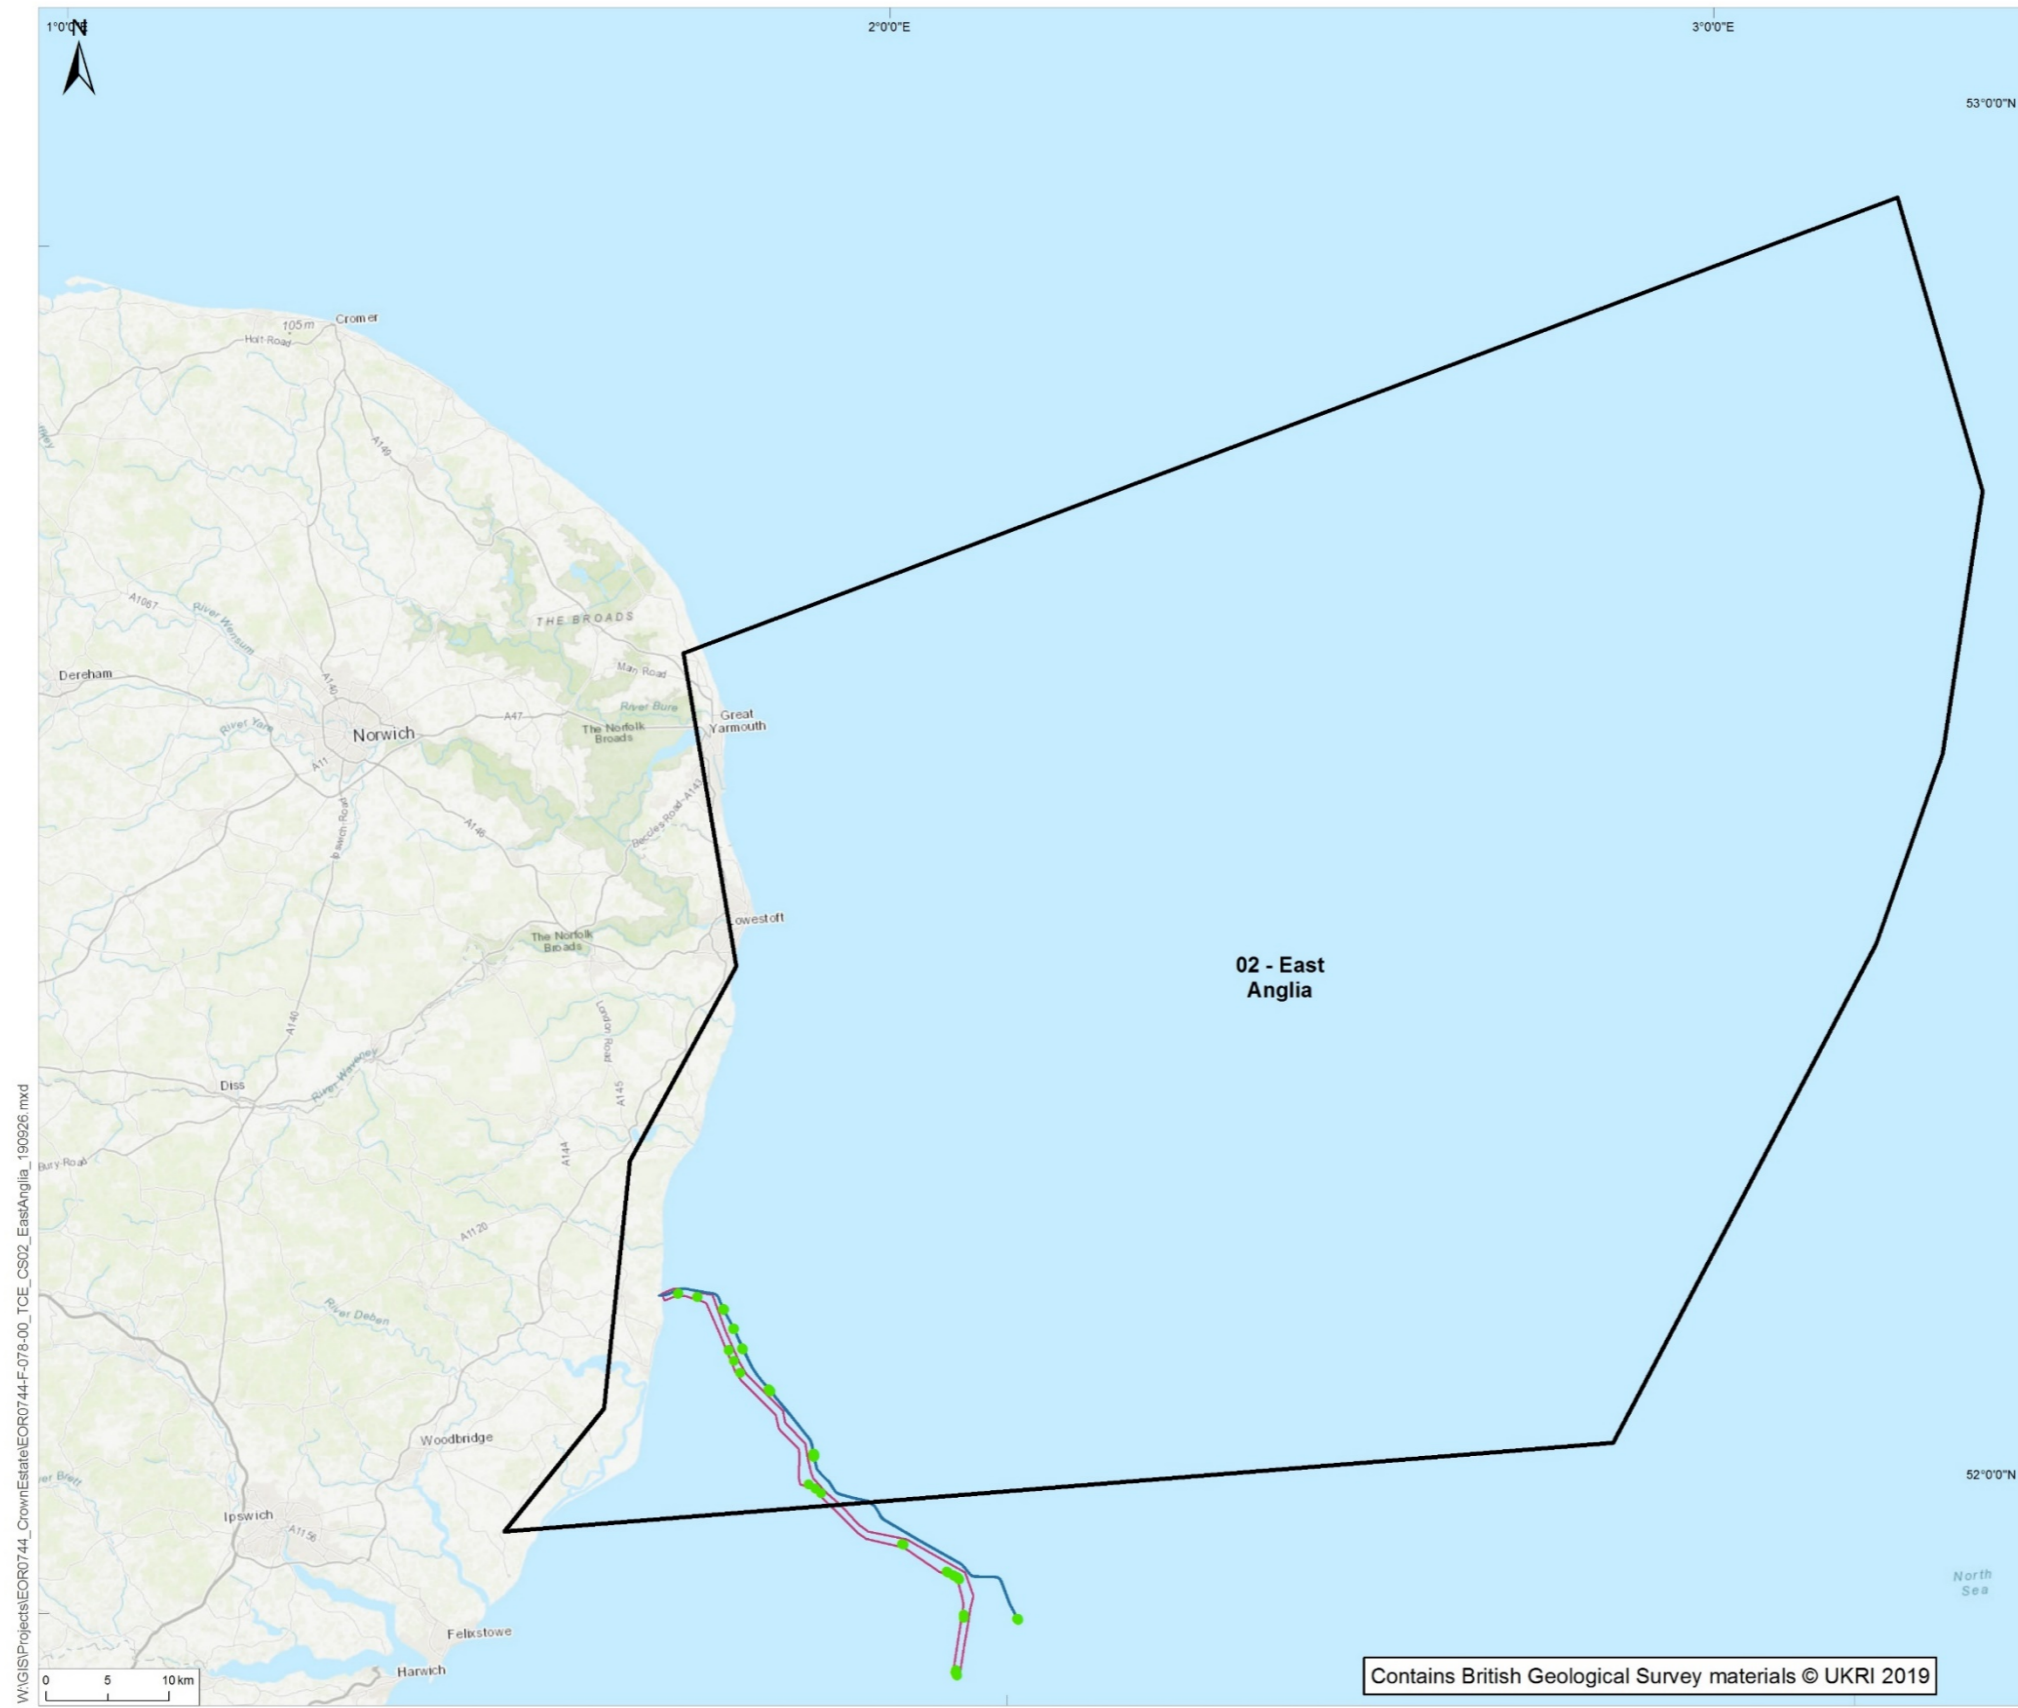
Client **The Crown Estate**  
 Project **Cable Installation & Habitat Recovery Review**  
 Title **Case Study Area 02 - East Anglia**

- Legend**
- Case Study Area 02 - East Anglia
  - Additional Cable Protection Locations**
  - Concrete Mattresses
  - Cables**
  - Gallop Export Cable Route
  - Greater Gabbard OFTO

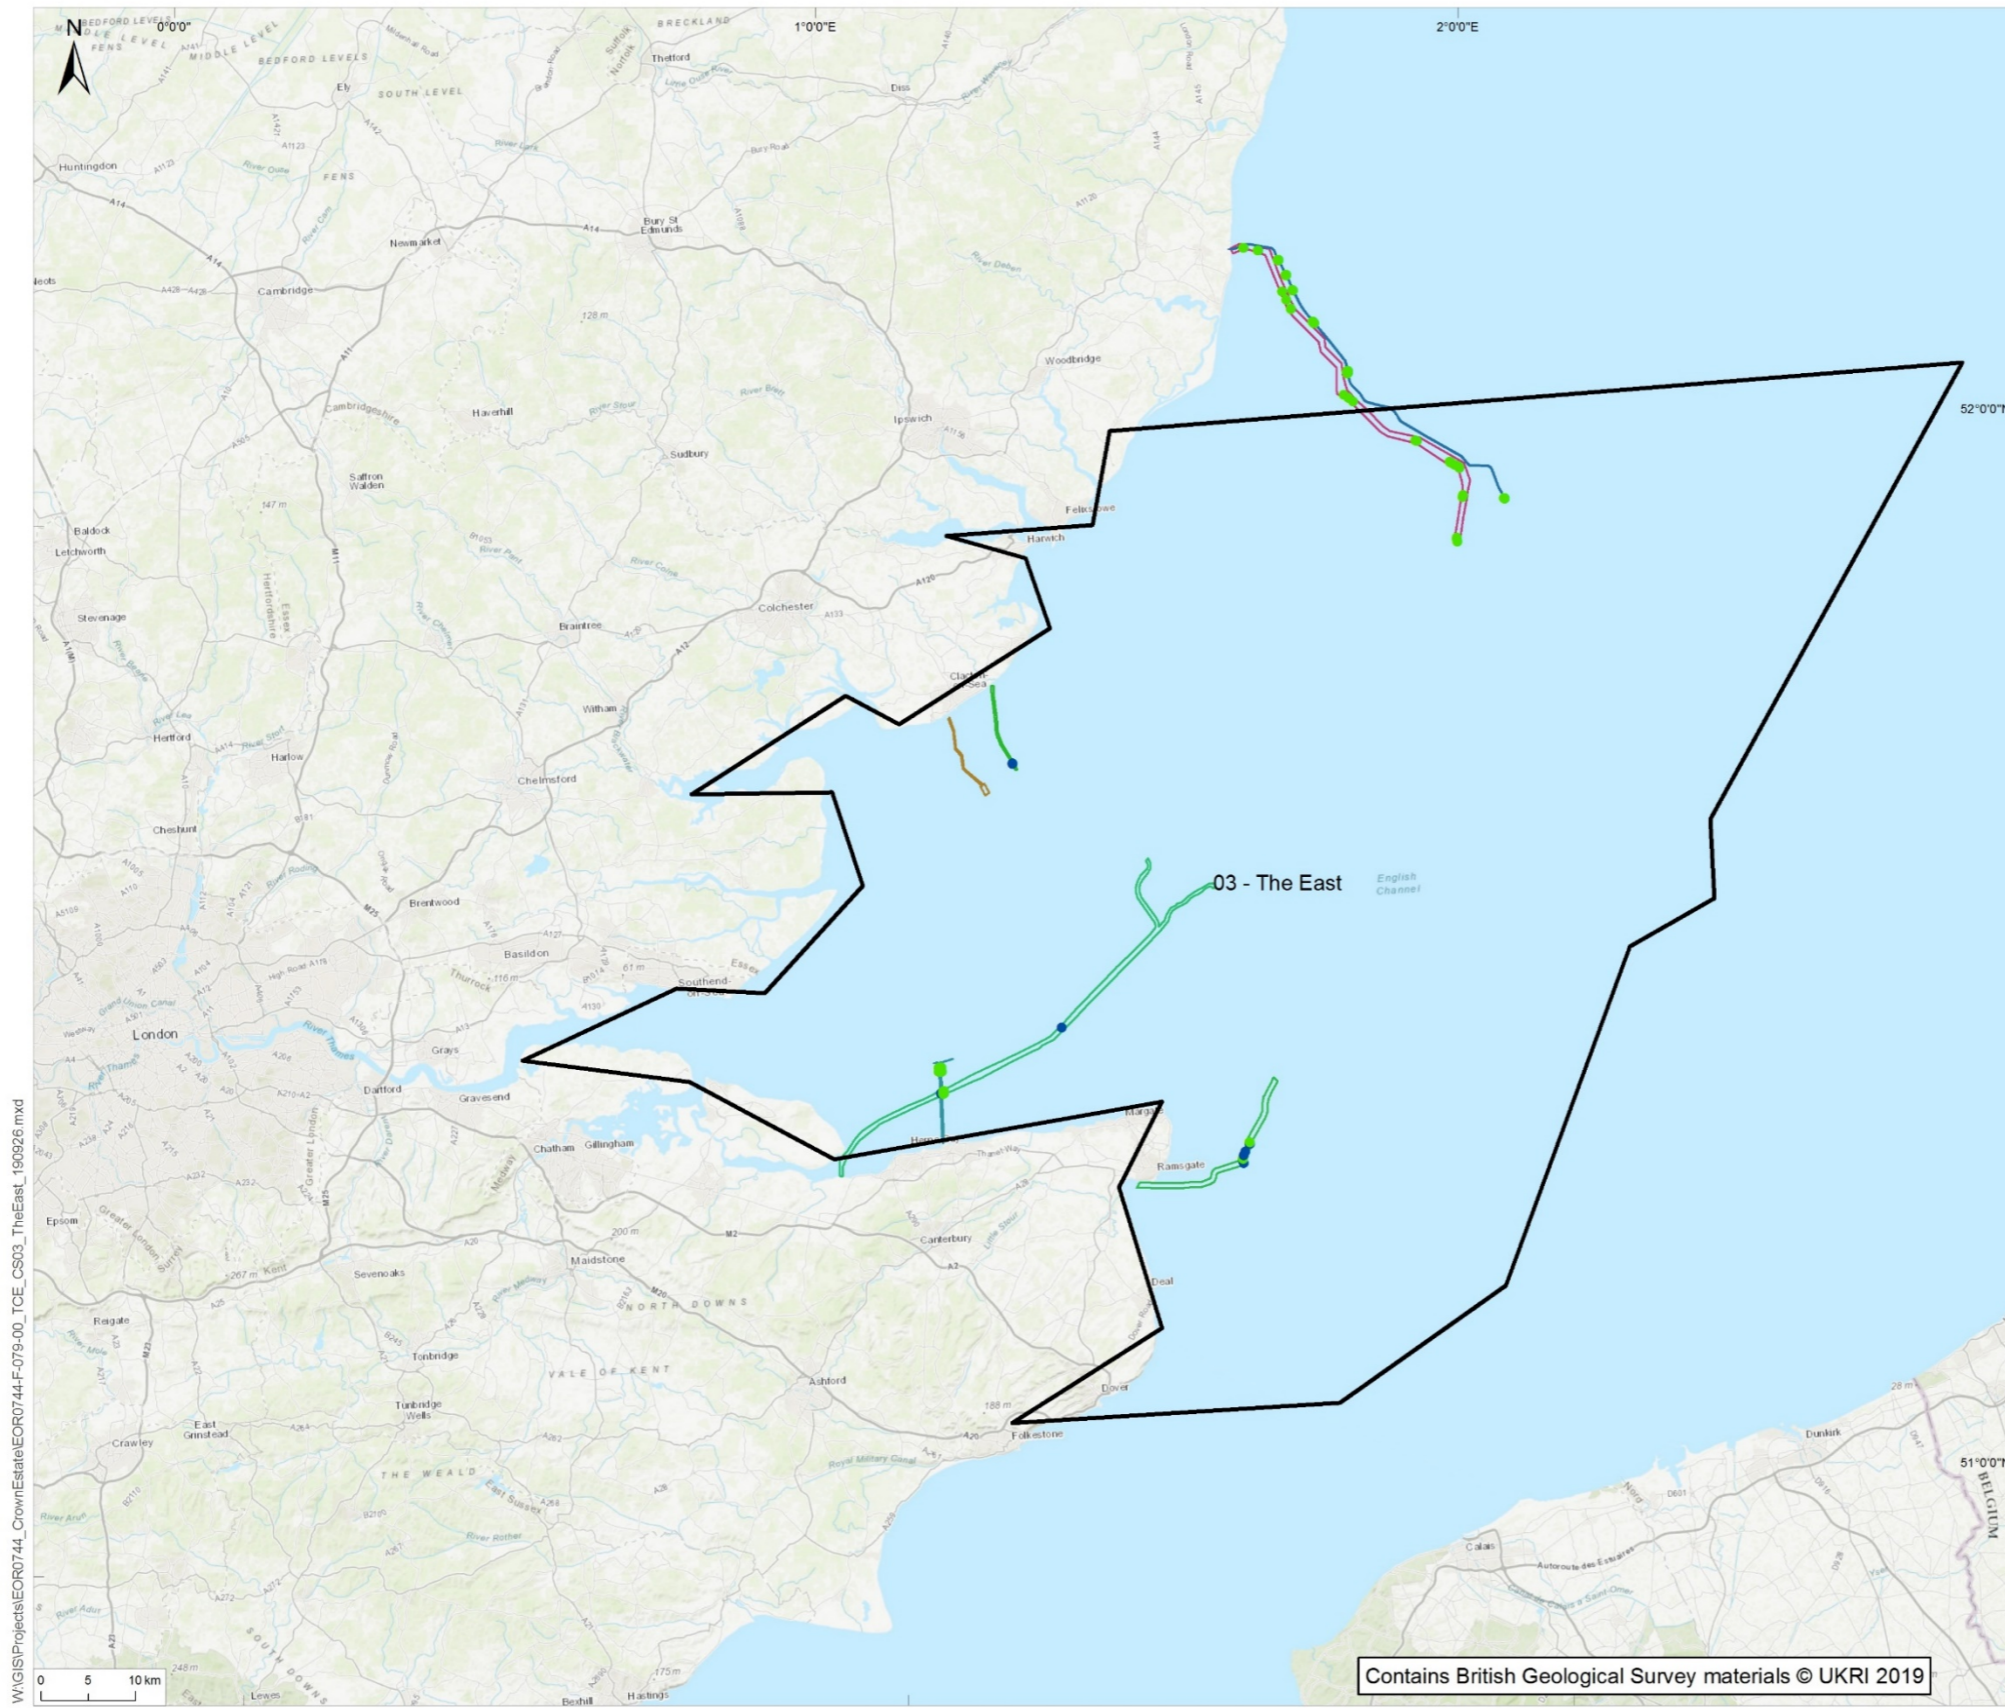
- Legend**
- Case Study Area 03 - The East
  - Additional Cable Protection Locations**
  - Concrete Mattresses
  - Rock Protection
  - Cables**
  - Galloper Export Cable Route
  - Greater Gabbard OFTO
  - Gunfleet Sands 1 and 2
  - Gunfleet Sands 3
  - Kentish flats
  - London Array
  - Thanet OFTO
