# Norfolk Boreas Offshore Wind Farm

## Appendix 3. Review of Cable Installation, Protection Mitigation and Habitat recoverability.

# REVIEW OF CABLE INSTALLATION, PROTECTION, MITIGATION AND HABITAT RECOVERABILITY

EOR0744  
Cable Installation, Protection,  
Mitigation and Habitat  
Recoverability  
Rev03  
12 November 2019

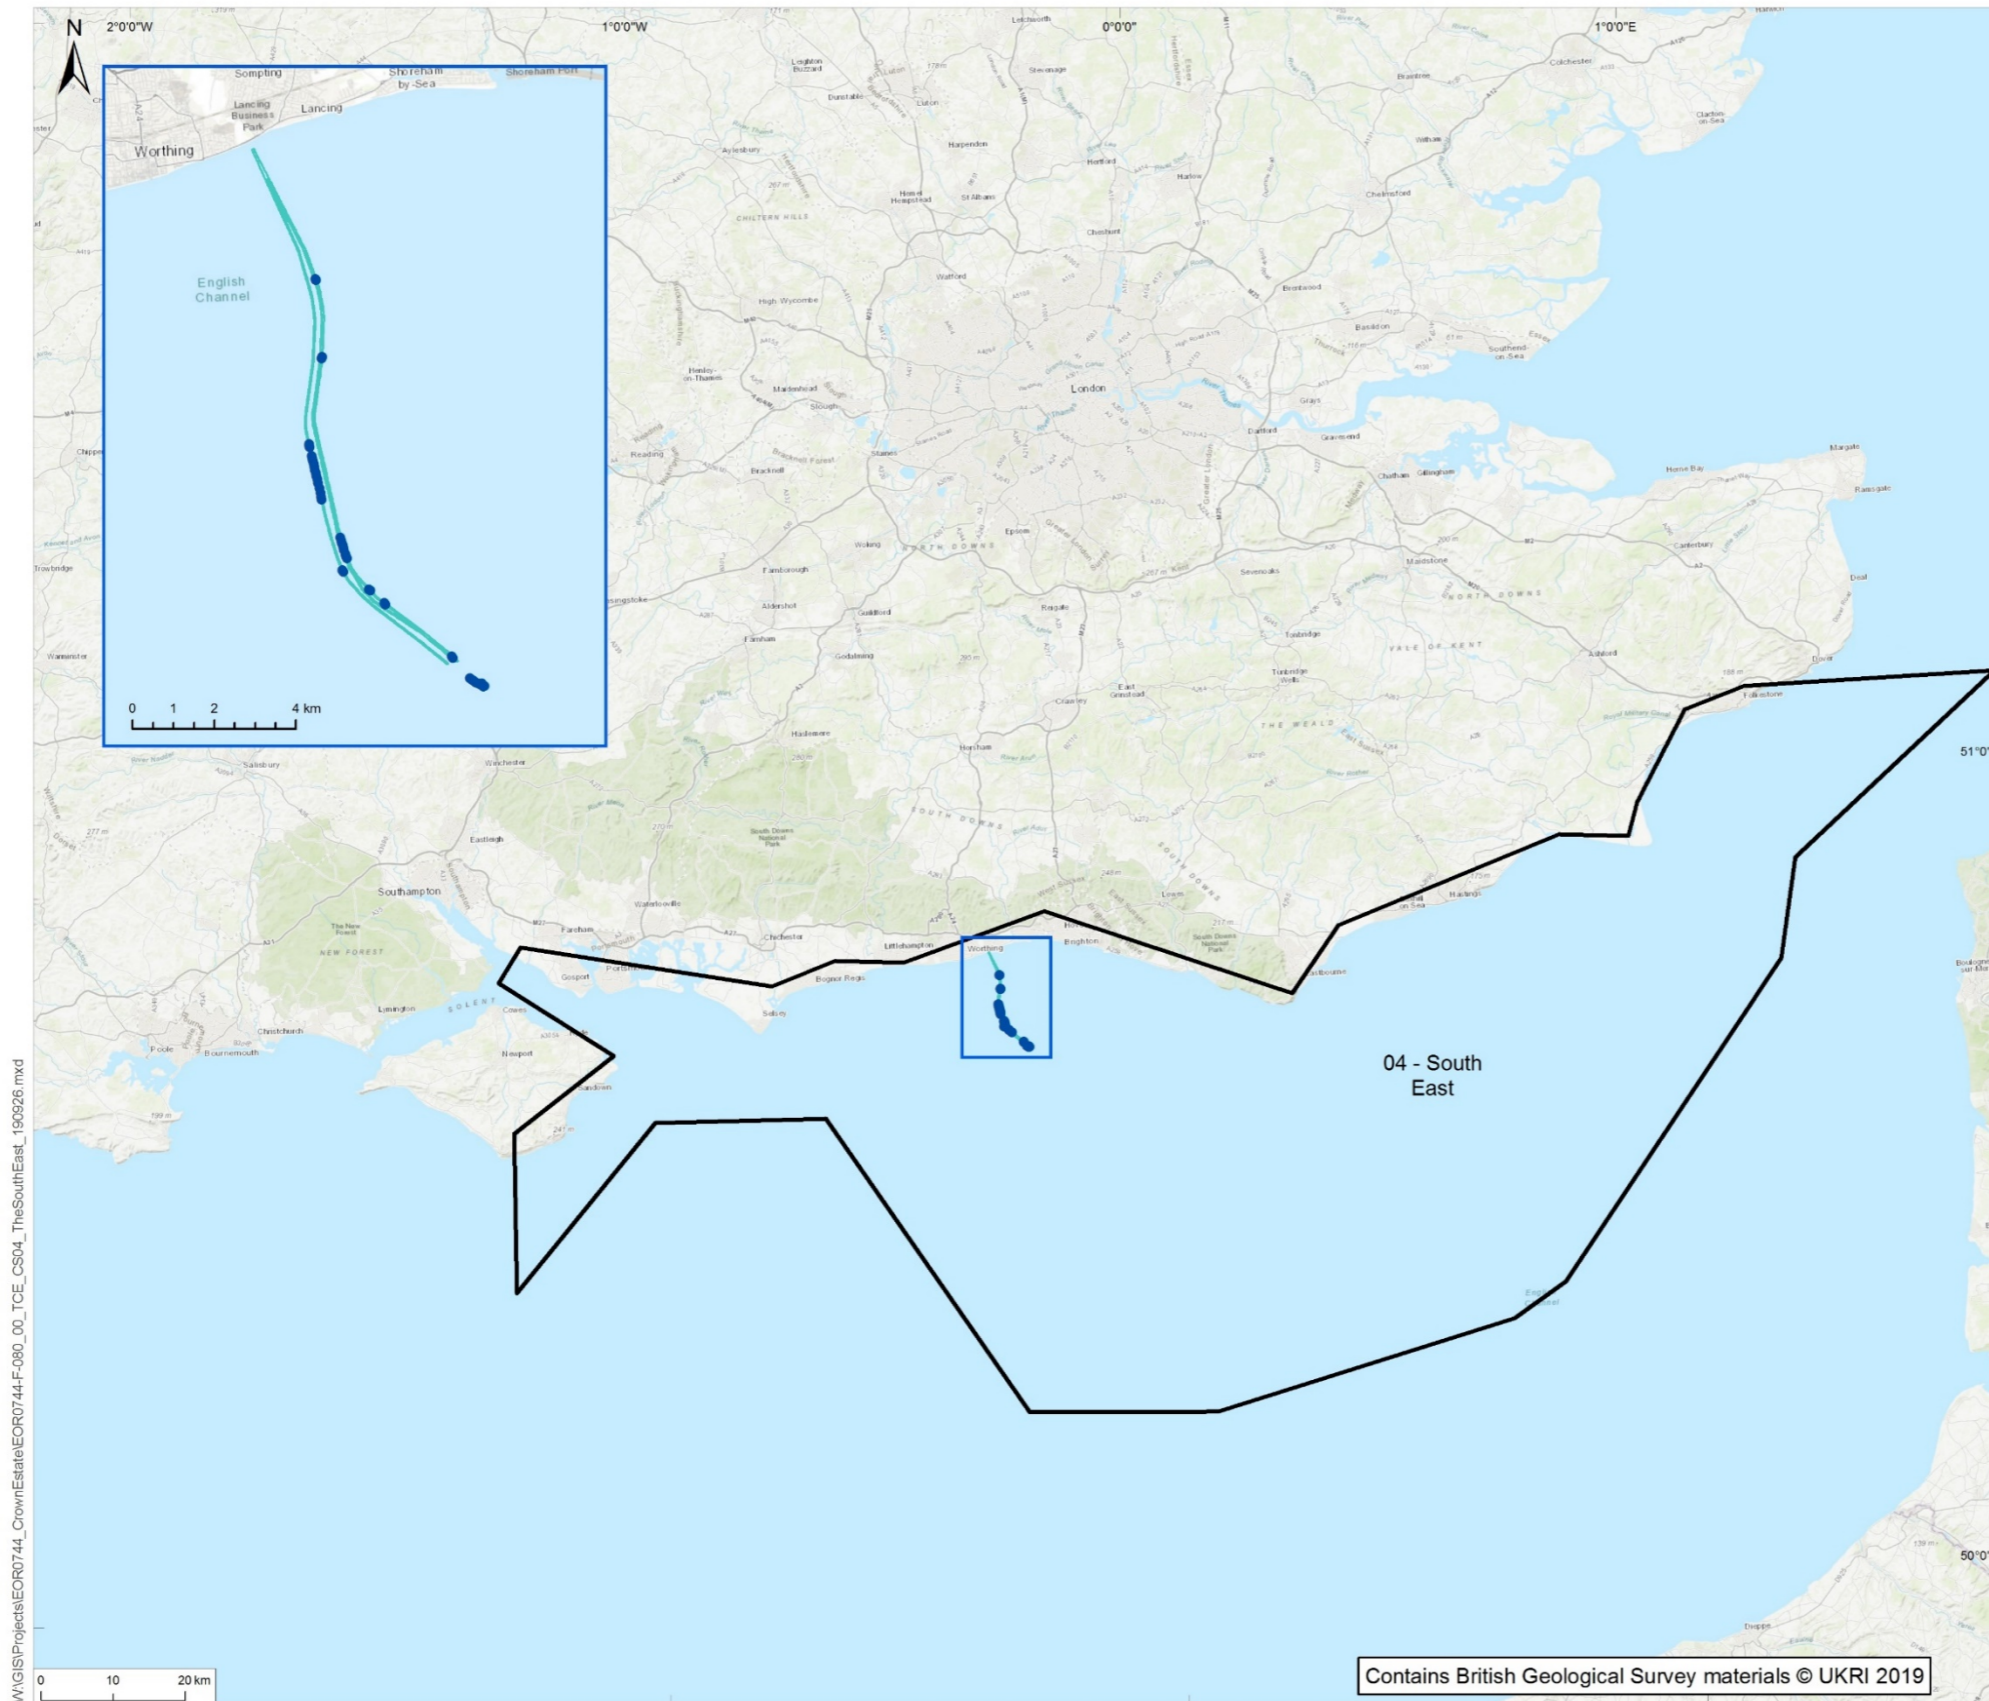
**Legend**  
 Case Study Area 04 - South East  
 Additional Cable Protection Locations  
 Rock Protection  
**Cables**  
 Rampion OFTO

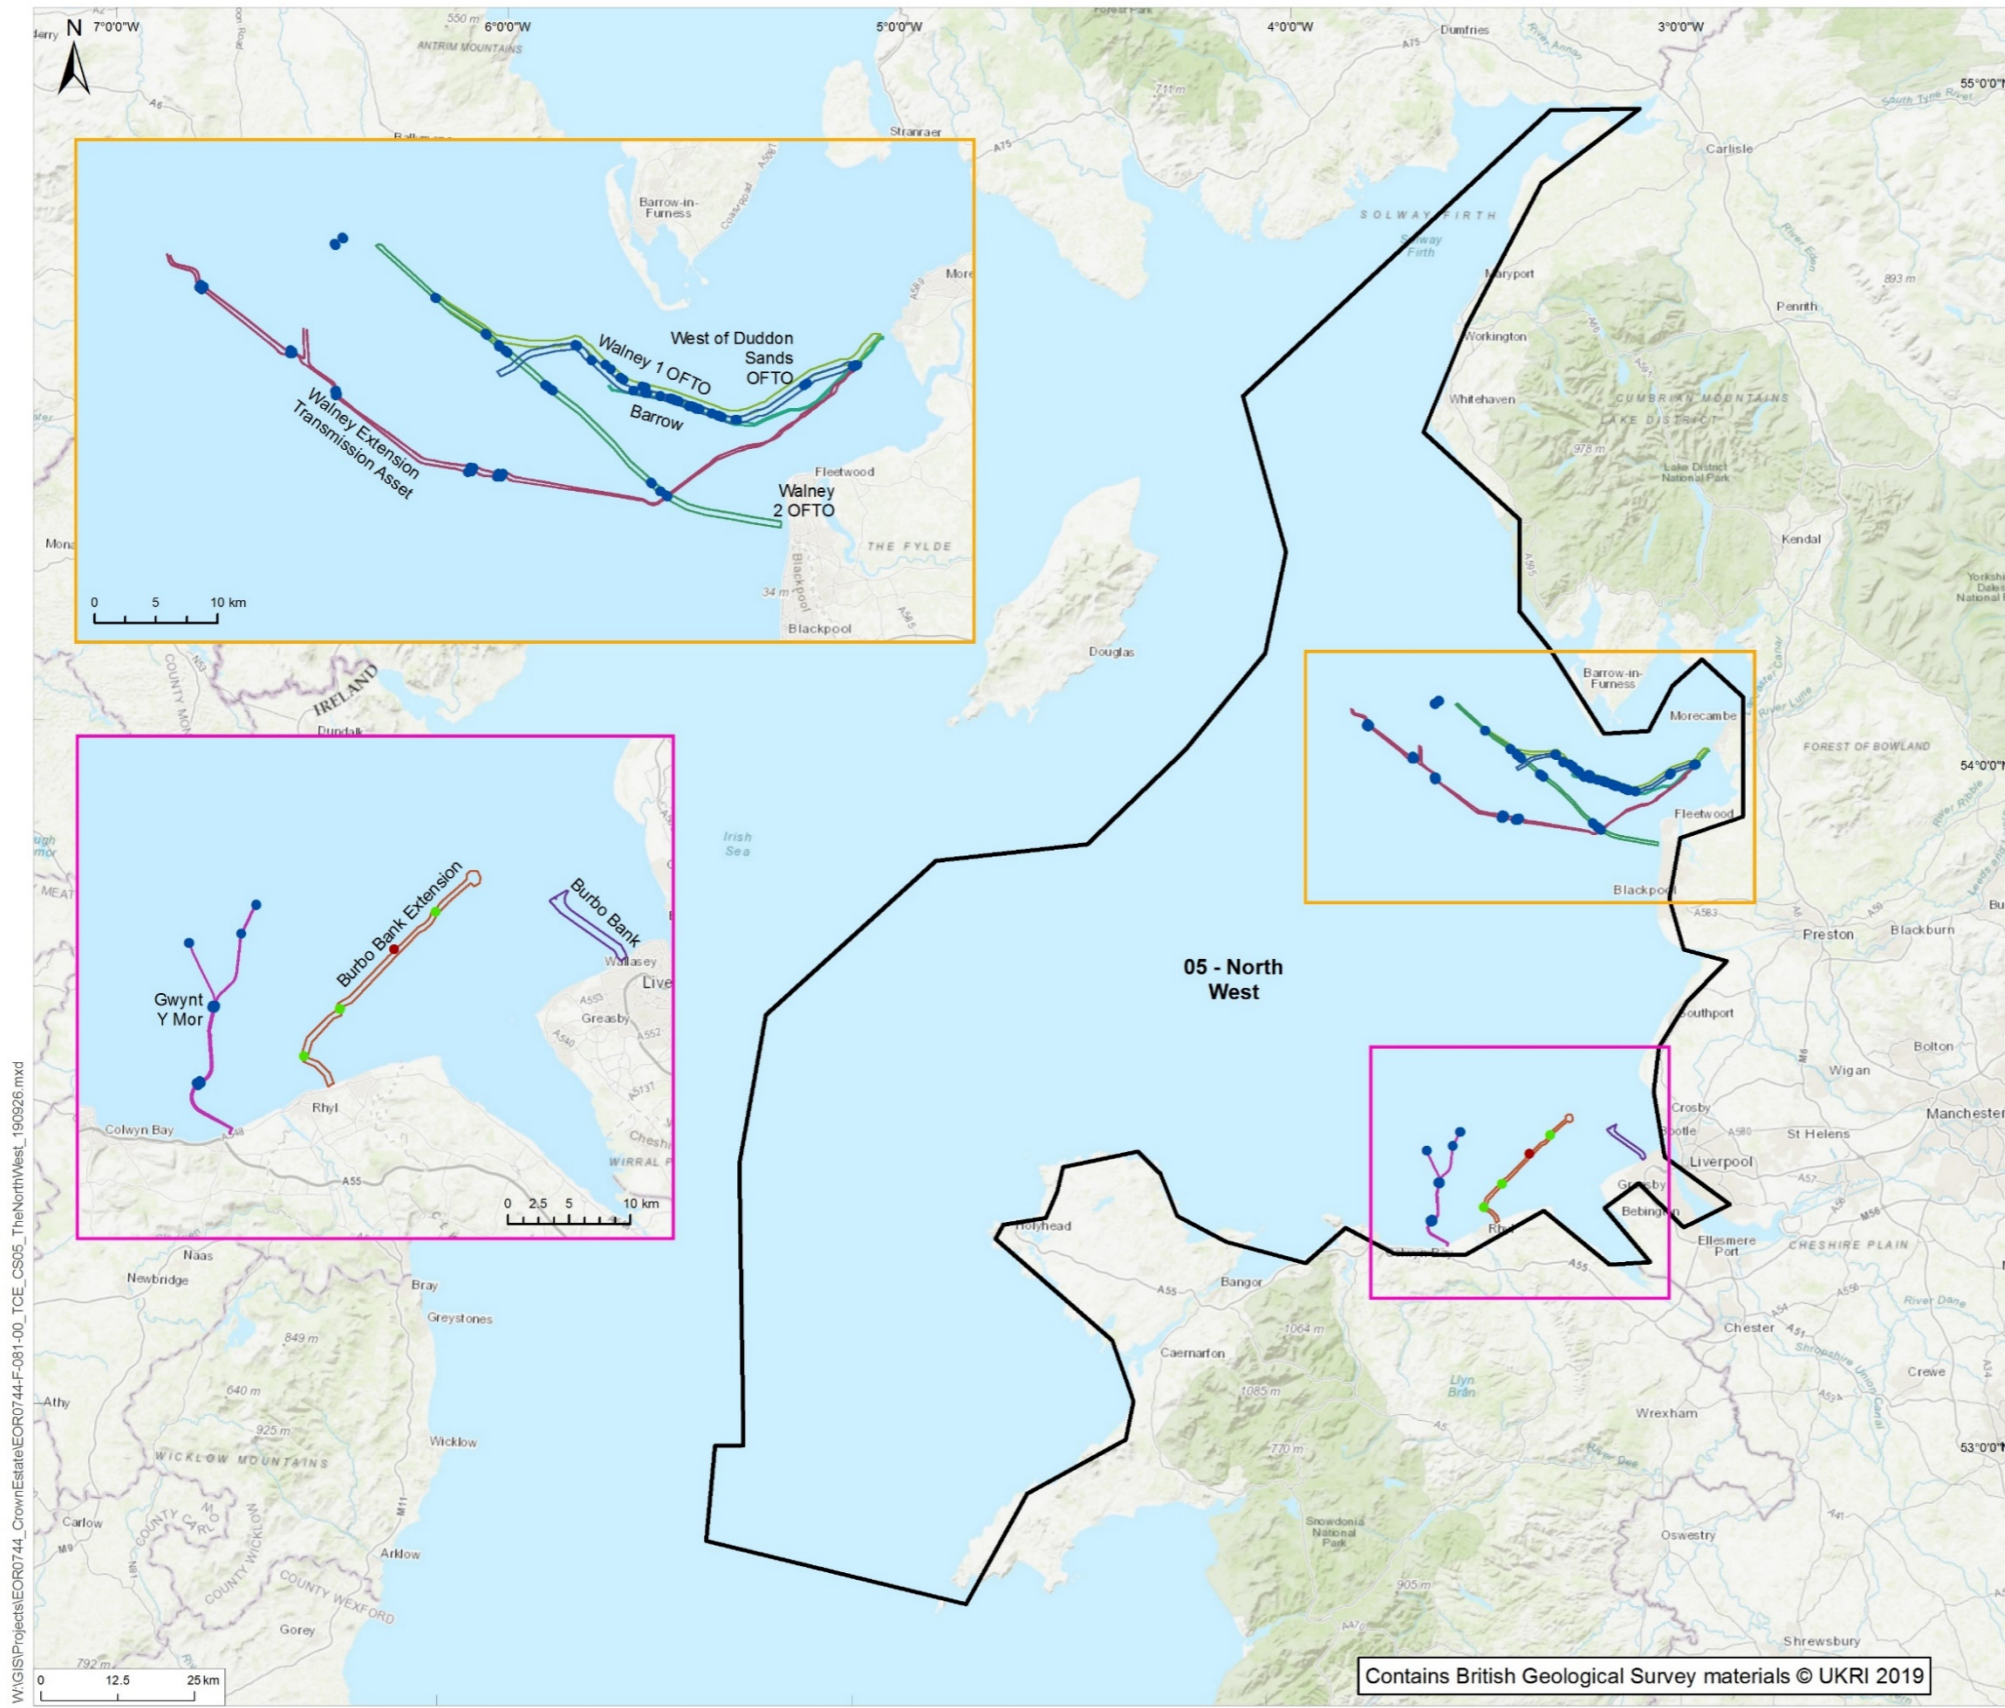
Client **The Crown Estate**  
 Project **Cable Installation & Habitat Recovery Review**  
 Title **Case Study Area 05 - The North West**

- Legend**
- Case Study Area 05 - North West
  - Additional Cable Protection Locations**
  - Concrete Mattresses
  - Rock Protection
  - Other Cable Protection Measures
  - Cables**
  - Barrow
  - Burbo Bank
  - Burbo Bank Extension
  - Gwynt Y Mor
  - Walney 1 OFTO
  - Walney 2 OFTO
  - Walney Extension Transmission Asset
  - West of Duddon Sands OFTO
