The Drax Power (Generating Stations) Order

Environmental Statement Appendix 9.5 - Bat Building Emergence Survey Report

Drax Repower Project

Applicant: DRAX POWER LIMITED
Date: May 2018
Document Ref: 6.2.9.5
PINS Ref: EN010091

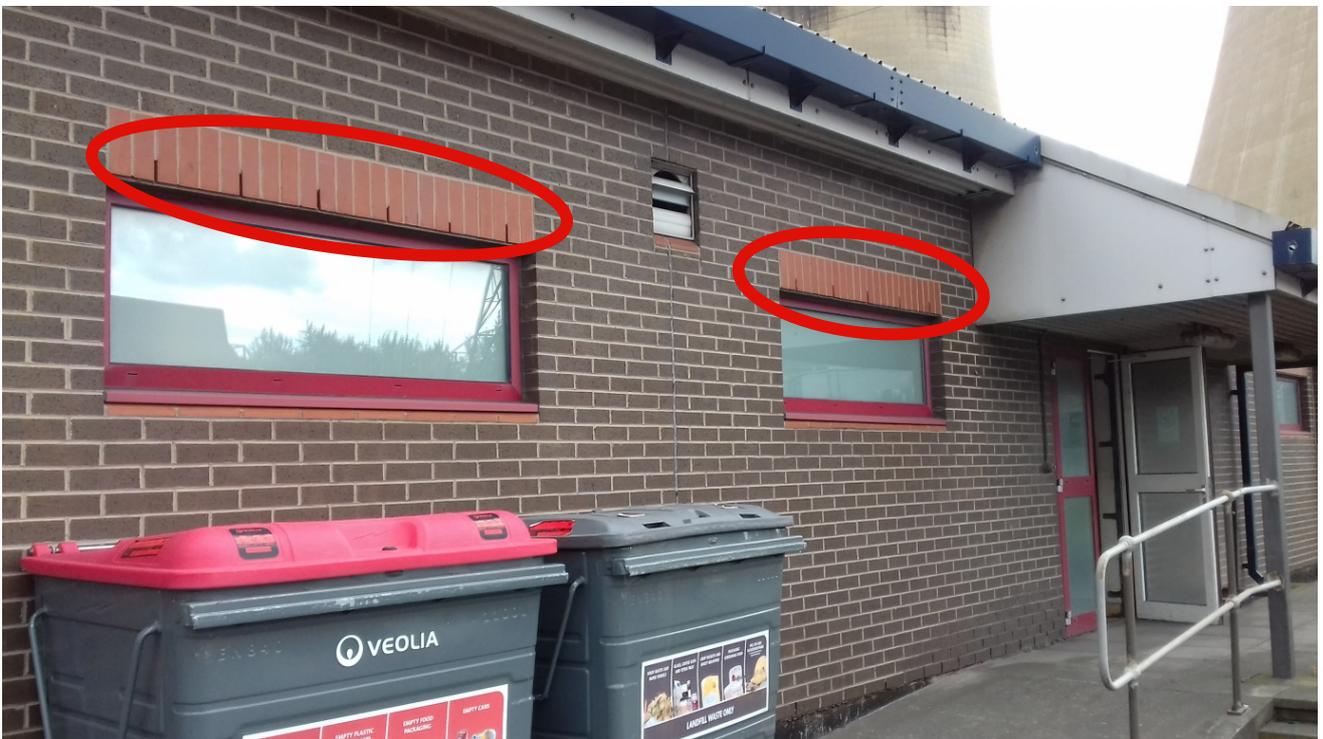
Photo 1 – Photo Building 1, Development Parcel C bat roosting opportunities

- 3.1.2. Building 1 in Development Parcel C was assessed as having low suitability for roosting bats during the Preliminary Roost Assessment. One type of feature was recorded on the building exterior, namely slits in the brick work above all windows.
- 3.1.3. The habitat surrounding Building 1 in Development Parcel C is predominantly hard standing, featuring access roads and paving. Surrounding areas include the existing power station cooling towers with some amenity grassland adjacent and scattered broad-leaved trees.
- 3.1.4. Photograph 1 (below) shows these features.

- 4.1.1. No bats, or evidence of bats, were recorded during the surveys on Development Parcel C Building 1 or Development Parcel F Buildings 1 and 2.
- 4.1.2. The slits in the brick work above the windows in Building 1 of Development Parcel C may create access points large enough for smaller bats (*Pipistrellus* and *Myotis* sp.) to crawl into. These features are considered likely to provide cool, stable conditions that could support low numbers of hibernating or transitional roosting bats. Due to the absence of other buildings with potential roosting features and the poor quality of the immediately surrounding habitat, Building 1 in Development Parcel C is considered of at most low suitability for roosting bats.

- 4.1.4. An internal inspection of the buildings will be carried out in winter 2017/18 to confirm the internal condition of the buildings. If the internal inspection identifies evidence of bats or significant additional PRF then the survey effort will be increased accordingly. In the event that a bat roost is identified and the building cannot be retained, specific avoidance and / or mitigation measures would be required. A draft European Protected Species (EPS) licence Method Statement would also need to be submitted with the DCO application in the event of a confirmed roost being lost.

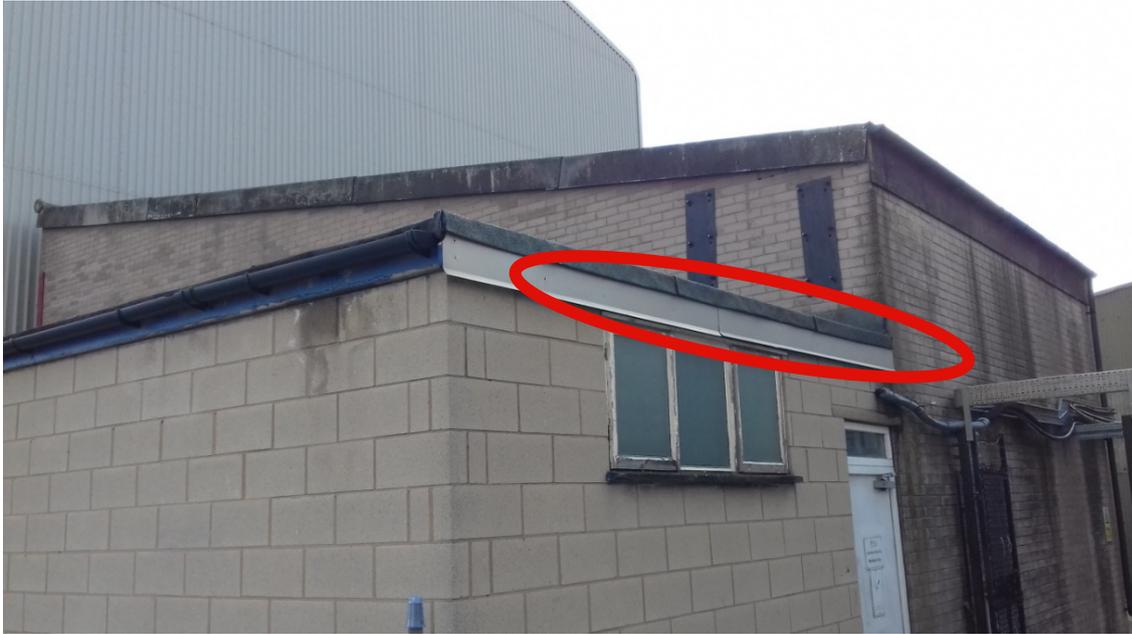
Photo 2 - Building 1, Development Parcel F

- 3.1.5. Building 1 and 2 in Development Parcel F were assessed as having low suitability for roosting bats during the Preliminary Roost Assessment. Gaps under the timber eaves of **Building 1** could provide suitable conditions for roosting bats. Building 2 had one hole in the north-east corner located in the eaves that could also have provided roosting opportunities for bats (See photographs 2 and 3 below).
- 3.1.6. The habitat surrounding Building 1 and 2 in Development Parcel F is predominantly hard standing, featuring access roads, paving and buildings.

- 4.1.3. The gaps under eaves (timber) in Building 1 of Development Parcel F and the hole in the eaves of Building 2 of Development Parcel F may create access points large enough for smaller bats (*Pipistrellus* and *Myotis* sp.) to crawl into. The depth of the access points and assessment of any internal space could not be made from the external preliminary roost assessment. Larger bat colonies and maternity colonies could potentially be present, although this is considered very unlikely due to the poor quality of the immediately surrounding habitat and in light of the 2017 survey results.

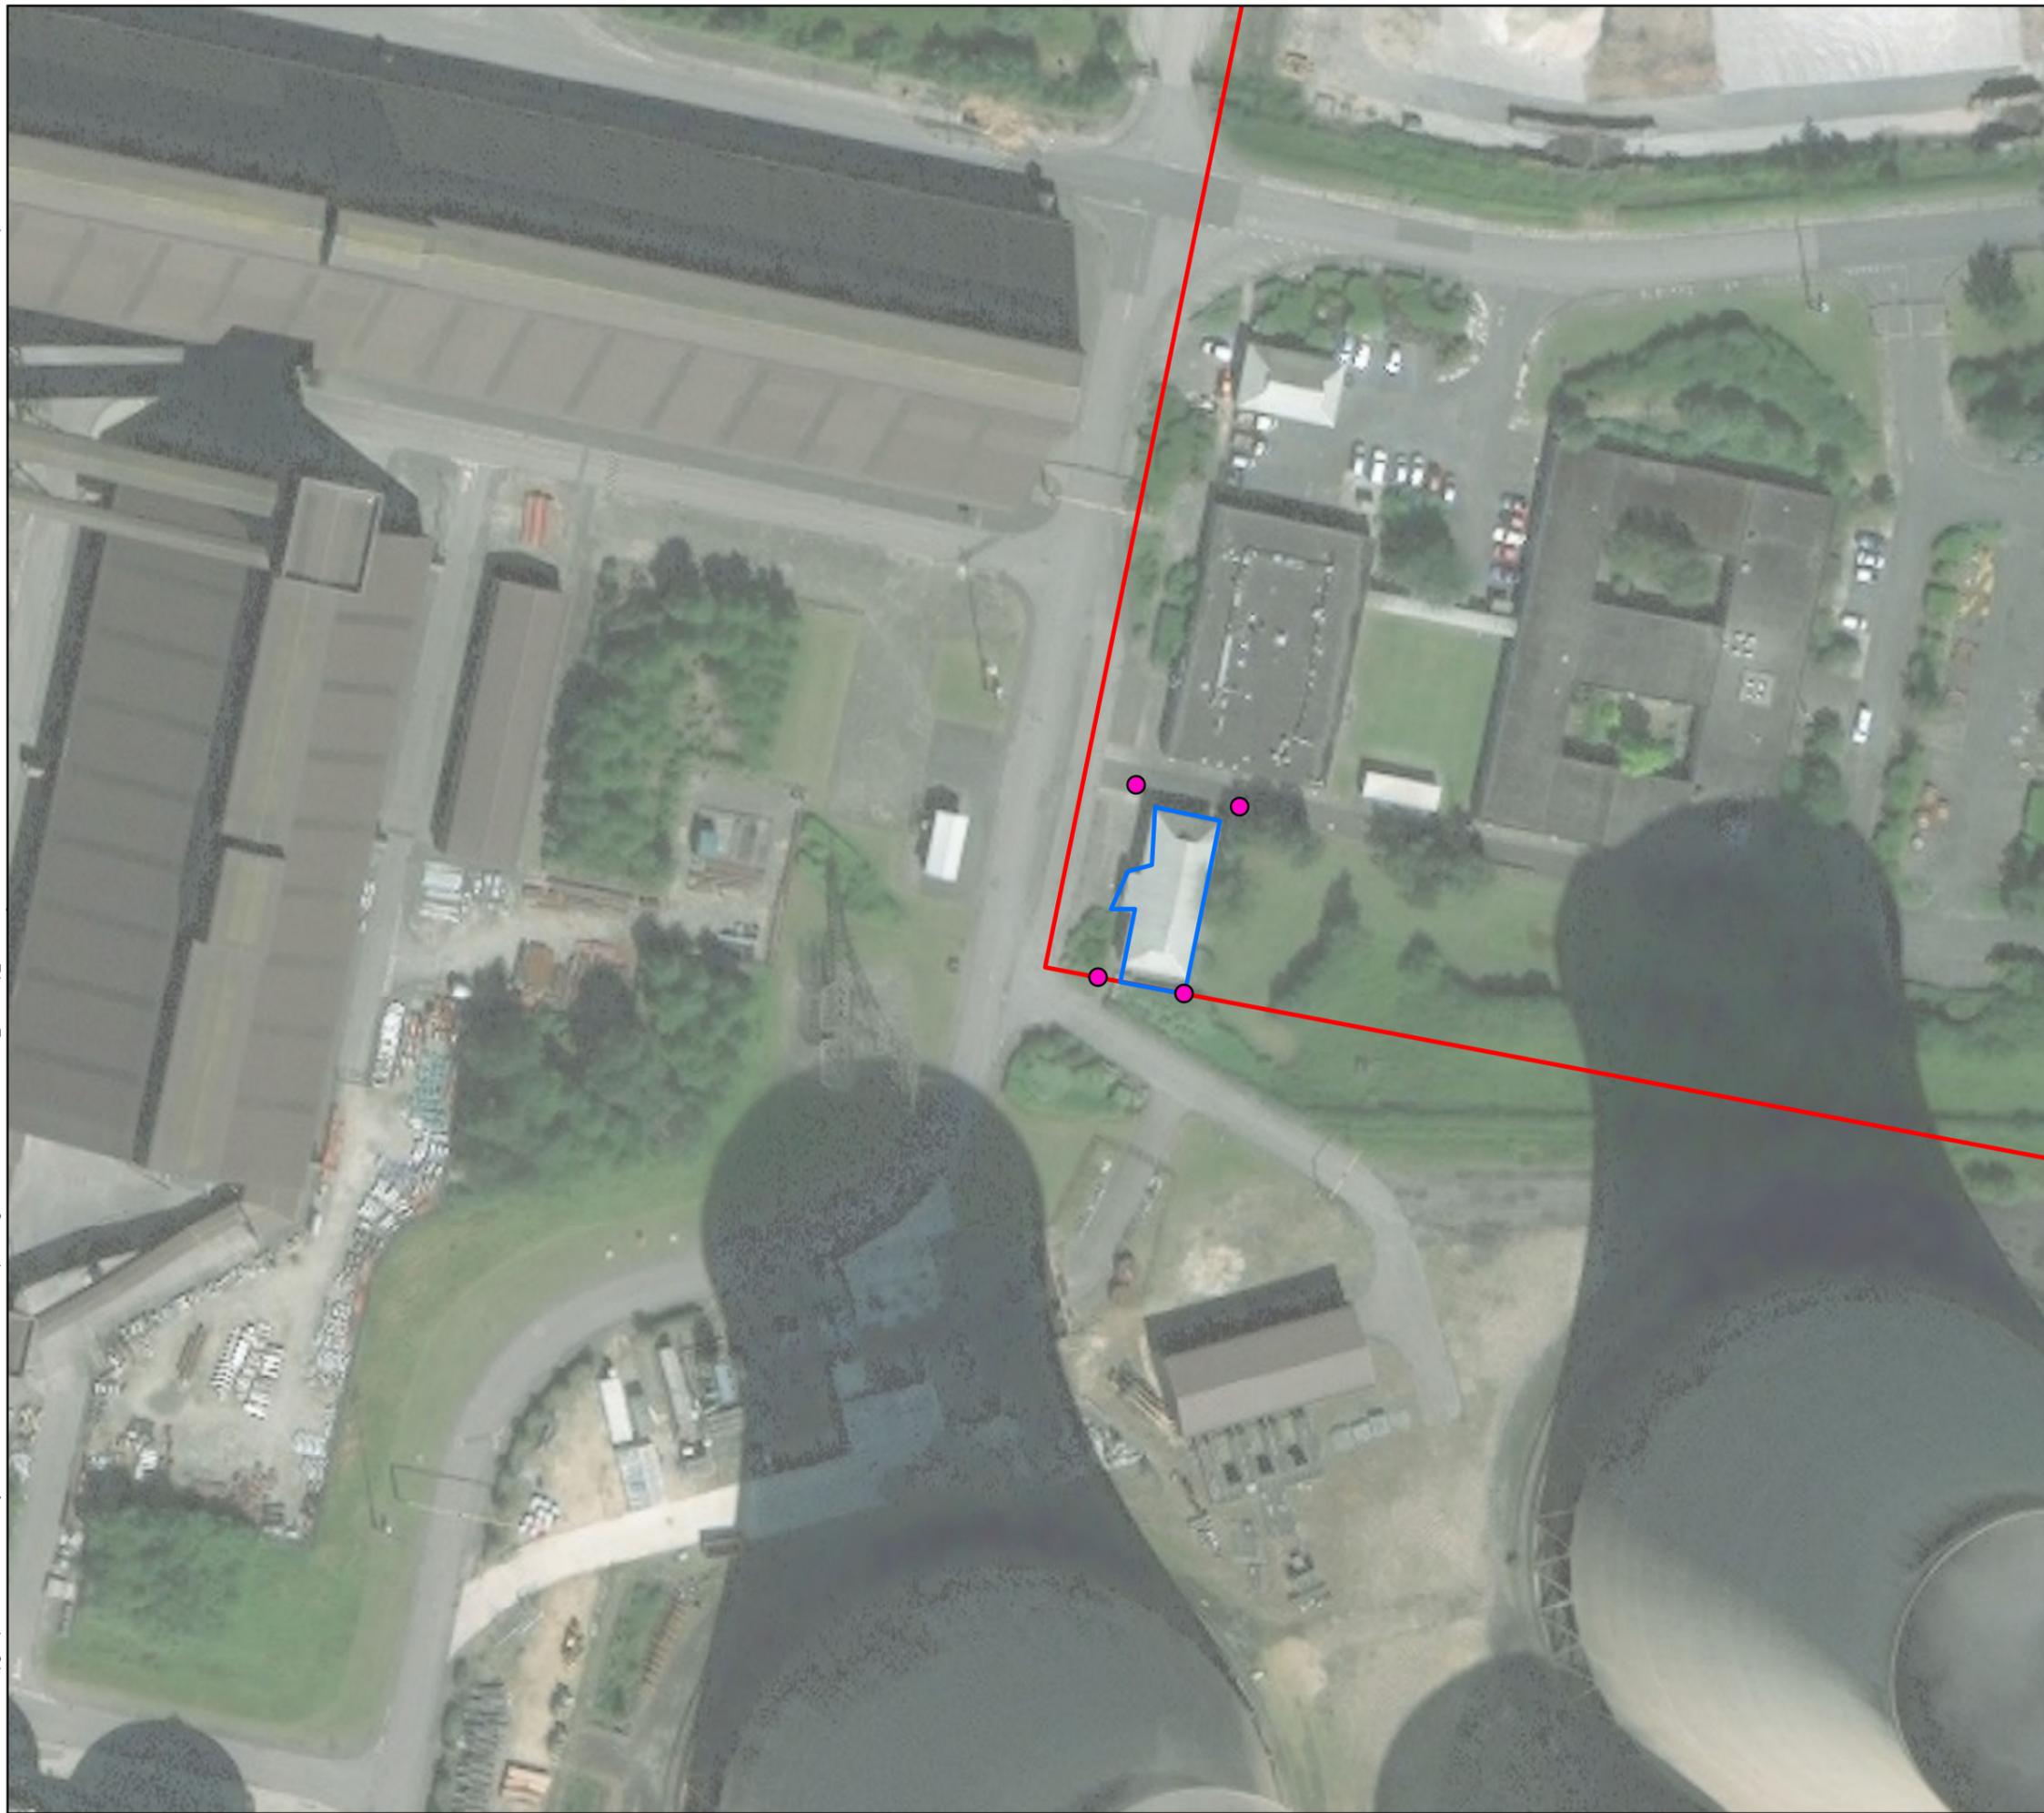
Title:
**FIGURE 2 - DEVELOPMENT
PARCEL C BUILDING 1**

- 3.1.8. A single dusk emergence survey was carried out on Development Parcel C Building 1. No bats were recorded emerging from or re-entering the building during the survey.

- Key
- Surveyor Positions
 - Development Parcel C Building1
 - Site Boundary

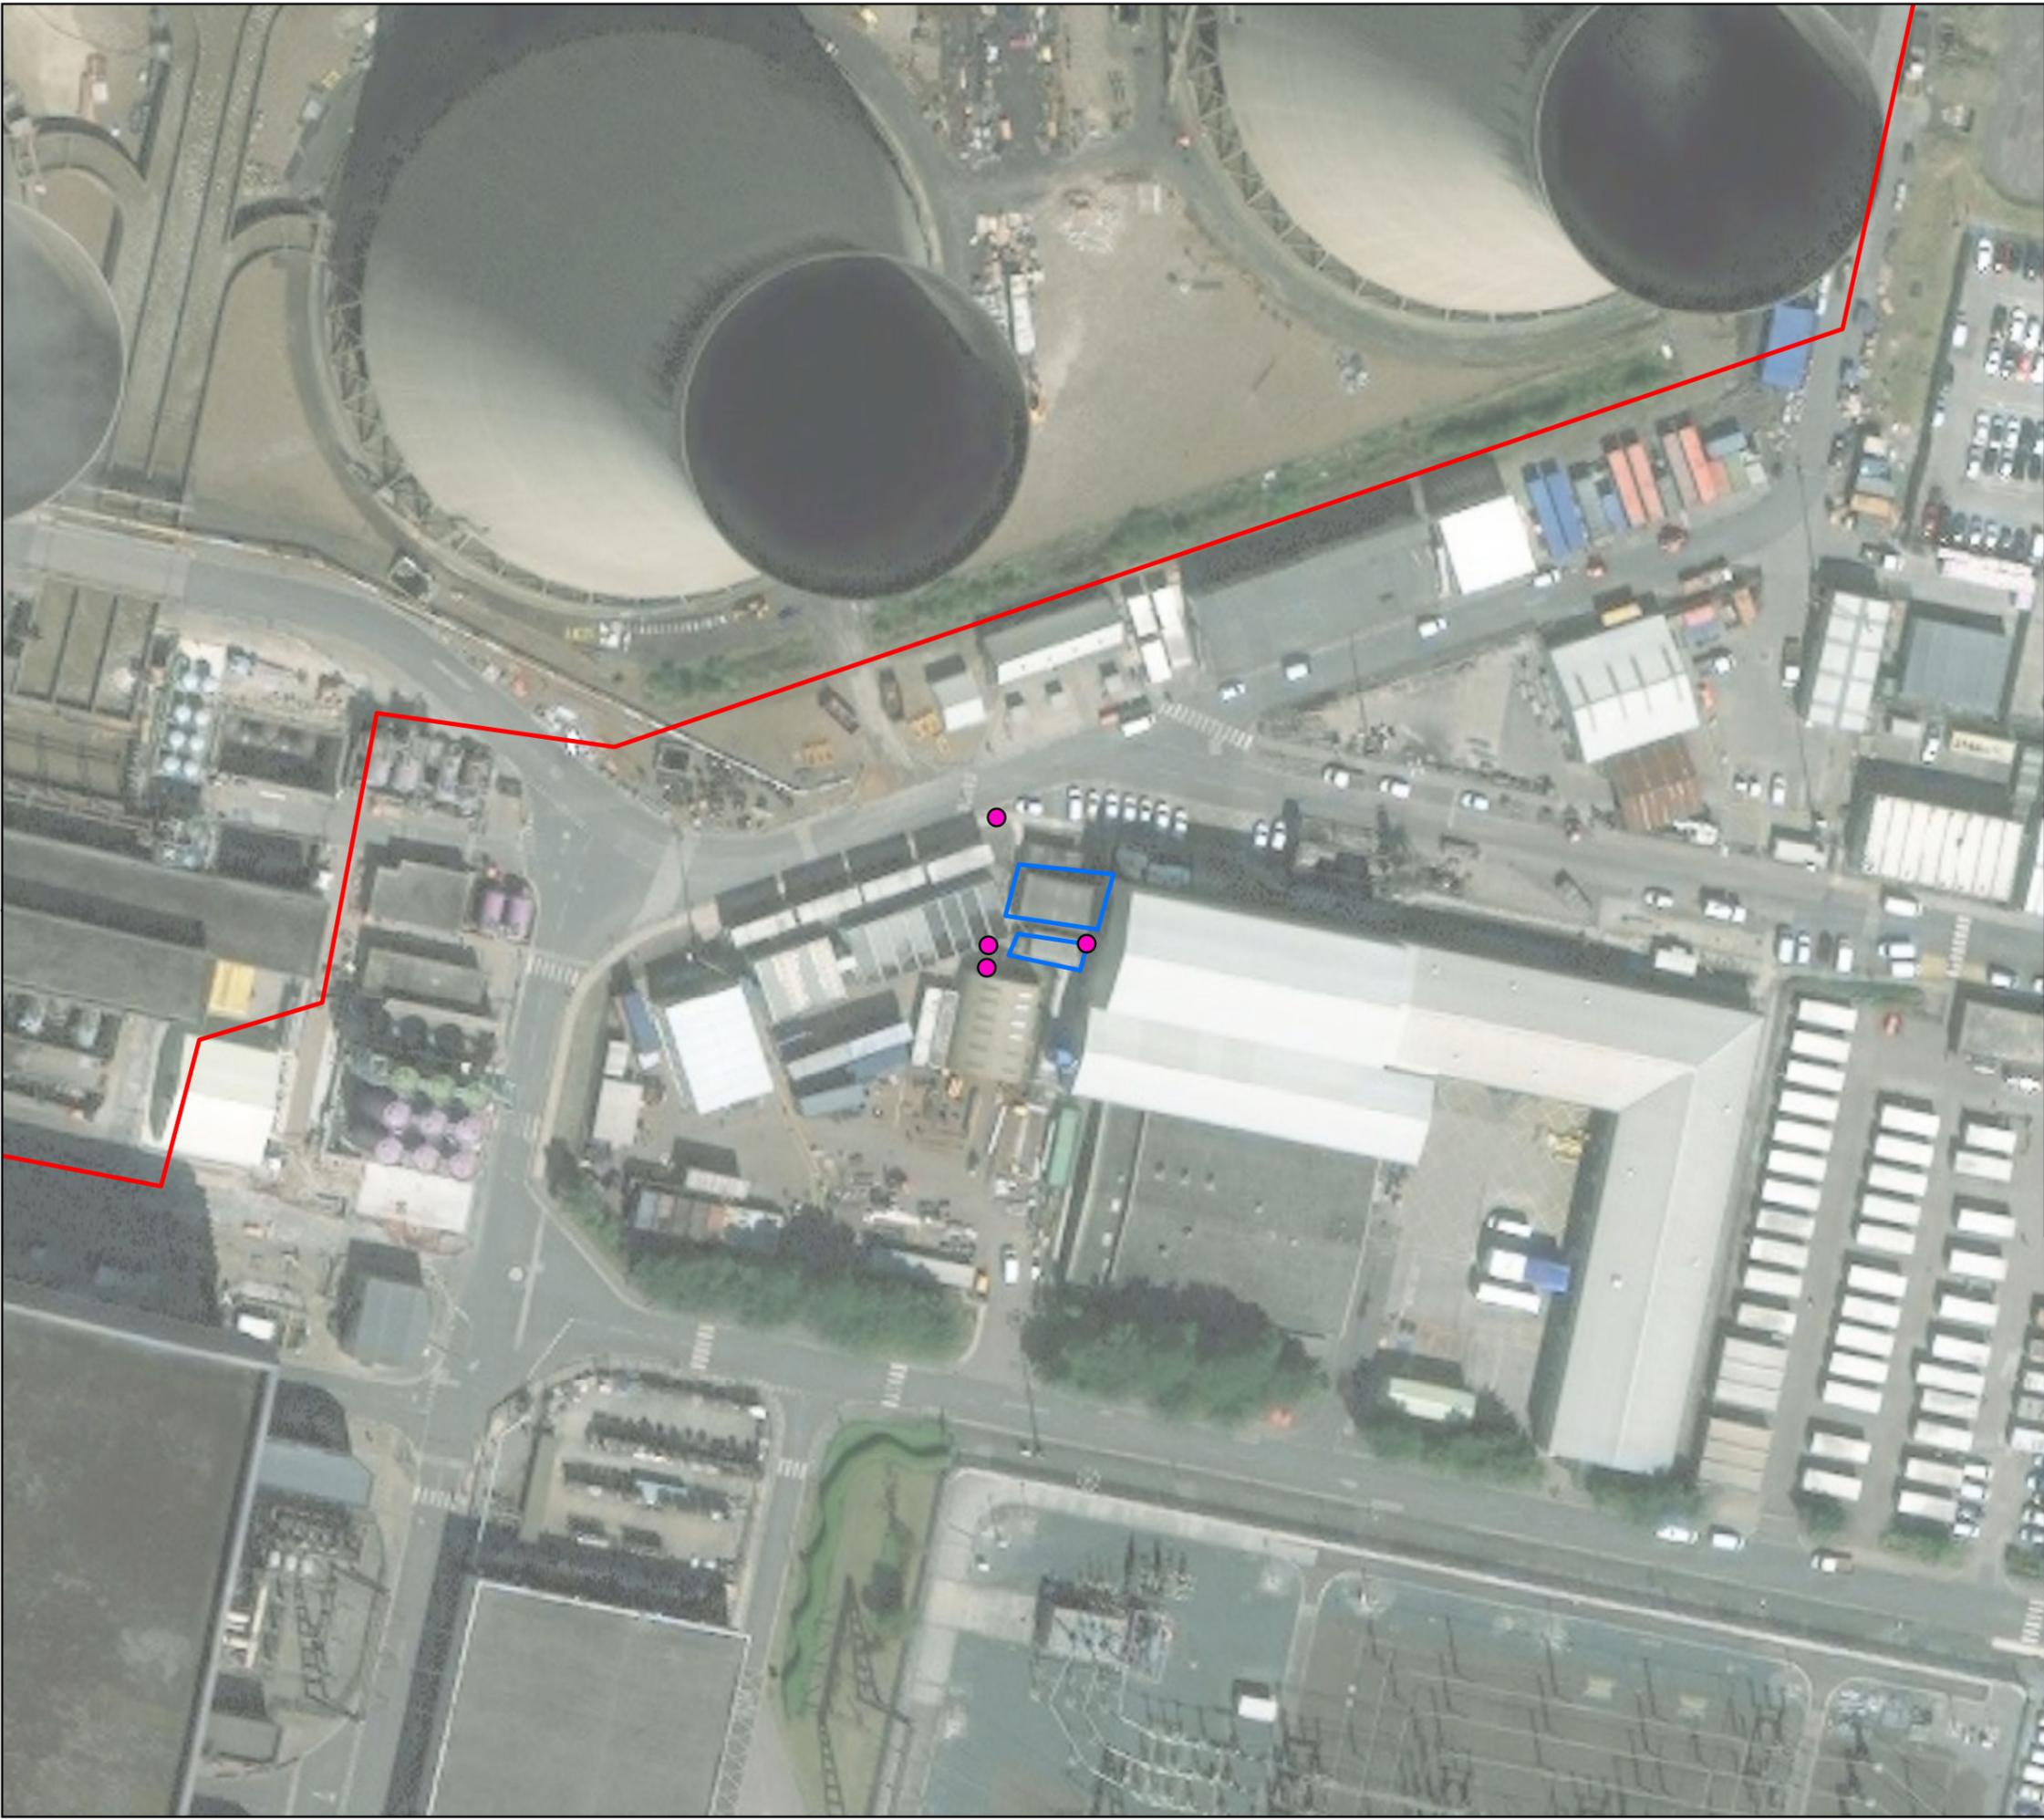
Title:
**FIGURE 3 - DEVELOPMENT
PARCEL F BUILDINGS 1 & 2**

- 3.1.9. A single dawn re-entry Site was carried out on Development Parcel F Buildings 1 and 2. No bats were recorded emerging from or re-entering either of the buildings during the survey.

- 3.1.10. This area of the Site was well lit throughout the survey due to the presence of artificial lighting: Buildings 1 and 2 are adjacent to access roads which are used by pedestrians and vehicles.

- Key
- Surveyors Position
 - Development Parcel F Buildings 1 & 2
 - Site Boundary
