THURROCK FLEXIBLE GENERATION PLANT

DEADLINE 2 – FURTHER INFORMATION

Historic Environment: updated baseline information, additional photomontages and assessment of effects: ExQ1 March 2021

HER-2: HISTORIC ENVIRONMENT FURTHER INFORMATION

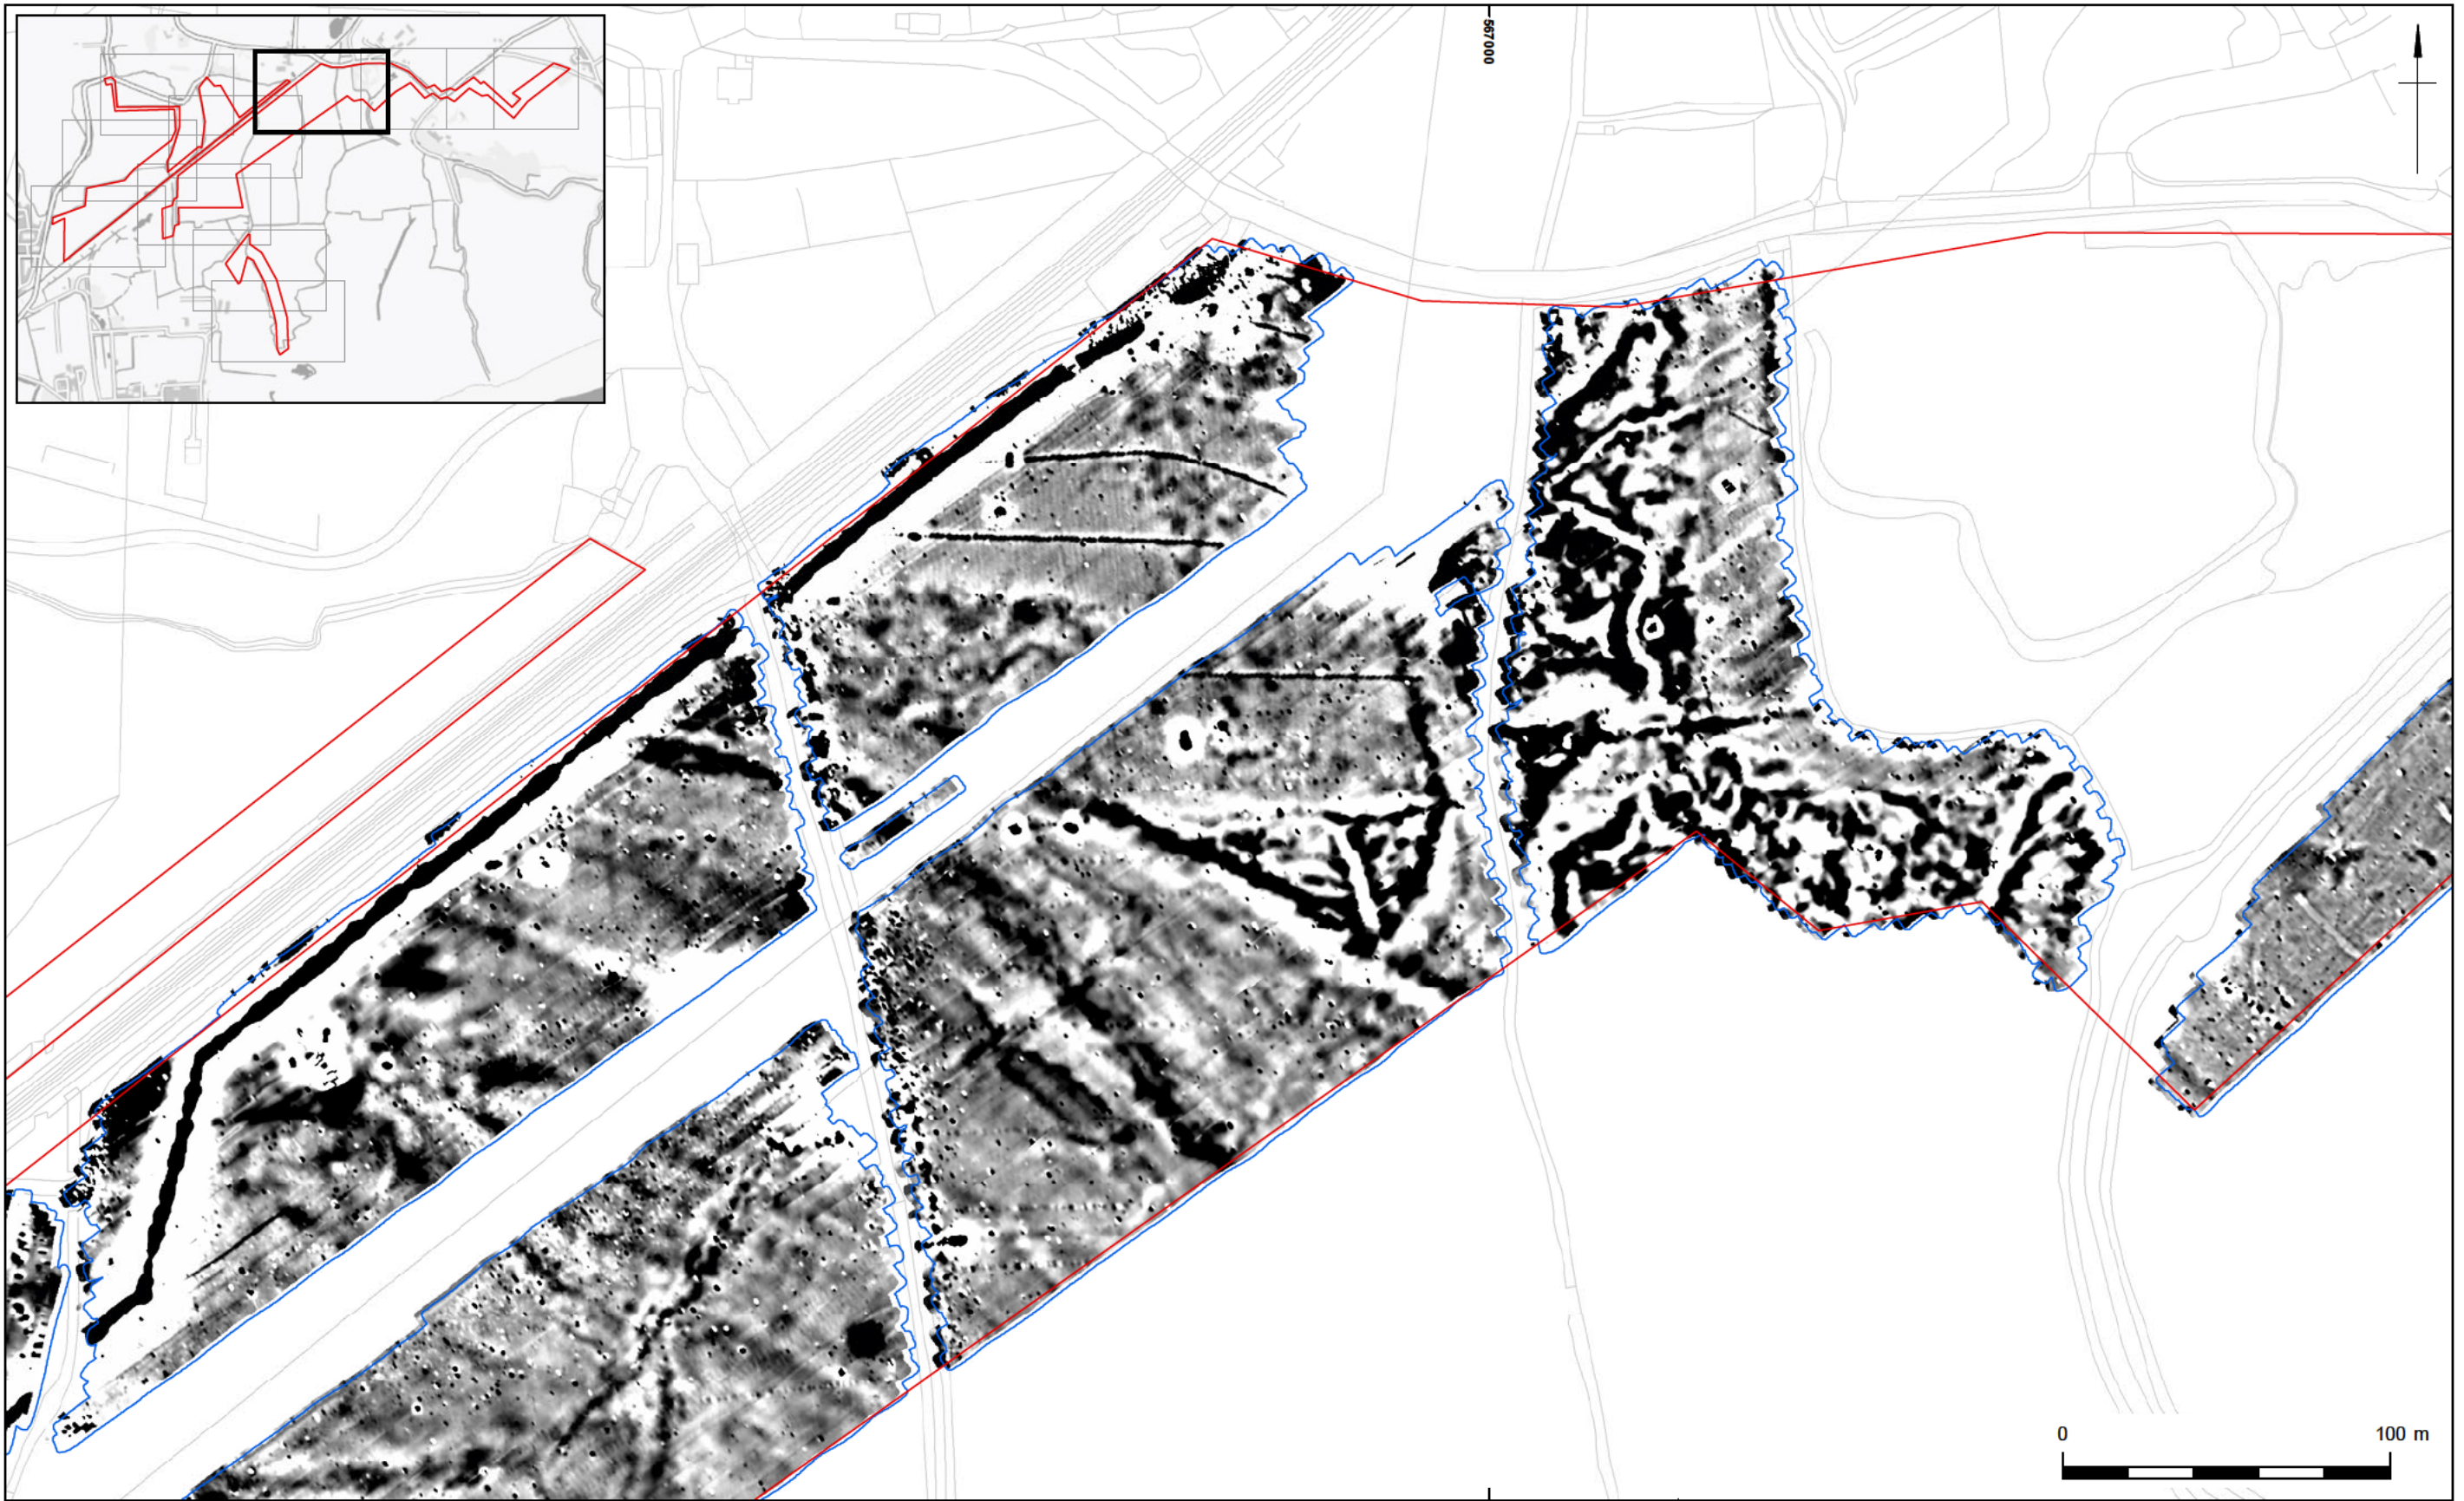
Figure 11

Detailed gradiometer survey results: interpretation

- 4.2.8 In the central portion of the survey area, a large, negative curving recti-linear anomaly has been identified at **4013 (Figure 11)**. This measures 171 m north-east to south-west and is 5 m wide. This indicates a bank feature and could relate to the boundary of a large enclosure. As such, it is interpreted as possibly archaeological in origin. A smaller, negative, curvi-linear anomaly is noted to the south-west of the anomaly at **4013 (4014)**. It is possible this indicates a further ditch-feature adjacent to the possible enclosure. It is not possible to determine whether any internal features are present within the possible enclosure due to the increased background response caused by the geological deposits.

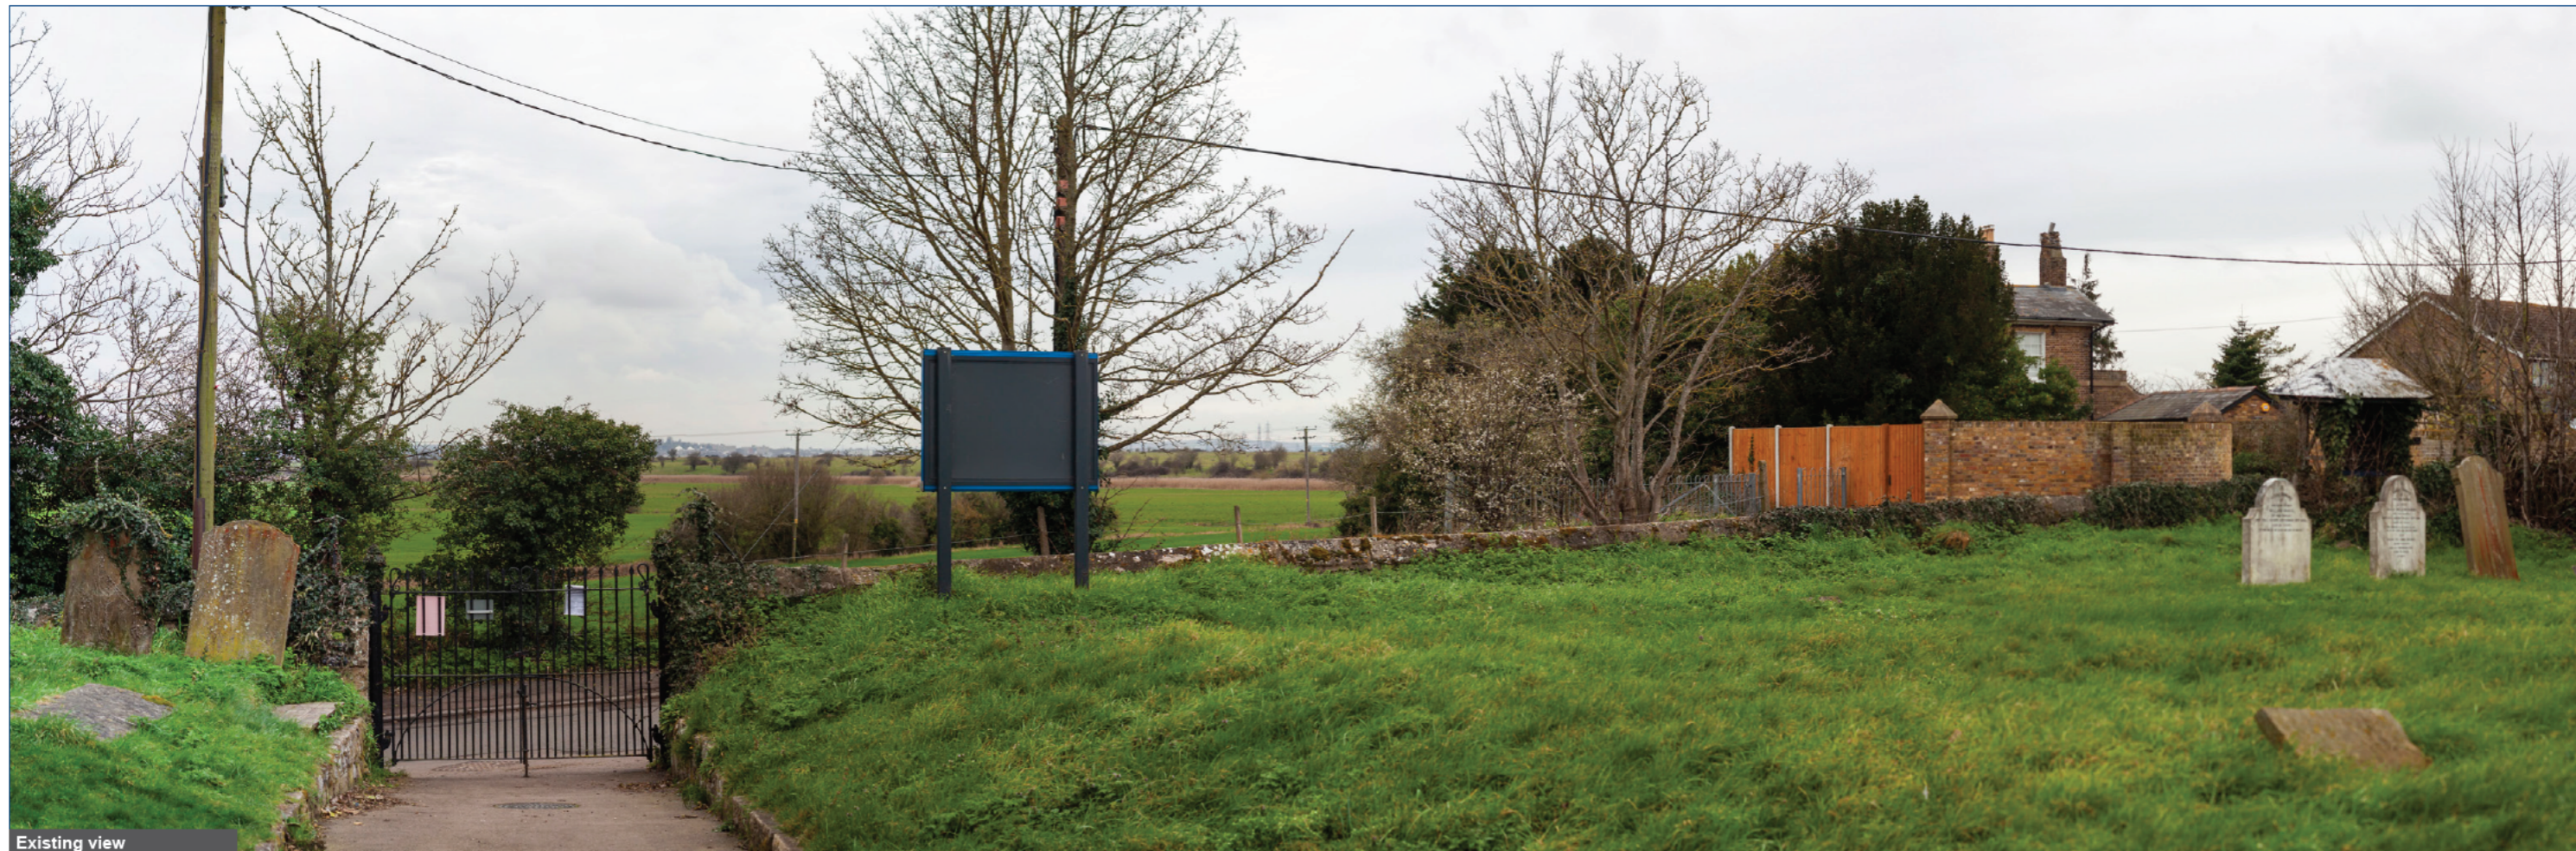
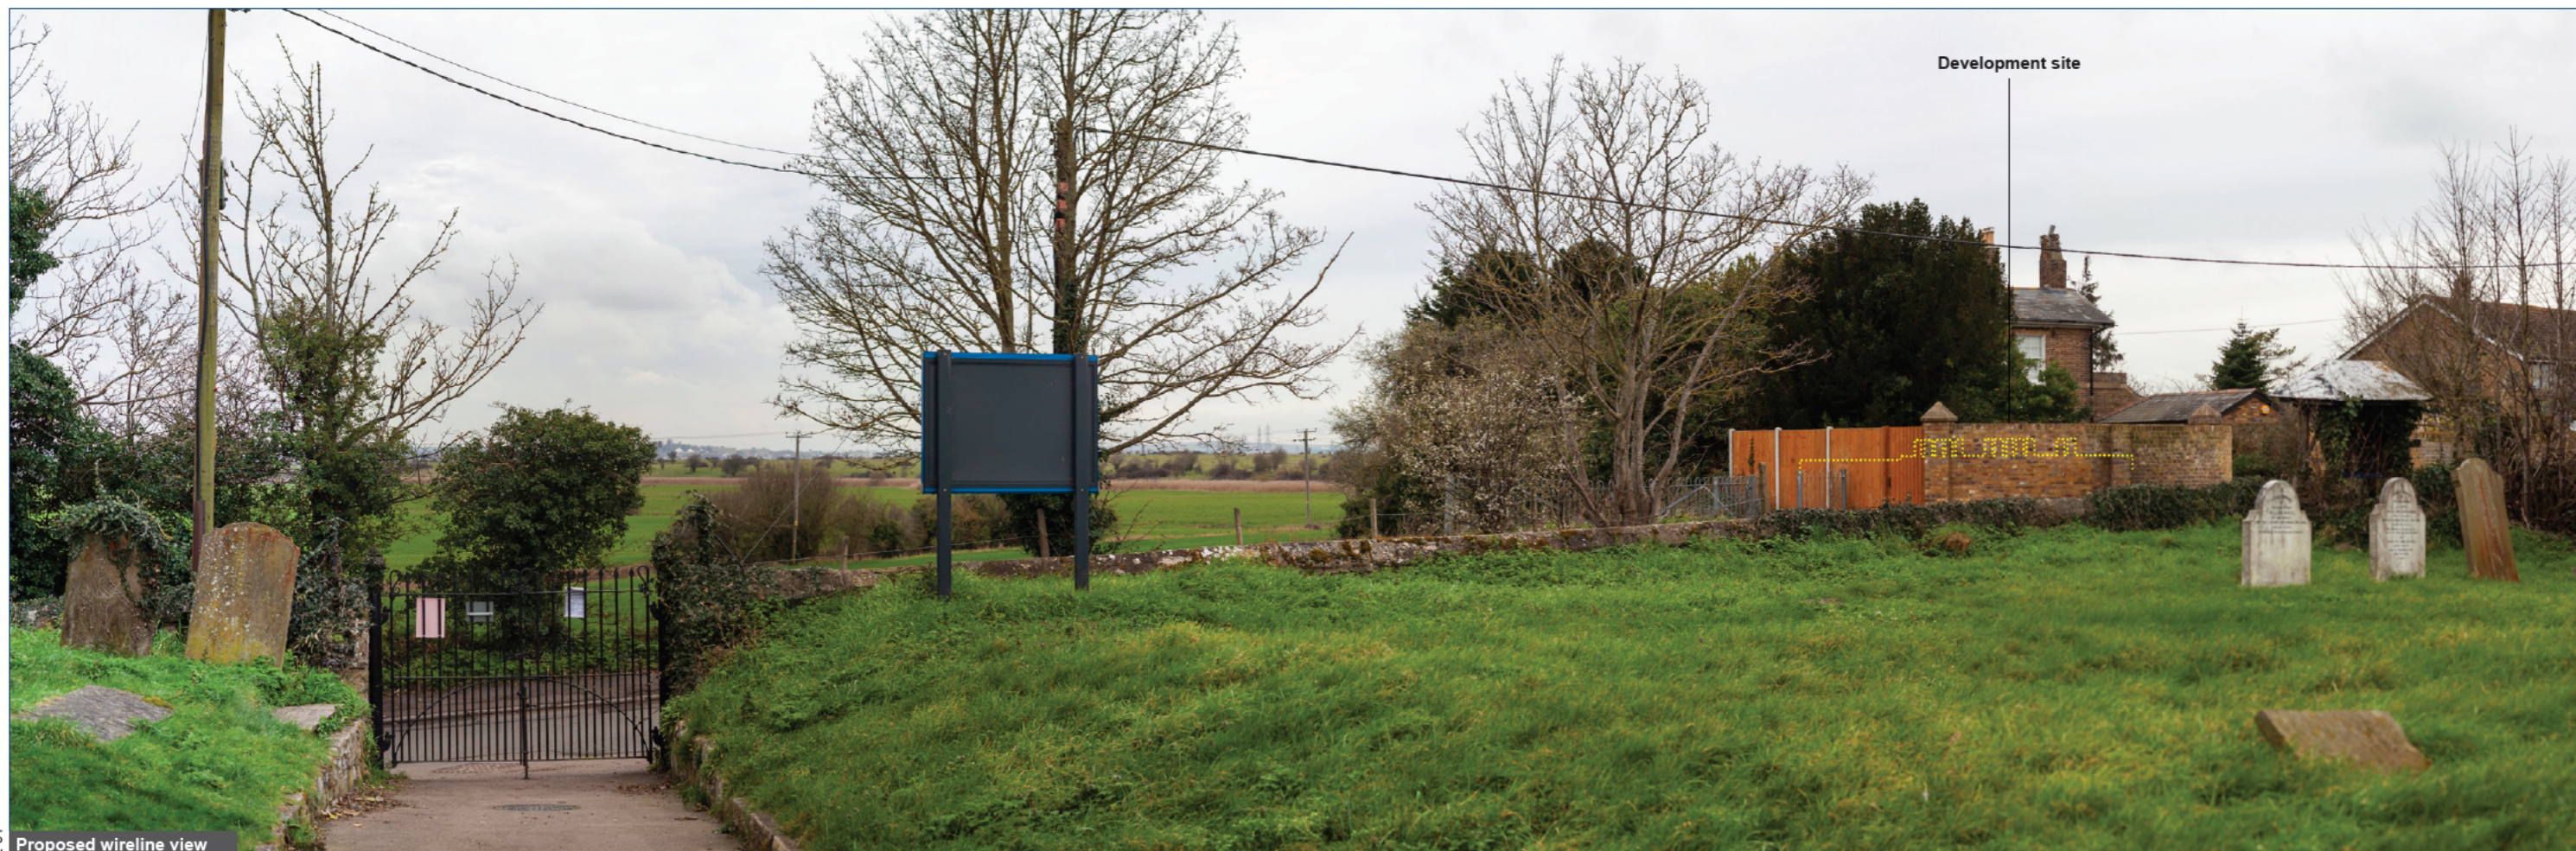
St Katherine's Church : Heritage Viewpoint 4a
10872-HER-04a

Existing view

Proposed wireline view

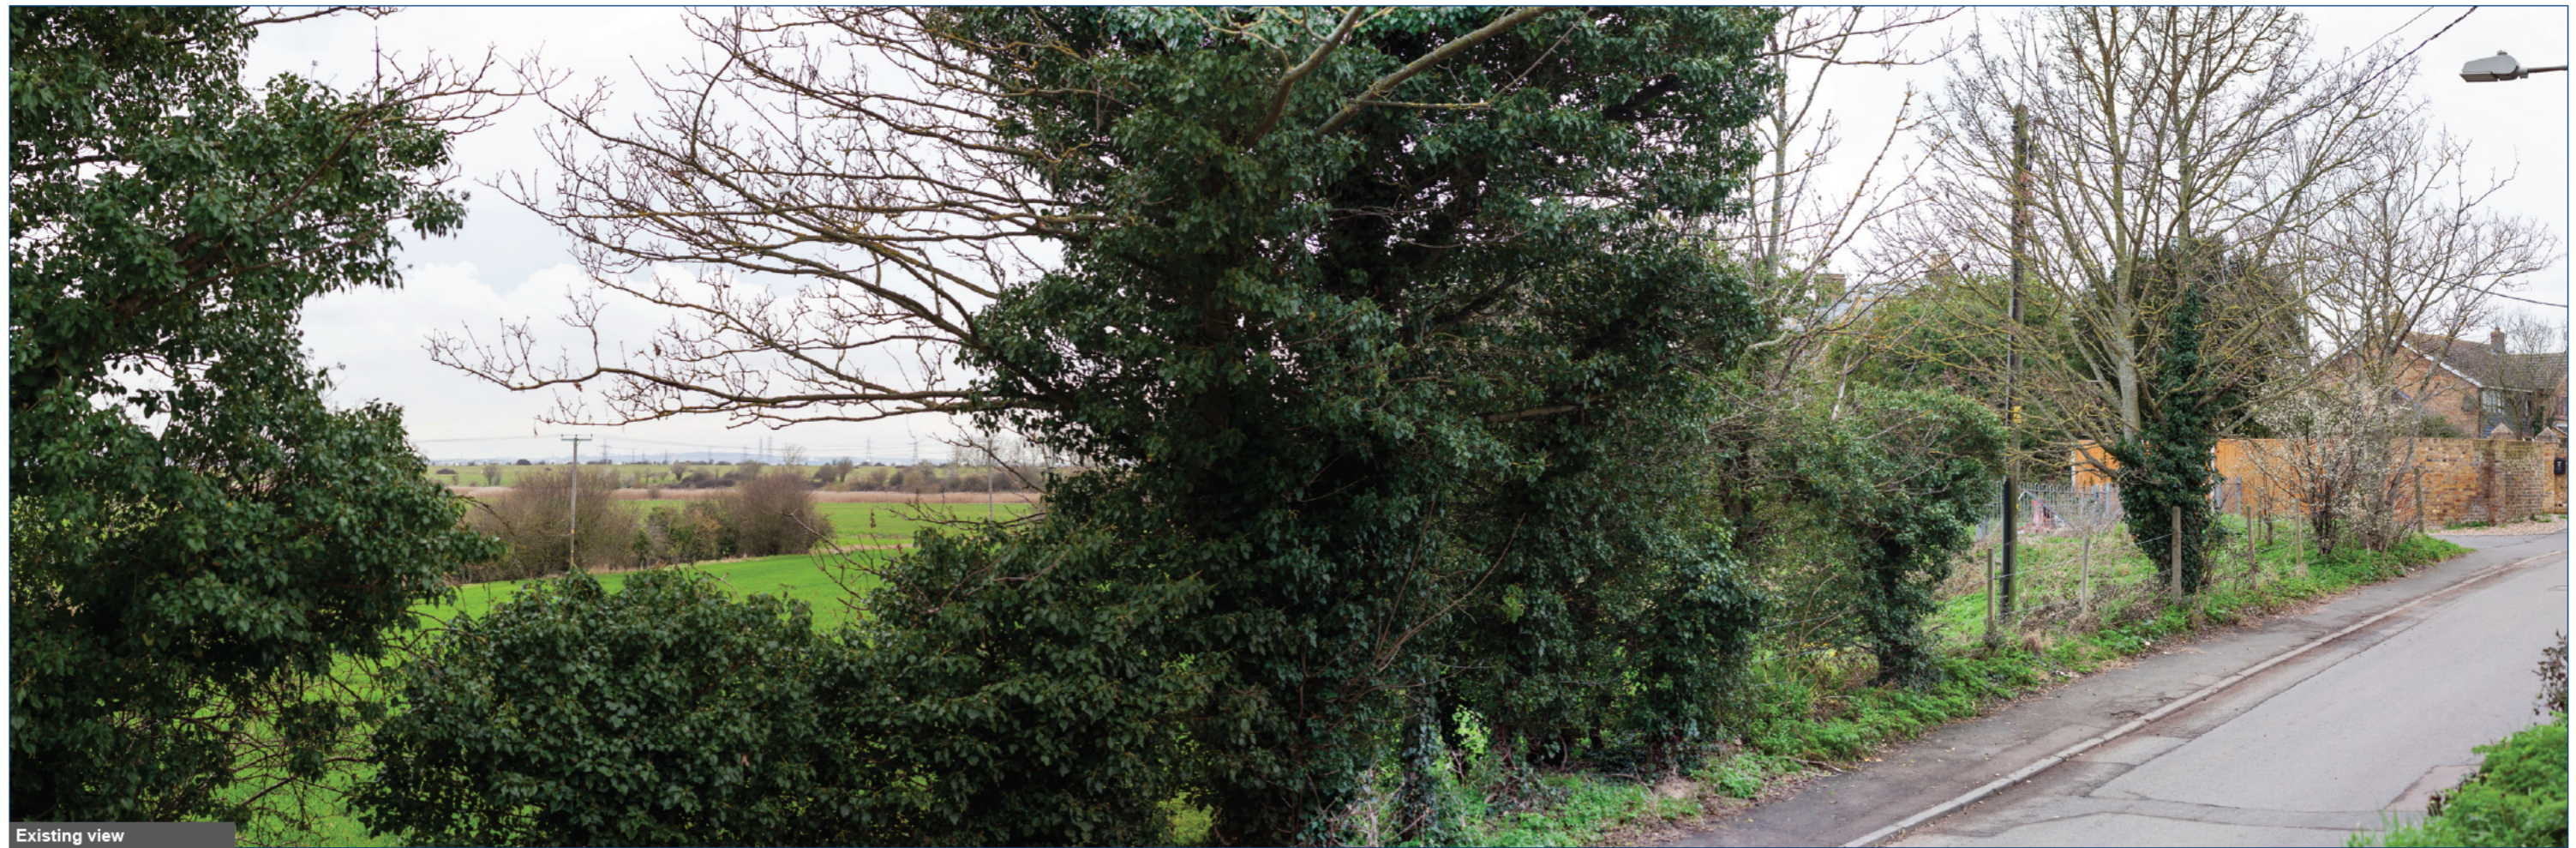
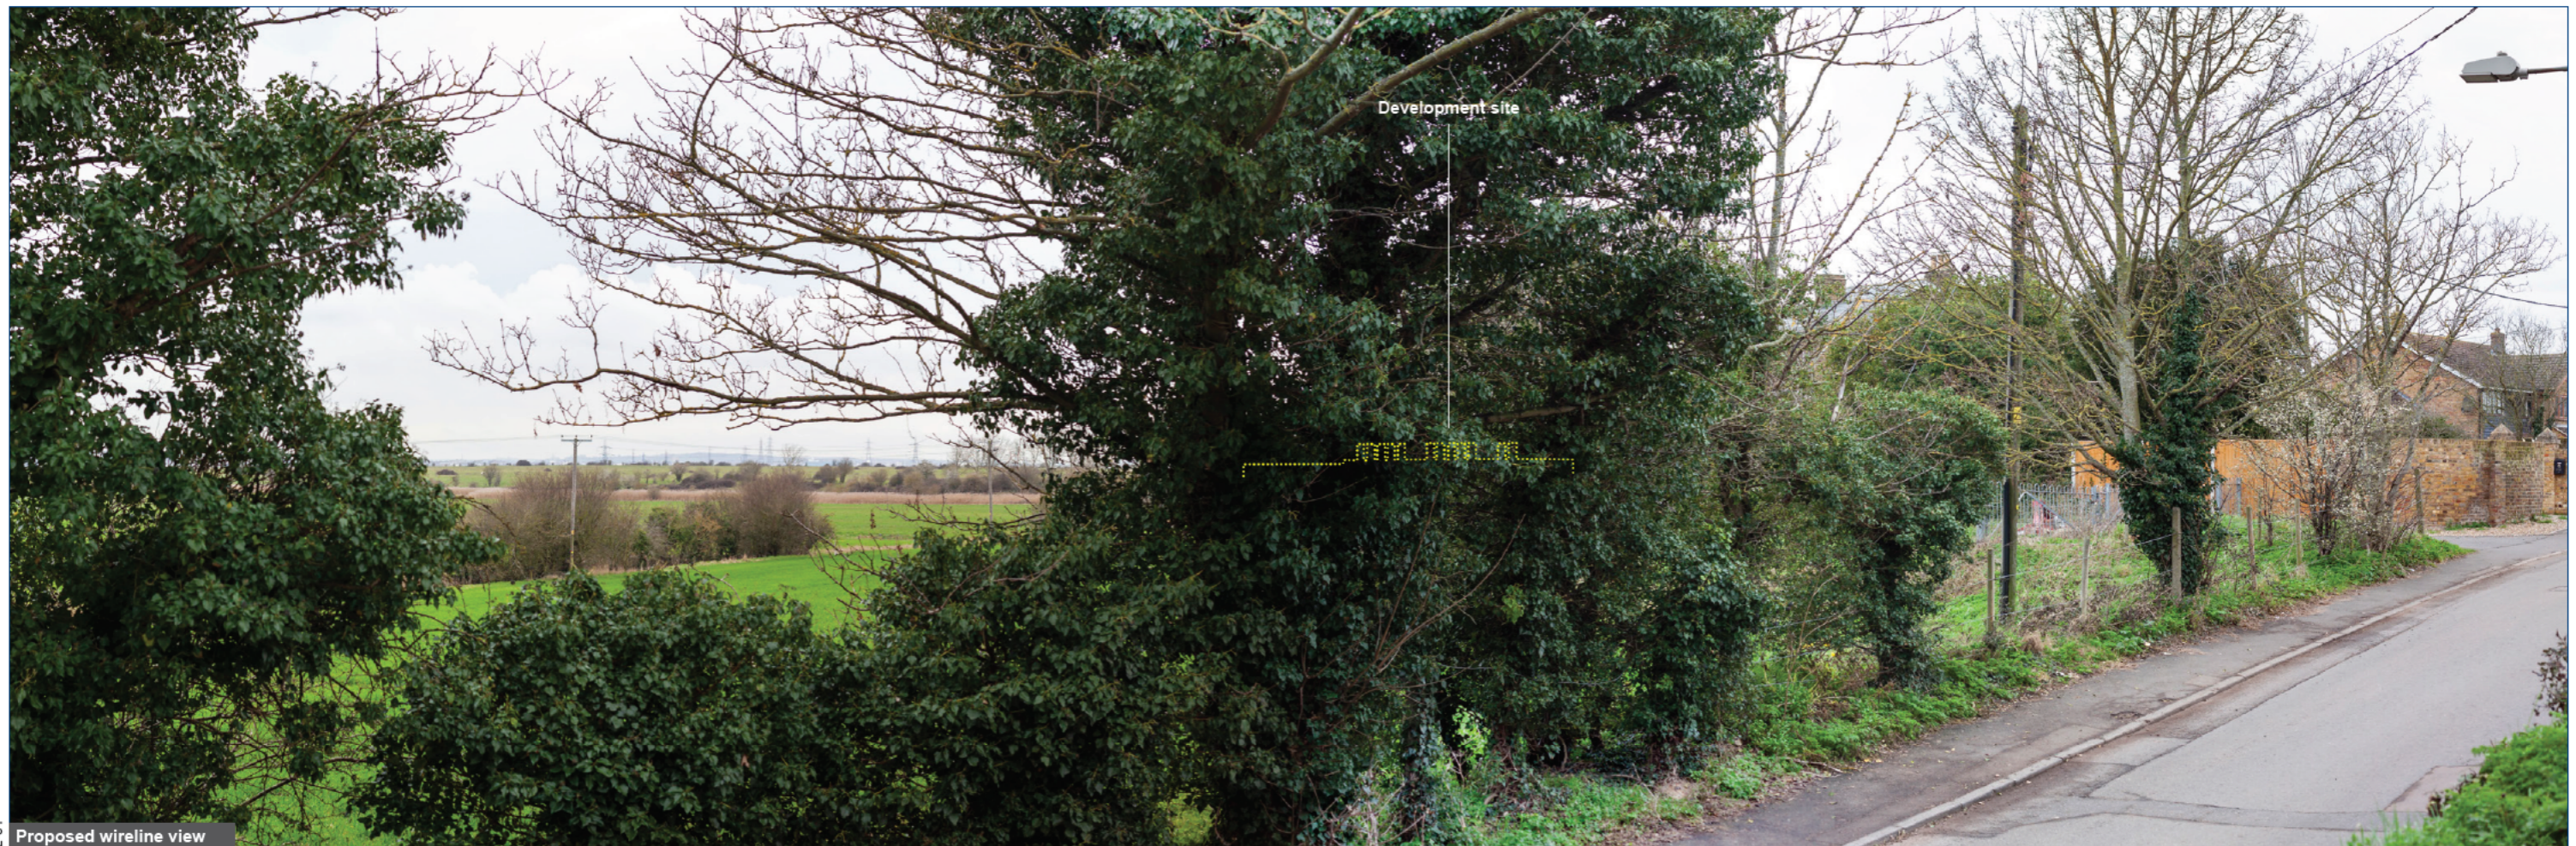
St Katherines Church : Heritage Viewpoint 4b
 10872-HER-04c

Existing view

Proposed wireline view

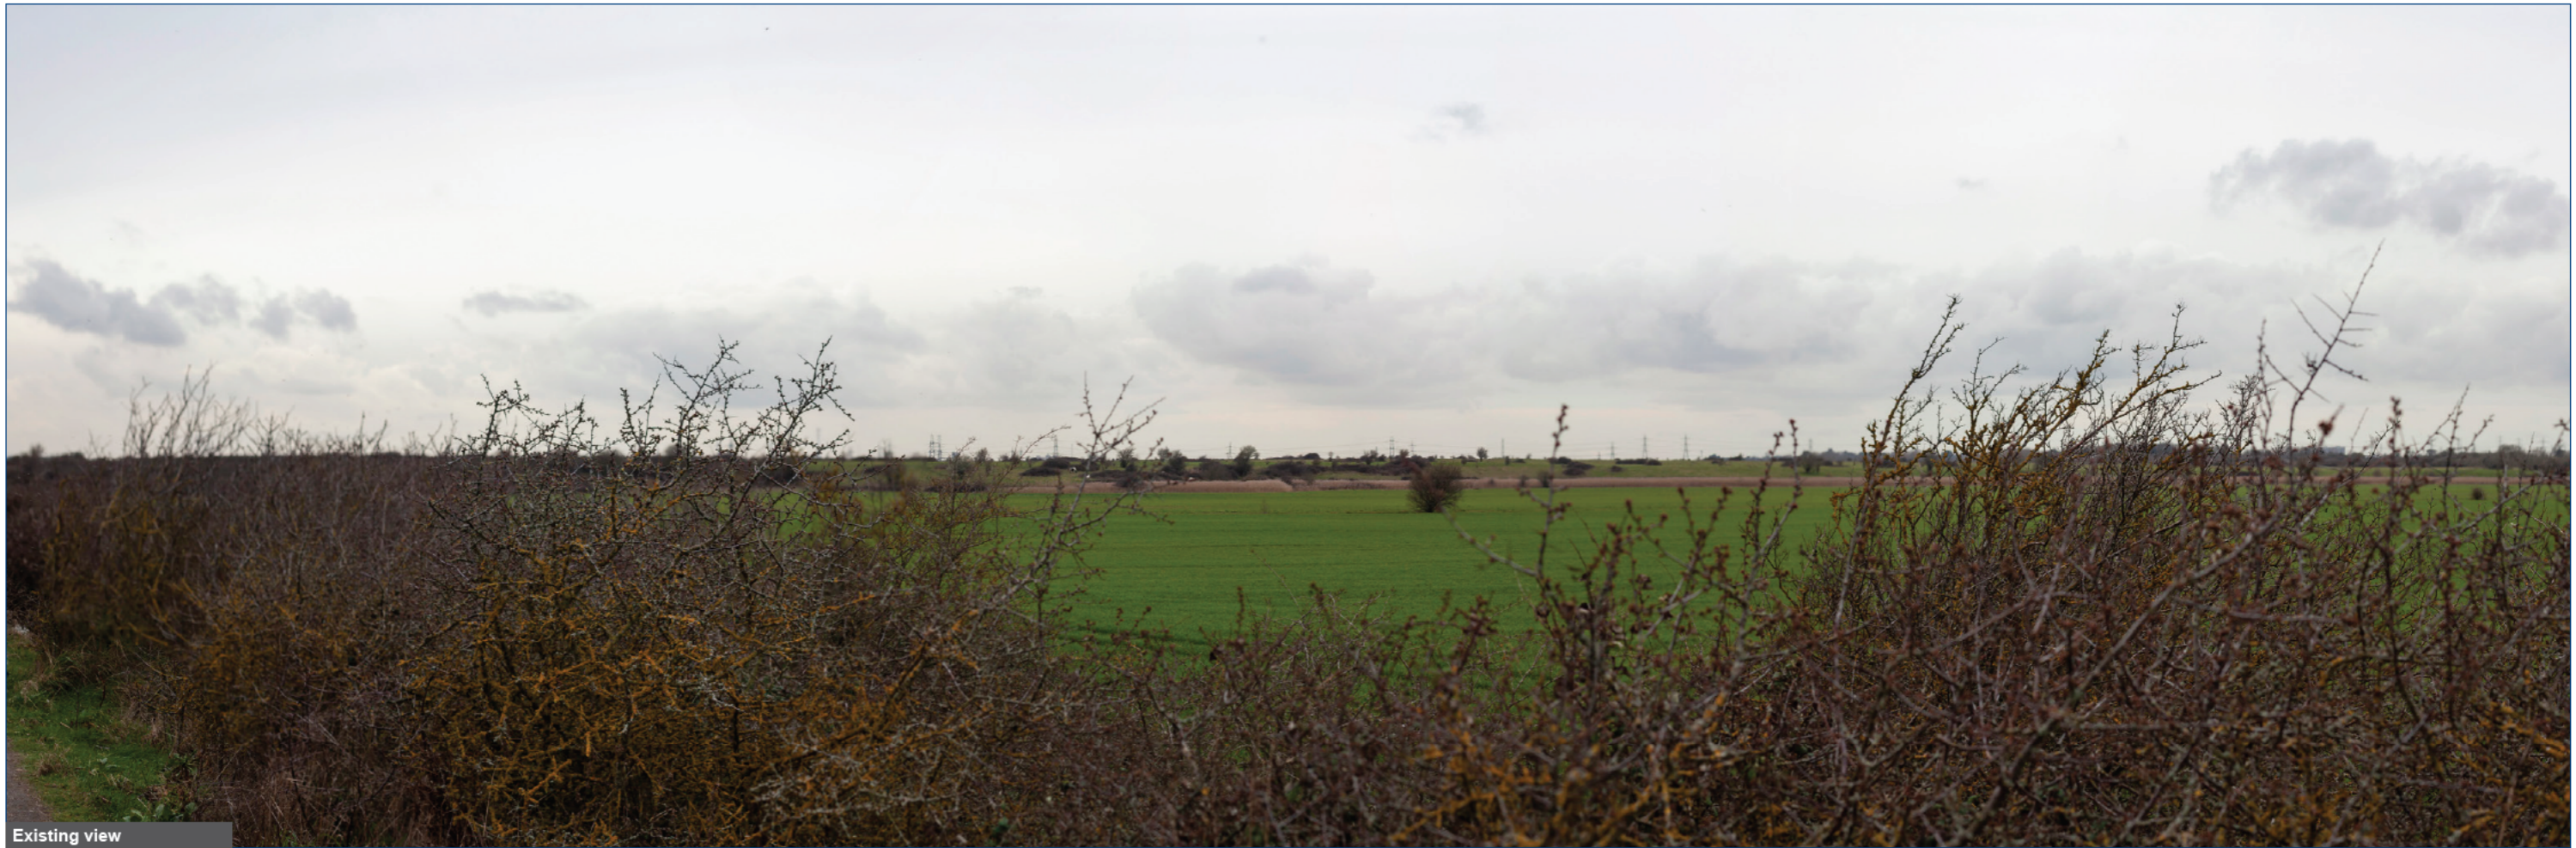
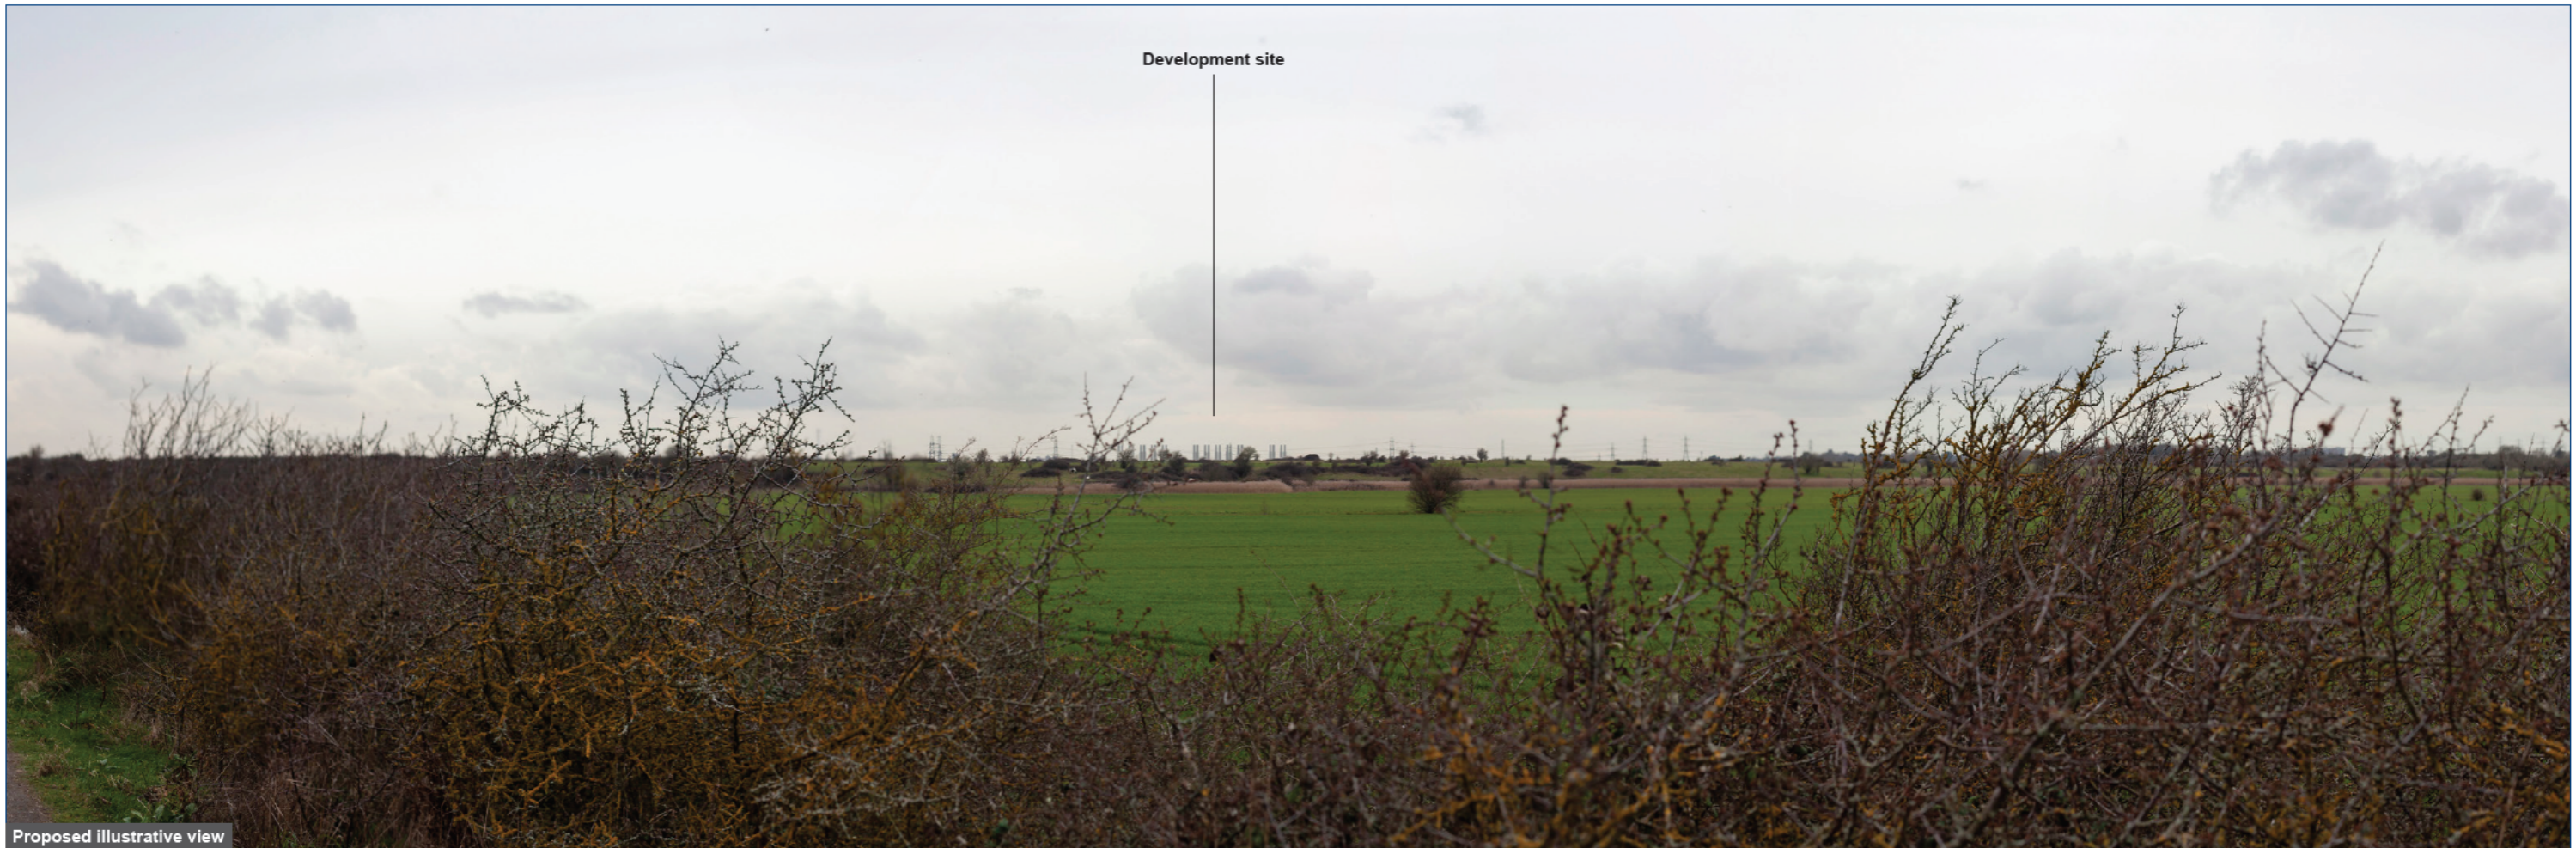
Coalhouse Point from the footpath: Heritage Viewpoint 5
 10872-HER-05a

Existing view

Proposed illustrative view

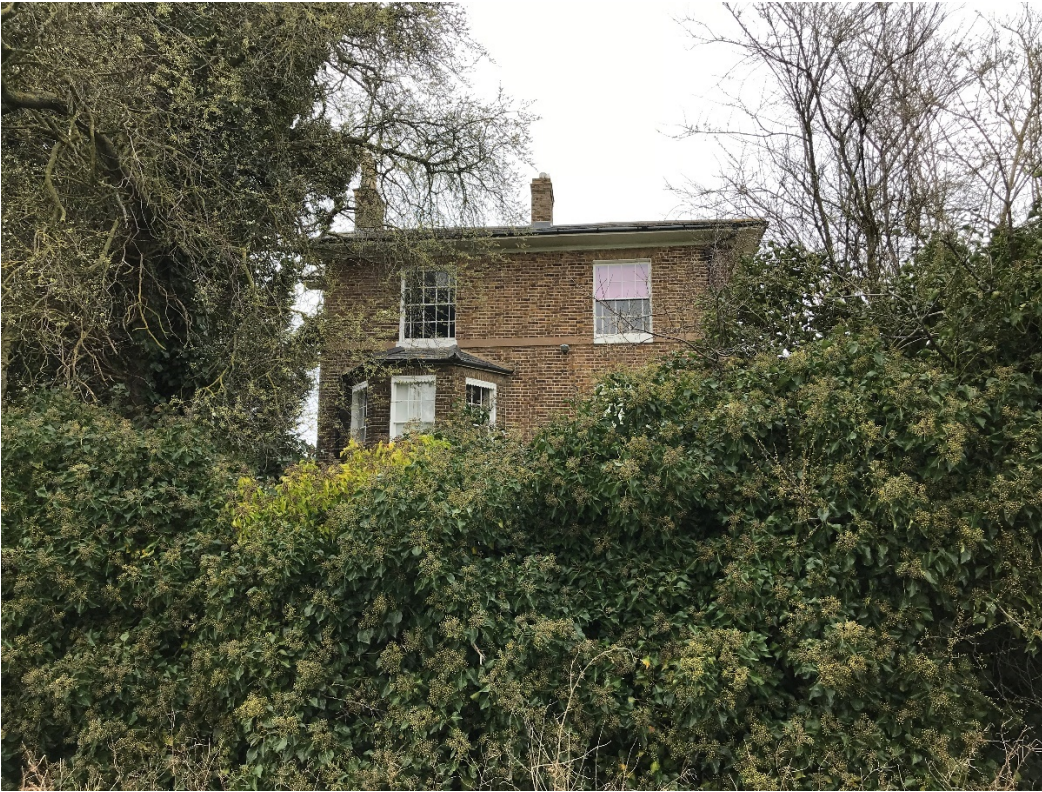
Plate 3 Principal (south) elevation of The Rectory, with views towards the river. The mature vegetation surrounding the property has been cut back here to afford views out: this is not the case for the remainder of the house which is secluded

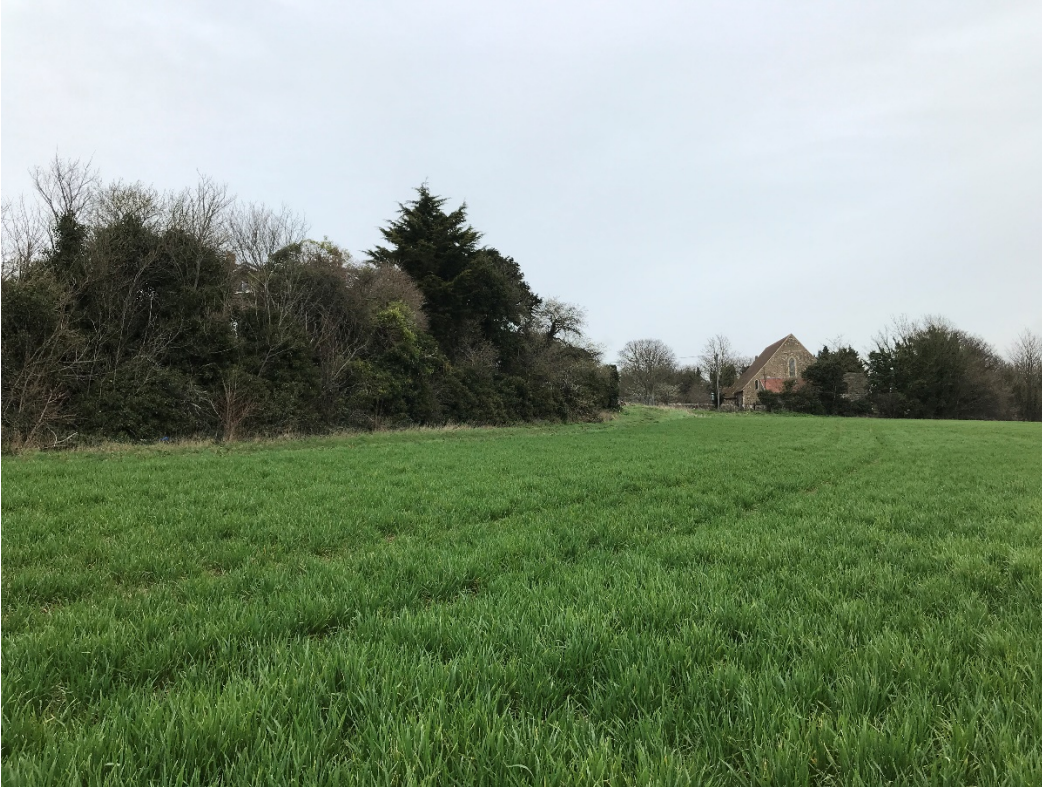
Plate 4 View east/east-northeast looking towards the rear of The Rectory (west elevation) and the Church, showing mature vegetation which obscures views of the Site

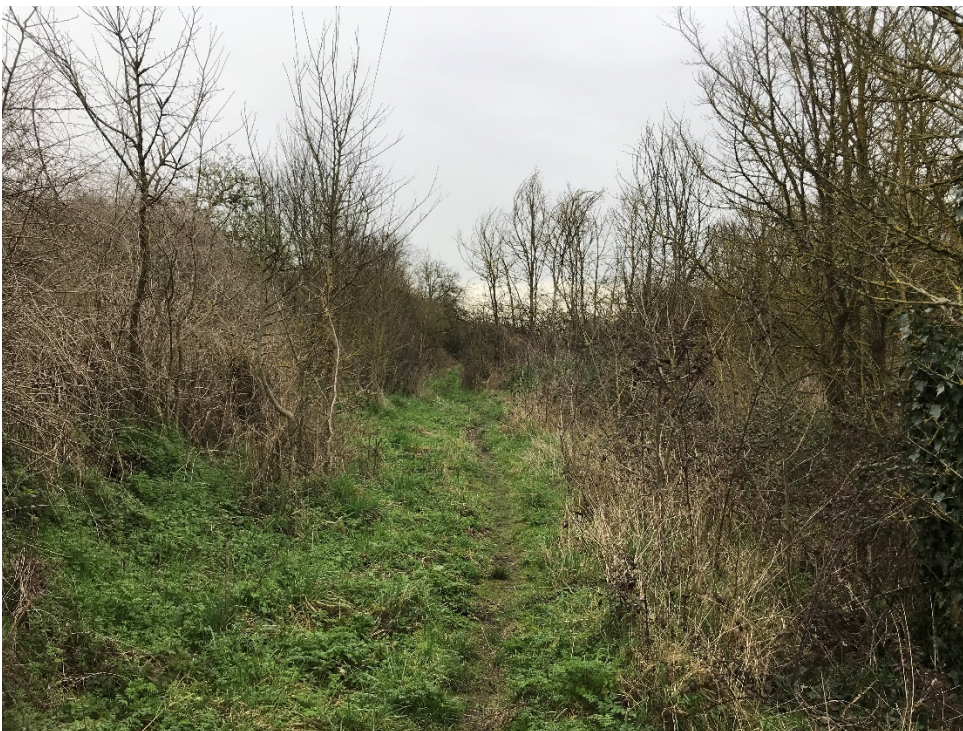
Plate 6 View of the track downslope and to the south of the Bowater HAA battery. The footpath mapped around the southern edge of the scheduled monument on modern OS mapping is impenetrable and it is not possible to access the footpath nor the monument.

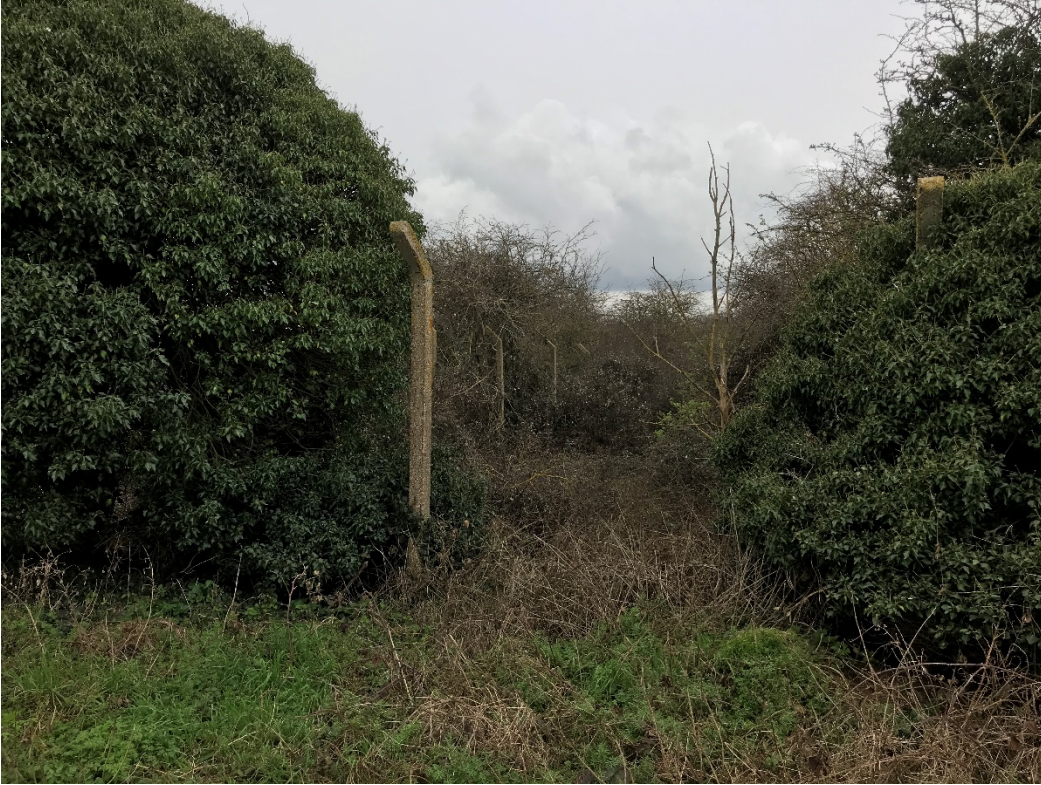
Plate 7 Eastern corner of the Bowater HAA Battery scheduled area. The monument is densely overgrown, illegible and impenetrable

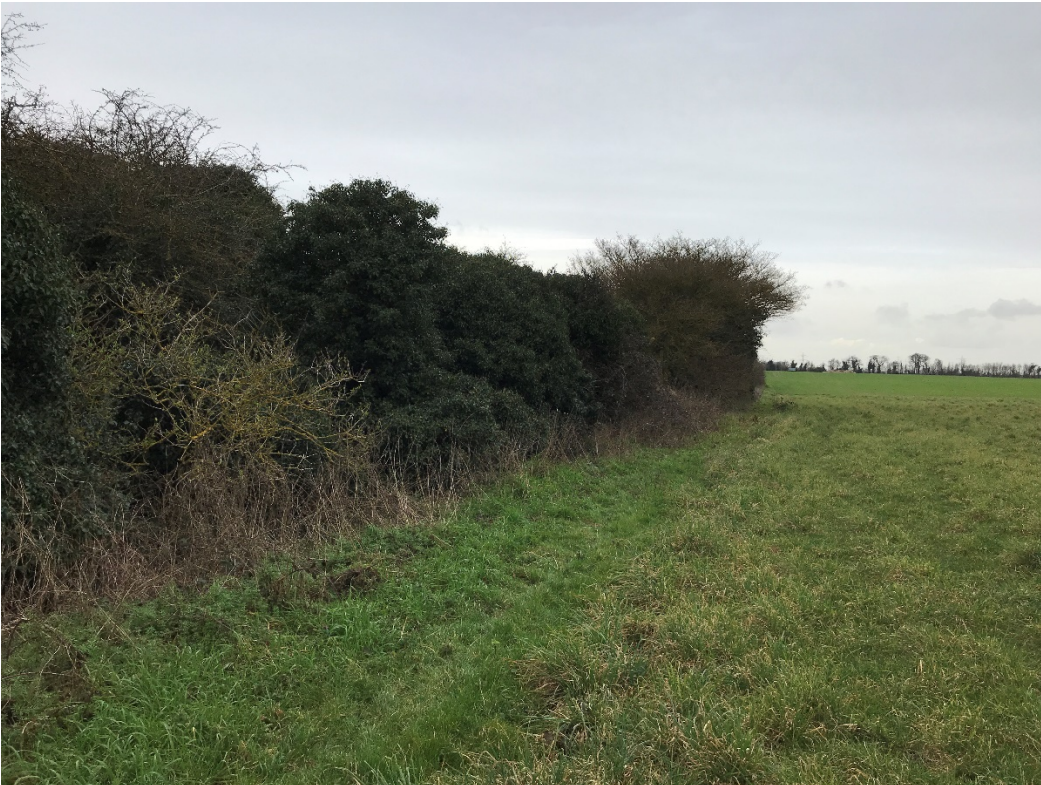
Plate 8 View along the east/northeast edge of the Bowater HAA battery showing the overgrown nature of the site

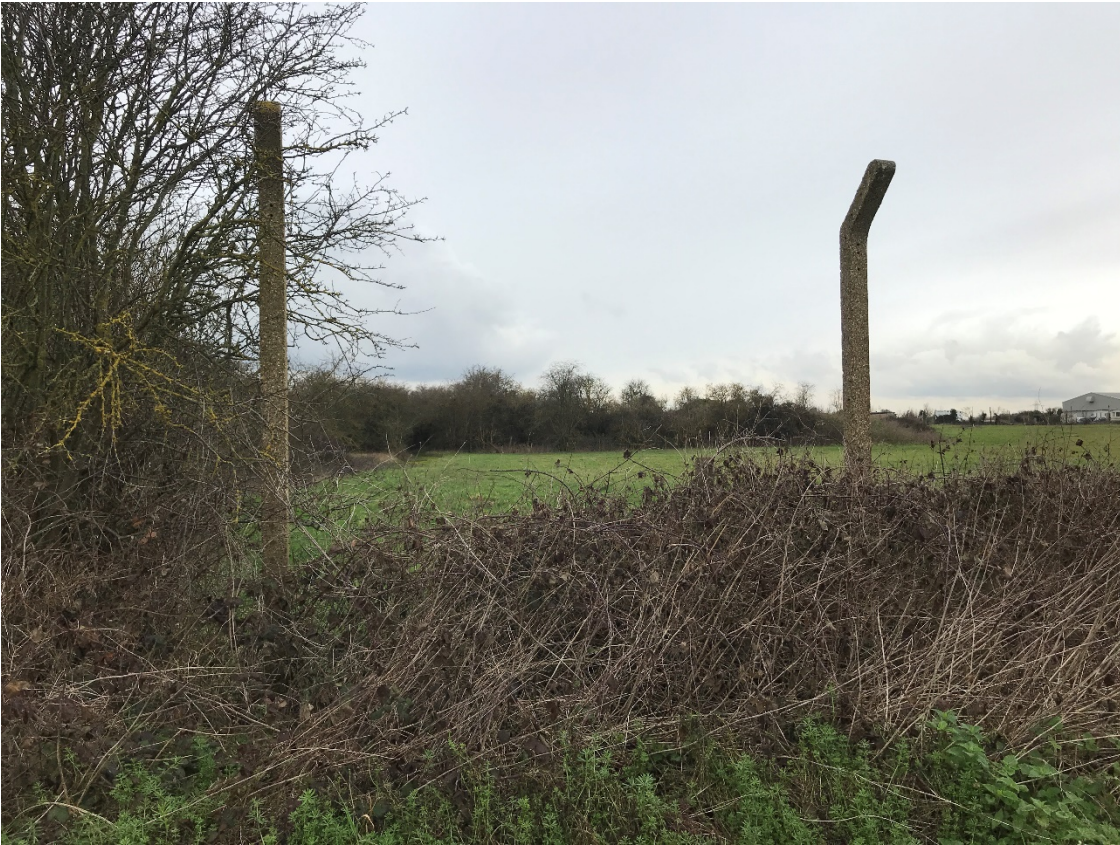
Plate 9 View from the north corner of the Scheduled area at Bowater HAA battery looking west towards Thurrock FGP Zone A. There is no view and the monument is densely overgrown, illegible and impenetrable.
