# Hornsea Project Four: Environmental Statement (ES)

PINS Document Reference: A6.2.1  
APFP Regulation 5(2)(a)

## Volume A6, Annex 2.1: Geomorphological Baseline Survey Report

A6.2.1  
Version B

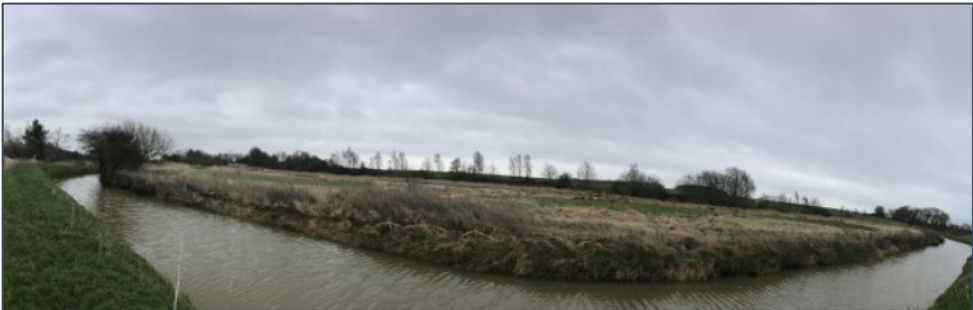
Parameter	Details
<p>Overview</p>	<p>The Barmston Sea Drain is approximately 15 km in length with a predominately straight planform. The channel displays very limited flow and geomorphological diversity, although large wetland features are evident on the floodplain directly north of the drain (<b>Plate 2</b>). However, overall the Barmston Sea Drain within the study area is typical of a large modified drainage system, with a uniform channel shape and incised as a result of historical re-sectioning and enlargement for land drainage purposes (<b>Plate 2</b>).</p>

<p><b>Plate 2: Barmston Sea Drain.</b></p>
<p>Channel Form</p>	<p>The channel has a straight planform. The banks are relatively steep, approximately 1 m – 2 m high, stable and well vegetated in places throughout the study area. The channel is approximately 7 m – 10 m wide at the bank top; and 7 m wide at the bank base, displaying a typical U-shape style channel (<b>Plate 2</b>). The substrate is dominated by sands and silts and appears to be a typical sediment deposition zone with slow flows, low gradients and low velocities contributing to the settling out of fine sediments/silts.</p>

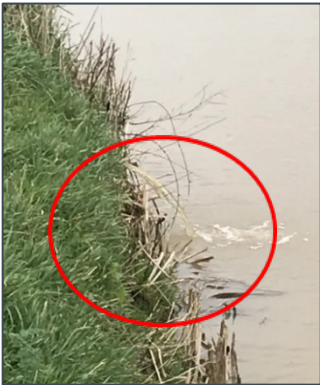
<p>Substrate Conditions</p>	<p>As stated above, the substrate is dominated by silts. Some local erosion of banks was evident alongside field drainage pipes and overland flow, all of which appear to contribute to local siltation of the channel bed within the study area (<b>Plate 3</b>). However, the dominant source of fine sediments appears to be associated with upstream land management practices.</p>

<p><b>Plate 3: Discharge from field drain into Barmston Sea Drain.</b></p>

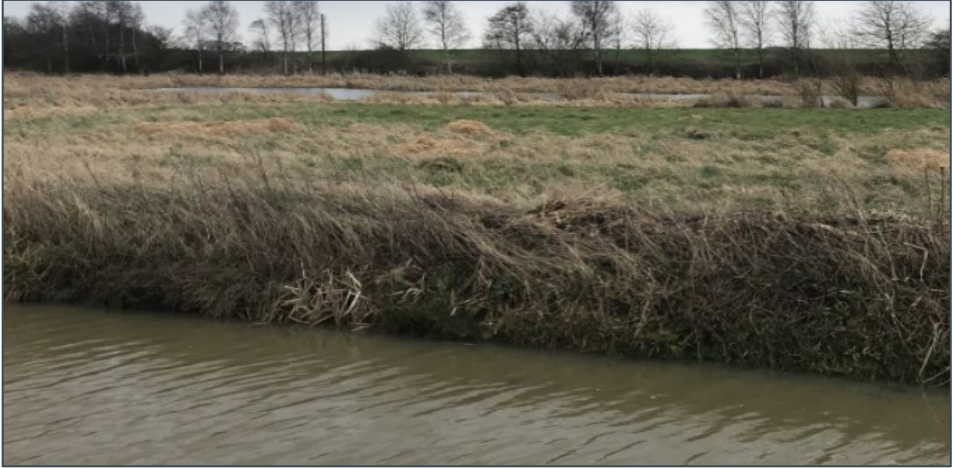
Parameter	Details
Flow (Habitat) Conditions	The wide, straight uniform channel is characterised by low energy glide flows, which were observed throughout the study area, with limited flow diversity or in-channel features.
Floodplain Characteristics	<p>Large floodplain wetland systems (<a href="#">Plate 2</a> and <a href="#">Plate 4</a>) suggest that there is a good degree of floodplain connectivity in parts of the study area.</p>

<p><b>Plate 4: Wetland on the floodplain of the Barmston Sea Drain.</b></p>
In-channel / Riparian Vegetation	The banks and margins are well vegetated with rushes, sedges and reeds. There is some in-channel aquatic vegetation, although the vegetation is heavily silted ( <a href="#">Plate 3</a> ).
Modifications / Structures	The channel is deeply incised and is likely to have been historically re-sectioned and enlarged for land drainage purposes.

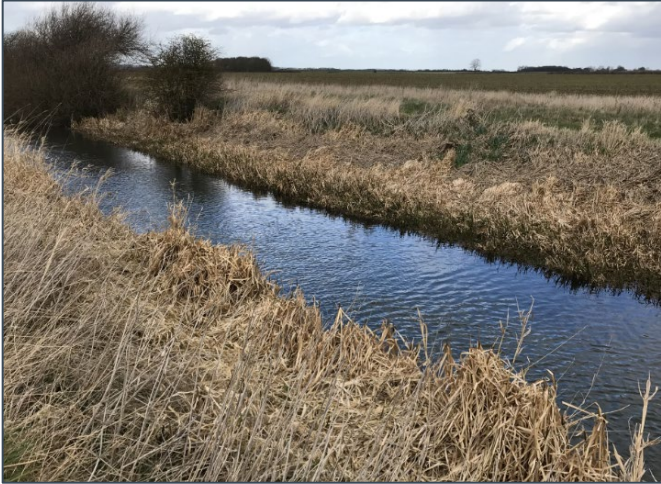
Parameter	Details
	<p>a two-stage channel is a feature (Plate 5). However, overall Foston Beck within the study area is typical of a large modified drainage system, with a uniform channel shape and bounded by embankments (Plate 5).</p>

<p><b>Plate 5: Foston Beck.</b></p>
Channel Form	<p>The channel has a straight planform. The banks are relatively steep, approximately 1 m high, stable and well vegetated in places throughout the study area. The channel is approximately 7 m – 10 m wide at the bank top; and 7 m wide at the bank base, displaying a two-stage channel in places, with a low flow channel and aligned with flood embankments (Plate 5). The substrate is dominated by sands and silts, resultant of a typical sediment deposition zone, with slow flows, low gradients and low velocities contributing to the settling out of fine sediments / silts. Limited exposures of the natural course substrates that would typically be expected in a chalk river were observed in this reach.</p>

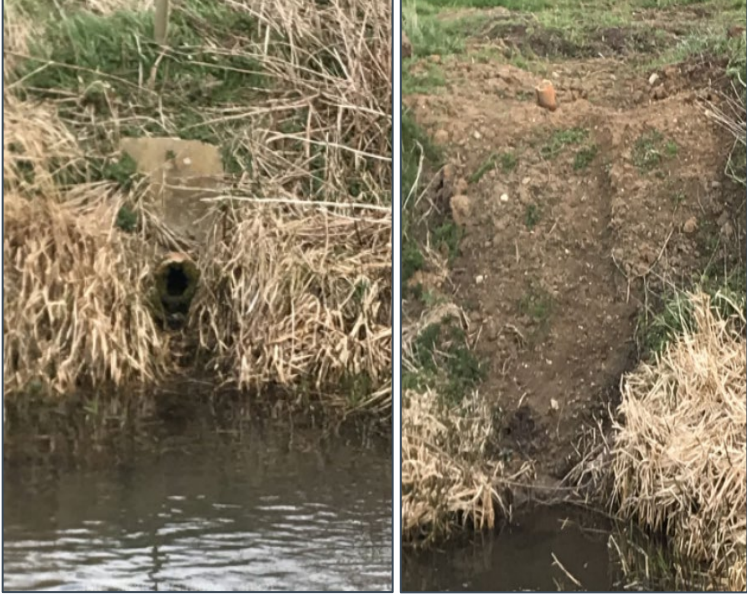
Substrate Conditions	<p>Temporary and semi-permanent fine channel deposits are present within the study area, as well as coarse deposits. Fine sediment deposits are mainly in the form of toe accumulation interspersed between marginal vegetation, with berm establishment in places. However, the channel is dominated by a silty flat bed, which may be the reason for the lack of aquatic vegetation within the study area. There is extensive fluvial erosion (toe scour) in places, although there was no evidence of geotechnical bank failure present during the time of the survey. There was also evidence of field drain outfalls and eroded access banks adjacent to arable land (Plate 6).</p>

<p data-bbox="395 936 941 969"><b>Plate 6: Sources of sediment to Foston Beck.</b></p>
Flow Conditions	<p data-bbox="395 981 1329 1048">The wide, straight channel is characterised by low energy glide flows, which were observed throughout the study area, with some flow diversity and in-channel features.</p>
Floodplain Characteristics	<p data-bbox="395 1081 1329 1149">Foston Beck does appear to be constrained within the flood embankments. As such, limited floodplain connectivity along the beck was observed throughout the study area.</p>
In-channel / Riparian Vegetation	<p data-bbox="395 1182 1377 1294">The banks and margins are well vegetated with rushes, sedges and reeds. In places emergent aquatic vegetation in the channel was noted, although obscured by silt deposition (<b>Plate 7</b>). The submerged vegetation cover varies from 5% to 40% throughout the study area.</p>

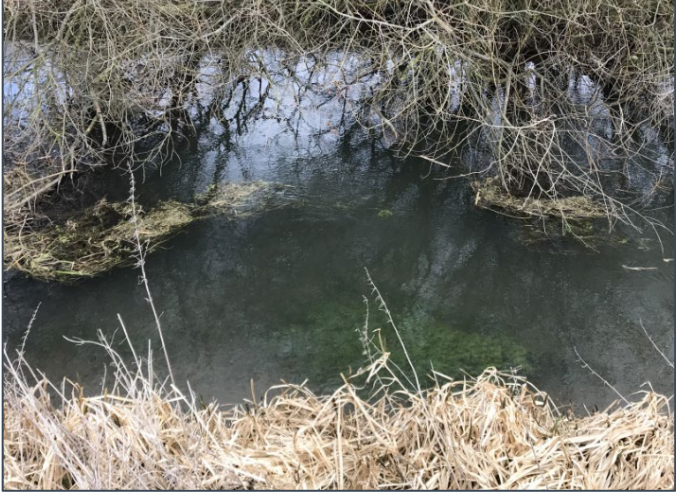
<p data-bbox="395 1854 1058 1888"><b>Plate 7: In-channel vegetation growth in Foston Beck.</b></p>

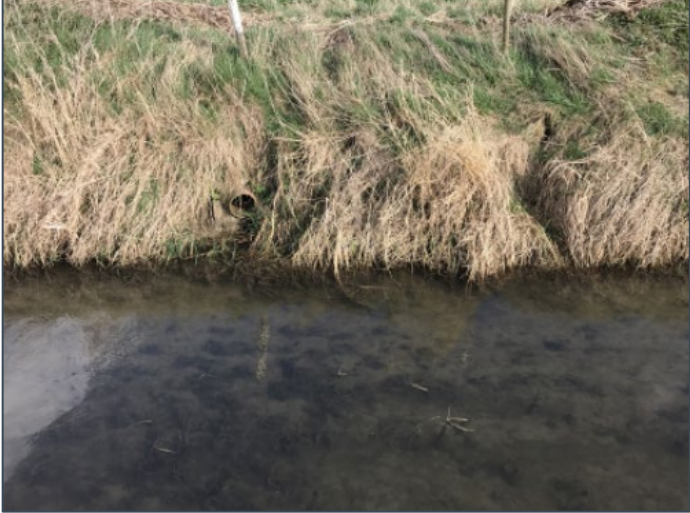
Parameter	Details
Overview	<p>White Dike within the study area is a uniform, incised channel that has been artificially straightened and aligned with flood embankments adjacent to arable farm land (<a href="#">Plate 8</a>). The channel is dominated by glide flows and silt deposition. No major sediment sources were noted, although drainage outfalls from the adjacent fields were noted, with possible local bank scour from bridge abutments. The dominant source of fine sediments appears to be associated with upstream land management.</p>   <p><a href="#">Plate 8: White Dike.</a></p>
Channel Form	<p>The channel has a straight planform and uniform morphology with a flat bed. The banks are relatively steep, approximately 1 m high, stable and well vegetated in places throughout the study area. The channel is approximately 7 m – 10 m wide at the bank top; and 6 m wide at the bank base. Both banks are aligned with flood embankments (<a href="#">Plate 8</a>). The channel within the study area appears to be of a typical sediment deposition zone, with slow flows, low gradients and low velocities contributing to the settling out of fine sediments / silts along a flat bed with limited geomorphological complexity (<a href="#">Plate 9</a>).</p>

<p data-bbox="395 860 1123 887"><b>Plate 9: Silt deposition and field drain outfall in White Dike.</b></p>
Substrate Conditions	The substrate is dominated by sands and silts, although silts / fine sediments are the main substrate material overlying the sands. No major sediment sources were noted, although outfalls from the adjacent fields were noted, with possible local bank scour from bridge abutments. The dominant source of fine sediments appears to be associated with upstream land management.
Flow Conditions	The wide, straight uniform channel is characterised by low energy glide flows, which were observed throughout the study area, with limited flow diversity or in-channel features.
Floodplain Characteristics	White Dike appears constrained within the flood embankments and as such, a limited floodplain area was observed throughout the study area.
In-channel / Riparian Vegetation	The banks and margins are well vegetated with rushes, sedges and reeds. There was some in-channel aquatic vegetation, although heavily silted ( <b>Plate 8</b> ).

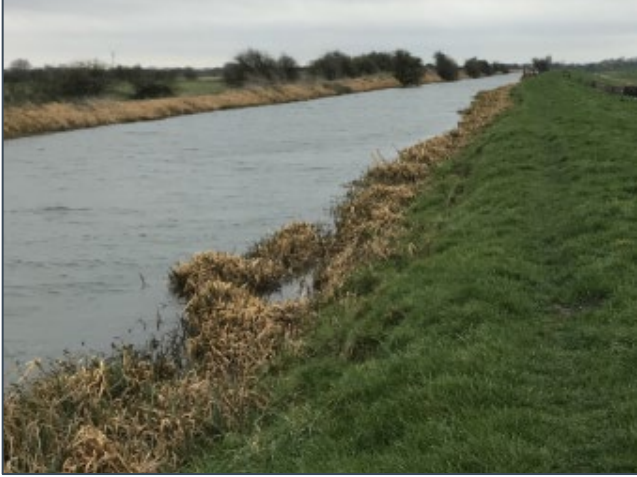
<b>Parameter</b>	<b>Details</b>
Overview	<p>The Driffield Navigation Canal is approximately 8 km in length with a predominately straight planform. Within the study area, the canal has uniform flow, medium gradient, gravelly bed with localised silt with bank material predominantly fine grained. The bed is dominated by sandy clay with a large proportion of silt in places. Both banks generally have vegetated graded profiles aligned with flood embankments, with a public right of way (PRoW) (and access track) following the left bank of the canal (<b>Plate 10</b>). The Driffield Navigation Canal within the study area is popular for recreational fishing, with some minor bank protection works evident in the study area.</p>   <p><b>Plate 10: Driffield Navigation.</b></p>
Channel Form	<p>The channel has a largely straight planform. The fine-grained banks are relatively steep, approximately 1 m – 2 m high, stable and well vegetated in places throughout the study area. The channel is approximately 10 m – 12 m wide at the bank top; and 7 m wide at the bank base, displaying a wide and deep channel profile (<b>Plate 11</b>).</p>

<p data-bbox="395 824 1075 853"><b>Plate 11: Wide and deep channel of the Driffield Canal.</b></p>
<p data-bbox="204 869 316 929">Substrate Conditions</p>	<p data-bbox="395 869 1385 1108">The substrate is dominated sandy clay with a large proportion of silt in places; and appears to be a typical sediment deposition zone, with slow flows, low gradients and low velocities contributing to the settling out of fine sediments / silts. The majority of channel-edge deposits are formed by toe accumulation, interspersed between trapping by marginal vegetation. There are a large number of temporary fine channel deposits. Some fluvial erosion (toe scour) on both banks throughout the study area was evident along with field drains and access tracks providing a sediment source to the watercourse (<b>Plate 12</b>).</p>

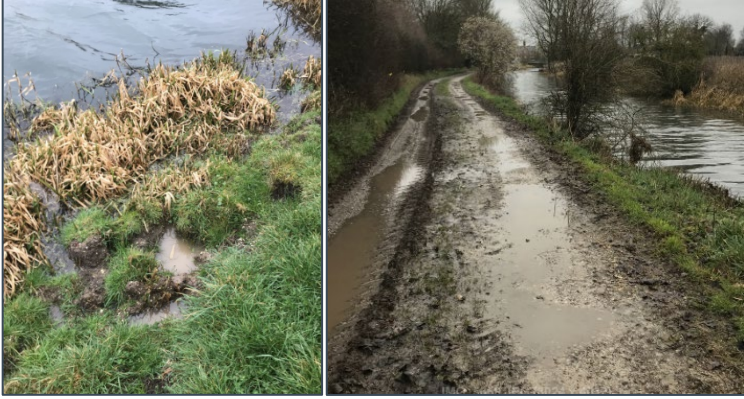
<p data-bbox="395 1581 1034 1610"><b>Plate 12: Sources of sediment to the Driffield Canal.</b></p>

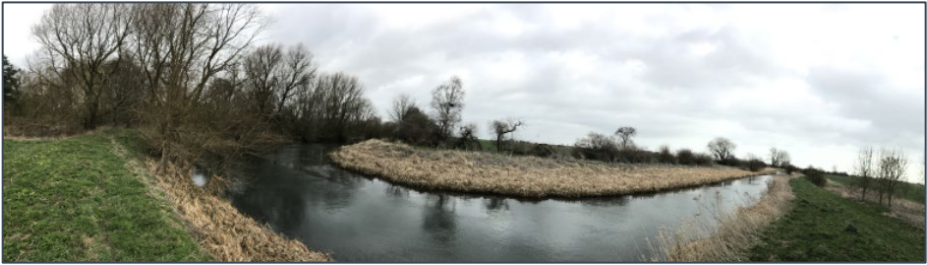
Parameter	Details
Overview	<p>West Beck within the study area is predominantly meandering and has been historically over-deepened and over-widened for navigation purposes. As a result, the river is very deep, with steep banks and uniform flow conditions (<a href="#">Plate 15</a>). The channel is largely bordered by flood embankments. Large parts of the banks are exposed, although there is localised tree and good wet woodland and backwaters (<a href="#">Plate 16</a>). Cleaves Weir is located upstream of the study area.</p>

<p><a href="#">Plate 15: West Beck.</a></p>

Parameter	Details
Channel Form	<p>Within the study area, West Beck is very deep with steep banks and uniform flow conditions (<b>Plate 15</b>). The channel is approximately 15 m wide at the bank top; and 8 m wide at the bank base with a good degree of geomorphological complexity in places, in particular, adjacent to the farm building. The study area is surrounded by arable farming, with flood embankments lining the river (<b>Plate 15</b>).</p>
Substrate Conditions	<p>Within the study area, the West Beck Lower has a medium gradient and a silty bed with occasional fine and coarse gravel. Bank material is fine grained, dominated by sandy gravelly clay with localised silt. Both banks display a predominantly vegetated graded profile and as stated aligned with flood embankments.</p>
Flow Conditions	<p>The West Beck study area is characterised by uniform laminar flow, contributing to the settling of fine silts on the bed and overall depositional nature of the study area (<b>Plate 17</b>). Only minor sediment sources were noted along the study area (e.g. bank erosion), suggesting that the majority of the sediment load is derived from the upstream catchment.</p> <div data-bbox="392 869 1217 1438" data-label="Image"> </div> <p><b>Plate 17: Fine Sedimentation on the bed of West Beck.</b></p>

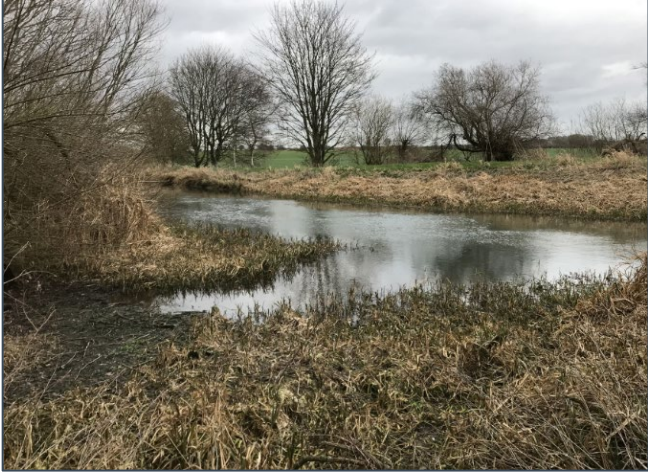
<p><a href="#">Plate 16: Wet woodland and backwater on West Beck.</a></p>

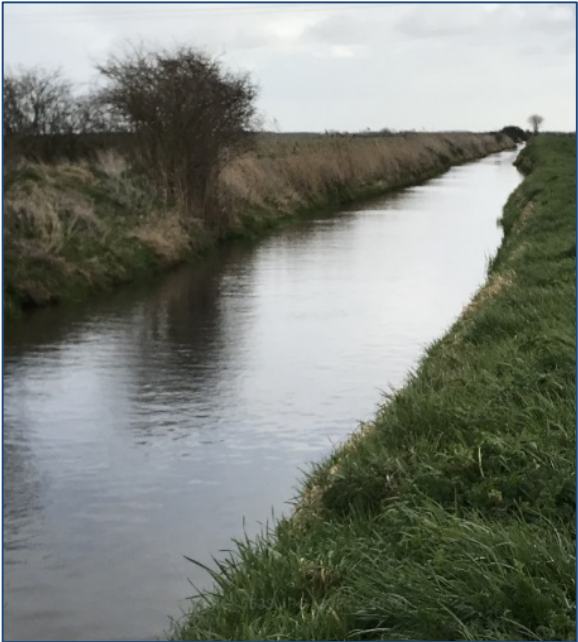
Parameter	Details
Overview	<p>Scurf Dike within the study area is a uniform incised channel that has been artificially straightened and is lined with flood embankments (<a href="#">Plate 18</a>). The channel is dominated by glide flows and silt deposition. No sediment sources were noted along the study area suggesting a dominant source of fine sediments is associated with land and catchment management.</p>

<p><a href="#">Plate 18: Scurf Dike.</a></p>
Channel Form	<p>The channel has a straight planform and uniform channel with a flat bed. The banks are relatively steep, approximately 0.7 m high, stable and well vegetated in places throughout the study area. The channel is approximately 7 m – 10 m wide at the bank top, and 6 m wide at the bank base. Both banks are aligned with flood embankments (<a href="#">Plate 18</a> and <a href="#">Plate 19</a>). The channel within the study area appears to be of a typical sediment deposition zone, with slow</p>

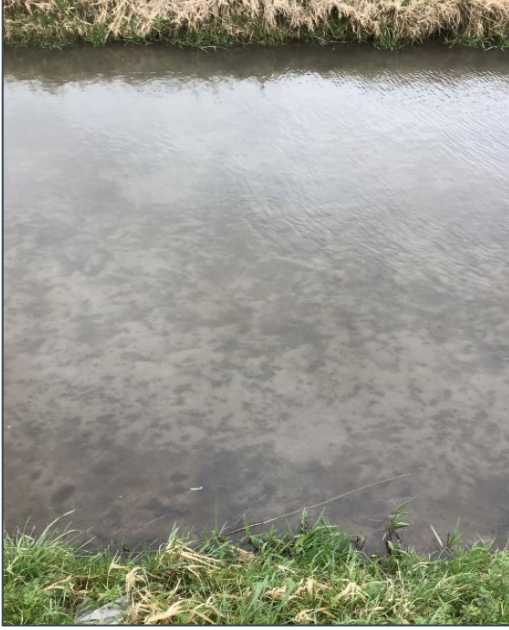
Parameter	Details
	<p>flows, low gradients and low velocities contributing to the settling out of fine sediments / silts along a flat bed, with limited geomorphological complexity (<a href="#">Plate 19</a>).</p>

<p><b>Plate 19: Fine siltation on the bed of Scurf Dike.</b></p>
Substrate Conditions	<p>The substrate is dominated by sands and silts. Although silts / fine sediments are the main substrate material overlying the sands, the water was generally clear at the time of the walkover survey, despite this high silt content. No sediment sources were noted along the study area, suggesting a dominant source of fine sediments is associated with land and catchment management.</p>
Flow Conditions	<p>The wide, straight uniform channel is characterised by low energy glide flows, which were observed throughout the study area, with limited flow diversity or in channel features.</p>
Floodplain Characteristics	<p>Scurf Dike appears to be constrained within the flood embankments and as such, limited floodplain connectivity along the beck was observed throughout the study area.</p>

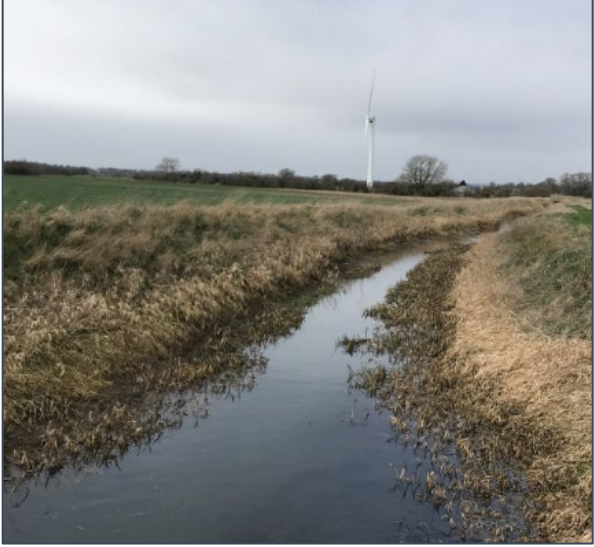
Parameter	Details
Overview	The Watton Beck is approximately 11 km in length with a predominately straight planform. The channel displays limited flow and geomorphological diversity, although in places a two-stage channel is a feature of the Watton Beck ( <a href="#">Plate 21</a> ). However, overall the Watton Beck within the study area is typical of a modified drainage system, with uniform channel shape and aligned with embankments ( <a href="#">Plate 21</a> ).

<p data-bbox="395 898 683 922"><b>Plate 21: Watton Beck.</b></p>
<p data-bbox="204 931 363 958">Channel Form</p>	<p data-bbox="395 931 1369 1178">The channel has a straight planform and the banks are relatively steep at approximately 1 m high. They are stable and well vegetated in places throughout the study area. The channel is approximately 7 m – 10 m wide at the bank top, and 5 m wide at the bank base, displaying a two-stage channel in places with a low flow channel and aligned with embankments (<a href="#">Plate 21</a> and <a href="#">Plate 22</a>). The substrate is dominated by sands and silts and appears to be of a typical sediment deposition zone, with slow flows, low gradients and low velocities contributing to the settling out of fine sediments/silts.</p>

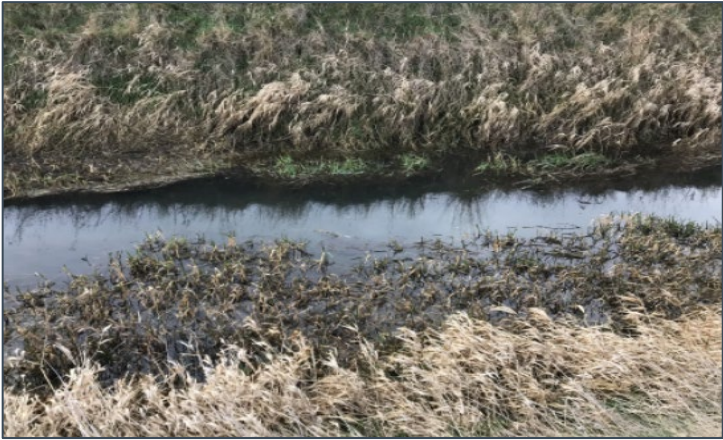
<p data-bbox="395 1682 938 1715"><b>Plate 22: Low flow channel in Watton Beck.</b></p>
<p data-bbox="204 1724 363 1792">Substrate Conditions</p>	<p data-bbox="395 1724 1369 1859">As stated above, the substrate is dominated by sands and silts. The overall quality of water reflects the high silt content influencing turbidity levels. No sediment sources were noted along the study area, suggesting a dominant source of fine sediments is associated with land and catchment management.</p>

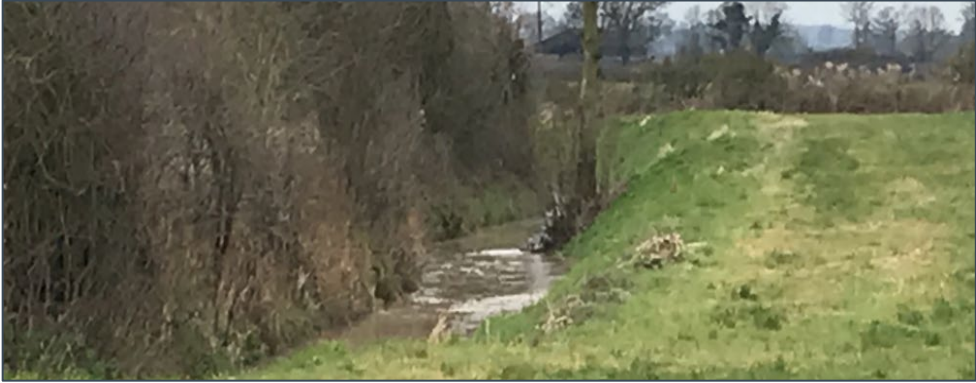
Parameter	Details
Overview	<p>Bryan Mills Beck displays a sinuous planform, although incised adjacent to arable farming in places (Plate 23).</p>

<p><b>Plate 23: Bryan Mills Beck.</b></p>
Channel Form	<p>The channel has a sinuous planform and although similar to Gransmoor Drain, the beck is deeply incised, with a 2 m - 3 m bank base, 5 m bank top and steep well vegetated banks up to 2 m in places (Plate 23). The beck does display a variety of in-channel features, such as riffles, bars with variety of geomorphological processes occurring such as deposition and erosion.</p>
Sediment	<p>Substrate is dominated by silts, with a dominant source of fine sediments which appears to be associated with land and catchment management along with exposed banks (as can be observed in Plate 23).</p>
Flow (Habitat) Conditions	<p>The Bryan Mills Beck displays a variety of flow habitats, such as deep riffles and glides.</p>

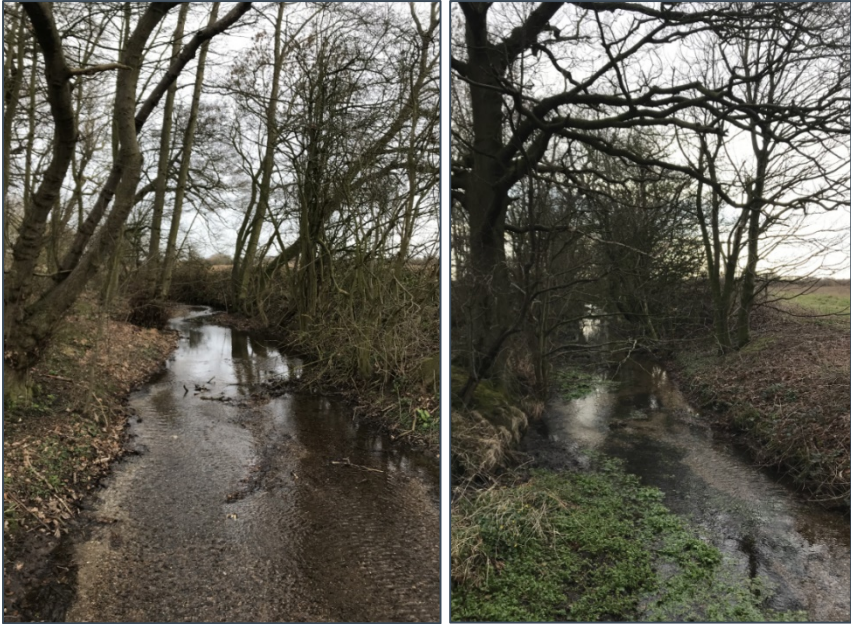
Parameter	Details
Overview	<p>Scarborough Beck is a chalk river approximately 8 km in length with a straight to moderately sinuous planform. The channel displays flow and geomorphological diversity in places. In particular, through Bealey's Plantation and Lakes Wood which encompass the study area. Springs are a dominant feature in Bealey's Plantation and Lakes Wood which contribute to the crystal-clear waters flowing through the study area (<a href="#">Plate 24</a>).</p> <div style="display: flex; justify-content: space-around;">

</div> <p><b>Plate 24: Scarborough Beck.</b></p>

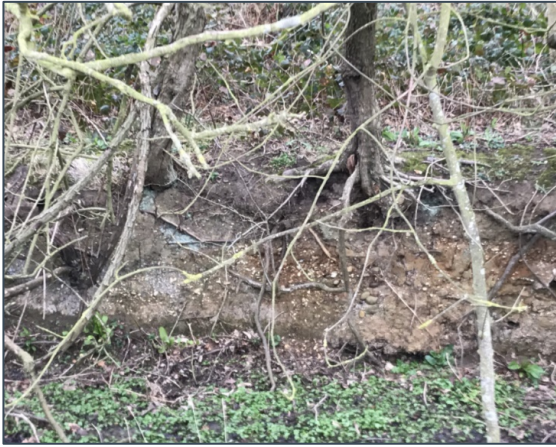
Parameter	Details
Channel Form	<p data-bbox="389 315 1391 591">The channel has a straight to moderately sinuous planform. The banks are relatively shallow, approximately 0.5 m to 1 m high, stable and well vegetated in places throughout the study area. The channel is approximately 5 m to 7 m wide at the bank top, and 3 m to 5 m wide at the bank base, displaying diversity in the channel width-depth ratio of the Scarborough Beck. The substrate is dominated by sands, gravels and organic matter with only localised deposits of silts noted at low flow velocity zones, such as the channel margins and in the lee of emergent aquatic vegetation. This was predominately associated with tree roots undercutting the banks, and local bank erosion during high flows (<a href="#">Plate 25</a>).</p>

<p data-bbox="389 1088 1067 1120"><b>Plate 25: Localised bank erosion on Scarborough Beck.</b></p> <p data-bbox="389 1128 1391 1263">The Scarborough Beck within the study area is influenced by a north-south running field drain, which is narrow and well vegetated in places, with steep, uniform banks and overall trapezoidal shape. The drain contained water at the time of the fluvial walkover, although does not appear to support regular flows (<a href="#">Plate 26</a>).</p>

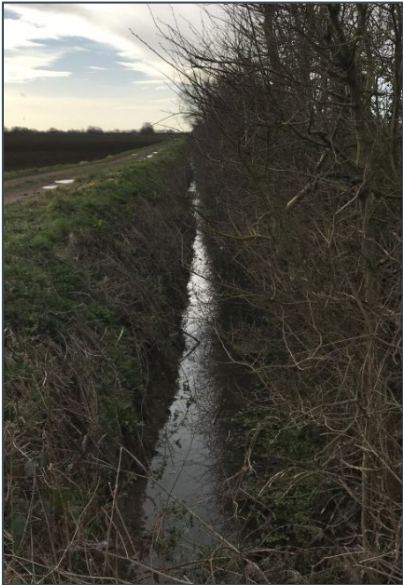
<p data-bbox="389 1906 1050 1937"><b>Plate 26: Field drain connected to Scarborough Beck.</b></p>

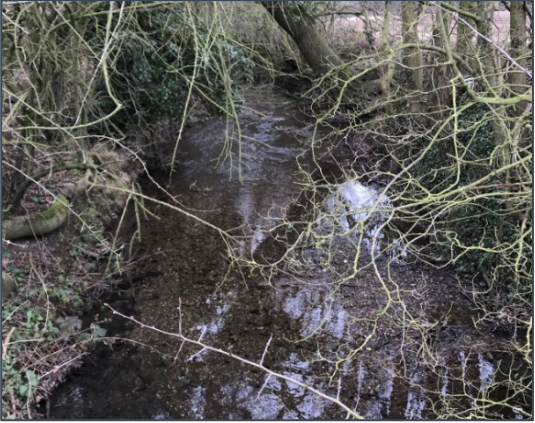
Parameter	Details
Substrate Conditions	As stated above, the substrate is dominated by sands, gravels and organic matter. The clear water reflects the spring fed Scarborough Beck within the study area and the low sediment yield from the surrounding catchment.
Flow Conditions	Flows are dominated by low energy glides and riffles, providing good flow diversity along the Scarborough Beck within the study area ( <a href="#">Plate 27</a> ).

**Plate 27: Evidence of flow diversity within Scarborough Beck.**
