Little Crow

Little Crow Solar Park, Scunthorpe

PHASE 1 GROUND CONDITIONS DESK STUDY

Intégrale Report No. 1844, Version 9, November 2020, Submission

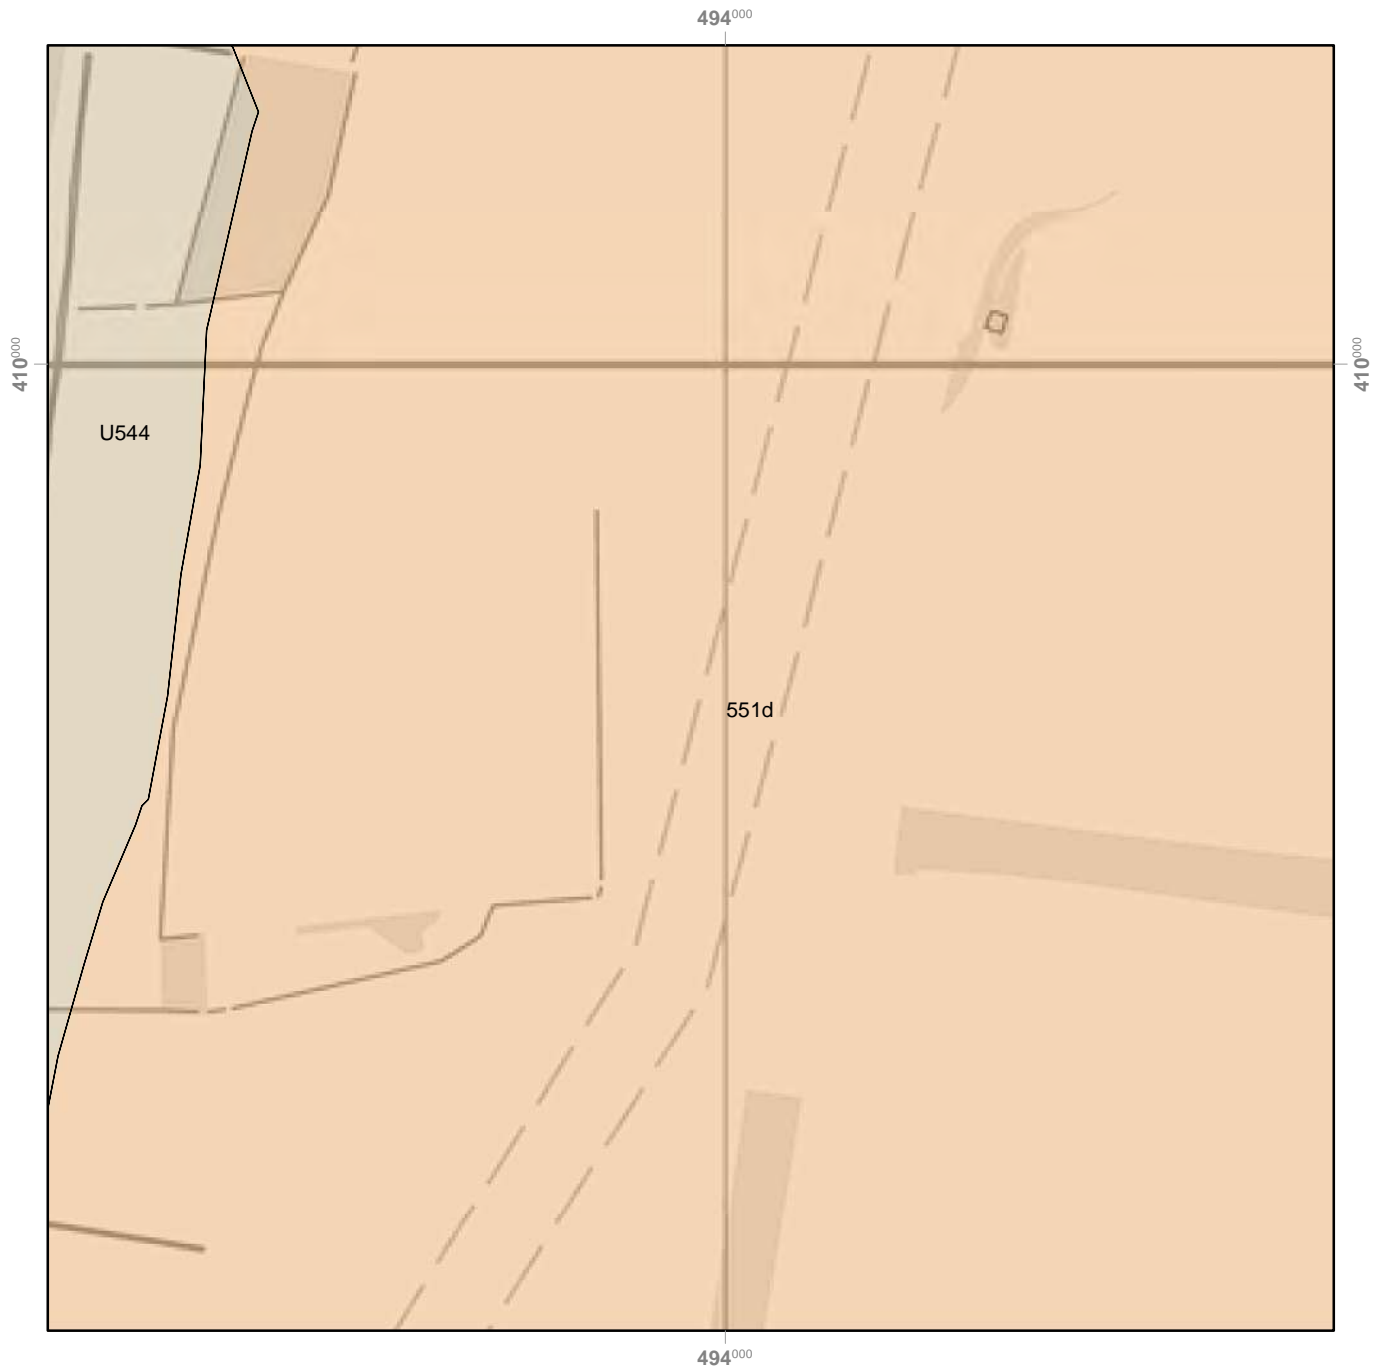
1a Soils - Spatial Distribution

Soil associations represent a group of soil series (soil types) which are typically found occurring together, associated in the landscape (Avery, 1973; 1980; Clayden and Hollis, 1984). Soil associations may occur in many geographical locations around the country where the environmental conditions are comparable. For each of these soil associations, a collection of soil types (or soil series) are recorded together with their approximate proportions within the association. Soil associations have codes as well as textual names, thus code '554a' refers to the 'Frilford' association. Where a code is prefixed with 'U', the area is predominantly urbanised (e.g. 'U571v'). The soil associations for your location, as mapped above, are described in more detail in Section 2: Soil Association Descriptions.

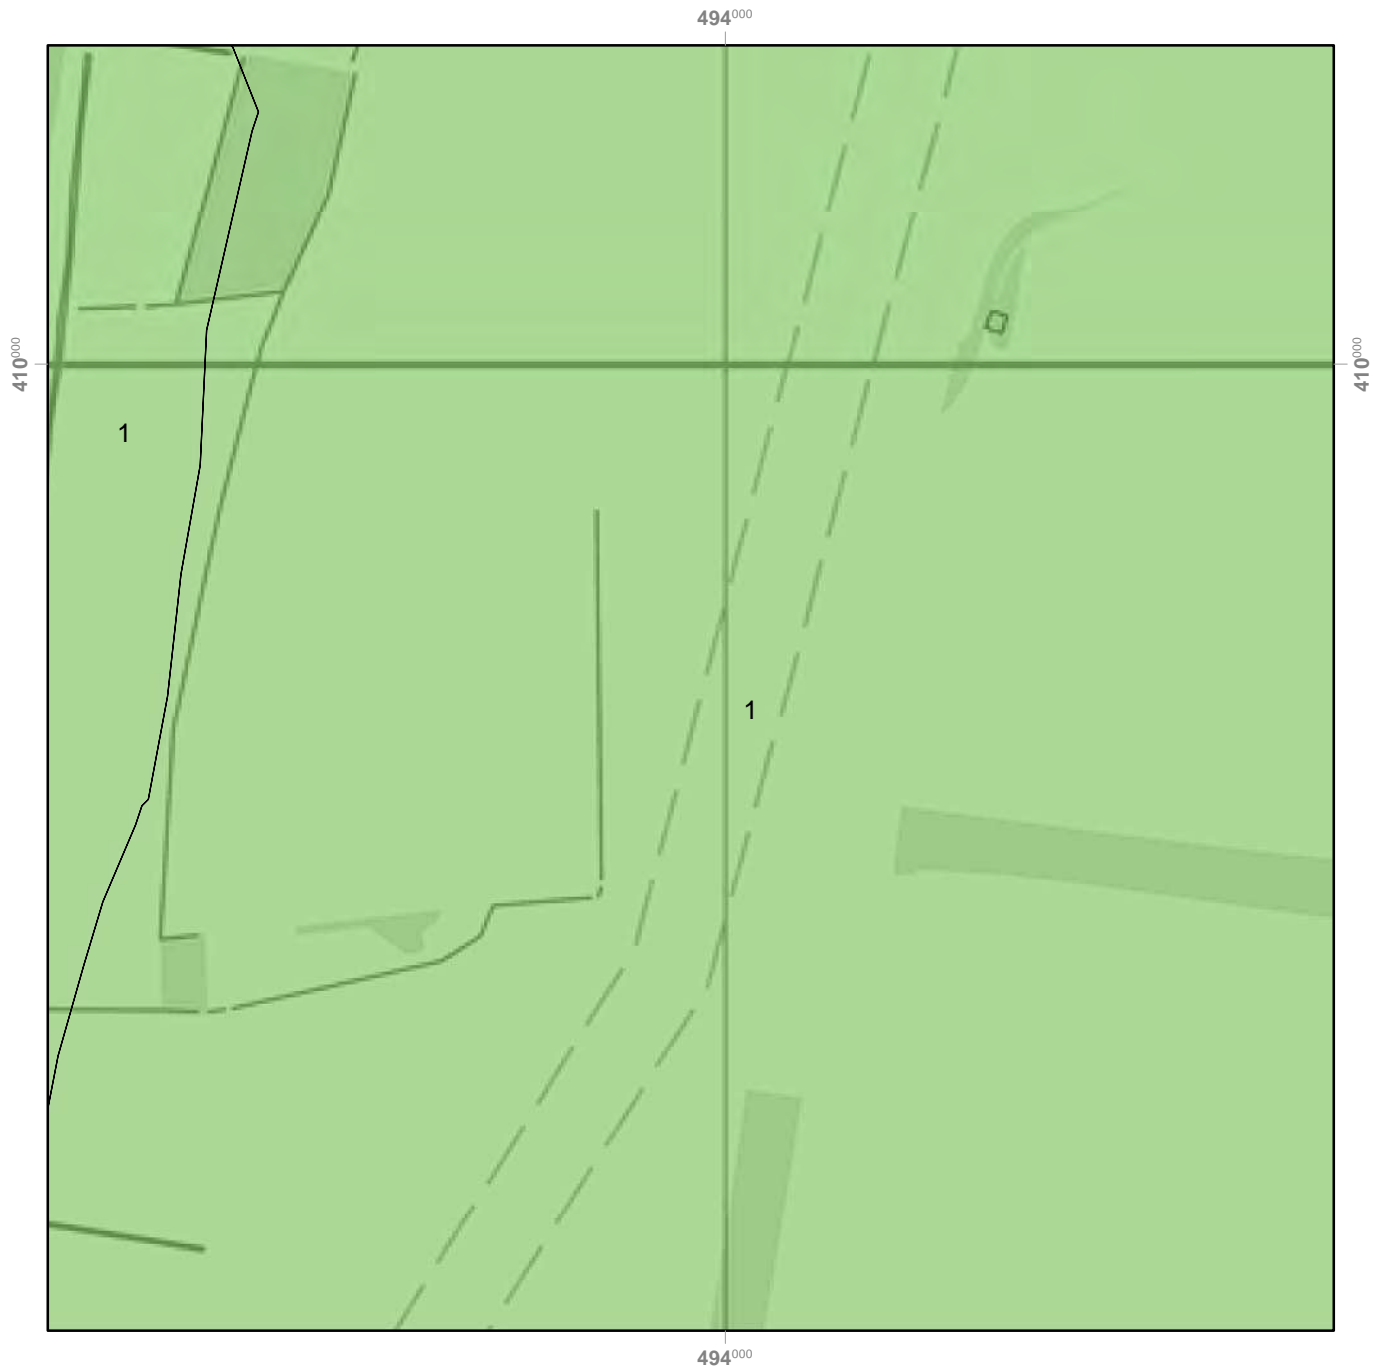
1e Risk of Corrosion to Ferrous Iron

Buried iron pipes and other infrastructure corrode at rates that are influenced by soil conditions (Jarvis and Hedges, 1994). Soil acidity, sulphide content, aeration and wetness all influence the corrosivity of the soil. These factors are used to map 5 major classes of relative corrosivity.

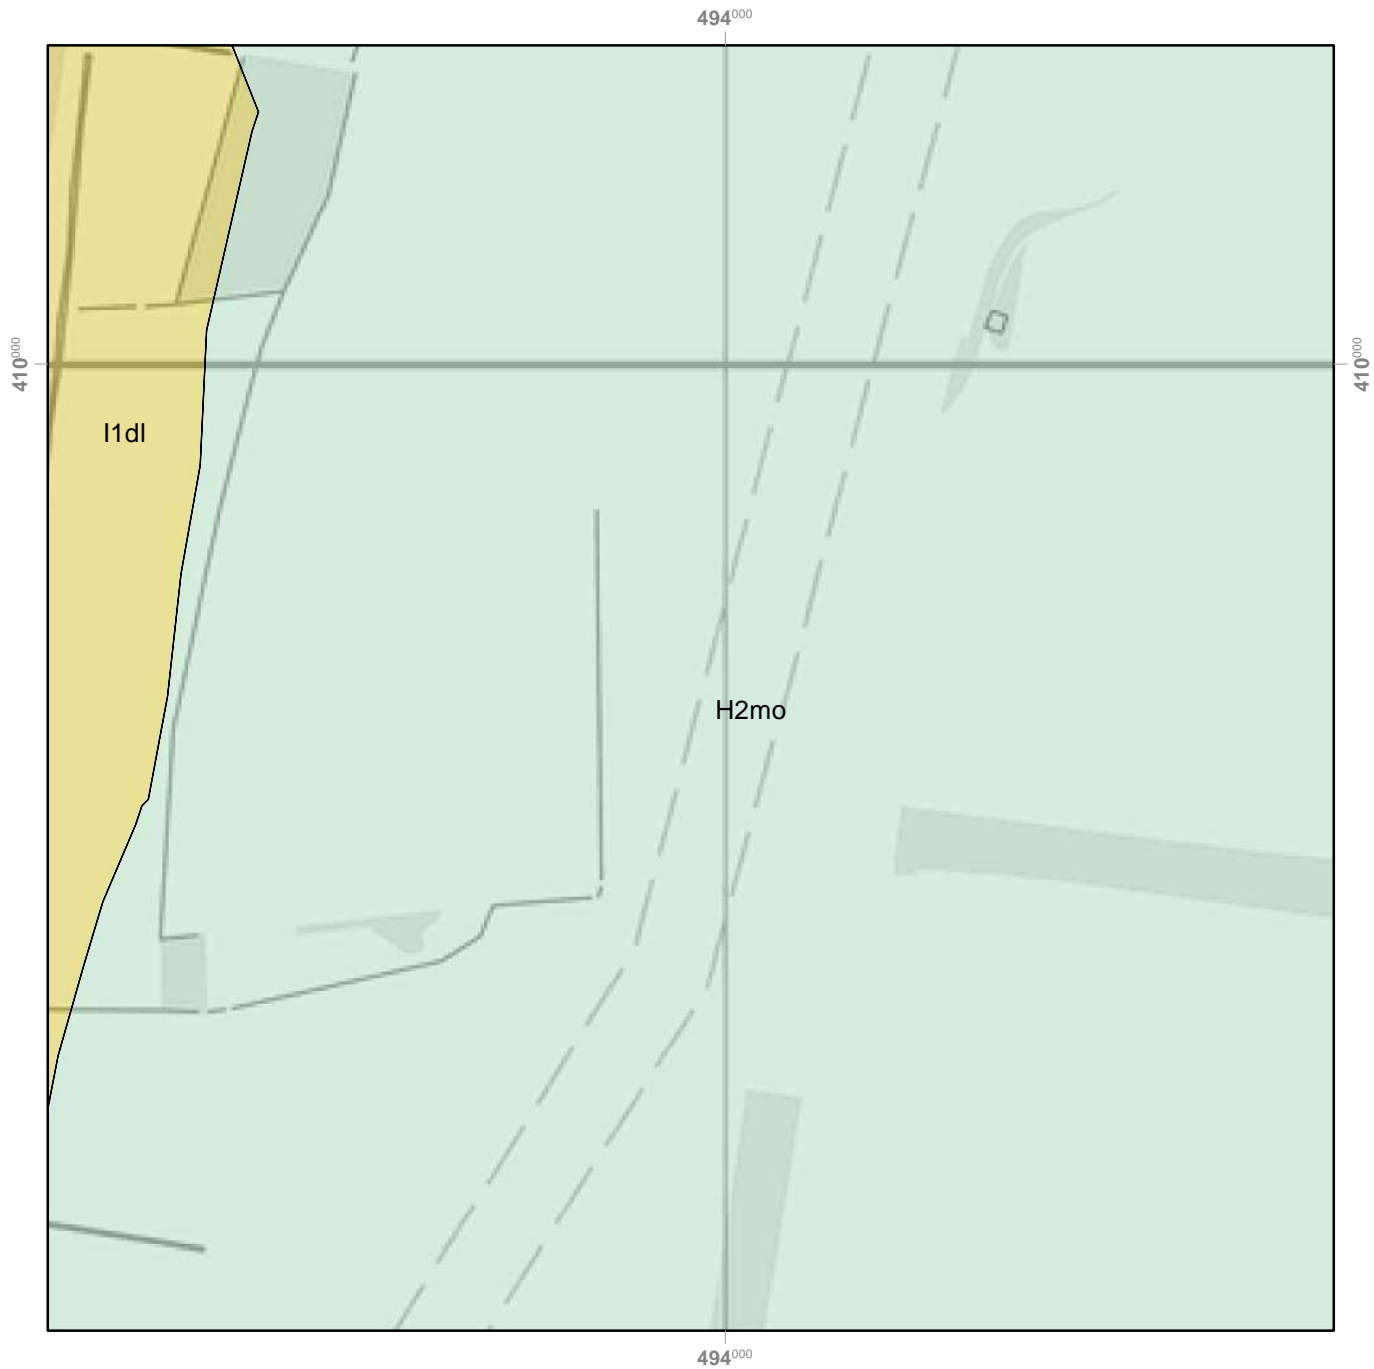
1f Pesticide Leaching Risk

The primary classes have been further subdivided into nearly forty subclasses. These subclasses, with their descriptions, are mapped above. These classes do not account for differences in land cultivation, which can also have a significant impact on pesticide behaviour.

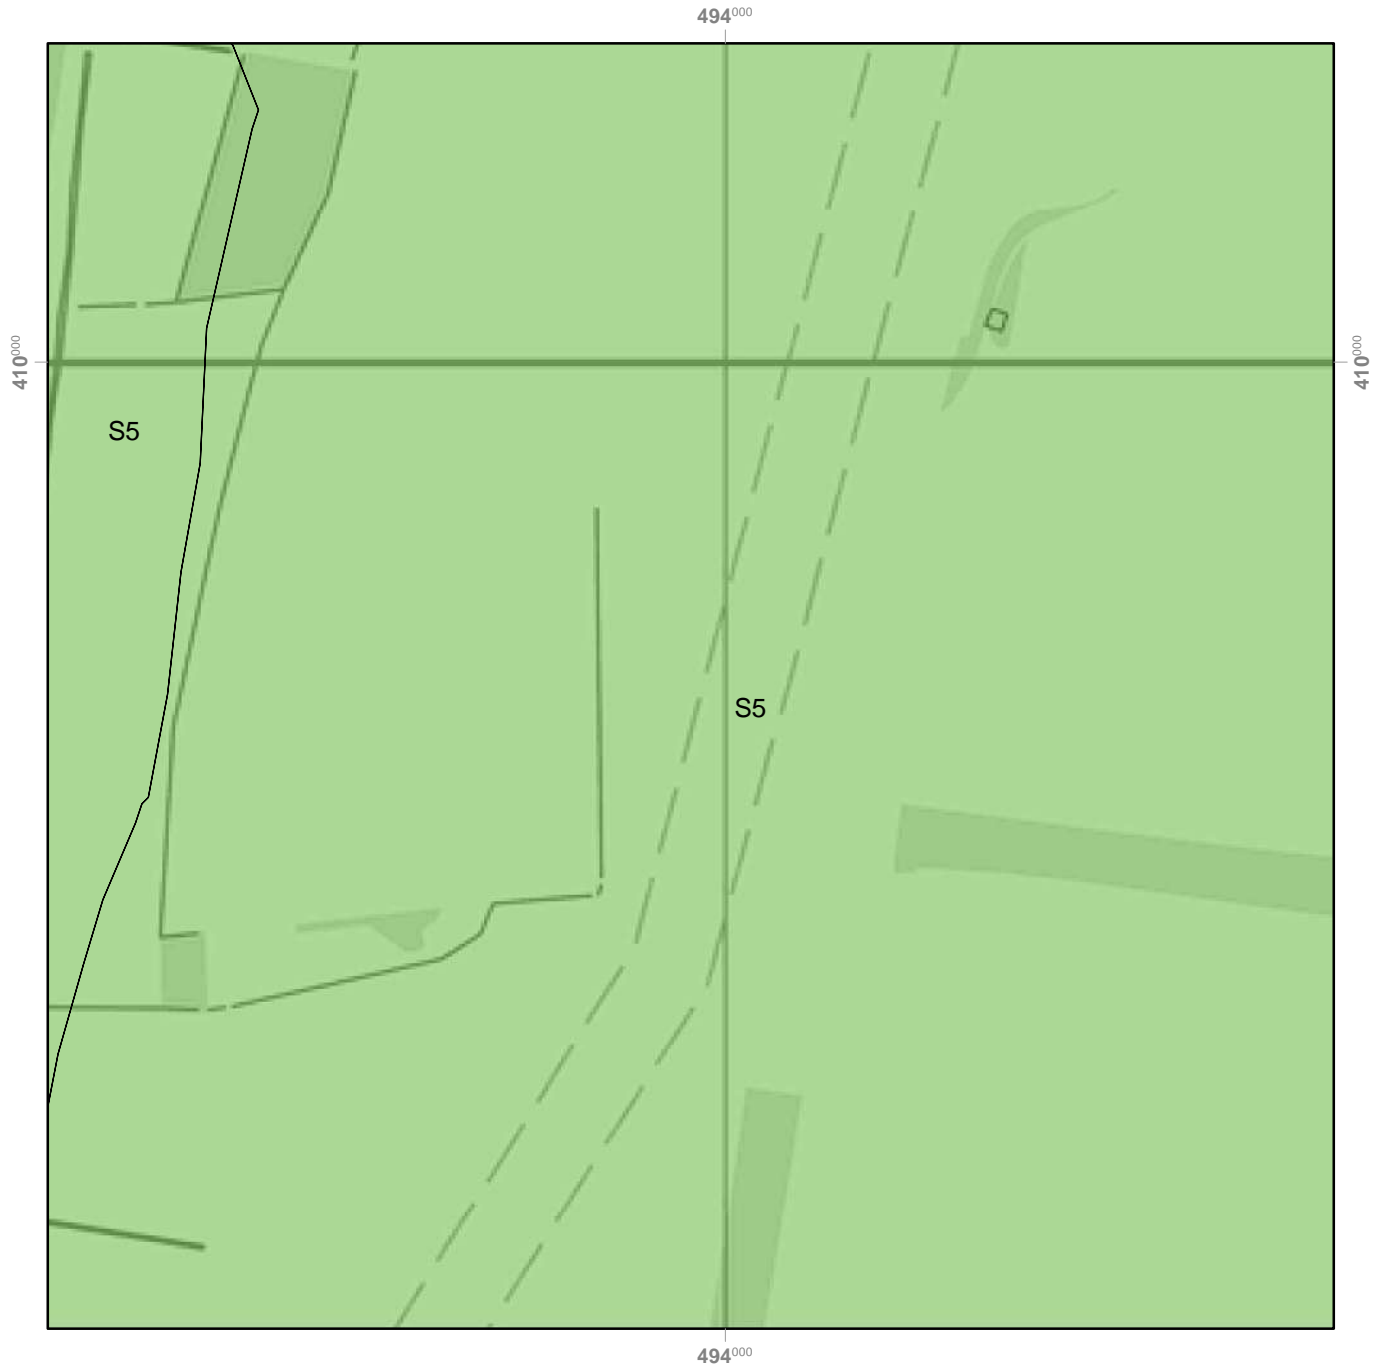
1g Pesticide Runoff Risk

The physical properties and natural water regime of soils influence the speed and extent of lateral water movement over and through the soil at different depths (Hollis et al, 1995). As a result, soils can be classed according to the potential for pesticide run-off. Five runoff potential classes are identified for mineral soils and a further two for peat soils.

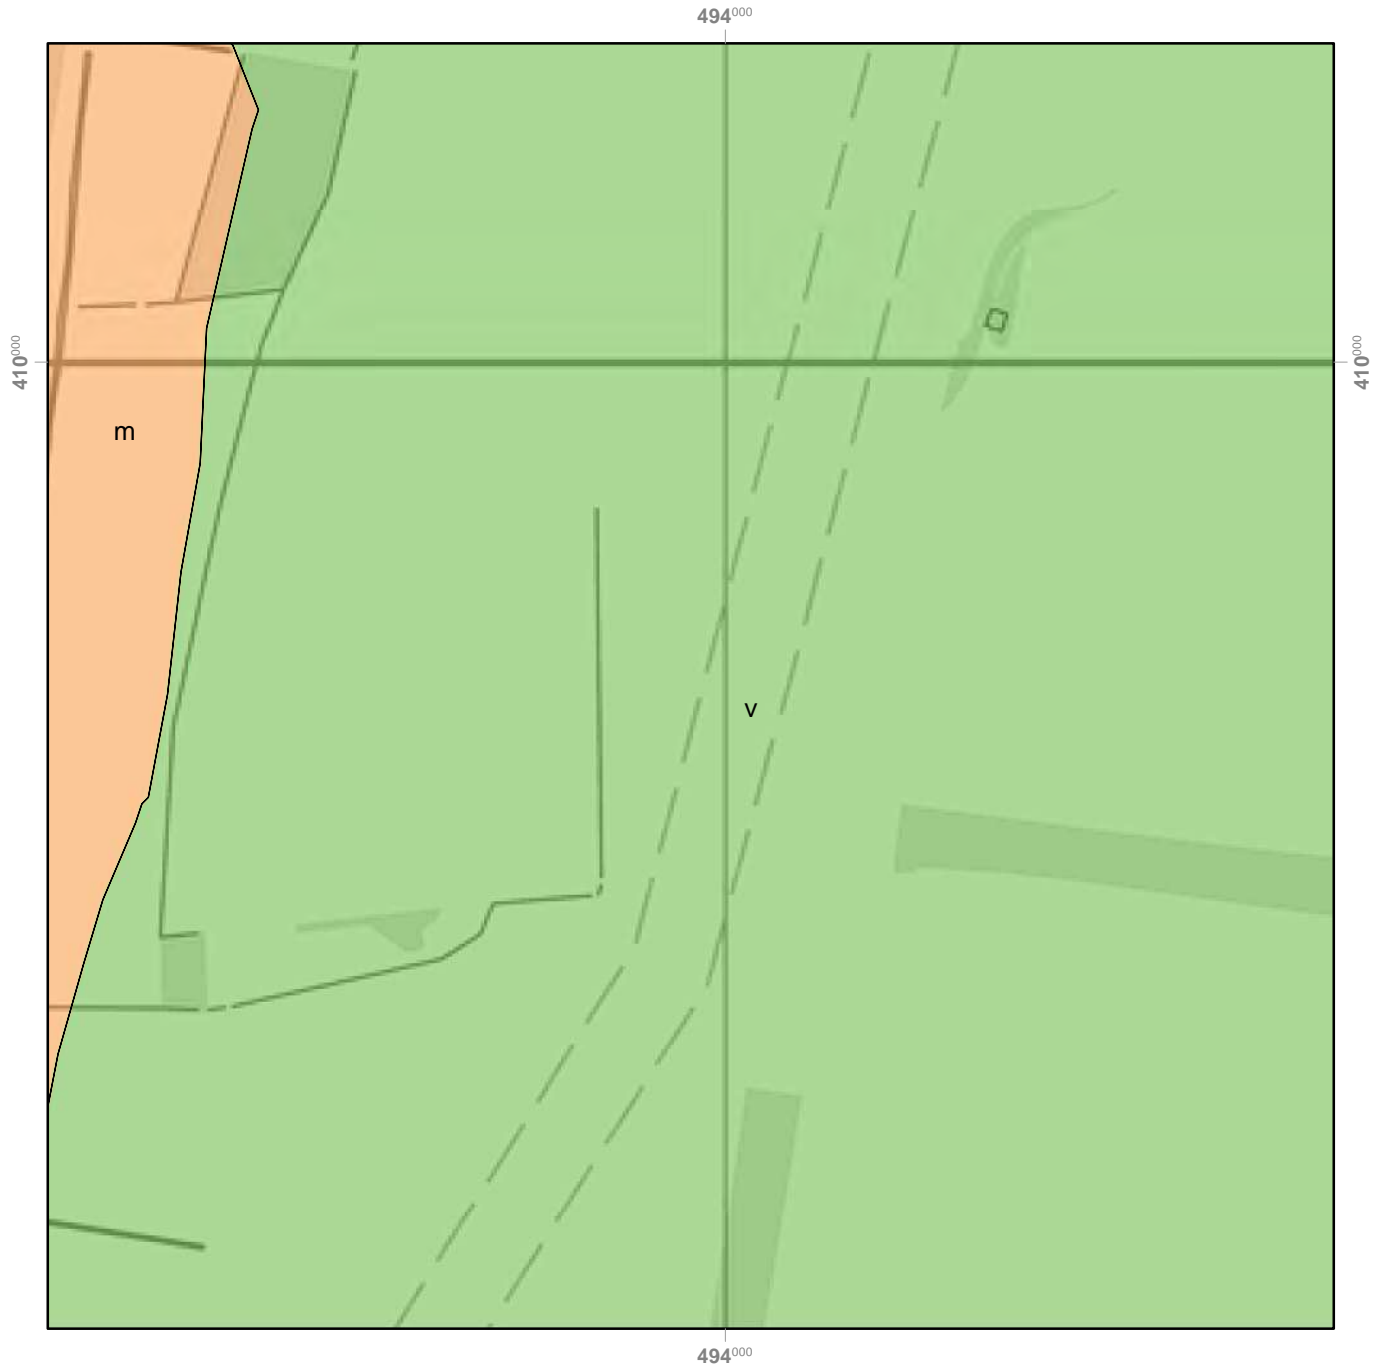
1h Potential for Pesticide Adsorption

The physical properties and natural water regime of soils influence the speed and extent of lateral water movement over and through the soil at different depths (Hollis et al, 1995). The mineral soil classes are further subdivided according to their potential for pesticide adsorption.

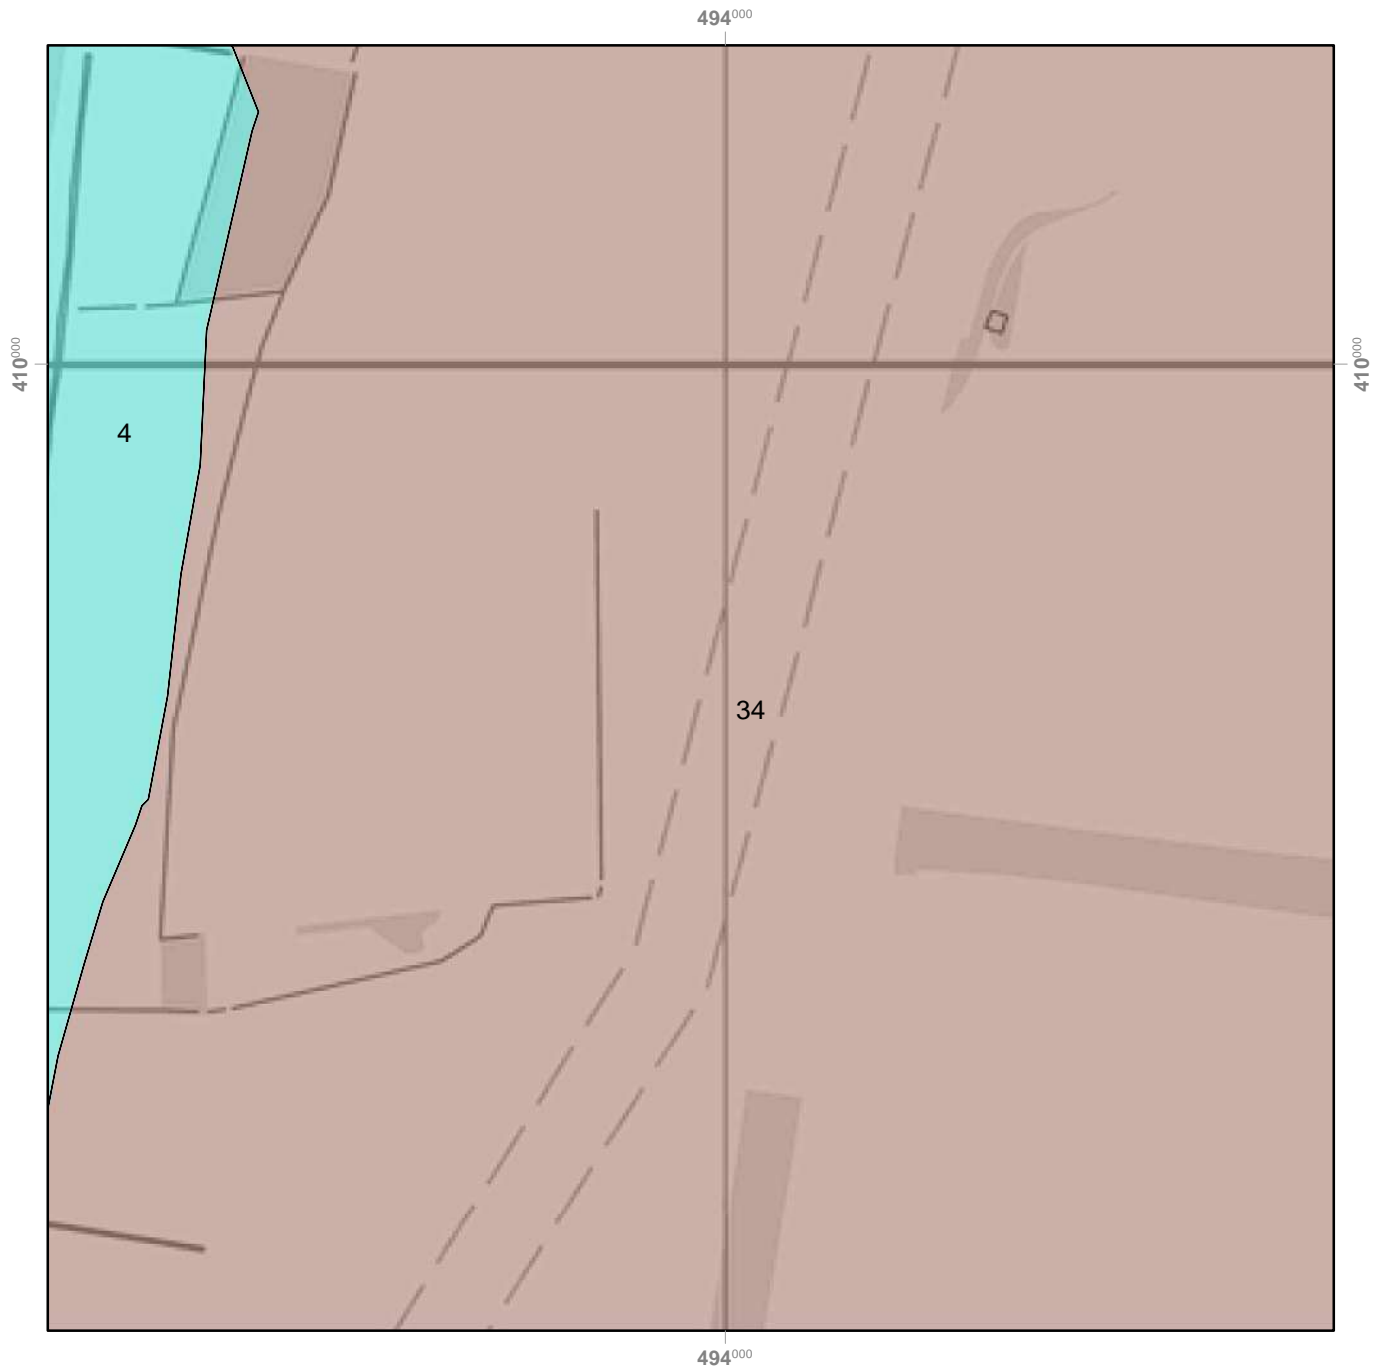
1i Hydrogeological Rock Type

The hydrogeological classification of the soil parent materials provides a framework for distinguishing between soil substrates according to their general permeability and whether they are likely to overlie an aquifer. Every soil series has been assigned one of the 32 substrate classes and each of these is characterised according to its permeability (being characterised as permeable, slowly permeable or impermeable). For further information, see Boorman et al (1995).

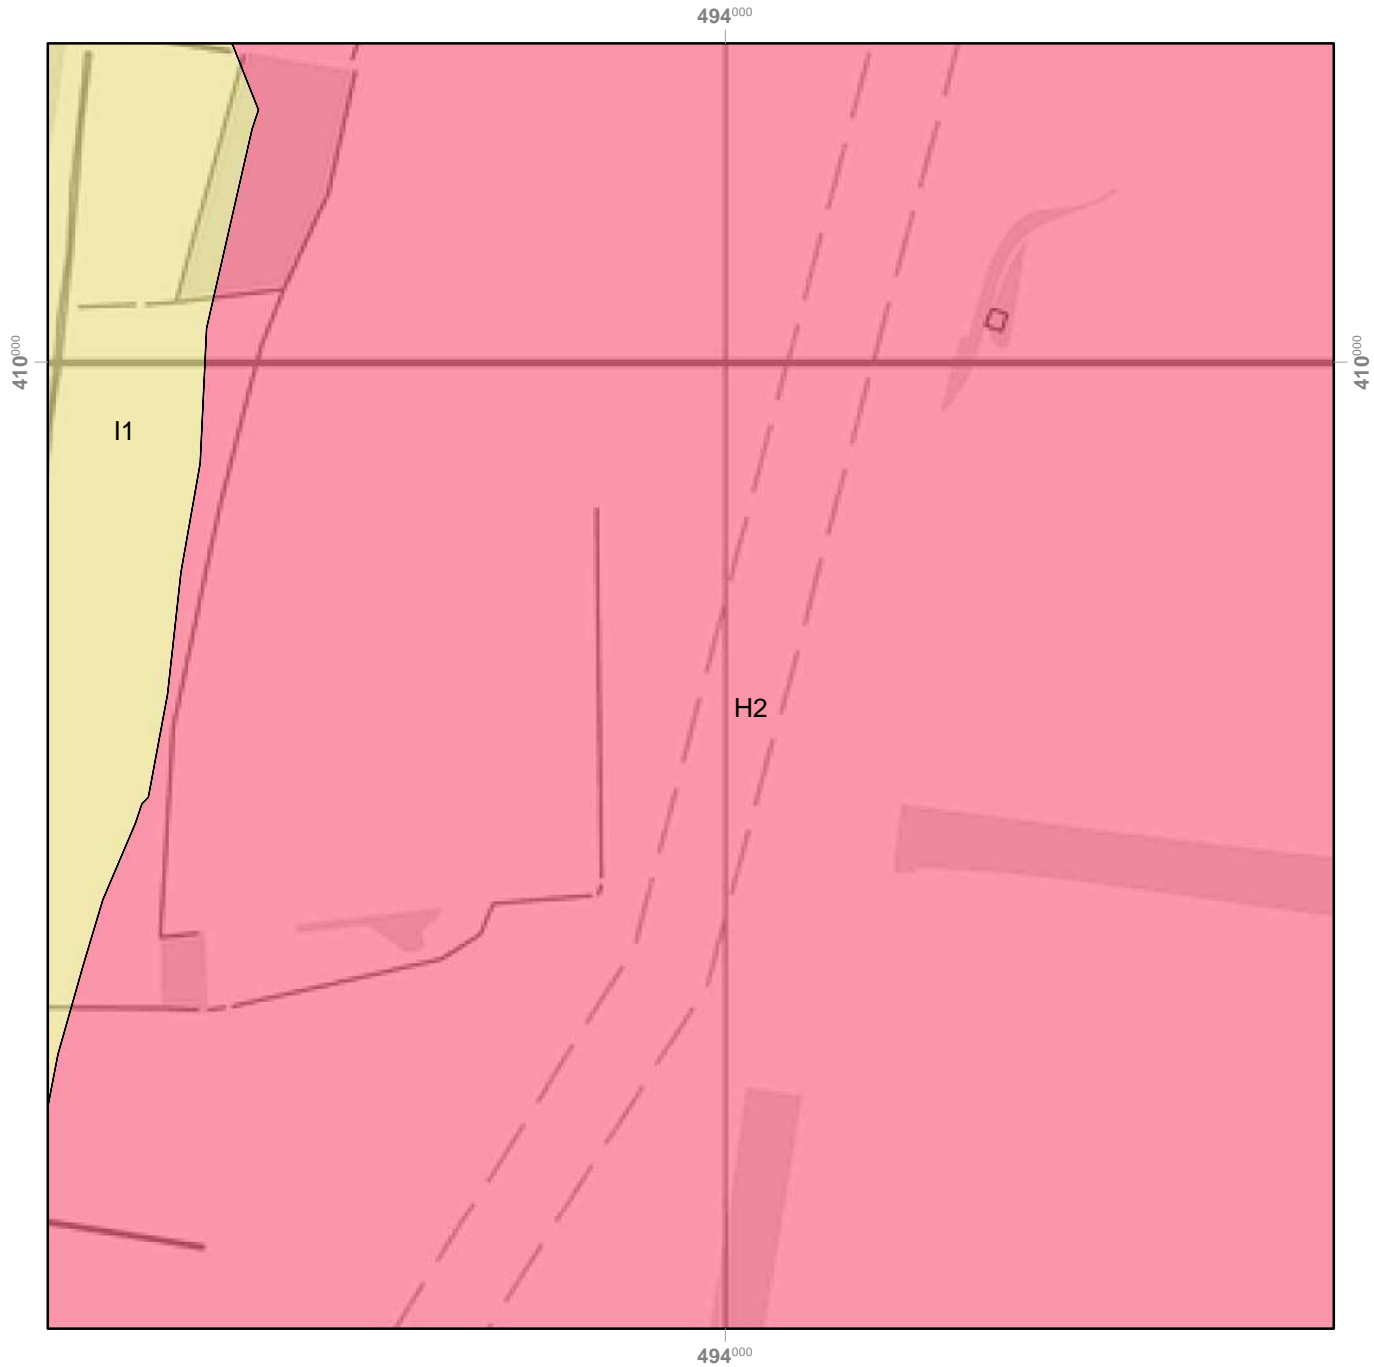
1j Ground Water Protection Policy (GWPP)

The Ground Water Protection Policy classes describe the leaching potential of pollutants through the soil (Hollis, 1991; Palmer et al, 1995). The likelihood of pollutants reaching ground water is described. Different classes of pollutants are described, including liquid discharges adsorbed and non-adsorbed pollutants.

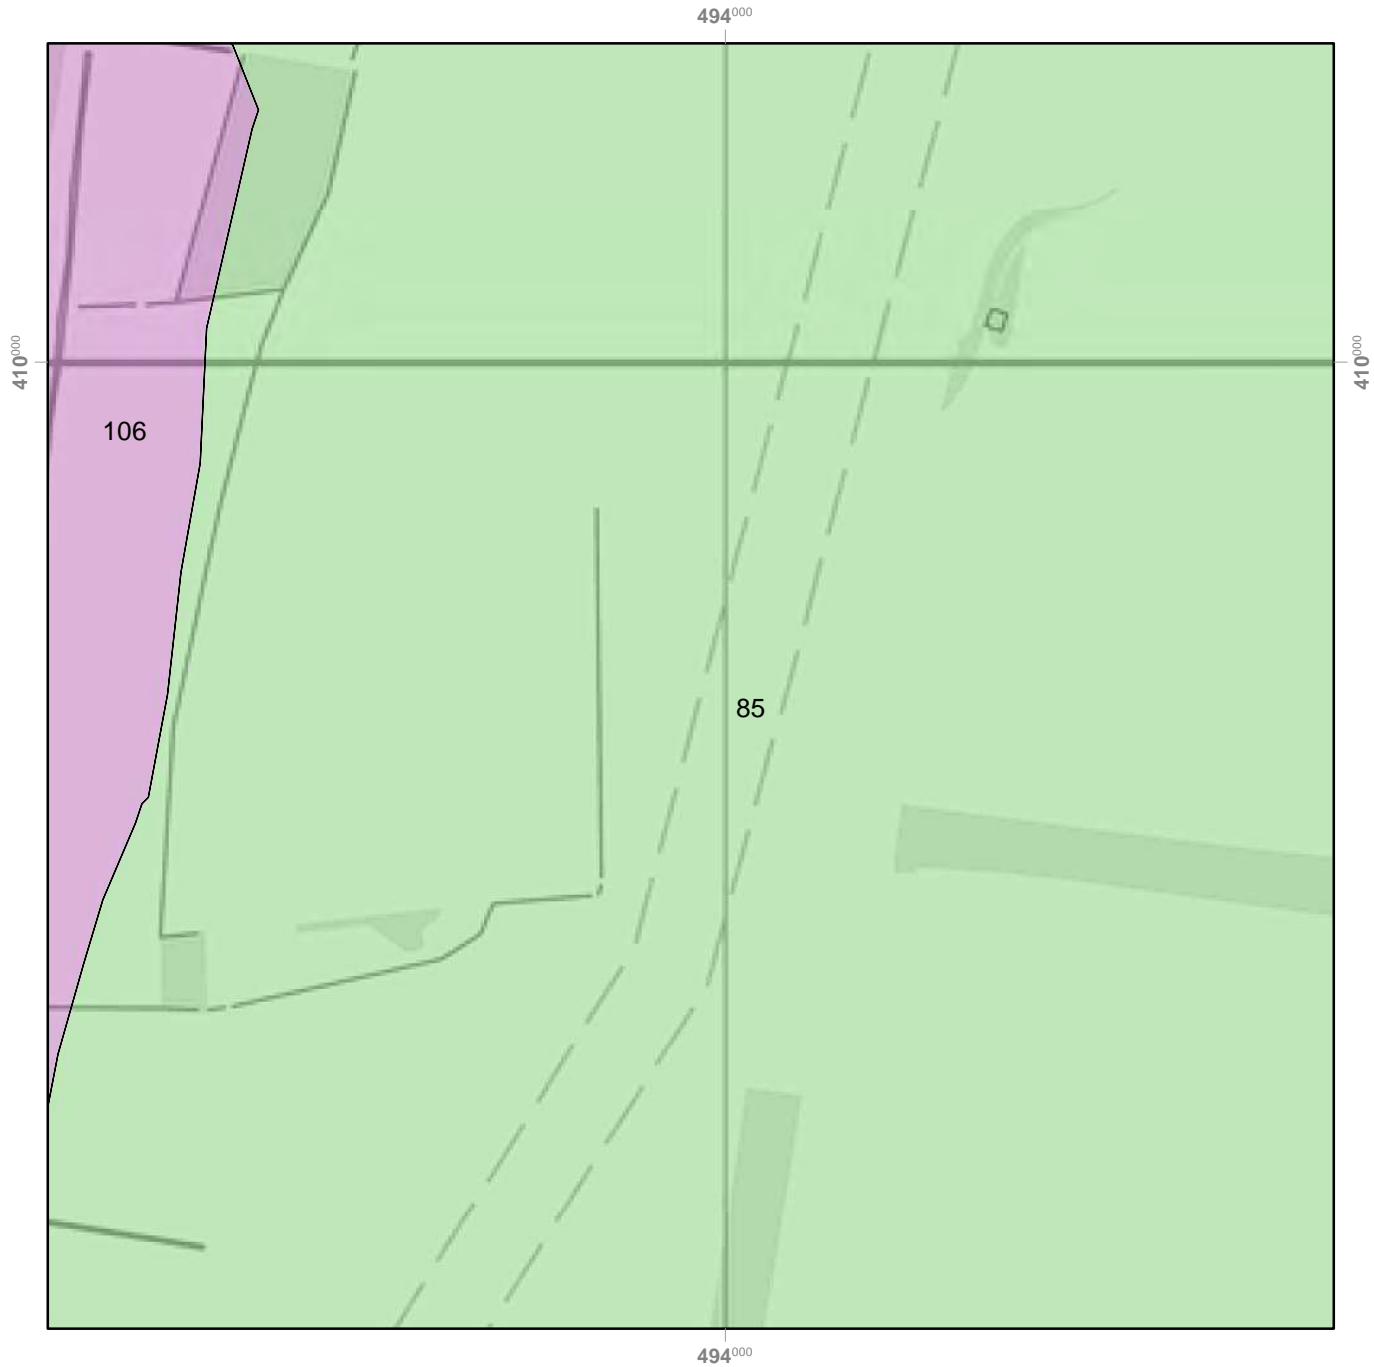
1k Soil Parent Material

Along with the effects of climate, relief, organisms and time, the underlying geology or 'parent material' has a very strong influence on the development of the soils of England and Wales. Through weathering, rocks contribute inorganic mineral grains to the soils and thus exhibit control on the soil texture. During the course of the creation of the national soil map, soil surveyors noted the parent material underlying each soil in England and Wales. It is these general descriptions of the regional geology which is provided in this map.

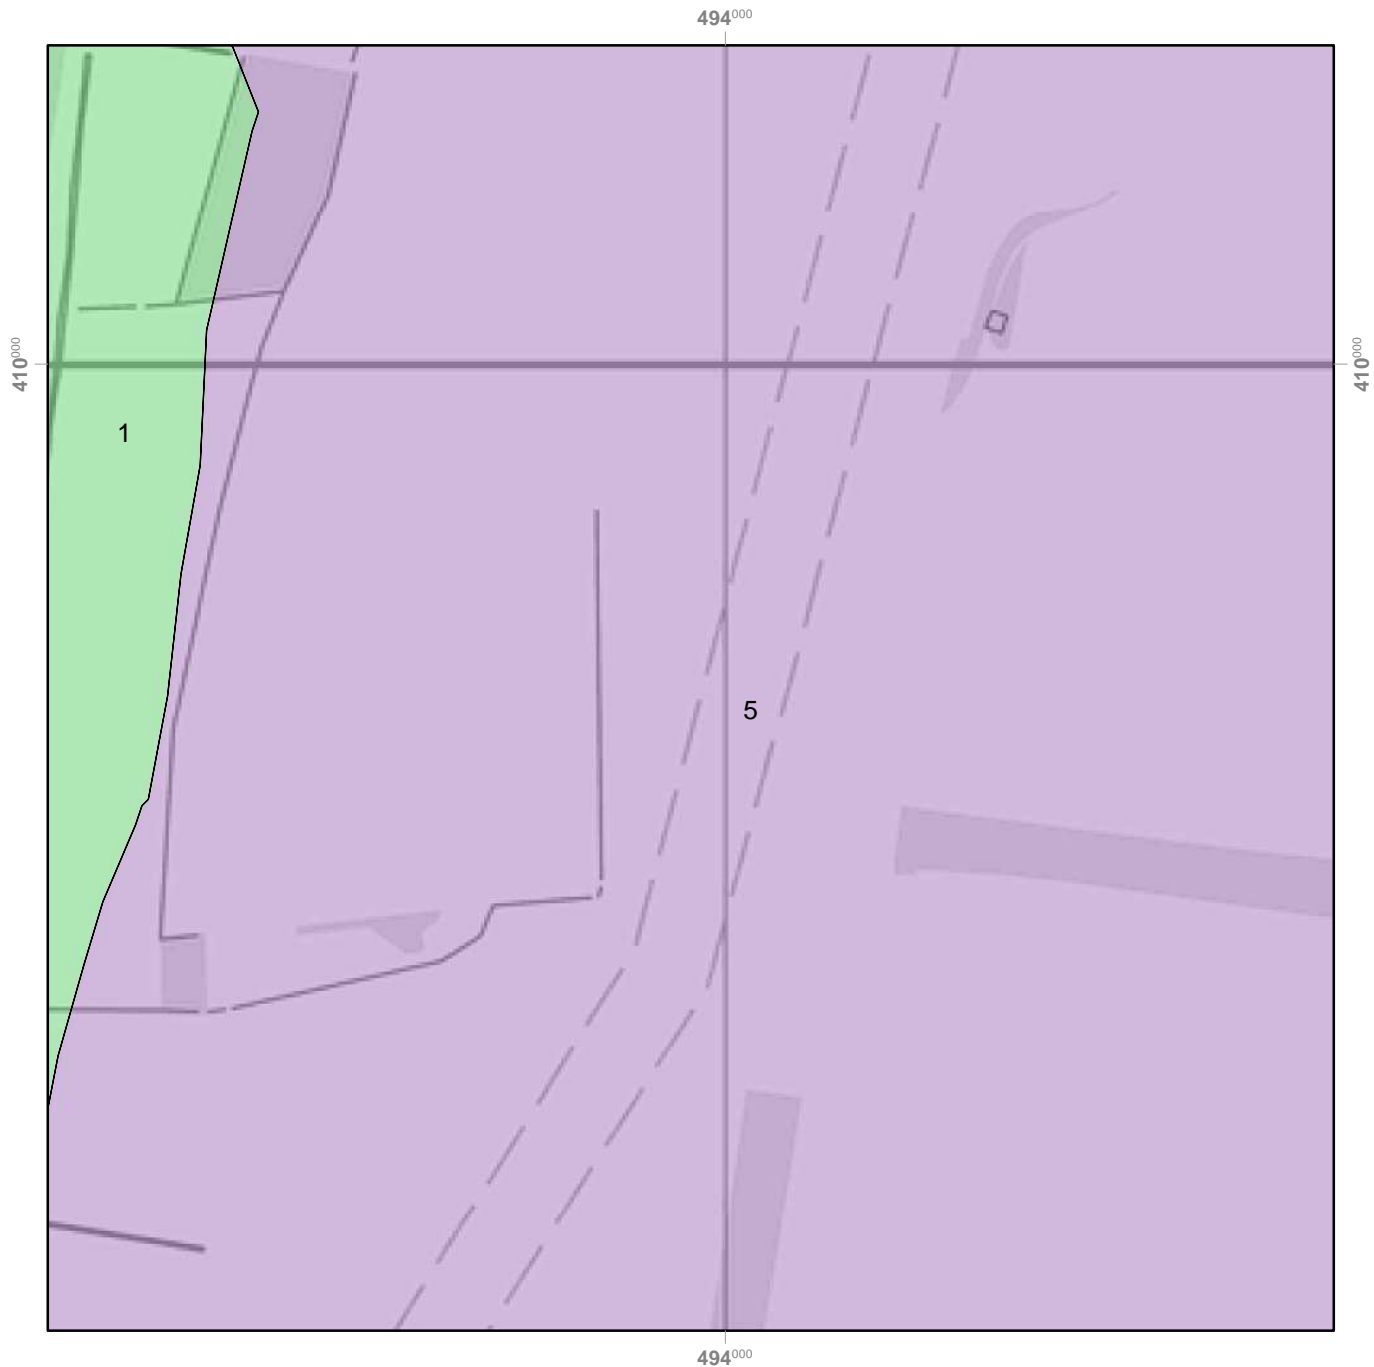
1m Natural Soil Fertility

Soil fertility can be greatly altered by land management especially through the application of manures, lime and mineral fertilisers. What is shown in this map, however, is the likely natural fertility of each soil type. Soils that are very acid have low numbers of soil-living organisms and support heathland and acid woodland habitats. These are shown as of very low natural fertility. Soils identified as of low natural fertility are usually acid in reaction and are associated with a wide range of habitat types. The moderate class contains neutral to slightly acid soils, again with a wide range of potential habitats. Soil of high natural fertility are both naturally productive and able to support the base-rich pastures and woodlands that are now rarely encountered. Lime-rich soils contain chalk and limestone in excess, and are associated with downland, herb-rich pastures and chalk and limestone woodlands.

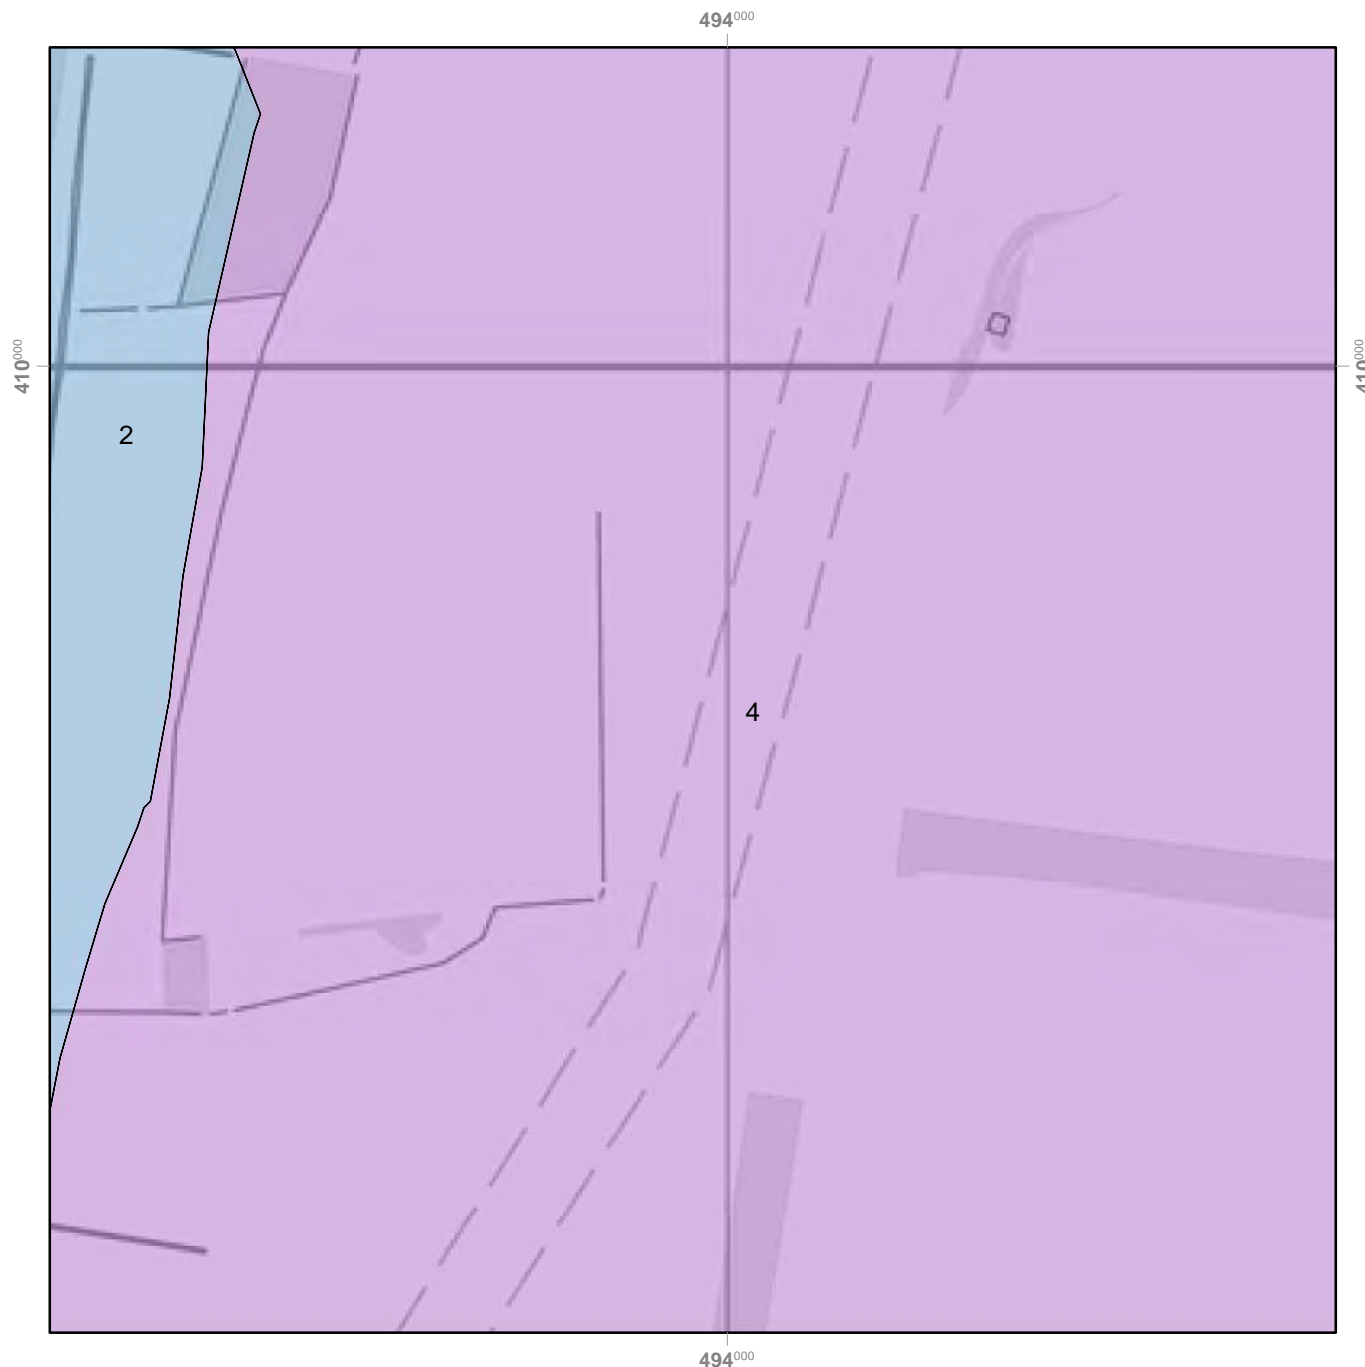
1n Simple Topsoil Texture

Soil texture is a term used in soil science to describe the physical composition of the soil in terms of the size of mineral particles in the soil. Specifically, we are concerned with the relative proportions of sand, silt and clay. Soil texture can vary between each soil layer or horizon as one moves down the profile. This map indicates the soil texture group of the upper 30 cm of the soil. `Light? soils have more sand grains and are described as sandy, while `heavy? soils have few sand grains but a lot of extremely small particles and are described as clayey. Loamy soils have a mix of sand, silt and clay-sized particles and are intermediate in character. Soils with a surface layer that is dominantly organic are described as Peaty. A good understanding of soil texture can enable better land management.

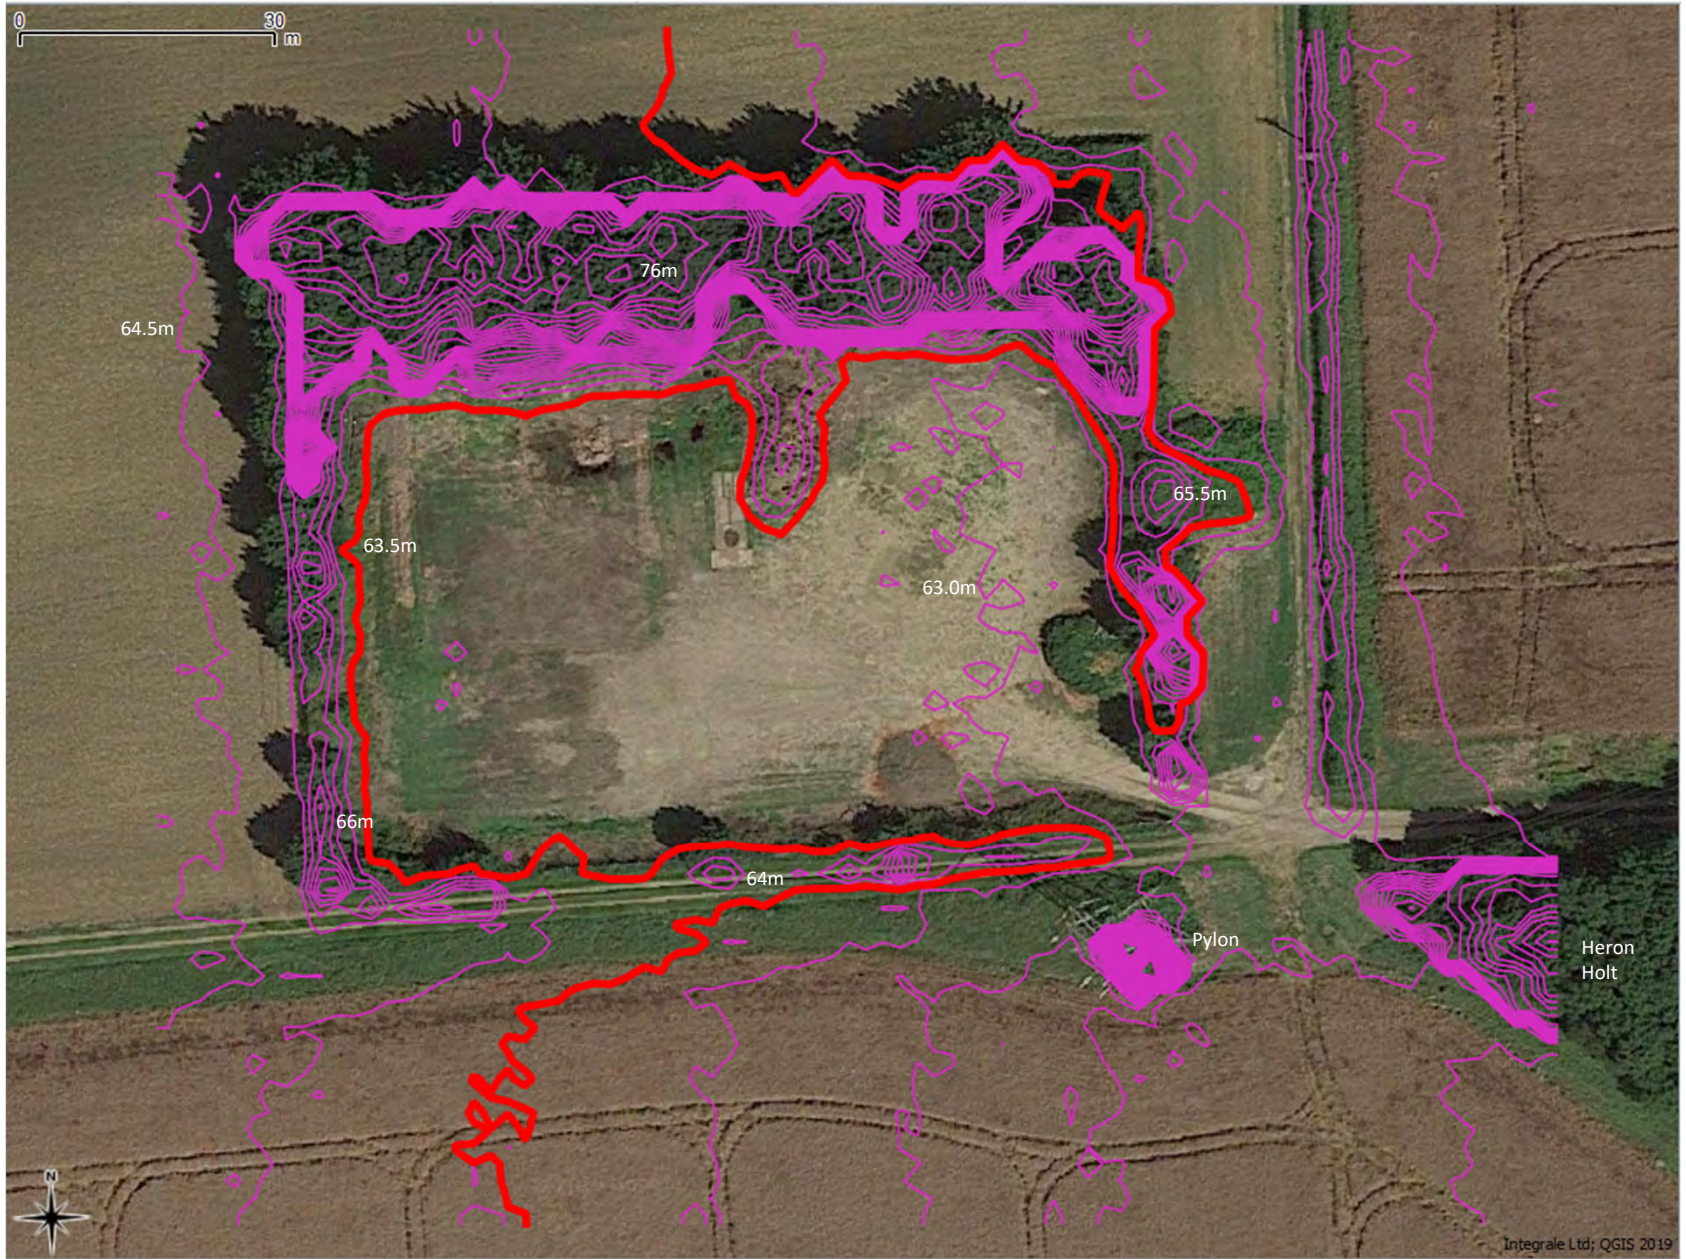
Little Crow
Off-Site Oil Well
Contours

North-South Profile
across Oil Well site

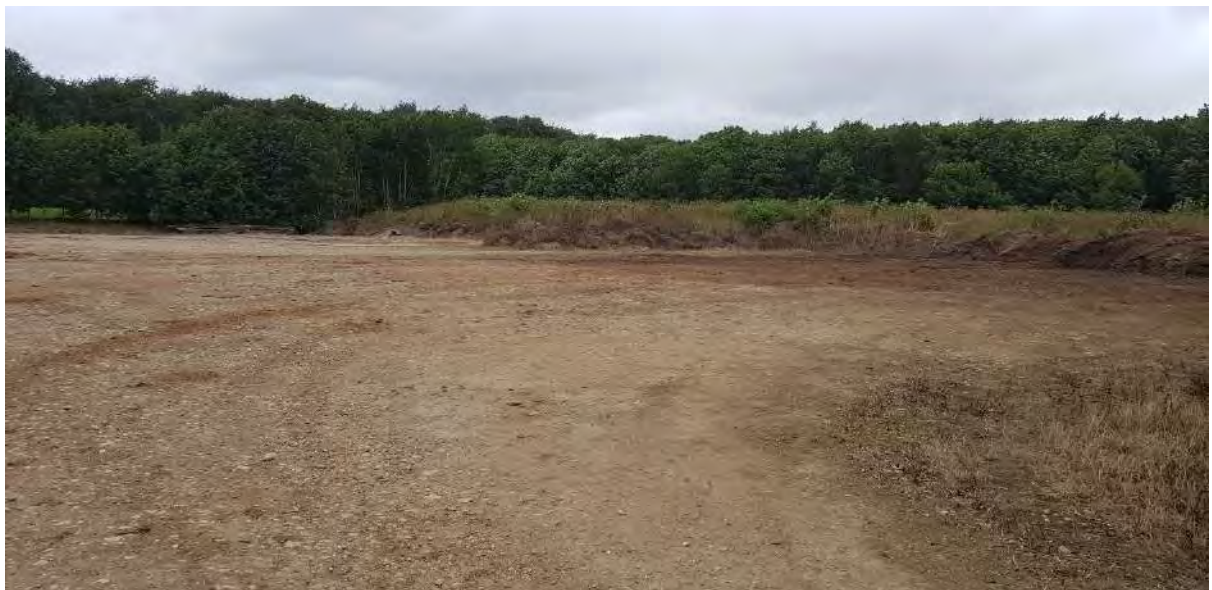
Former Oil Well compound entrance and general view
